LKK Auto Consultants Pte Ltd

Affiliated to Federation Internationale Des Experts En Automobile				
CHINA TAIPING INSURANCE (S) PTE LTD 3 ANSON ROAD #16-00 SPRINGLEAF TOWERSINGAPORE 079909			Ref: CC3/CTI20007443/T1es3q2	
			Date: 18/01/2021	
			Code: CTI

ADJUSTMENT ON REPAIR COST FOR VEHICLE NO. SHA 2834Y

PHOTOGRAPHS FOR VEHICLE NO. SHA 2834Y

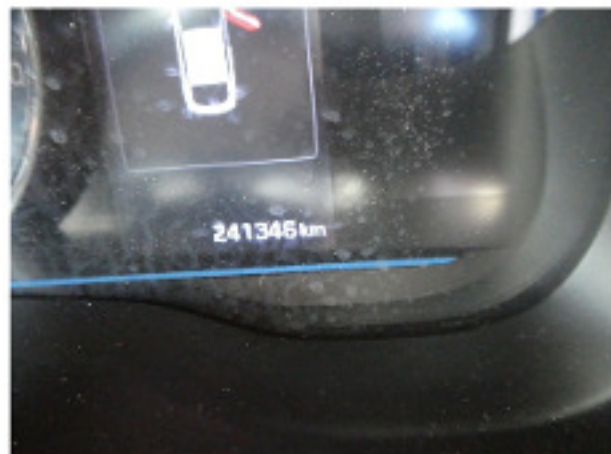
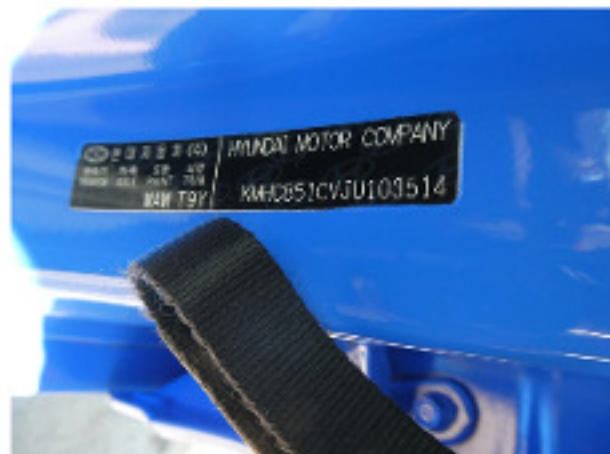
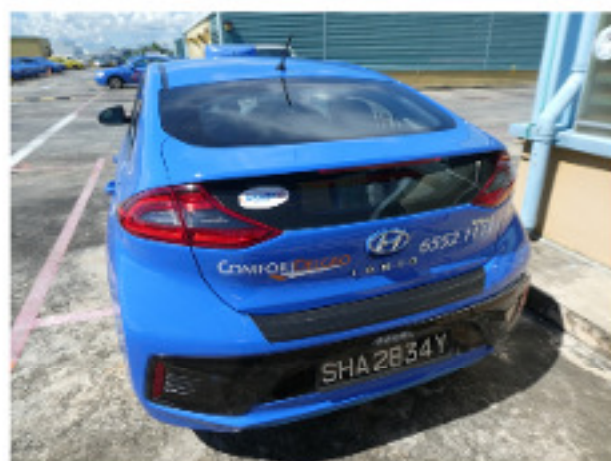
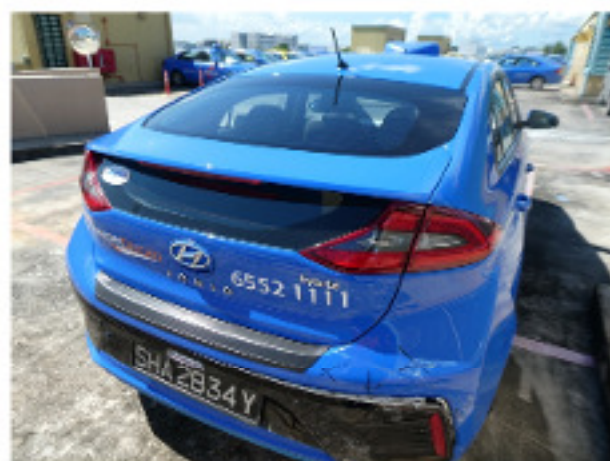
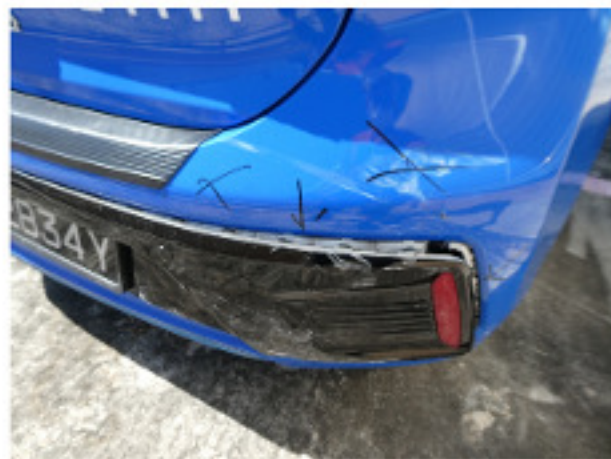
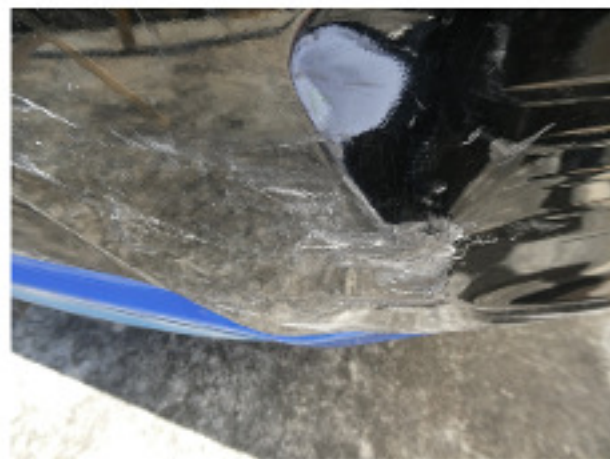
4. Description of Damages				
THE VEHICLE SUSTAINED DAMAGES AT THE REAR O/S PORTION. DAMAGES SEE DETAILS.				
5. General Information				
Accident Date	16/07/2020	Inspection Date	17/07/2020	
Survey held at	COMFORTDELGRO ENGINEERING PTE LTD 59 LOYANG DRIVE SINGAPORE 508969			
5a. Remarks				
A)THE INSPECTION WAS CONDUCTED ON A"WITHOUT PREJUDICE" BASIS. B)IN ACCORDANCE TO YOUR INSTRUCTIONS, WE HAVE NOT AUTHORISED REPAIRS.				
5b. Estimate Days of Repair				
ESTIMATED NORMAL PERIOD FOR REPAIR:			2 Working Days
