Your Ref: Mercedes Benz B180  
(chassis number WDD2470842J002736)  
Our Ref : CI/TP20007453/D

20 July 2020

**INSPECTION REPORT OF AN UNREGISTERD MERCEDES BENZ B180  
MOTOR CAR WITH CHASSIS NUMBER WDD2470842J002736**

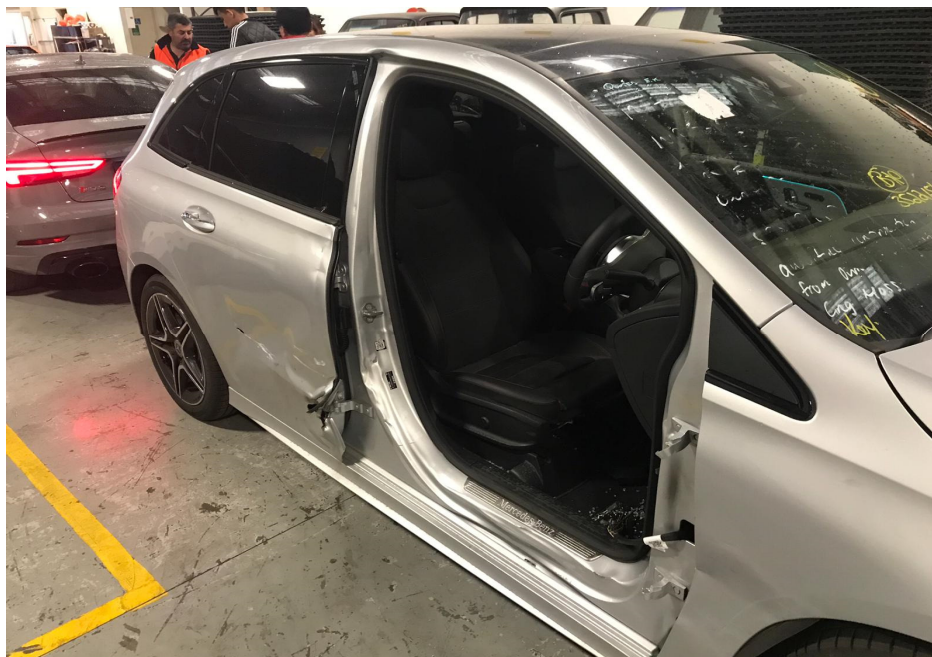
3. From the photographs provided to me, it was observed that the Motor Car had sustained damages along its right side. Body parts observed to have been damaged and/or dislodged include its front bumper, front right fender, front right door, rear right door, right side rocker panel, right side "A" pillar, right side "B" pillar and front right door hinges amongst others. See photo 1 – 3 below.

**Photo 1** shows the right side of the Motor Car prior to any repairs being carried out (photograph provided to me). The Motor Car was observed to have sustained damages along its right side. The body parts observed to be damaged and/or dislodged had included its front right fender, front right door, rear right door, right side "B" pillar, right side rocker panel and front right door hinges amongst others.

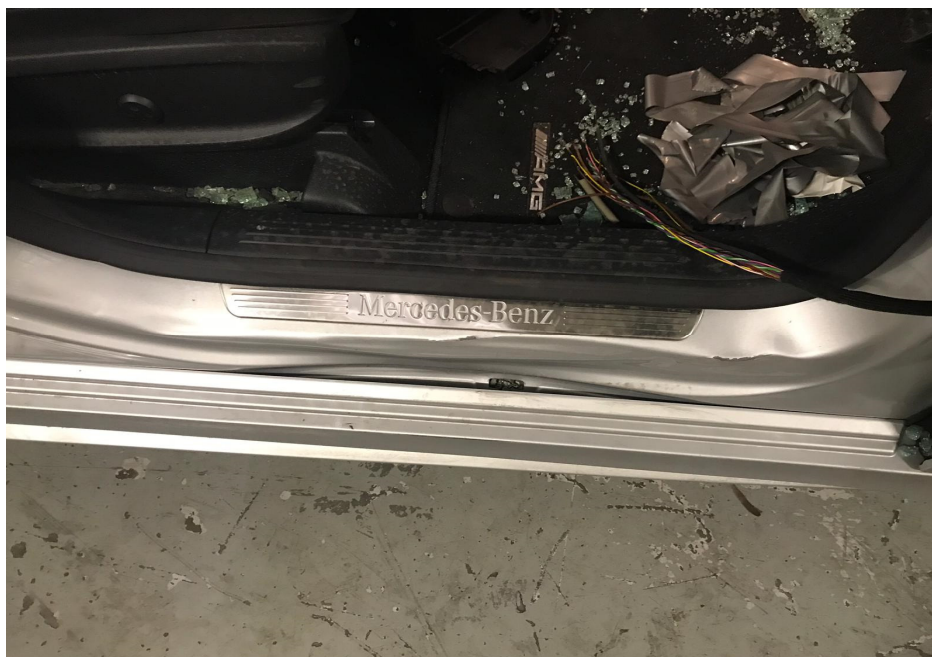
**Photo 2** shows the right side rocker panel of the Motor Car prior to any repairs being carried out (photograph provided to me). The Motor Car was observed to have sustained damages along its right side. Amongst the body parts damaged was the right side rocker panel.

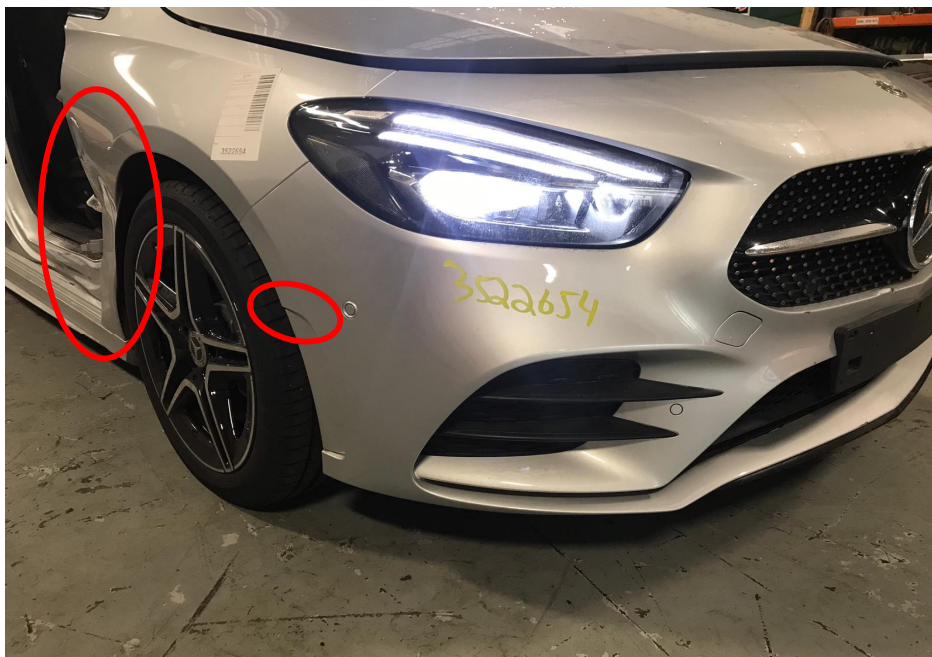
**Photo 3** shows the front right body of the Motor Car prior to any repairs being carried out (photograph provided to me). The front bumper and front right fender (circled) were amongst the body parts that were observed to be damaged.

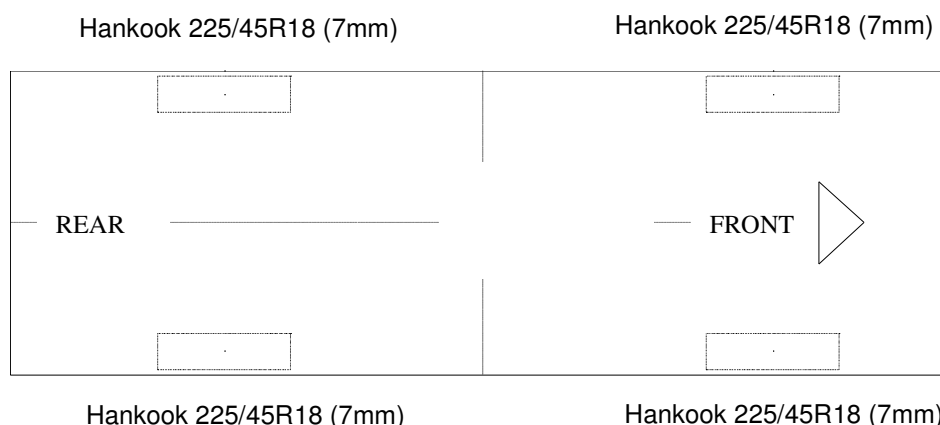
7. It was fitted with 18inch sport wheel rims that were wrapped with tyres that were observed to be of serviceable condition. The tyres were also sufficiently inflated for vehicular operation. The tyre brand, tyre size and approximate remaining tread depth of the 4 tyres of the Motor Car were recorded as follows: -

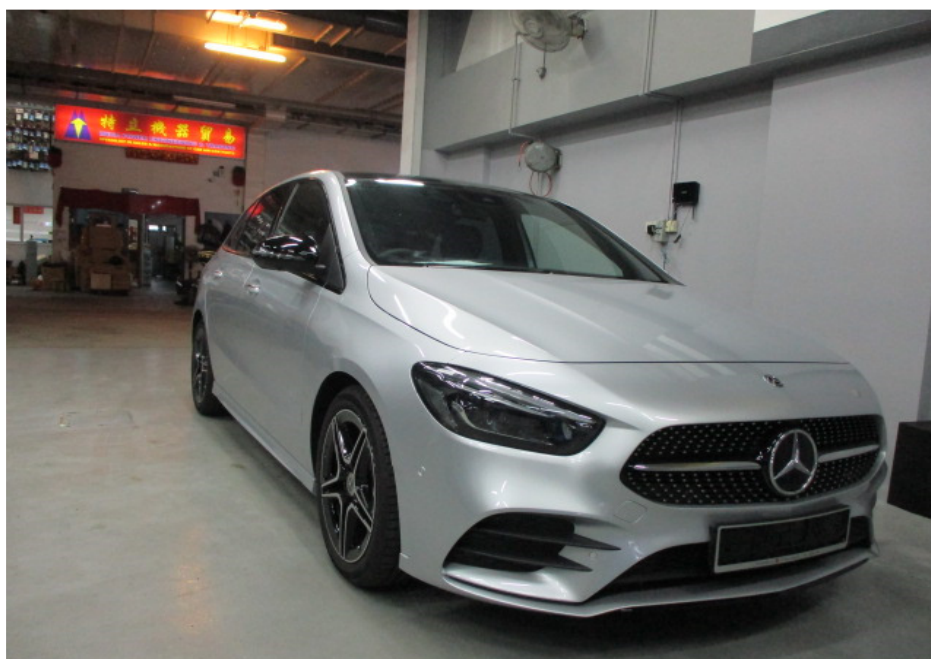
**Photo 4** shows a general view of the front right body of the Motor Car at the time of my inspection. The Motor Car was observed to be in relatively good general condition with no loose exterior fittings observed. The body parts along the right side of the Motor Car were visually examined and it was observed that the repair/restoration works carried out to the damaged area of the Motor Car (refer photograph 1 to 3 above) were reasonably adequate and in order.

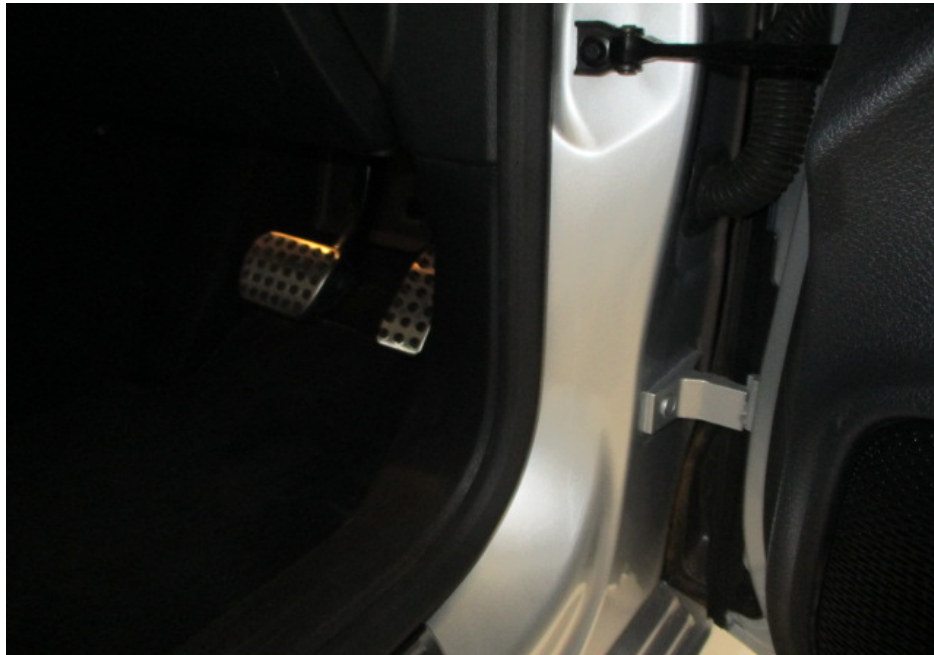
**Photo 5** shows the right side "A" pillar and front right door hinges of the Motor Car. The body parts along the right side of the Motor Car were visually examined and it was observed that the repair/restoration works carried out to the damaged area of the Motor Car (refer photograph 1 to 3 above) were reasonably adequate and in order.

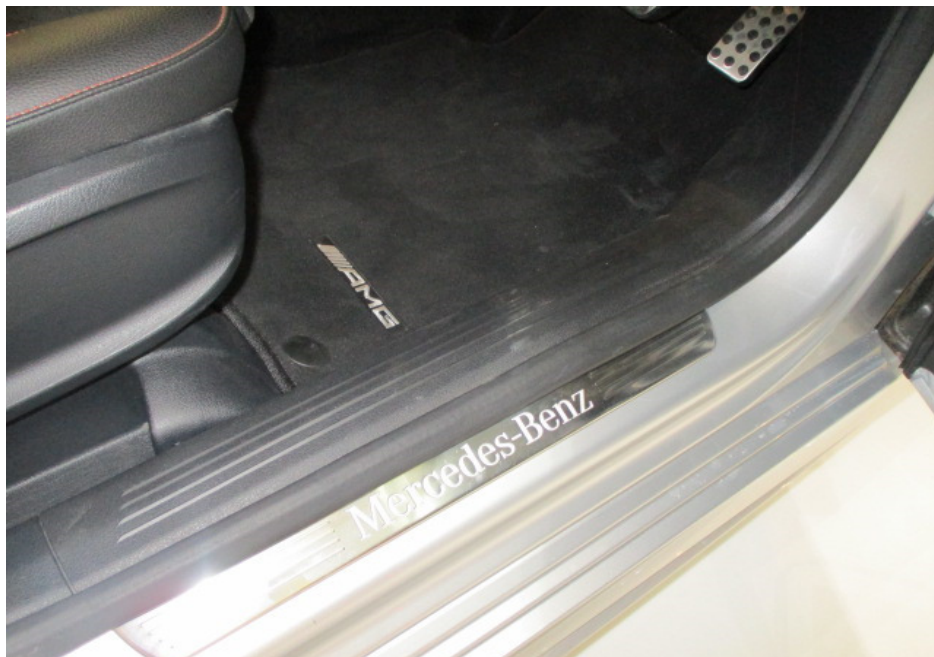
**Photo 6** shows the right side rocker panel of the Motor Car. The body parts along the right side of the Motor Car were visually examined and it was observed that the repair/restoration works carried out to the damaged area of the Motor Car (refer photograph 1 to 3 above) were reasonably adequate and in order.

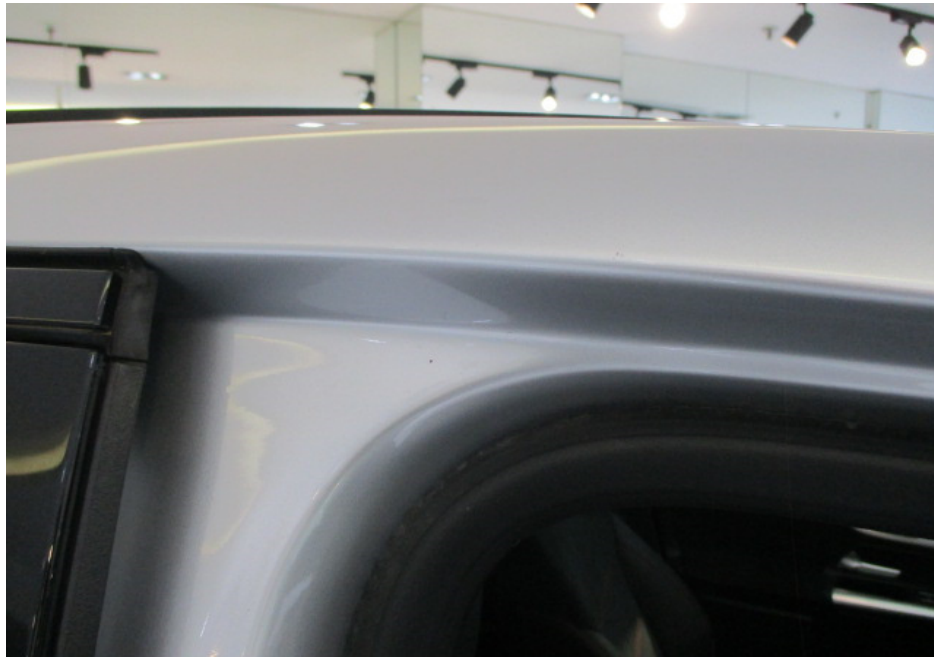
**Photo 7** shows the right side "B" pillar of the Motor Car. The body parts along the right side of the Motor Car were visually examined and it was observed that the repair/restoration works carried out to the damaged area of the Motor Car (refer photograph 1 to 3 above) were reasonably adequate and in order.

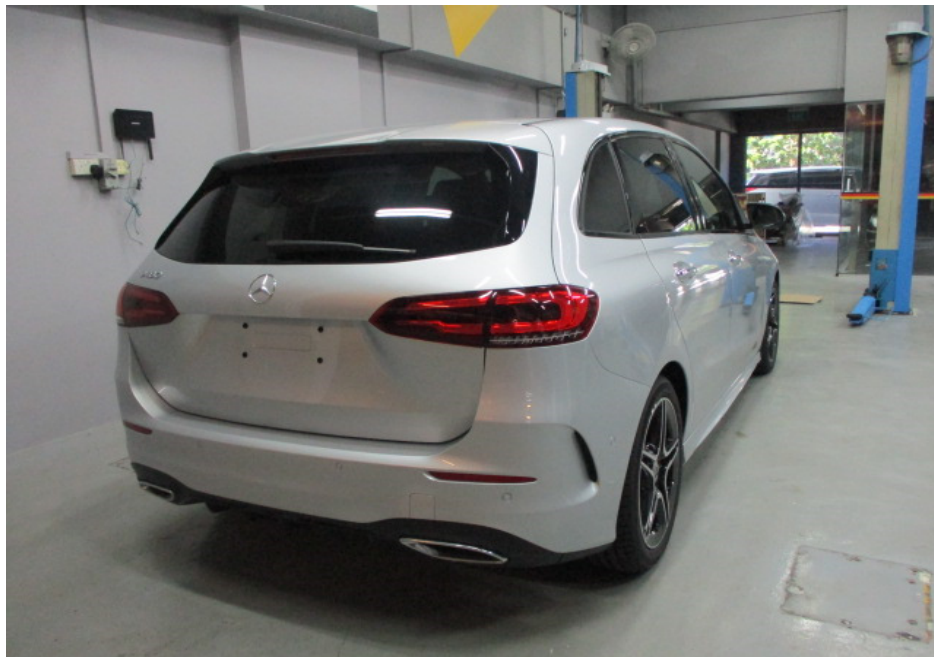
**Photo 8** shows a general view of the rear right body of the Motor Car at the time of my inspection. The Motor Car was observed to be in relatively good general condition with no loose exterior fittings observed.

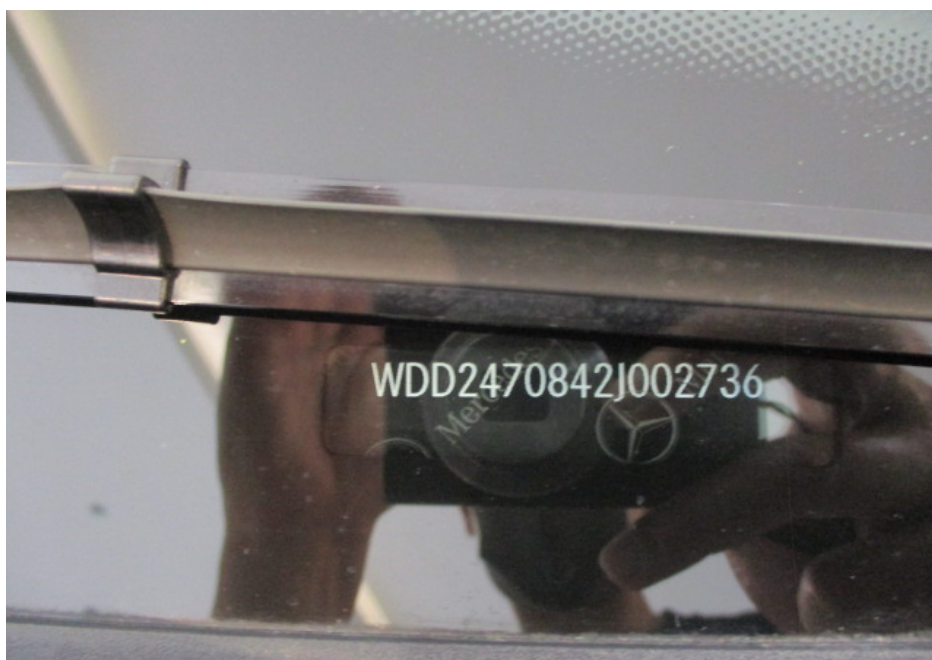
**Photo 9** shows the chassis number of the Motor Car. The chassis number recorded was WDD2470842J002736.

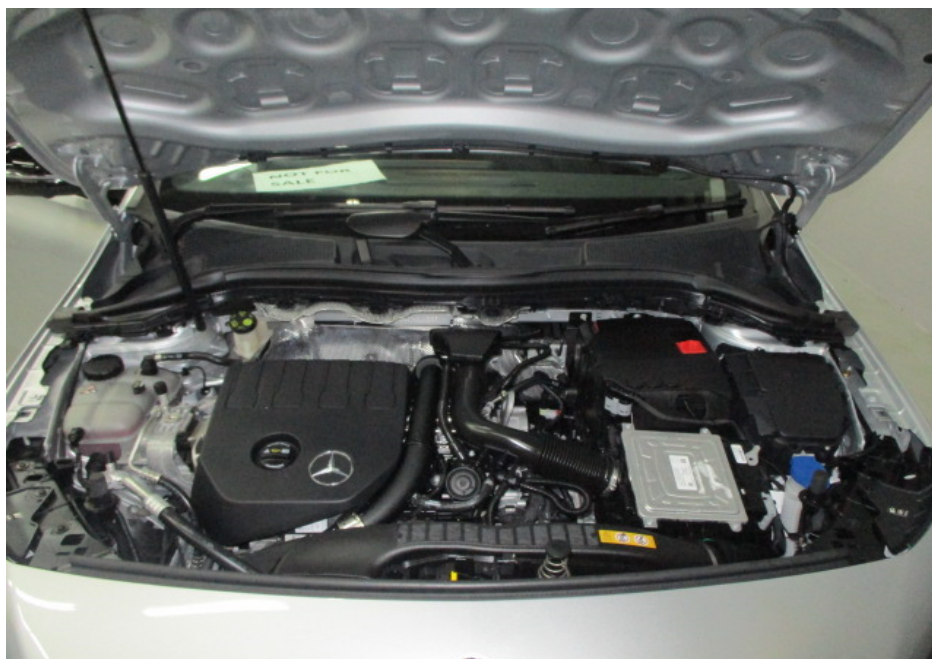
**Photo 10** shows a general view of the engine compartment of the Motor Car at the time of my inspection. The various parts and components inside the engine compartment were all observed to be intact and properly fitted. There was also no sign(s) or indication(s) of fluid leak and/or fluid stain found inside the engine compartment.

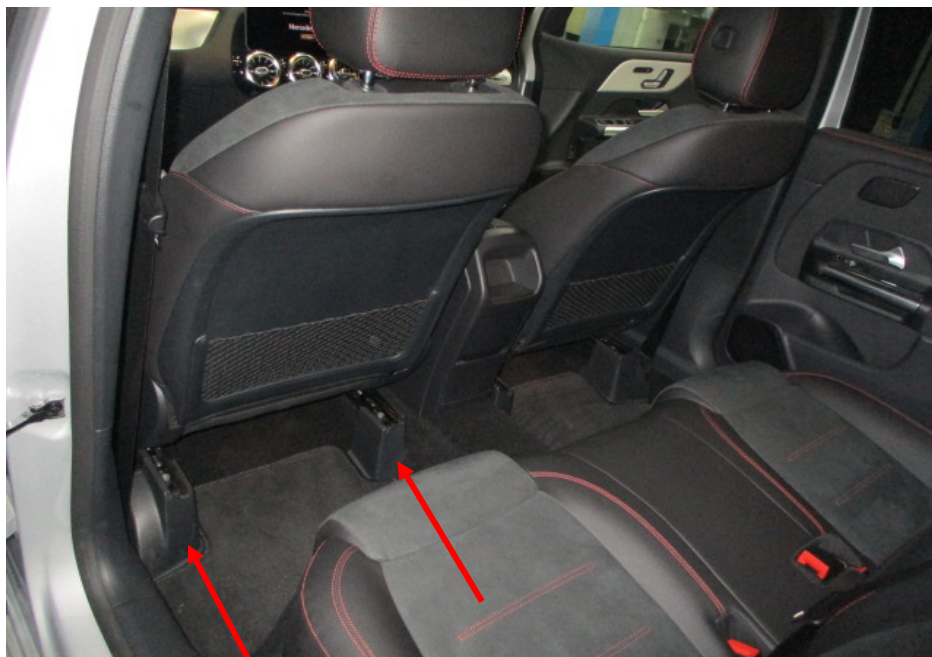
**Photo 11** shows the seats of the Motor Car, which were secured via seat rails (arrowed) to the floor board. All the seats of the Motor Car were fitted with a retractable seat belt reel and pre-tensioner. The seat belts were tested and able to be fastened into the respective pre-tensions that were fitted on the side of each individual seat.

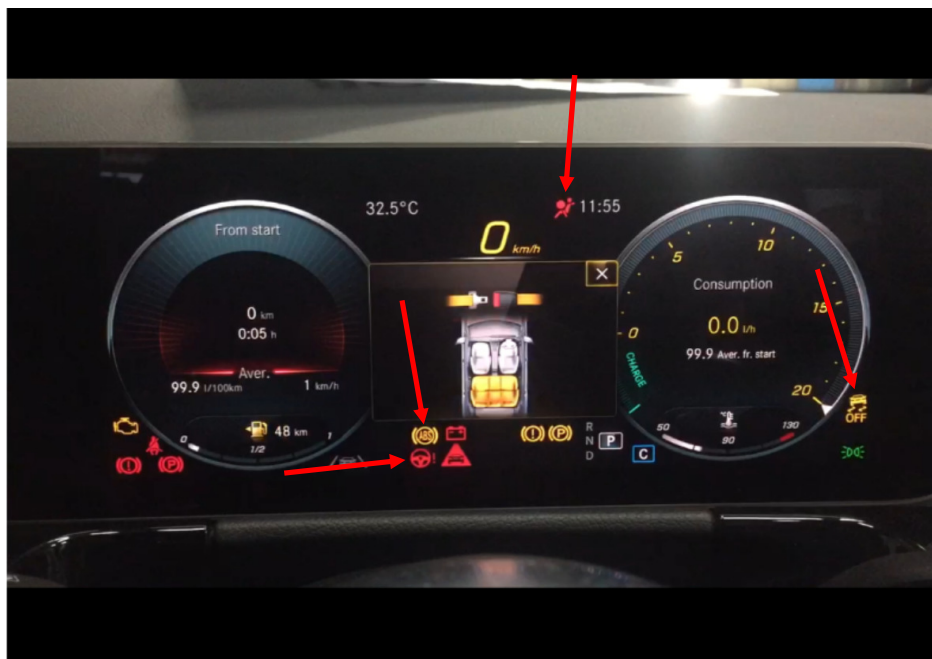
**Photo 12** shows the warning lights for the various electronic safety features appearing on the instrument panel of the Motor Car during its self-test when the engine is cranked, in particular the ABS, SRS, EPS and ESP lights (arrowed).

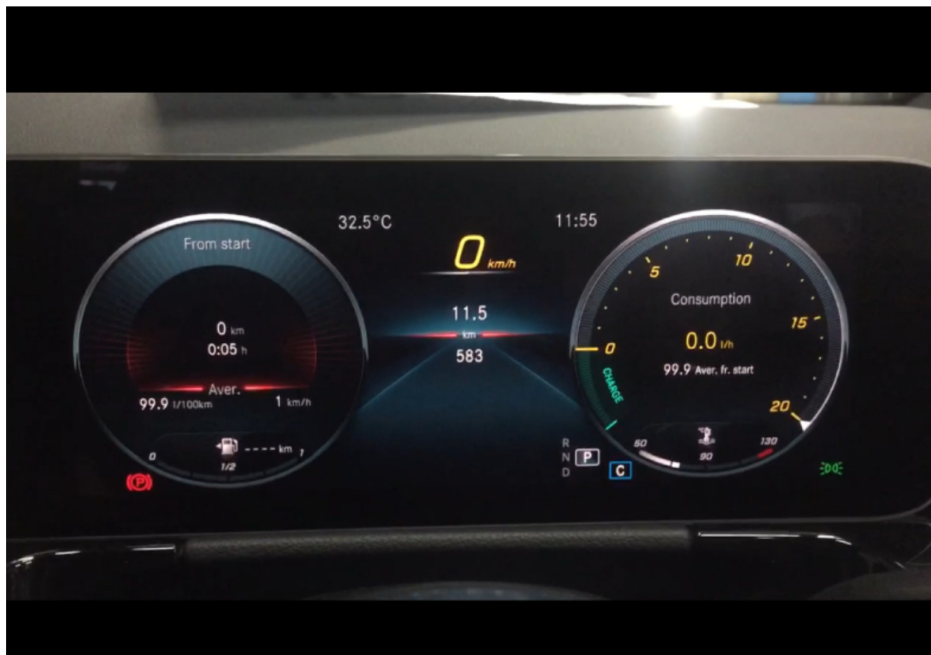
**Photo 13** shows the respective warning lights no longer illuminated, indicating that there is no fault detected to the ABS, SRS, EPS and ESP systems of the Motor Car during the self-test. These electronic systems were hence in working condition at the time of my inspection.

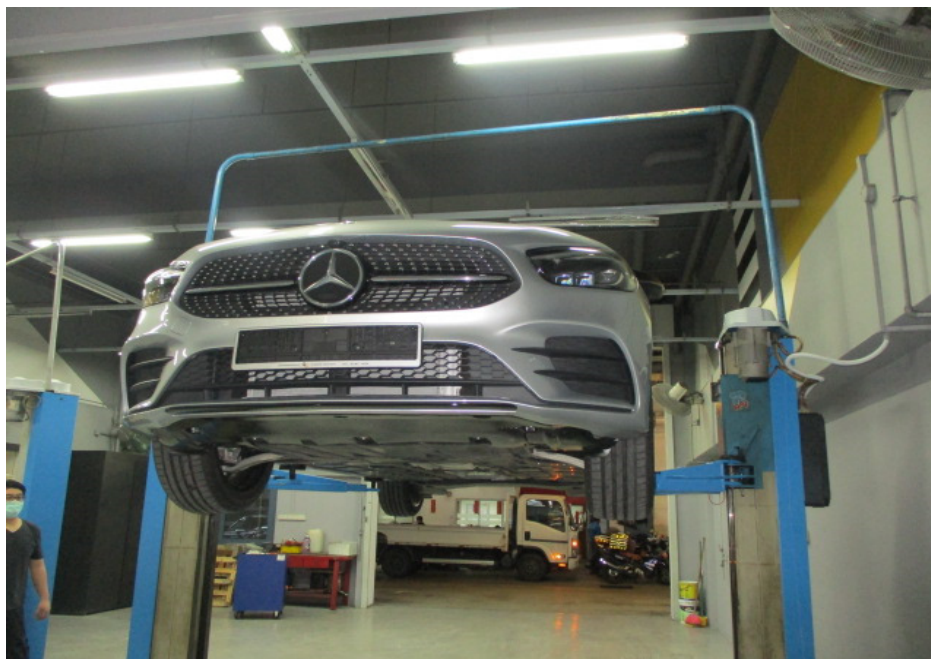
**Photo 14** shows the Motor Car hoisted up for checks on its undercarriage. There was no sign(s) or indication(s) of fluid leakage and/or fluid stain(s) on the underside of the Motor Car. The undercarriage components of the Motor Car were also all observed to be intact and secured in an appropriate manner.

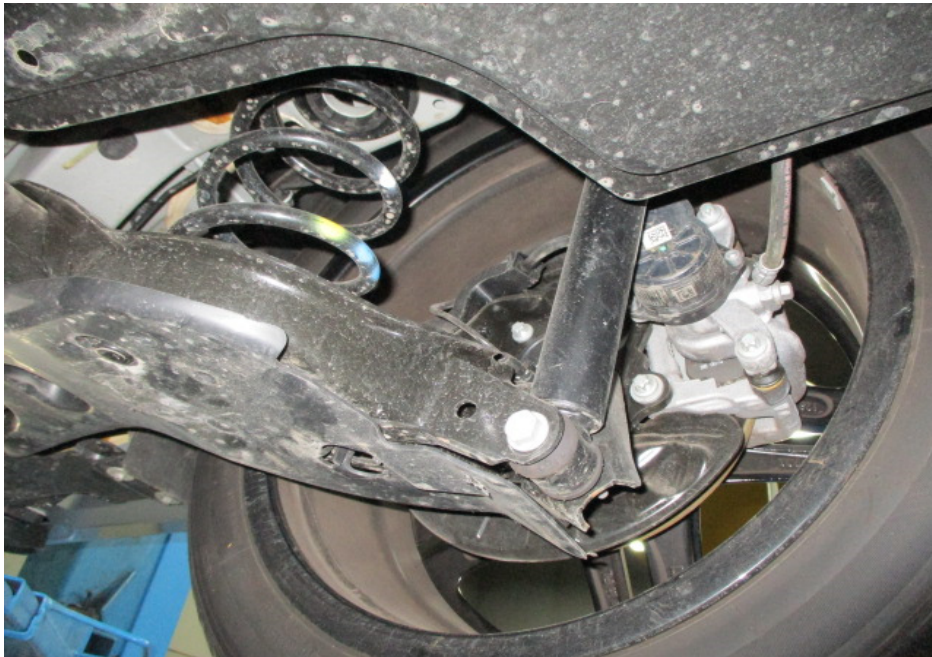
**Photo 15** shows a general view of the control arms and linkages at the rear right wheel of the Motor Car. I did not observe any fluid leak and/or fluid stain on the underside of the Motor Car. All of the Motor Car's undercarriage components were observed to be intact and secured in an appropriate manner.

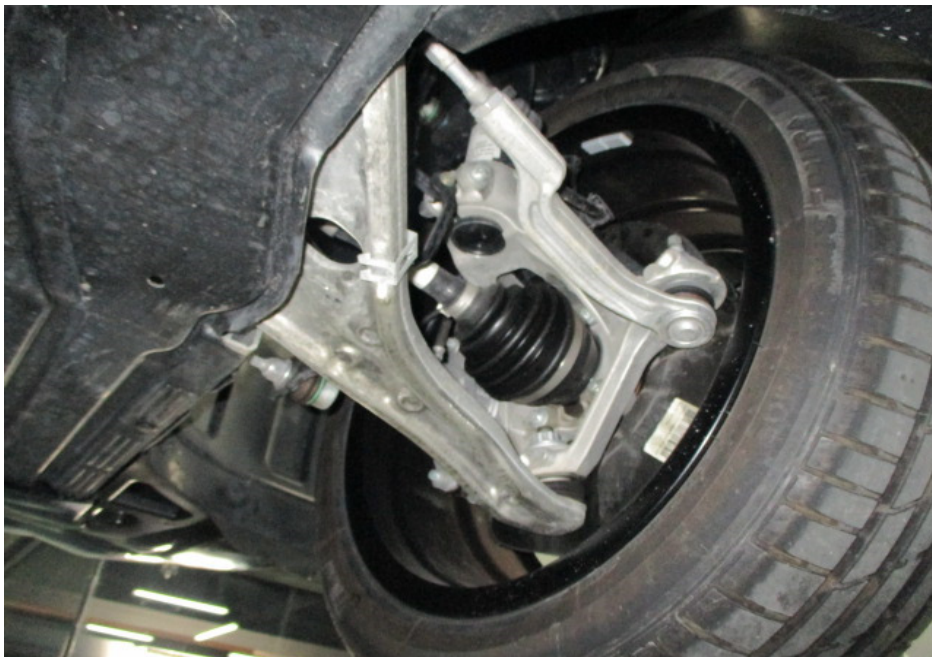
**Photo 16** shows the various undercarriage components at the front right wheel of the Motor Car. The mechanical components, control arms and linkages were all found to be intact and secured in an appropriate manner.

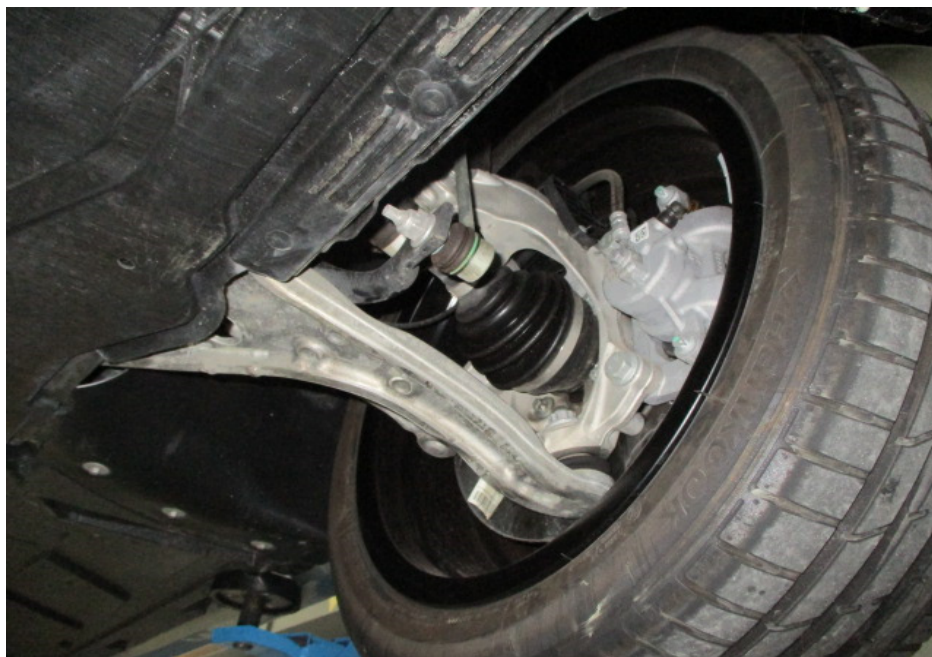
**Photo 17** shows the various undercarriage components at the front left wheel of the Motor Car. The mechanical components, control arms and linkages were all found to be intact and secured in an appropriate manner. I also did not observe any fluid leak and/or fluid stain on the underside of the Motor Car.

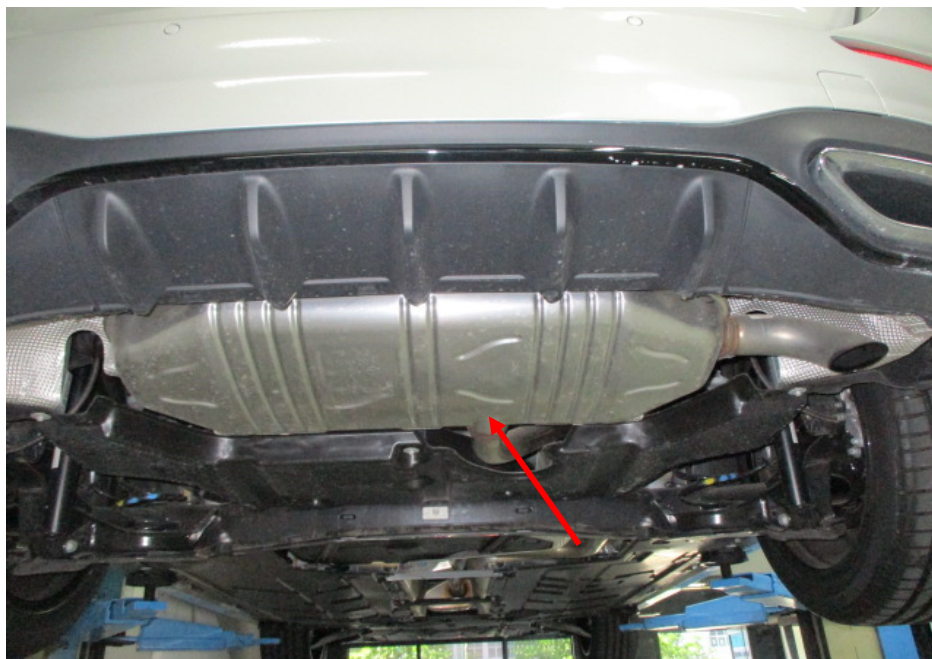
**Photo 18** shows the Motor Car's rear muffler (arrowed). My examination of the Motor Car's exhaust system revealed no sign(s) or indication(s) of any cut or weld marks along its exhaust pipes and on its catalytic converter.

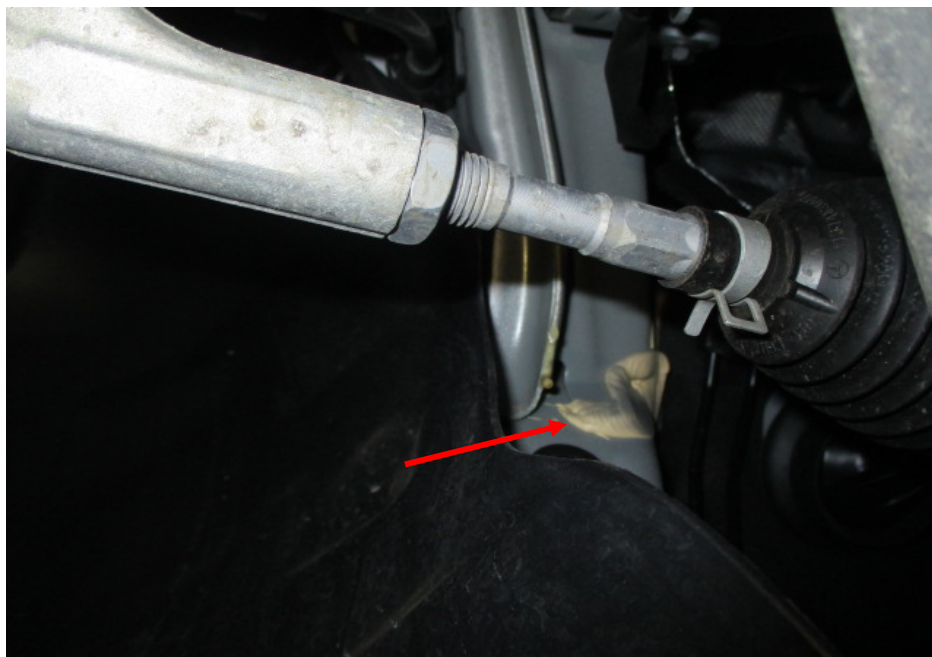
**Photo 19** shows the chassis/structural body at the underside front right of the Motor Car. Visually, I did not find any weld marks other than original spot weld marks on the chassis/structural body of the Motor Car. The original factory sealant (arrowed) at the joints along the chassis/structural body was also untouched, indicating no work was done on the chassis/structural body of the Motor Car and that the chassis/structural body was originally fitted.

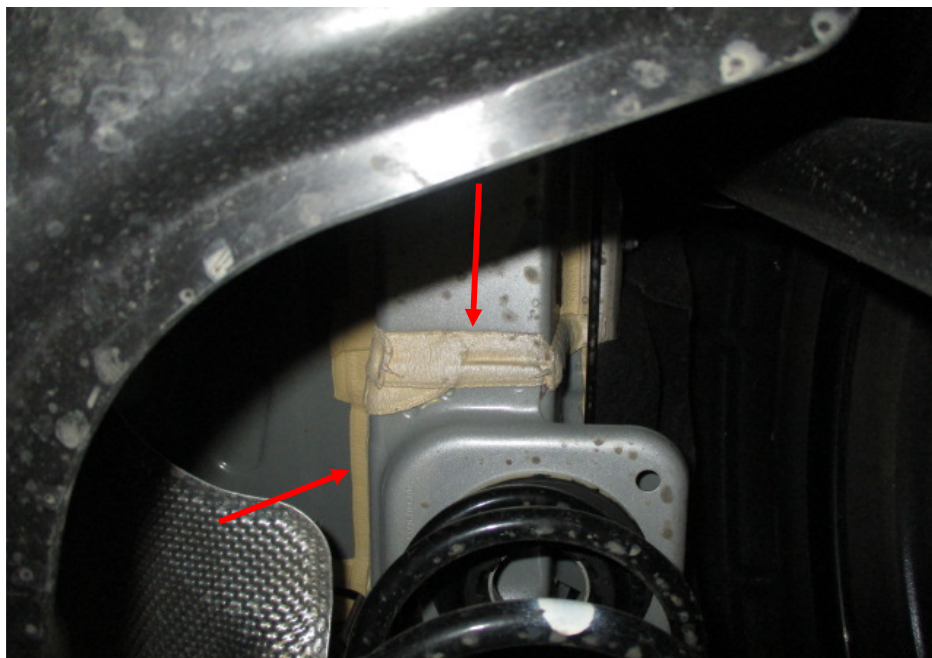
**Photo 20** shows the chassis/structural body at the underside rear right of the Motor Car. Visually, The original factory sealant (arrowed) at the joints along the chassis/structural body was untouched, indicating no work was done on the chassis/structural body of the Motor Car and that the chassis/structural body was originally fitted.

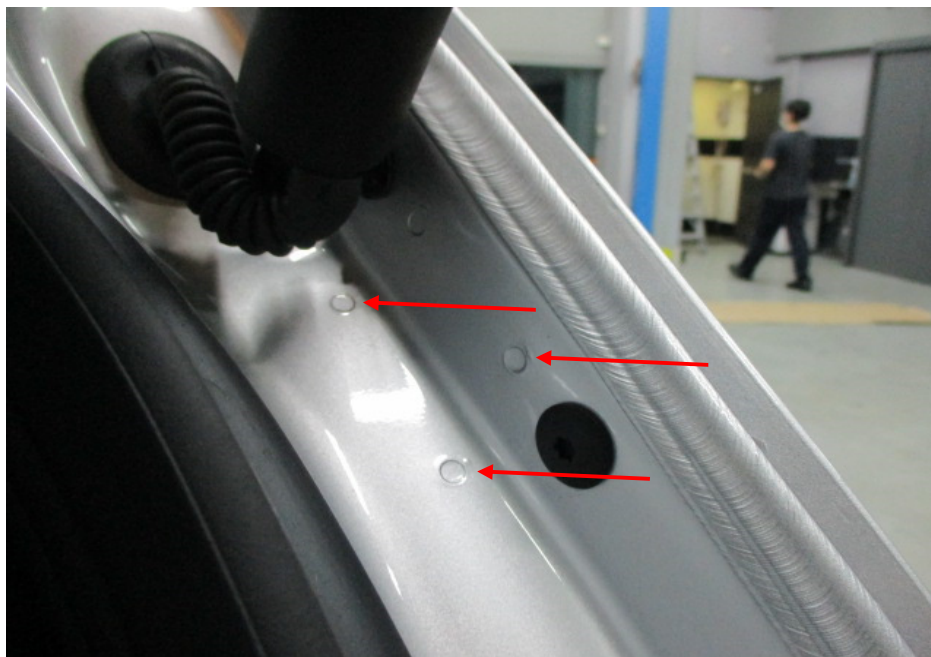
**Photo 21** shows the right rear body panel of the Motor Car. I did not find any weld marks other than original spot weld marks (arrowed) on the non-detachable body panels of the Motor Car, indicating that there was no re-welding works carried out; and that the non-detachable body panels of the Motor Car were originally fitted.
