Our Ref : CS4/ASM20007497/N

22 July 2020

TECHNICAL INVESTIGATION REPORT OF FIRE INCIDENT INVOLVING THE INSURED VEHICLE SJA 3323A ON 19 JULY 2020

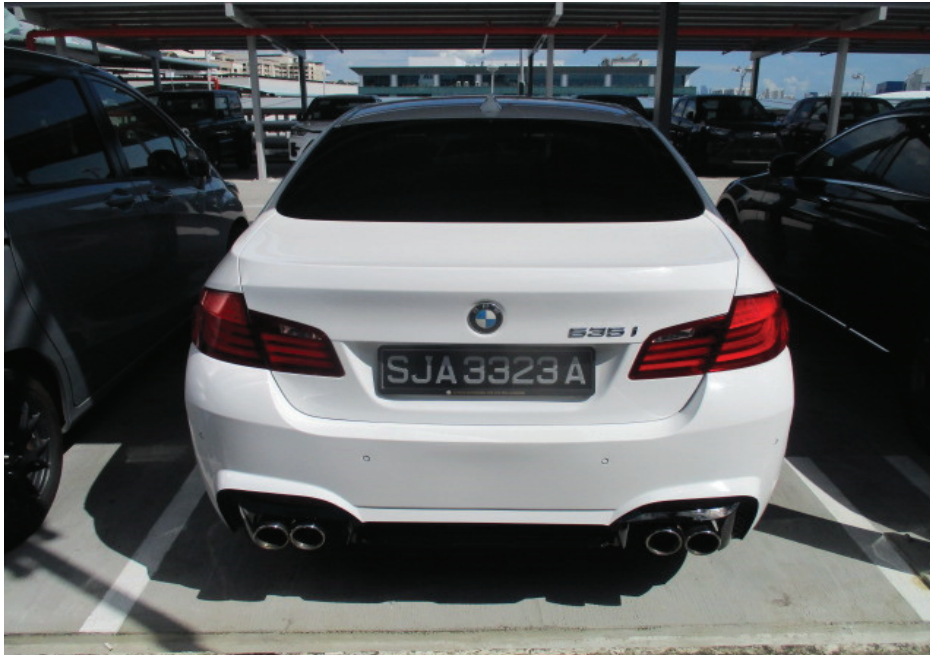
Photo 1 shows the general view of the rear portion of the Insured Vehicle at the time of our inspection. The rear portion of the Insured Vehicle was observed to be unaffected by the fire.

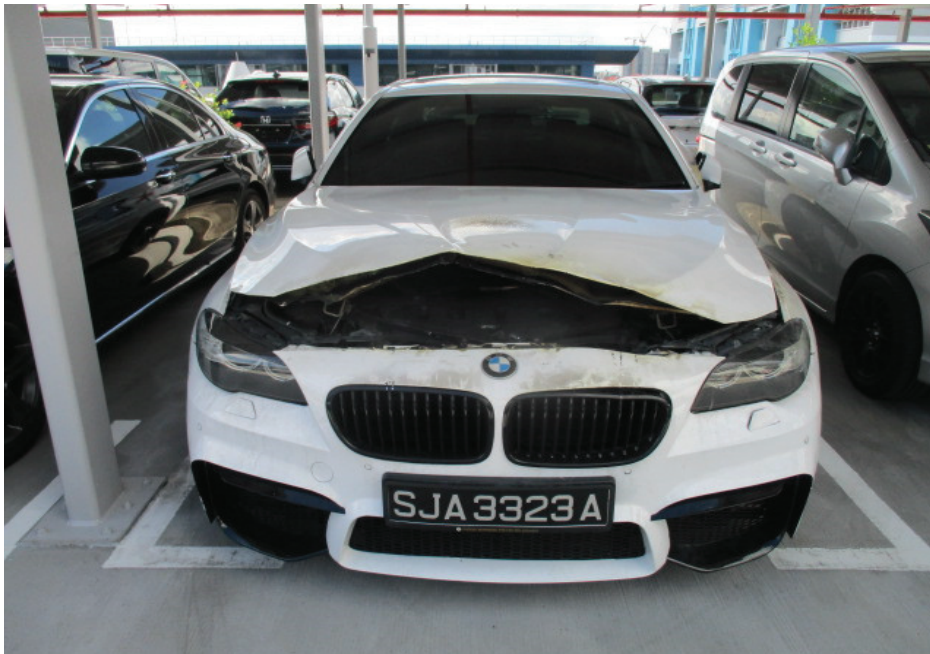
5. The exterior front body and engine compartment of the Insured Vehicle sustained visible fire damage. This included its front windscreen, front bonnet, headlights, front bumper and side panels.
6. The fire had resulted in serious damage to the engine compartment of the Insured Vehicle. Most of the components inside the engine compartment were found to be severely burnt and/or melted as a result of the fire. See photos 1 – 6 below.

Photo 2 shows the general view of the front portion of the Insured Vehicle at the time of our inspection. The exterior body of the Insured Vehicle had sustained visible fire damage. This included its front windscreen, front bonnet, headlights, front bumper and side panels.

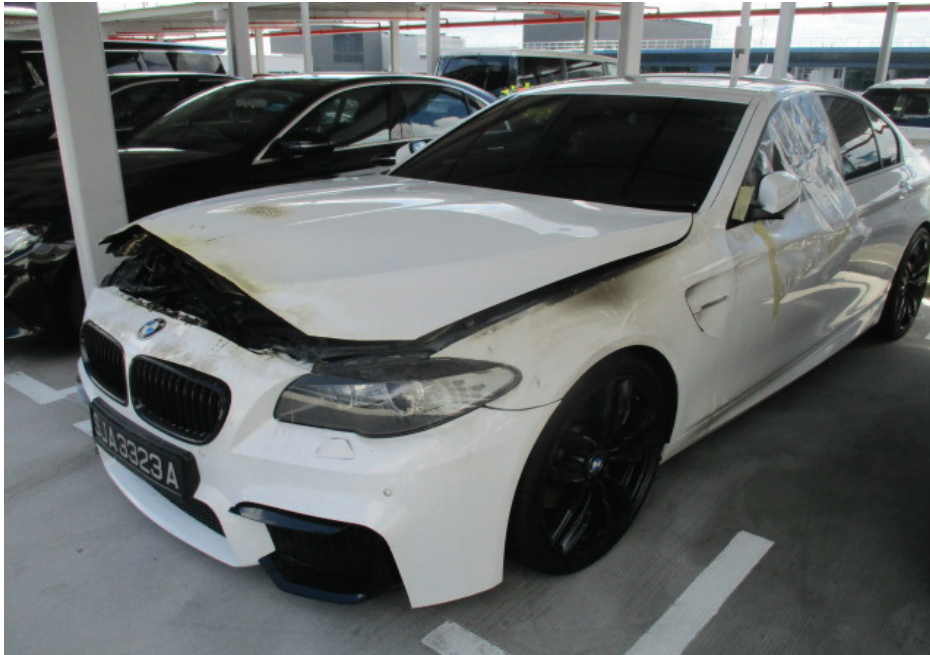
Photo 3 shows the general view of the left frontal portion of the Insured Vehicle at the time of our inspection. The exterior body of the Insured Vehicle had sustained visible fire damage. This included its front windscreen, front bonnet, left headlight, front bumper and left side panel.

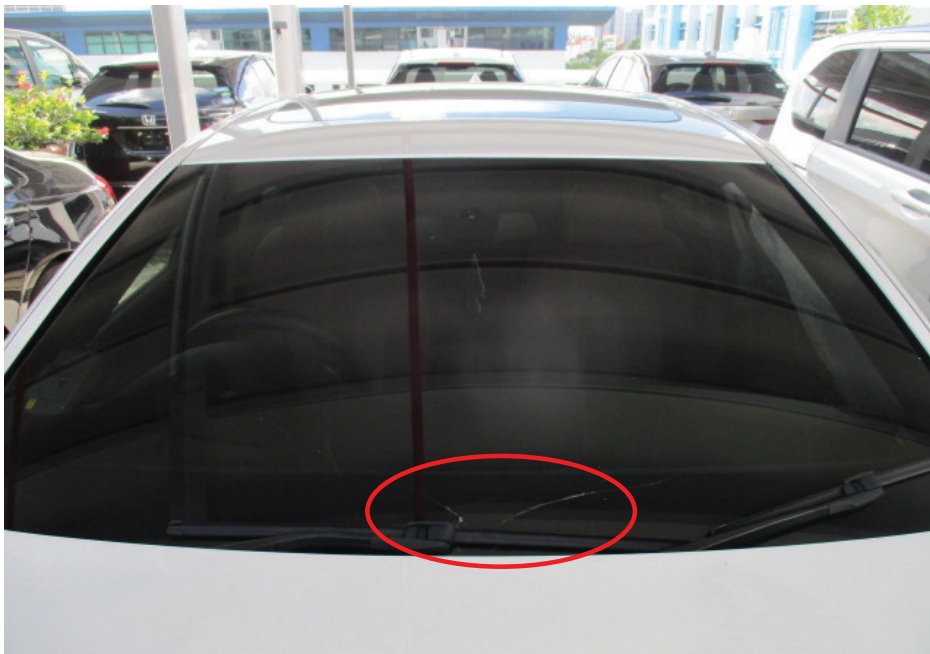
Photo 4 shows a closer view of the front windscreen of the Insured Vehicle at the time of our inspection. The front windscreen had sustained minimal fire damage (circled).

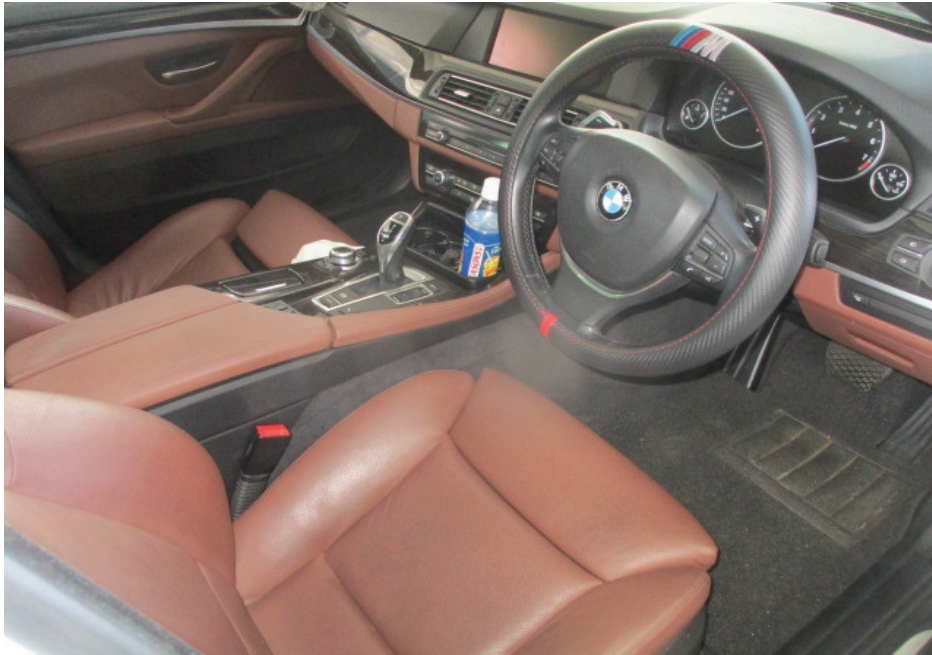
Photo 5 shows the interior compartment of the Insured Vehicle at the time of our inspection. The interior compartment of the Insured Vehicle was relatively unaffected by the fire.

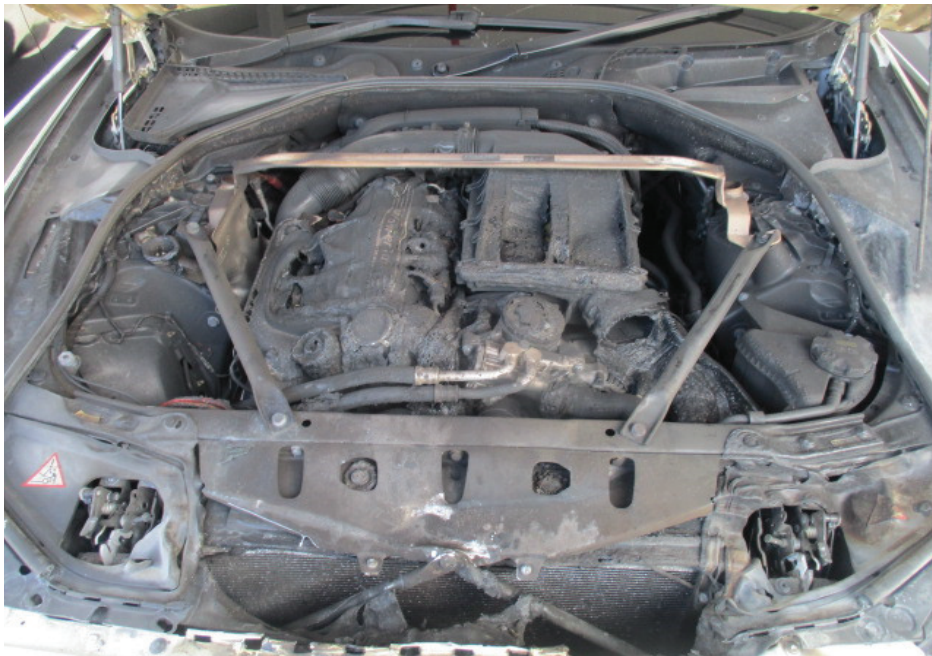
Photo 6 shows a general view of the engine compartment of the Insured Vehicle at the time of our inspection. Most of the components inside the engine compartment were found to be severely burnt and/or melted as a result of the fire.

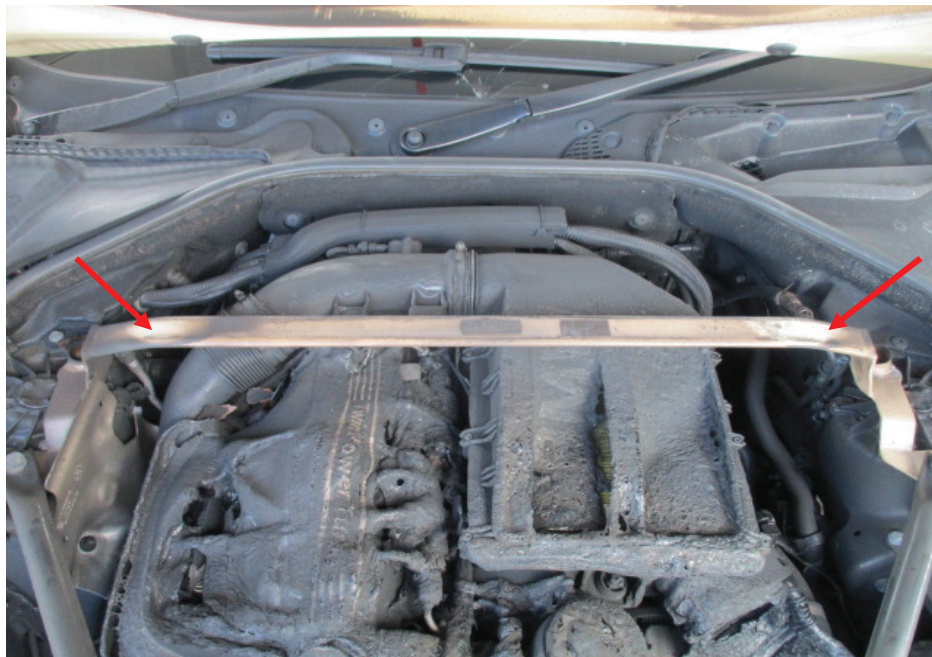
7. At the time of physical inspection of the Insured Vehicle, we had found several modifications on the Insured Vehicle. These included an engine strut bar (which had sustained minor fire damage) and aftermarket 20- inch alloy rims. All these fitted components were not the standard type for the Insured Vehicle. See photos 7 & 8 below.

Photo 7 shows the engine strut bar (arrowed) fitted on the Insured Vehicle. However it had sustained minor fire damage.

31. Although the engine strut bar and aftermarket alloy rims fitted on the Insured Vehicle were not the standard type for the Insured Vehicle, we are of the view that these parts did not cause and/or contribute to the fire incident.

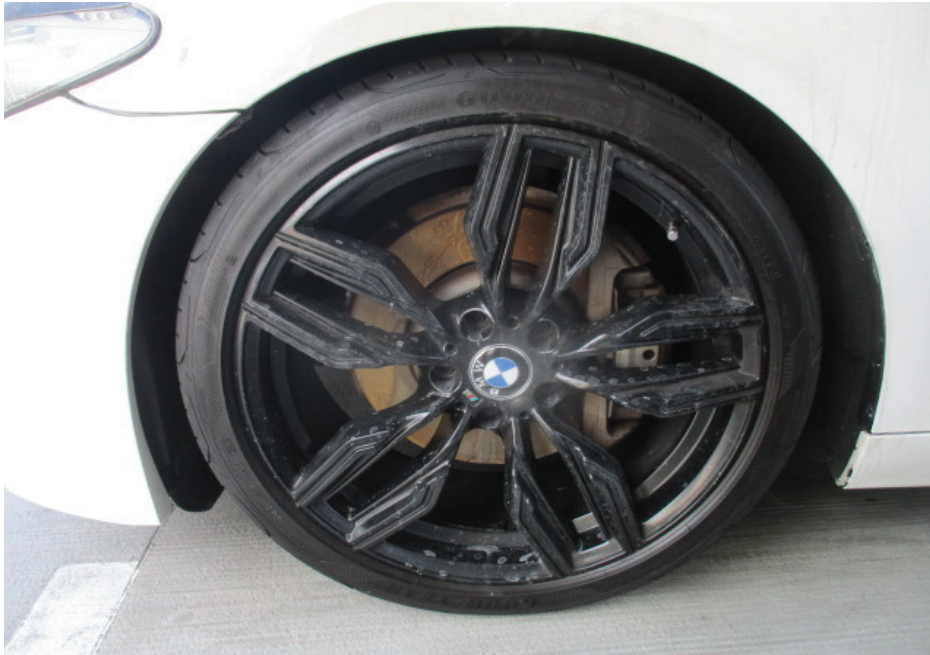
Photo 8 shows the non-standard rim found to be fitted on the Insured Vehicle at the time of our inspection. The 20- inch alloy rims fitted on the Insured Vehicle were not the standard type for the Insured Vehicle.

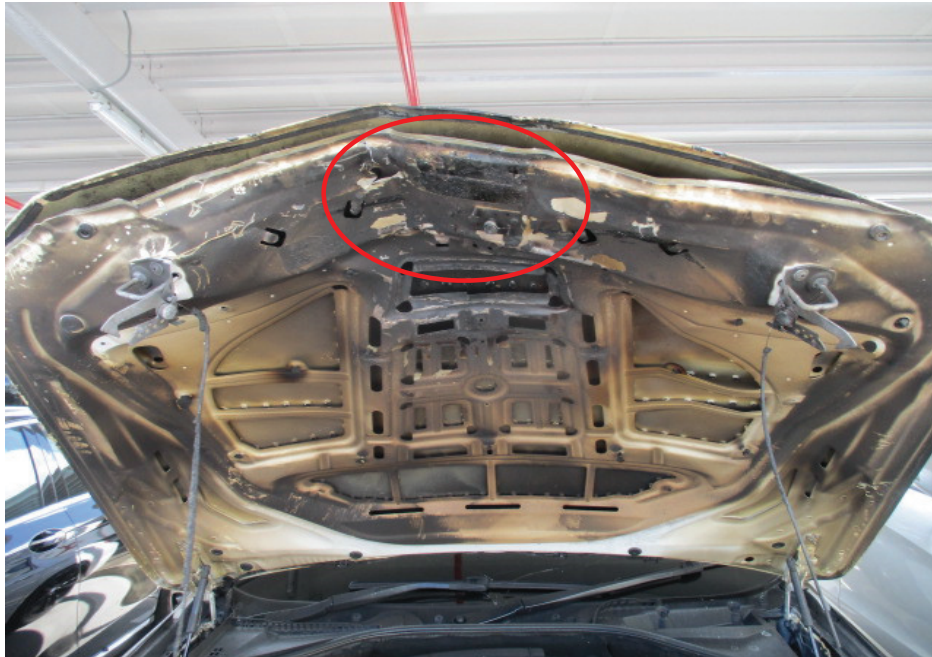
8. For this particular case, the fire appears to have originated within the engine compartment of the Insured Vehicle, somewhere around the front centre portion of the engine compartment. This can be determined from the discolouration found on the top centre portion of the underside of the bonnet due to prolonged exposure to high heat intensity. A closer examination revealed faint whitish burn marks on the top centre portion on the underside of the bonnet due to prolonged exposure to high heat intensity. We also observed paint bubbles on the front centre portion of the front bonnet. In general the location of the fires' origin was determined given that the damage of fire nature was confined to these particular areas on the Insured Vehicle. See photos 9 - 11 below.

Photo 9 shows the burn pattern on the underside of the bonnet of the Insured Vehicle due to prolonged exposure to high heat intensity caused by the fire (circled).

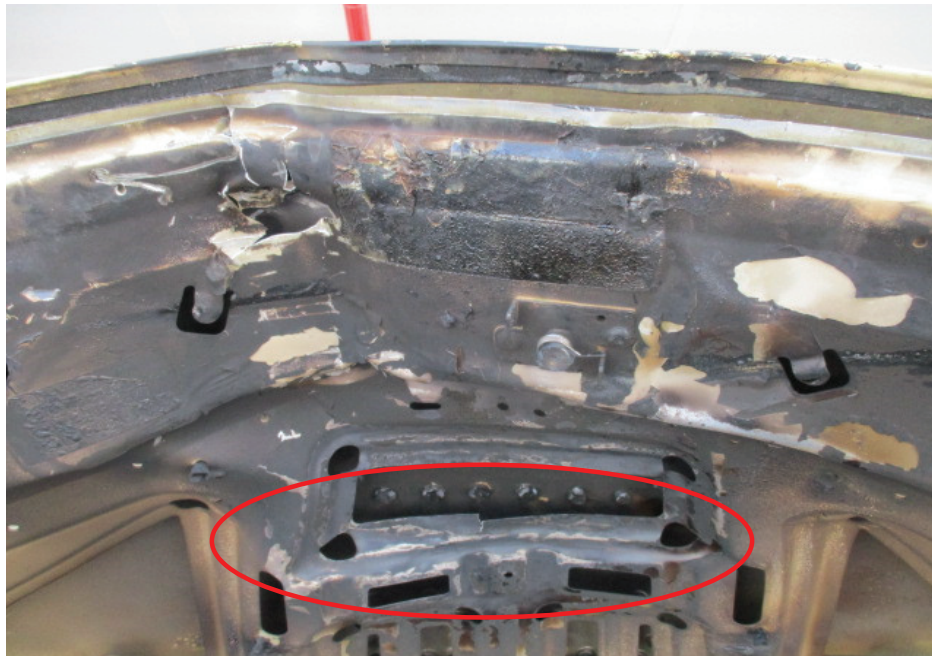
Photo 10 shows upon closer examination, we noticed whitish burn marks on the top centre portion on the underside of the bonnet of the Insured Vehicle due to prolonged exposure to high heat intensity caused by the fire (circled).

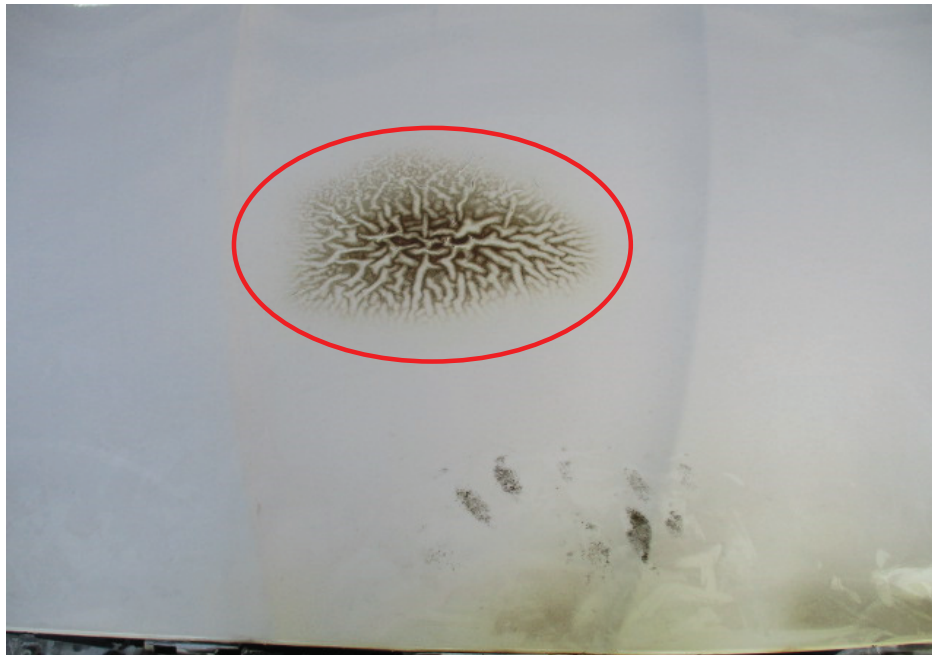
Photo 11 shows the burn marks and paint bubbles on the front centre portion of the front bonnet of the Insured Vehicle (circled).

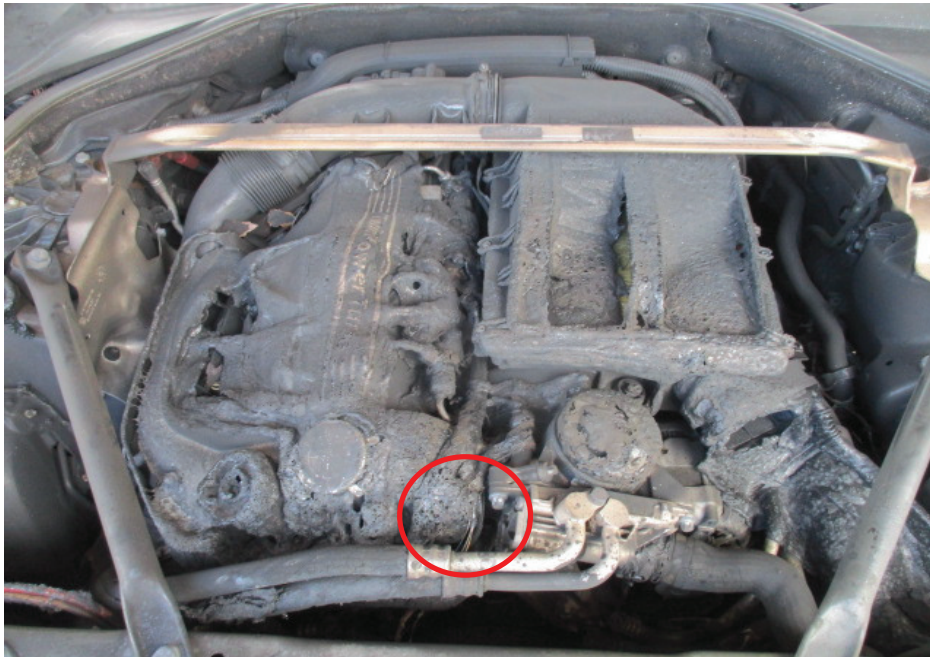
9. Upon closer examination of the front centre portion of the engine compartment which was where the fire to the Insured Vehicle had likely started, we had found traces of greenish residue on several stretches of burnt wirings. The presence of greenish residue indicates internal heating of copper wires, a sign of an electrical short circuit occurring. The greenish residue is normally left behind from oxidation as a result of chemical reaction involving the copper wires. This physical evidence would then appear to suggest that the cause of fire to the Insured Vehicle could have possibly been due to electrical in nature. See photos 12 - 15 below.

Photo 12 shows the burnt wirings around the front centre portion of the engine compartment (circled), which is in the immediate vicinity where the fire to the Insured Vehicle had likely started.

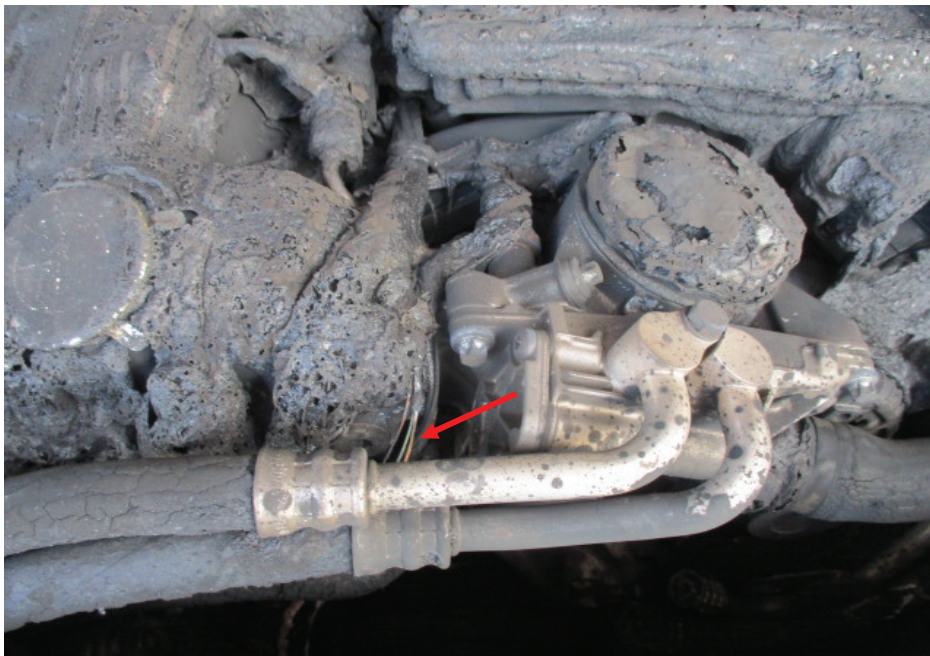
Photo 13 shows a closer view of the burnt wirings around the front centre portion of the engine compartment, which is in the immediate vicinity where the fire to the Insured Vehicle had likely started. We noticed greenish residue on several stretches of burnt wirings (arrowed). The presence of greenish residue indicates internal heating of copper wires, a sign of an electrical short circuit occurring. The greenish residue is normally left behind from oxidation as a result of chemical reaction involving the copper wires.

28. Having investigated and technically analysed the damages of burnt nature to the Insured Vehicle, we are of the view that the cause of fire to the Insured Vehicle was of electrical in nature. For this particular case, the fire had originated along the wirings inside the engine compartment, somewhere around the front centre portion of the engine compartment. The wirings were original factory wirings of the Insured Vehicle.

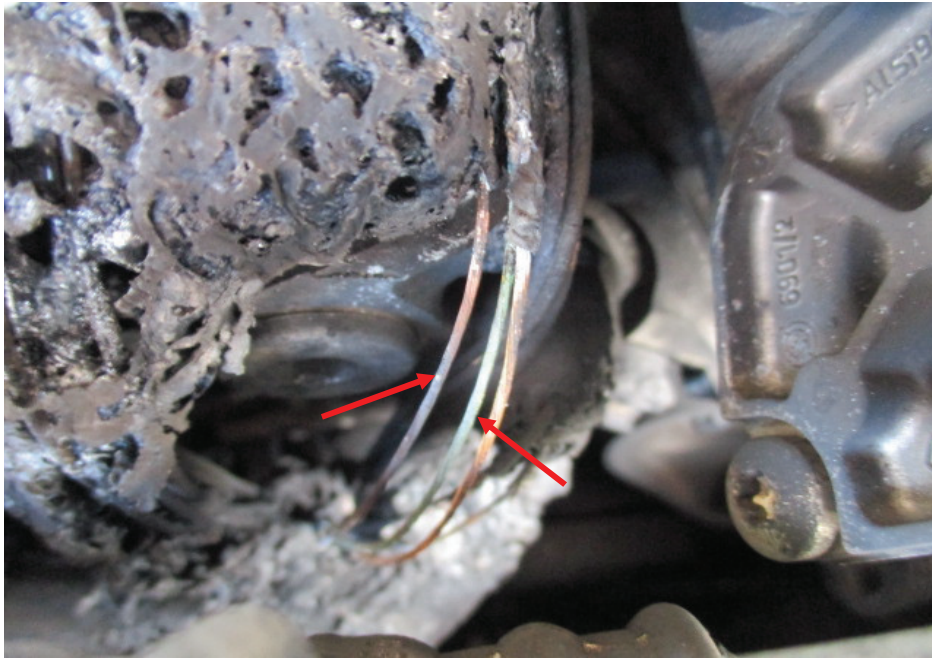
Photo 14 shows a close up view of the greenish residue found on several stretches of burnt wirings (red arrows). The presence of such greenish residue suggests occurrence of an electrical short circuit.

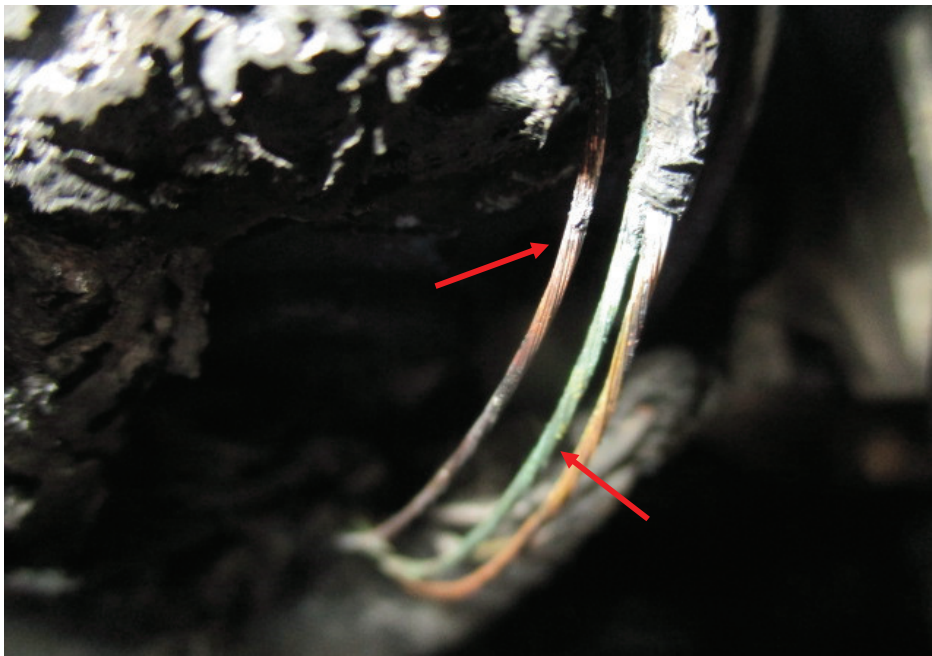
Photo 15 shows a close up view of the greenish residue found on several stretches of burnt wirings (red arrows). The presence of such greenish residue suggests occurrence of an electrical short circuit.

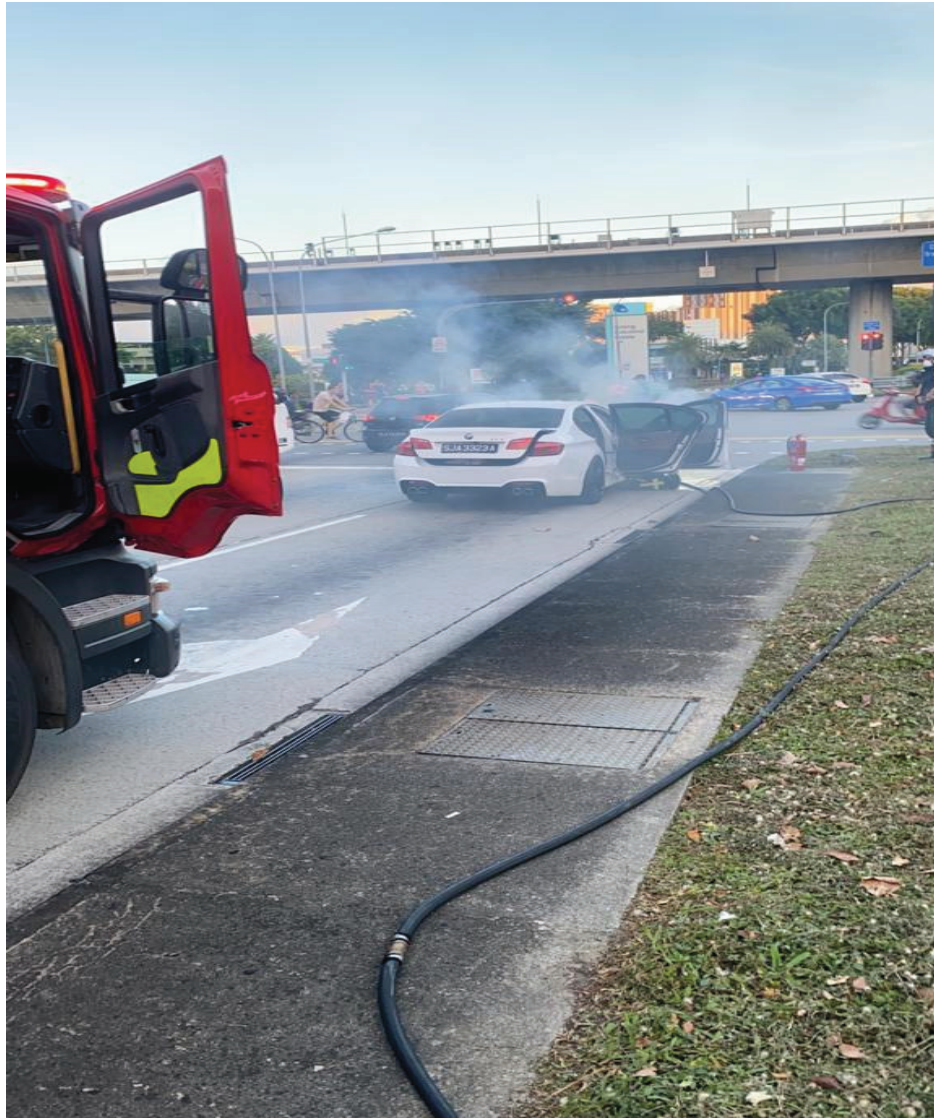
Photo 16 shows firefighters attempting to put out the fire.

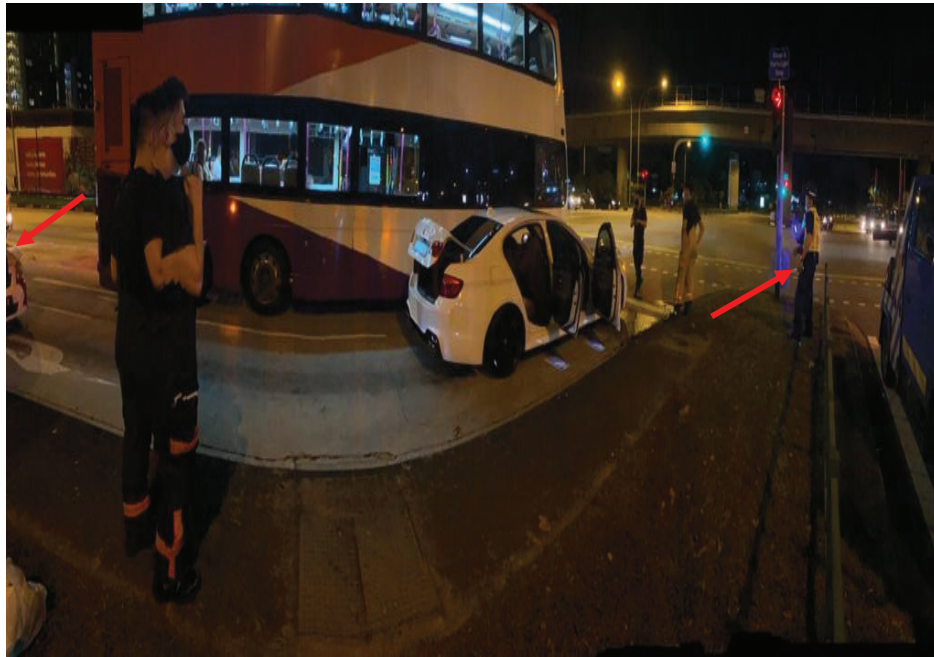
Photo 17 shows the SCDF conducting preliminary investigations post- incident. In general, the information that could be gathered from this photograph had corresponded to the events that were related to us by Mr Razali, which is the police were present at the incident location together with the SCDF (arrowed).

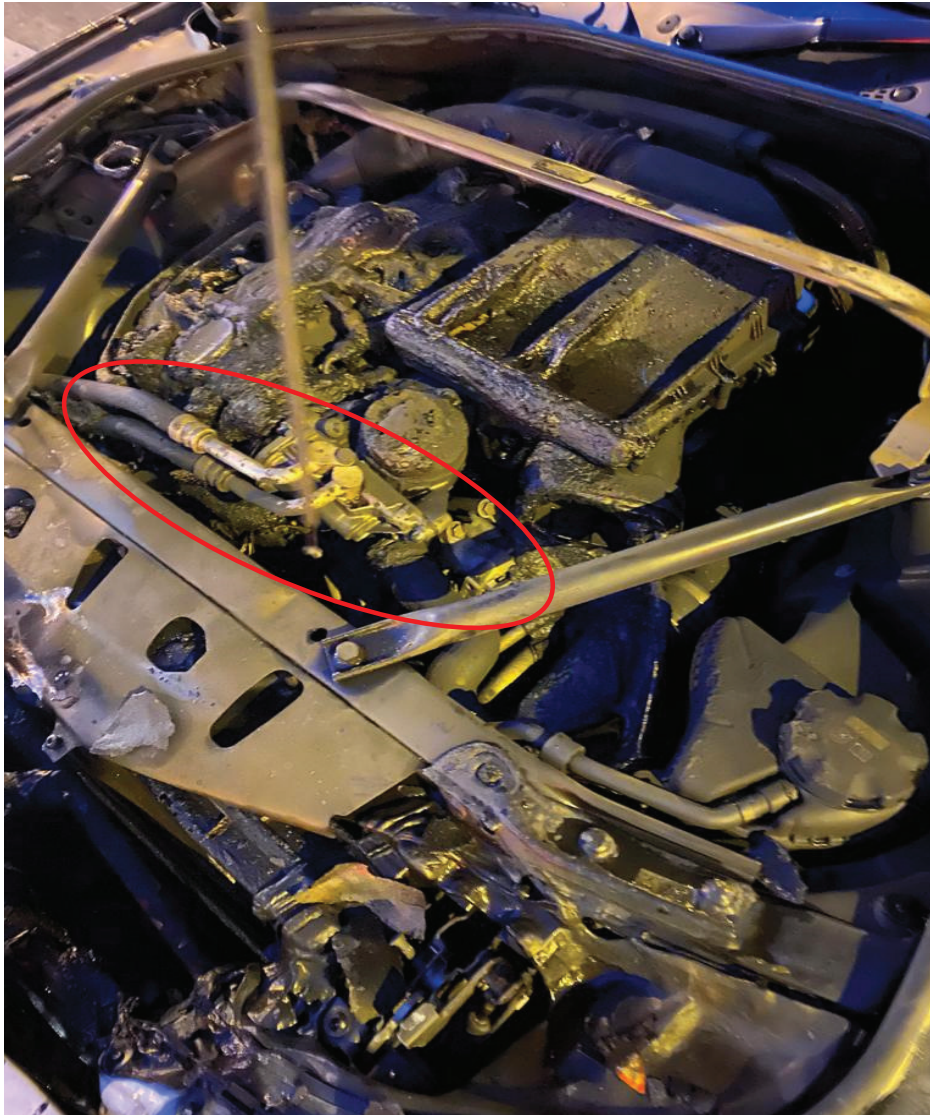
Photo 18 shows the engine compartment of the Insured Vehicle after the fire was extinguished. In general, the extensive damages sustained (circled) had corresponded to the events that were related to us by Mr Razali, which is the fire started from the engine compartment.
