Our Ref : CS4/ASM20007497/N

22 July 2020

**TECHNICAL INVESTIGATION REPORT OF FIRE INCIDENT INVOLVING THE  
INSURED VEHICLE SJA 3323A ON 19 JULY 2020**

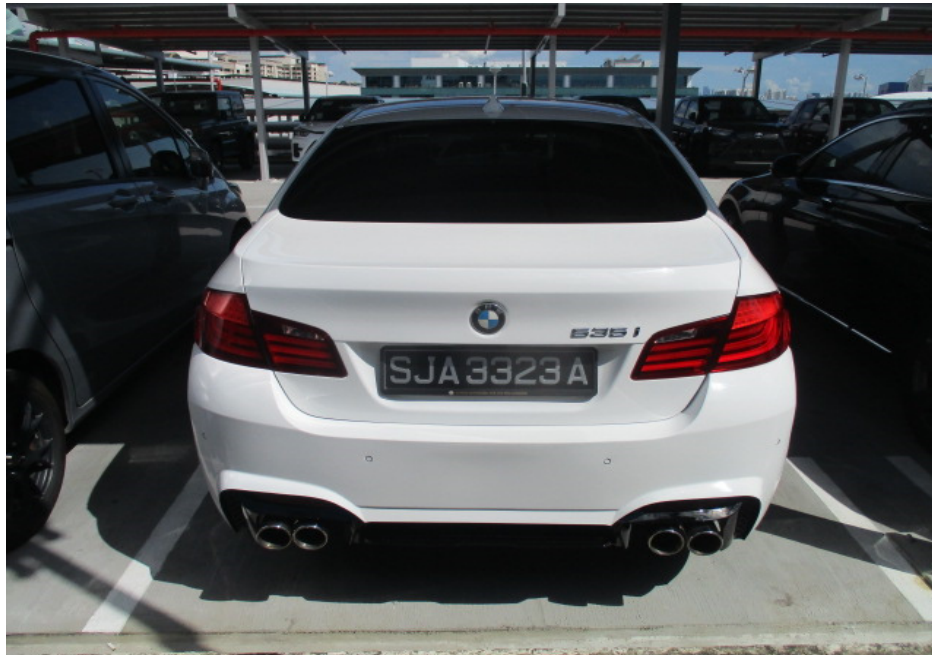
**Photo 1** shows the general view of the rear portion of the Insured Vehicle at the time of our inspection. The rear portion of the Insured Vehicle was observed to be unaffected by the fire.

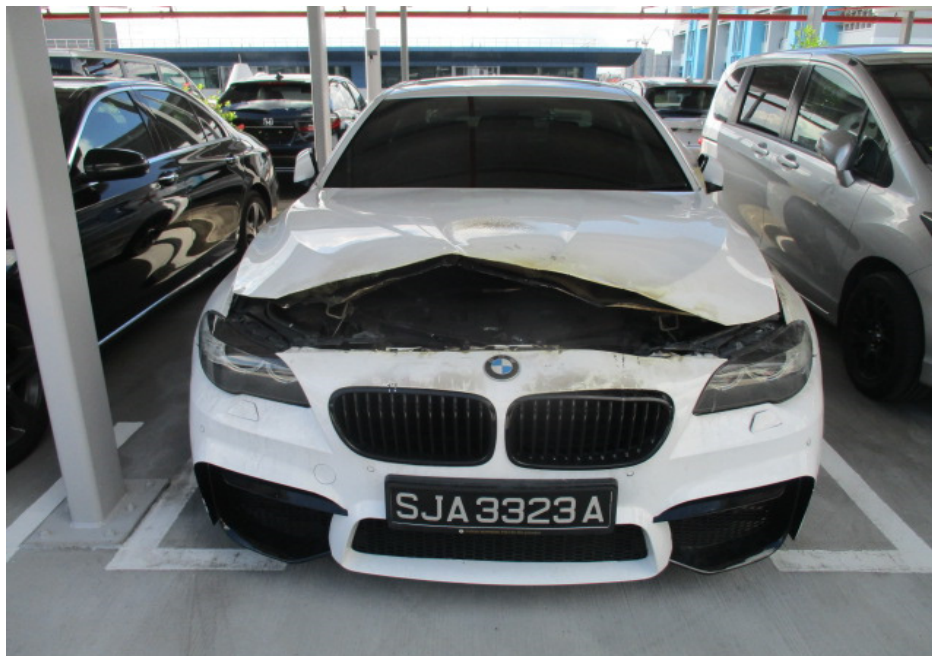
5. The exterior front body and engine compartment of the Insured Vehicle sustained visible fire damage. This included its front windscreen, front bonnet, headlights, front bumper and side panels.
6. The fire had resulted in serious damage to the engine compartment of the Insured Vehicle. Most of the components inside the engine compartment were found to be severely burnt and/or melted as a result of the fire. See photos 1 – 6 below.

**Photo 2** shows the general view of the front portion of the Insured Vehicle at the time of our inspection. The exterior body of the Insured Vehicle had sustained visible fire damage. This included its front windscreen, front bonnet, headlights, front bumper and side panels.

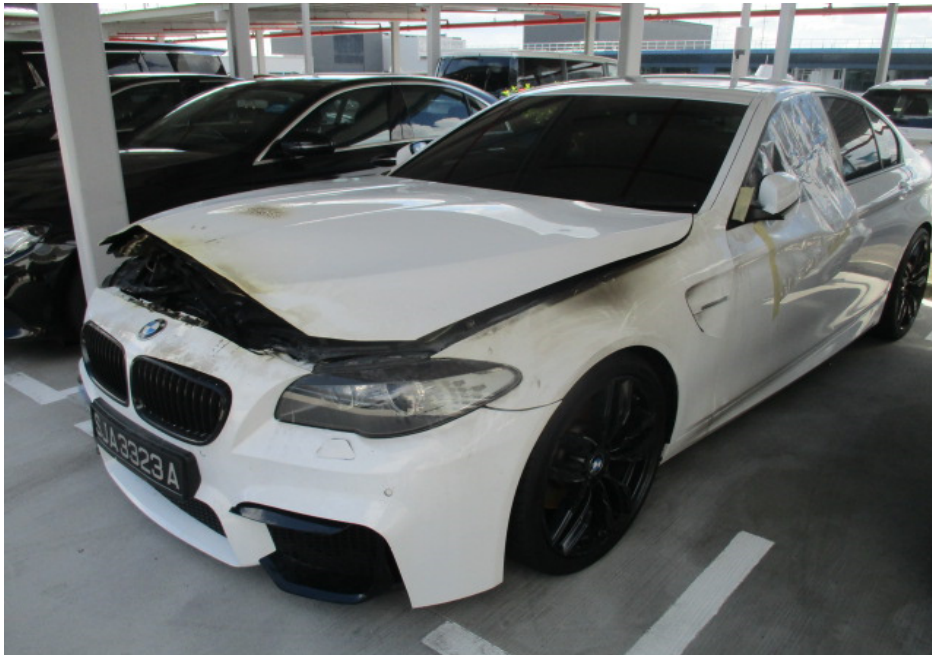
**Photo 3** shows the general view of the left frontal portion of the Insured Vehicle at the time of our inspection. The exterior body of the Insured Vehicle had sustained visible fire damage. This included its front windscreen, front bonnet, left headlight, front bumper and left side panel.

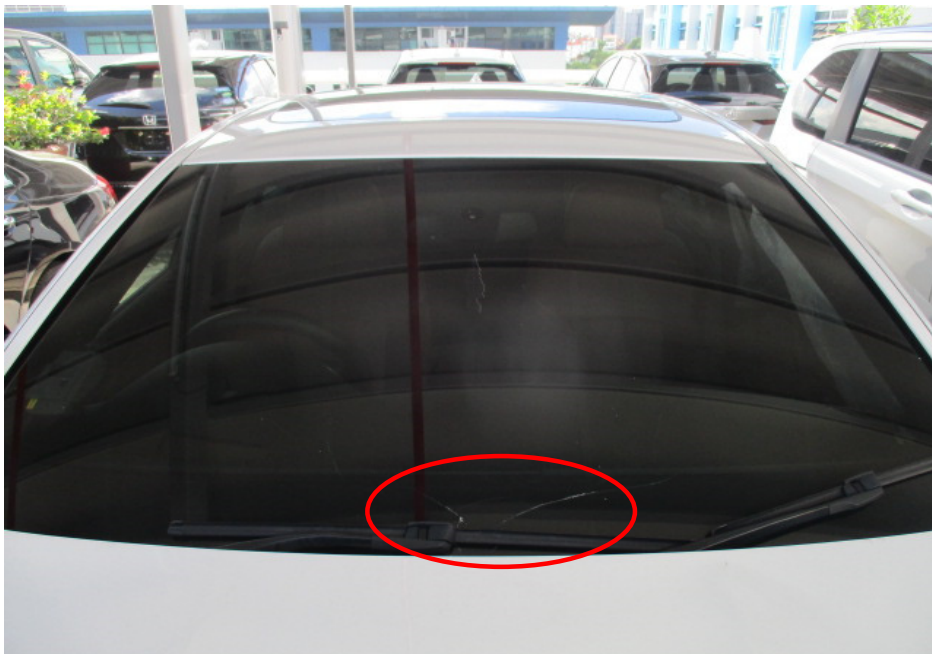
**Photo 4** shows a closer view of the front windscreen of the Insured Vehicle at the time of our inspection. The front windscreen had sustained minimal fire damage (circled).

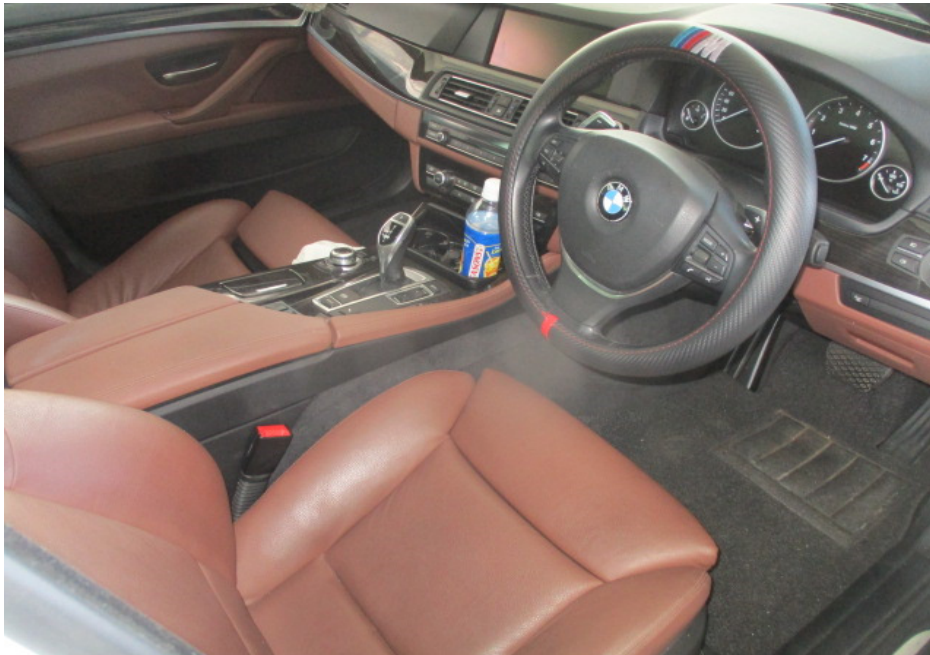
**Photo 5** shows the interior compartment of the Insured Vehicle at the time of our inspection. The interior compartment of the Insured Vehicle was relatively unaffected by the fire.

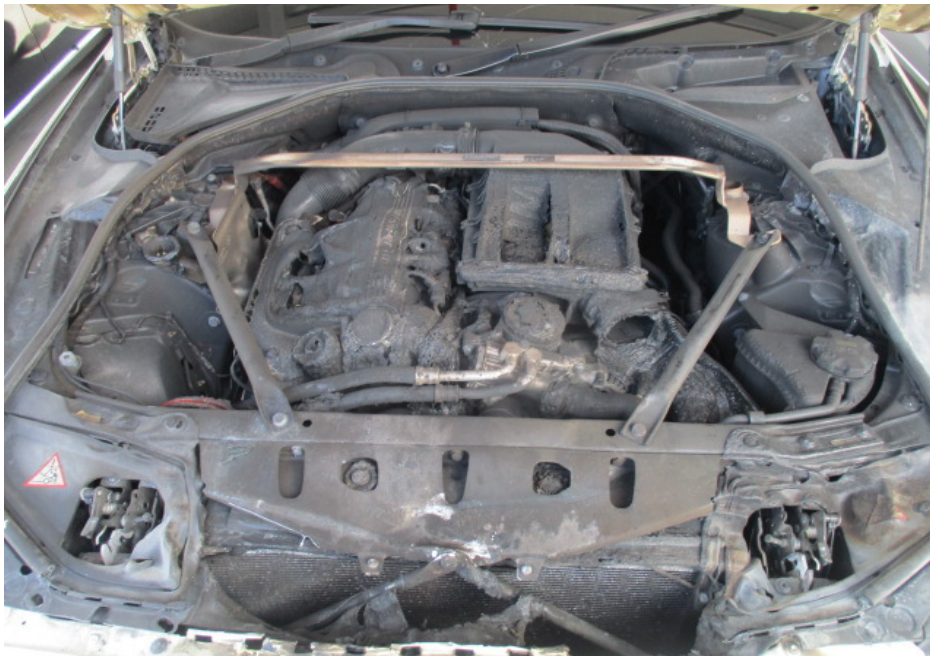
**Photo 6** shows a general view of the engine compartment of the Insured Vehicle at the time of our inspection. Most of the components inside the engine compartment were found to be severely burnt and/or melted as a result of the fire.

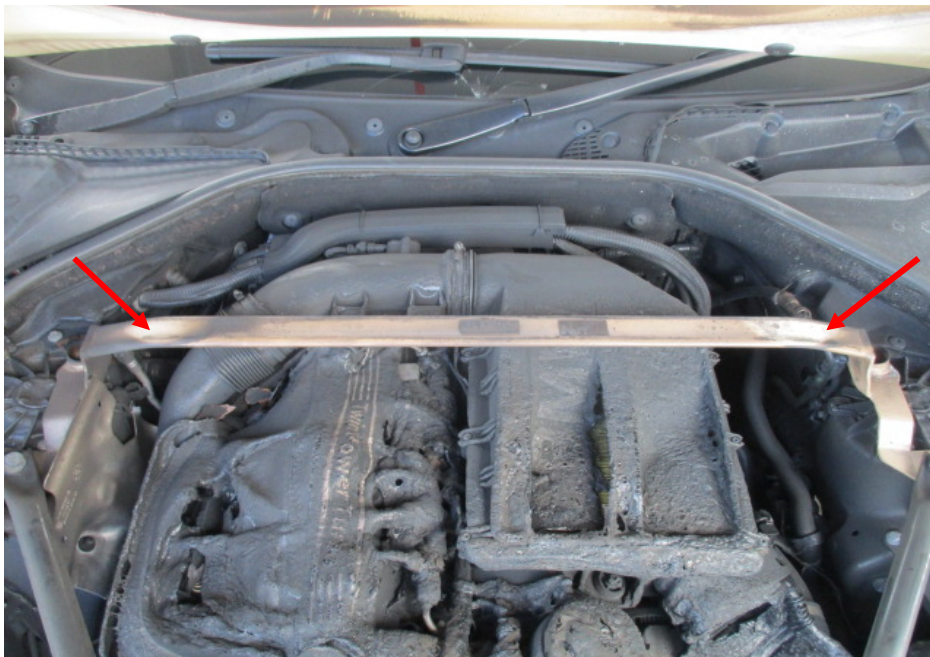
7. At the time of physical inspection of the Insured Vehicle, we had found several modifications on the Insured Vehicle. These included an engine strut bar (which had sustained minor fire damage) and aftermarket 20- inch alloy rims. All these fitted components were not the standard type for the Insured Vehicle. See photos 7 & 8 below.

**Photo 7** shows the engine strut bar (arrowed) fitted on the Insured Vehicle. However it had sustained minor fire damage.

31. Although the engine strut bar and aftermarket alloy rims fitted on the Insured Vehicle were not the standard type for the Insured Vehicle, we are of the view that these parts did not cause and/or contribute to the fire incident.

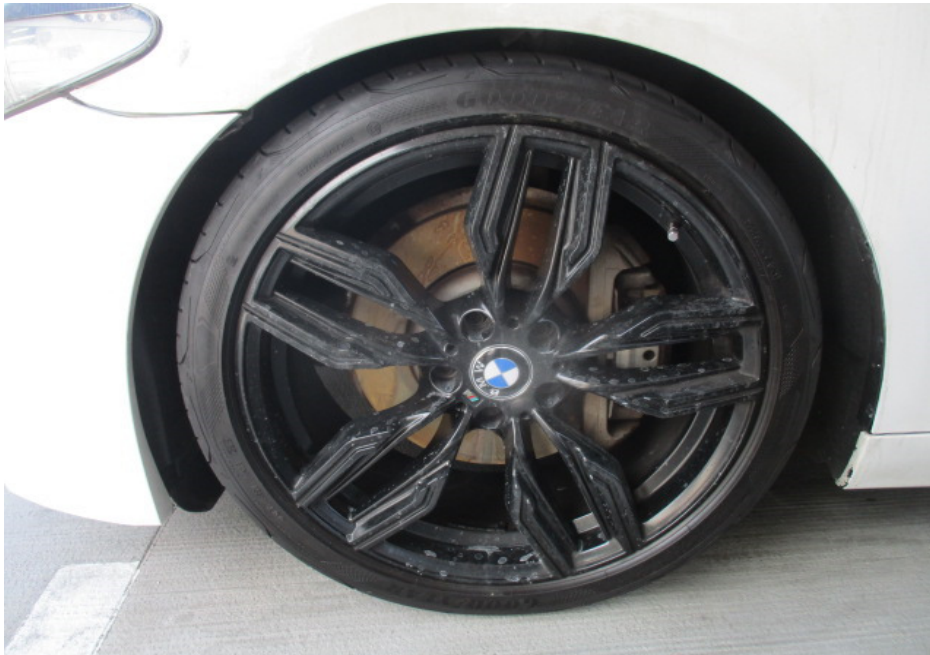
**Photo 8** shows the non-standard rim found to be fitted on the Insured Vehicle at the time of our inspection. The 20- inch alloy rims fitted on the Insured Vehicle were not the standard type for the Insured Vehicle.

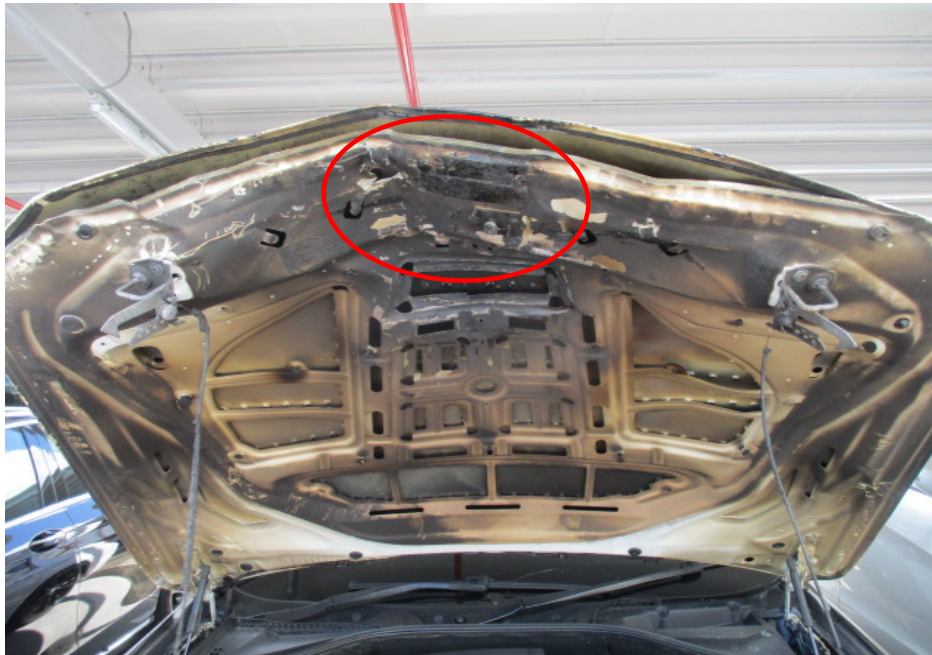
8. For this particular case, the fire appears to have originated within the engine compartment of the Insured Vehicle, somewhere around the front centre portion of the engine compartment. This can be determined from the discolouration found on the top centre portion of the underside of the bonnet due to prolonged exposure to high heat intensity. A closer examination revealed faint whitish burn marks on the top centre portion on the underside of the bonnet due to prolonged exposure to high heat intensity. We also observed paint bubbles on the front centre portion of the front bonnet. In general the location of the fires' origin was determined given that the damage of fire nature was confined to these particular areas on the Insured Vehicle. See photos 9 - 11 below.

**Photo 9** shows the burn pattern on the underside of the bonnet of the Insured Vehicle due to prolonged exposure to high heat intensity caused by the fire (circled).

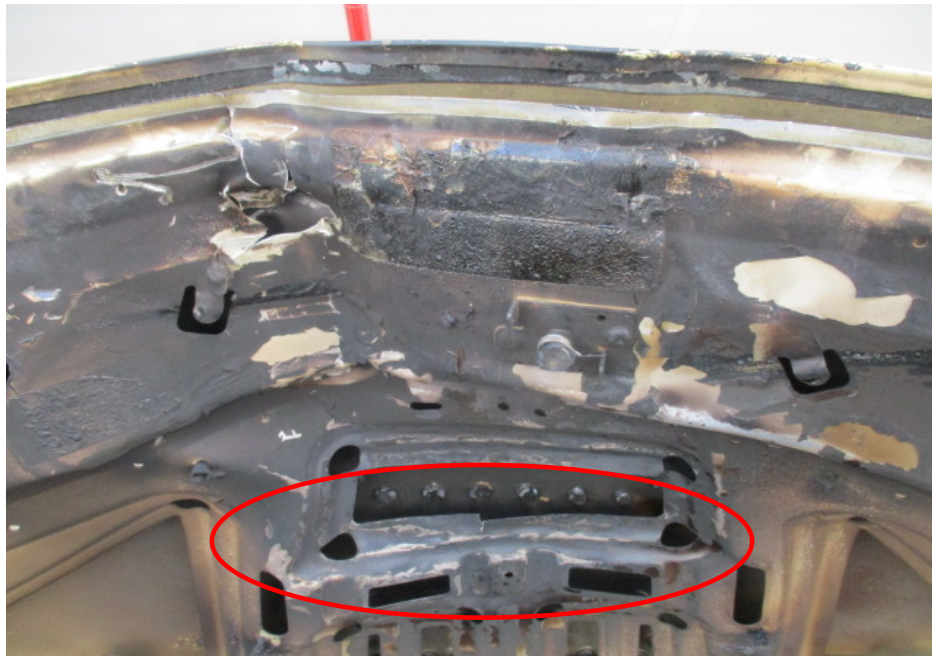
**Photo 10** shows upon closer examination, we noticed whitish burn marks on the top centre portion on the underside of the bonnet of the Insured Vehicle due to prolonged exposure to high heat intensity caused by the fire (circled).

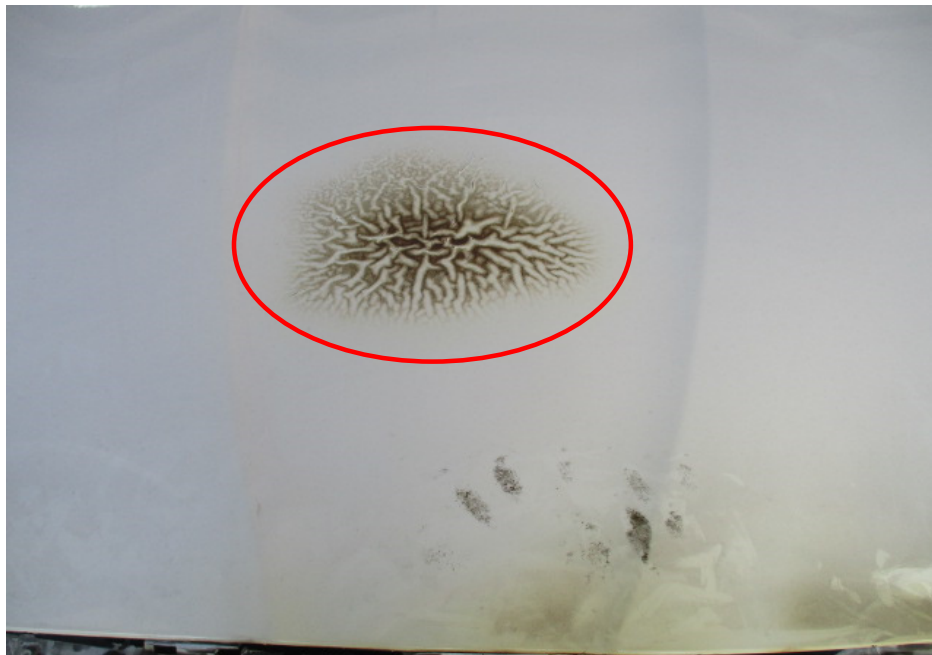
**Photo 11** shows the burn marks and paint bubbles on the front centre portion of the front bonnet of the Insured Vehicle (circled).

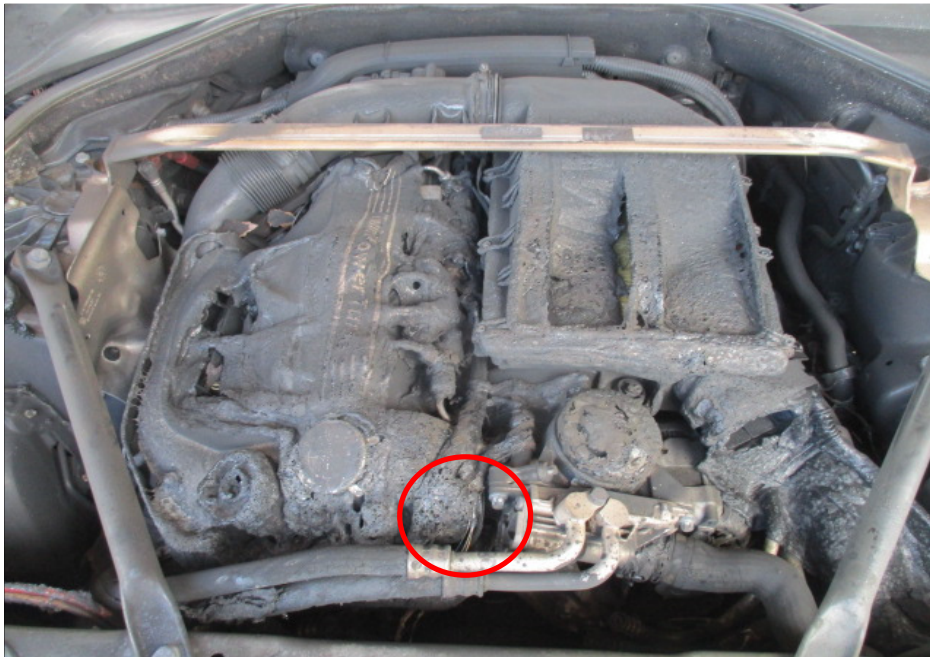
9. Upon closer examination of the front centre portion of the engine compartment which was where the fire to the Insured Vehicle had likely started, we had found traces of greenish residue on several stretches of burnt wirings. The presence of greenish residue indicates internal heating of copper wires, a sign of an electrical short circuit occurring. The greenish residue is normally left behind from oxidation as a result of chemical reaction involving the copper wires. This physical evidence would then appear to suggest that the cause of fire to the Insured Vehicle could have possibly been due to electrical in nature. See photos 12 - 15 below.

**Photo 12** shows the burnt wirings around the front centre portion of the engine compartment (circled), which is in the immediate vicinity where the fire to the Insured Vehicle had likely started.

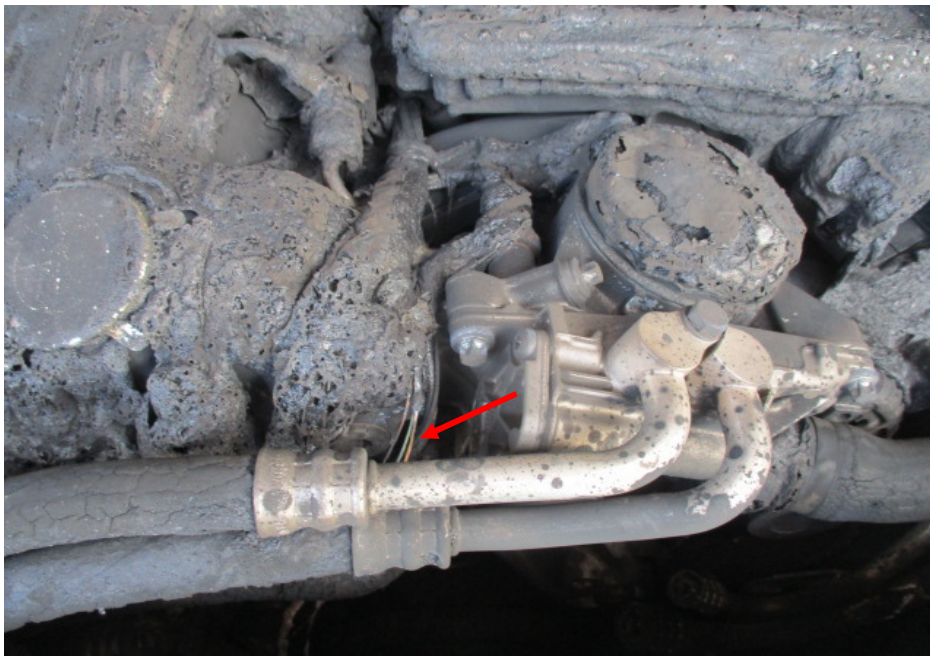
**Photo 13** shows a closer view of the burnt wirings around the front centre portion of the engine compartment, which is in the immediate vicinity where the fire to the Insured Vehicle had likely started. We noticed greenish residue on several stretches of burnt wirings (arrowed). The presence of greenish residue indicates internal heating of copper wires, a sign of an electrical short circuit occurring. The greenish residue is normally left behind from oxidation as a result of chemical reaction involving the copper wires.

28. Having investigated and technically analysed the damages of burnt nature to the Insured Vehicle, we are of the view that the cause of fire to the Insured Vehicle was of electrical in nature. For this particular case, the fire had originated along the wirings inside the engine compartment, somewhere around the front centre portion of the engine compartment. The wirings were original factory wirings of the Insured Vehicle.

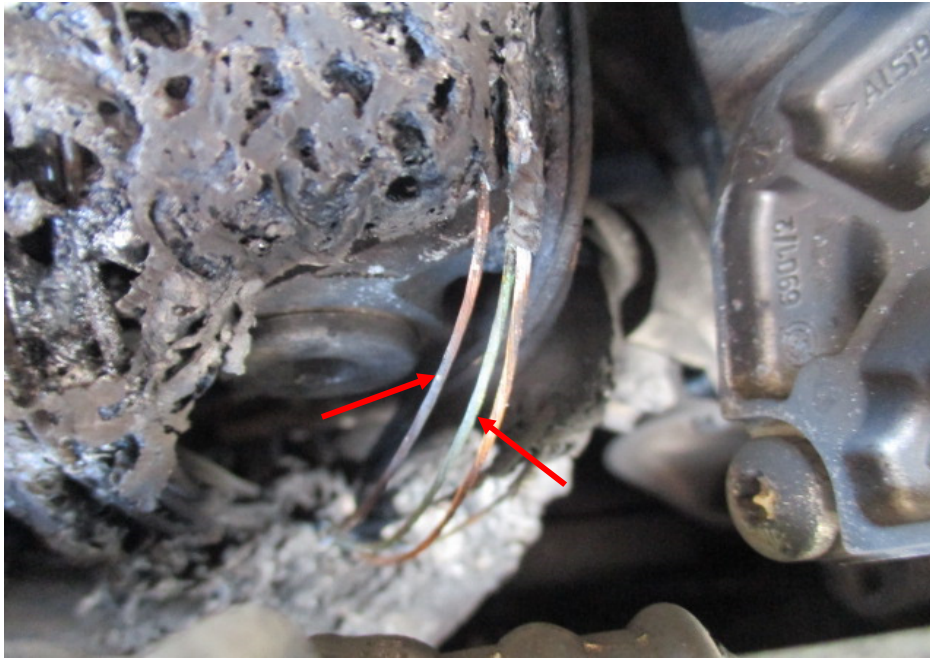
**Photo 14** shows a close up view of the greenish residue found on several stretches of burnt wirings (red arrows). The presence of such greenish residue suggests occurrence of an electrical short circuit.

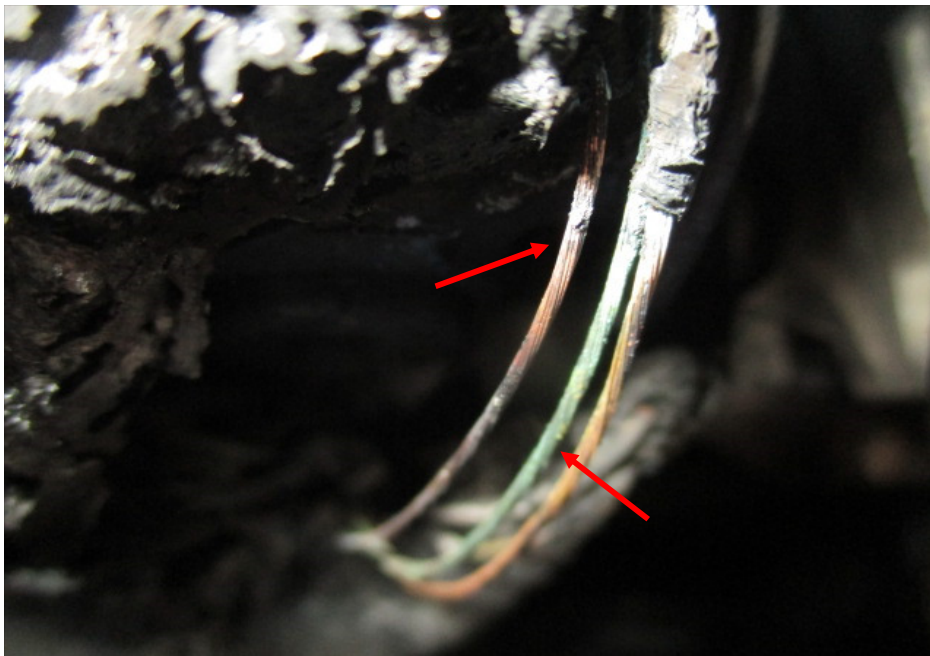
**Photo 15** shows a close up view of the greenish residue found on several stretches of burnt wirings (red arrows). The presence of such greenish residue suggests occurrence of an electrical short circuit.

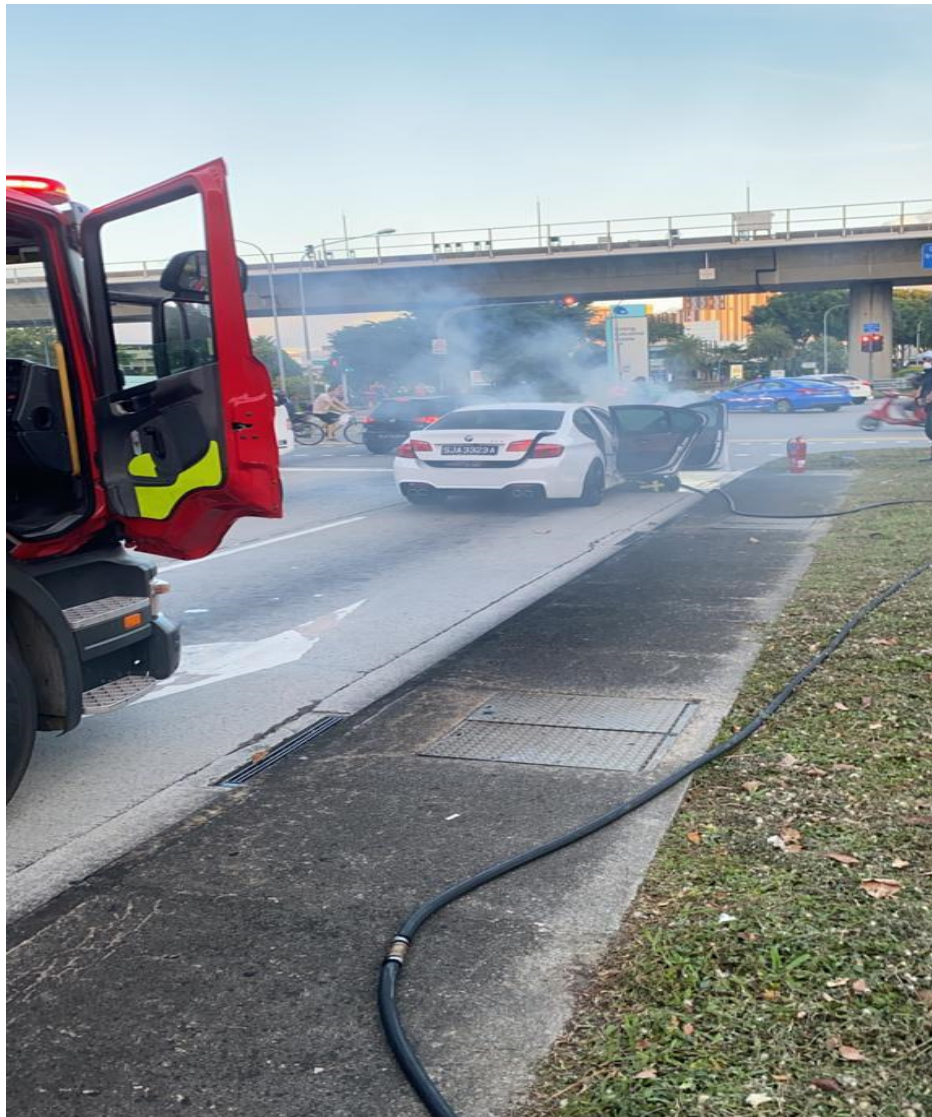
**Photo 16** shows firefighters attempting to put out the fire.

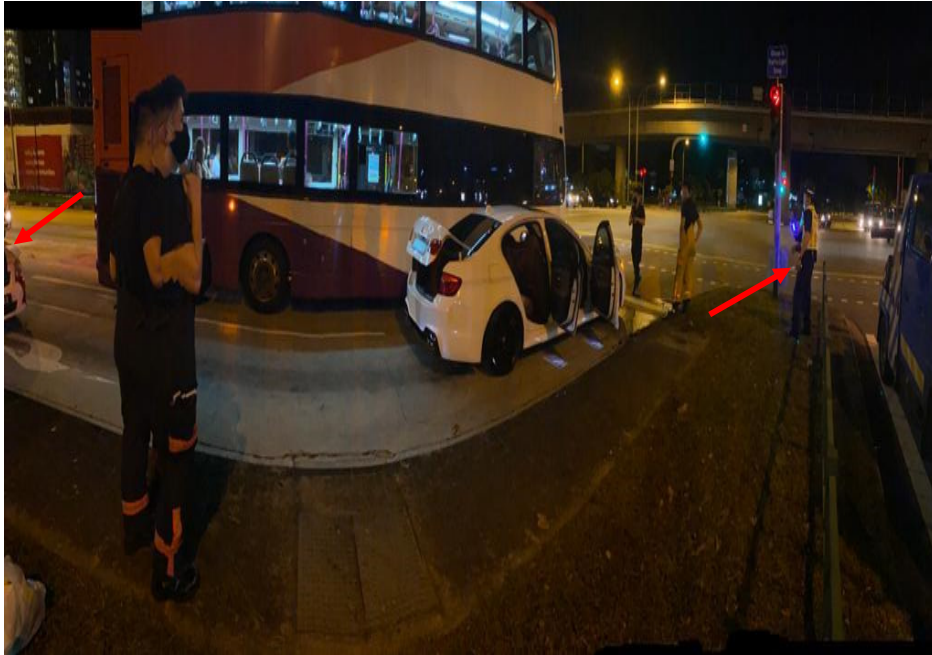
**Photo 17** shows the SCDF conducting preliminary investigations post- incident. In general, the information that could be gathered from this photograph had corresponded to the events that were related to us by Mr Razali, which is the police were present at the incident location together with the SCDF (arrowed).

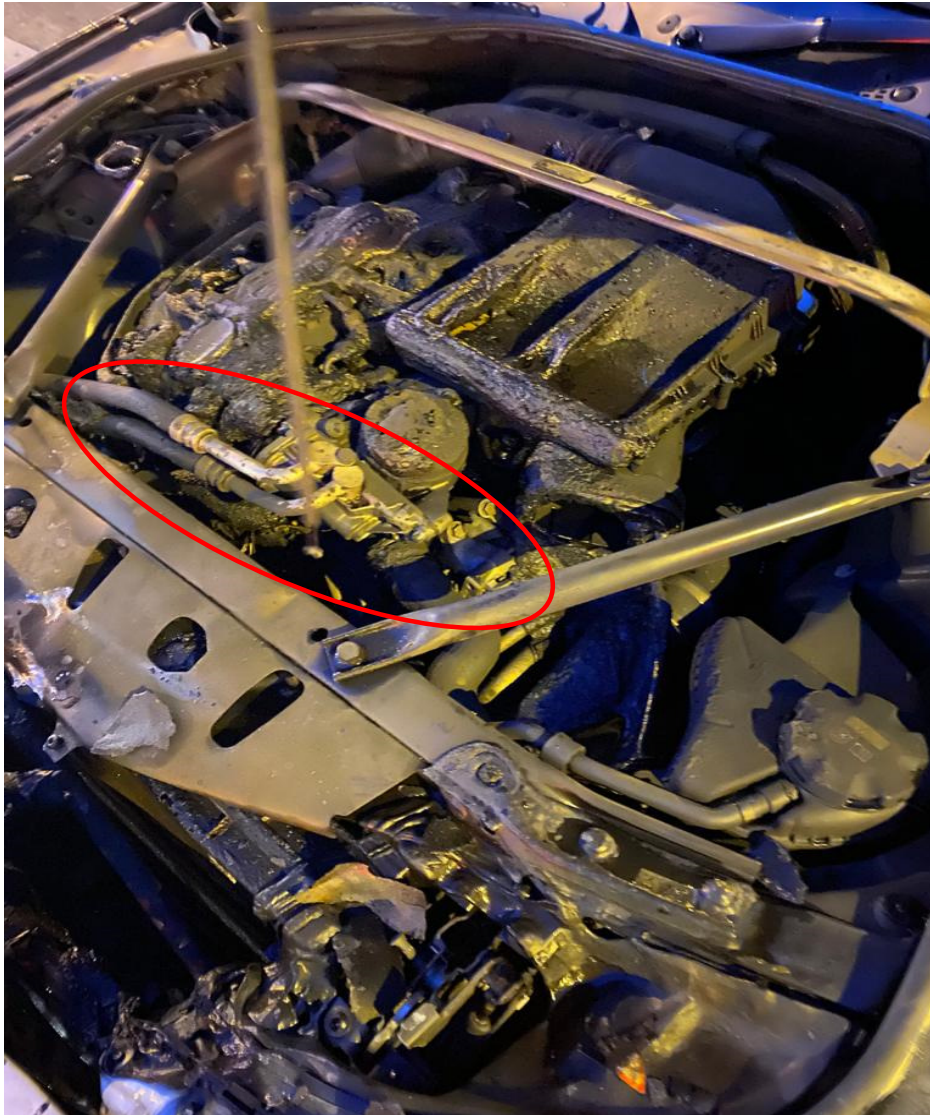
**Photo 18** shows the engine compartment of the Insured Vehicle after the fire was extinguished. In general, the extensive damages sustained (circled) had corresponded to the events that were related to us by Mr Razali, which is the fire started from the engine compartment.
