Your Ref: Audi RS 5
(chassis number WUAZZZF5XJA904716)
Our Ref : CI/TP20007503/D

22 July 2020

**INSPECTION REPORT OF AN UNREGISTERD AUDI RS 5 MOTOR CAR
WITH CHASSIS NUMBER WUAZZZF5XJA904716**

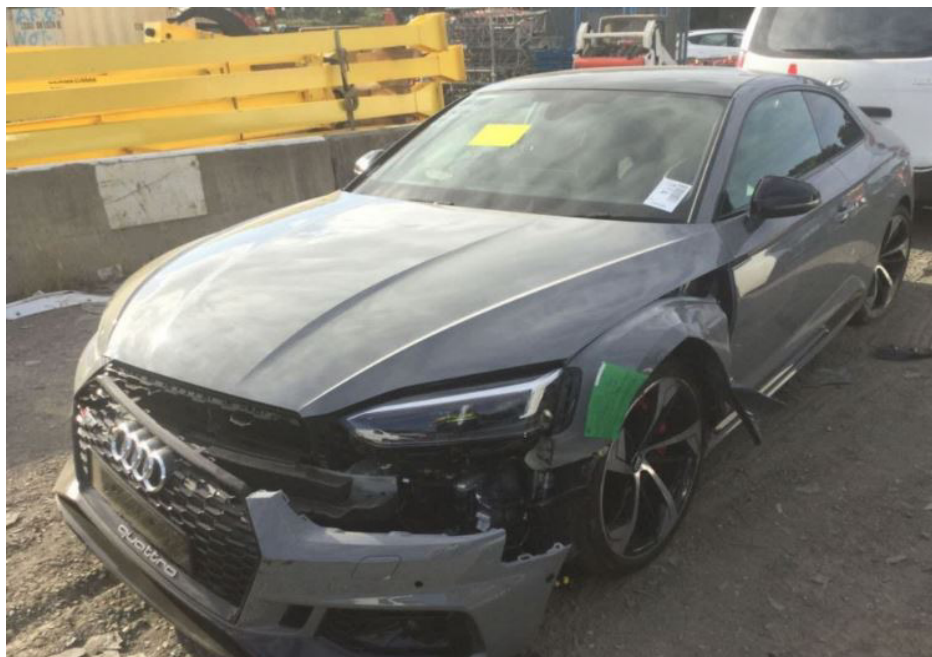
3. From the photographs provided to me, it was observed that the Motor Car had sustained damages at its front left body. Body parts observed to have been damaged and/or dislodged include its front bumper, front grille, front left fender, and front left wheel rim amongst others. The rear left undercarriage parts were also affected as the orientation of the rear left wheel rim was towards the right instead of in a straight orientation. See photo 1 – 3 below.

Photo 1 shows the front left body of the Motor Car prior to any repairs being carried out (photograph provided to me). The Motor Car was observed to have sustained damages at its front left body. The body parts observed to be damaged and/or dislodged had included its front bumper, front grille, front left fender and front left wheel rim amongst others.

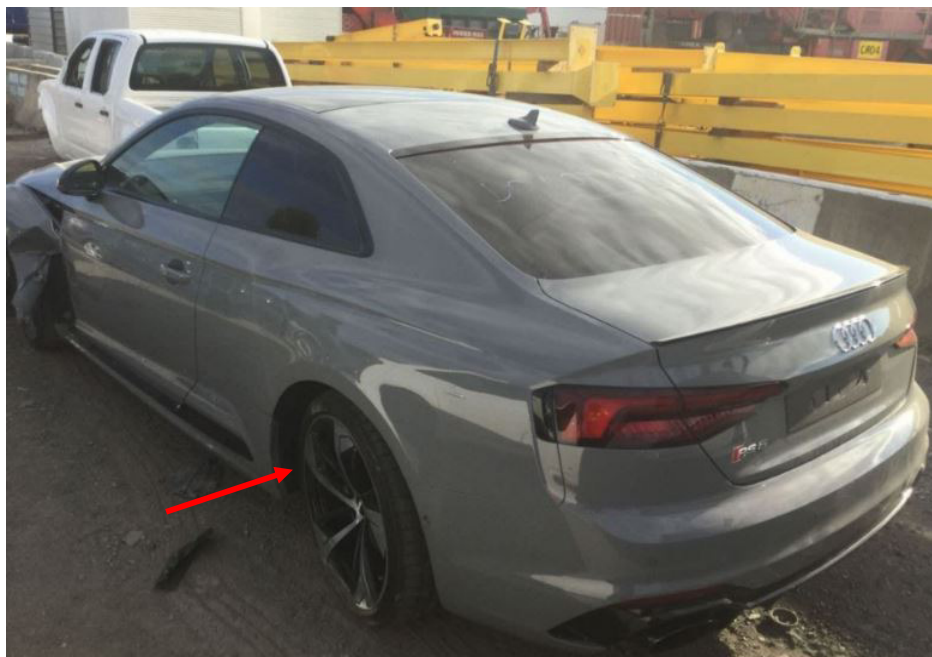
Photo 2 shows the rear left body of the Motor Car prior to any repairs being carried out (photograph provided to me). The rear left wheel rim was observed to be oriented towards the right (arrowed), which would indicate that the rear left undercarriage parts of the Motor Car were affected.

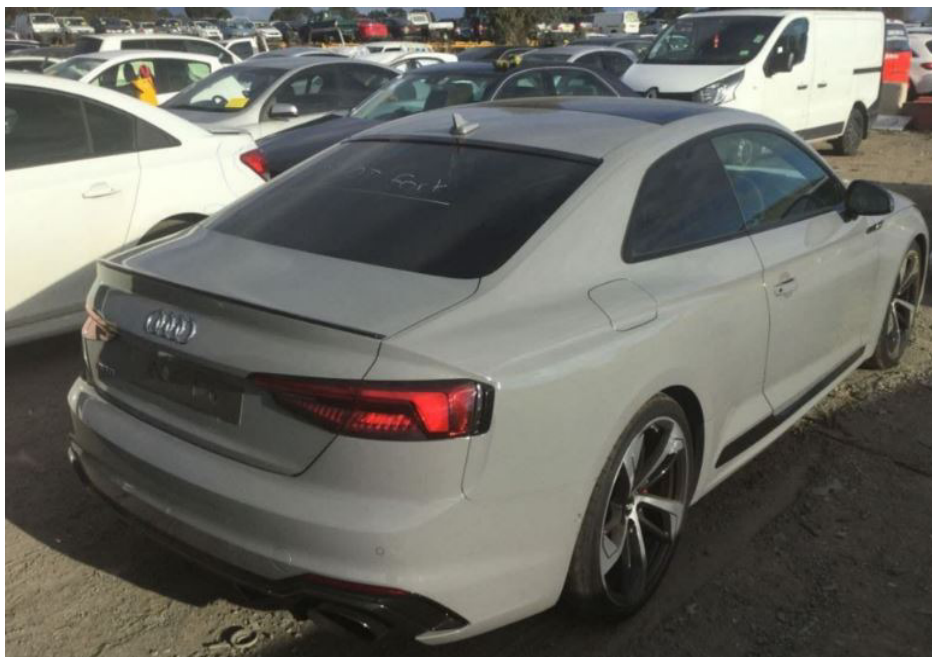
Photo 3 shows the rear right body of the Motor Car prior to any repairs being carried out (photograph provided to me). No damage was seen on the right side of the Motor Car. The rear right wheel rim was oriented straight as compared to the rear left wheel rim as shown in photograph 2 above.

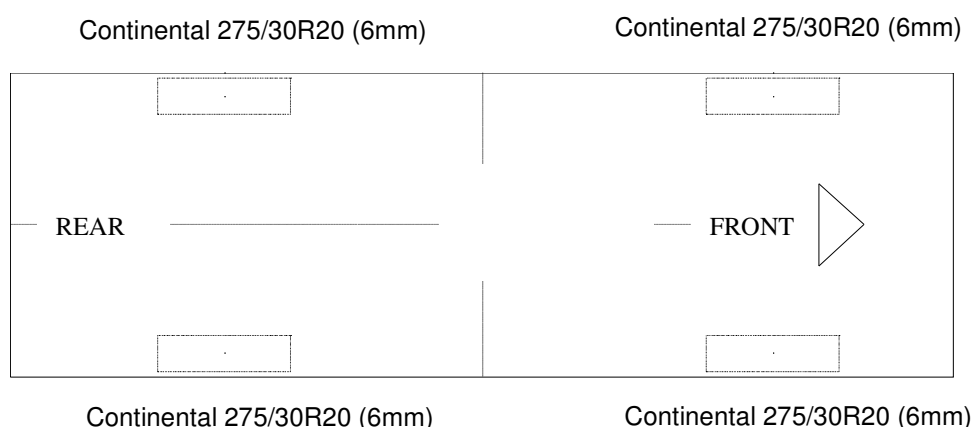
7. It was fitted with 20inch sport wheel rims that were wrapped with tyres that were observed to be of serviceable condition. The tyres were also sufficiently inflated for vehicular operation. The tyre brand, tyre size and approximate remaining tread depth of the 4 tyres of the Motor Car were recorded as follows: -

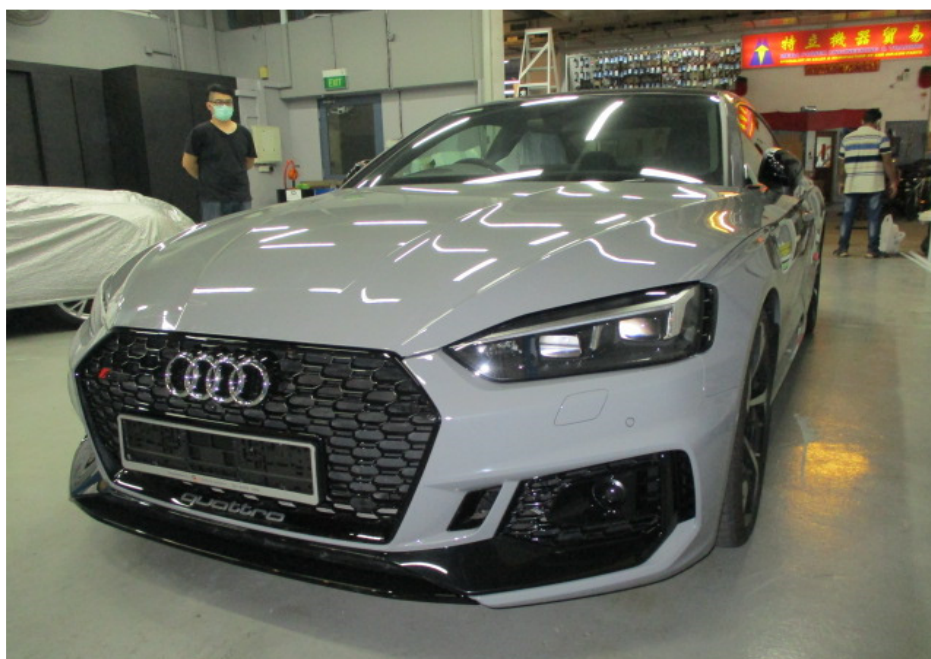
Photo 4 shows a general view of the front left body of the Motor Car at the time of my inspection. The Motor Car was observed to be in relatively good general condition with no loose exterior fittings observed. The body parts at the front left portion of the Motor Car were visually examined and it was observed that the repair/restoration works carried out to the damaged area of the Motor Car (refer photograph 1 above) were reasonably adequate and in order.

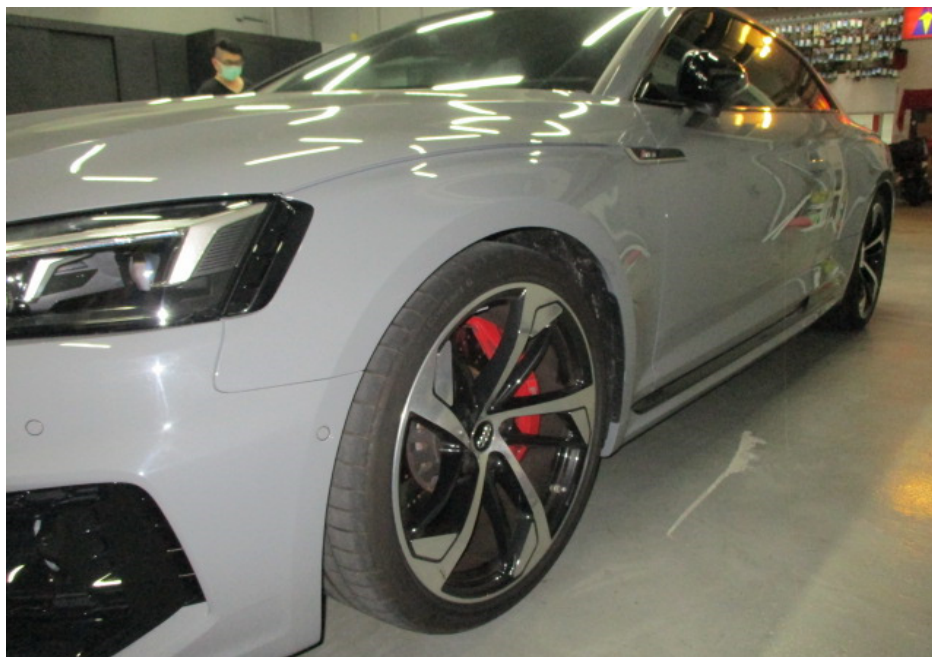
Photo 5 shows the front bumper, front left fender and front left wheel rim at the time of my inspection. The body parts at the front left portion of the Motor Car were visually examined and it was observed that the repair/restoration works carried out to the damaged area of the Motor Car (refer photograph 1 above) were reasonably adequate and in order.

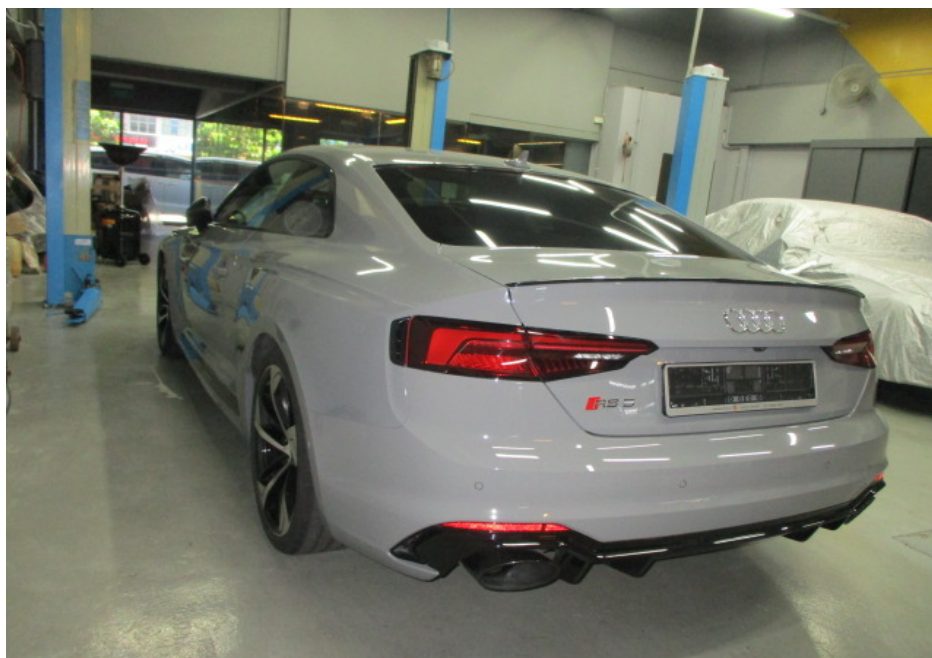
Photo 6 shows the rear left body of the Motor Car. The rear left wheel rim was orientated straight instead of towards the right (refer photograph 2 above) The undercarriage parts at the rear left wheel rim were visually examined (refer to photograph 14 below) and it was observed that the repair/restoration works carried out to the damaged area of the Motor Car were reasonably adequate and in order.

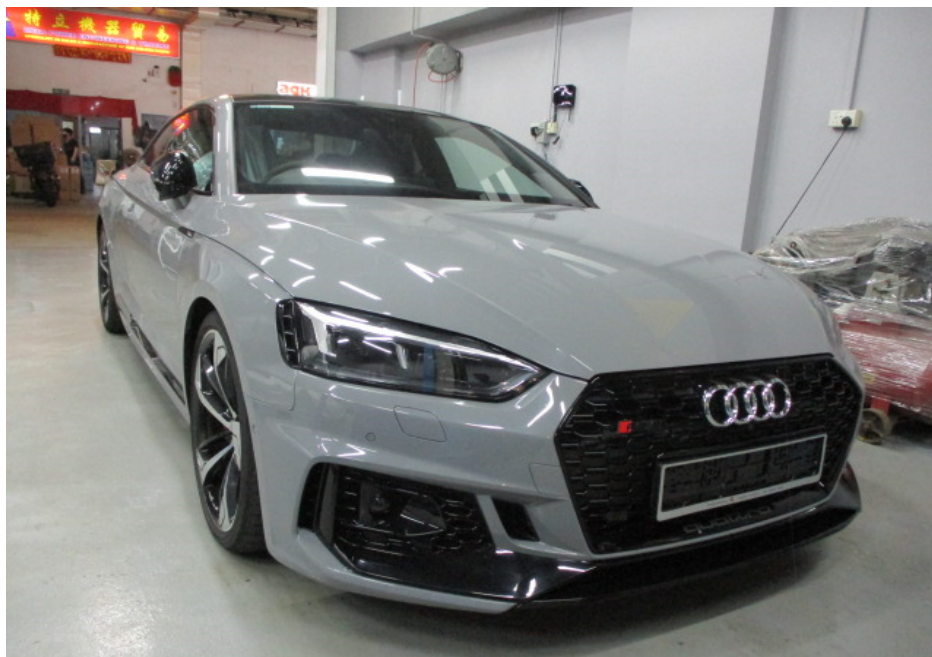
Photo 7 shows a general view of the front right body of the Motor Car at the time of my inspection. The Motor Car was observed to be in relatively good general condition with no loose exterior fittings observed.

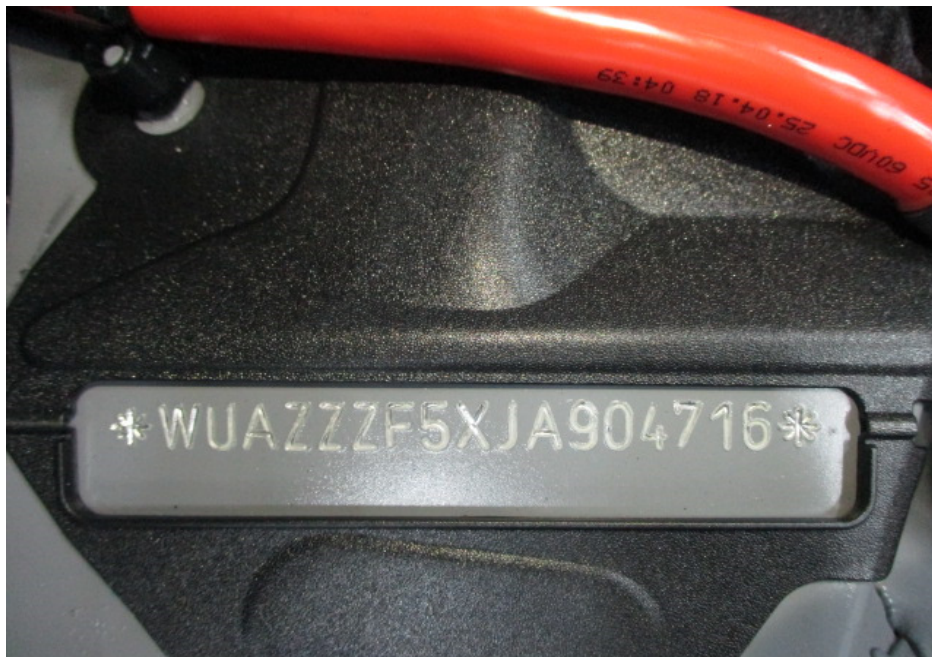
Photo 8 shows the chassis number of the Motor Car. The chassis number recorded was WUAZZZF5XJA904716.

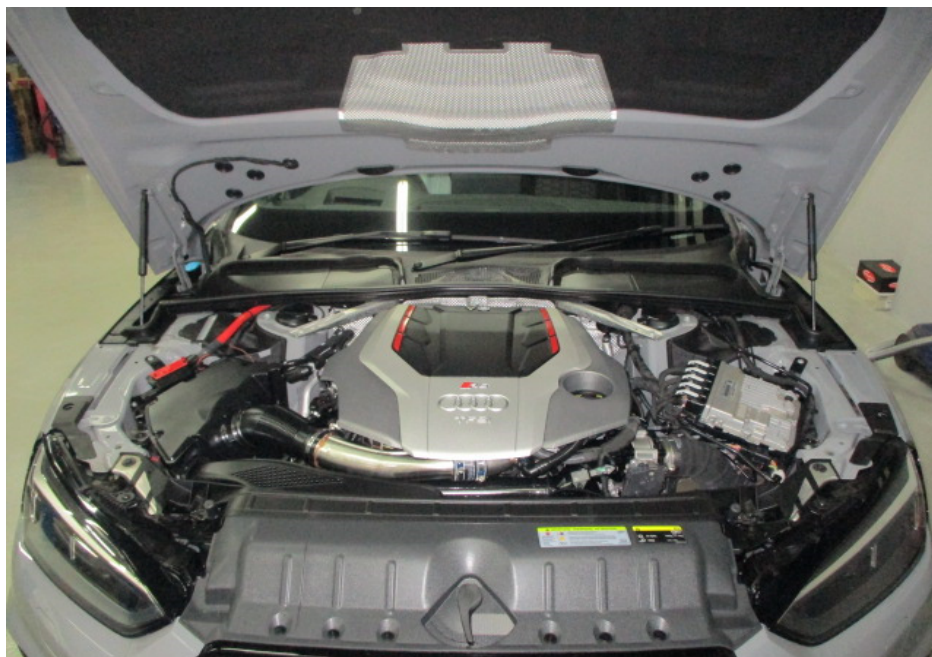
Photo 9 shows a general view of the engine compartment of the Motor Car at the time of my inspection. The various parts and components inside the engine compartment were all observed to be intact and properly fitted. There was also no sign(s) or indication(s) of fluid leak and/or fluid stain found inside the engine compartment.

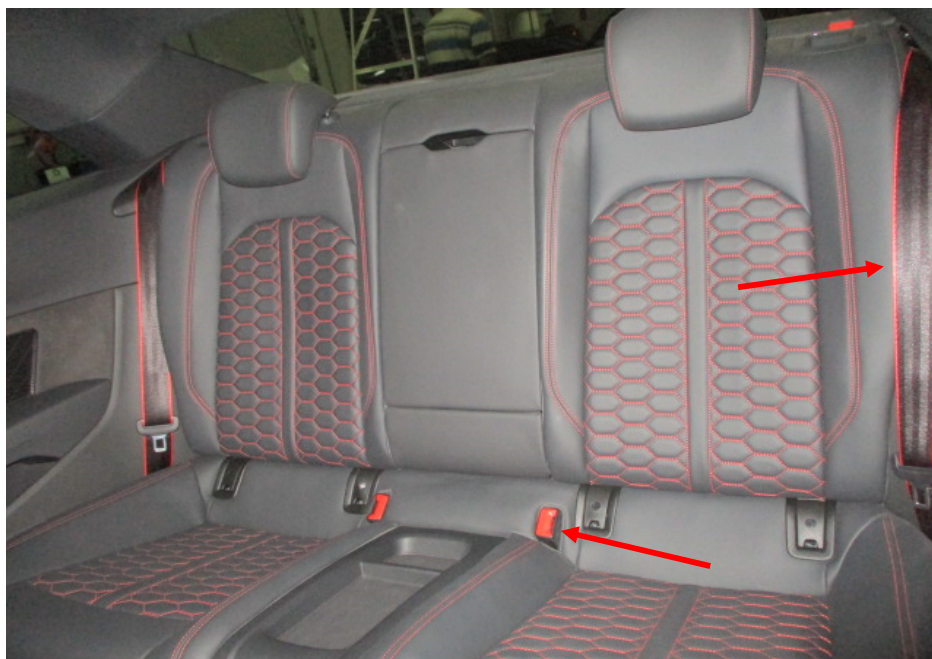
Photo 10 shows the rear seats of the Motor Car. All the seats of the Motor Car were fitted with a retractable seat belt reel and pre-tensioner (arrowed). The seat belts were tested and able to be fastened into the respective pre-tensions that were fitted on the side of each individual seat.

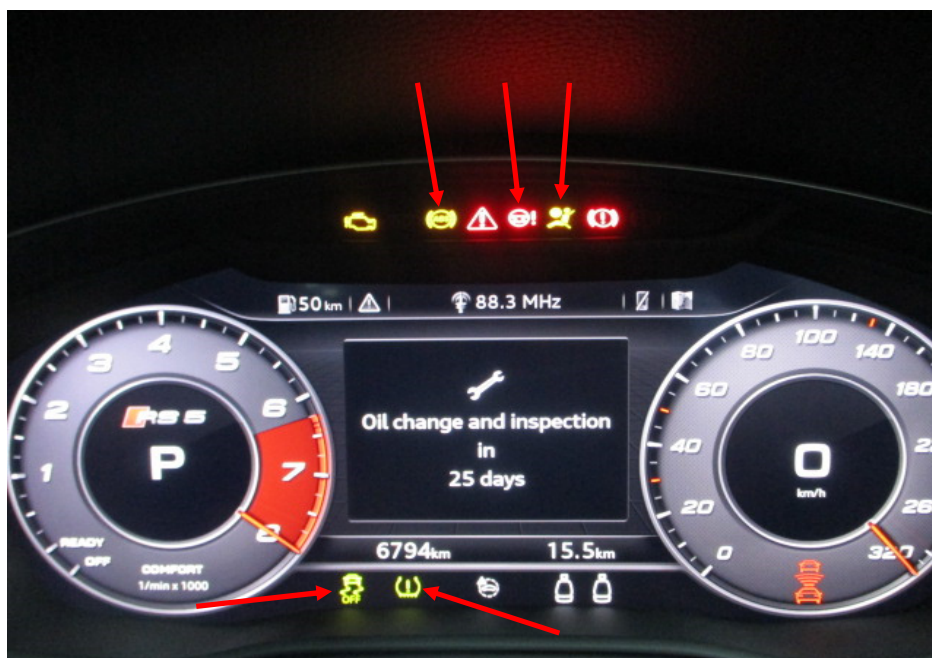
Photo 11 shows the warning lights for the various electronic safety features appearing on the instrument panel of the Motor Car during its self-test when the engine is cranked, in particular the ABS, SRS, EPS, ESC and TPM lights (arrowed).

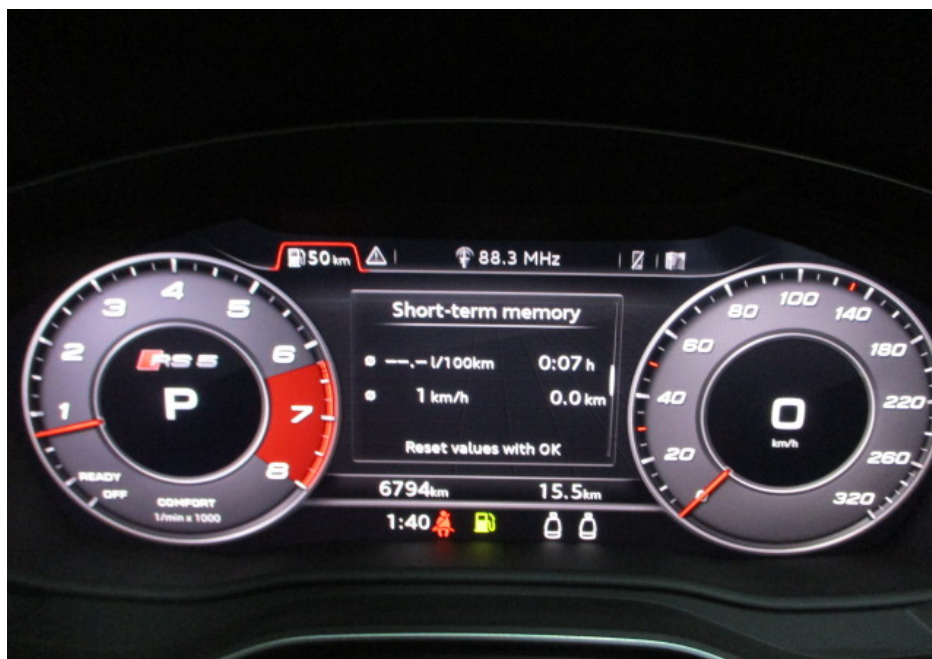
Photo 12 shows the respective warning lights no longer illuminated, indicating that there is no fault detected to the ABS, SRS, EPS, ESC and TPM systems of the Motor Car during the self-test. These electronic systems were hence in working condition at the time of my inspection.

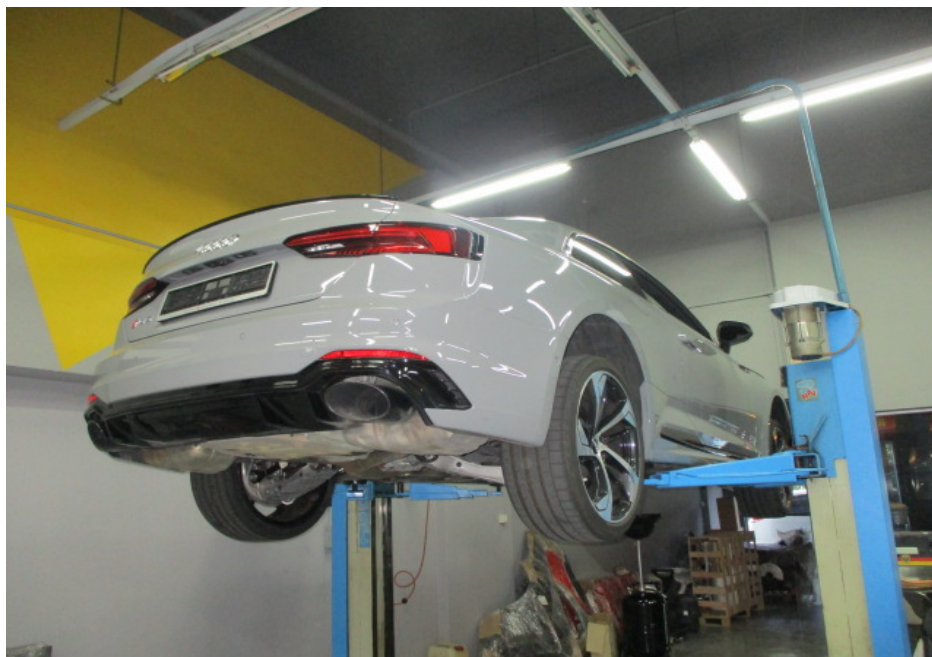
Photo 13 shows the Motor Car hoisted up for checks on its undercarriage. There was no sign(s) or indication(s) of fluid leakage and/or fluid stain(s) on the underside of the Motor Car. The undercarriage components of the Motor Car were also all observed to be intact and secured in an appropriate manner.

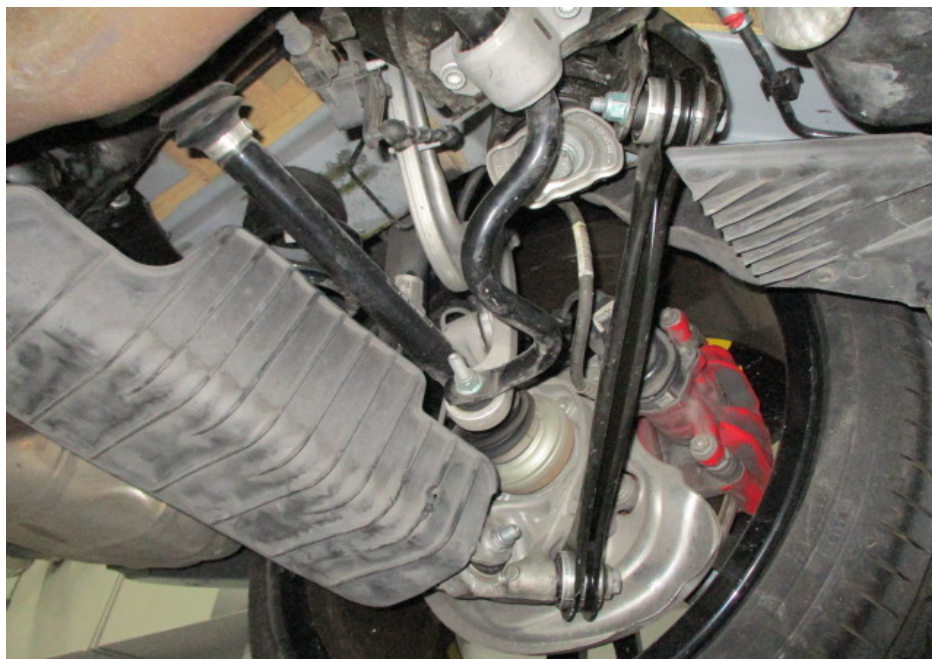
Photo 14 shows a general view of the control arms and linkages at the rear left wheel of the Motor Car. I did not observe any fluid leak and/or fluid stain on the underside of the Motor Car. All of the Motor Car's undercarriage components were observed to be intact and secured in an appropriate manner.

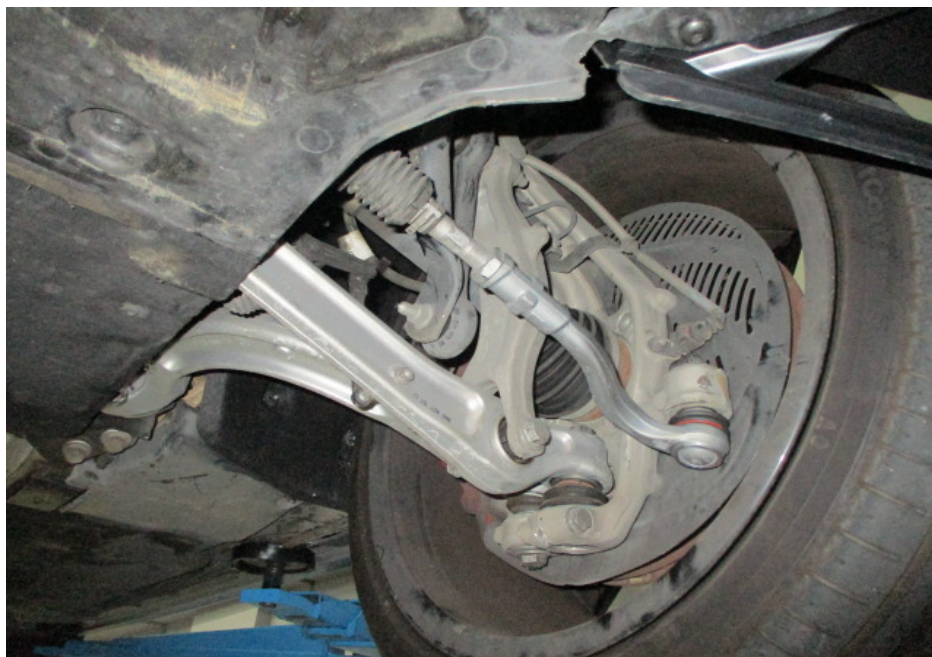
Photo 15 shows the various undercarriage components at the front left wheel of the Motor Car. The mechanical components, control arms and linkages were all found to be intact and secured in an appropriate manner.

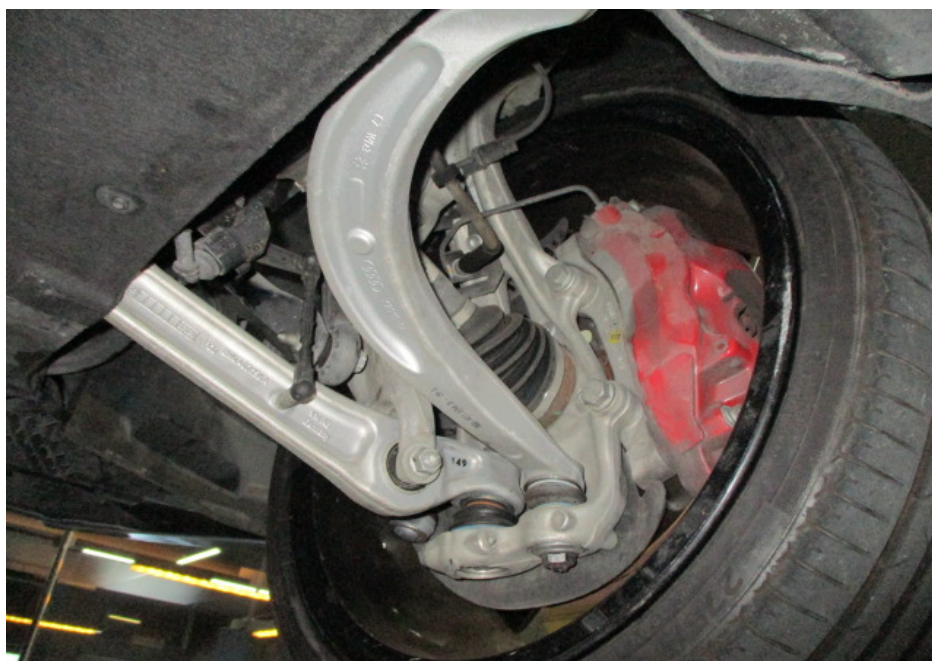
Photo 16 shows the various undercarriage components at the front right wheel of the Motor Car. The mechanical components, control arms and linkages were all found to be intact and secured in an appropriate manner. I also did not observe any fluid leak and/or fluid stain on the underside of the Motor Car.

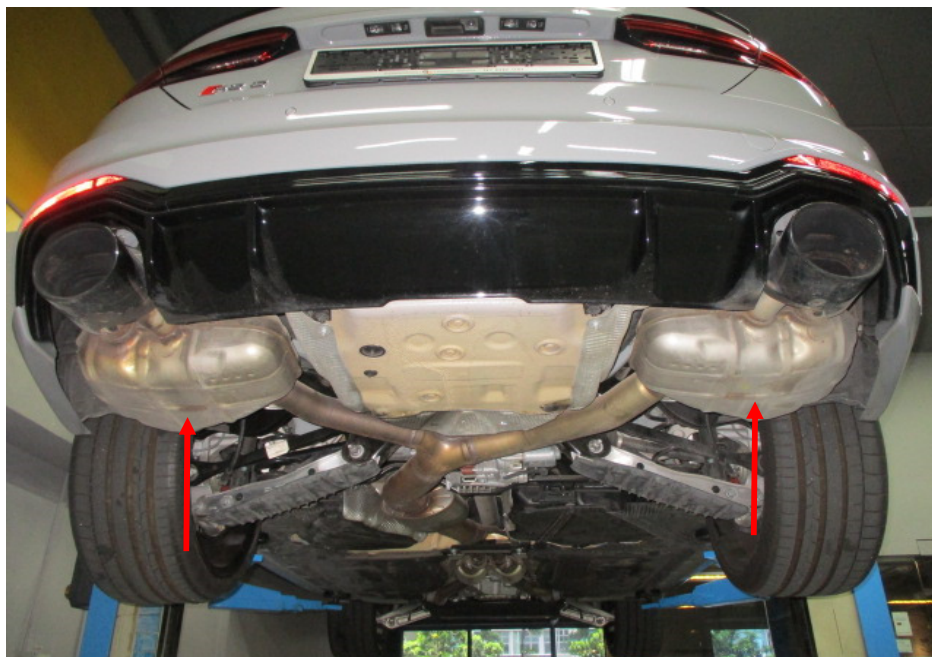
Photo 17 shows the Motor Car's rear mufflers (arrowed). My examination of the Motor Car's exhaust system revealed no sign(s) or indication(s) of any cut or weld marks along its exhaust pipes and on its catalytic converters.

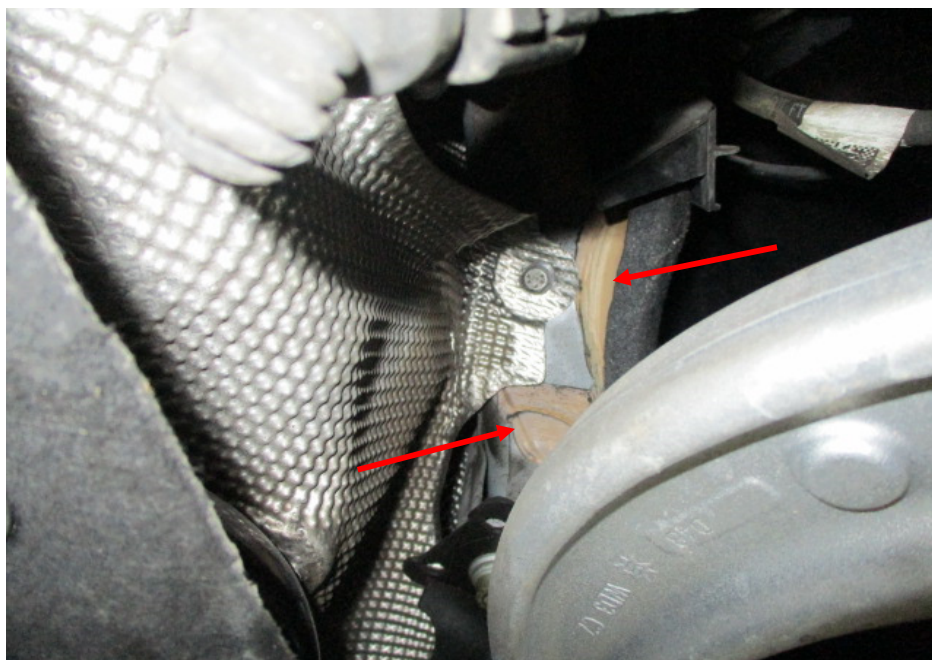
Photo 18 shows the chassis/structural body at the underside front left of the Motor Car. Visually, I did not find any weld marks other than original spot weld marks on the chassis/structural body of the Motor Car. The original factory sealant (arrowed) at the joints along the chassis/structural body was also untouched, indicating no work was done on the chassis/structural body of the Motor Car and that the chassis/structural body was originally fitted.

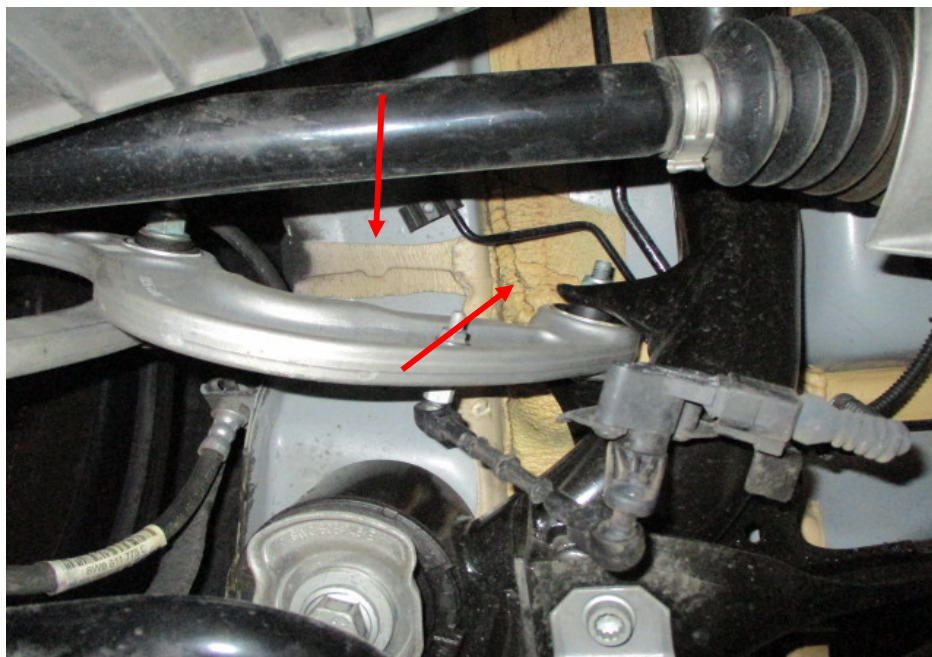
Photo 19 shows the chassis/structural body at the underside rear left of the Motor Car. Visually. The original factory sealant (arrowed) at the joints along the chassis/structural body was untouched, indicating no work was done on the chassis/structural body of the Motor Car and that the chassis/structural body was originally fitted.

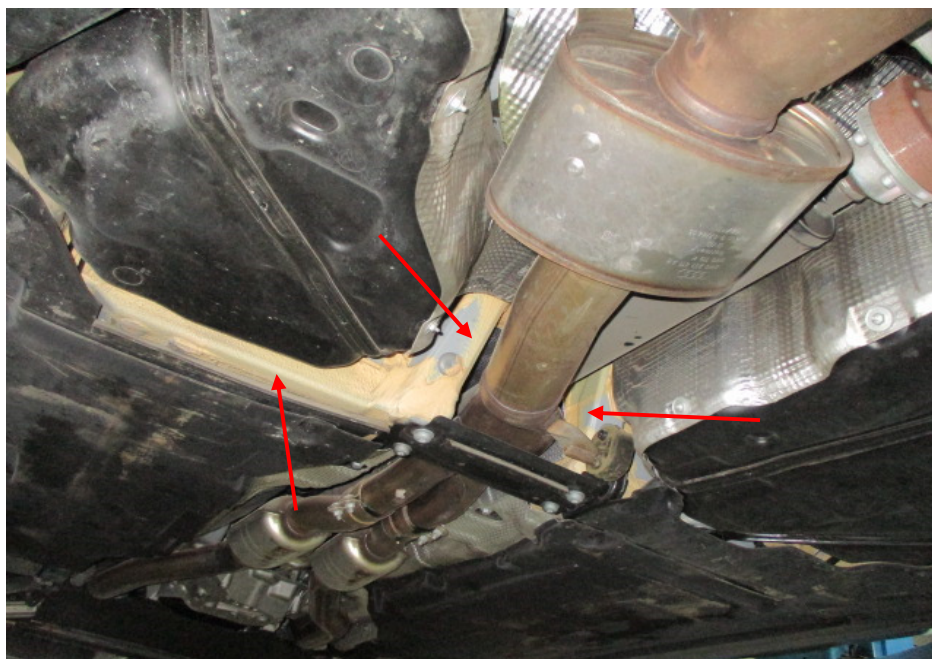
Photo 20 shows the floor board at the underside centre of the Motor Car. The original factory sealant (arrowed) at the joints along the non-detachable body panels were untouched, indicating no work was done on the non-detachable body panels of the Motor Car; and that these body panels were originally fitted.

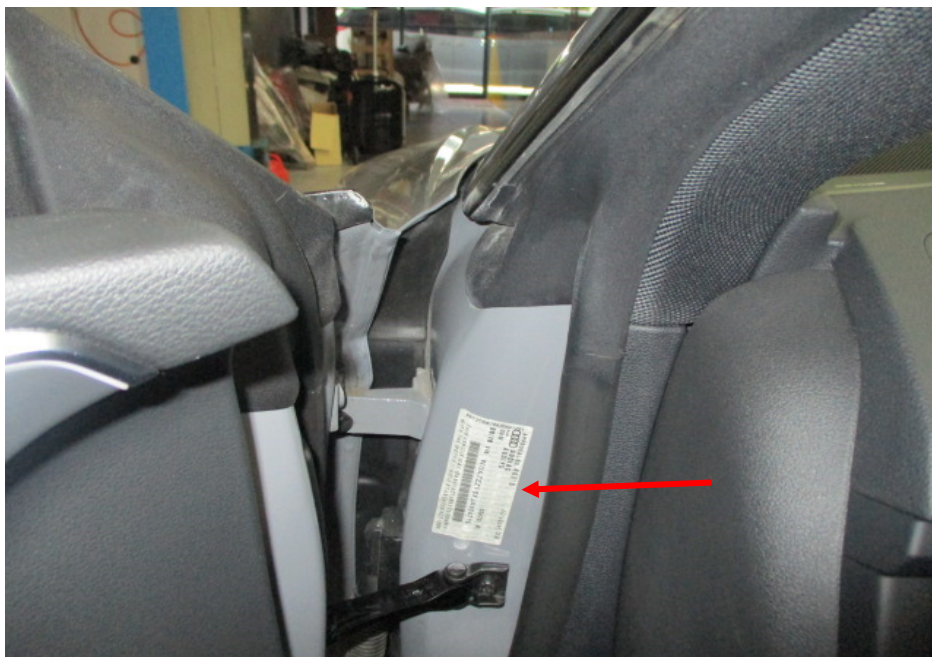
Photo 21 shows the left side "A" pillar of the Motor Car. The original factory label (arrowed) was seen at the left side "A" pillar indicating that the left side "A" pillar was originally fitted.
