## LKK Auto Consultants Pte Ltd

Affiliated to Federation Internationale Des Experts En Automobile				
CHINA TAIPING INSURANCE (S) PTE LTD		Ref : CC6/CTI20007512/Kks3q2		
3 ANSON ROAD #16-00 SPRINGLEAF TOWERS SINGAPORE 079909		Date : 19-10-2020

## ADJUSTMENT ON REPAIR COST FOR VEHICLE NO. SJZ 7866S

PHOTOGRAPHS FOR VEHICLE NO. SJZ 7866S

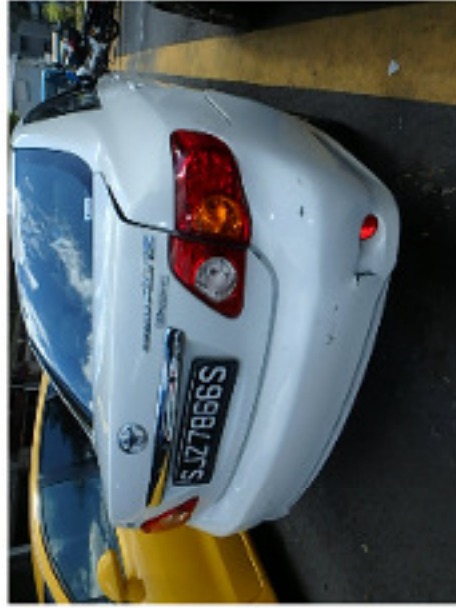
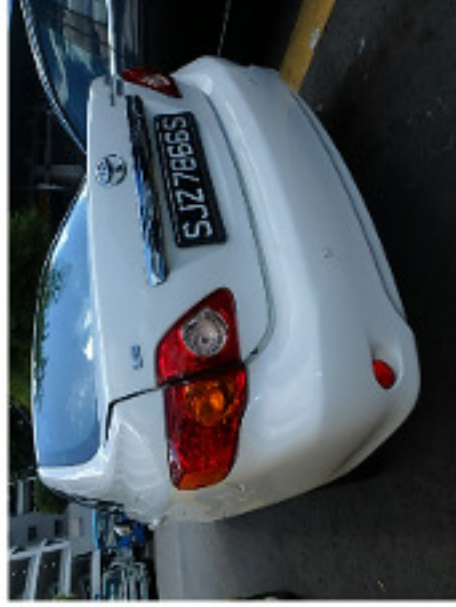
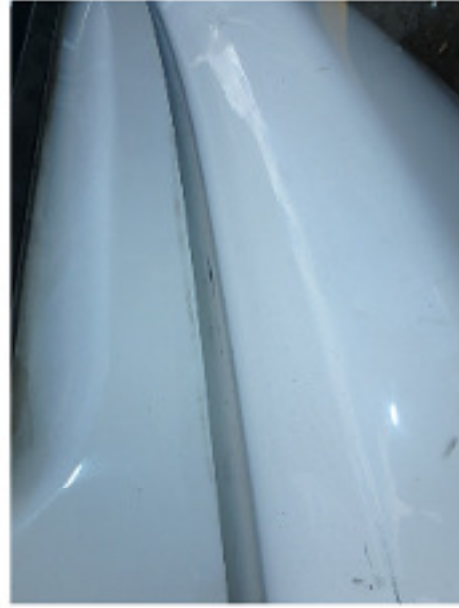
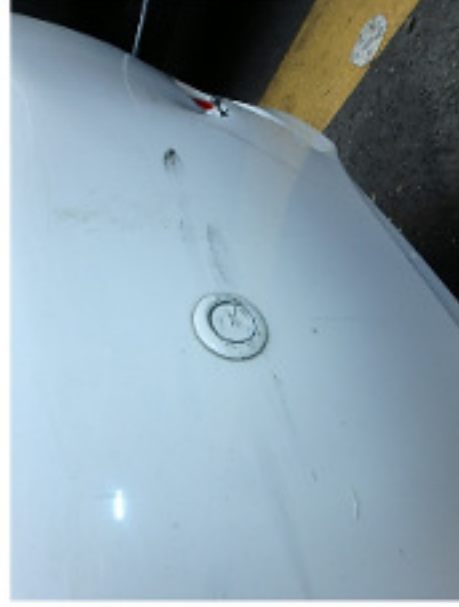
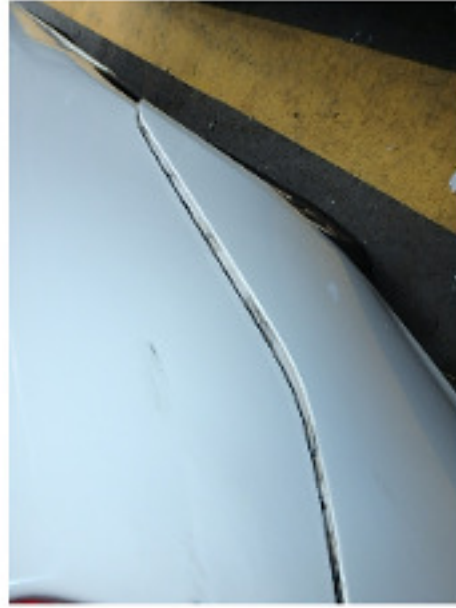
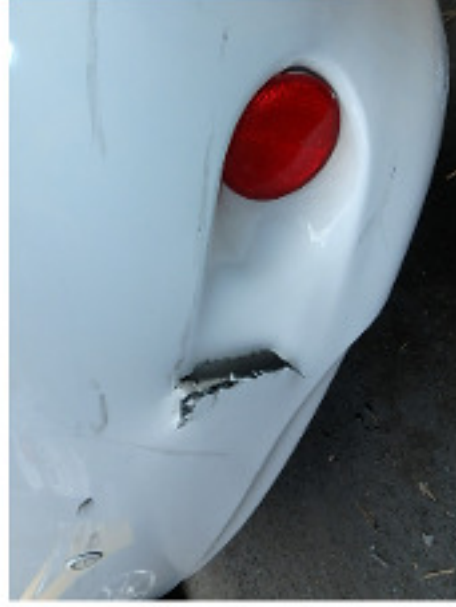
INSPECTION

<b>4. Description of Damages</b>				
THE VEHICLE SUSTAINED DAMAGES AT THE REAR PORTION.				
DAMAGES SEE DETAILS.				
<b>5. General Information</b>				
Accident Date	20/07/2020	Inspection Date	21/07/2020	
Survey held at	WEI LEE MOTOR WORKS BLOCK 9 SIN MING INDUSTRIAL ESTATE #01-32 SINGAPORE 575644.			
<b>5a. Remarks</b>
