Your Ref: S0M02R5X
Our Ref : CS4/ASM20007667/P

7th August 2020

**TECHNICAL INVESTIGATION REPORT OF FIRE INCIDENT INVOLVING THE
INSURED VEHICLE SJR 6161R ON 22nd JULY 2020**

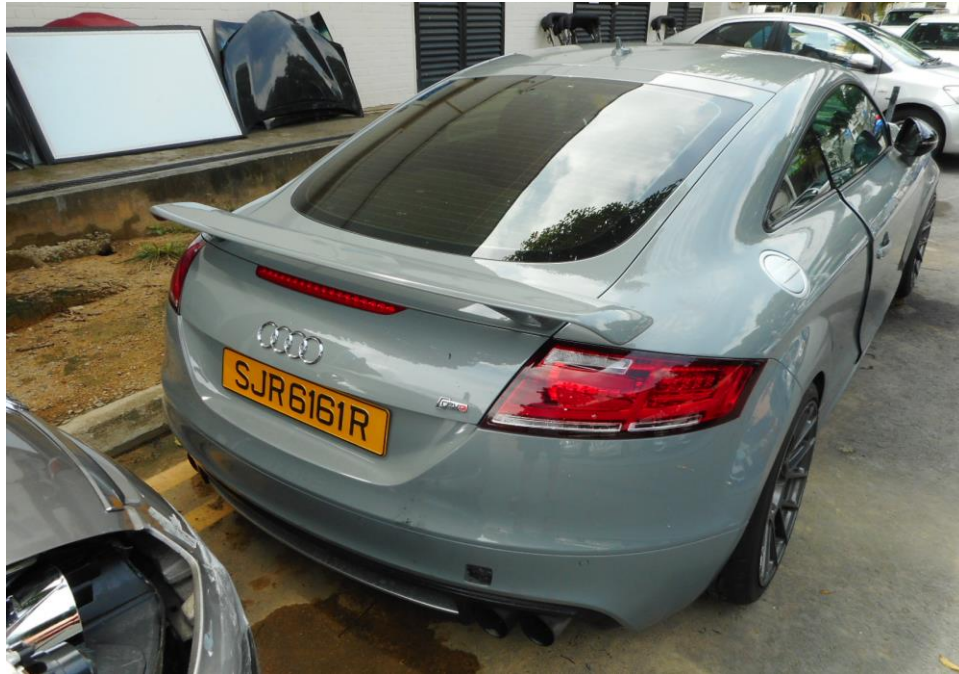
Photo 1 shows the rear portion of the Insured Vehicle, which was observed to be unaffected by the fire.

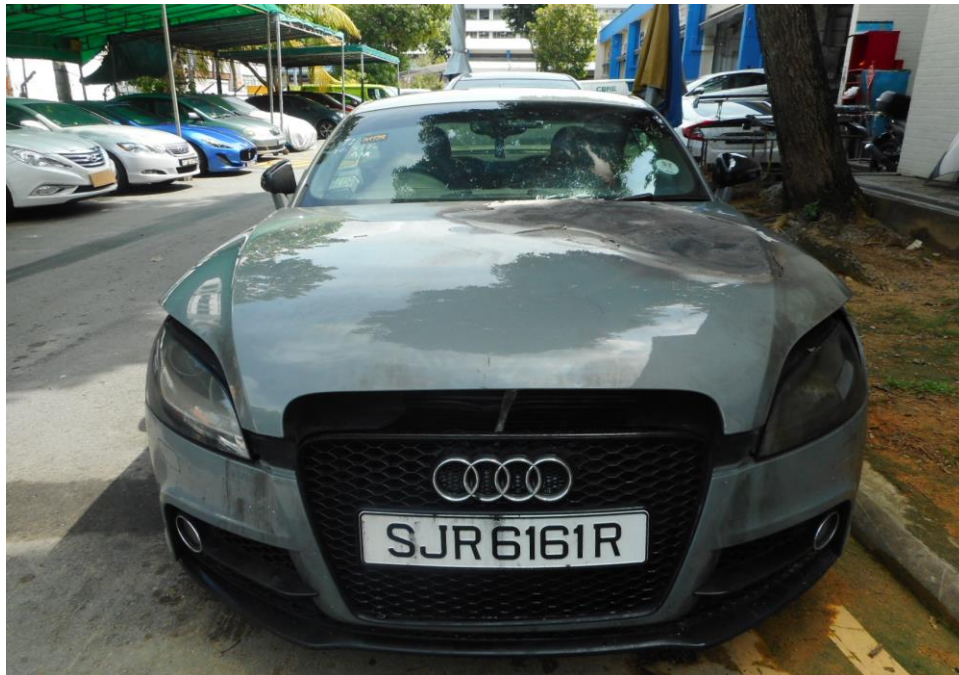
Photo 4 shows the general view of the front portion of the Insured Vehicle at the time of our inspection. The Insured Vehicle was observed to have sustained severe fire damage. Its engine compartment was completely burnt. Rust had accumulated around the engine compartment of the Insured Vehicle as a result of exposure to environmental condition for a period of time.

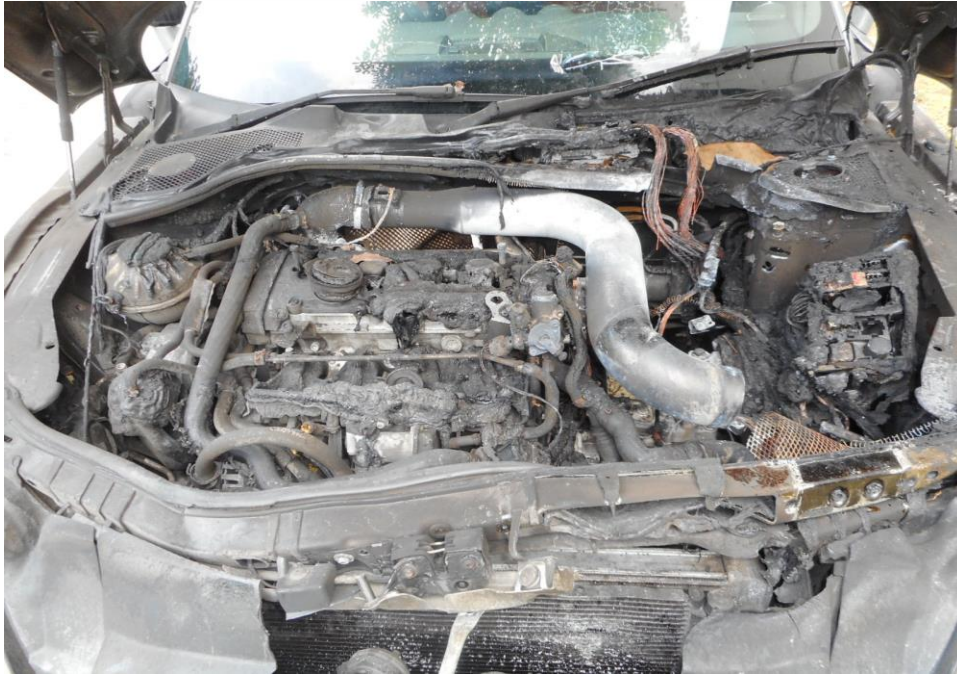
Photo 5 shows the engine compartment of the Insured Vehicle at the time of our inspection. The entire engine compartment of the Insured Vehicle was observed to be severely burnt. Most of the parts inside the engine compartment were found to be burnt and/or melted as a result of the fire.

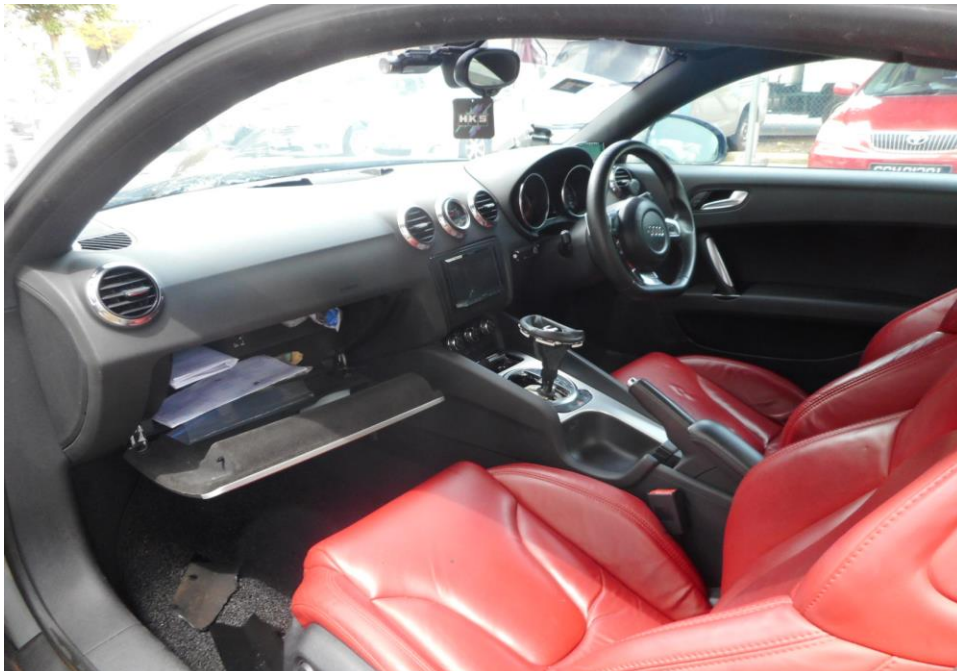
Photo 6 shows the interior view from the right side of the Insured Vehicle at the time of our inspection. The right side of the Insured Vehicle was observed to be unaffected by the fire.

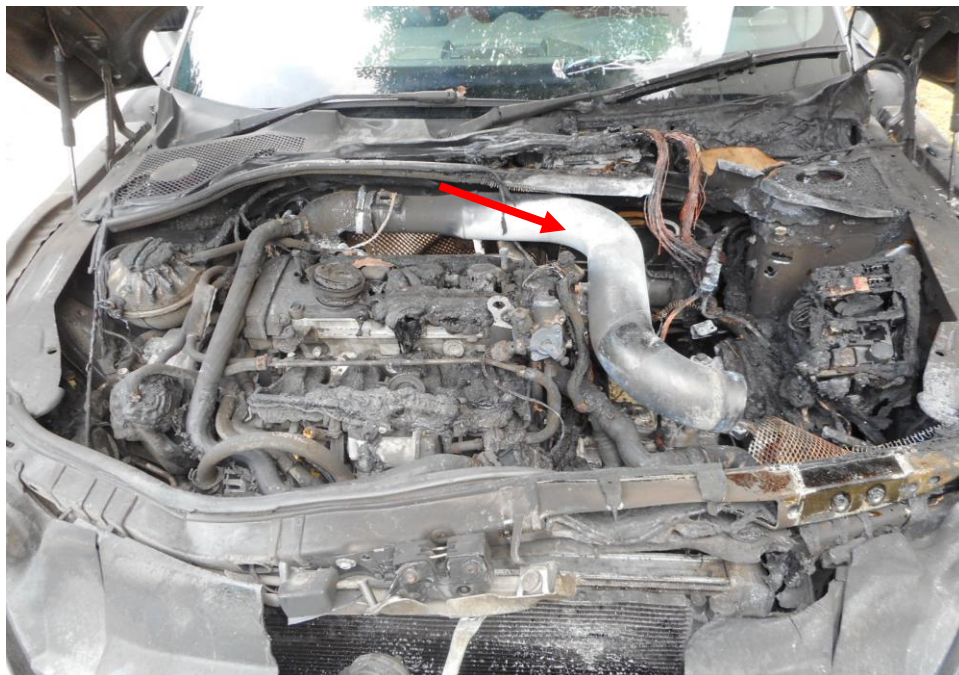
Photo 7 shows an aftermarket air filter pipe (arrowed) on the Insured Vehicle, which was observed to be affected by the fire.

26. We observed aftermarket air filter pipe, aftermarket brake capliers, brake disc component(s), audio head unit, monitoring gauges and exhaust system fitted on the Insured Vehicle at the time of our inspection of the Insured Vehicle. In our opinion, this components did not cause or contribute to the fire incident as the cause of fire was observed to be of short circuit origin on the original wiring harness of the Insured Vehicle.

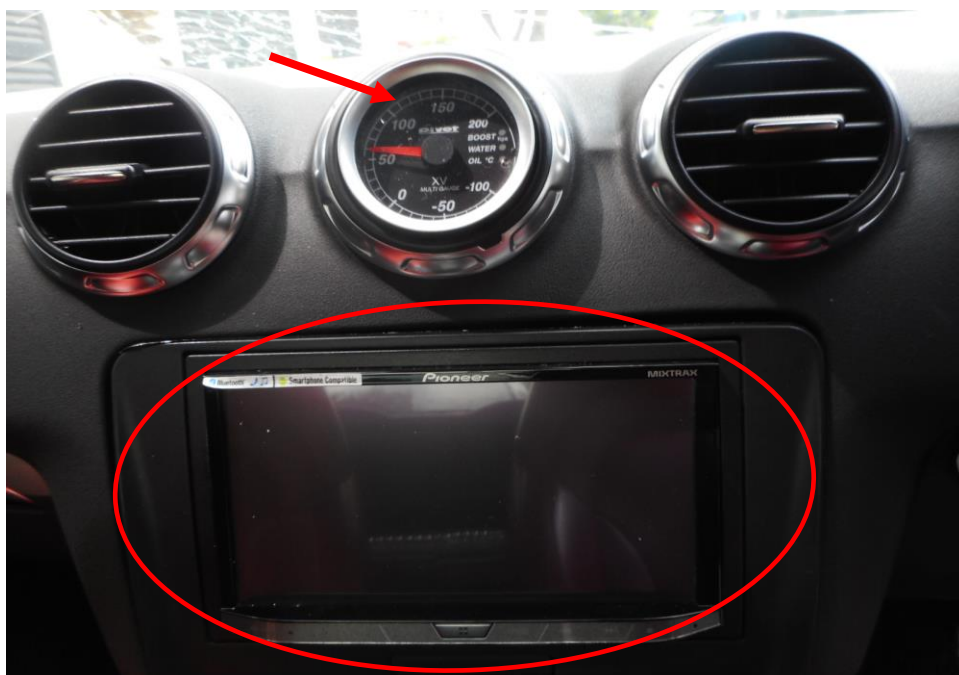
Photo 8 shows an aftermarket audio head unit (arrowed) and monitoring gauge (circled) on the Insured Vehicle, which was observed to be unaffected by the fire.

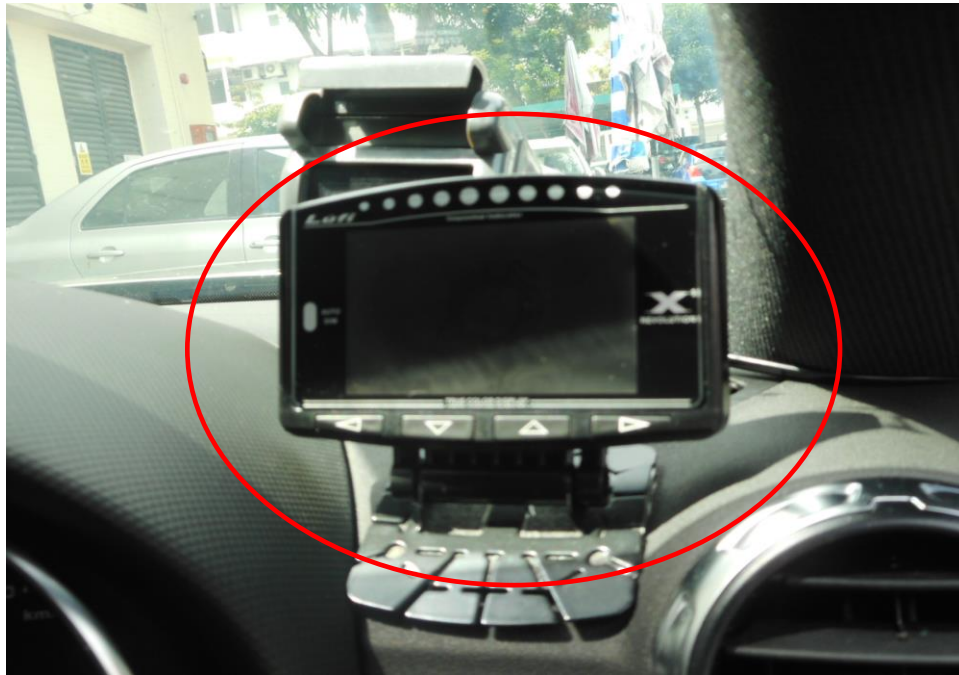
Photo 9 shows an aftermarket monitoring gauge (circled) on the Insured Vehicle, which was observed to be unaffected by the fire.

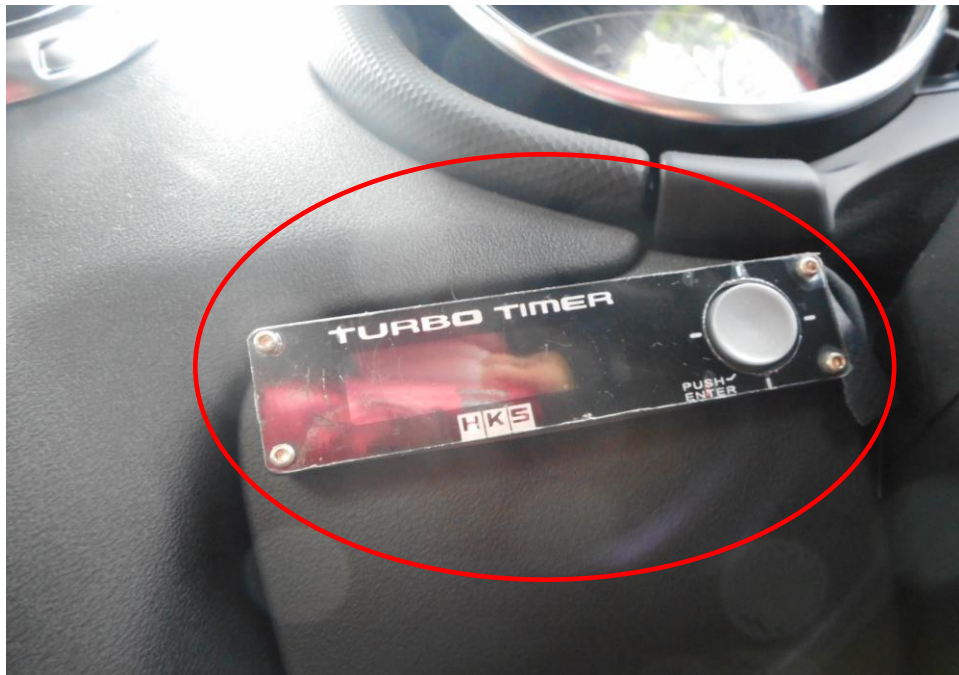
Photo 10 shows an aftermarket monitoring gauge (circled) on the Insured Vehicle, which was observed to be unaffected by the fire.

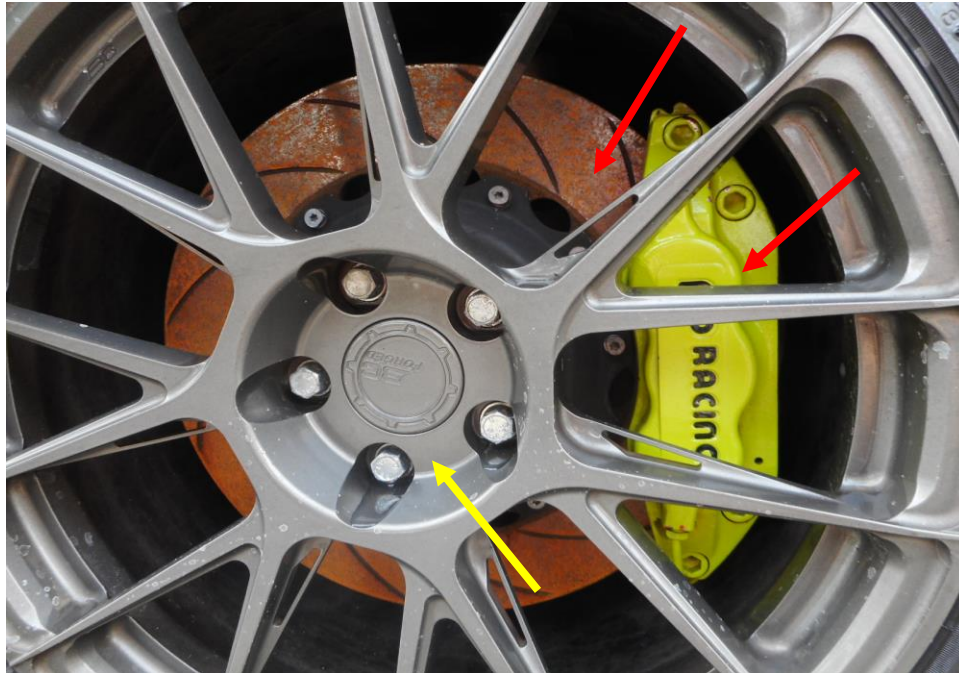
Photo 11 shows an aftermarket rim (yellow arrow) and upgraded brake caliper and disc brake (red arrow) on the Insured Vehicle, which was observed to be unaffected by the fire.

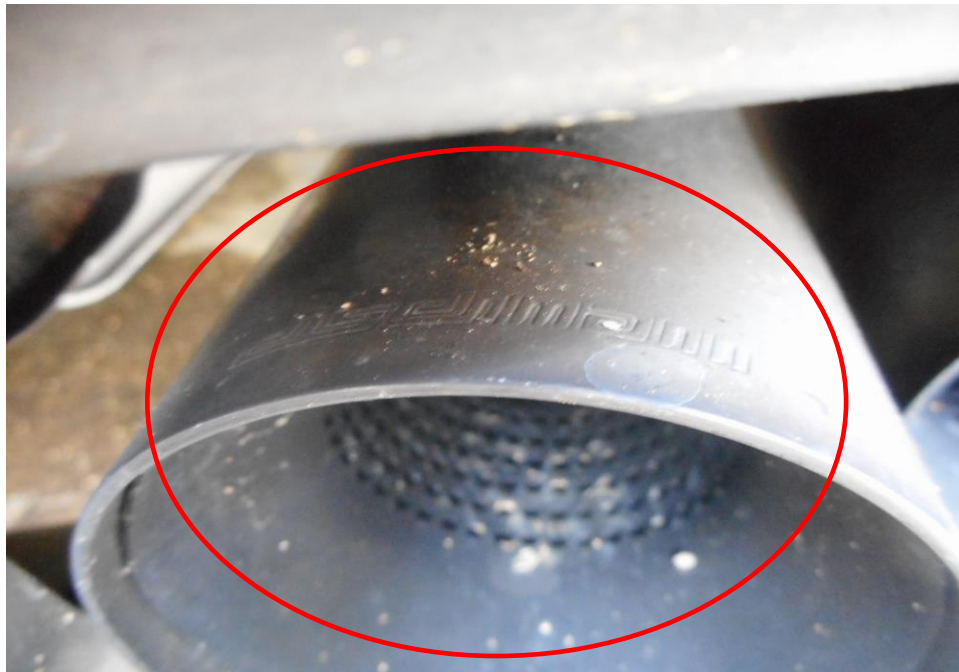
Photo 12 shows a set of aftermarket exhaust system (circled) on the Insured Vehicle, which was observed to be unaffected by the fire.

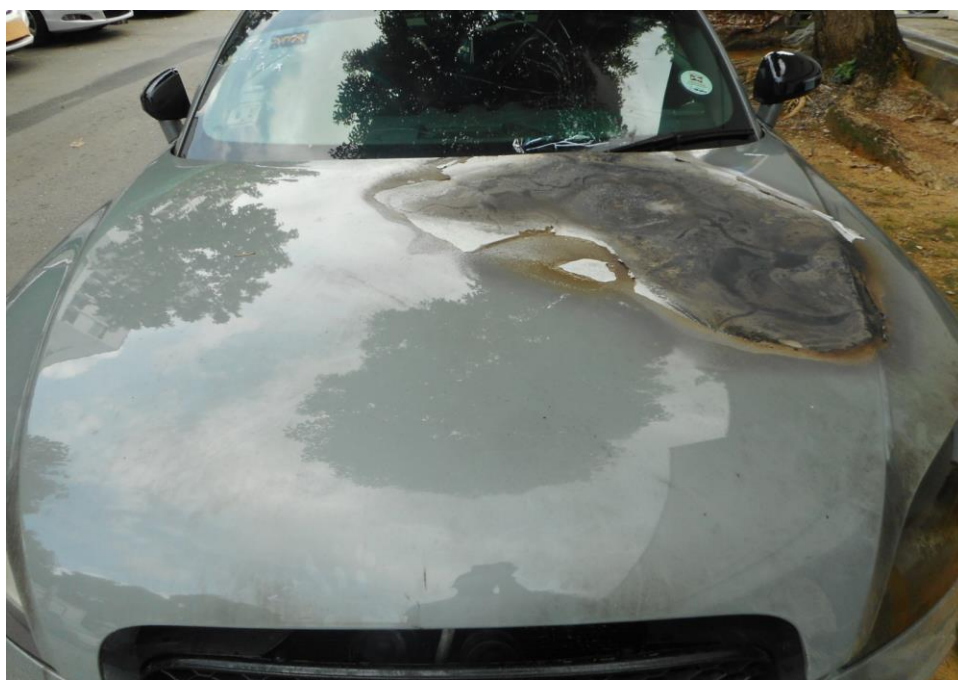
8. The whitish burn marks are a result of exposure to prolonged heat intensity. Rust would normally start to develop around these areas soon after a fire as prolonged exposure to high heat intensity usually causes steel/metal material body parts to be exposed to natural environmental condition. The rust that had developed on the metal brackets is an indication that the front right position of the Insured Vehicle had sustained exposure to prolonged high heat intensity. See photos 13 & 14 below.

Photo 13 shows the top of the front bonnet cover of the Insured Vehicle at the time of our inspection. The high heat intensity burn marks (whitish burn marks) and rust that had development on the left exterior surface of the bonnet indicates that the fire had originated from the left engine compartment portion of the Insured Vehicle.

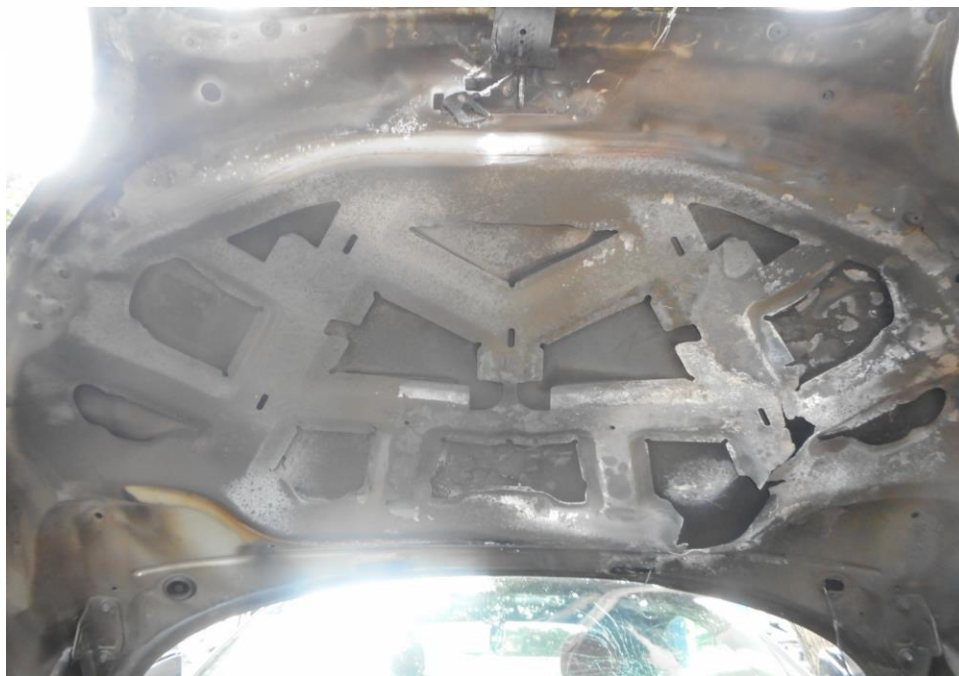
Photo 14 shows the underside of the front bonnet cover of the Insured Vehicle at the time of our inspection. The High heat intensity burn marks (whitish burn marks) and rust that had development found on the exterior surface of the bonnet indicates that the fire had originated from the left engine compartment portion of the Insured Vehicle.

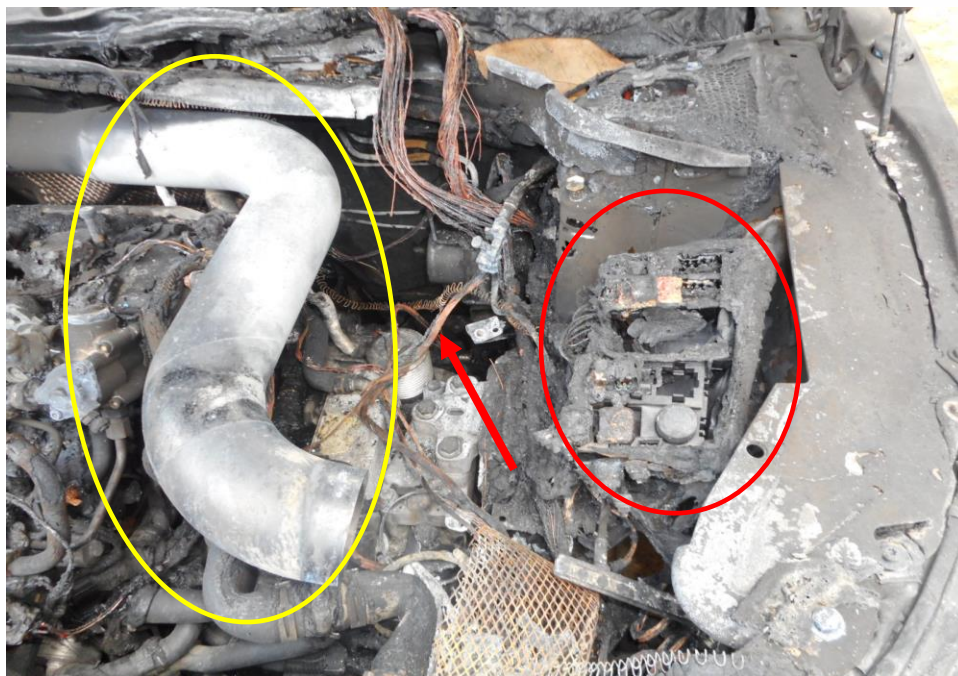
Photo 15 shows the general view of the front engine compartment portion of the Insured Vehicle where the fire had likely started from at the time of our inspection. The fire damage to the Insured Vehicle was confined to its right engine compartment portion as seen that the metal air intake pipe had sustained high heat intensity burn marks (whitish burn marks) (yellow circle) and its fuse box (circled), original wiring harnesses (red arrow) and abs pump and was amongst the parts in the compartment that were found to have been affected as a result of the fire.

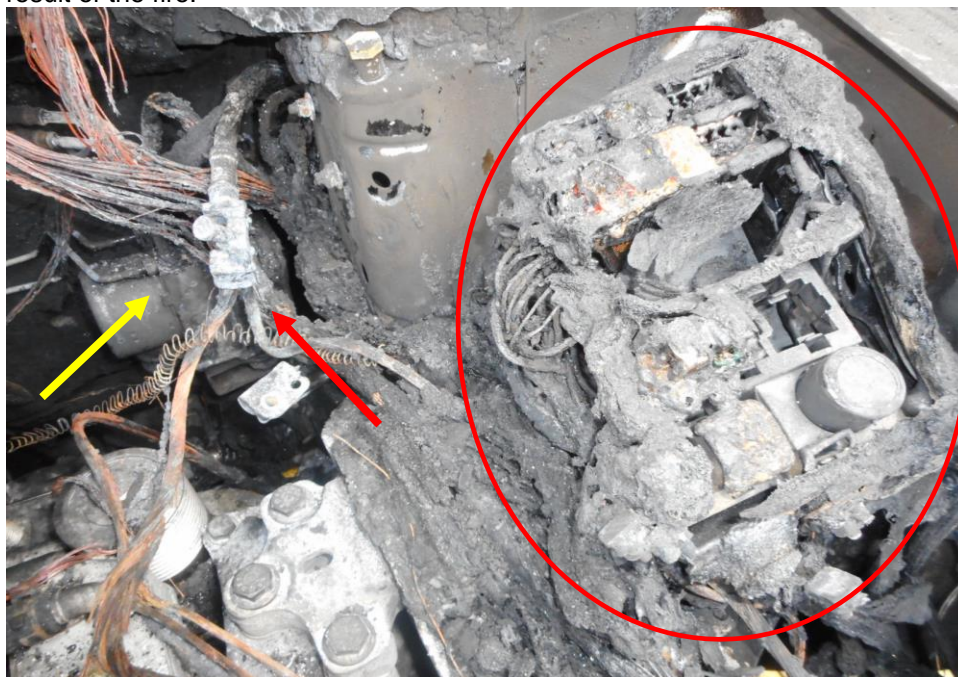
Photo 16 shows the close up view of the front right engine compartment portion of the Insured Vehicle at the time of our inspection. The fire damage to the Insured Vehicle was confined to its engine compartment portion and. Its fuse box (circled), original wiring harnesses (red arrow) and abs pump (yellow arrow) and was amongst the parts in the compartment that were found to have been affected as a result of the fire.

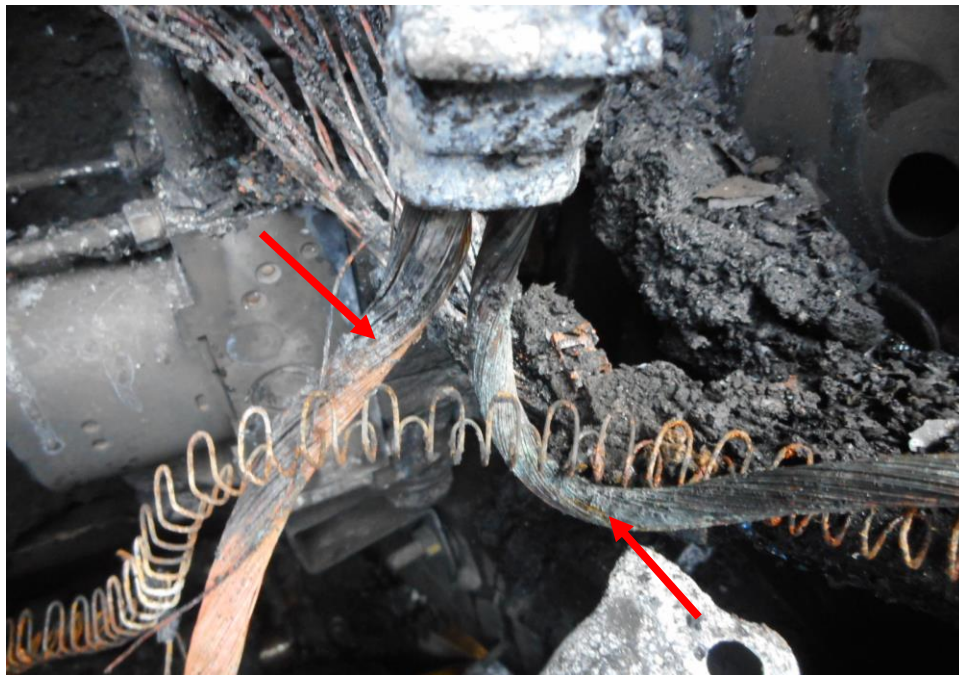
9. Upon closer examination of the engine compartment of the Insured Vehicle which was where the fire had started, we had found traces of greenish residue on the wirings leading from the fuse box to the electrical components. The wirings were original wirings fitting from manufacturer. The presence of greenish residue indicates internal heating of copper wires, a sign of an electrical short circuit occurring. The greenish residue is normally left behind from the oxidation as a result of chemical reaction involving the copper wires. This physical evidence would then appear to suggest that the cause of fire to the Insured Vehicle could have possibly been due to electrical in nature. See photos 15 - 18 below.

Photo 17 shows a general view of the original wiring harness in the engine compartment. The original wiring harness (arrowed) was observed with greenish residue on the surface. The presence of greenish residue indicates internal heating of copper wires, a sign of an electrical short circuit occurring. The greenish residue is normally left behind from oxidation as a result of chemical reaction involving the copper wires.

22. The possibility of the fire being due to electrical in nature would then seem more likely given that engine overheating and external factors would both seem unlikely. The fire being due to electrical nature is also supported by the condition of the wirings that were found leading from the fuse box assembly to the electrical components on the Insured Vehicle, which was earlier discussed in paragraph 9 above.

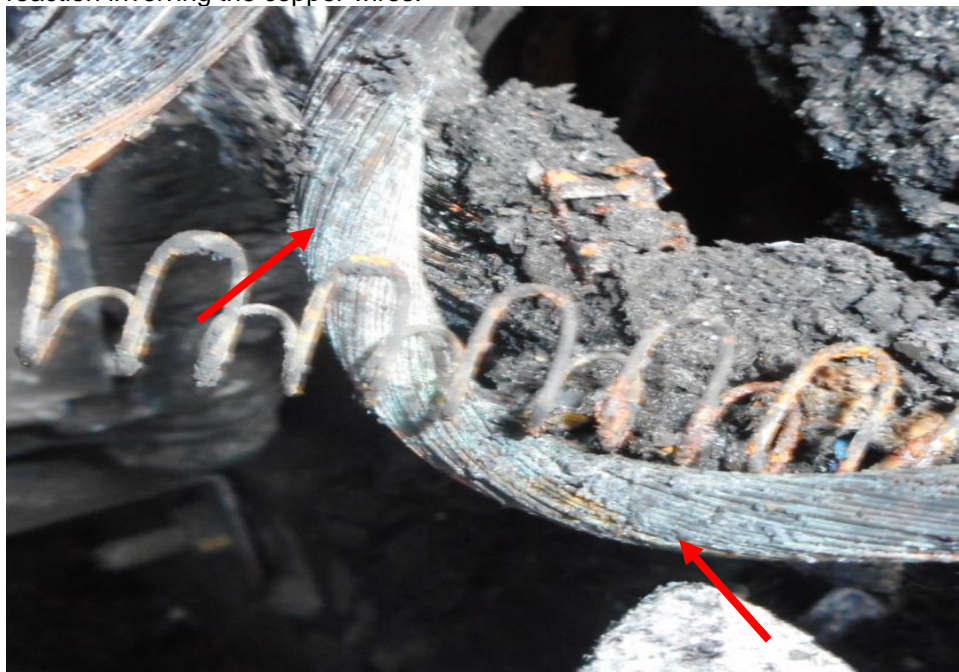
Photo 18 shows a close up view of the original wiring harness in the engine compartment. The original wiring harness (arrowed) was observed with greenish residue on the surface. The presence of greenish residue indicates internal heating of copper wires, a sign of an electrical short circuit occurring. The greenish residue is normally left behind from oxidation as a result of chemical reaction involving the copper wires.

24. Having investigated and technically analysed the damages of burnt nature to the Insured Vehicle, we are of the view that the cause of fire to the Insured Vehicle was of electrical nature. For this particular case, the fire had originated along the wirings leading to the original manufacturer fuse box of the Insured Vehicle.
25. We did not find any evidence which had suggested that the cause of fire to the Insured Vehicle was due to poor maintenance and/or recurring electrical problem.

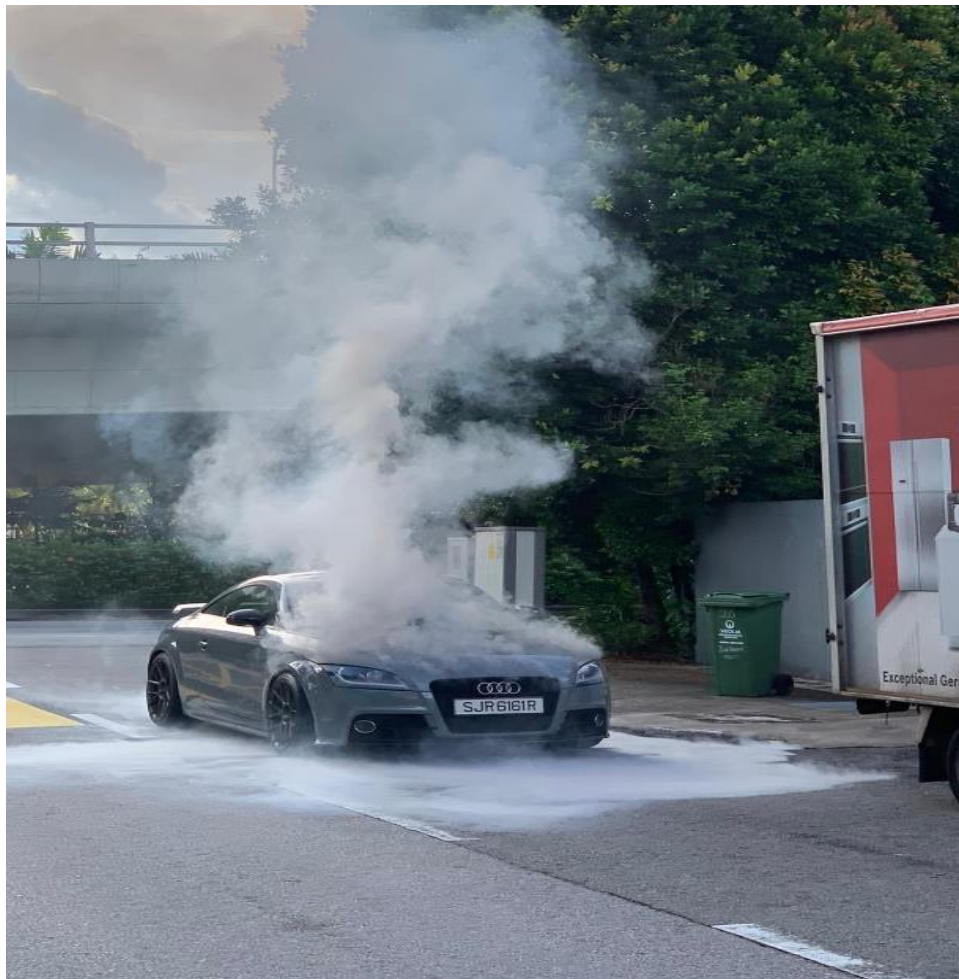
Photo 19 shows the smoke emitting from the front and undercarriage of the Insured Vehicle before the arrival of the SCDF. In general, the information that could be gathered from this photograph had corresponded to the events that were related to us by Mr Lim, location when the fire broke out.

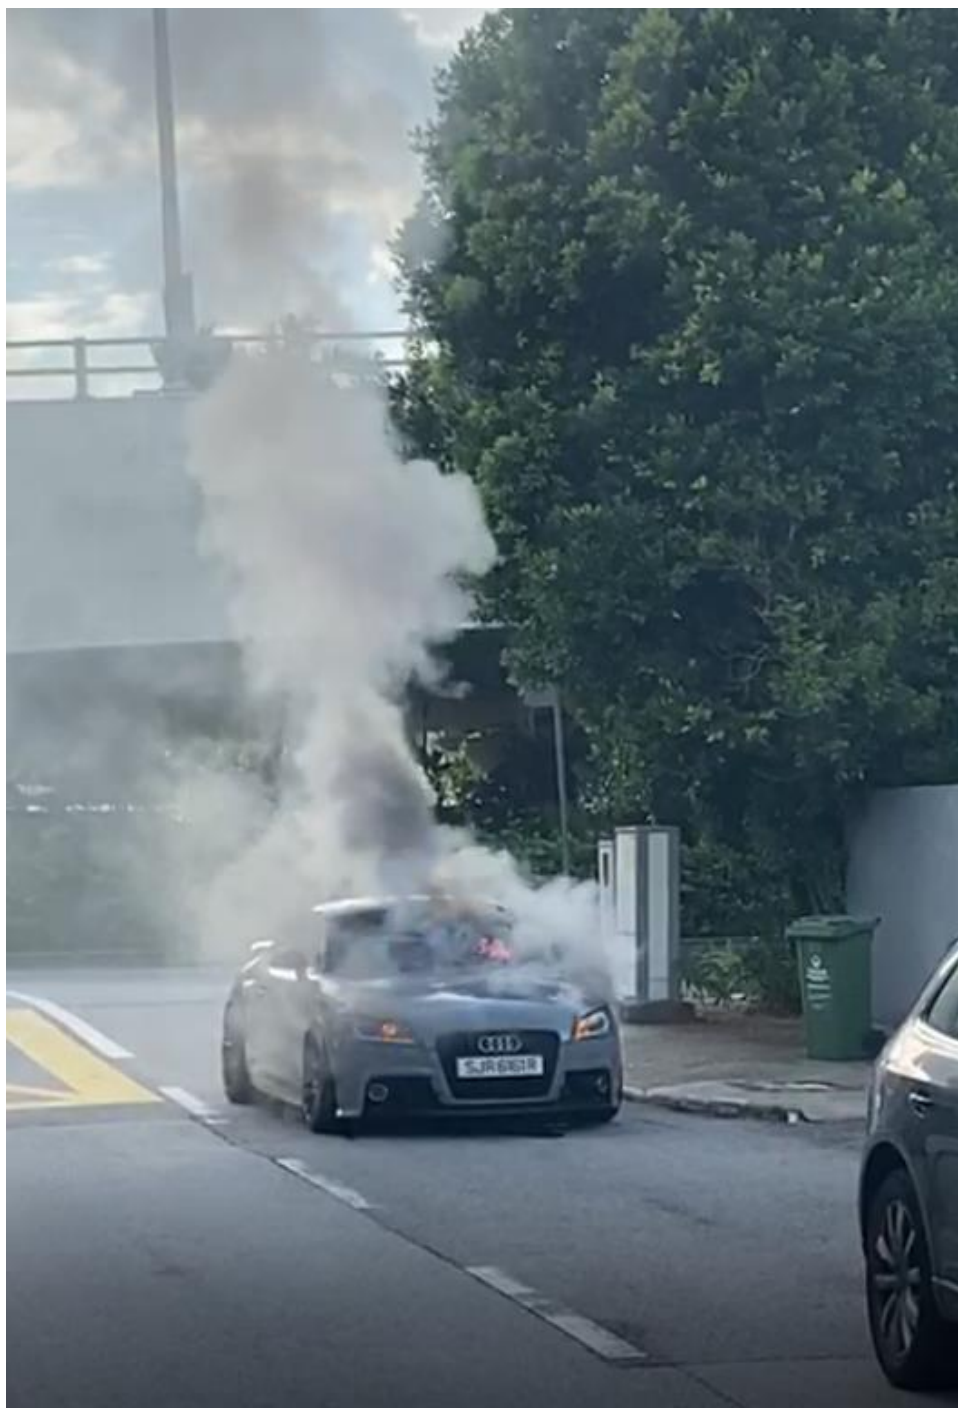
Photo 20 shows the start of the fire at the front left engine compartment of the Insured Vehicle before the arrival of the SCDF. In general, the information that could be gathered from this photograph had corresponded to the events that were related to us by Mr Lim, location when the fire broke out.

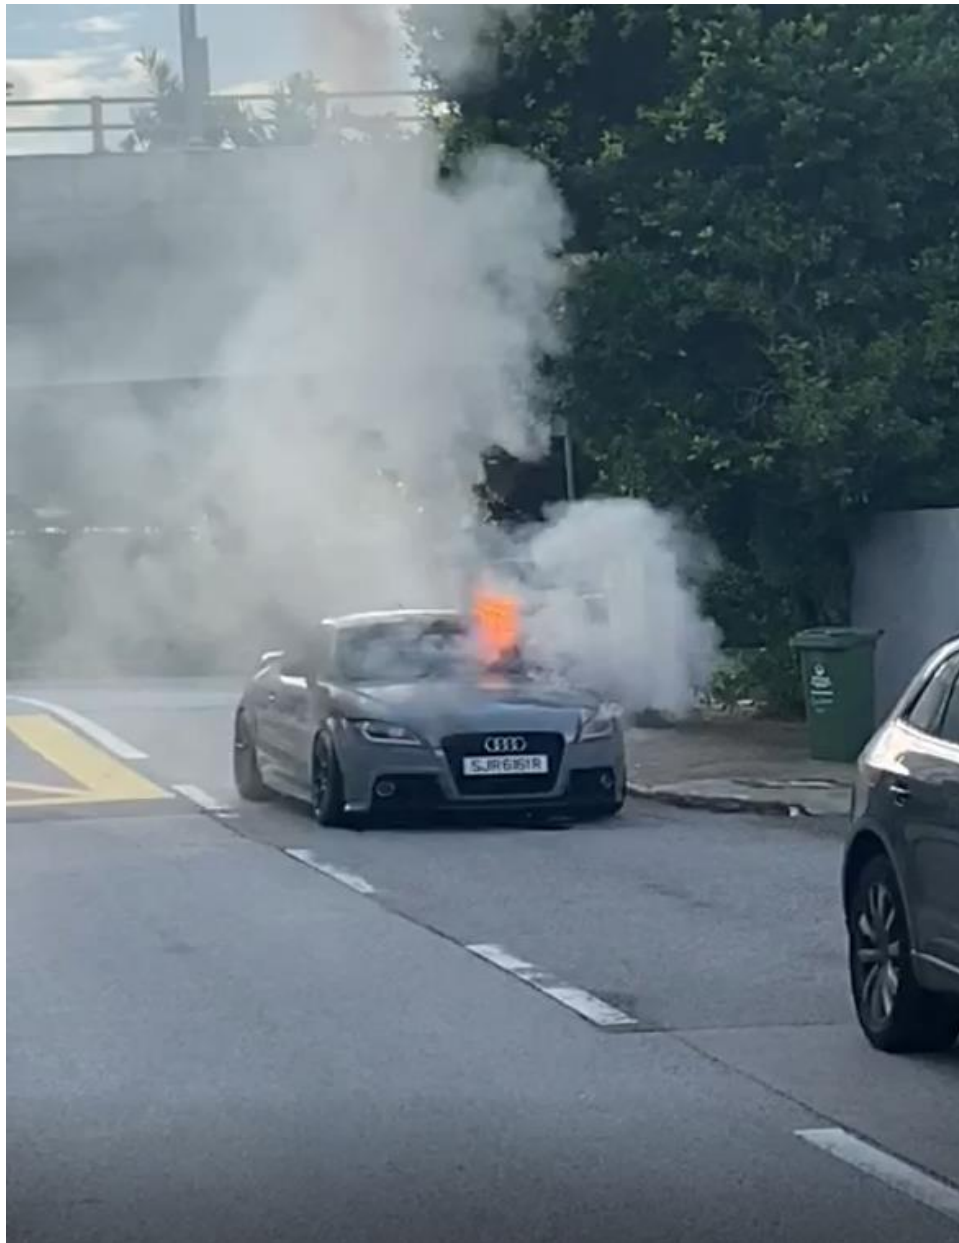
Photo 21 shows the smoke and flames engulfing the front of the Insured Vehicle before the arrival of the SCDF. In general, the information that could be gathered from this photograph had corresponded to the events that were related to us by Mr Lim, location when the fire broke out.

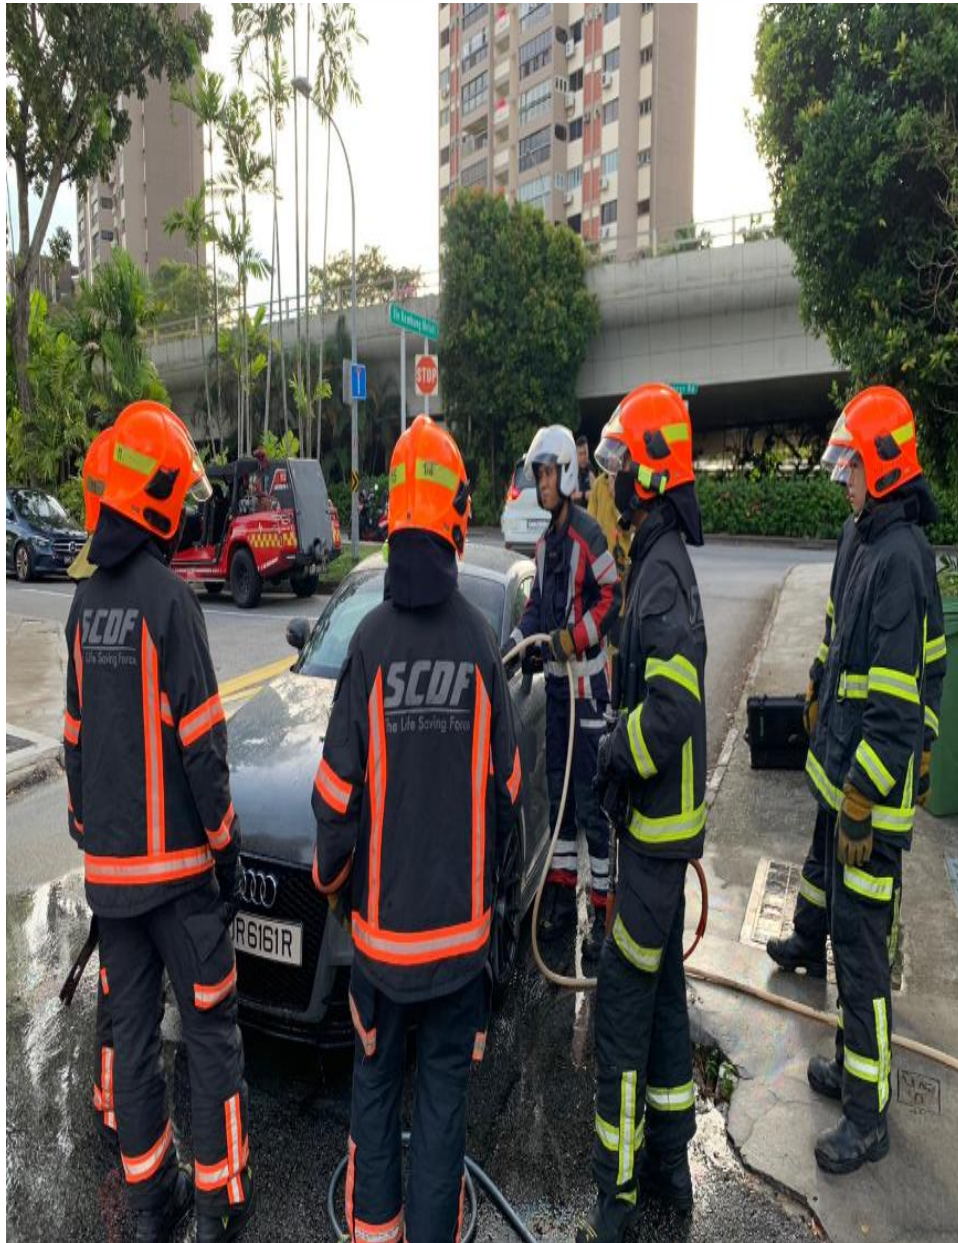
Photo 22 shows the Insured Vehicle at the incident location after the fire was extinguished by SCDF personnel. Firefighters can be seen to be extinguishing the fire and inspecting the extent of damage.
