Your Ref: Mercedes Benz A250  
(chassis number WDD1770472N030432)  
Our Ref : CI/TP20007703/D

28 July 2020

**INSPECTION REPORT OF AN UNREGISTERD MERCEDES BENZ A250  
MOTOR CAR WITH CHASSIS NUMBER WDD1770472N030432**

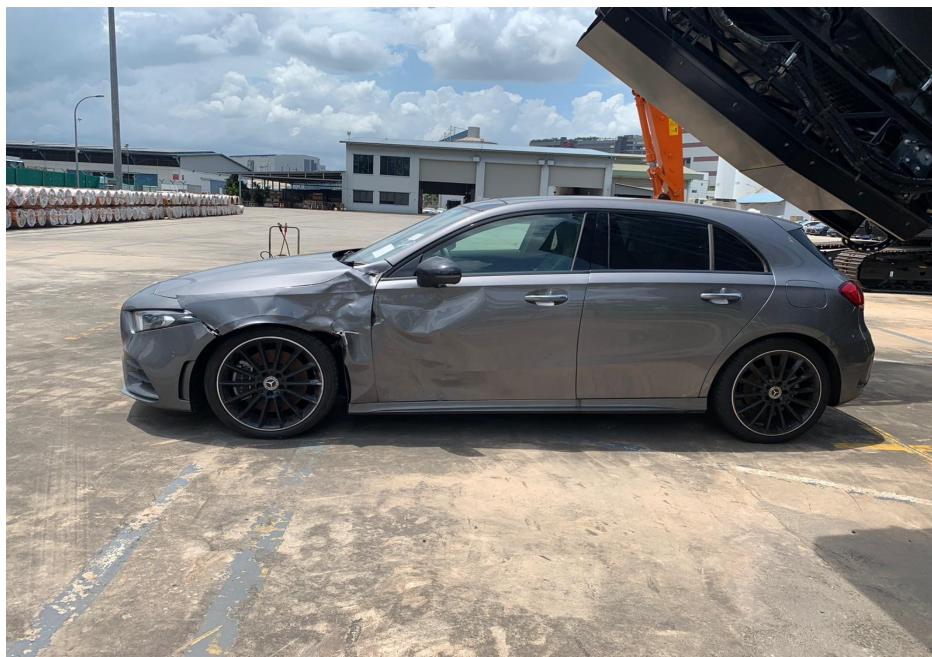
3. From the photographs provided to me, it was observed that the Motor Car had sustained damages along its left side front. Body parts observed to have been damaged include its front bumper, front left fender and front left door. The photographs had also showed damage to the front left wheel rim of the Motor Car.
4. There was no damage observed to the various parts within the engine compartment, including its engine assembly. The airbags of the Motor Car were also not deployed. See photo 1 – 3 below.

**Photo 1** shows the left side of the Motor Car prior to any repairs being carried out (photograph provided to me). The Motor Car was observed to have sustained damages along its left side front. Body parts observed to have been damaged include its front bumper, front left fender and front left door. Upon closer examination, I had also observed damage to the front left wheel rim of the Motor Car.

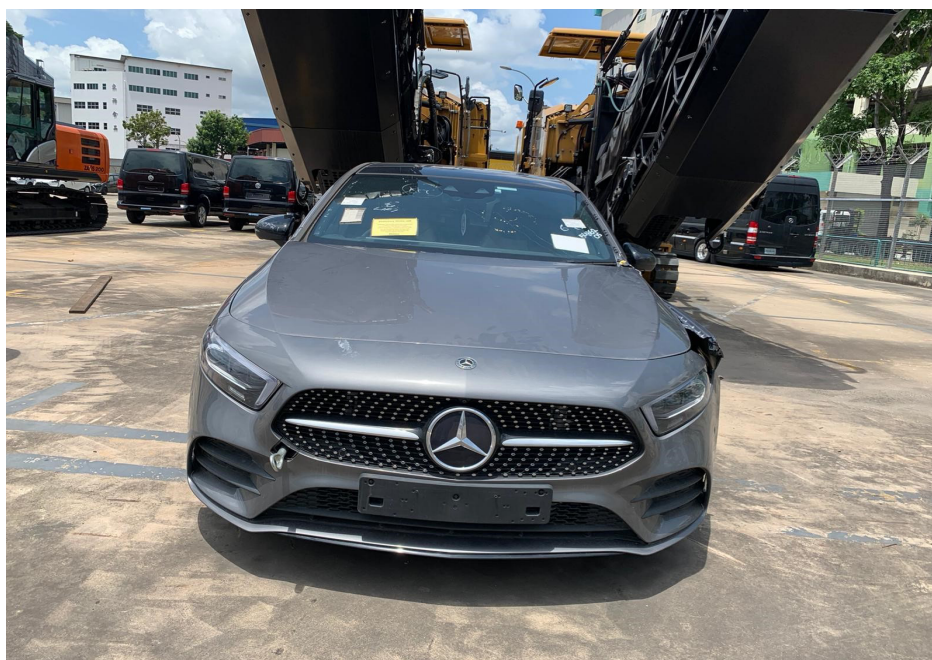
**Photo 2** shows the frontal body of the Motor Car prior to any repairs being carried out (photograph provided to me). No damage was observed to the frontal body of the Motor Car.

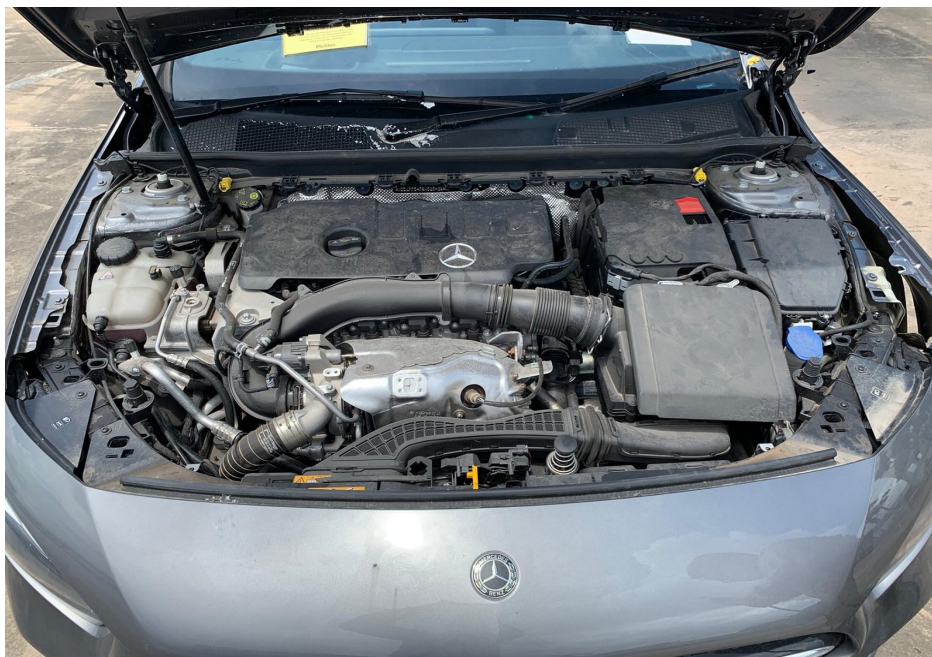
**Photo 3** shows the engine compartment of the Motor Car prior to any repairs being carried out (photograph provided to me). Parts within the engine compartment were observed to be intact and undamaged, including the engine assembly of the Motor Car.

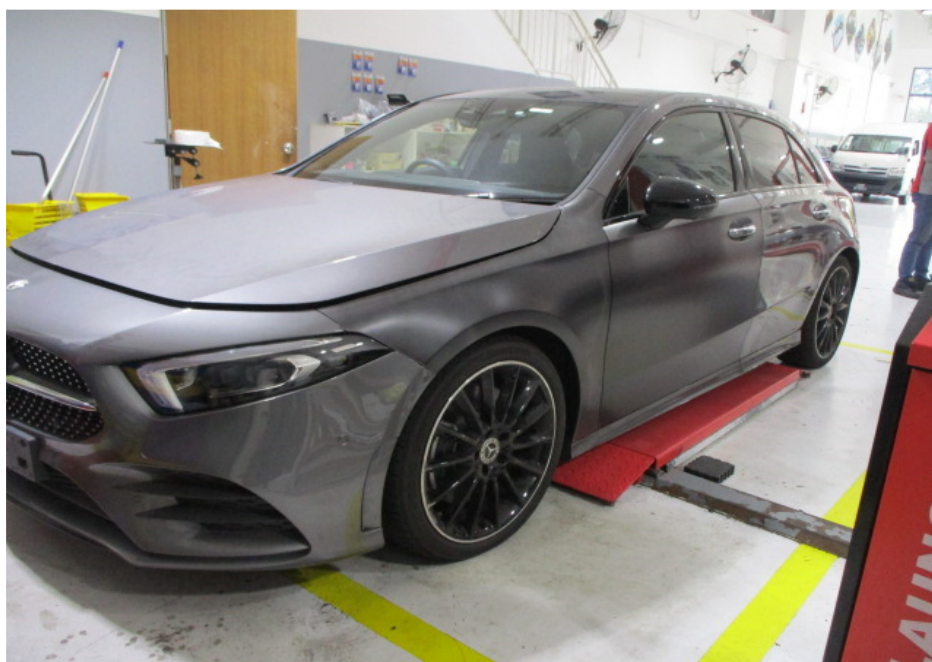
**Photo 4** shows a general view of the front left body of the Motor Car at the time of my inspection. The Motor Car was observed to be in relatively good general condition with no loose exterior fittings observed. The body parts along the left side front of the Motor Car were visually examined and it was observed that the repair/restoration works carried out to the damaged area of the Motor Car (refer photograph 1 above) were reasonably adequate and in order.

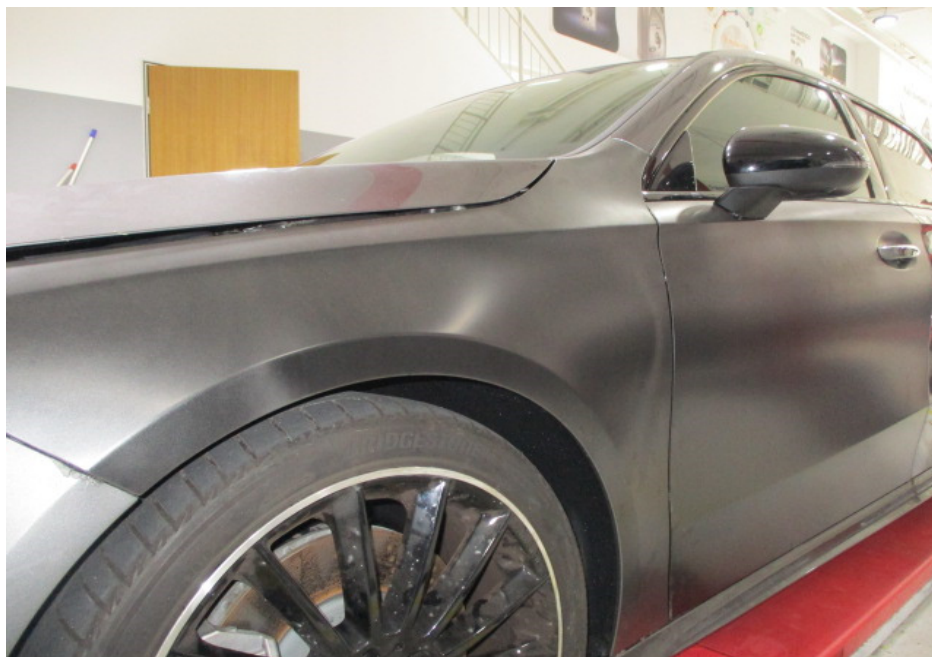
**Photo 5** shows a newly replaced left front fender and left front door of the Motor Car. The body parts along the left side front of the Motor Car were visually examined and it was observed that the repair/restoration works carried out to the damaged area of the Motor Car (refer photograph 1 above) were reasonably adequate and in order.

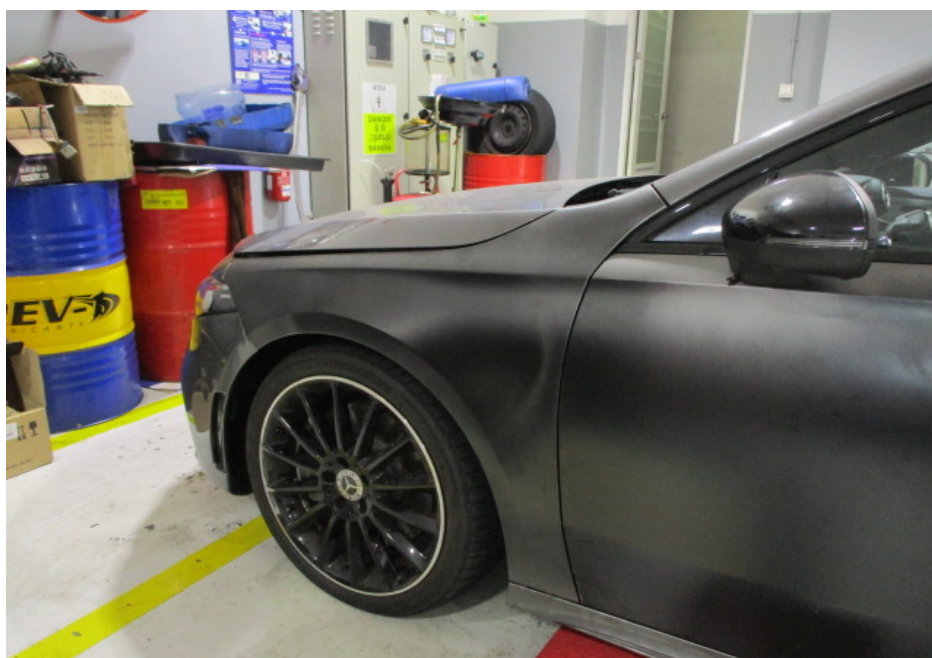
**Photo 6** shows a newly replaced left front fender and left front door of the Motor Car. The body parts along the left side front of the Motor Car were visually examined and it was observed that the repair/restoration works carried out to the damaged area of the Motor Car (refer photograph 1 above) were reasonably adequate and in order.

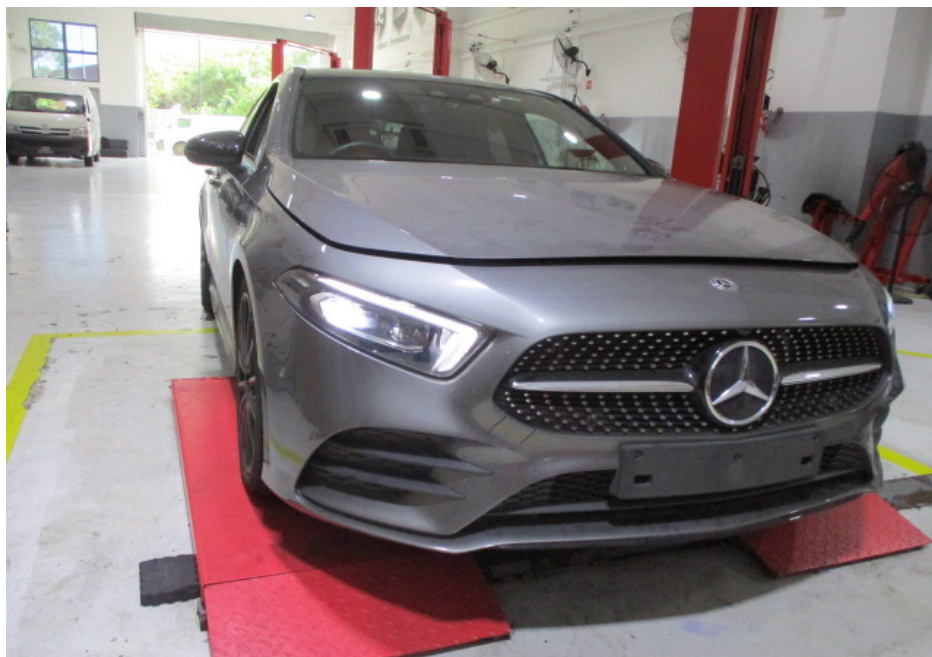
**Photo 7** shows a general view of the front right body of the Motor Car at the time of my inspection. The Motor Car was observed to be in relatively good general condition with no loose exterior fittings observed.

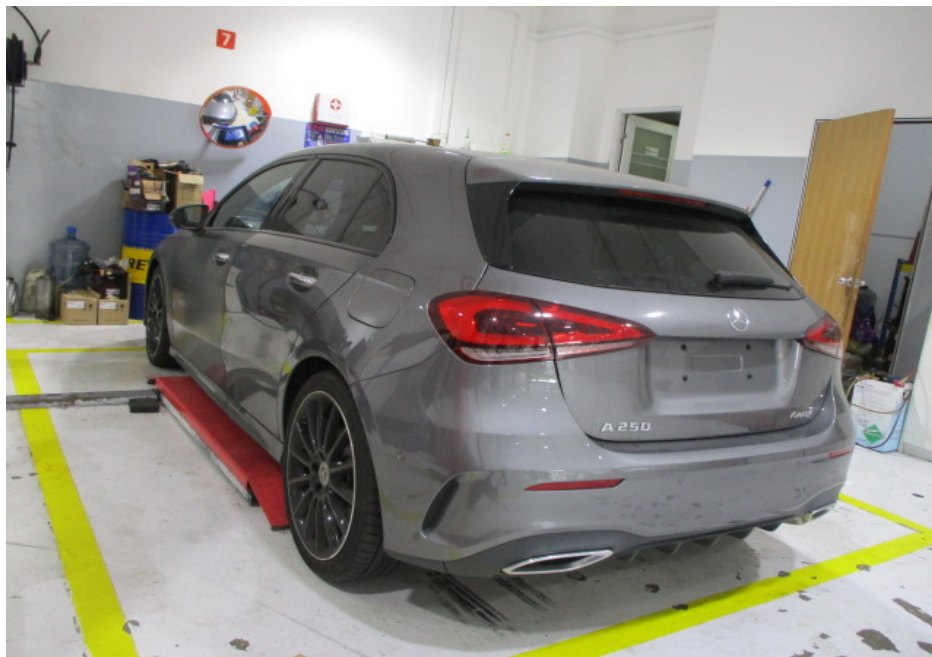
**Photo 8** shows a general view of the rear left body of the Motor Car at the time of my inspection. The Motor Car was observed to be in relatively good general condition with no loose exterior fittings observed.

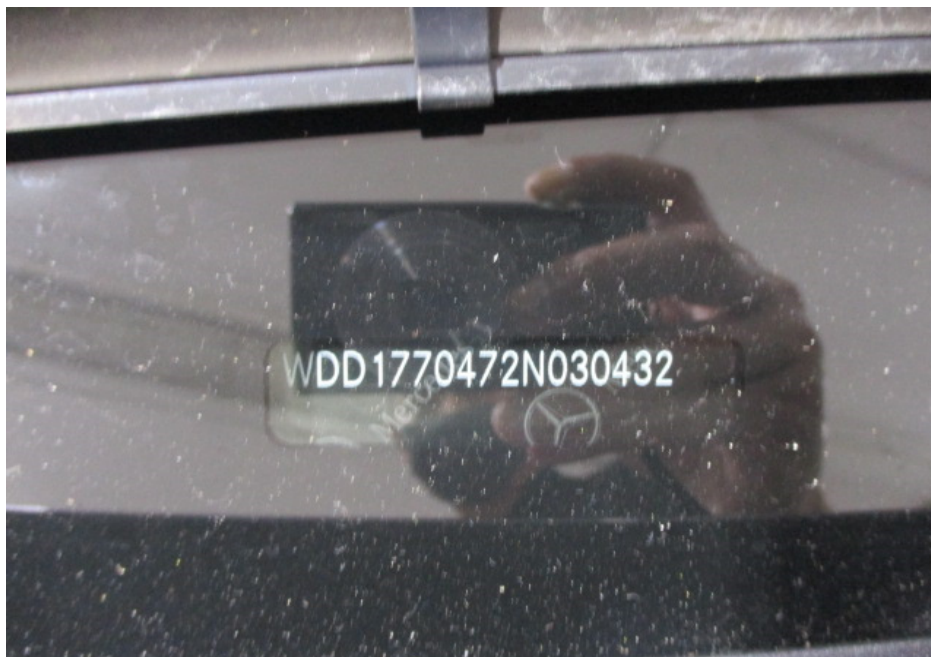
**Photo 9** shows the chassis number of the Motor Car. The chassis number recorded was WDD1770472N030432.

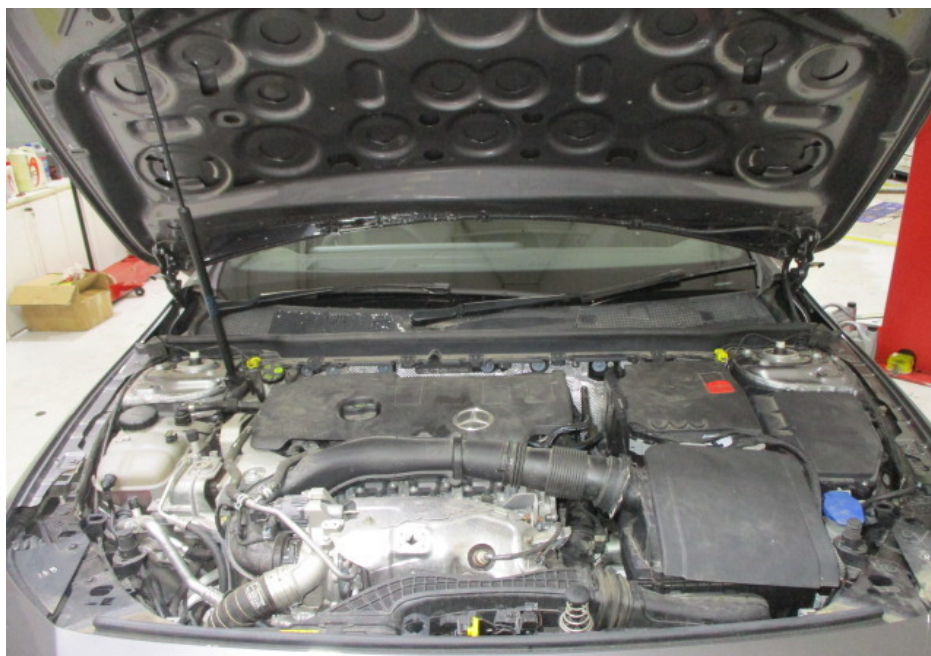
**Photo 10** shows a general view of the engine compartment of the Motor Car at the time of my inspection. The various parts and components inside the engine compartment were all observed to be intact and properly fitted. There was also no sign(s) or indication(s) of fluid leak and/or fluid stain found inside the engine compartment.

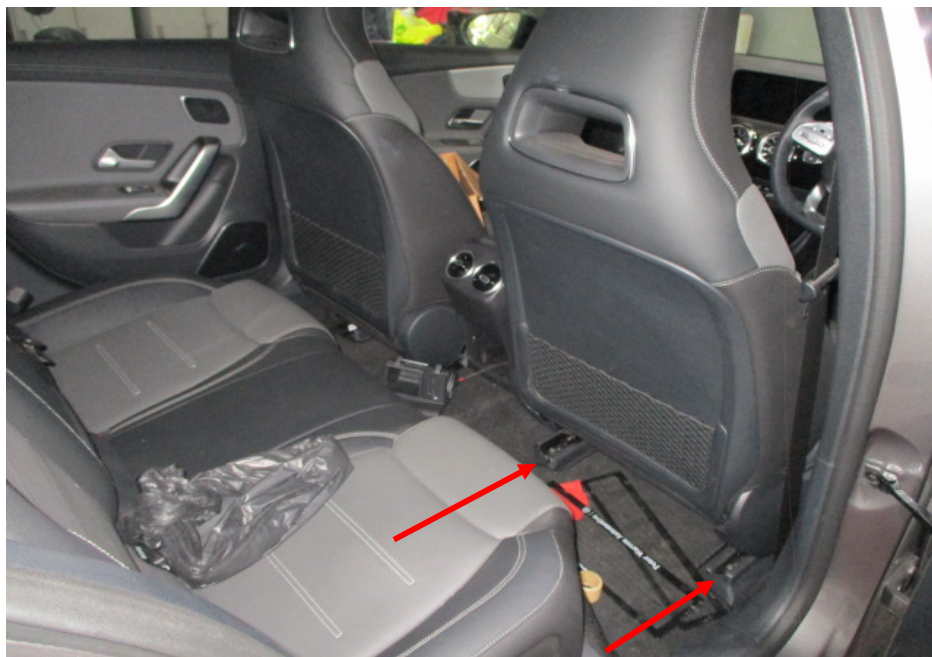
**Photo 11** shows the seats of the Motor Car, which were secured via seat rails (arrowed) to the floor board. All the seats of the Motor Car were fitted with a retractable seat belt reel and pre-tensioner. The seat belts were tested and able to be fastened into the respective pre-tensions that were fitted on the side of each individual seat.

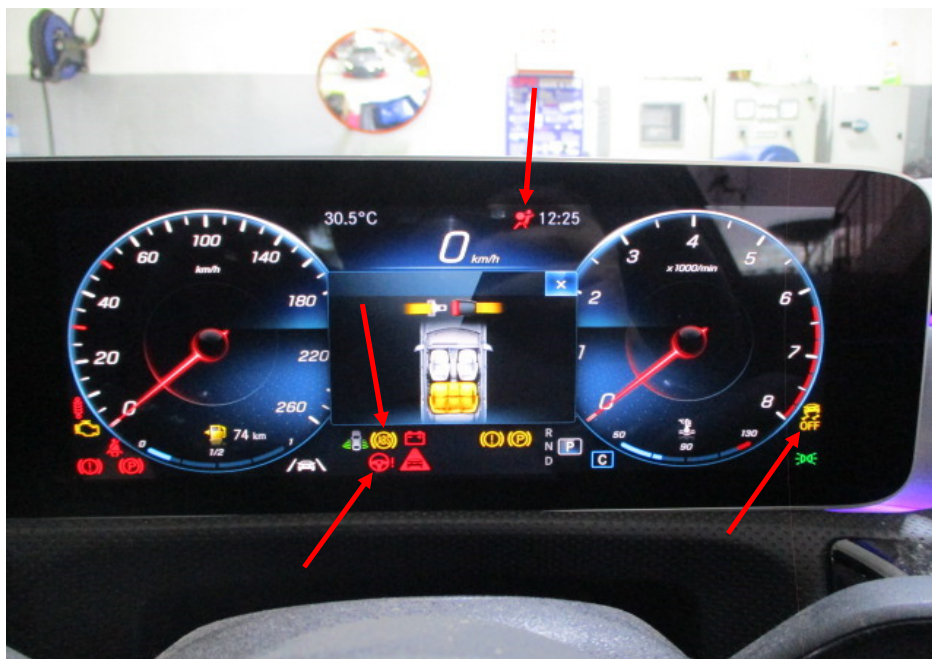
**Photo 12** shows the warning lights for the various electronic safety features appearing on the instrument panel of the Motor Car during its self-test when the engine is cranked, in particular the ABS, SRS, EPS and ESP lights (arrowed).

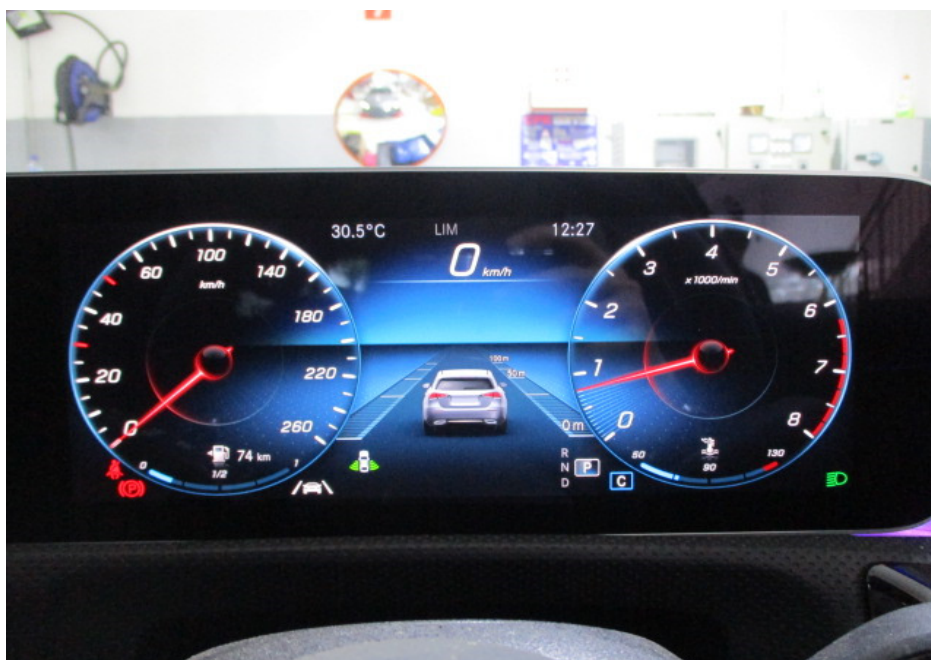
**Photo 13** shows the respective warning lights no longer illuminated, indicating that there is no fault detected to the ABS, SRS, EPS and ESP systems of the Motor Car during the self-test. These electronic systems were hence in working condition at the time of my inspection.

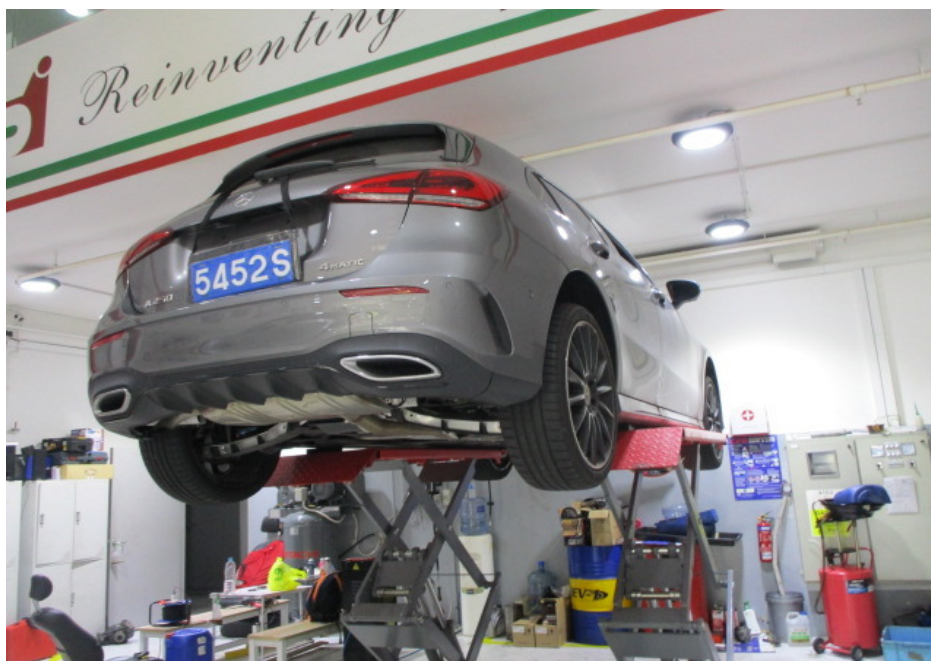
**Photo 14** shows the Motor Car hoisted up for checks on its undercarriage. There was no sign(s) or indication(s) of fluid leakage and/or fluid stain(s) on the underside of the Motor Car. The undercarriage components of the Motor Car were also all observed to be intact and secured in an appropriate manner.

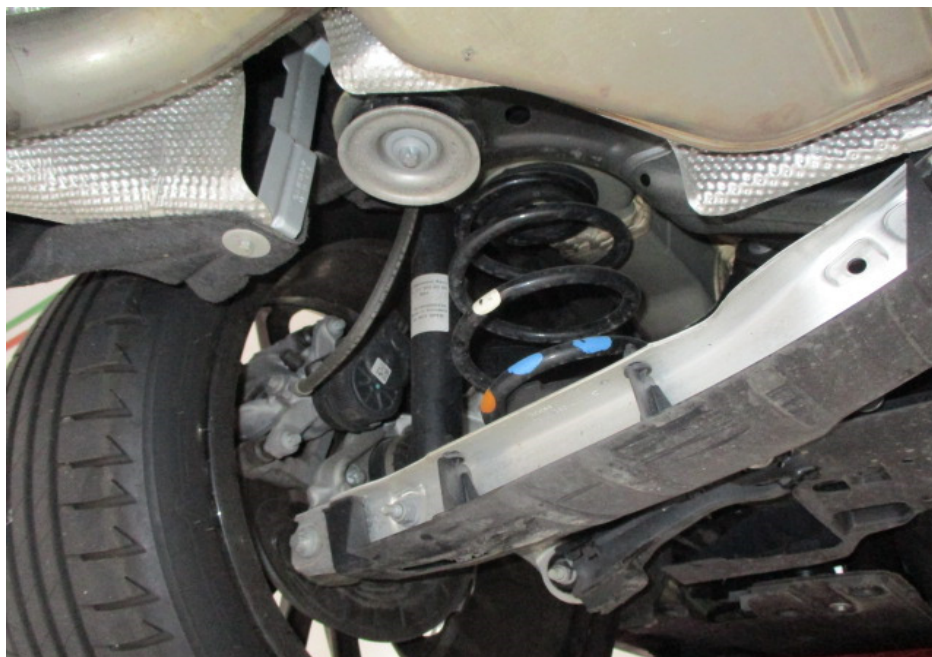
**Photo 15** shows a general view of the control arms and linkages at the rear left wheel of the Motor Car. I did not observe any fluid leak and/or fluid stain on the underside of the Motor Car. All of the Motor Car's undercarriage components were observed to be intact and secured in an appropriate manner.

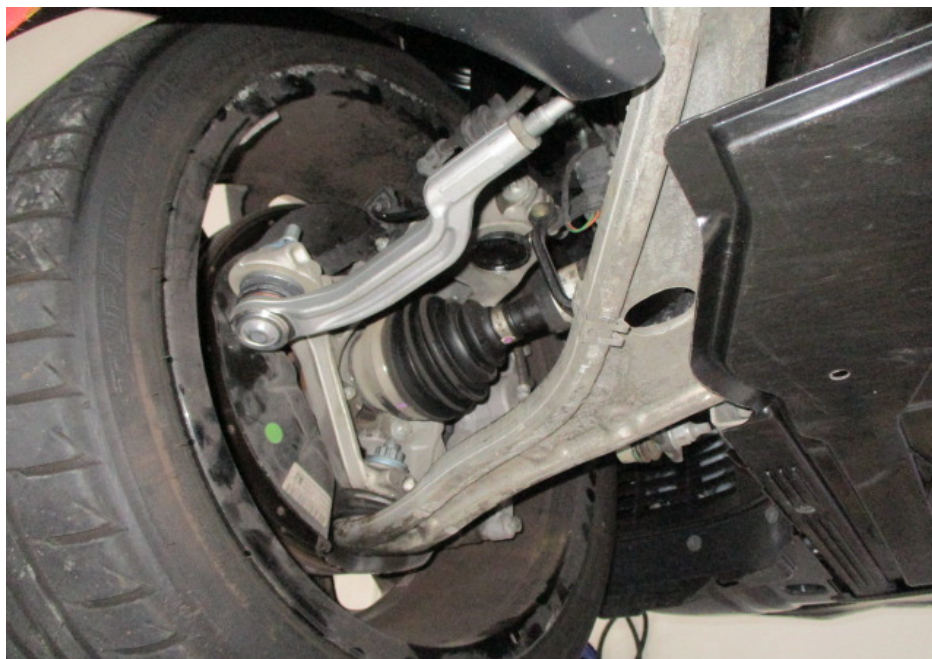
**Photo 16** shows the various undercarriage components at the front left wheel of the Motor Car. The mechanical components, control arms and linkages were all found to be intact and secured in an appropriate manner.

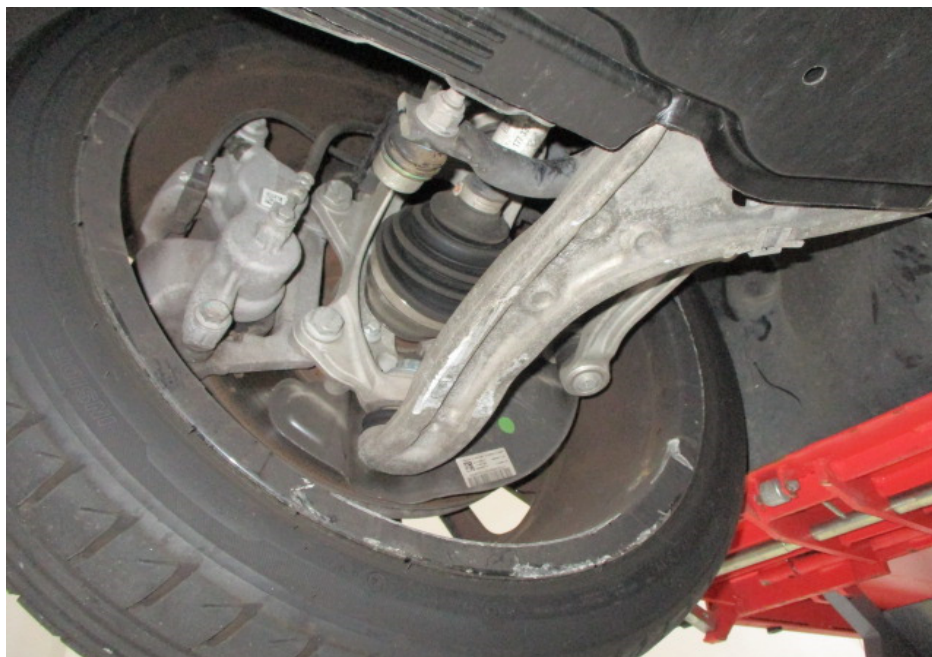
**Photo 17** shows the various undercarriage components at the front right wheel of the Motor Car. The mechanical components, control arms and linkages were all found to be intact and secured in an appropriate manner. I also did not observe any fluid leak and/or fluid stain on the underside of the Motor Car.

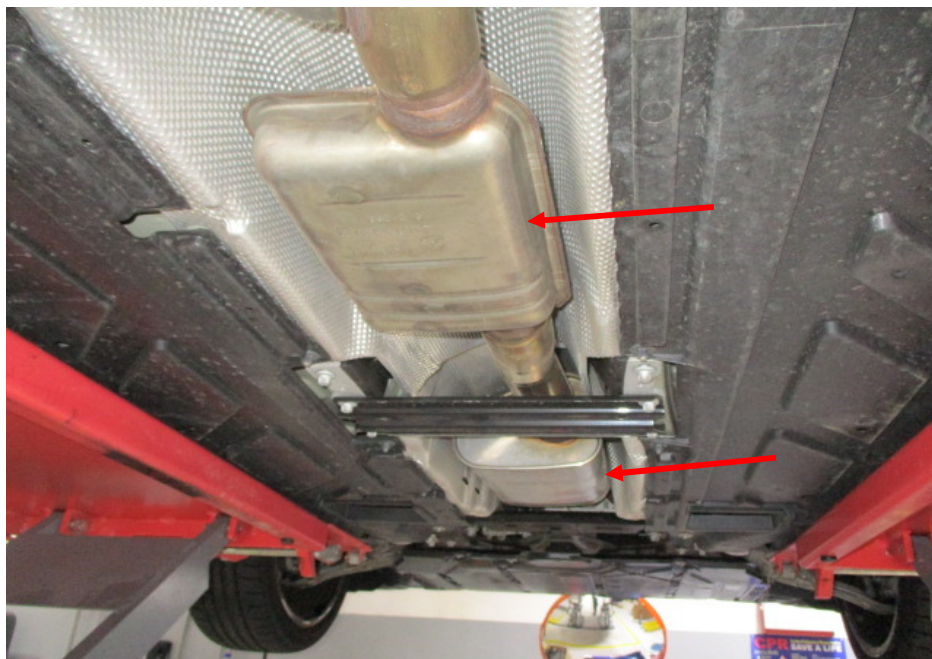
**Photo 18** shows the Motor Car's centre resonators (arrowed). My examination of the Motor Car's exhaust system revealed no sign(s) or indication(s) of any cut or weld marks along its exhaust pipes and on its catalytic convertor.

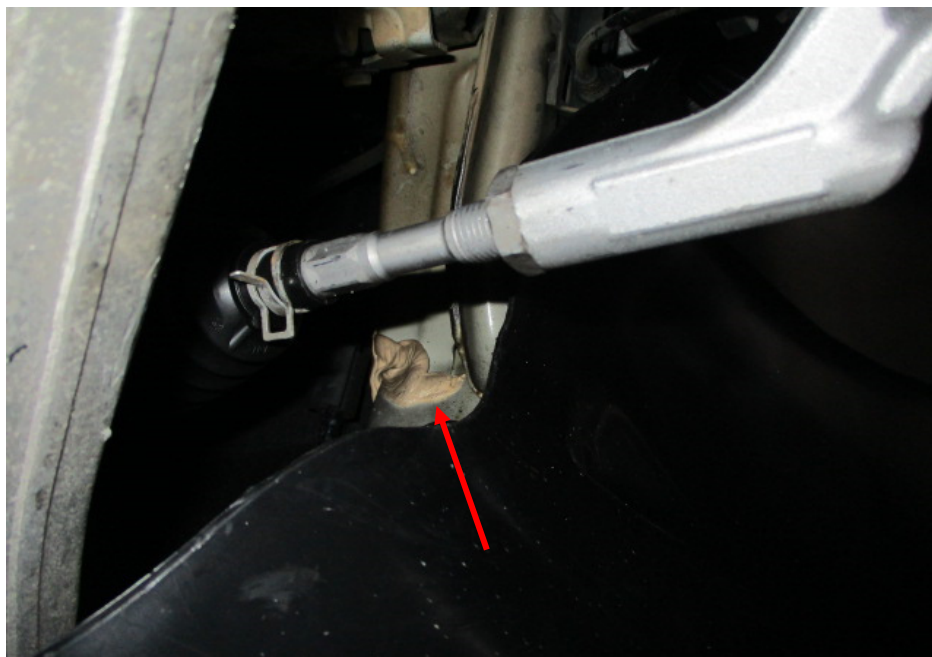
**Photo 19** shows the chassis/structural body at the underside front left of the Motor Car. Visually, I did not find any weld marks other than original spot weld marks on the chassis/structural body of the Motor Car. The original factory sealant (arrowed) at the joints along the chassis/structural body was also untouched, indicating no work was done on the chassis/structural body of the Motor Car and that the chassis/structural body was originally fitted.

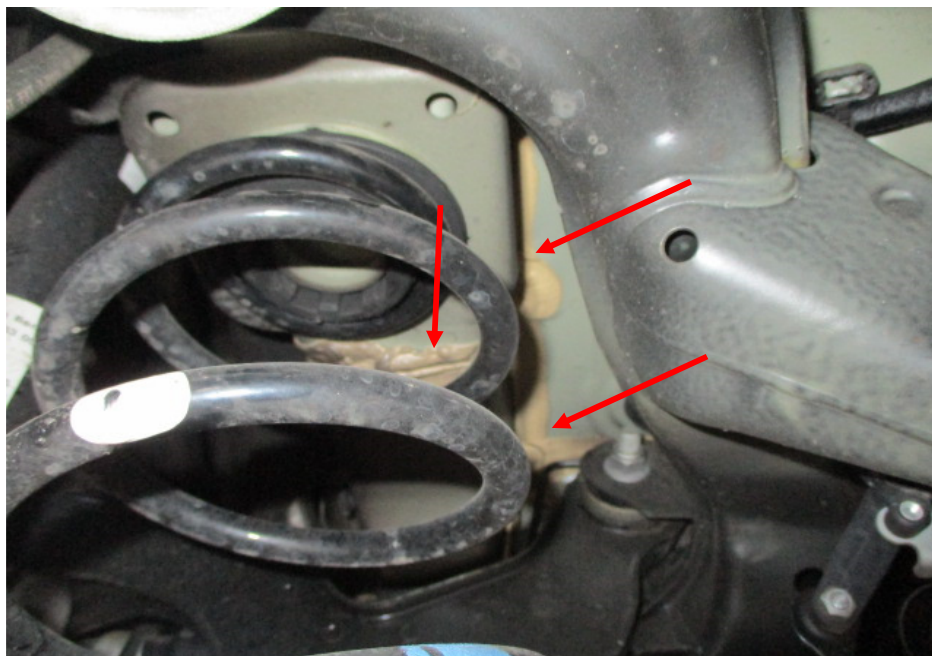
**Photo 20** shows the chassis/structural body at the underside rear left of the Motor Car. Visually, The original factory sealant (arrowed) at the joints along the chassis/structural body was untouched, indicating no work was done on the chassis/structural body of the Motor Car and that the chassis/structural body was originally fitted.

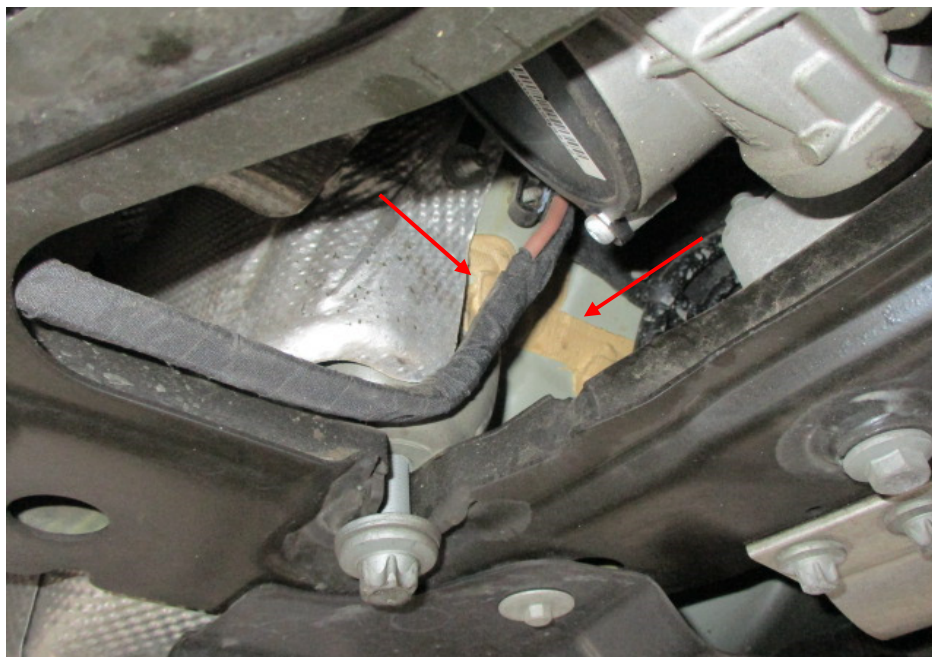
**Photo 21** shows the floor board at the underside left front of the Motor Car. The original factory sealant (arrowed) at the joints along the non-detachable body panels were untouched, indicating no work was done on the non-detachable body panels of the Motor Car; and that these body panels were originally fitted.
