CC4/ALG 20007744/T1 ks3

## ASSIGNMENT

ChiangVeh No: SHD3350D Yr Regn: 2016 / JulyType: M.Car / M.Cycle / Bus / Van / Lorry / ① Taxi / Prime Mover /

Make: Hyundai I40 c.c. 1685Colour: Blue A/C: Insured / Std / NI / NASp. Reading: 619/47 T/Radio: Insured / Std / NI / NA

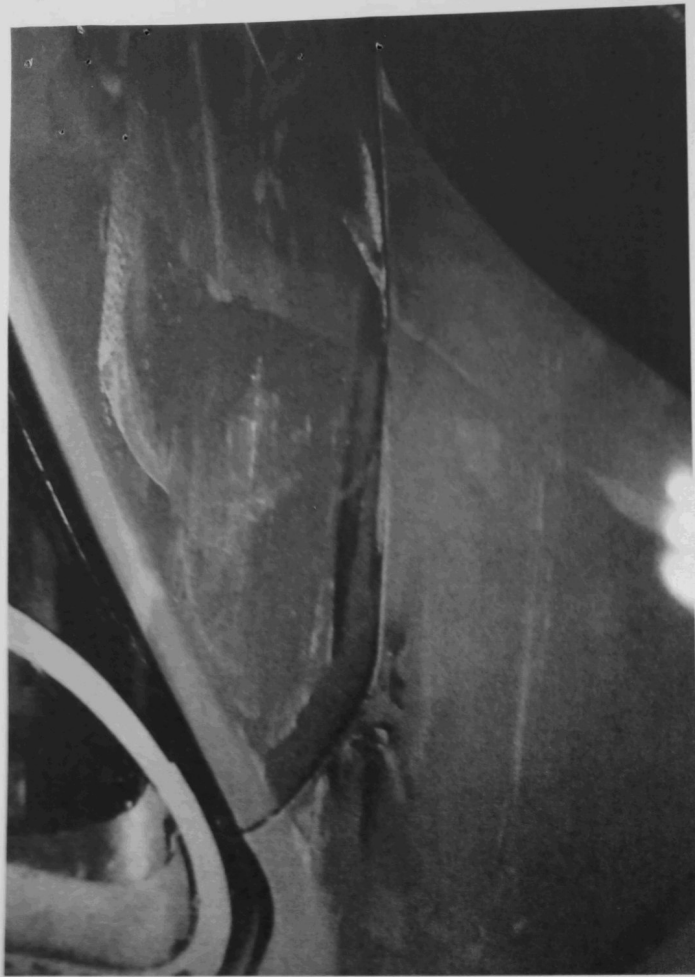
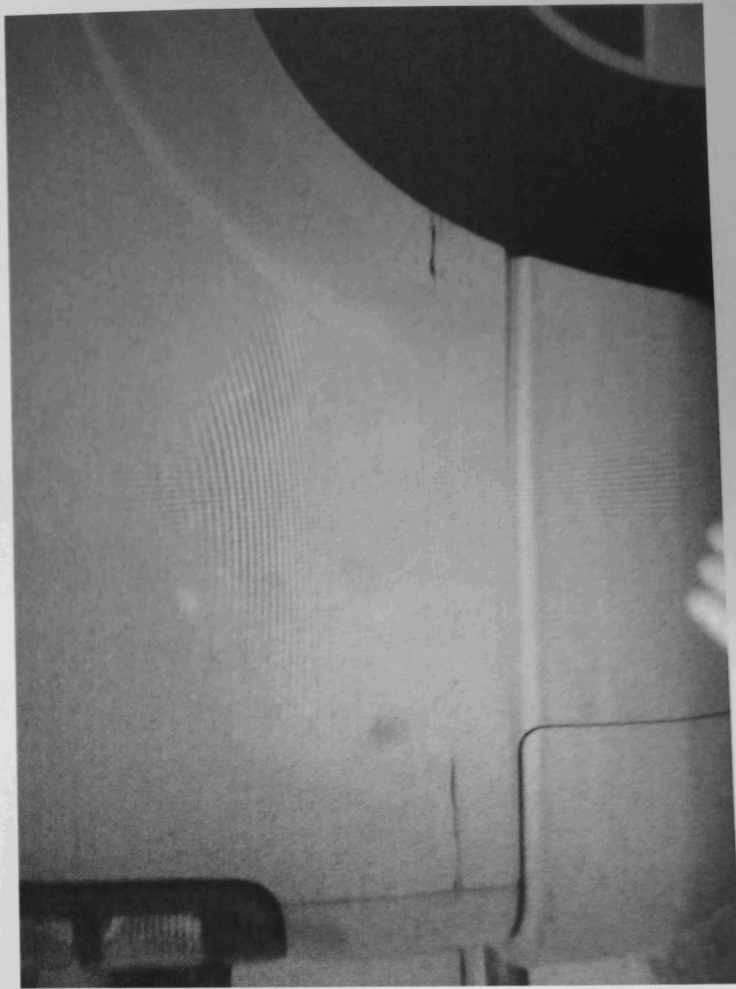
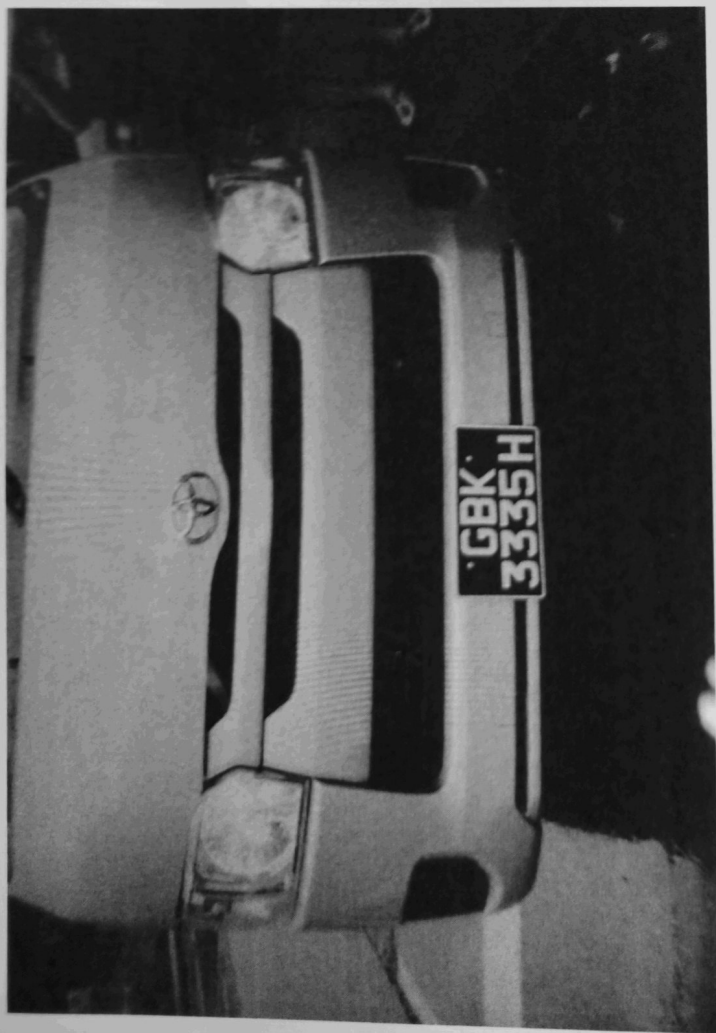
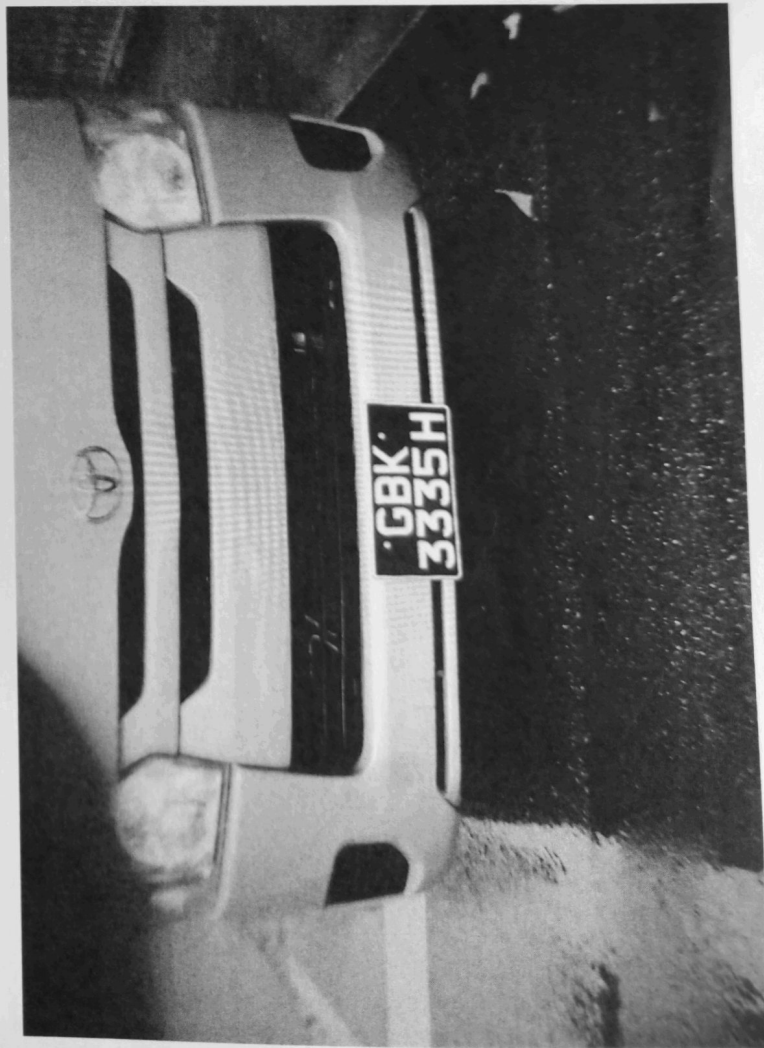
Remark: The veh had commenced its  
repair at the time of inspection.

Frt N/S

The U/C / Chassis frame / Body Structure affected due to collision.
