Your Ref : SHC 6227M
Our Ref : CI/TP20007757/N

28 July 2020

TECHNICAL INVESTIGATION REPORT OF FIRE INCIDENT INVOLVING THE INSURED VEHICLE SHC 6227M ON 27 JULY 2020

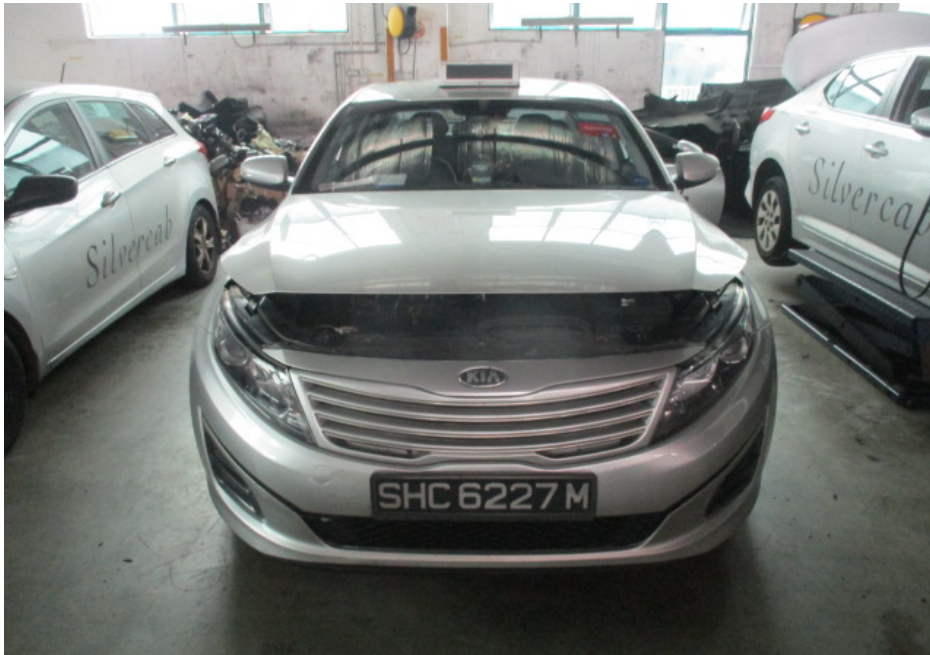
Photo 1 shows the general view of the front portion of the Insured Vehicle at the time of our inspection. The fire damage to the Insured Vehicle was confined to its front portion. Its front bonnet, front windscreen and side panels were amongst the body parts that were found to have been affected as a result of the fire.

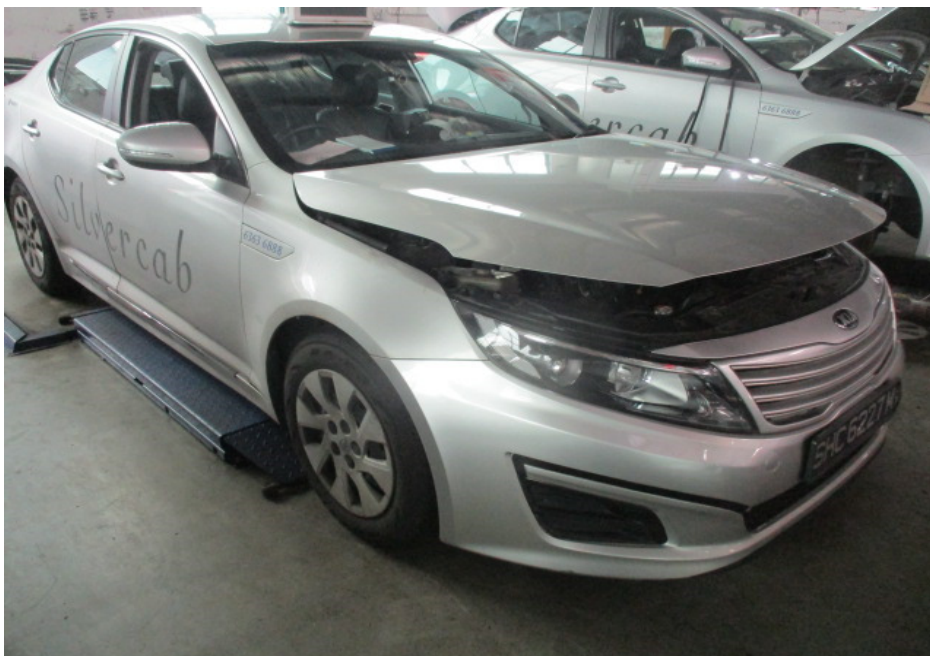
Photo 2 shows the general view of the right body of the Insured Vehicle at the time of our inspection. The exterior body of the Insured Vehicle had sustained visible fire damage. This included its front windscreen, front bonnet and right front panel.

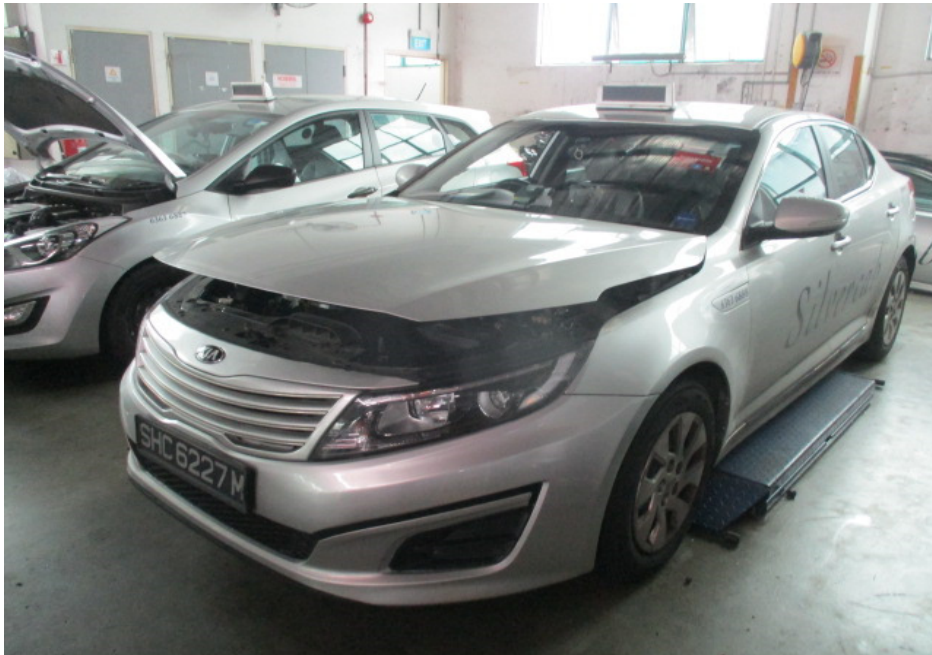
Photo 3 shows the general view of the left body of the Insured Vehicle at the time of our inspection. The exterior body of the Insured Vehicle had sustained visible fire damage. This included its front windscreen, front bonnet and left front panel.

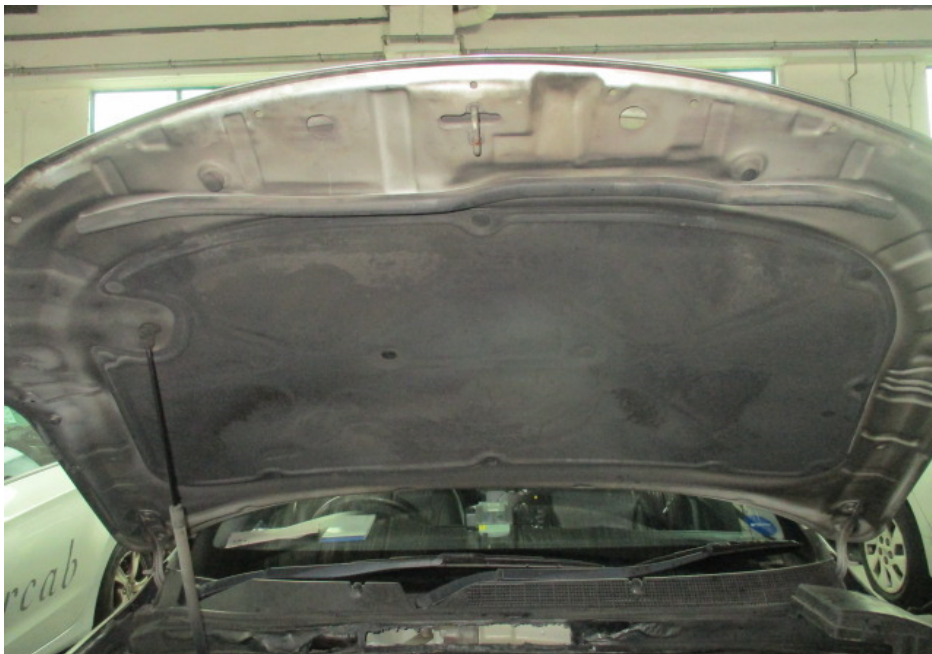
Photo 4 shows a closer view of the underside of the front bonnet of the Insured Vehicle at the time of our inspection. The fire damage to the Insured Vehicle was confined to its front portion. Its insulating material on the underside of the front bonnet was amongst the body parts that were found to have been affected by the fire.

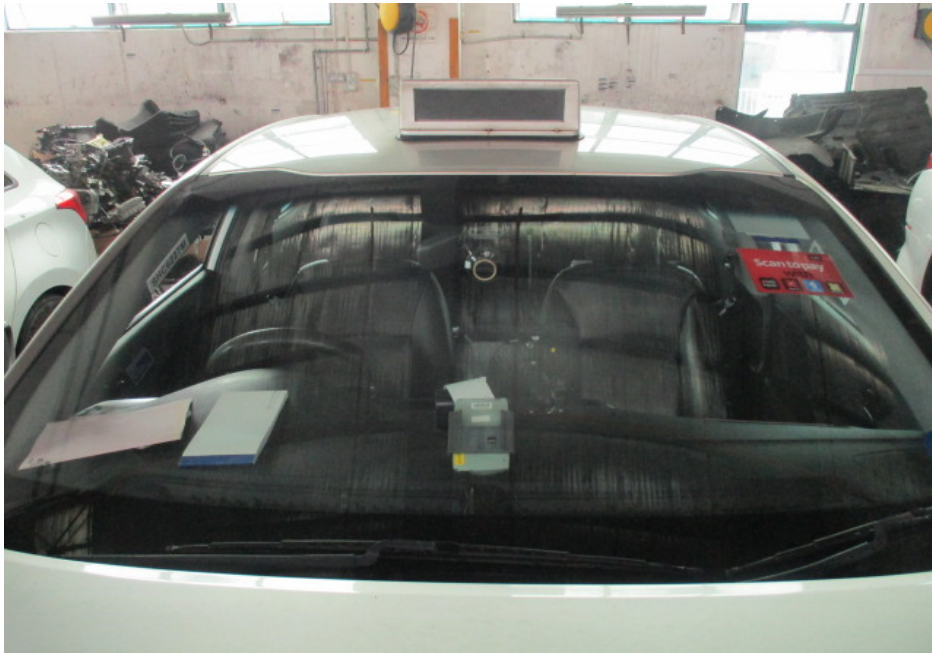
Photo 5 shows the general view of the front windscreen of the Insured Vehicle at the time of our inspection. The front windscreen was slightly affected by the fire.

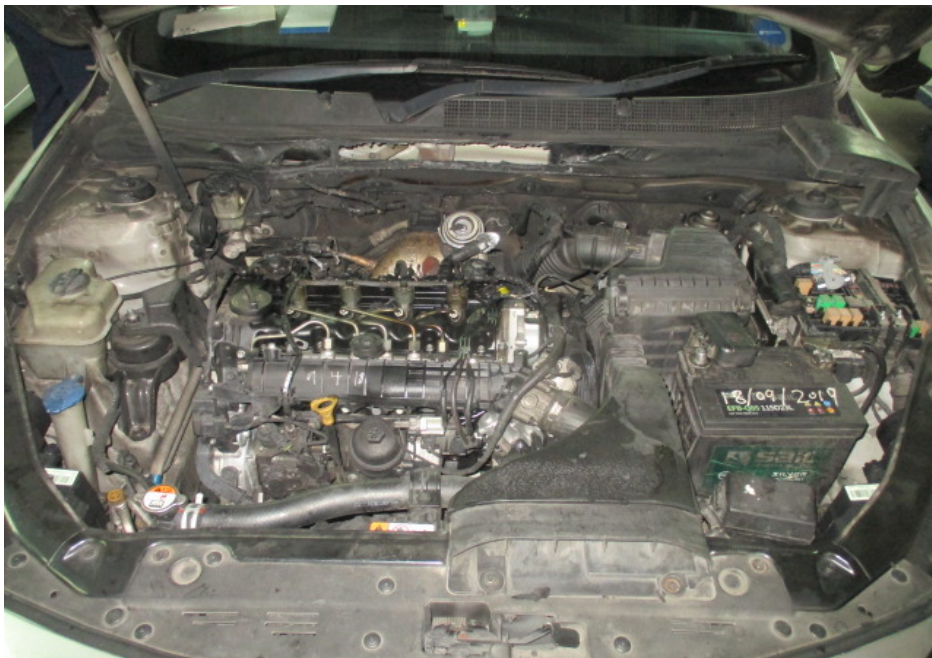
Photo 6 shows the engine compartment of the Insured Vehicle at the time of our inspection. The rear portion of the engine compartment of the Insured Vehicle was observed to be seriously burnt. Some of the parts inside the engine compartment were found to be burnt and/or melted as a result of the fire.

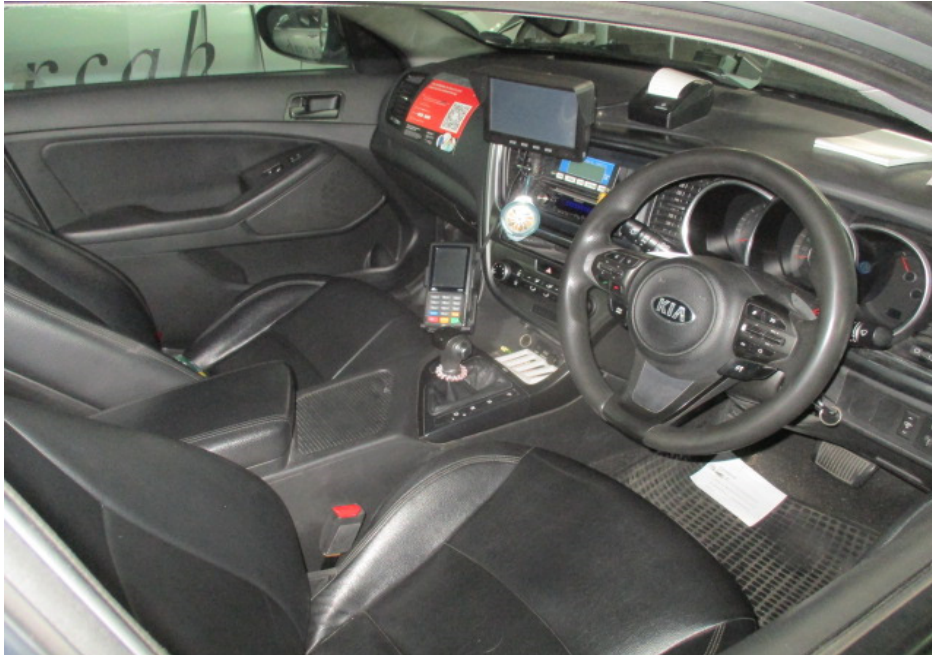
Photo 7 shows the interior compartment of the Insured Vehicle, which was relatively unaffected by the fire.

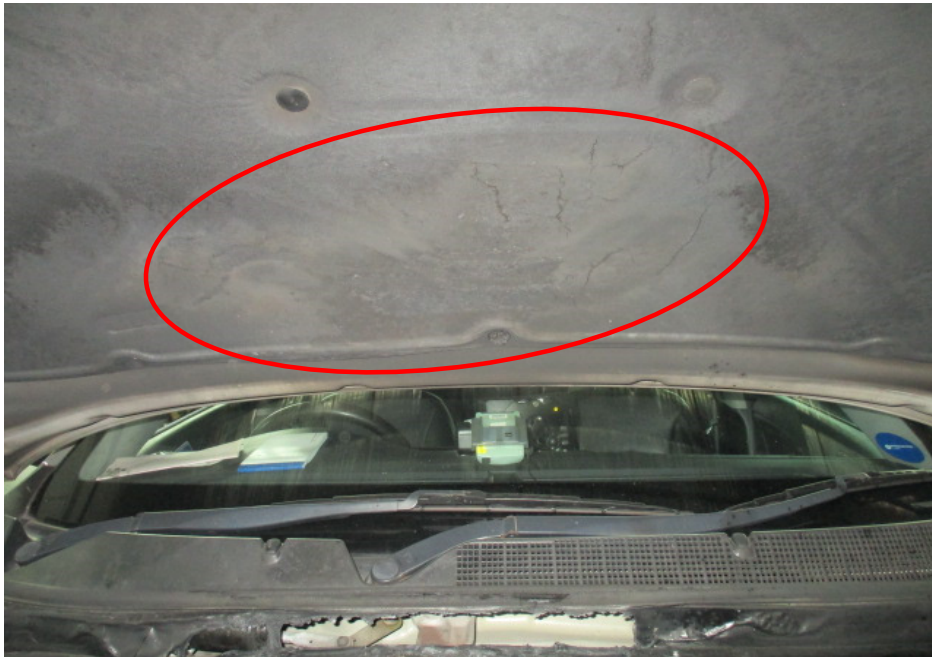
7. For this particular case, the fire appears to have originated within the engine compartment of the Insured Vehicle, somewhere around the rear centre portion of the engine compartment. This can be determined from the cracks in the insulating material on the underside of the front bonnet, the melted wiper panel and also the parts around this area which were more severely affected by the fire. See photos 8 & 9 below.

Photo 8 shows a close up view of the cracks in the insulating material on the underside of the front bonnet of the Insured Vehicle (circled).

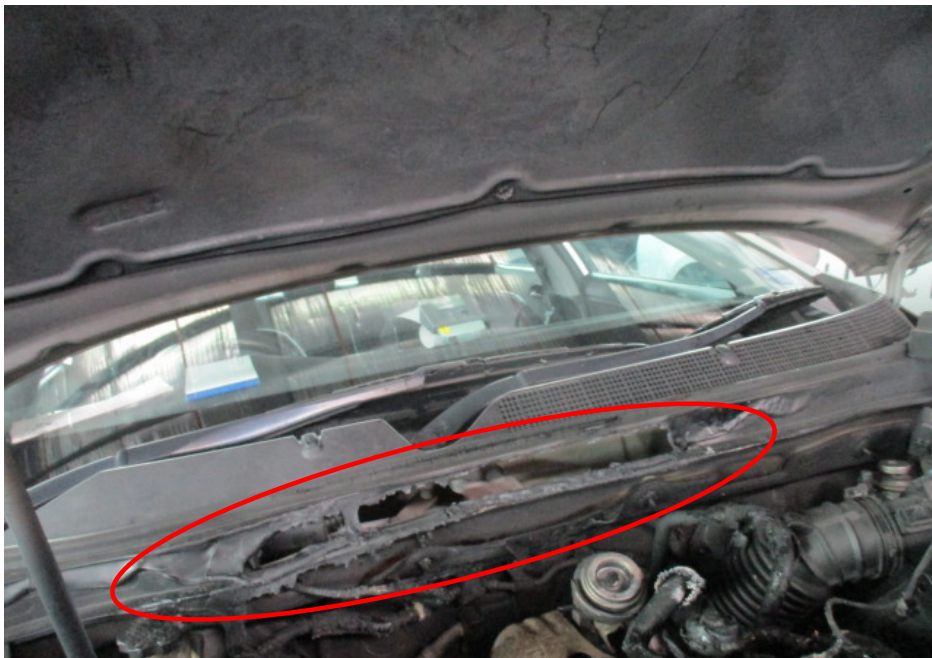
Photo 9 shows a close up view of the melted wiper panel found upon our inspection of the Insured Vehicle (circled).

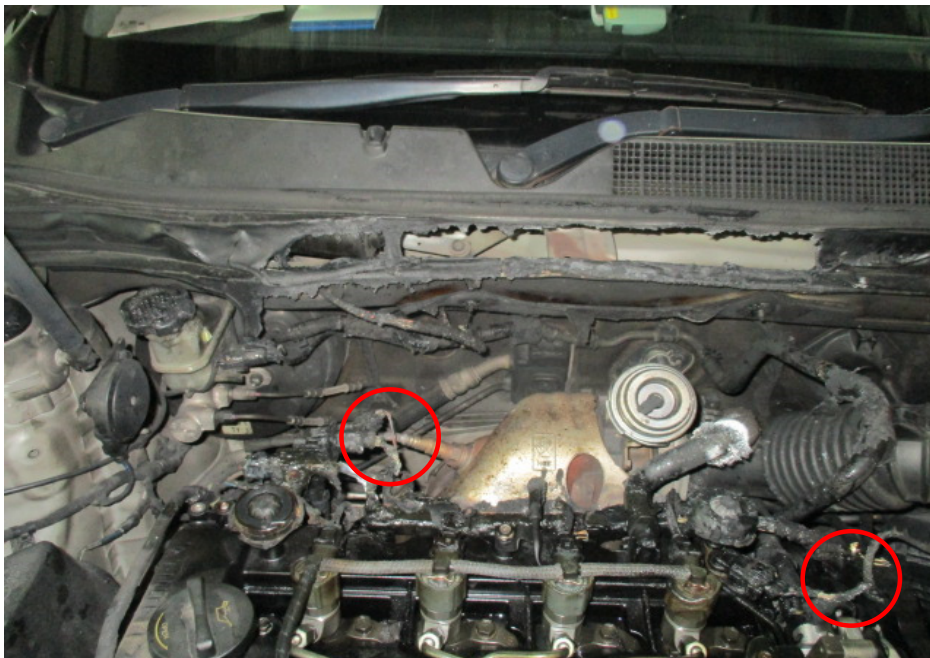
8. Upon closer examination of the rear centre portion of the engine compartment, which was where the fire to the Insured Vehicle had likely started, we had found greenish residue on several burnt stretches of original factory fitted wirings around the rear centre portion of the engine compartment. The presence of such greenish residue indicates internal heating of copper wires, a sign of an electrical short circuit occurring. The greenish residue is normally left behind from oxidation as a result of chemical reaction involving the copper wires. This physical evidence would then appear to suggest that the cause of fire to the Insured Vehicle could have possibly been due to electrical in nature. See photos 10 - 14 below.

Photo 10 shows the original factory fitted wirings around the rear centre portion of the engine compartment, which is in the immediate vicinity where the fire to the Insured Vehicle had likely started. We had found greenish residue on several burnt stretches of these wirings (circled). The presence of such greenish residue indicates internal heating of copper wires, a sign of an electrical short circuit occurring. The greenish residue is normally left behind from oxidation as a result of chemical reaction involving the copper wires.

26. Having investigated and technically analysed the damages of burnt nature to the Insured Vehicle, we are of the view that the cause of fire to the Insured Vehicle was of electrical in nature. For this particular case, the fire had originated along the original factory fitted wirings inside the engine compartment, somewhere around the rear centre portion of the engine compartment.

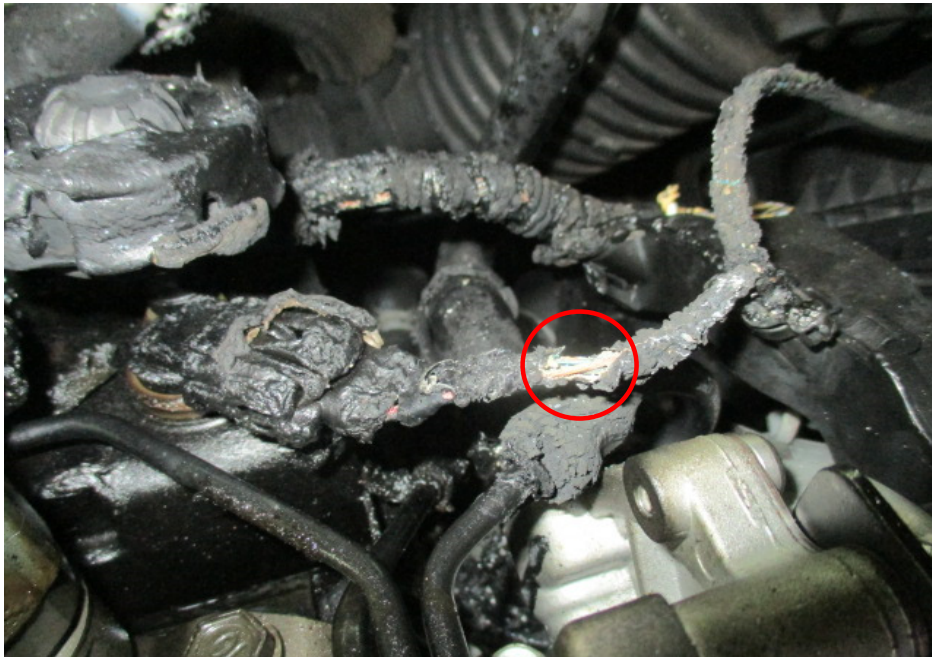
Photo 11 shows a closer view of the greenish residue found on some of the burnt stretches of original factory fitted wirings (circled). The presence of such greenish residue suggests occurrence of an electrical short circuit.

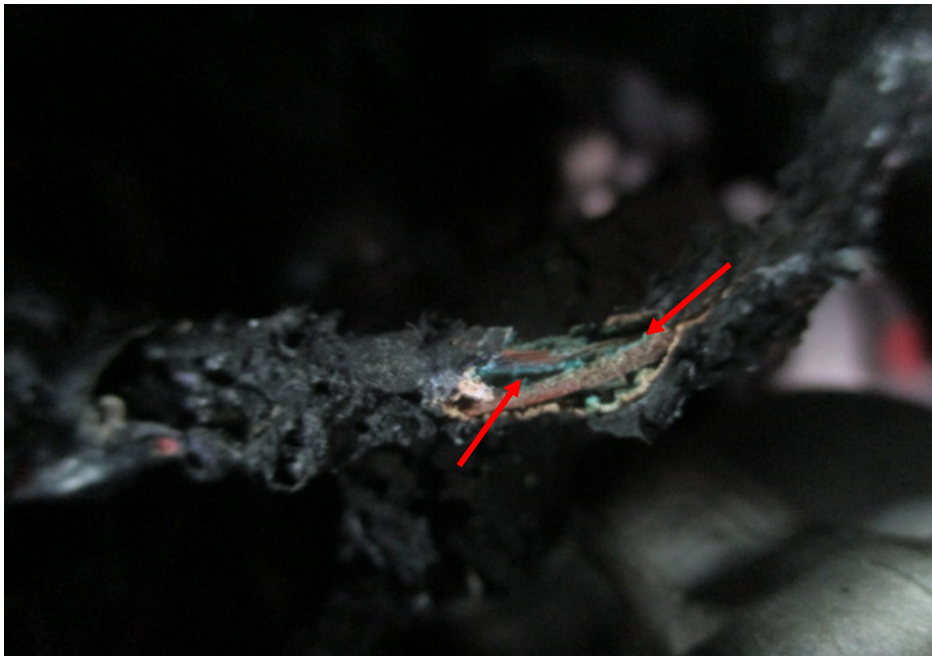
Photo 12 shows a close up view of the greenish residue found on some of the burnt stretches of original factory fitted wirings (arrowed). The presence of such greenish residue suggests occurrence of an electrical short circuit.

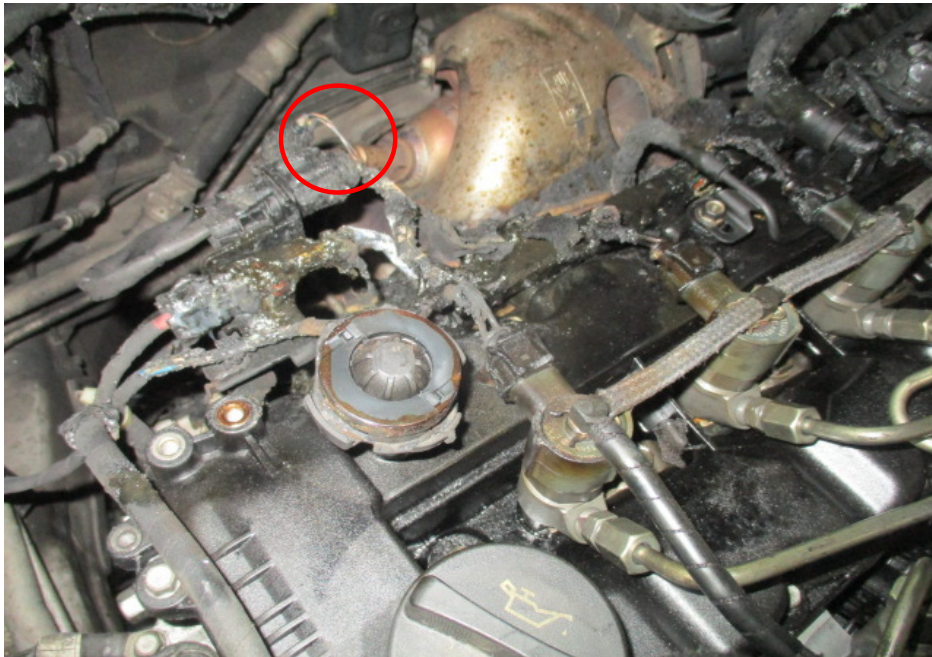
Photo 13 shows a closer view of the greenish residue found on some of the burnt stretches of original factory fitted wirings (circled). The presence of such greenish residue suggests occurrence of an electrical short circuit.

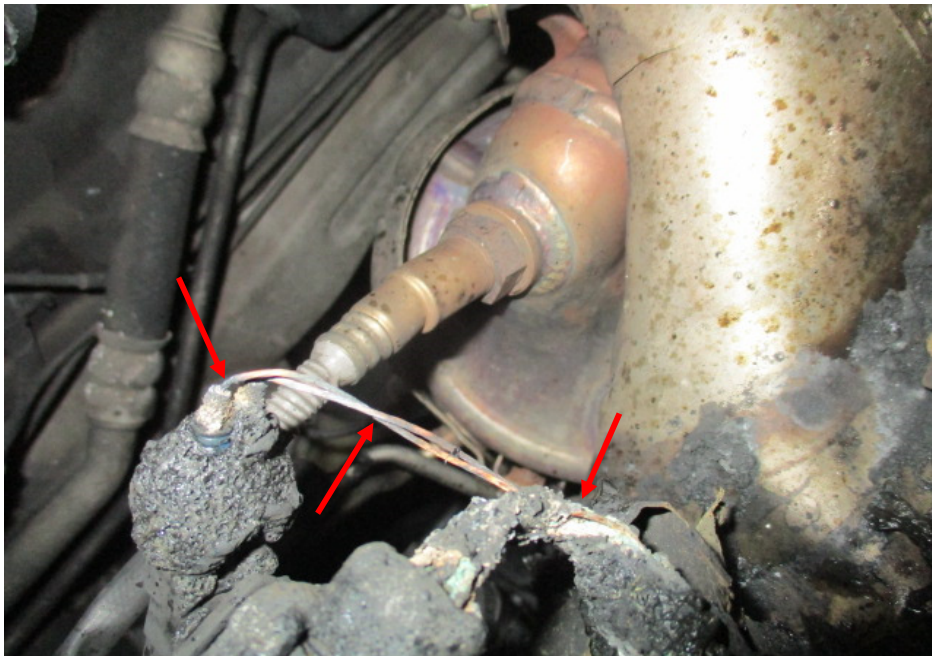
Photo 14 shows a close up view of the greenish residue found on some of the burnt stretches of original factory fitted wirings (arrowed). The presence of such greenish residue suggests occurrence of an electrical short circuit.

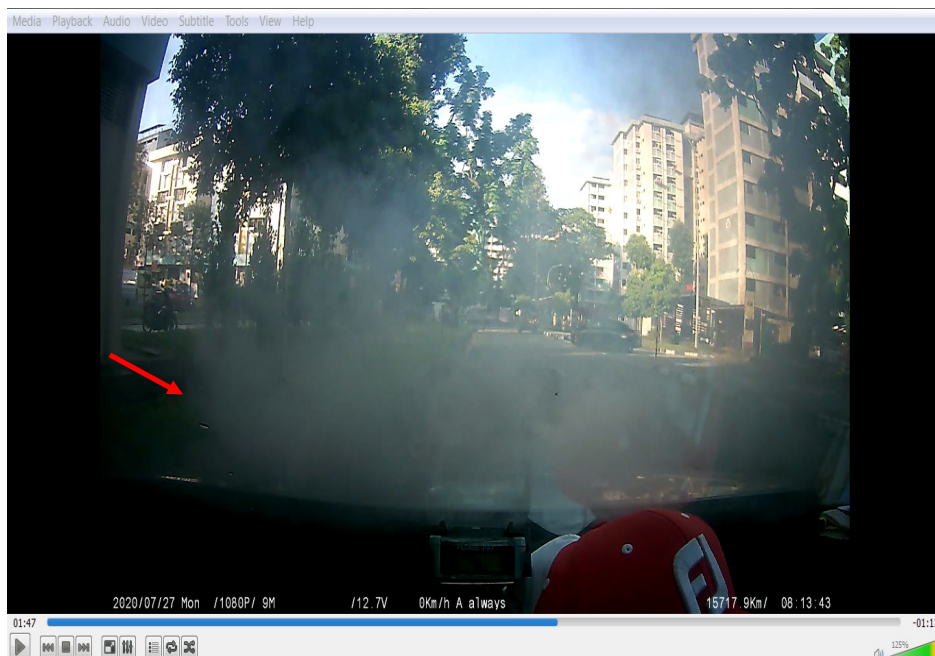
Screenshot 1 shows smoke emitting from the front bonnet of the Insured Vehicle after Mr Teng pulled over to the side of the road (arrowed).

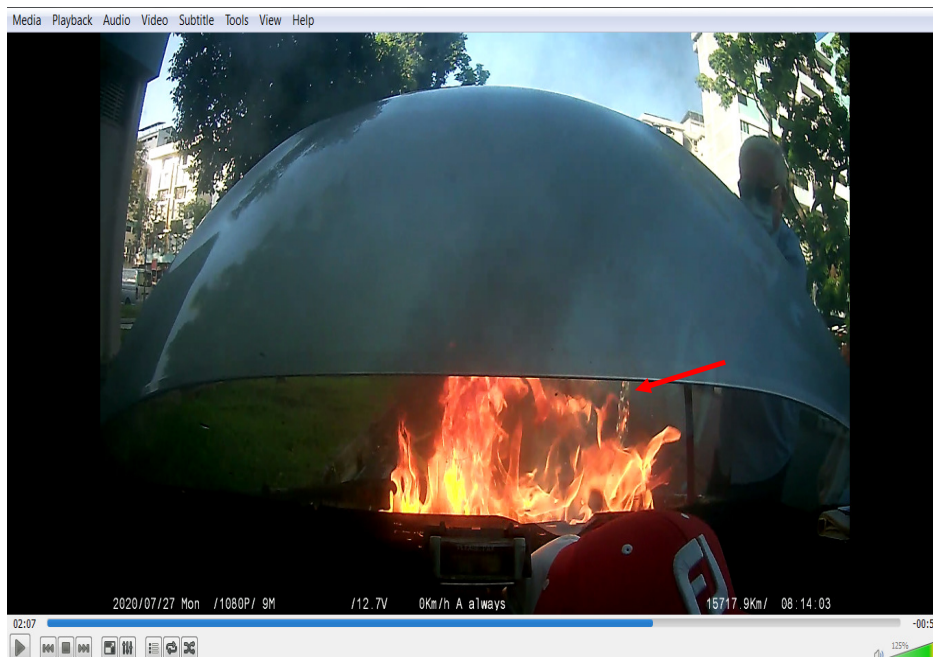
Screenshot 2 shows Mr Teng attempting to put out the fire to the Insured Vehicle with a bottle of water (arrowed).

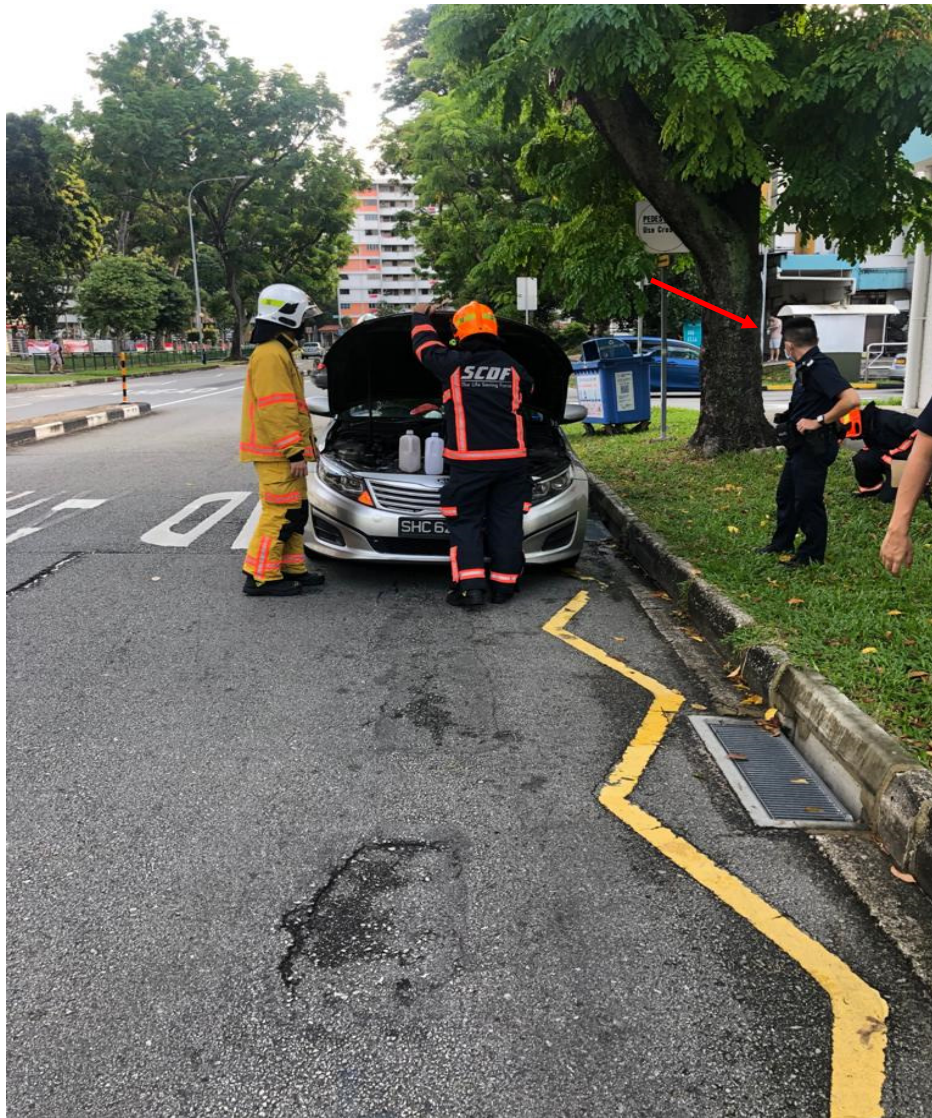
Photo 15 shows the SCDF conducting preliminary investigations on the Insured Vehicle post- incident. In general, the information that could be gathered from this photograph had corresponded to the events that were related to us by Mr Teng which is the police were also present at the incident location (arrowed).

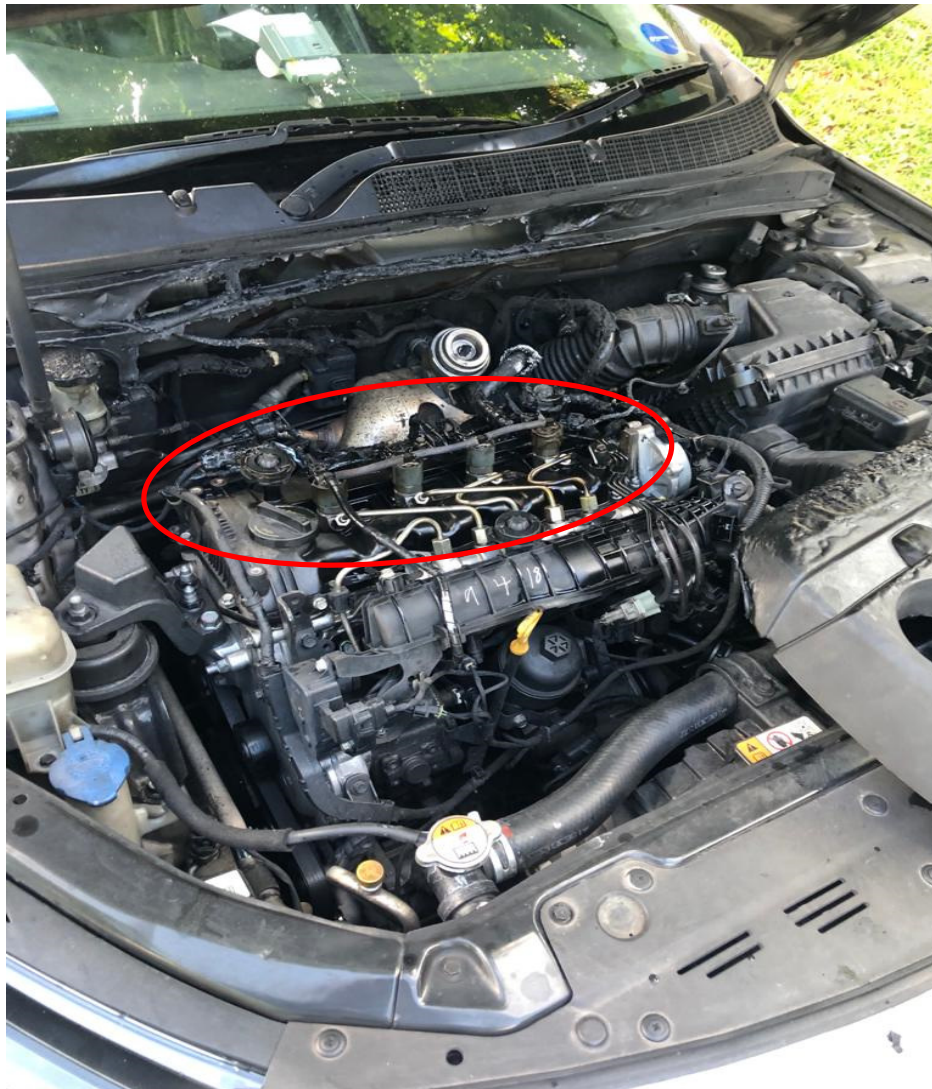
Photo 16 shows the Insured Vehicle at the incident scene after the fire was extinguished. In general, the information that could be gathered from this photograph had corresponded to the events that were related to us by Mr Teng, which is the fire had started in the rear centre portion of the engine compartment (circled).
