LKK Auto Consultants Pte Ltd

Vehicle No. GBH 9742S
Insured Veh. GBG 1395T
Claim No. SNM20D202636
Policy No. DMCVSNW00033412001
Accident Date 26/07/2020
Inspection Date 28/07/2020

ADJUSTMENT ON REPAIR COST FOR VEHICLE NO. GBH 9742S

PHOTOGRAPHS FOR VEHICLE NO. GBH 9742S

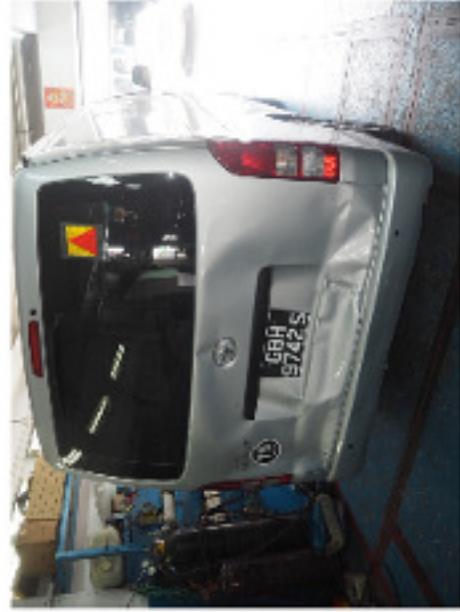
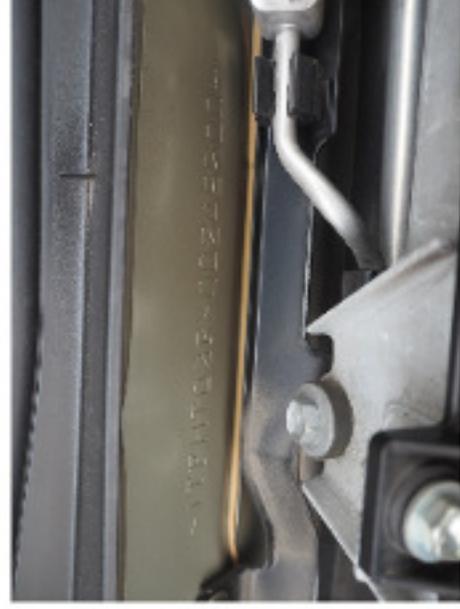
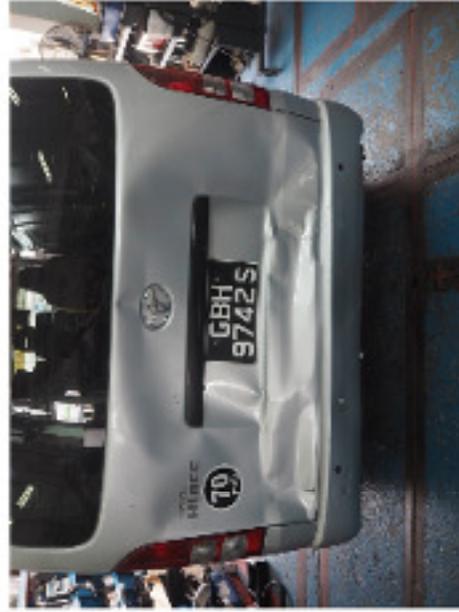
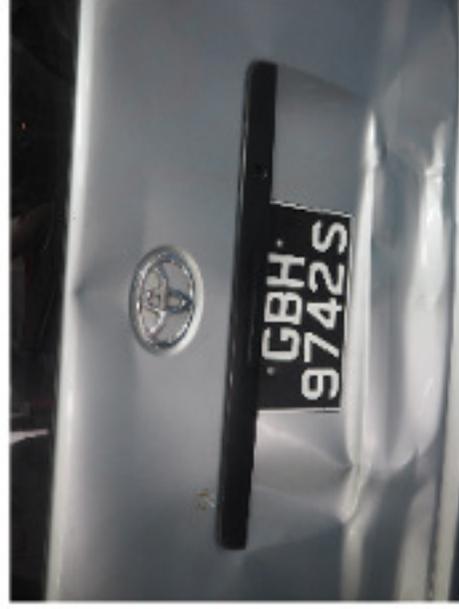
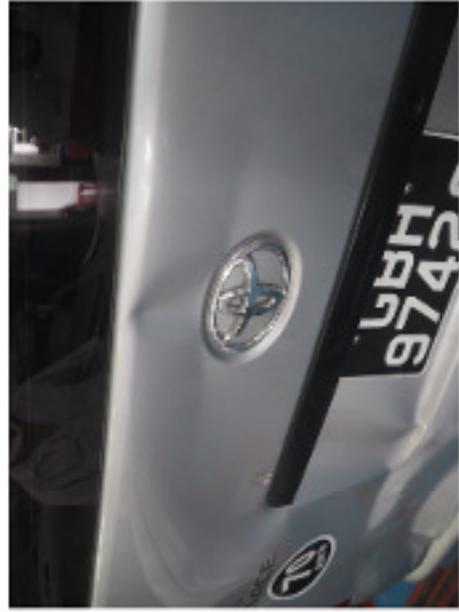
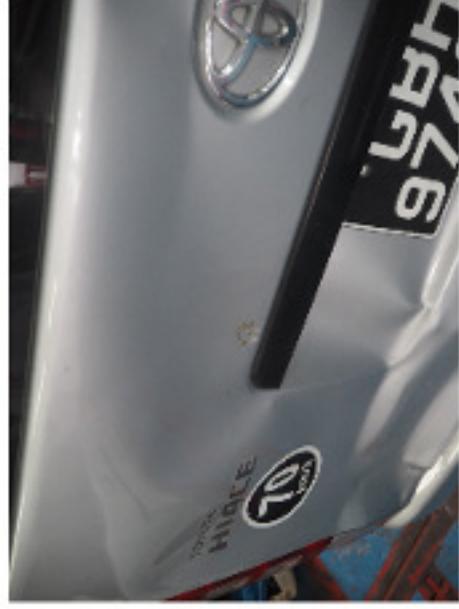
INSPECTION

THE VEHICLE SUSTAINED DAMAGES AT THE REAR PORTION.
DAMAGES SEE DETAILS.
