Your Ref: Porsche Marcan  
(chassis number WP1ZZZ95ZKLB08651)  
Our Ref : CI/TP20007840/D

03 August 2020

**INSPECTION REPORT OF AN UNREGISTERD PORSCHE MARCAN MOTOR CAR WITH CHASSIS NUMBER WP1ZZZ95ZKLB08651**

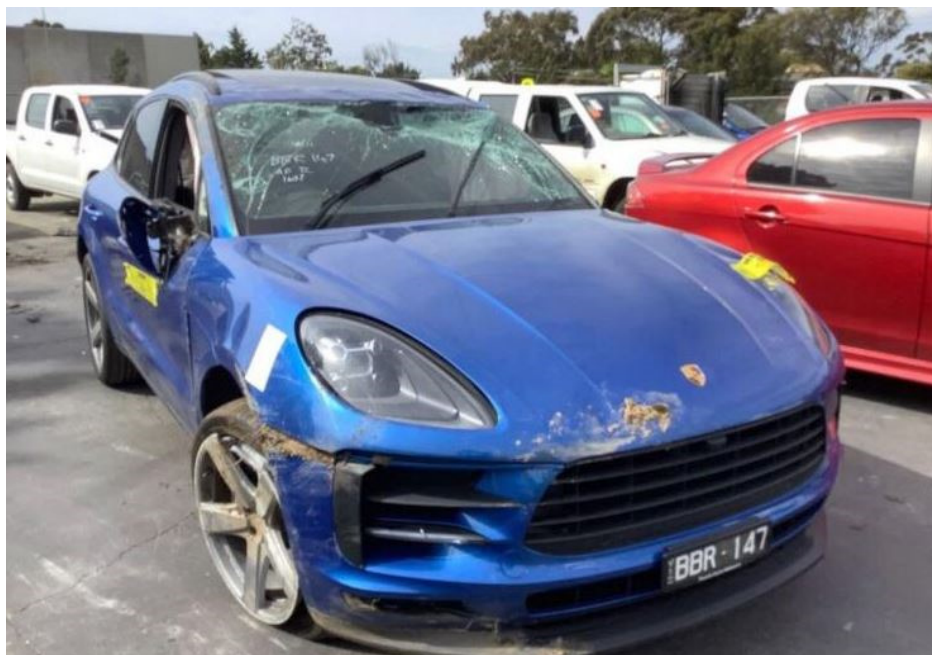
**Photo 1** shows the front right body of the Motor Car prior to any repairs being carried out (photograph provided to me). The Motor Car was observed to have sustained damages at its front right body. The body parts observed to be damaged include its front bumper, front right fender, front right door, right side wing mirror, right side "A" pillar and roof panel amongst others. The front right wheel rim was also observed to be broken.

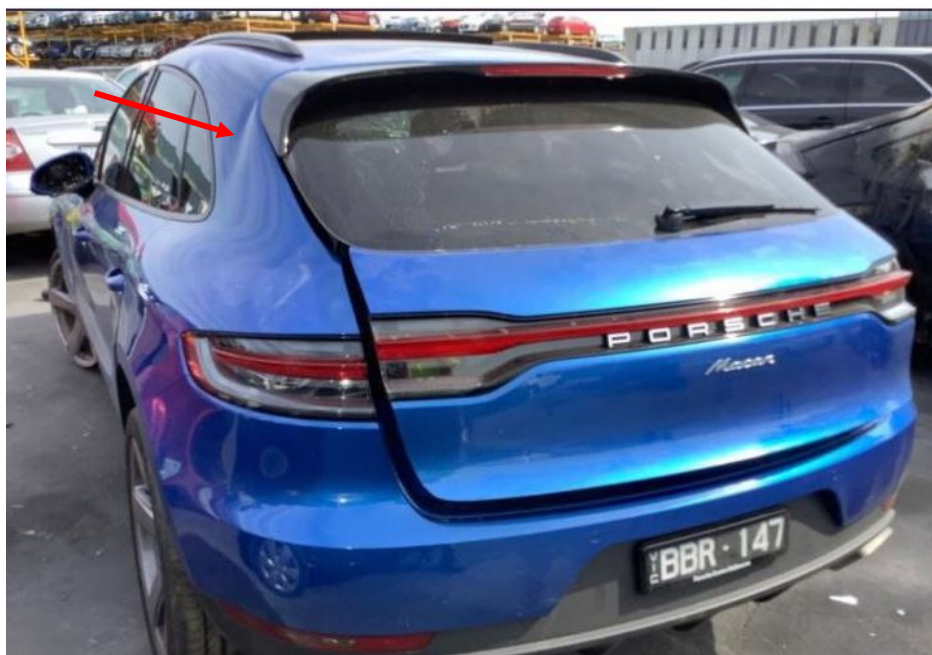
**Photo 2** shows the rear left body of the Motor Car prior to any repairs being carried out (photograph provided to me). The rear left fender was observed to be dented (arrowed).

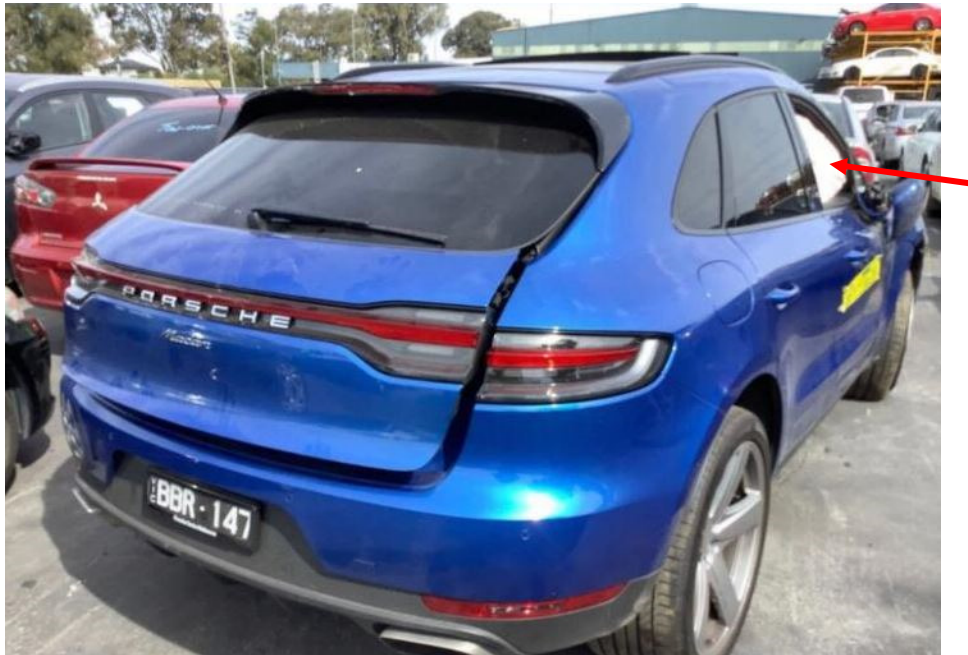
**Photo 3** shows the rear right body of the Motor Car prior to any repairs being carried out (photograph provided to me). The right side curtain airbag was observed to be deployed (arrowed).

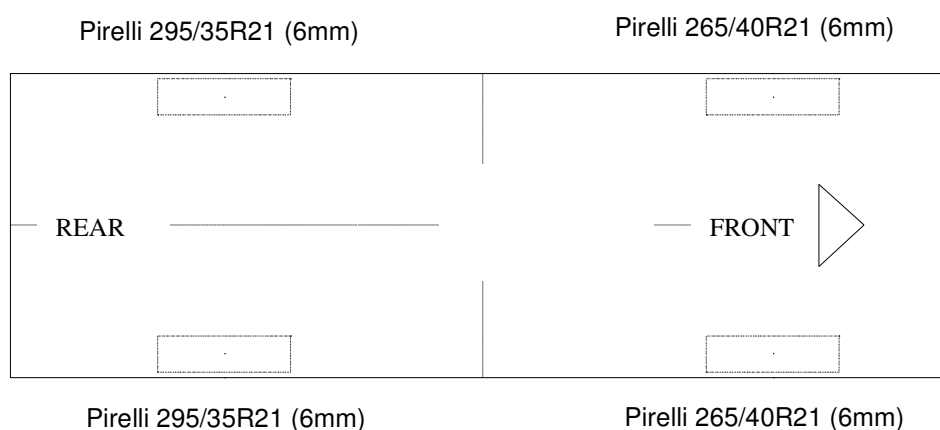
8. It was fitted with 21inch sport wheel rims that were wrapped with tyres that were observed to be of serviceable condition. The tyres were also sufficiently inflated for vehicular operation. The tyre brand, tyre size and approximate remaining tread depth of the 4 tyres of the Motor Car were recorded as follows: -

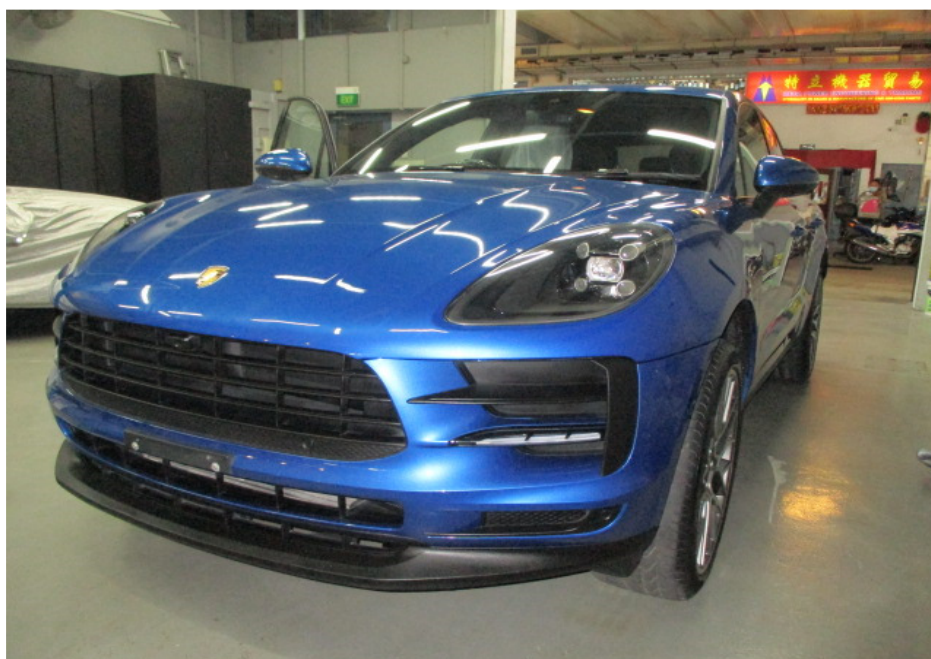
**Photo 4** shows a general view of the front left body of the Motor Car at the time of my inspection. The Motor Car was observed to be in relatively good general condition with no loose exterior fittings observed. The body parts at the front left portion of the Motor Car were visually examined and it was observed that the repair/restoration works carried out to the damaged area of the Motor Car were reasonably adequate and in order.

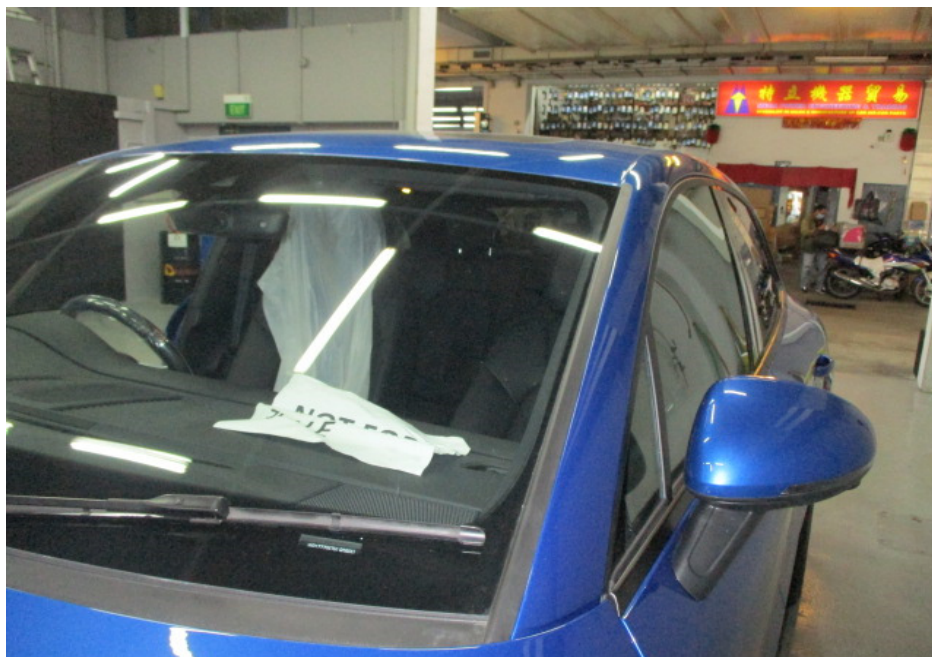
**Photo 5** shows a general view of the front windscreen, roof panel and left “A” pillar of the Motor Car. The body parts at the front left portion of the Motor Car were visually examined and it was observed that the repair/restoration works carried out to the damaged area of the Motor Car were reasonably adequate and in order.

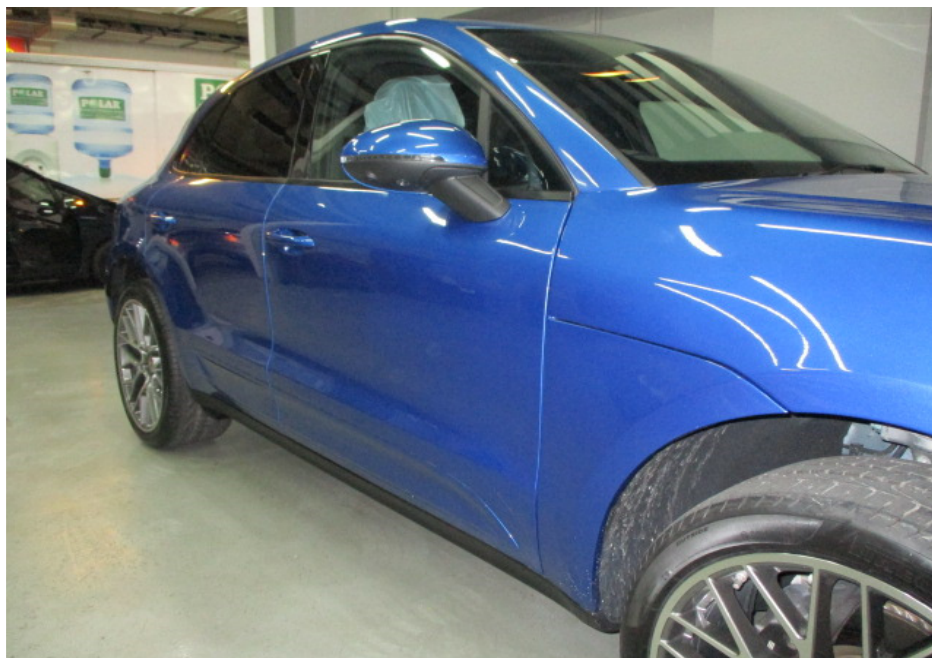
**Photo 6** shows the right body of the Motor Car. The Motor Car was observed to be in relatively good general condition with no loose exterior fittings observed. The body parts at the right side of the Motor Car were visually examined and it was observed that the repair/restoration works carried out to the damaged area of the Motor Car were reasonably adequate and in order.

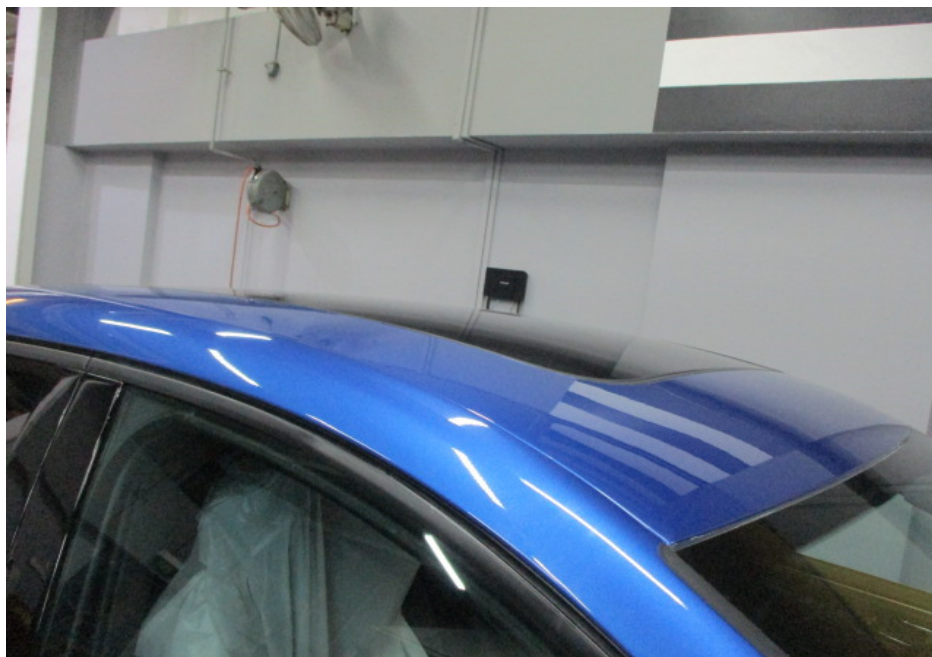
**Photo 7** shows the roof panel of the Motor Car at the time of my inspection. The roof panel of the Motor Car were visually examined, and it was observed that the repair/restoration works carried out to the damaged area of the Motor Car were reasonably adequate and in order

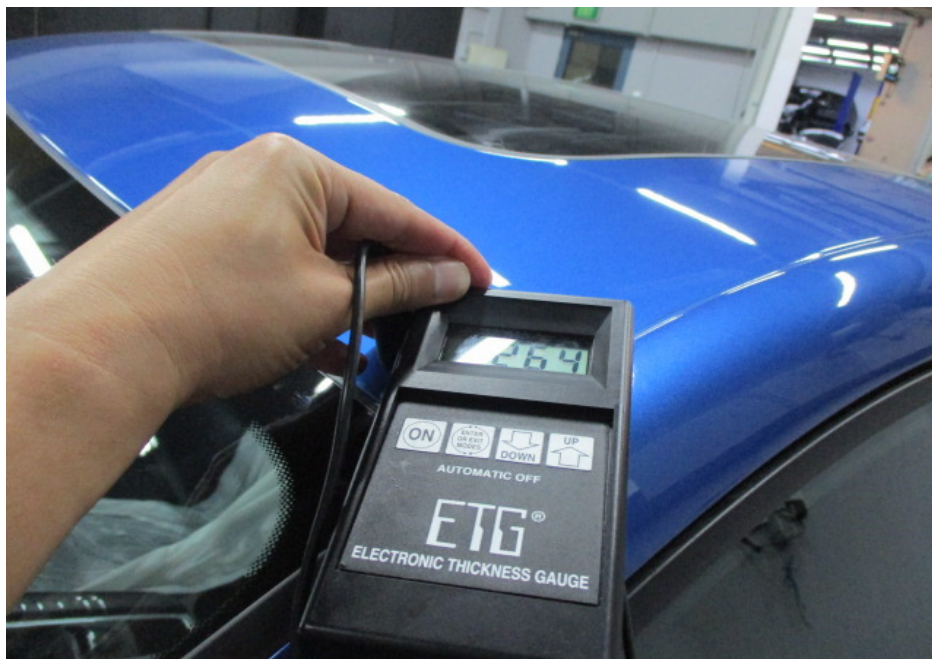
9. The detachable body panels of the Motor Car like the front fenders, front bumper, rear bumper, doors, bonnet and rear tailgate amongst others were all found to be fitted securely.
10. Checks on the non-detachable body panels like the rear fenders, floor board, roof panel, pillars and rocker panels amongst others, revealed that these body panels were spot welded onto the chassis/structural body of the Motor Car. The original factory sealant at the joints of the non-detachable body panels was all untouched indicating no replacement of the non-detachable body panels was carried out; and that these body panels were all originally fitted except for the roof panel, which was found to be replaced (refer to photograph 8 & 9 Below..

**Photo 8** shows measurement being carried out to the thickness of the paint at the left side front of the Motor Car's roof panel. This area of the roof panel was observed to be damaged (refer to photograph 1 above). The reading of the paint thickness was recorded at 264micron.

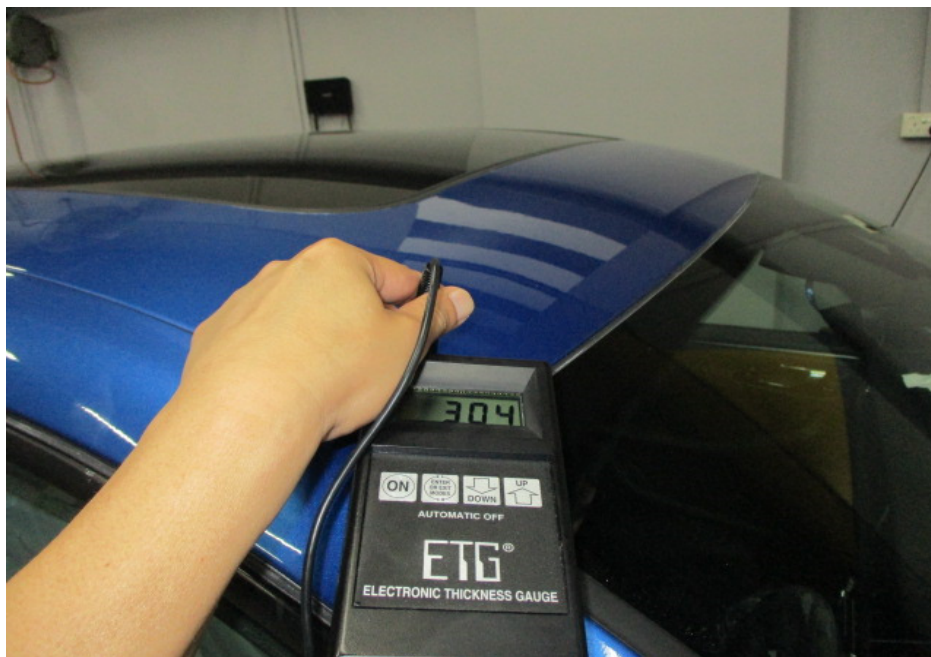
**Photo 9** shows measurement being carried out to the thickness of the paint at the right side front of the Motor Car's roof panel. This area of the roof panel was observed to be damaged (refer to photograph 1 above). The reading of the paint thickness was recorded at 304micron. The readings obtained at the left and right front of the Motor Car's roof panel were relatively close, which indicates that the roof panel was replaced.

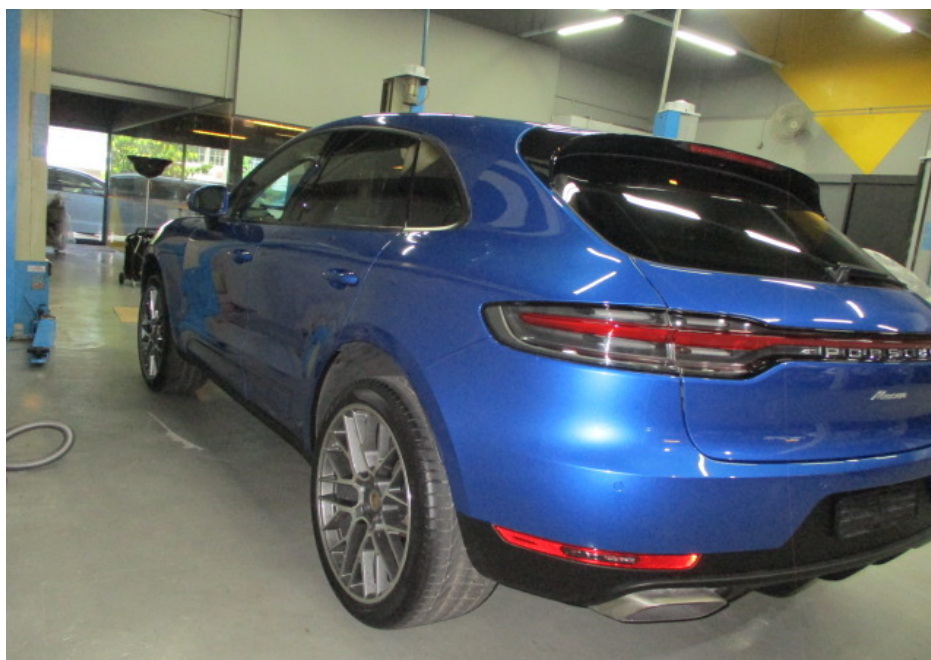
**Photo 10** shows a general view of the rear left body of the Motor Car at the time of my inspection. The Motor Car was observed to be in relatively good general condition with no loose exterior fittings observed.

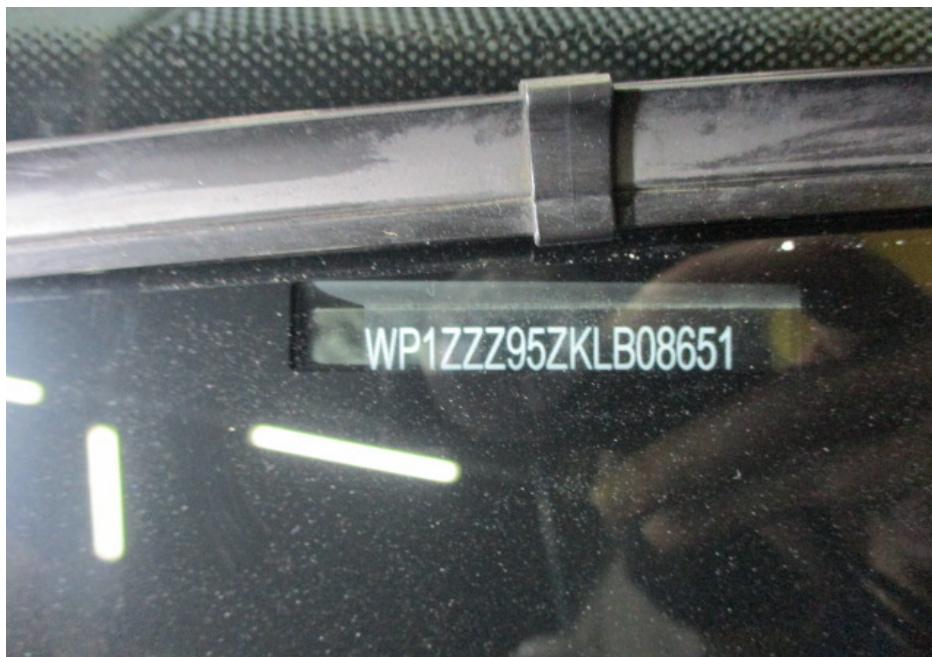
**Photo 11** shows the chassis number of the Motor Car. The chassis number recorded was WP1ZZZ95ZKLB08651.

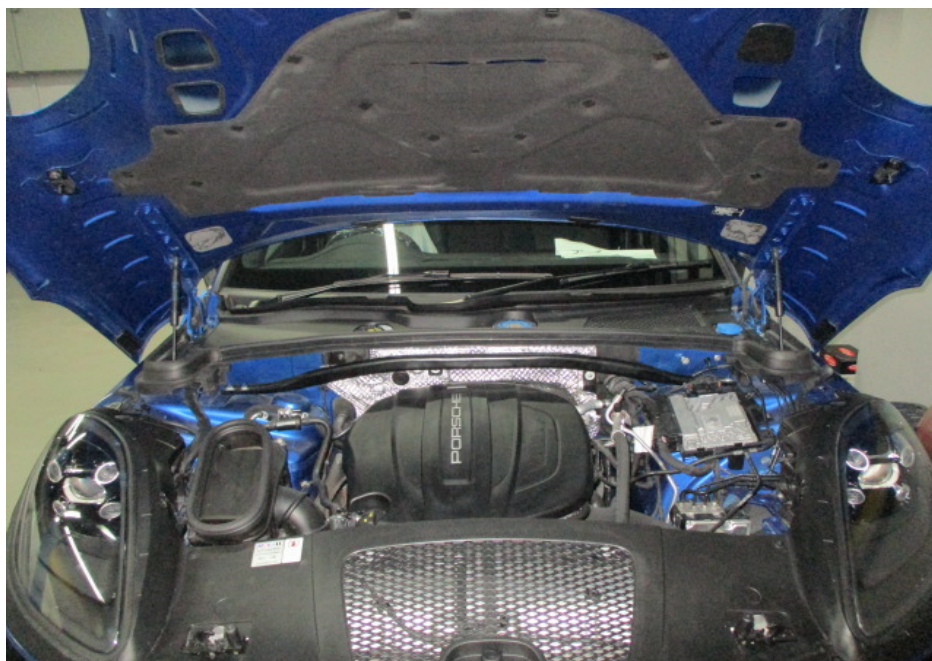
**Photo 12** shows a general view of the engine compartment of the Motor Car at the time of my inspection. The various parts and components inside the engine compartment were all observed to be intact and properly fitted. There was also no sign(s) or indication(s) of fluid leak and/or fluid stain found inside the engine compartment.

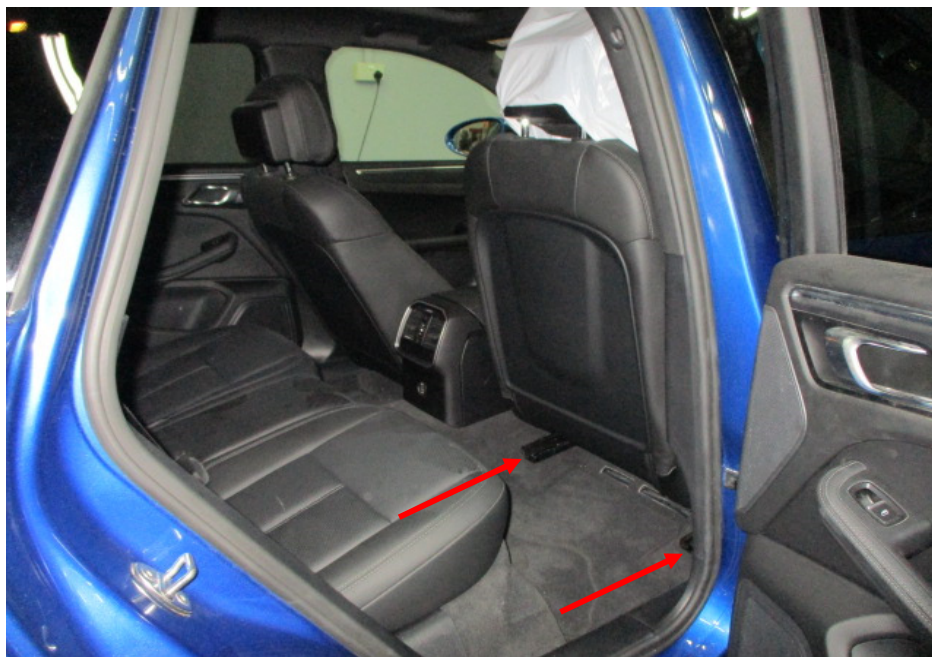
**Photo 13** shows the seats of the Motor Car, which were secured via seat rails (arrowed) to the floor board. All the seats of the Motor Car were fitted with a retractable seat belt reel and pre-tensioner. The seat belts were tested and able to be fastened into the respective pre-tensions that were fitted on the side of each individual seat.

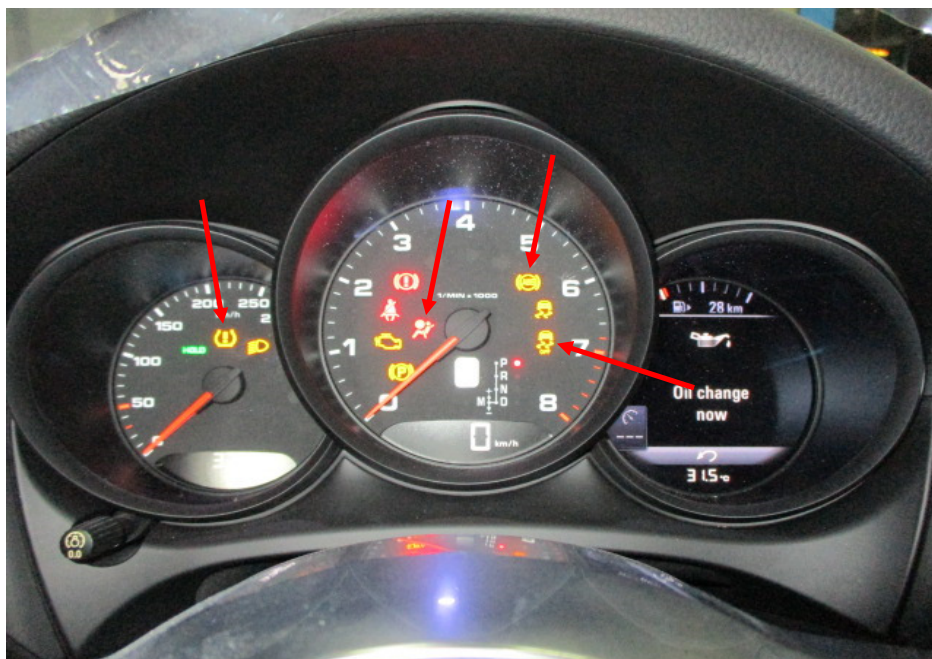
**Photo 14** shows the warning lights for the various electronic safety features appearing on the instrument panel of the Motor Car during its self-test when the engine is cranked, in particular the ABS, SRS, TPM and TCS lights (arrowed).

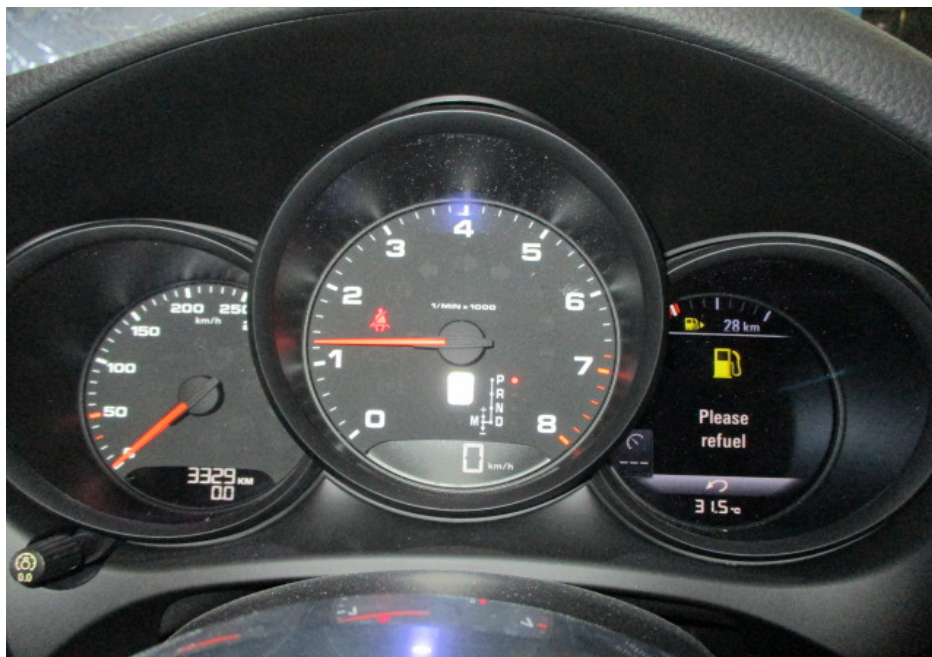
**Photo 15** shows the respective warning lights no longer illuminated, indicating that there is no fault detected to the ABS, SRS, TPM and TCS systems of the Motor Car during the self-test. These electronic systems were hence in working condition at the time of my inspection.

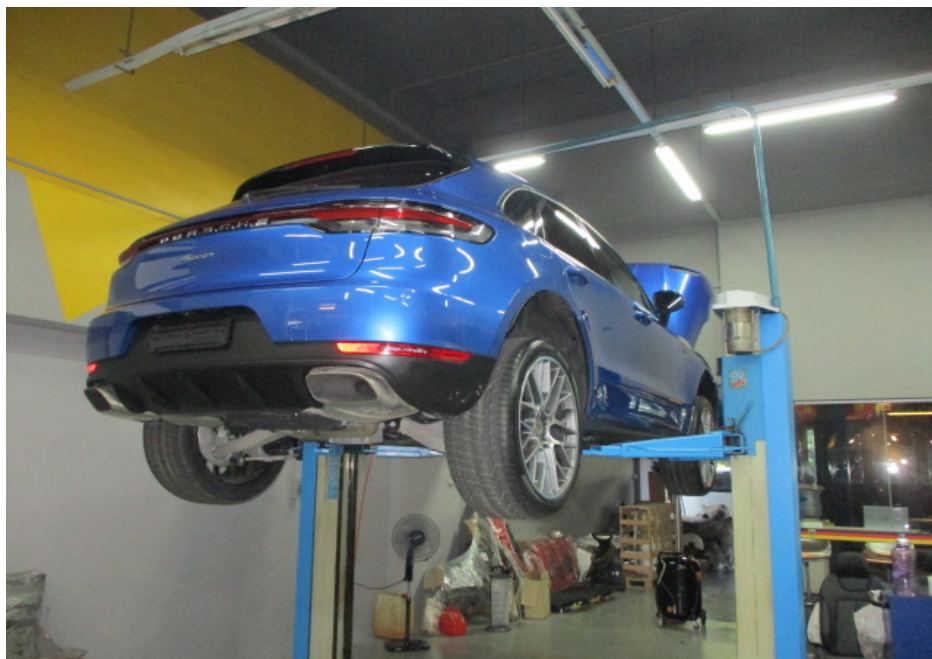
**Photo 16** shows the Motor Car hoisted up for checks on its undercarriage. There was no sign(s) or indication(s) of fluid leakage and/or fluid stain(s) on the underside of the Motor Car. The undercarriage components of the Motor Car were also all observed to be intact and secured in an appropriate manner.

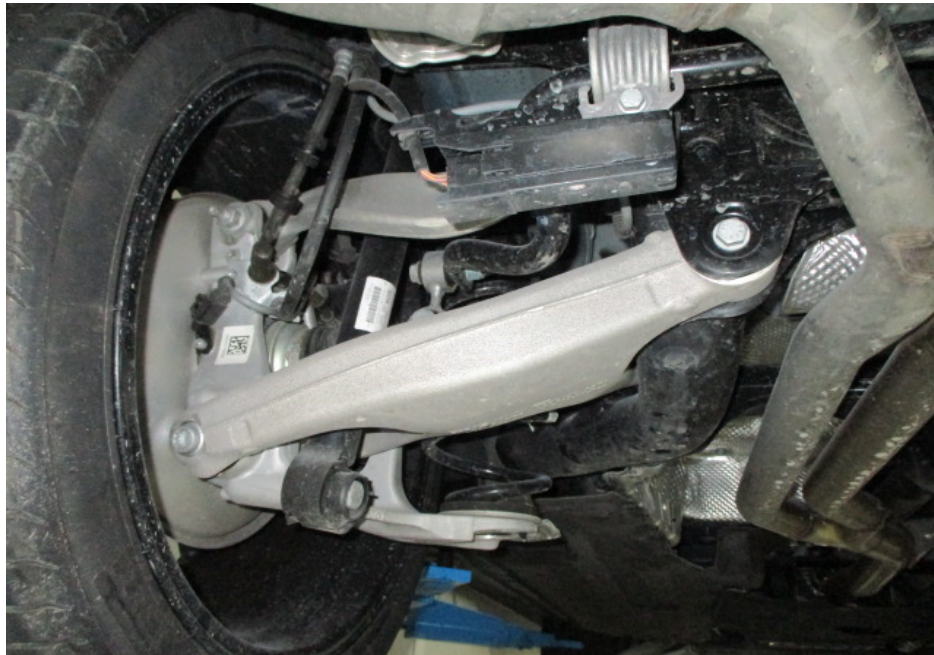
**Photo 17** shows a general view of the control arms and linkages at the rear left wheel of the Motor Car. I did not observe any fluid leak and/or fluid stain on the underside of the Motor Car. All of the Motor Car's undercarriage components were observed to be intact and secured in an appropriate manner.

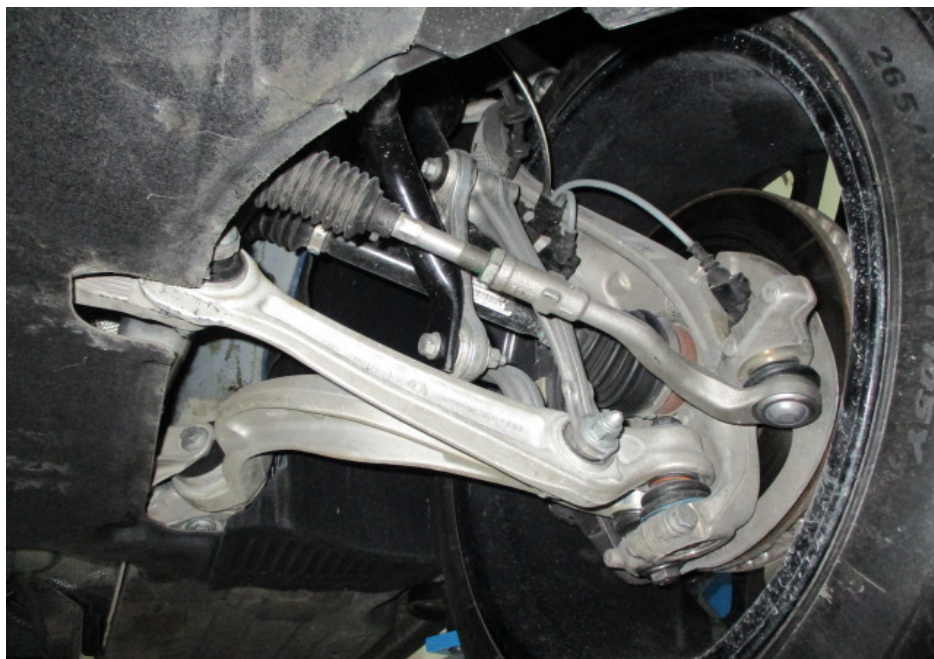
**Photo 18** shows the various undercarriage components at the front left wheel of the Motor Car. The mechanical components, control arms and linkages were all found to be intact and secured in an appropriate manner.

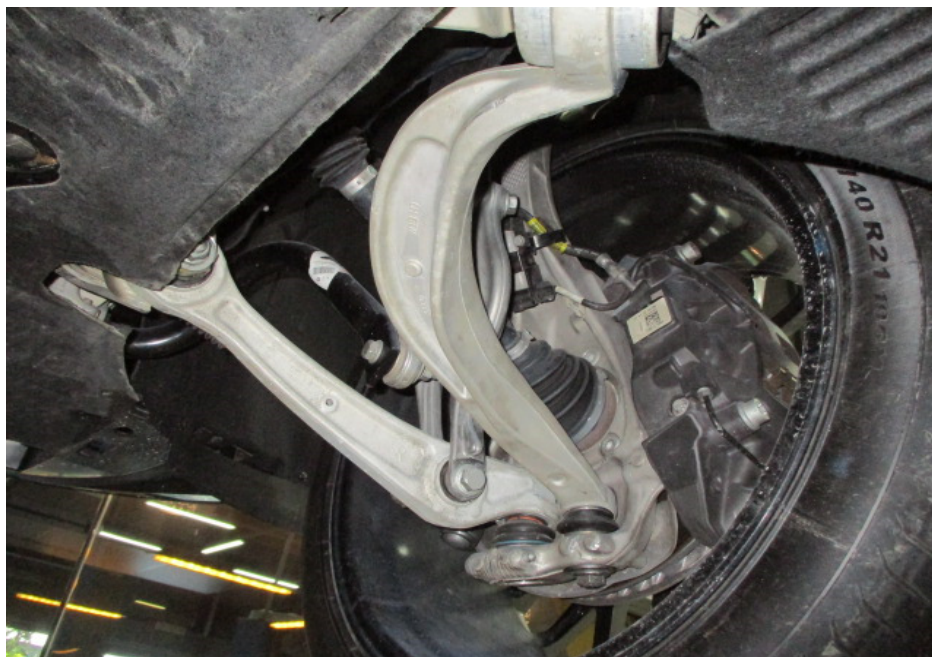
**Photo 19** shows the various undercarriage components at the front right wheel of the Motor Car. The mechanical components, control arms and linkages were all found to be intact and secured in an appropriate manner. I also did not observe any fluid leak and/or fluid stain on the underside of the Motor Car.

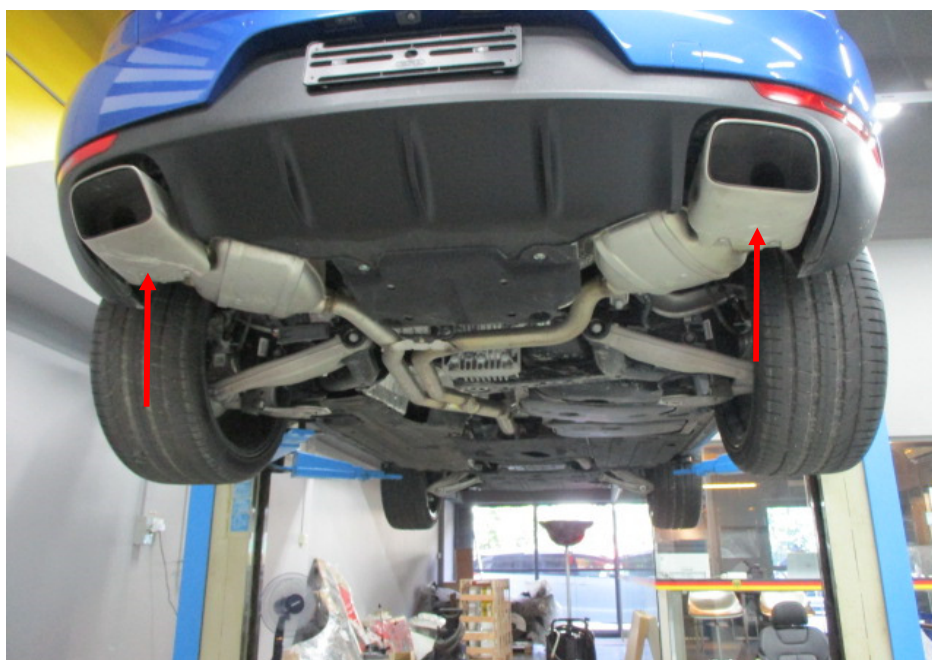
**Photo 20** shows the Motor Car's rear mufflers (arrowed). My examination of the Motor Car's exhaust system revealed no sign(s) or indication(s) of any cut or weld marks along its exhaust pipes and on its catalytic converters.

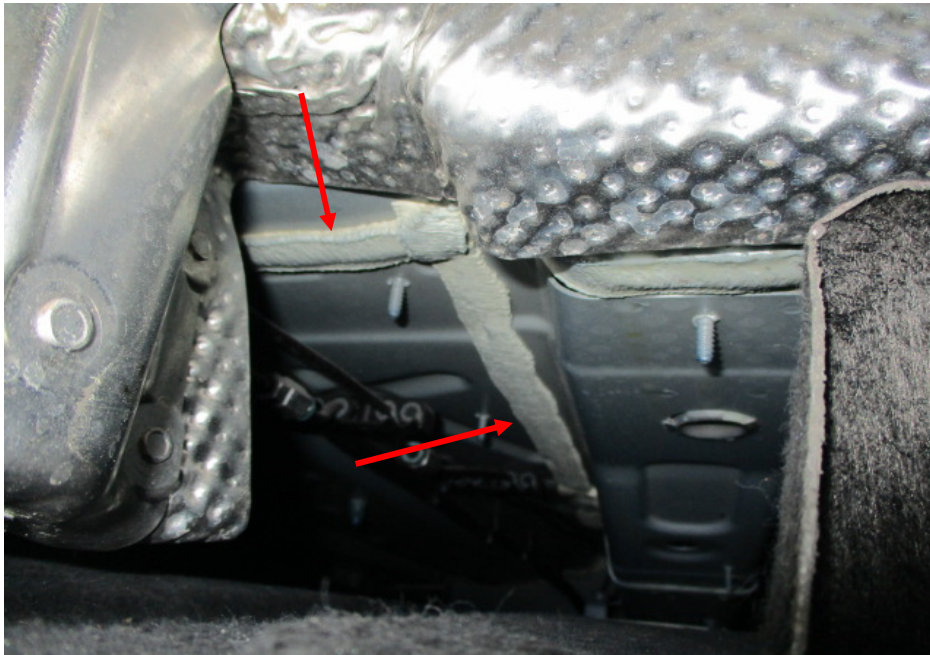
**Photo 21** shows the floor board at the underside left of the Motor Car. The original factory sealant (arrowed) at the joints along the non-detachable body parts at the underside of the Motor Car was untouched, indicating no work was done on the floor board of the Motor Car and that the floor board was originally fitted.

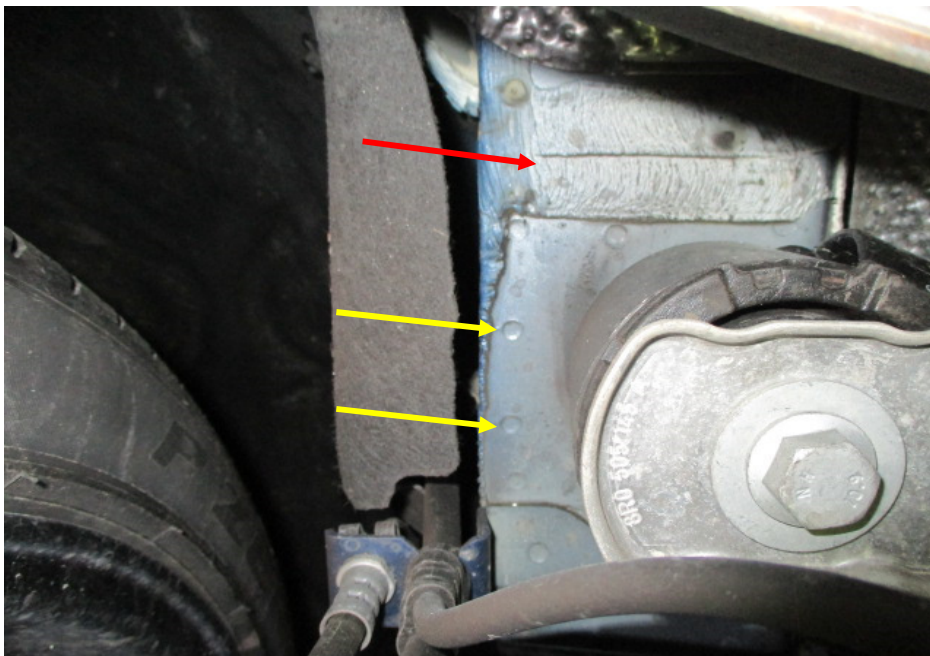
**Photo 22** shows the chassis/structural body at the underside rear left of the Motor Car. Visually, I did not find any weld marks other than original spot weld marks (yellow arrow) on the chassis/structural body of the Motor Car. The original factory sealant (red arrow) at the joints along the chassis/structural body was also untouched, indicating no work was done on the chassis/structural body of the Motor Car and that the chassis/structural body was originally fitted.

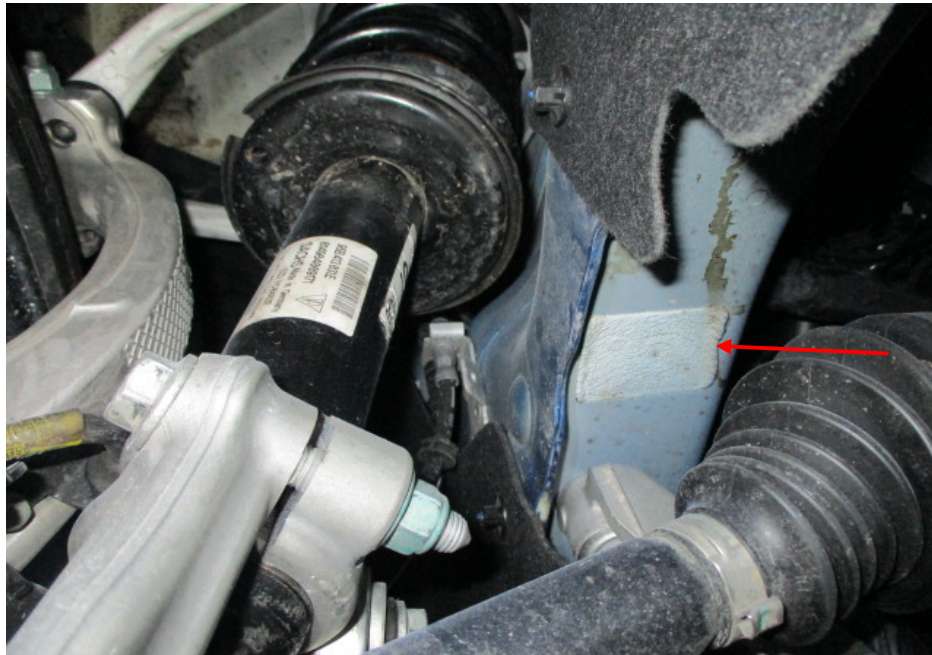
**Photo 23** shows the chassis/structural body at the underside front left of the Motor Car. The original factory sealant (arrowed) at the joints along the chassis/structural body was untouched, indicating no work was done on the chassis/structural body of the Motor Car and that the chassis/structural body was originally fitted.
