VEHICLE DAMAGE INSPECTION REPORT

Our Ref: 597/TP/2019

Reg No:	SMD5428S	Make &	Honda
Reg date:	24/8/2018	Model	Shuttle Hybrid 1.5 Auto
Colour:	Black	Engine No:	LEB6556242
Type:	Motor Car	Chassis No:	GP71213369
Type of Claims:	Third Party	Odometer No:	137092km
		Engine Cap:	1496cc

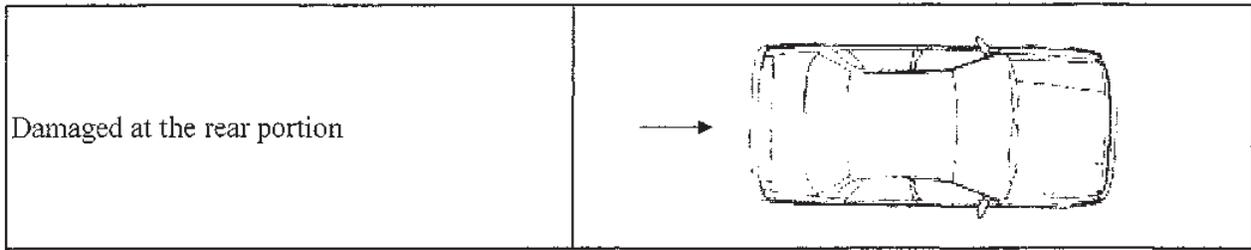
POINT OF IMPACT

Our visual inspection of the vehicle revealed that the damages noted are at the rear portion.

We have inspected the actual damages found on the vehicle and recommend the replacement of parts and repairs accordingly. The estimated repair cost is \$10,498.88. The repairer has agreed to undertake the repairs at our adjusted lump sum amount of \$7,000.00.
