**VEHICLE DAMAGE INSPECTION REPORT**

Our Ref: 282/TP/2019

Reg No: GBG1953H  
Reg date: 22/6/2017  
Colour: White  
Type: Lorry  
Type of Claims: Third Party

Make & Model: Toyota Dyna 3.0M  
Engine No: 1KD2702130  
Chassis No: KDY2318029040  
Odometer No: 25953km  
Engine Cap: 2982cc

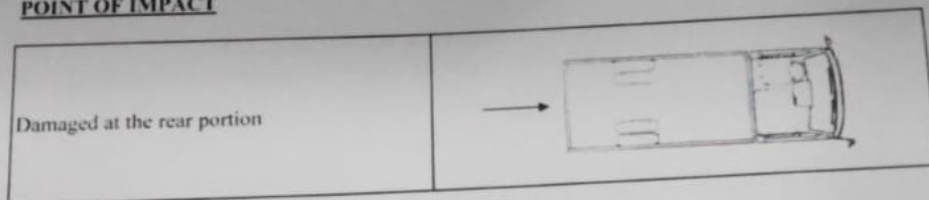
**POINT OF IMPACT**

Our visual inspection of the vehicle revealed that the damages noted are at the rear portion.
