Your Ref: TP/IP/16737/2020  
Our Ref : CI/TPD20007954/N

30 September 2020

**INSPECTION REPORT OF MOTORCYCLE FBN 7084P**

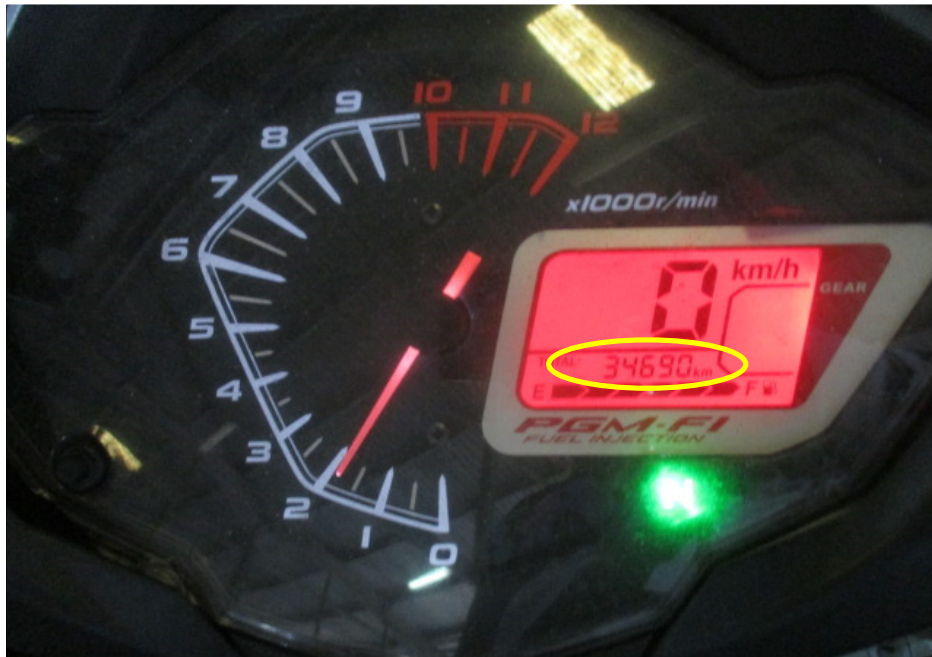
**Photo 1** shows the speedometer gauge of the Motorcycle. The mileage of the Motorcycle at the time of our inspection was 34, 690km (circled).

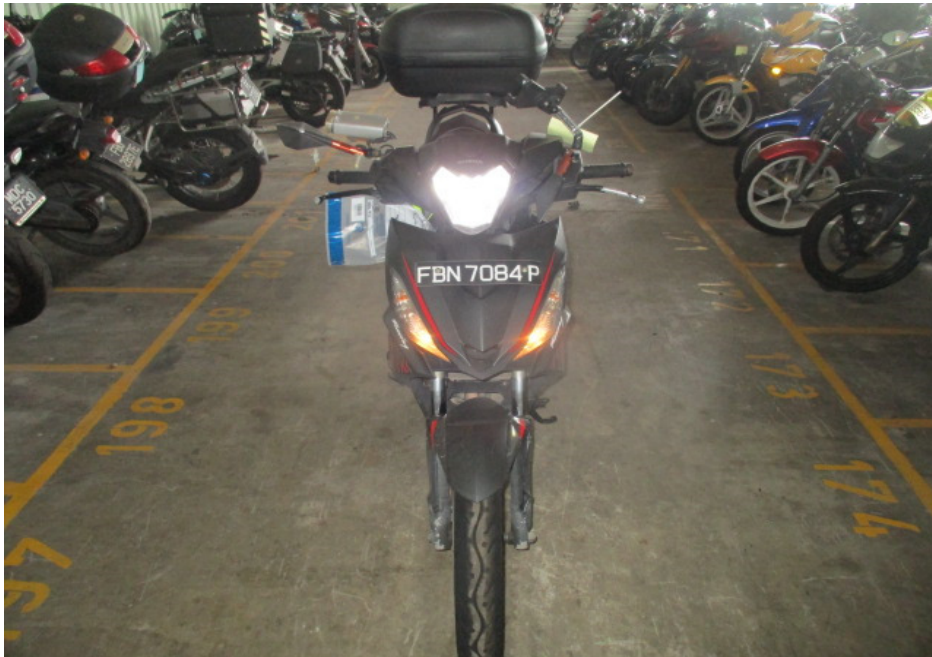
**Photo 2** shows a general view of the frontal portion of the Motorcycle at the time of our inspection. The Motorcycle was observed to have sustained damages along its frontal portion and right body.

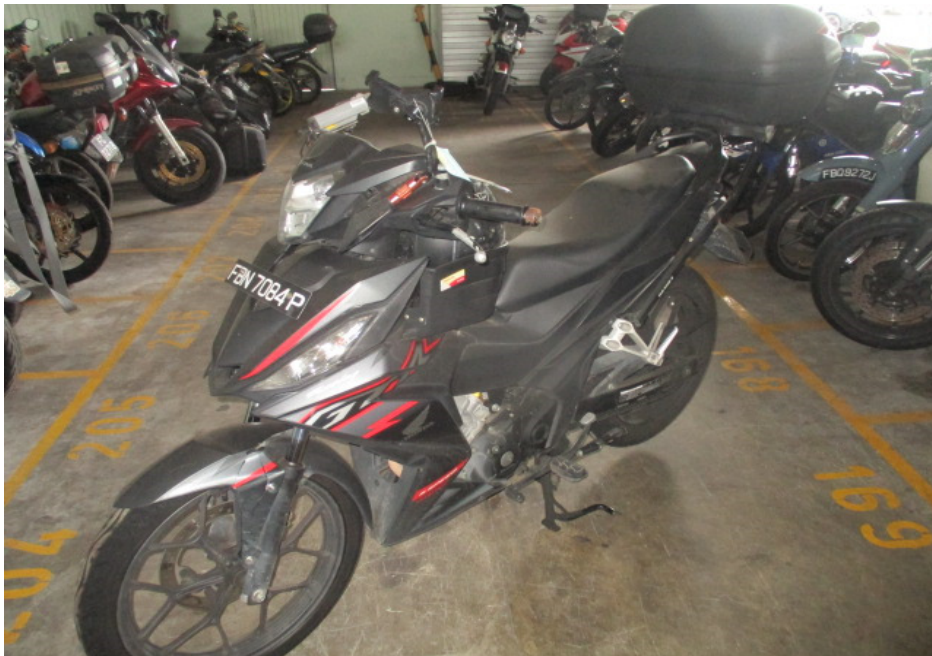
**Photo 3** shows a general view of the left body of the Motorcycle at the time of our inspection. The Motorcycle was observed to have sustained damages along its frontal portion and right body.

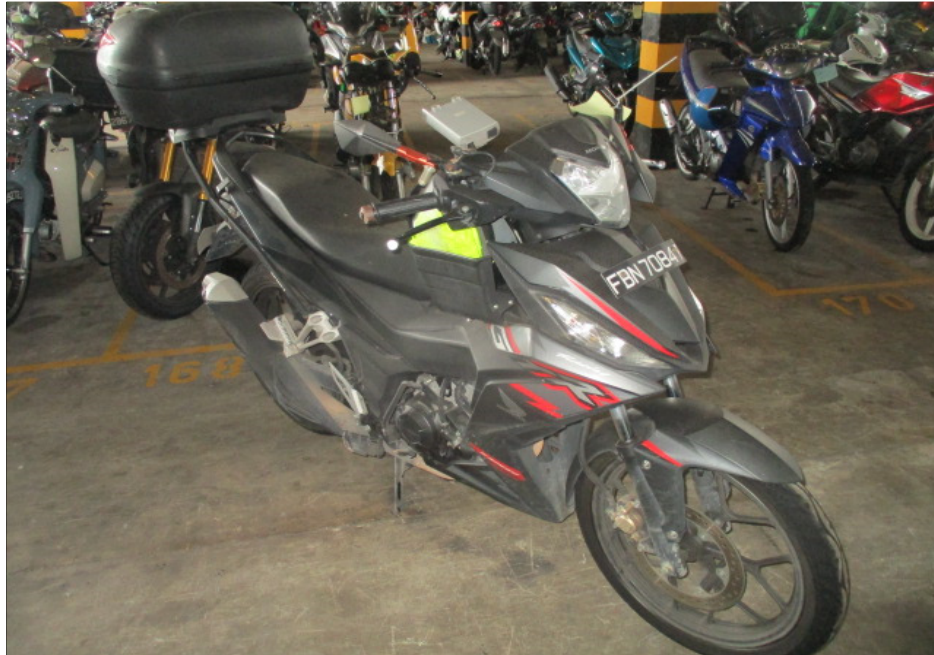
4. The mileage of the Motorcycle at the time of our inspection was 34, 690km.
5. The Motorcycle was observed to have sustained damages along its frontal portion and right body. The body parts that were found to have been damaged include its right cowling, front mudguard, front brake lever, right side mirror, right handlebar end, rear brake pedal, right front footrest and exhaust muffler, amongst others.

**Photo 4** shows a general view of the right body of the Motorcycle at the time of our inspection. The Motorcycle was observed to have sustained damages along its frontal portion and right body. Amongst the right cowling, front mudguard, front brake lever, right side mirror, right handlebar end, rear brake pedal, right front footrest and exhaust muffler, amongst others.

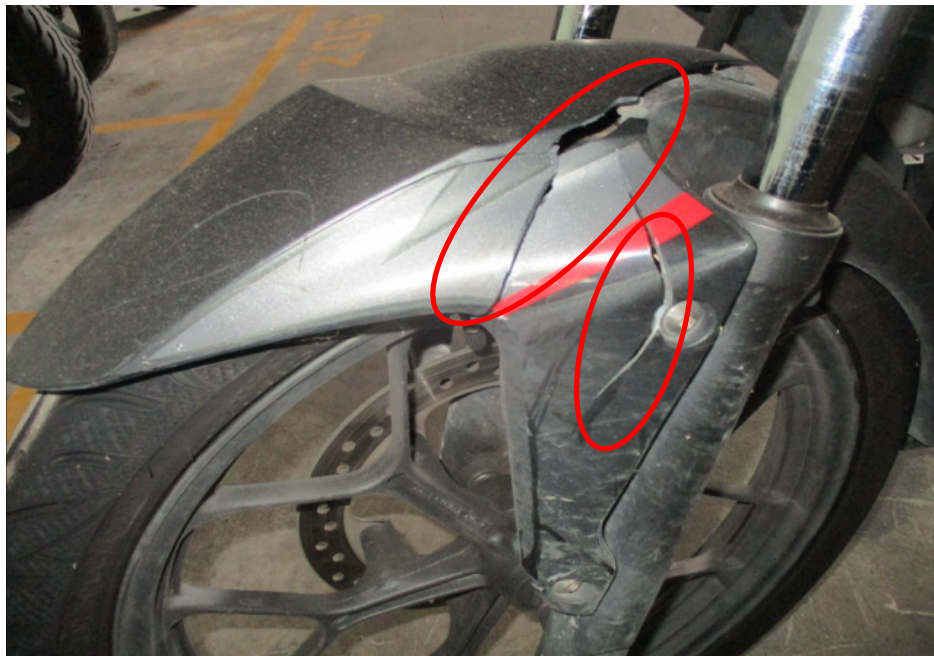
**Photo 5** shows a closer view of the cracked front mudguard (circled) of the Motorcycle as a result of the accident.

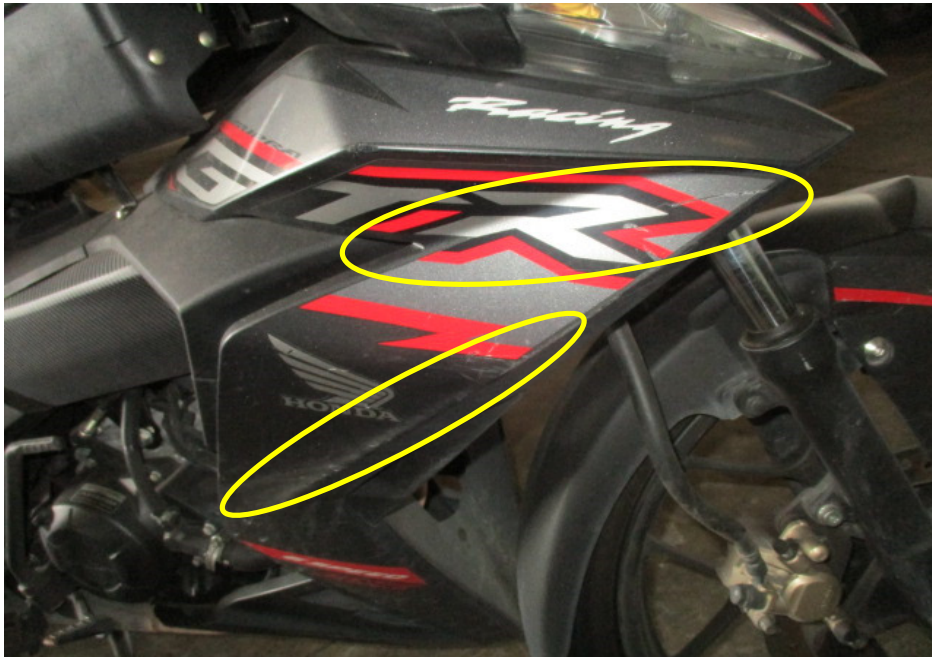
**Photo 6** shows a closer view of the right cowling (circled) which was amongst the body parts of the Motorcycle that had sustained damage as a result of the accident.

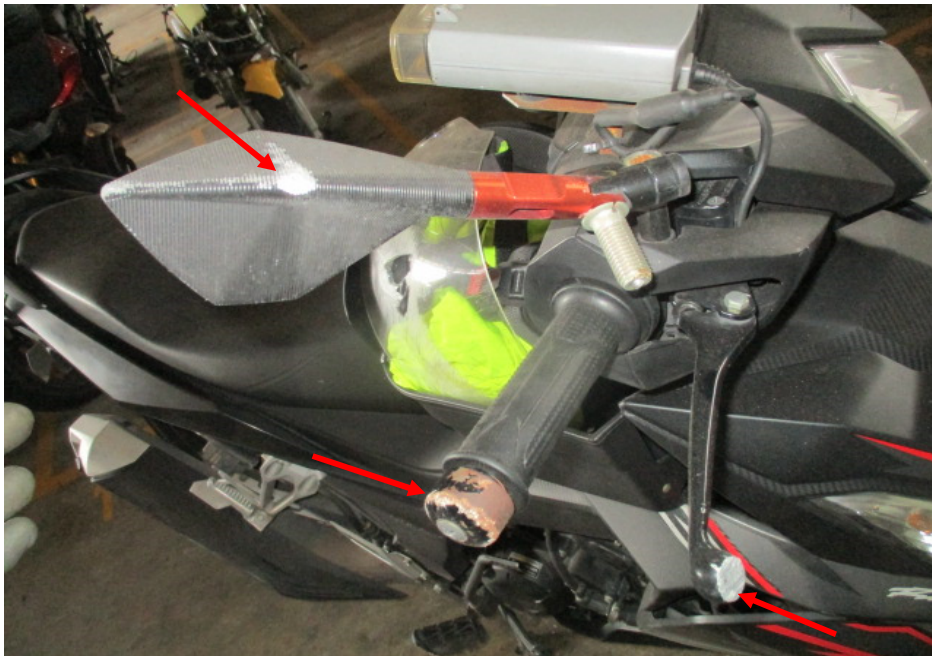
**Photo 7** shows the front brake lever, right handlebar end and right side mirror (arrowed), which were amongst the body parts of the Motorcycle that had sustained damage as a result of the accident.

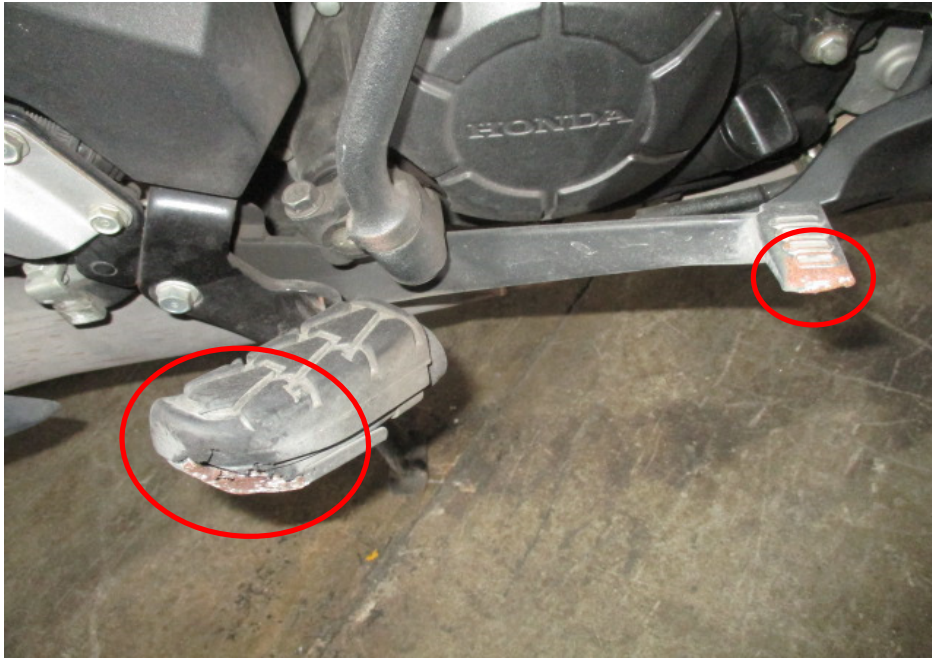
**Photo 8** shows a closer view of the rear brake pedal and right front footrest (circled) which were amongst the body parts of the Motorcycle that had sustained damage as a result of the accident.

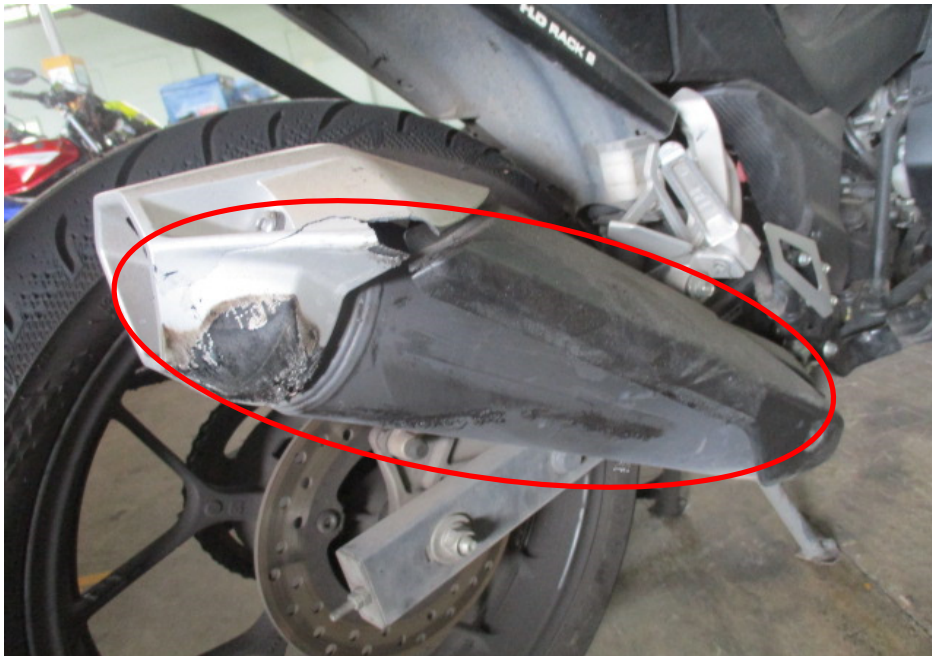
**Photo 9** shows the exhaust muffler and exhaust muffler heat shield (circled) of the Motorcycle that had sustained damage as a result of the accident.

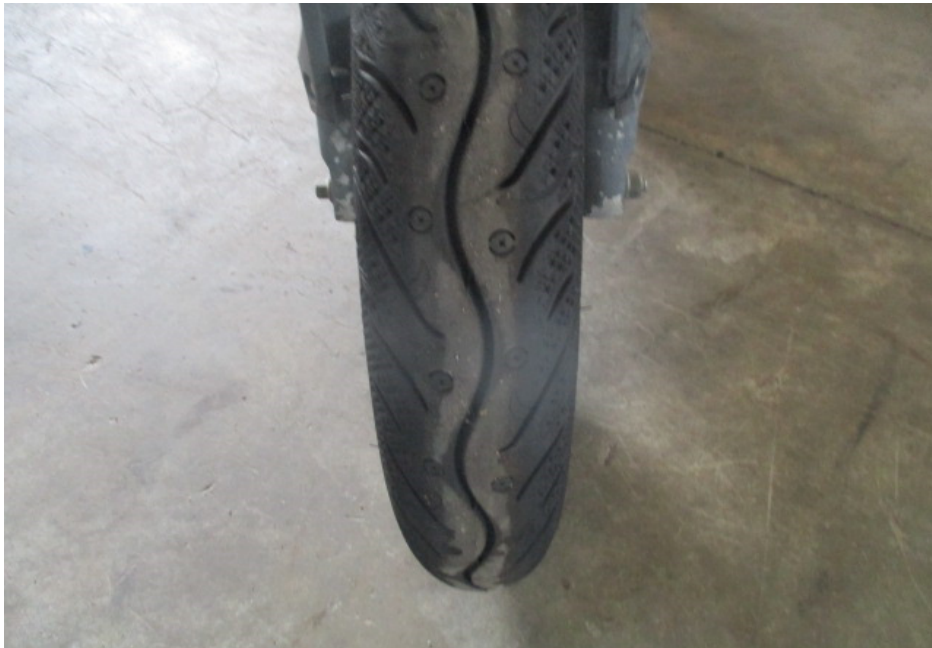
**Photo 10** shows the front tyre of the Motorcycle at the time of our inspection. The front tyre was observed to be in serviceable condition with remaining tread depth of approximately 4mm. The pattern of the tread was also clearly visible. There was no tear, burst mark(s) and/or punctured hole(s) on the sidewalls as well as across the tread of the front tyre.

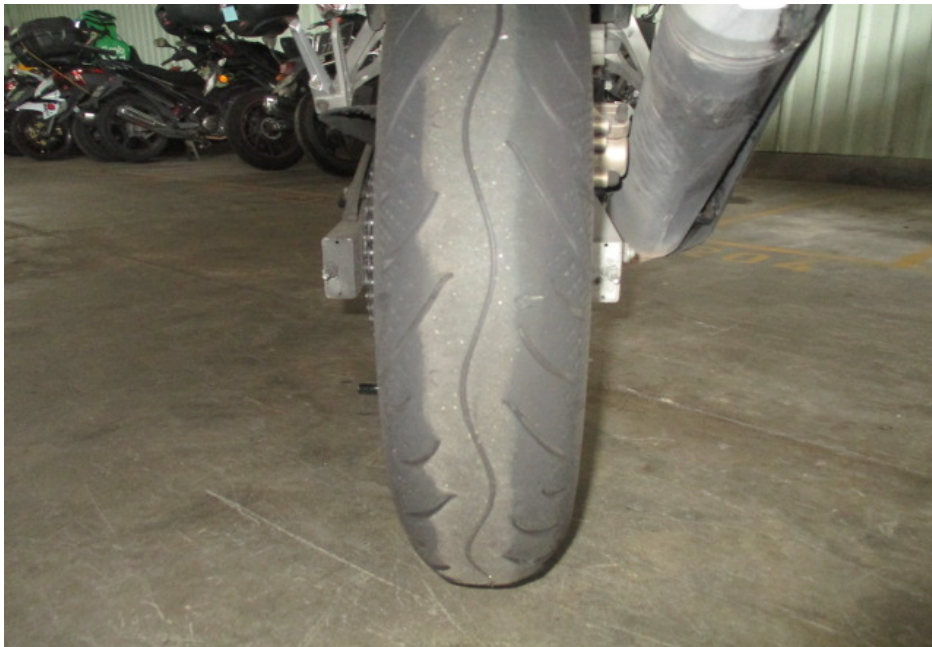
**Photo 11** shows the condition of the Motorcycle's rear tyre. The rear tyre was observed to be in serviceable condition with remaining tread depth of approximately 3mm. The tyre was also observed to be sufficiently inflated for vehicular operation. We did not observe any tear, burst mark(s) and/or punctured hole(s) on the sidewalls as well as across the tread of the rear tyre.

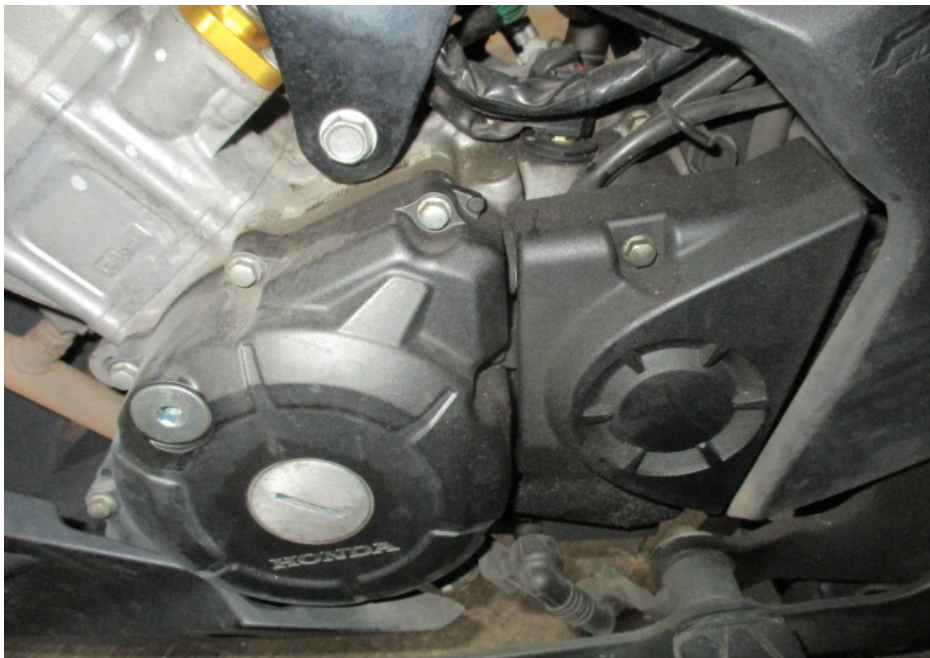
**Photo 12** shows the left side of the engine of the Motorcycle at the time of our inspection. The various engine related parts and components were found to be intact with no visible damage. There was also no sign(s) or indication(s) of fluid leak observed around the left engine area of the Motorcycle.

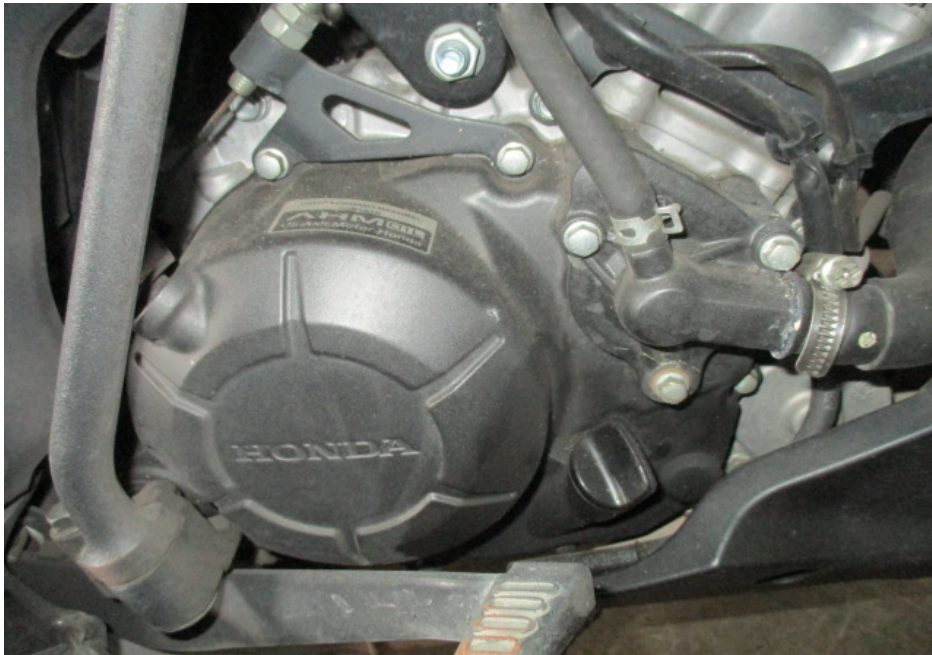
**Photo 13** shows the right side of the engine of the Motorcycle at the time of our inspection. The various engine related parts and components were found to be intact with no visible damage. There was also no sign(s) or indication(s) of fluid leak observed around the right engine area of the Motorcycle.

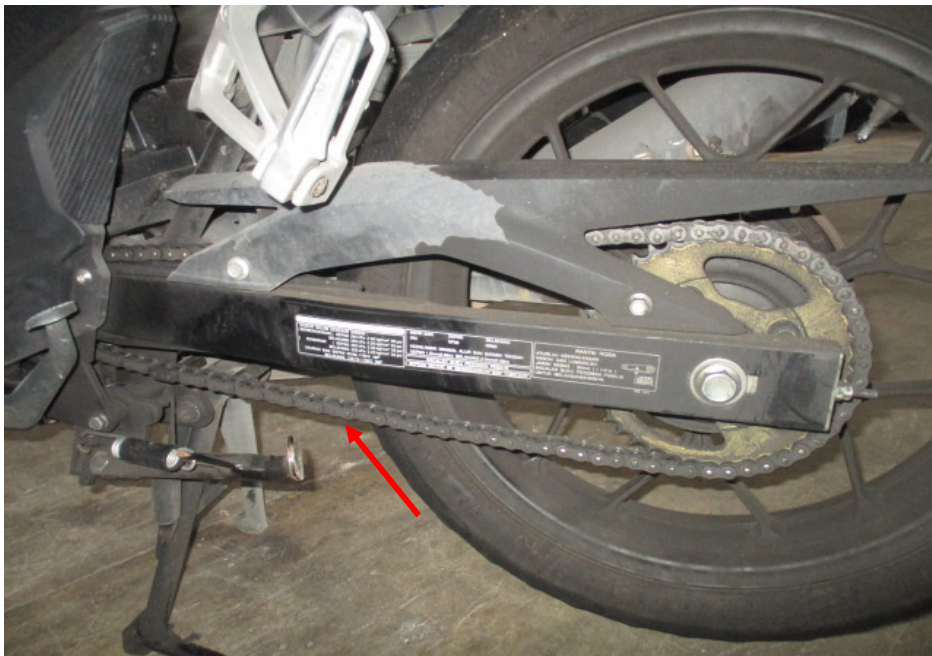
**Photo 14** shows the general view of the gear train (arrowed) of the Motorcycle, which was observed to be intact with no misalignment. It was also adequately lubricated for operating purposes.

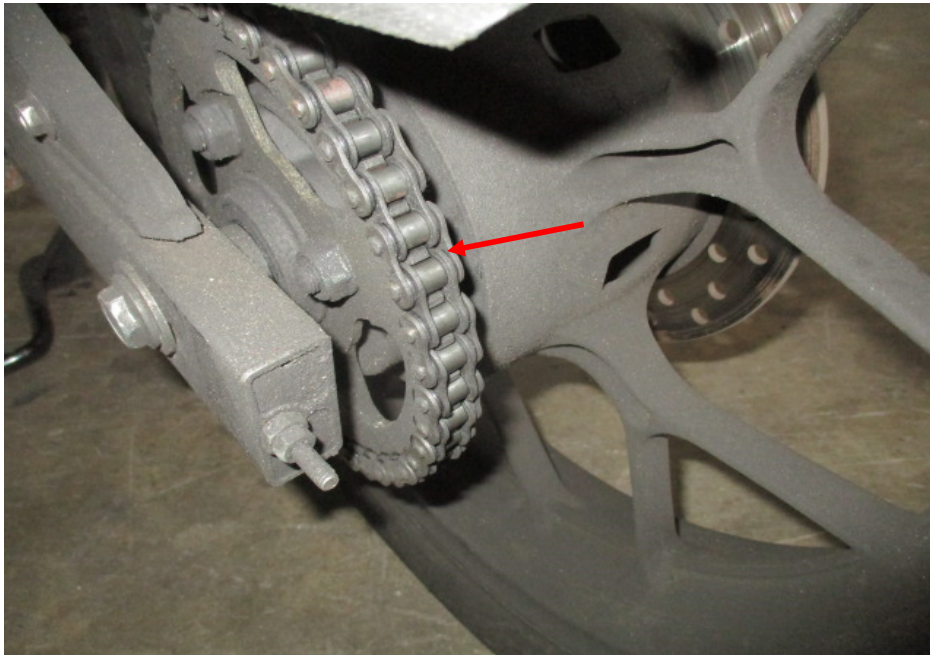
**Photo 15** shows a closer view of the gear train (arrowed) of the Motorcycle, which was observed to be intact with no misalignment. It was also adequately lubricated for operating purposes.

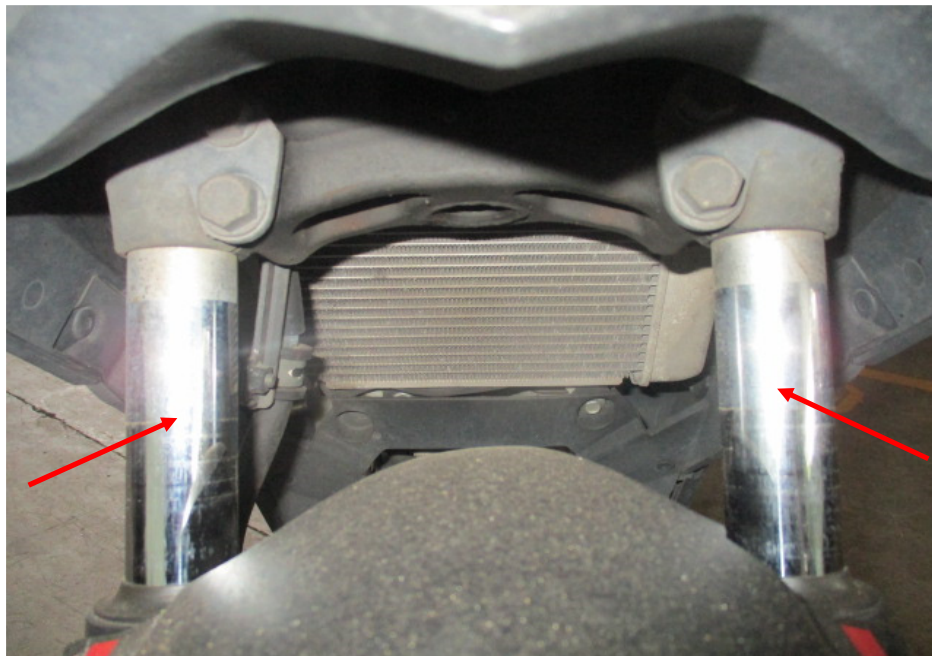
**Photo 16** shows the front fork (arrowed) of the Motorcycle. The front fork and fork bracket of the Motorcycle were both found to be intact and undamaged. Turning the Motorcycle's handle bar towards the left and right did not produce any abnormal free play. The steering system of the Motorcycle was in serviceable condition at the time of our inspection.

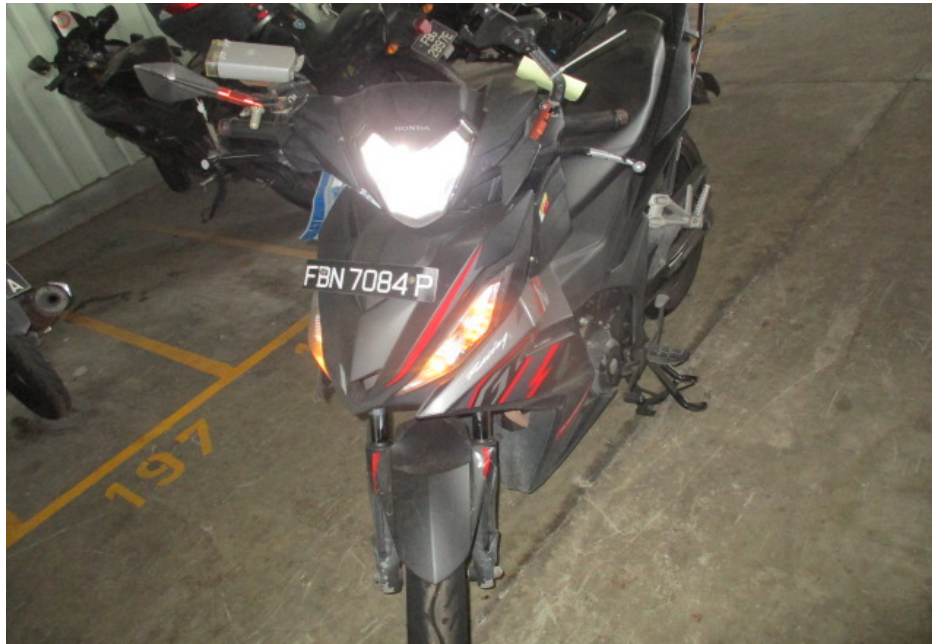
**Photo 17** shows the front wheel of the Motorcycle turned towards its full left. Turning the Motorcycle's handle bar towards the left did not produce any abnormal free play and/or resistance. This would indicate that the steering system of the Motorcycle was in serviceable condition at the time of our inspection.

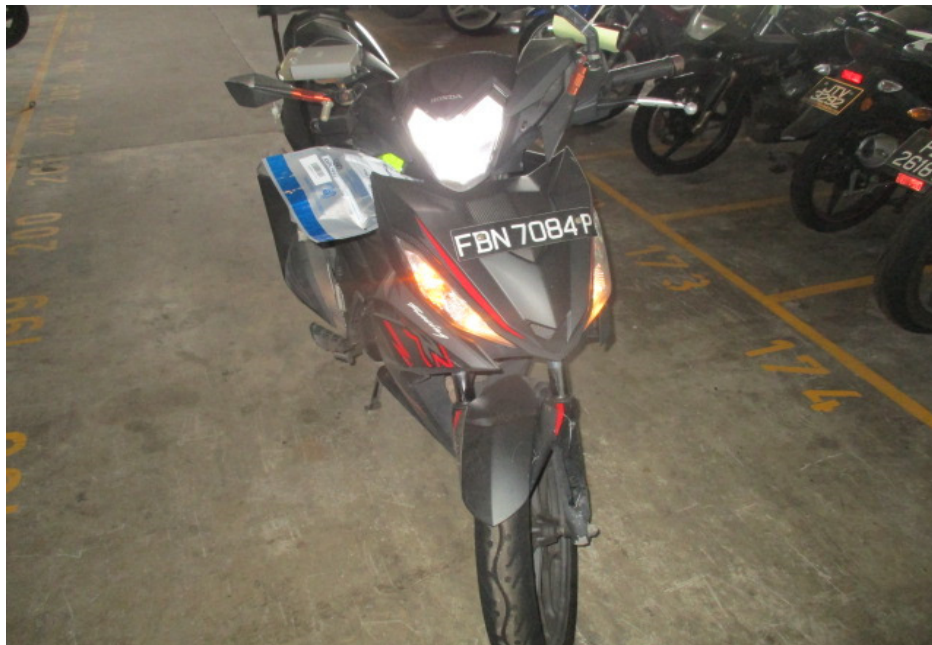
**Photo 18** shows the front wheel of the Motorcycle turned towards its full right. Turning the Motorcycle's handle bar towards the right did not produce any abnormal free play and/or resistance. This would indicate that the steering system of the Motorcycle was in serviceable condition at the time of our inspection.

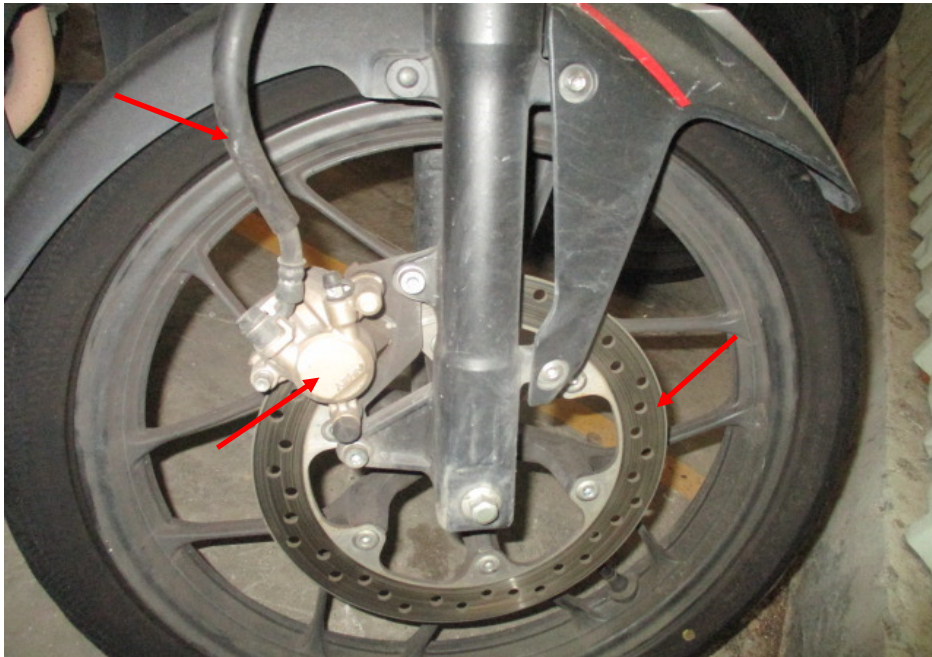
**Photo 19** shows a close up view of the front brake caliper, front brake disc and front brake hose (arrowed) of the Motorcycle, which are all part of the components in the hydraulic front brake system of the Motorcycle. Our visual checks of these various components had revealed all to be intact with no visible damage. No leakage of brake fluid was also observed.

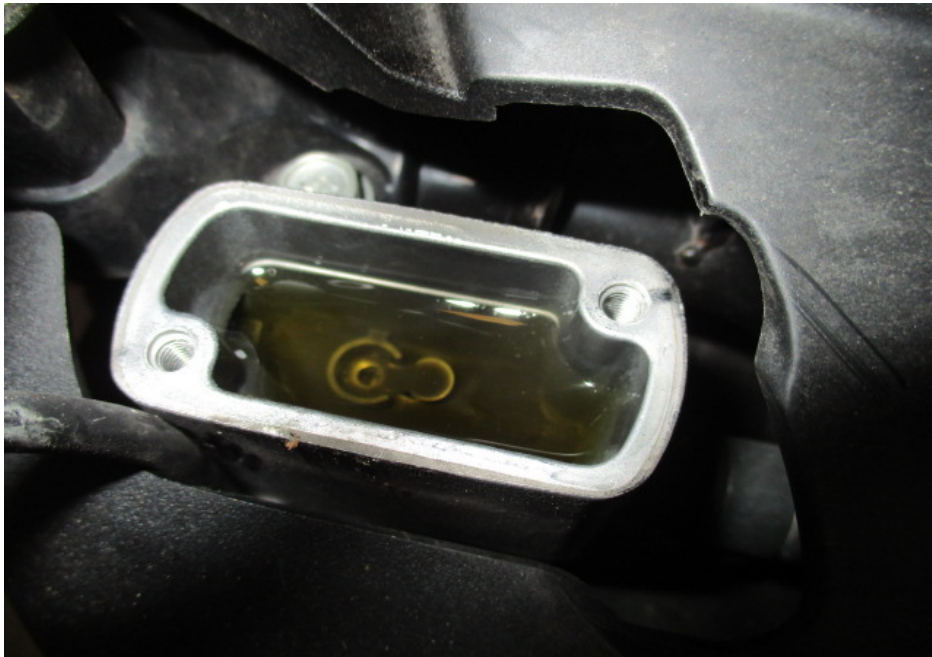
**Photo 20** shows the brake fluid reservoir for the front brake of the Motorcycle. The brake fluid was observed to be of sufficient level and without contamination for operational purposes.

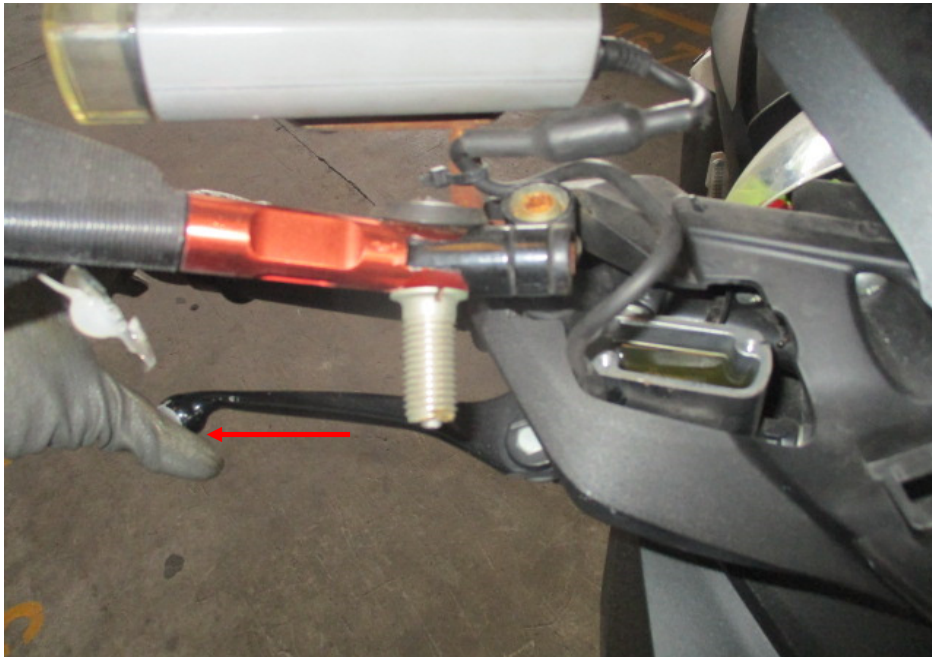
**Photo 21** shows the front brake lever being depressed. There was some resistance felt (spongy like feel) upon pressing the front brake lever (arrowed). This would indicate that there is no leakage of pressure/vacuum in the brake system.

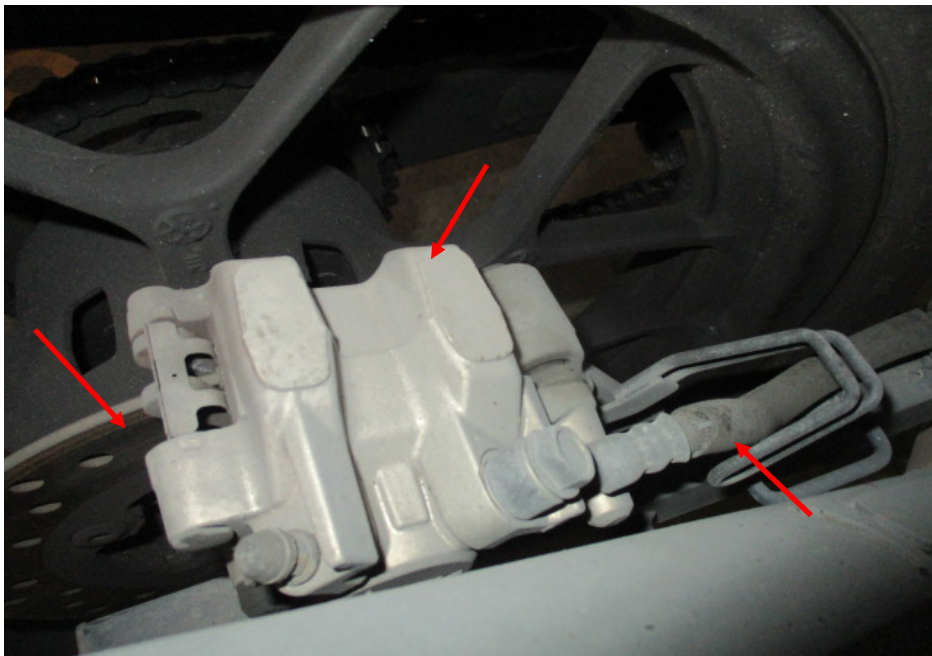
**Photo 22** shows a close up view of the rear brake caliper, rear brake disc and rear brake hose (arrowed) of the Motorcycle, which are all part of the components in the hydraulic rear brake system of the Motorcycle. Our visual checks of these various components had revealed all to be intact with no visible damage. No leakage of brake fluid was also observed.
