Your Ref: TP/IP/25603/2020
Our Ref : CI/TPD20007956/N

14 August 2020

INSPECTION REPORT OF MOTORCYCLE FBL 936M

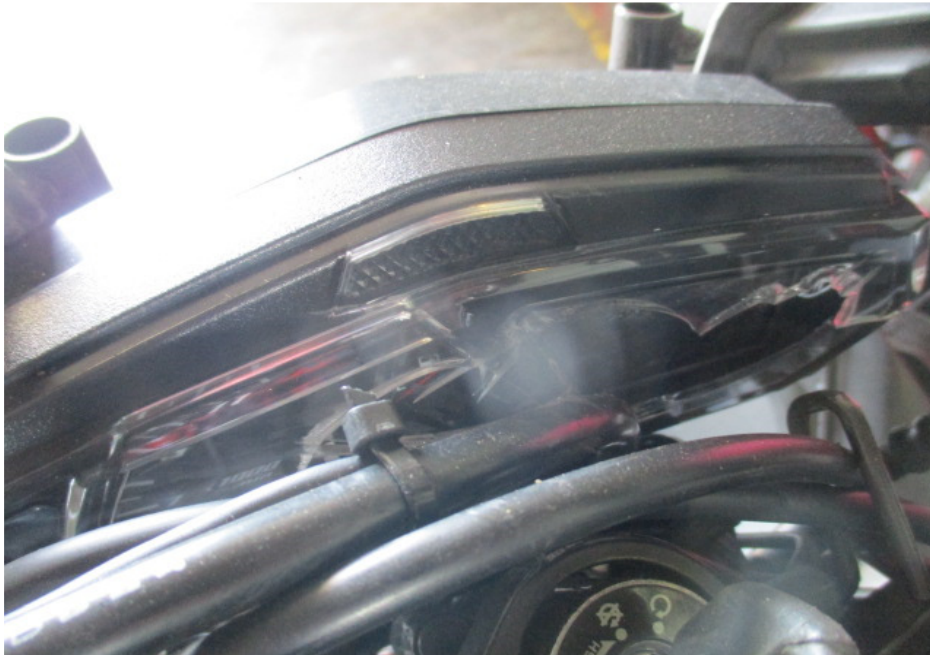
4. The mileage of the Motorcycle could not be recorded at the time of our inspection due to a damaged speedometer gauge.
5. The Motorcycle was observed to have sustained damages all around. The body parts that were found to have been damaged include its head cowling, front mudguard, side cowlings, handlebar, side mirrors, petrol tank, right pillion footrest, left rear side cover and exhaust muffler, amongst others.

Photo 1 shows the damaged speedometer gauge of the Motorcycle as a result of the accident. Hence, we were unable to record the mileage of the Motorcycle at the time of our inspection.

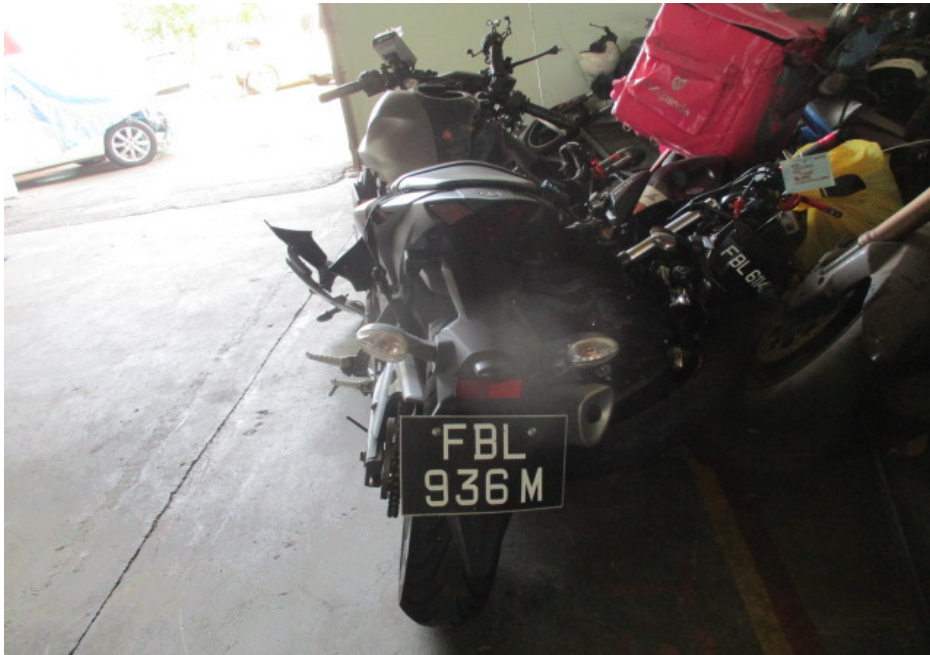
Photo 2 shows a general view of the rear portion of the Motorcycle at the time of our inspection. The Motorcycle was observed to have sustained damages all around.

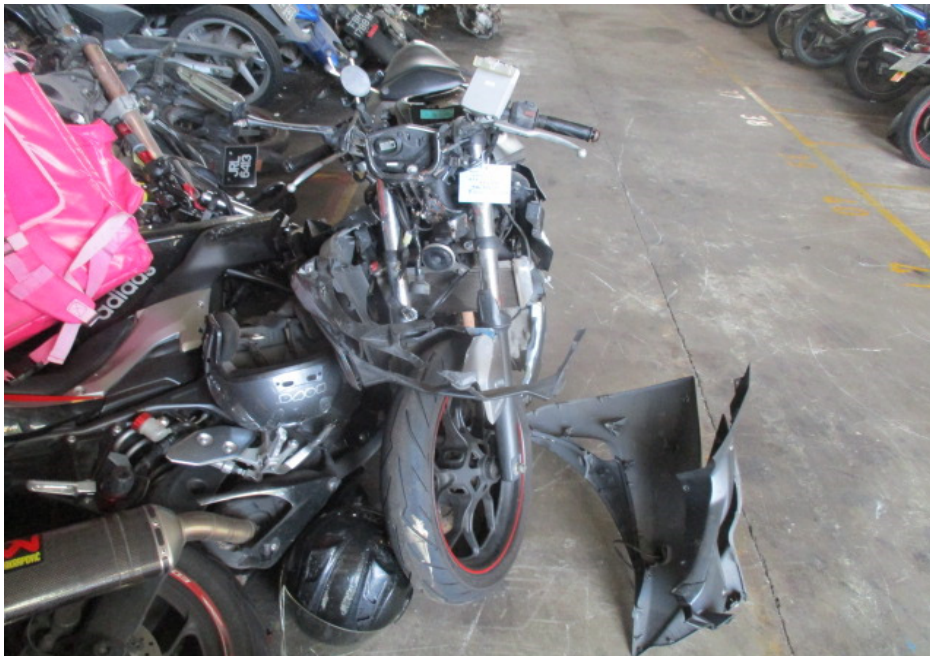
Photo 3 shows a general view of the frontal portion of the Motorcycle at the time of our inspection. The Motorcycle was observed to have sustained damages all around.

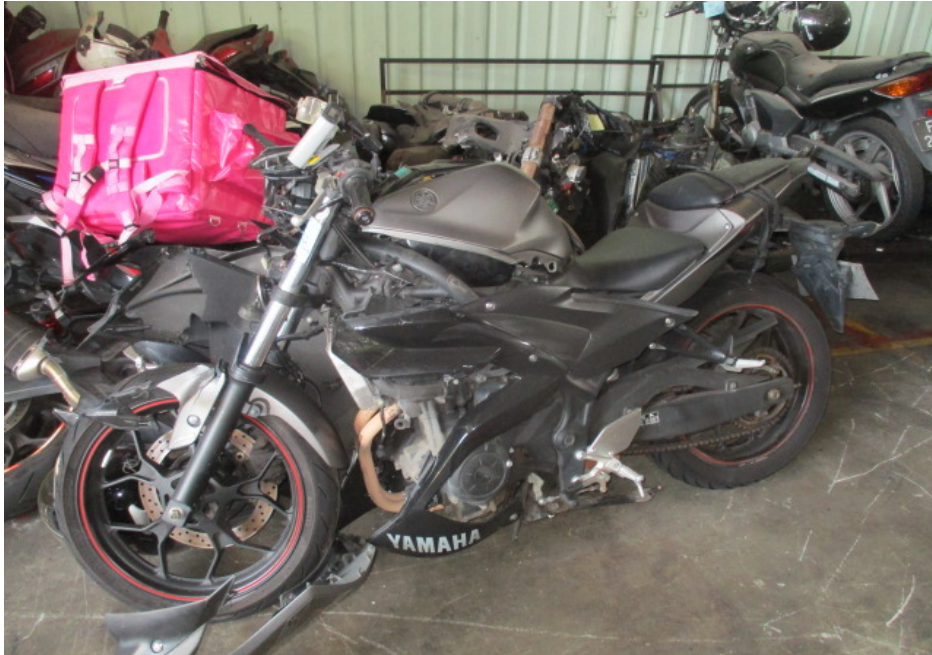
Photo 4 shows a general view of the left body of the Motorcycle at the time of our inspection. The Motorcycle was observed to have sustained damages all around. Amongst the body parts that were found to have been damaged include its head cowl, front mudguard, side cowlings, handlebar, side mirrors, petrol tank, right pillion footrest, left rear side cover and exhaust muffler, amongst others.

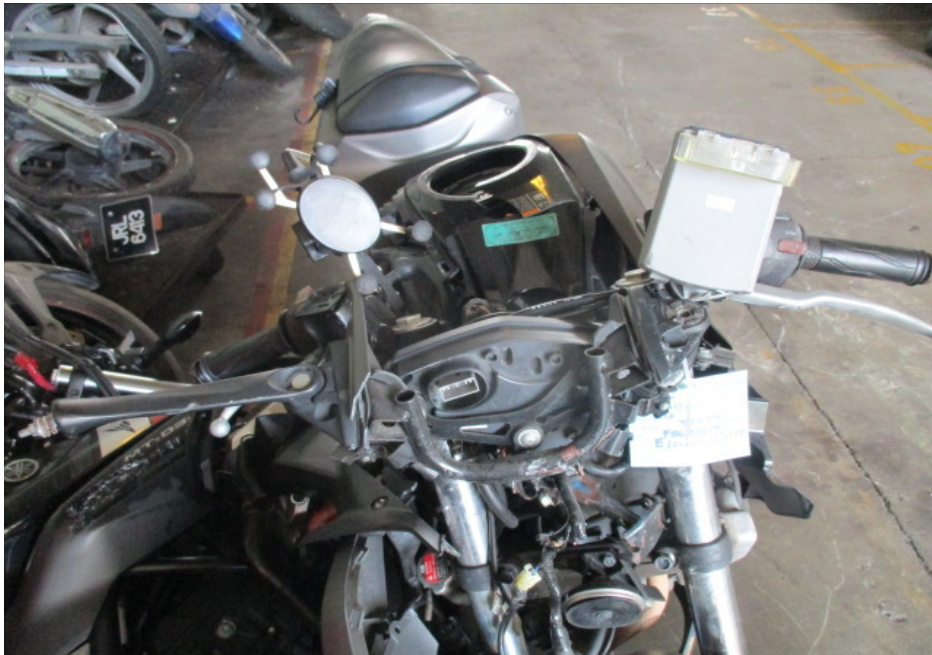
Photo 5 shows a closer view of the missing head cowl and headlight assembly of the Motorcycle as a result of the accident.

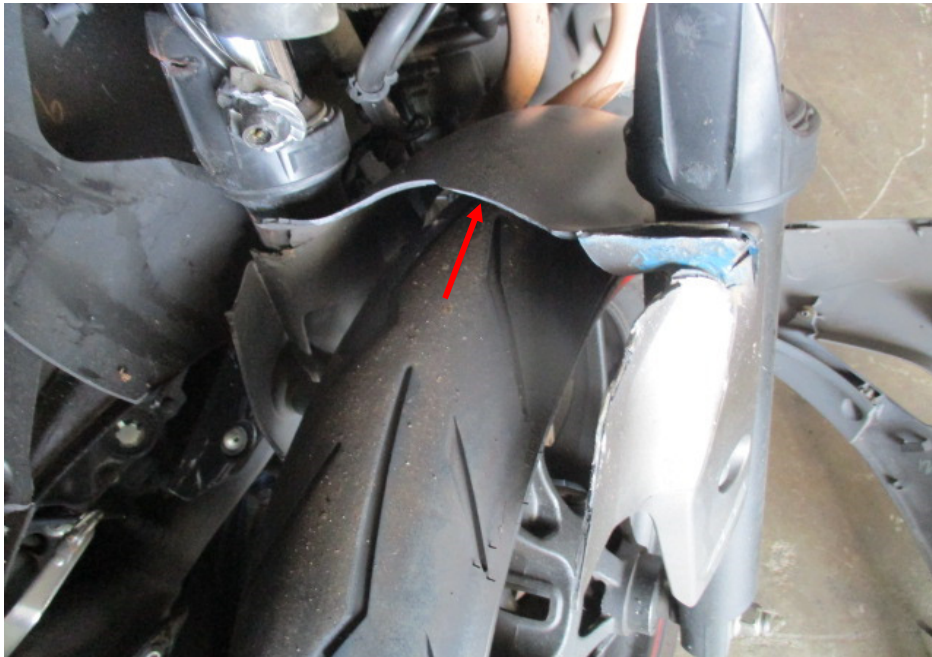
Photo 6 shows a closer view of the front mudguard (arrowed) which was amongst the body parts at the front body of the Motorcycle that had sustained damage as a result of the accident.

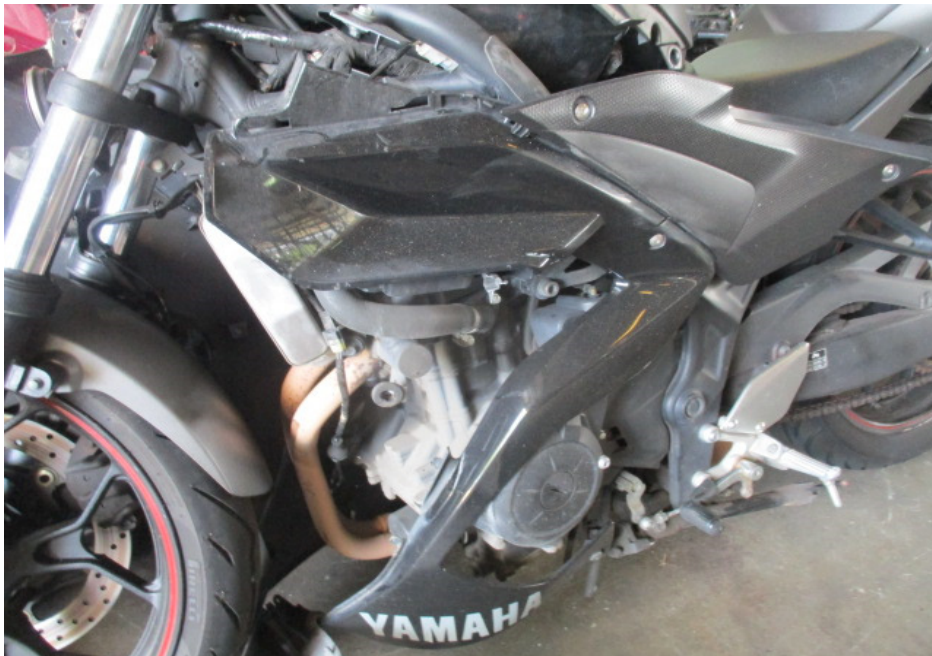
Photo 7 shows a closer view of the cracked left cowling of the Motorcycle as a result of the accident.

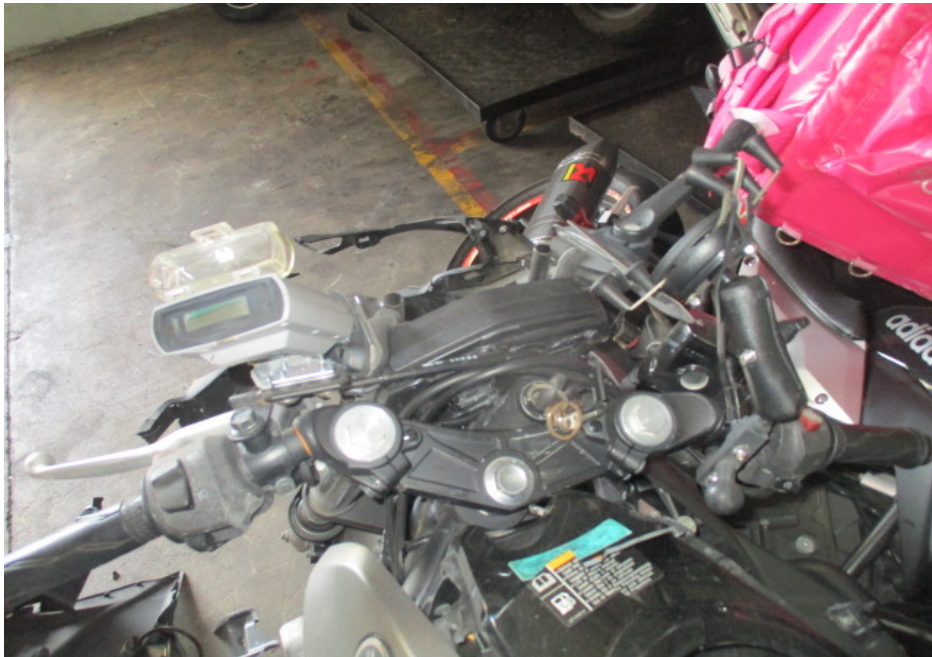
Photo 8 shows a closer view of the handlebar, front brake lever, side mirrors and clutch lever which were amongst the body parts of the Motorcycle that had sustained damage as a result of the accident.

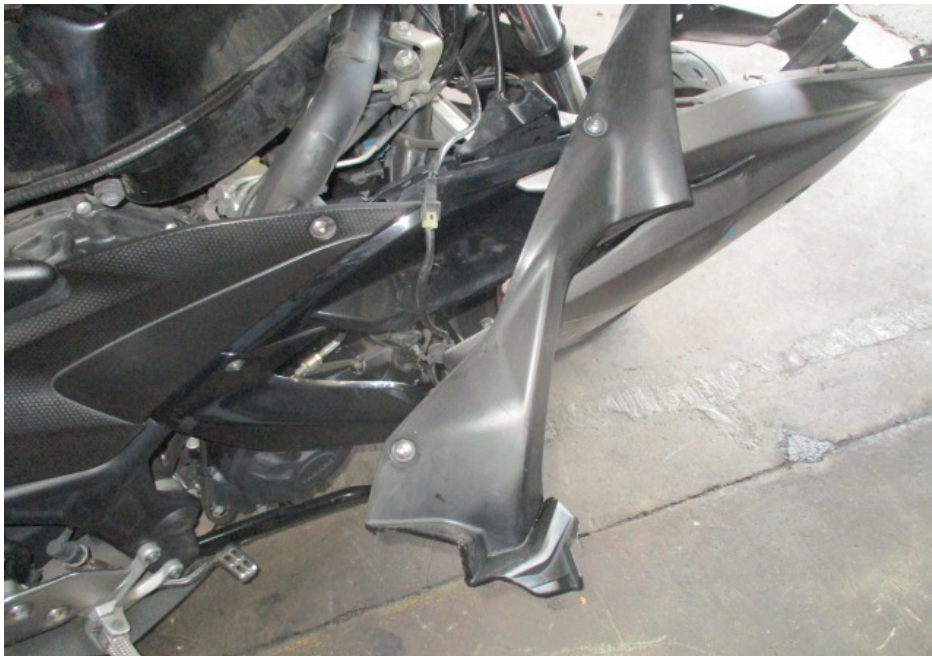
Photo 9 shows a closer view of the cracked right cowling of the Motorcycle as a result of the accident.

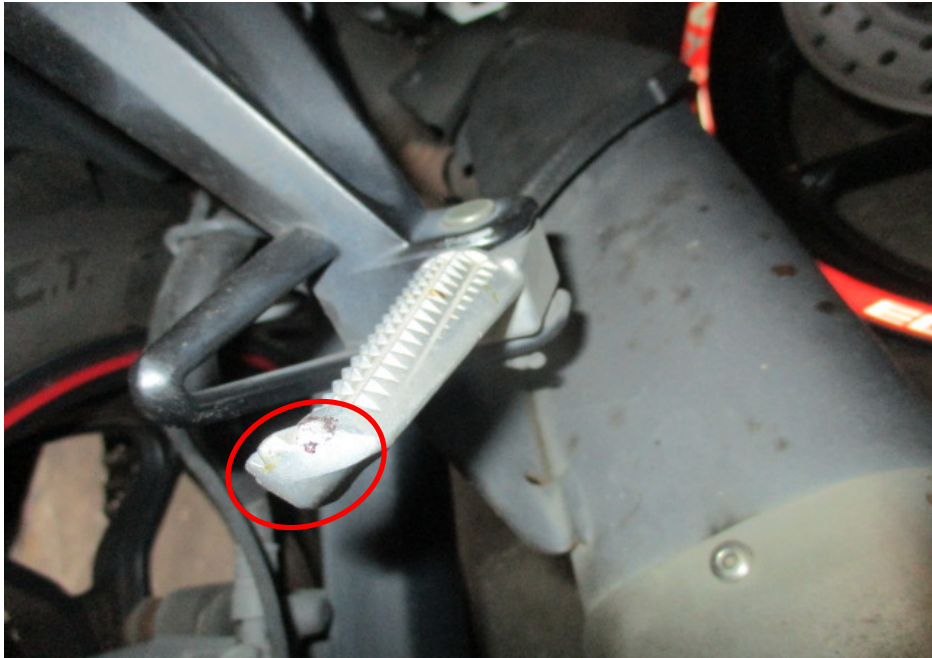
Photo 10 shows a closer view of the right pillion foot peg (circled) which was amongst the body parts of the Motorcycle that had sustained damage as a result of the accident.

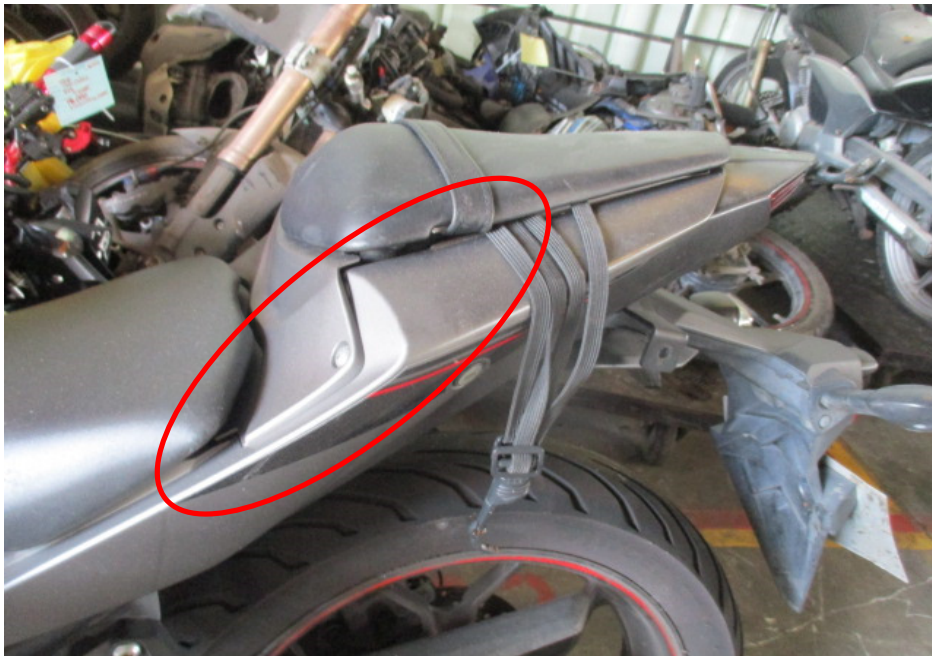
Photo 11 shows the deformed left rear side cover of the Motorcycle as a result of the accident (circled).

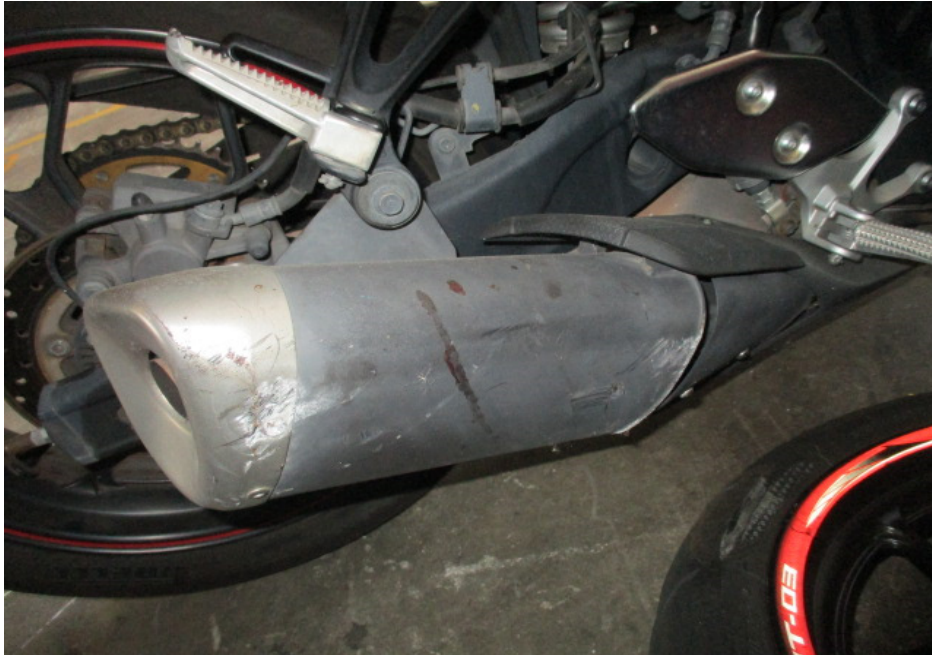
Photo 12 shows a closer view of the exhaust muffler which was amongst the body parts of the Motorcycle that had sustained damages of grazing nature as a result of the accident.

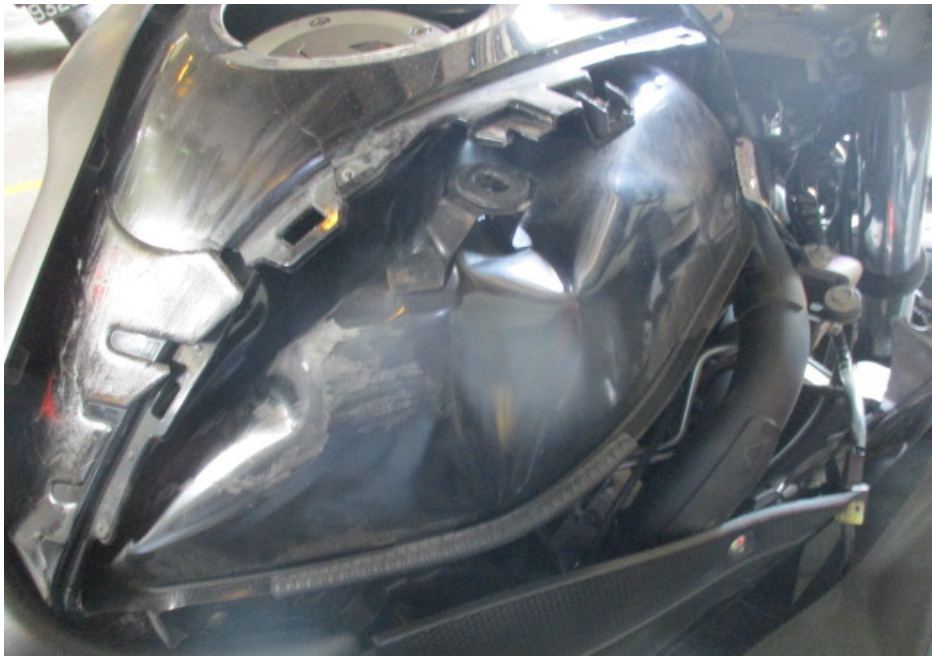
Photo 13 shows the dented petrol tank of the Motorcycle as a result of the accident.

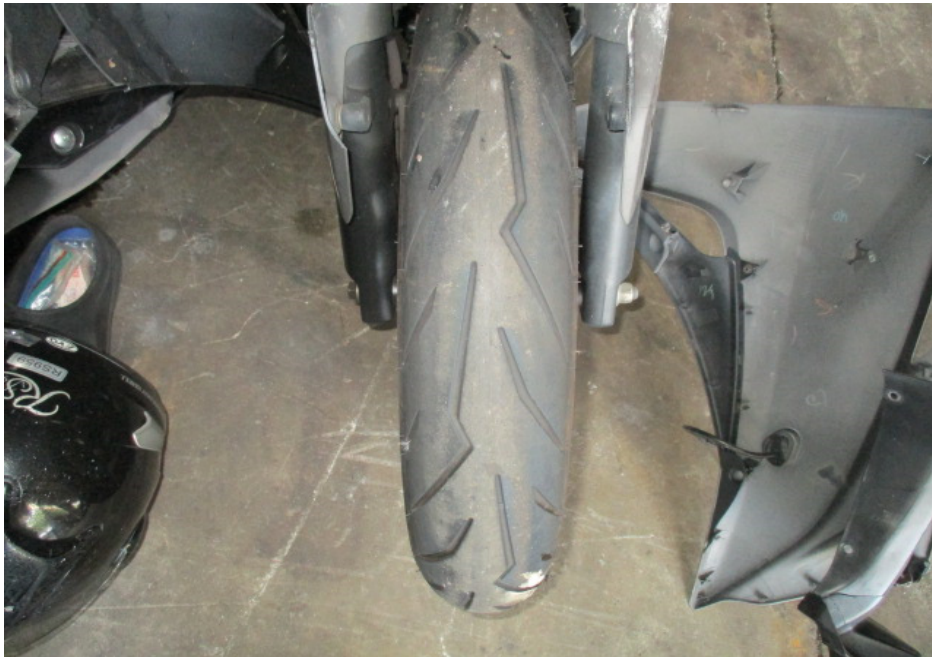
Photo 14 shows the condition of the Motorcycle's front tyre. The front tyre was observed to be in serviceable condition with remaining tread depth of approximately 3mm. There was no tear, burst mark(s) and/or punctured hole(s) on the sidewalls as well as across the tread of the front tyre.

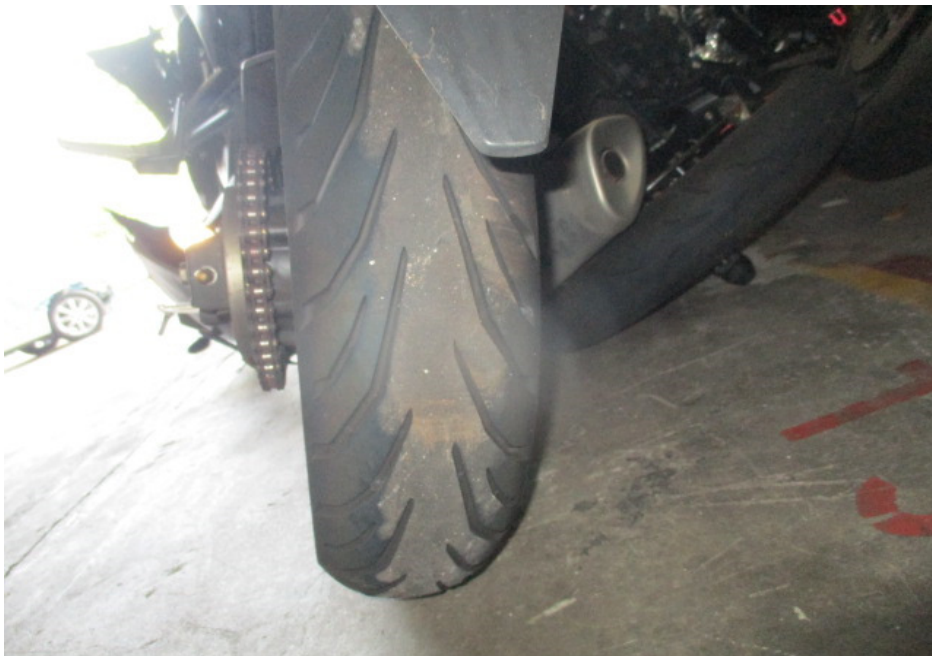
Photo 15 shows the condition of the Motorcycle's rear tyre. The rear tyre was observed to be in serviceable condition with remaining tread depth of approximately 3mm. The tyre was also observed to be sufficiently inflated for vehicular operation. We did not observe any tear, burst mark(s) and/or punctured hole(s) on the sidewalls as well as across the tread of the rear tyre.

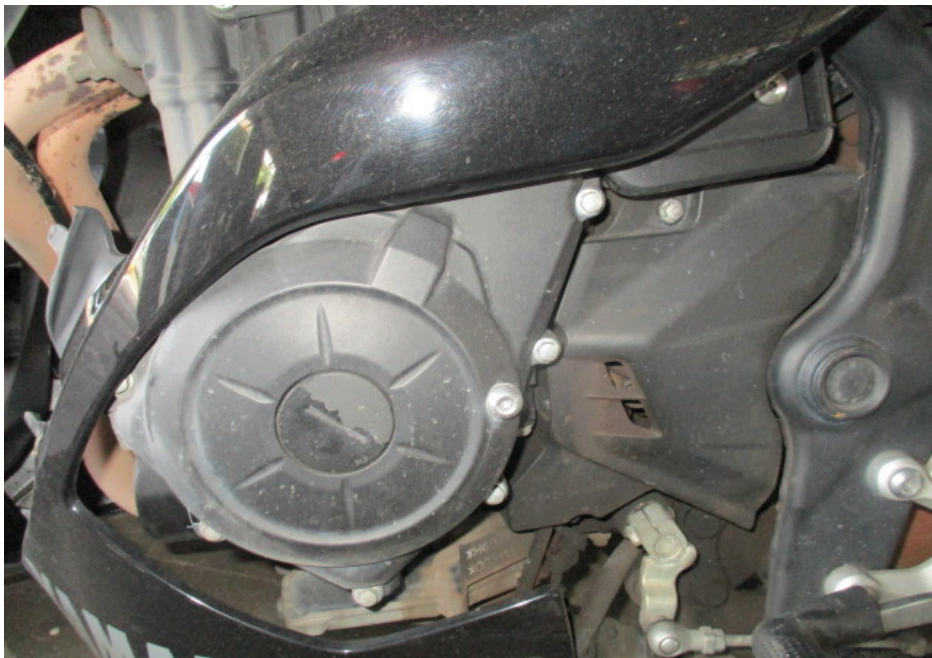
Photo 16 shows the left side of the engine of the Motorcycle at the time of our inspection. The various engine related parts and components were found to be intact with no visible damage. There was also no sign(s) or indication(s) of fluid leak observed around the left engine area of the Motorcycle.

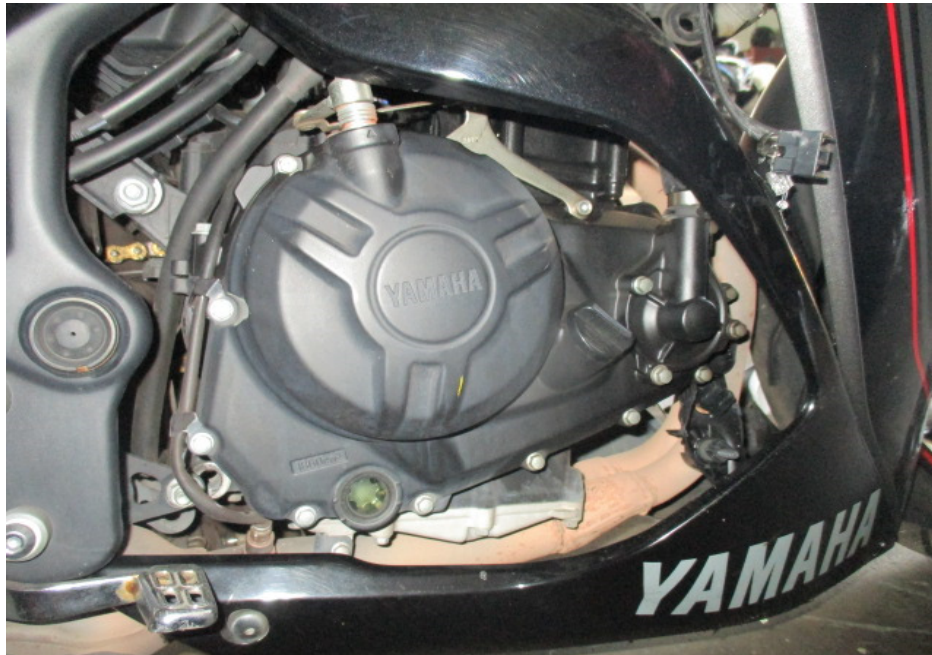
Photo 17 shows the right side of the engine of the Motorcycle at the time of our inspection. The various engine related parts and components were found to be intact with no visible damage. There was also no sign(s) or indication(s) of fluid leak observed around the right engine area of the Motorcycle.

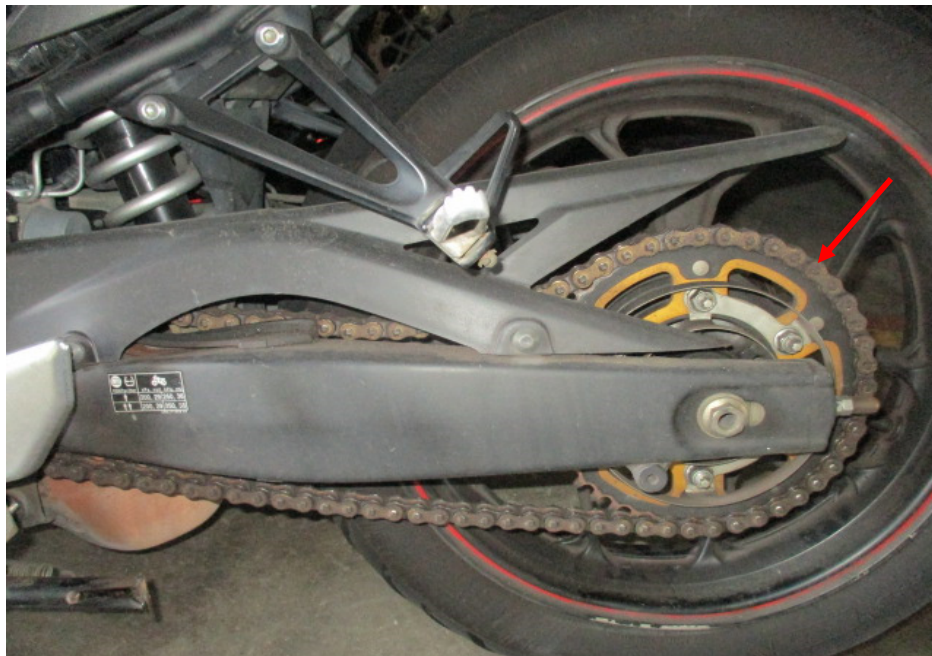
Photo 18 shows the general view of the gear train (arrowed) of the Motorcycle, which was observed to be intact with no misalignment. It was also adequately lubricated for operating purposes.

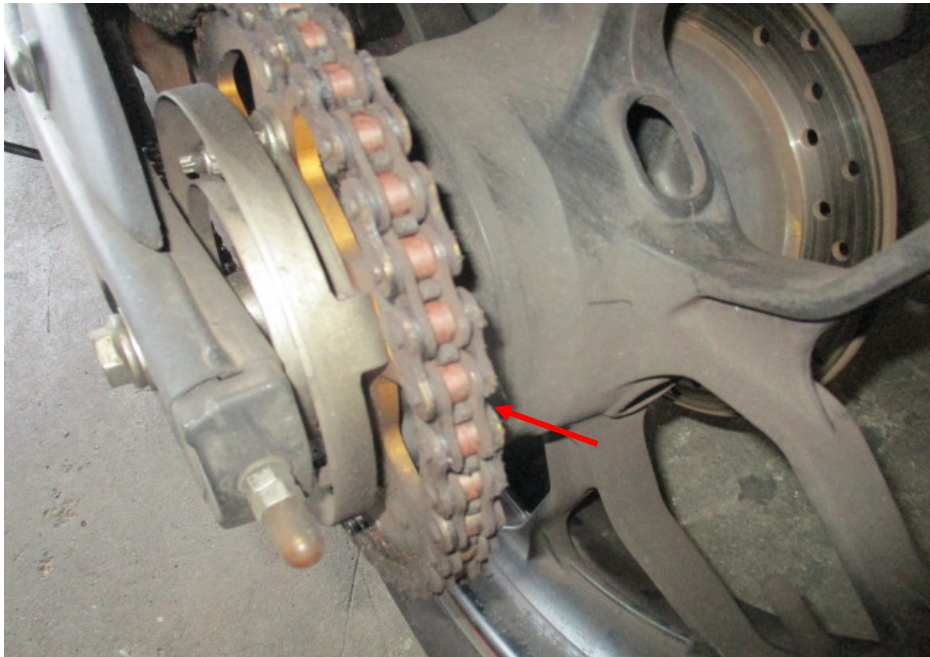
Photo 19 shows a closer view of the gear train (arrowed) of the Motorcycle, which was observed to be intact with no misalignment. It was also adequately lubricated for operating purposes.

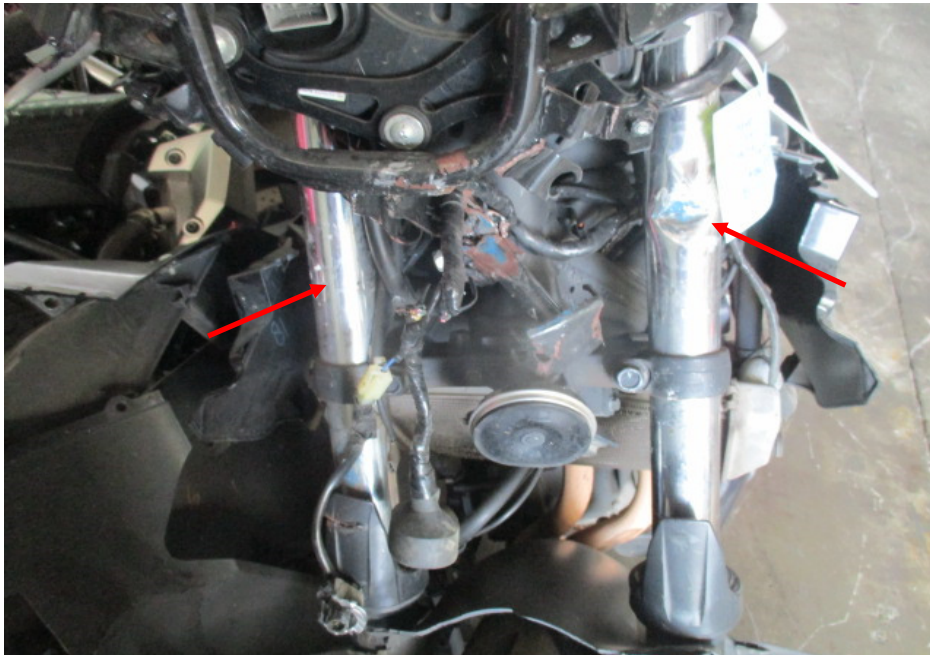
11. For this case, we were not able to conduct any test(s) on the steering system of the Motorcycle due to the damage to its fork assembly. The left front fork was observed to be dented as a result of the accident. Hence we were unable to turn the handle bar towards the left or right.

Photo 20 shows the front forks (arrowed) of the Motorcycle. The left front fork was observed to be dented as a result of the accident. Hence we were unable to turn the handle bar towards the left or right.

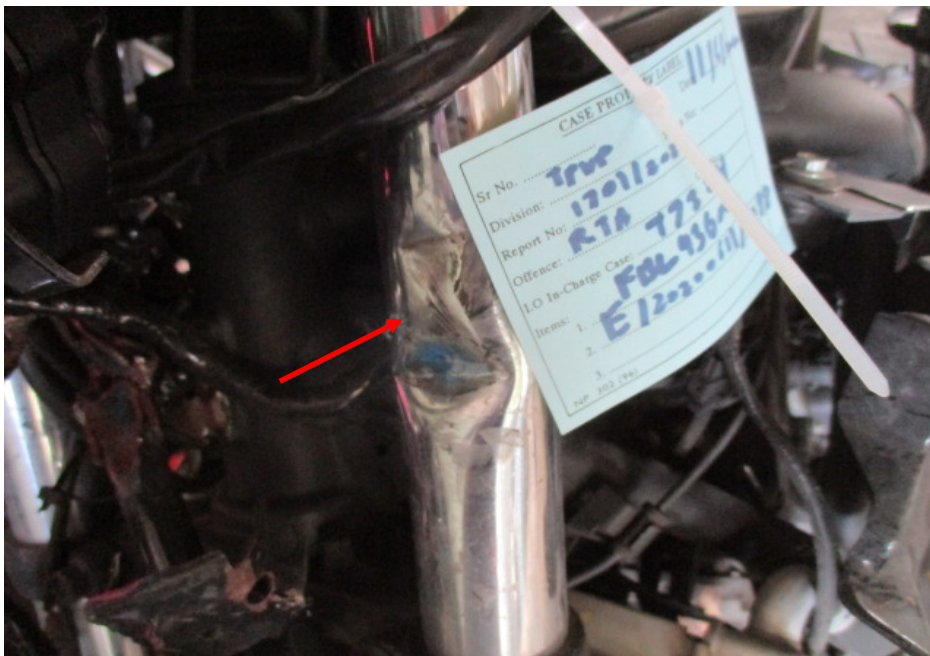
Photo 21 shows a closer view of the dented left front fork of the Motorcycle as a result of the accident (arrowed). Hence we were not able to conduct any test(s) on the steering system of the Motorcycle

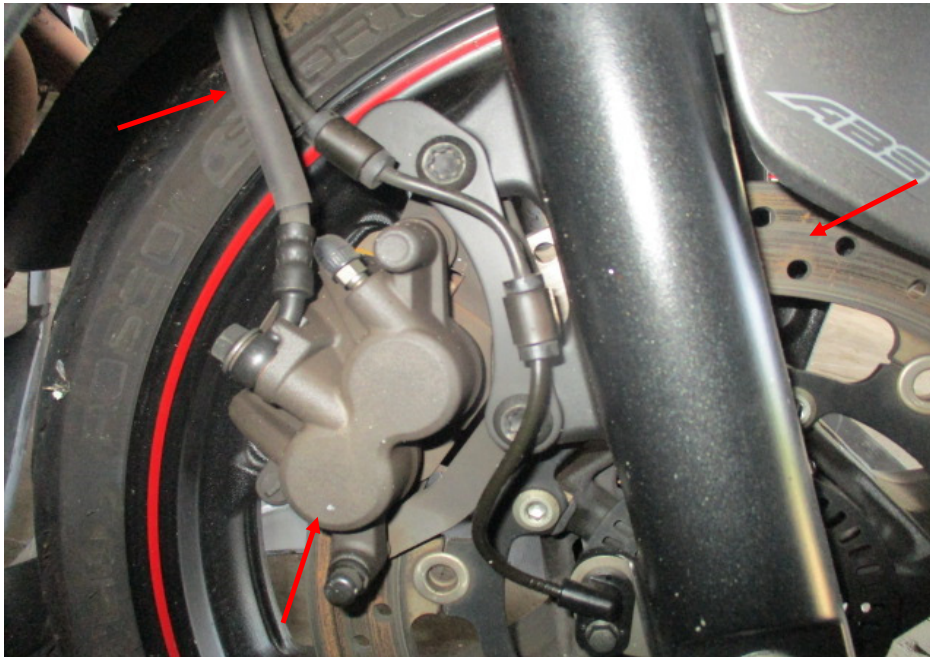
Photo 22 shows a close up view of the front brake caliper, front brake disc and front brake hose (arrowed) of the Motorcycle, which are all part of the components in the hydraulic front brake system of the Motorcycle. Our visual checks of these various components had revealed all to be intact with no visible damage. No leakage of brake fluid was also observed.

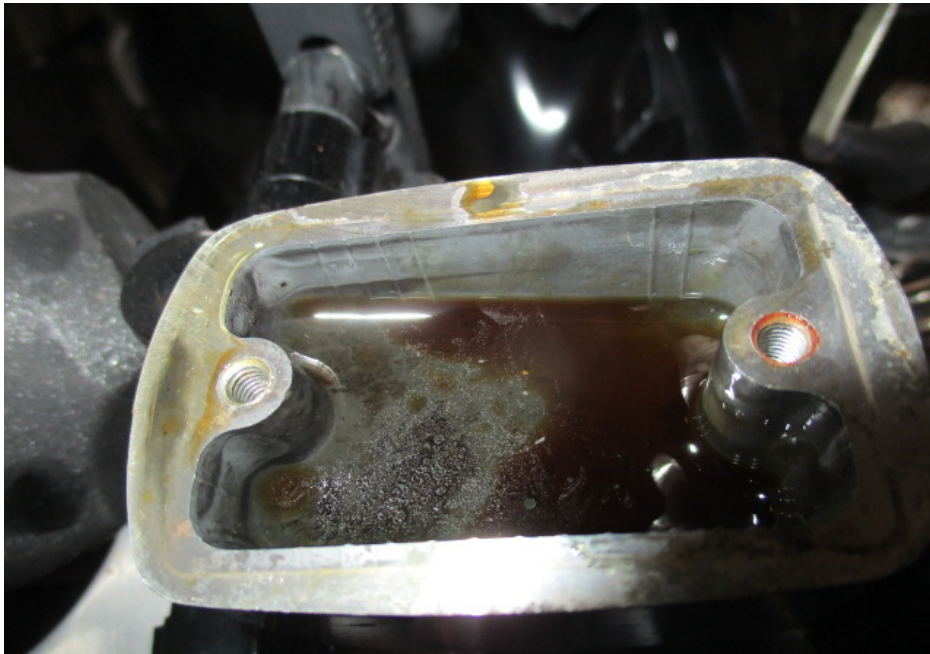
Photo 23 shows the brake fluid reservoir for the front brake of the Motorcycle. The brake fluid was observed to be of sufficient level for operational purposes and without contamination.

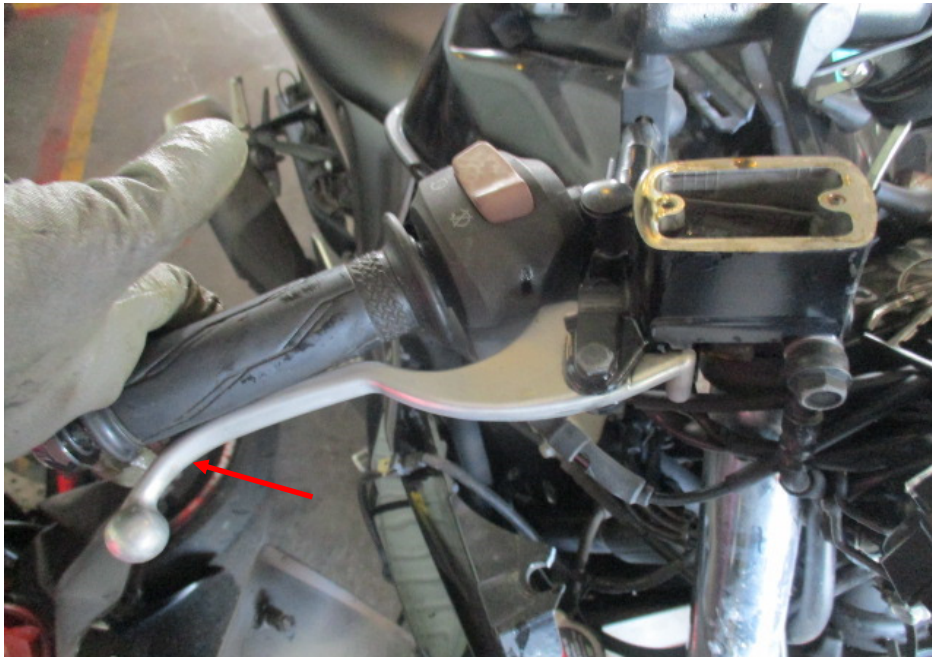
14. However the front brake lever was jammed as a result of the accident.
15. Static brake tests could not be conducted on the front brake of the Motorcycle due to the jammed brake lever. Hence we were unable to indicate if there was any leakage of pressure/vacuum in the front brake system.

Photo 24 shows the front brake lever. The accident caused the front brake lever to be jammed (arrowed). We were unable to depress the front brake lever. Hence we were unable to indicate if there was any leakage of pressure/vacuum in the brake system.

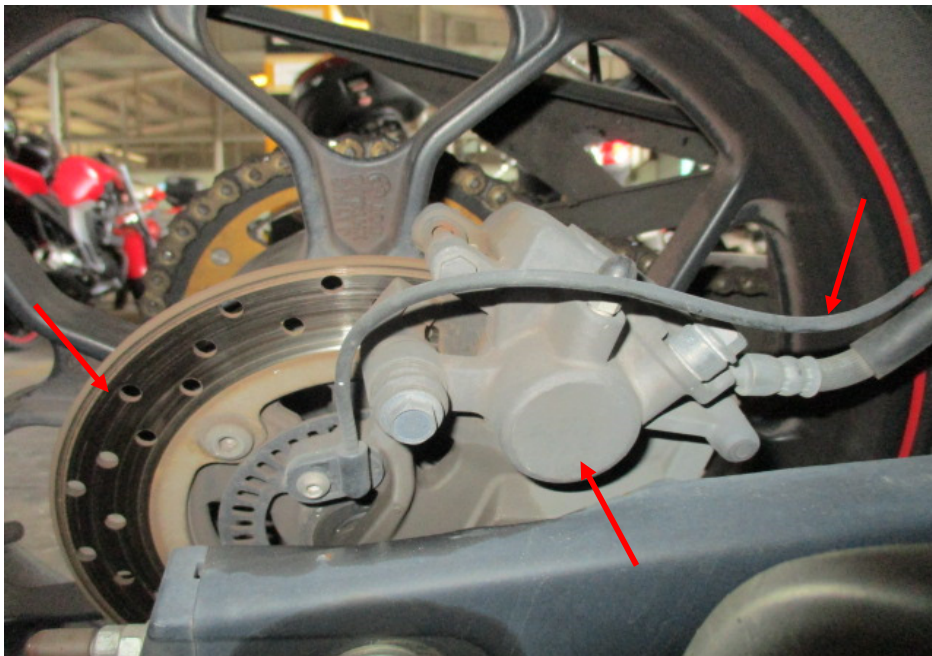
Photo 25 shows a close up view of the rear brake caliper, rear brake disc and rear brake hose (arrowed) of the Motorcycle, which are all part of the components in the hydraulic rear brake system of the Motorcycle. Our visual checks of these various components had revealed all to be intact with no visible damage. No leakage of brake fluid was also observed.

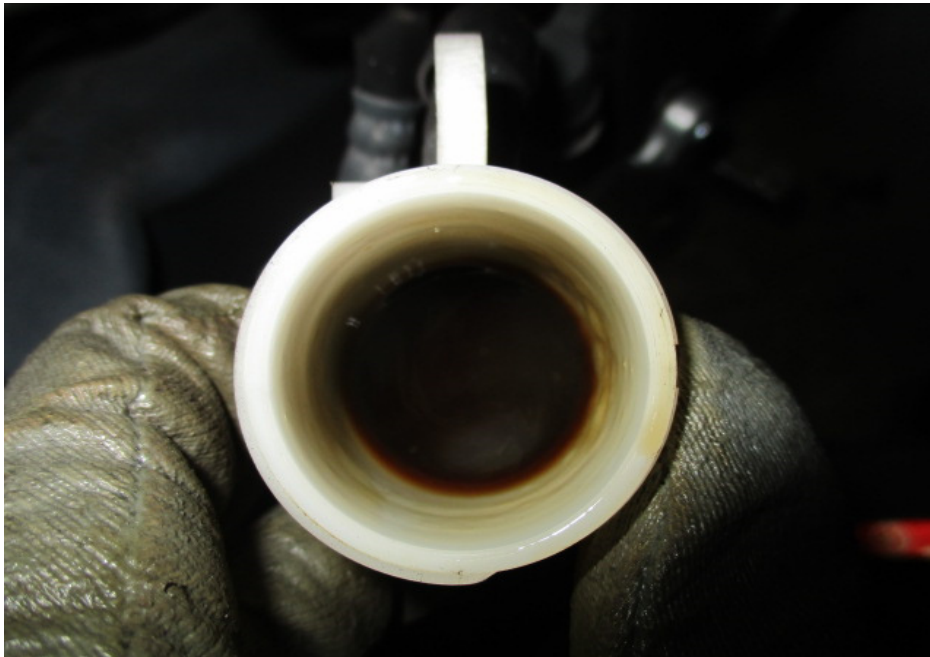
Photo 26 shows the brake fluid reservoir for the rear brake of the Motorcycle. The brake fluid was observed to be of sufficient level and without contamination for operational purposes.
