Your Ref: TP/IP/18129/2020
Our Ref : CI/TPD20007959/N

Fatal Accident Investigation Team

INSPECTION REPORT OF MOTORCYCLE FBM 8394T

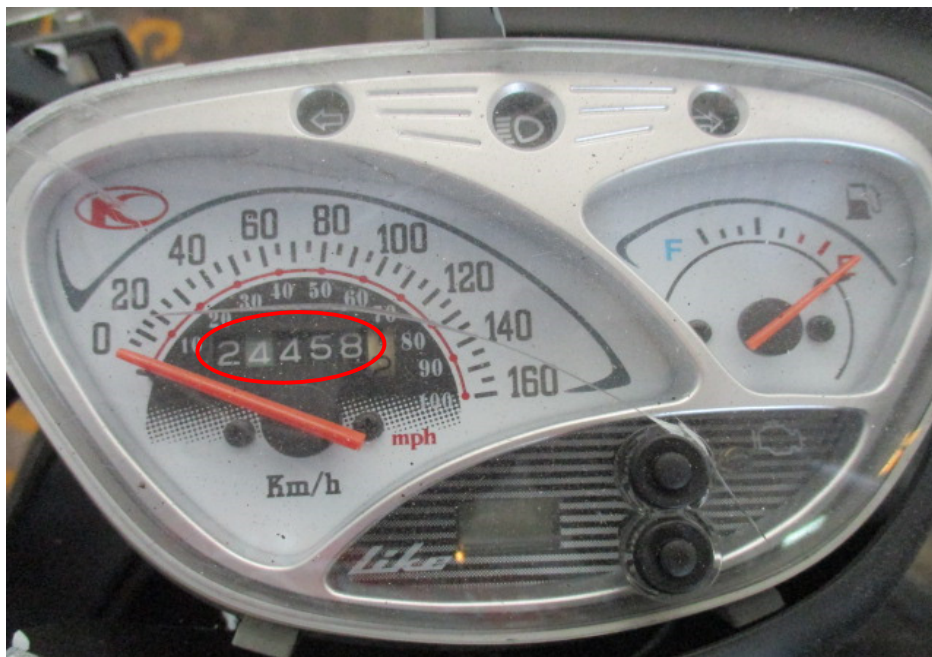
Photo 1 shows the speedometer gauge of the Motorcycle where the mileage recorded at time of our inspection was 24,458km.

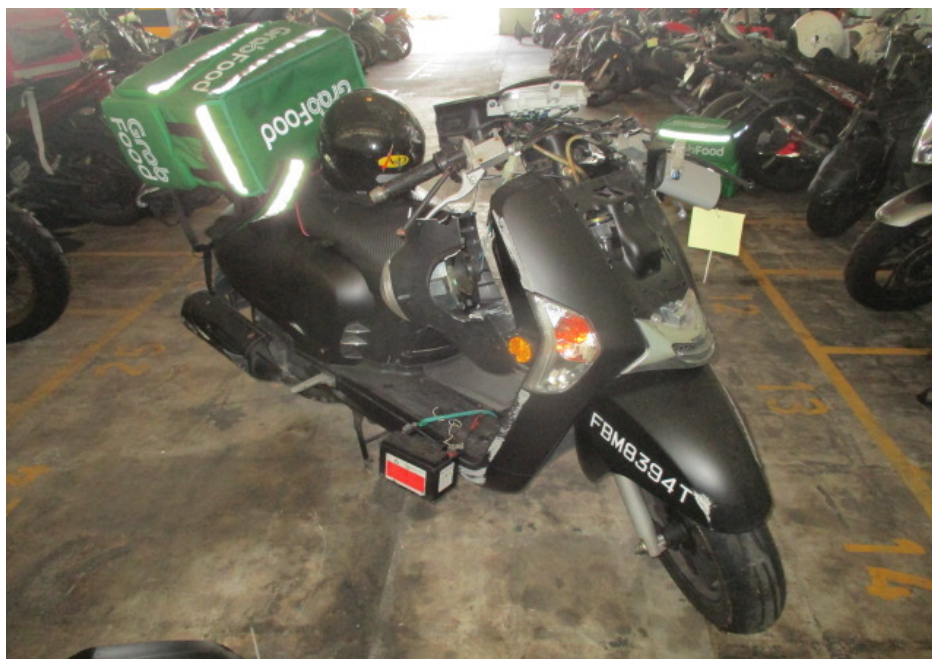
Photo 2 shows a general view of the front right body of the Motorcycle at the time of our inspection. The Motorcycle was observed to have sustained damages all around.

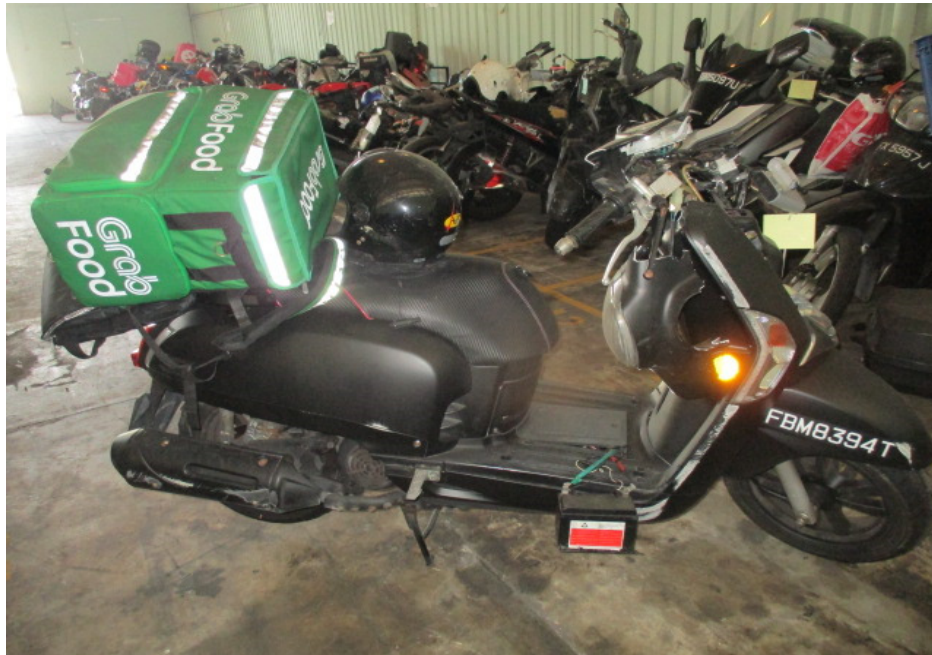
Photo 3 shows a general view of the right body of the Motorcycle at the time of our inspection. The Motorcycle was observed to have sustained damages all around.

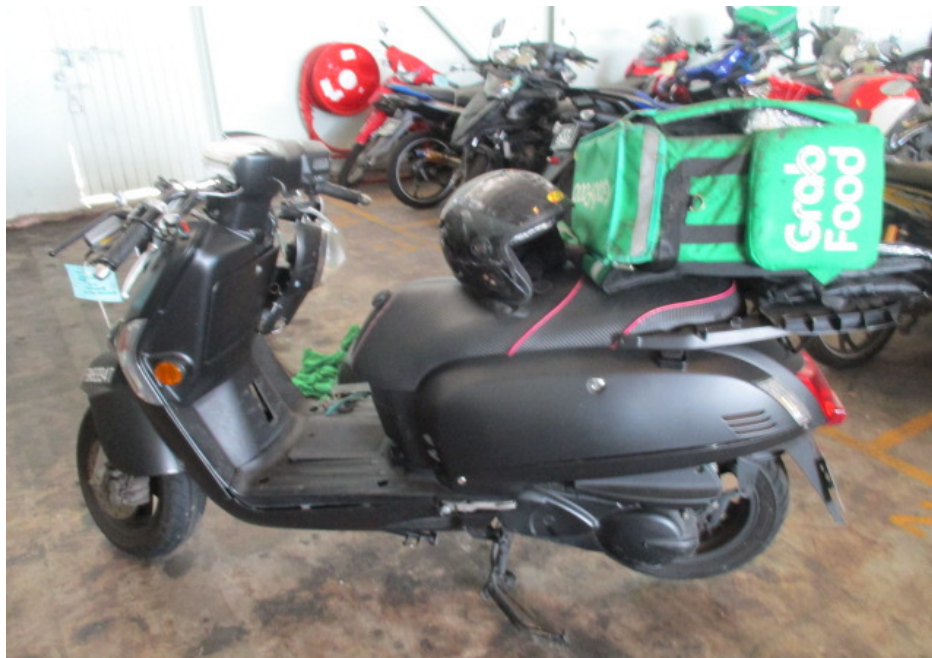
Photo 4 shows a general view of the left body of the Motorcycle at the time of our inspection. The Motorcycle was observed to have sustained damages all around. The body parts that were found to have been damaged include its headlight assembly, front mudguard, front brake lever, right side mirror, right handlebar end, side cowlings, left rear bottom cowlings, rear side covers, top box rack and exhaust muffler, amongst others as a result of the accident.

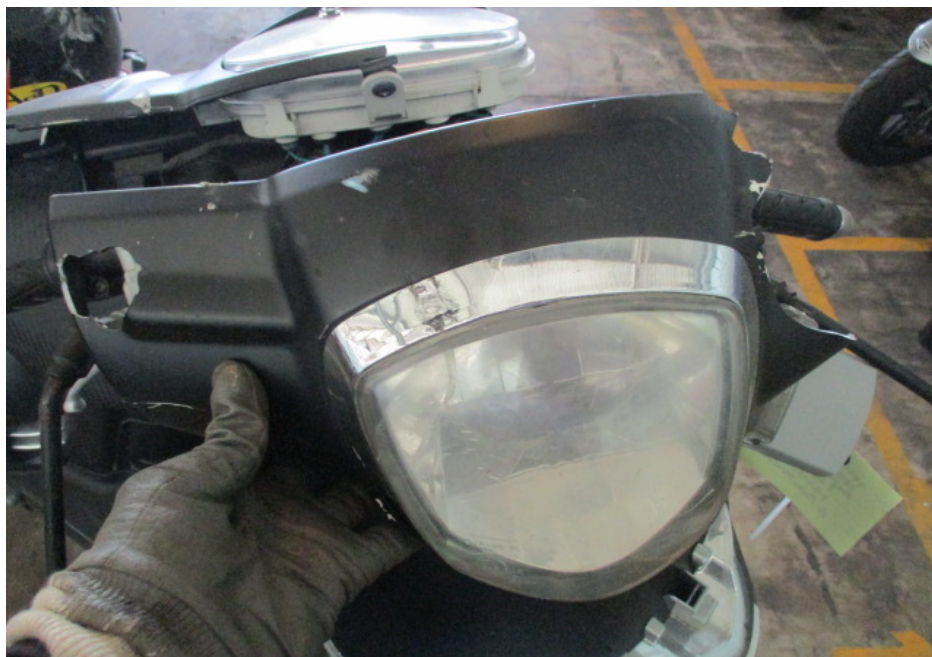
Photo 5 shows a closer view of the broken headlight assembly of the Motorcycle at the time of our inspection.

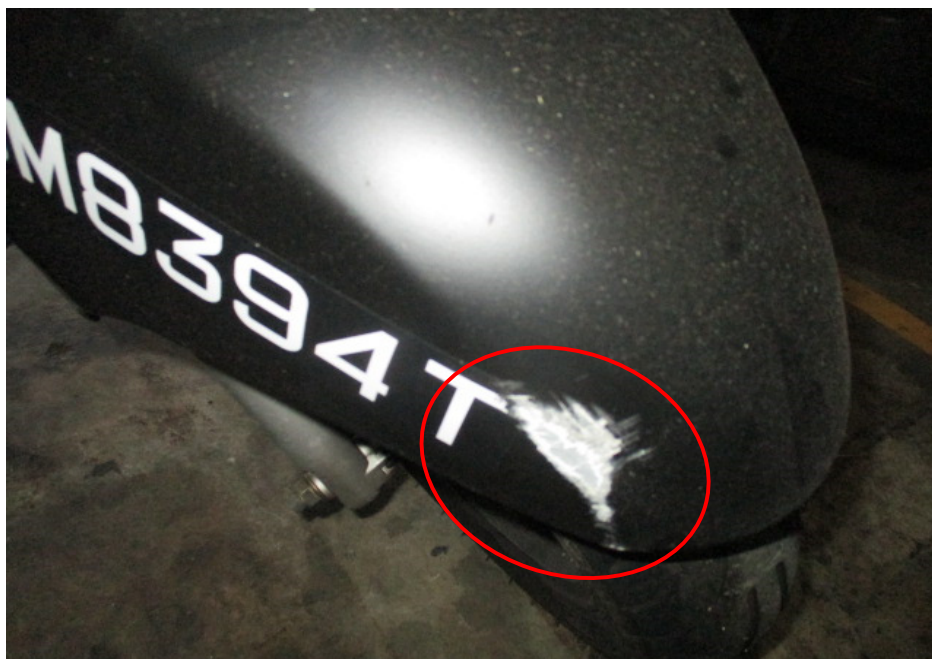
Photo 6 shows a closer view of the front mudguard which was amongst the body parts at the front body of the Motorcycle that had sustained damage as a result of the accident (circled).

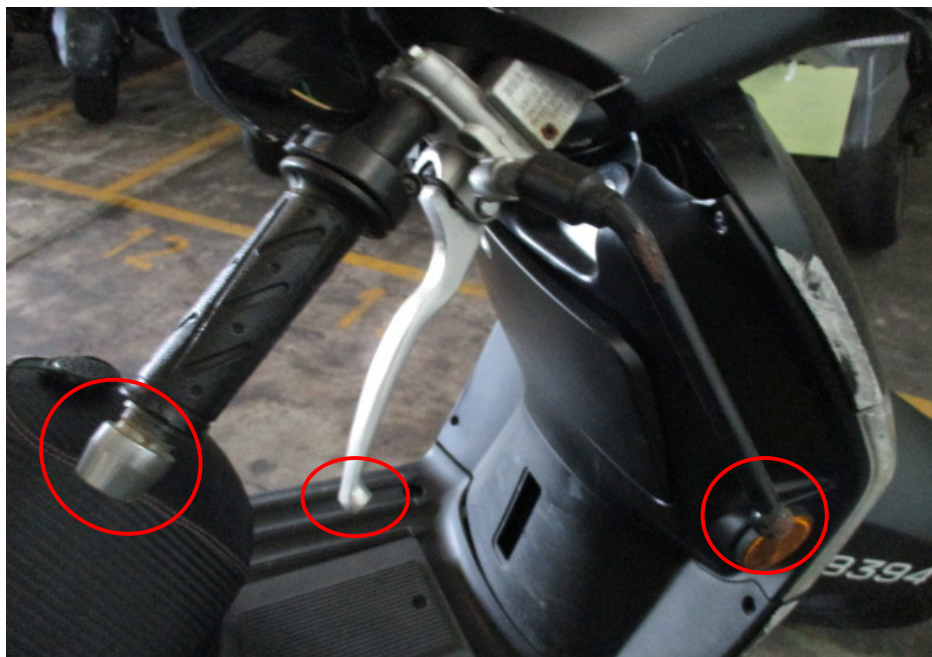
Photo 7 shows a closer view of the right side mirror, right handlebar end and front brake lever of the Motorcycle which were observed to be damaged due to the accident (circled).

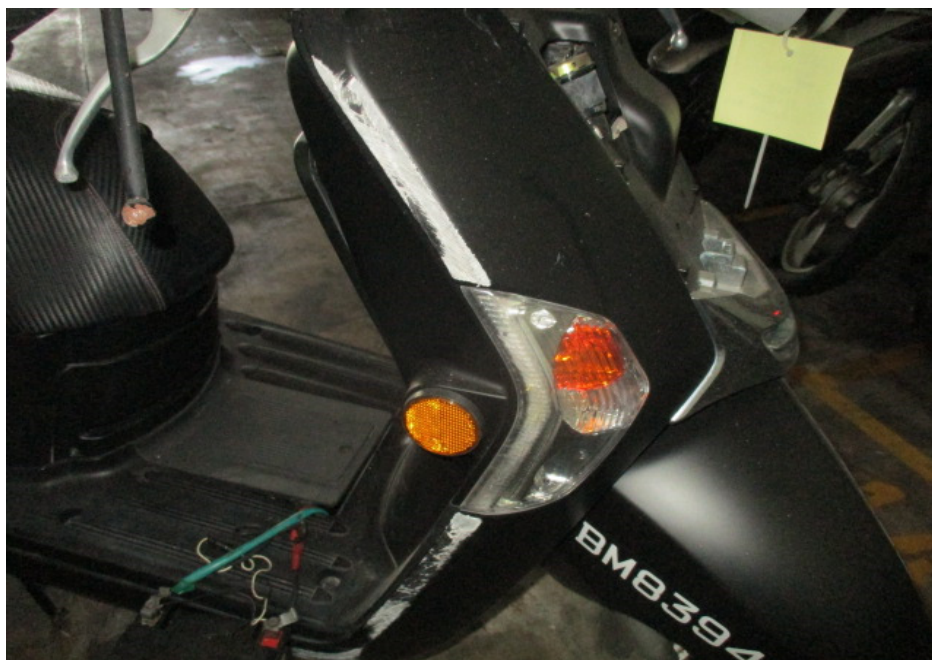
Photo 8 shows the damaged right side cowling of the Motorcycle. The damage sustained was mainly of grazing nature.

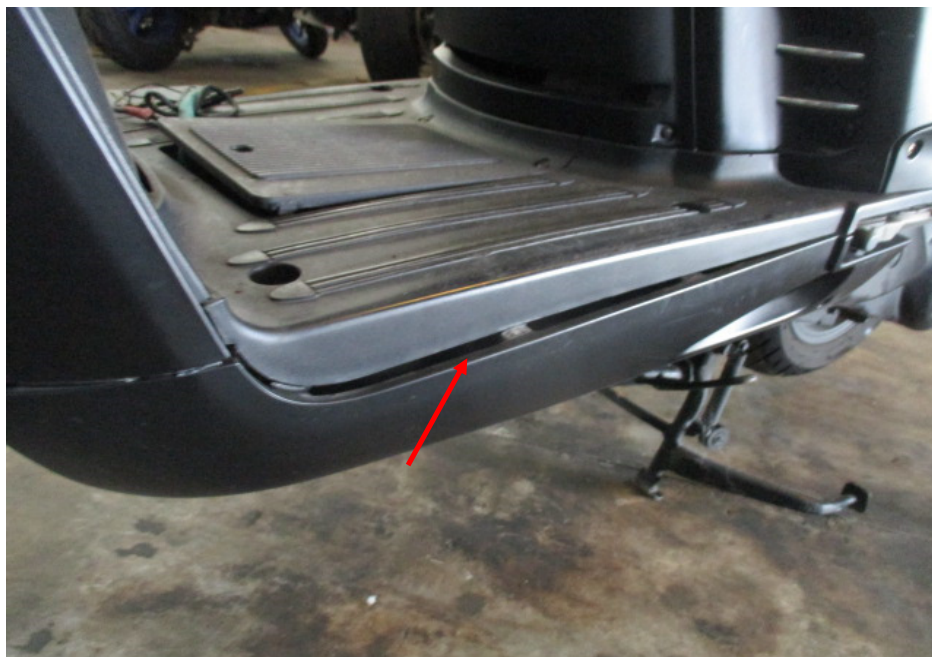
Photo 9 shows a close-up view of the deformed left lower side cowling of the Motorcycle at the time of our inspection (arrowed).

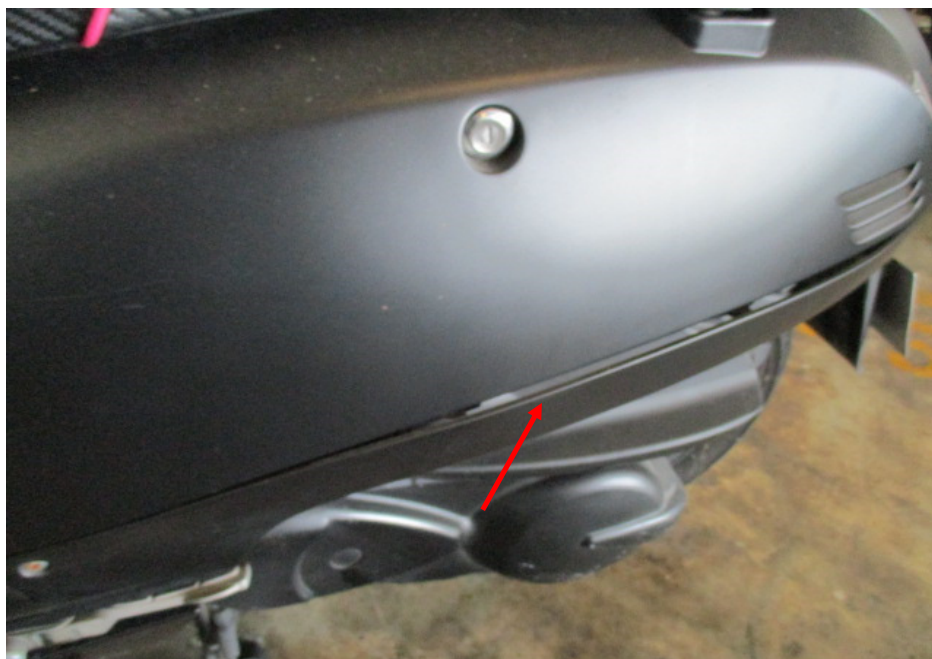
Photo 10 shows a closer view of the deformed left rear side cover of the Motorcycle as a result of the accident (arrowed).

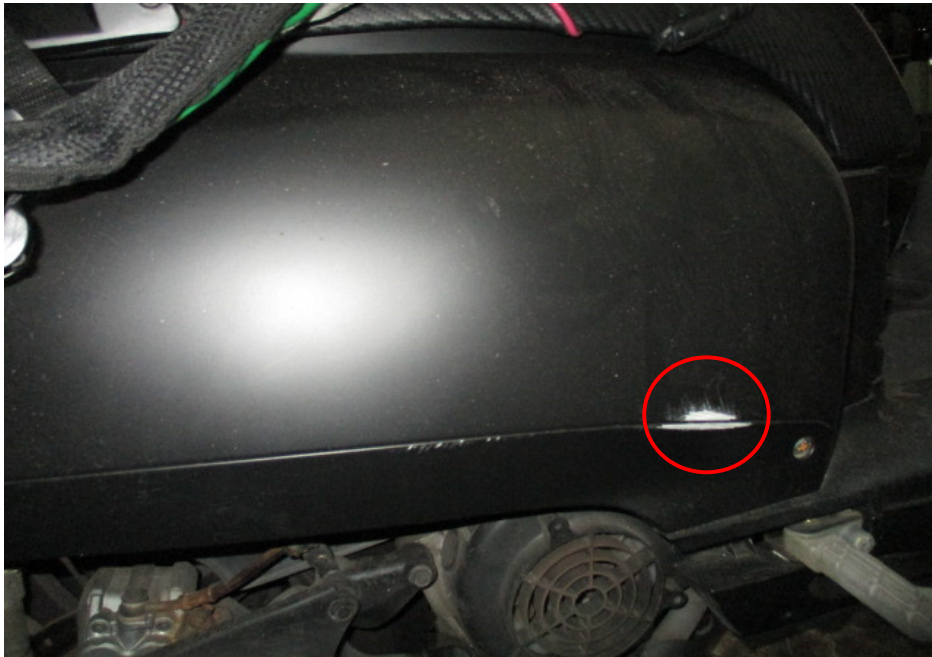
Photo 11 shows a closer view of the right rear side cover of the Motorcycle which sustained damages of grazing nature as a result of the accident (circled).

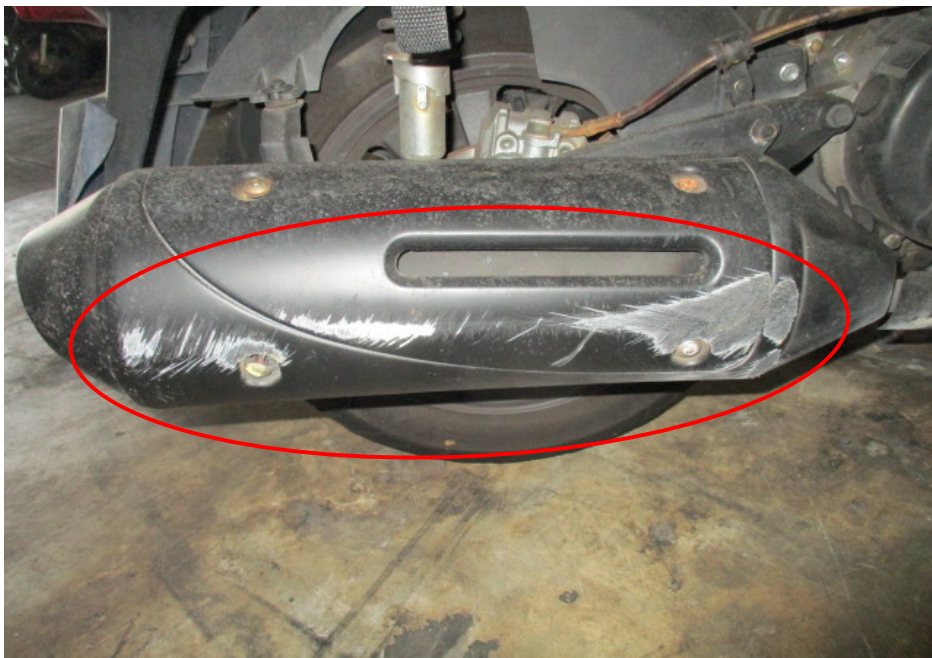
Photo 12 shows a closer view of the damaged exhaust muffler of the Motorcycle at the time of our inspection (circled).

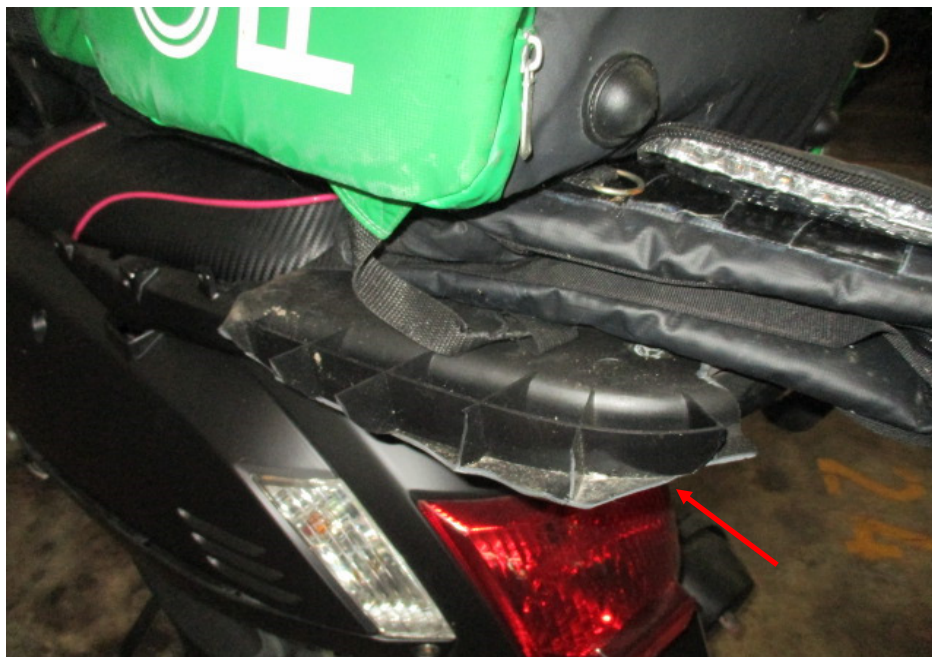
Photo 13 shows a closer view of the cracked top box rack of the Motorcycle as a result of the accident (arrowed).

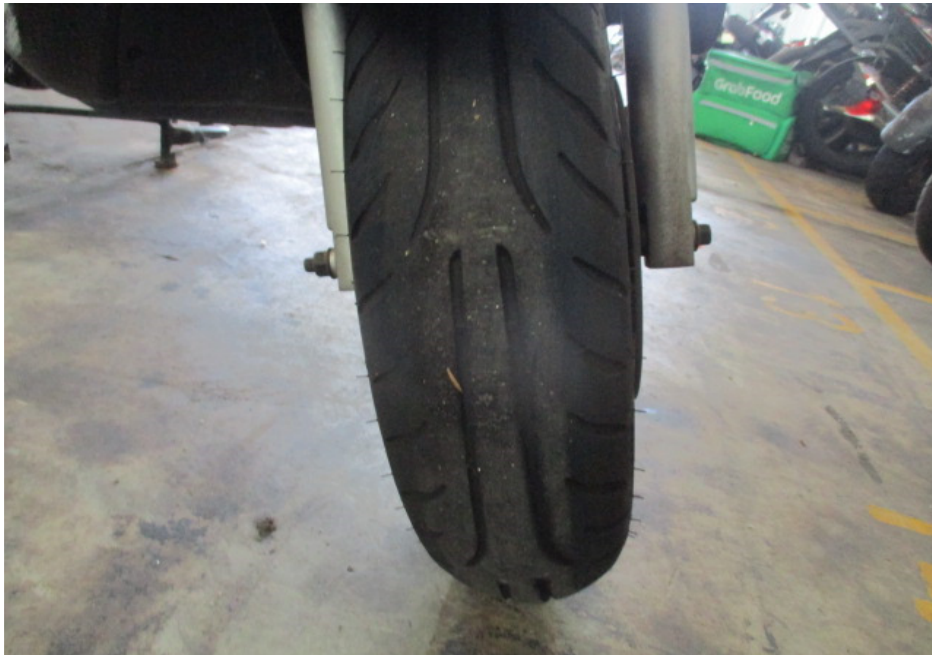
Photo 14 shows the condition of the Motorcycle's front tyre. The front tyre was observed to be in serviceable condition with remaining tread depth of approximately 3mm. There was no tear, burst mark(s) and/or punctured hole(s) on the sidewalls as well as across the tread of the front tyre.

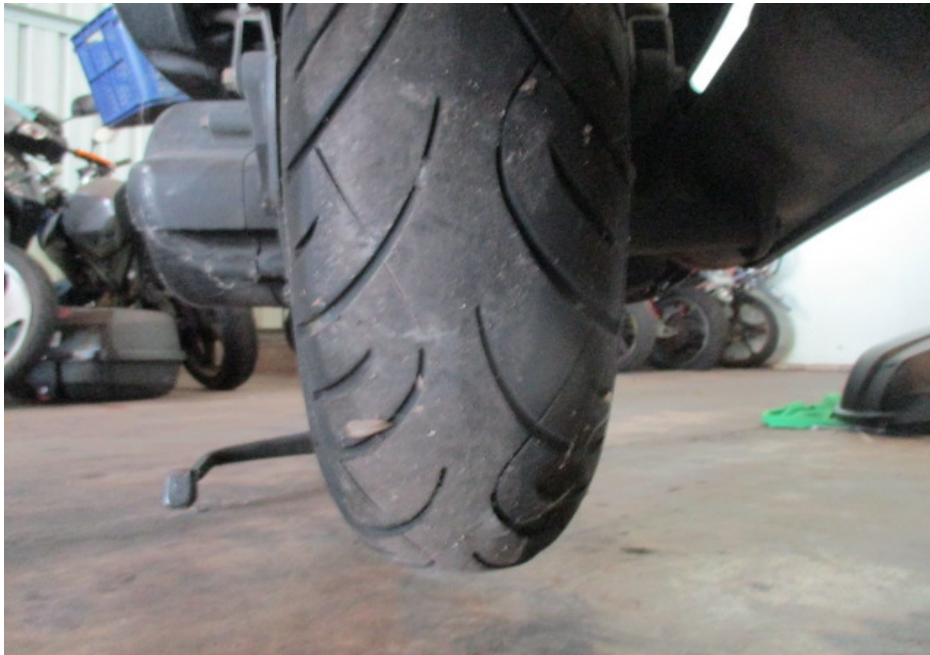
Photo 15 shows the condition of the Motorcycle's rear tyre. The rear tyre was observed to be in serviceable condition with remaining tread depth of approximately 3mm. The tyre was also observed to be sufficiently inflated for vehicular operation. We did not observe any tear, burst mark(s) and/or punctured hole(s) on the sidewalls as well as across the tread of the rear tyre.

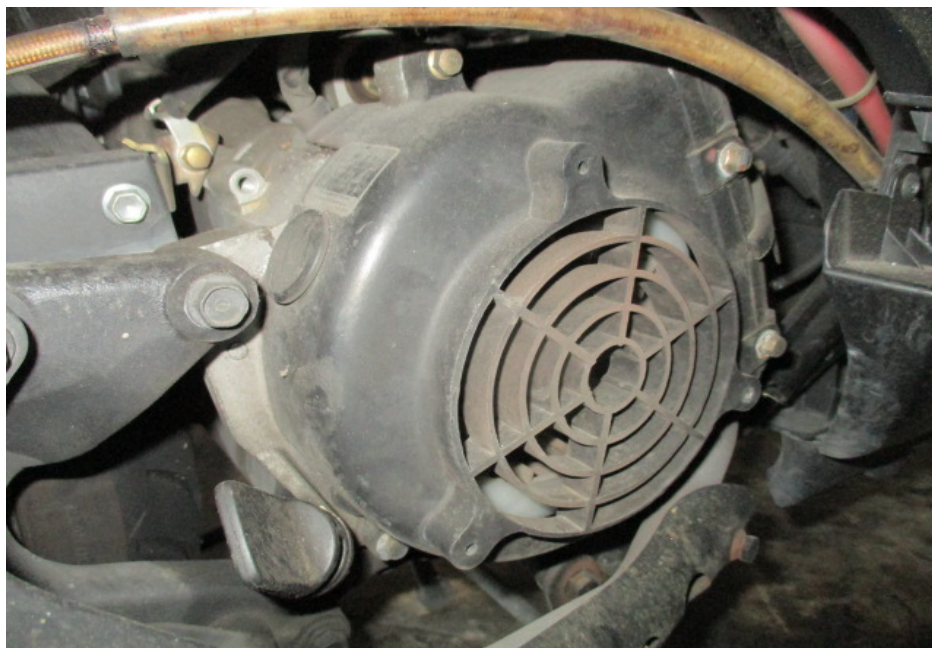
Photo 16 shows the right side of the engine of the Motorcycle at the time of our inspection. The various engine related parts and components were found to be intact with no visible damage. There was also no sign(s) or indication(s) of fluid leak observed around the right engine area of the Motorcycle.

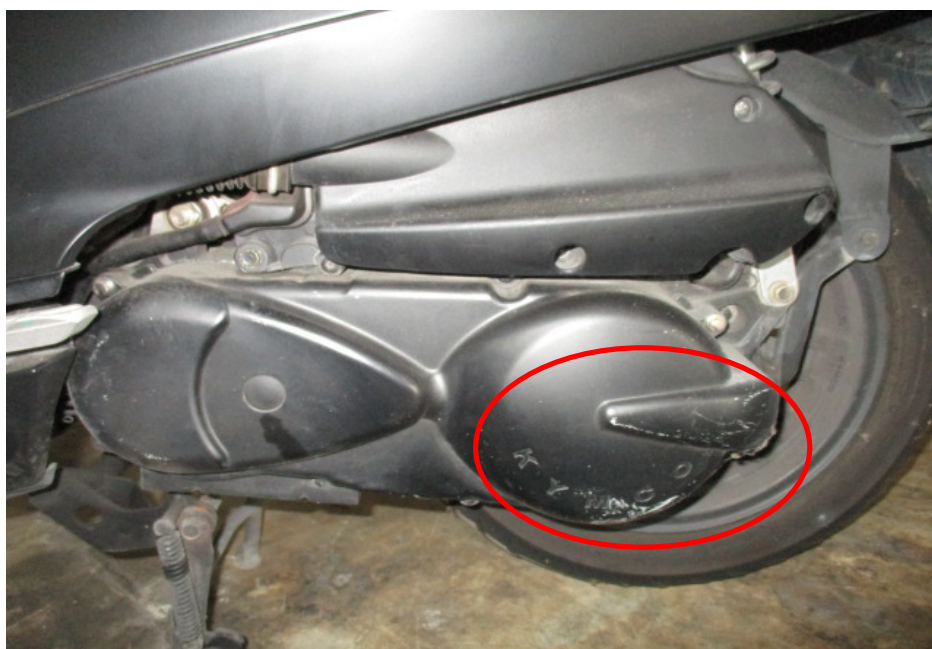
Photo 17 shows the drive train of the Motorcycle which was found to be intact without any misalignment. However the drive train cover had sustained damages of grazing nature as a result of the accident (circled). Upon examination of the Motorcycle's engine area, we had observed that the various engine related parts and components were intact with no visible damage. There was also no sign(s) or indication(s) of fluid leak observed around the engine area of the Motorcycle.

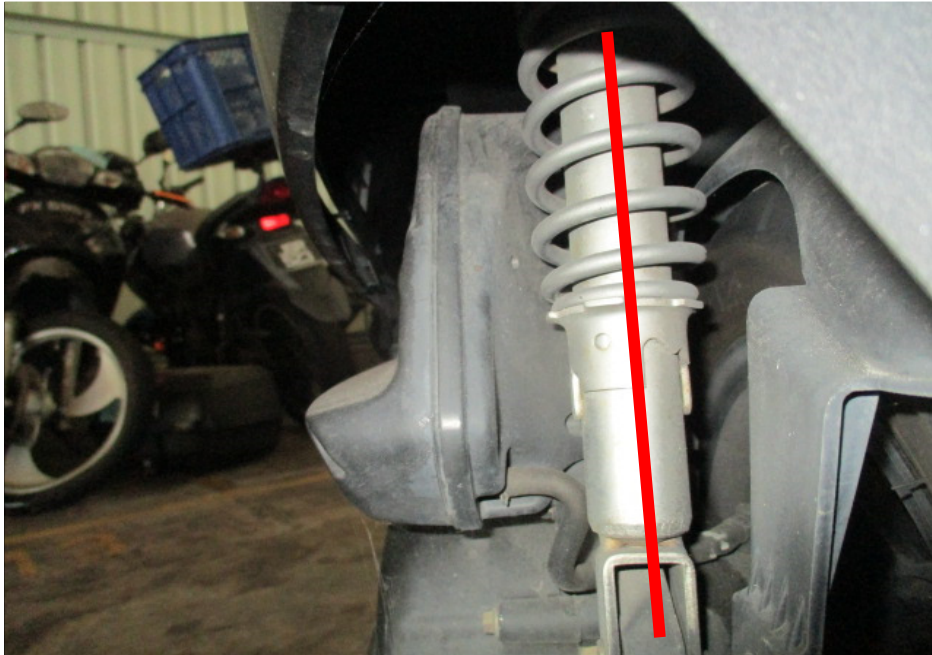
Photo 18 shows the left shock absorber of the Motorcycle which was found to be intact without any misalignment.

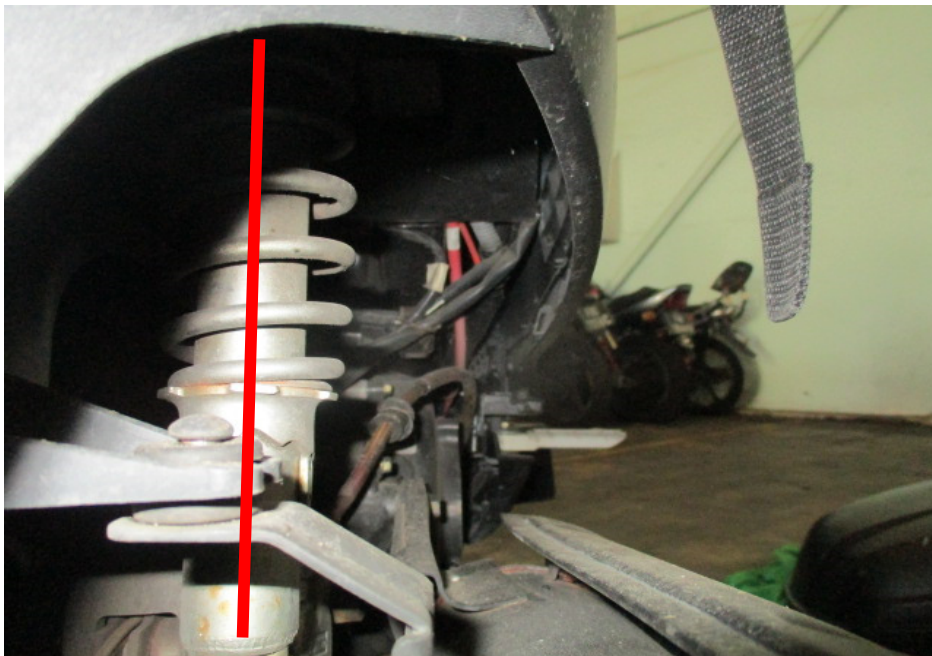
Photo 19 shows the right shock absorber of the Motorcycle which was found to be intact without any misalignment.

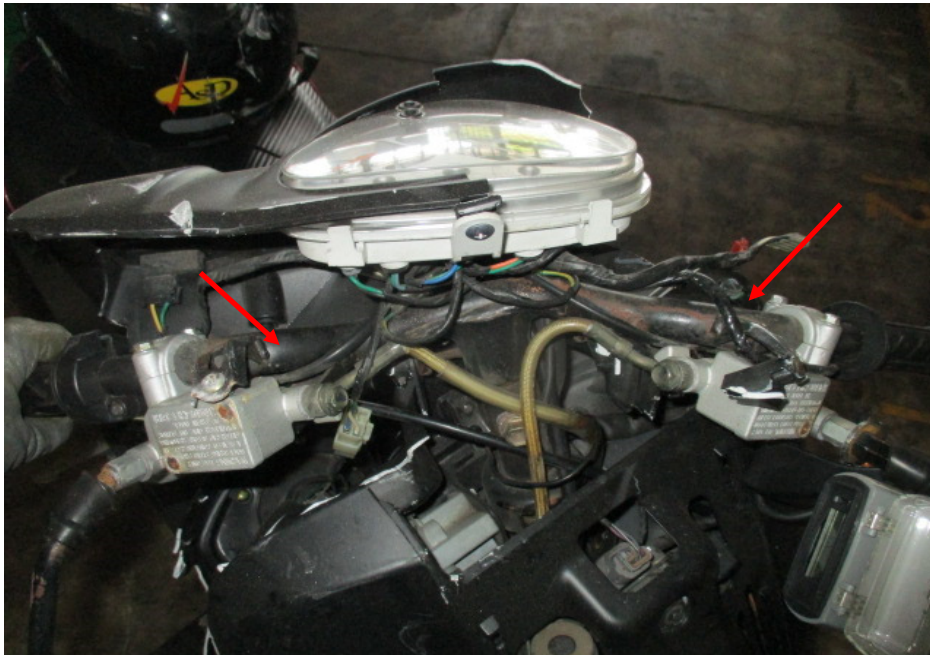
10. For this case, we were not able to conduct any test(s) on the steering system of the Motorcycle due to the damage to its handlebar. The handlebar was observed to be bent inwards as a result of the accident. Hence we were unable to turn the handle bar towards the left or right.

Photo 20 shows the handlebar of the Motorcycle. The handlebar was observed to be bent inwards as a result of the accident (arrowed). Hence we were unable to turn the handle bar towards the left or right.

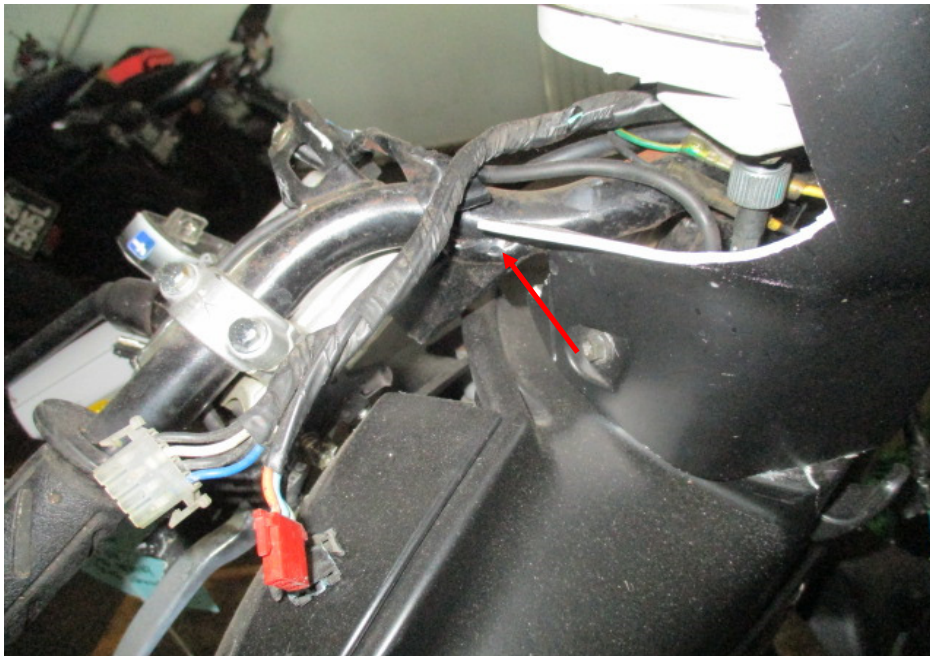
Photo 21 shows a close up view of the bent handlebar of the Motorcycle as a result of the accident (arrowed). Hence we were unable to turn the handle bar towards the left or right.

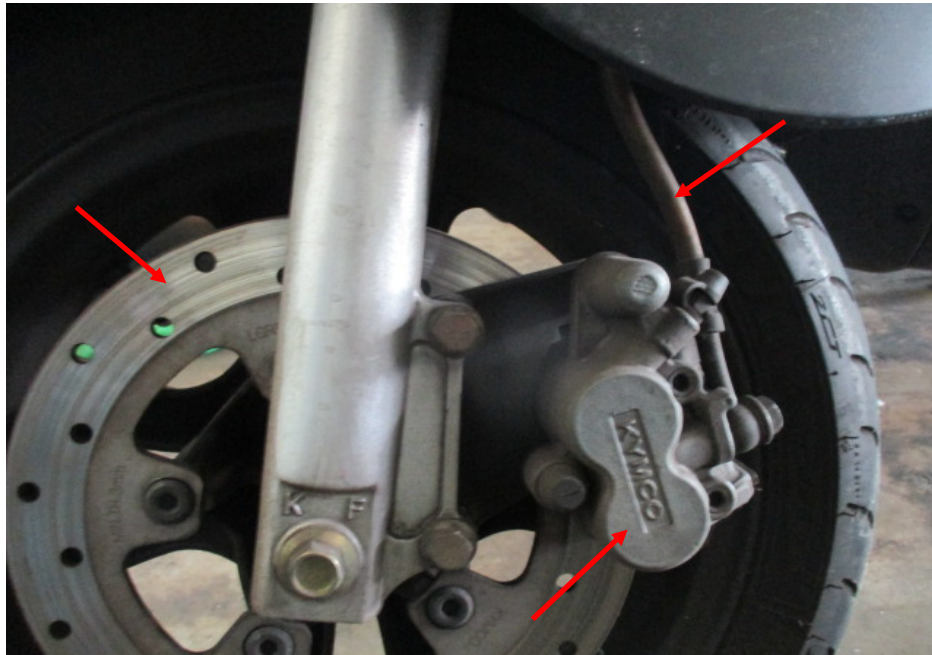
Photo 22 shows a close up view of the front brake caliper, front brake disc and front brake hose (arrowed) of the Motorcycle, which are all part of the components in the hydraulic front brake system of the Motorcycle. Our visual checks of these various components had revealed all to be intact with no visible damage. No leakage of brake fluid was also observed.

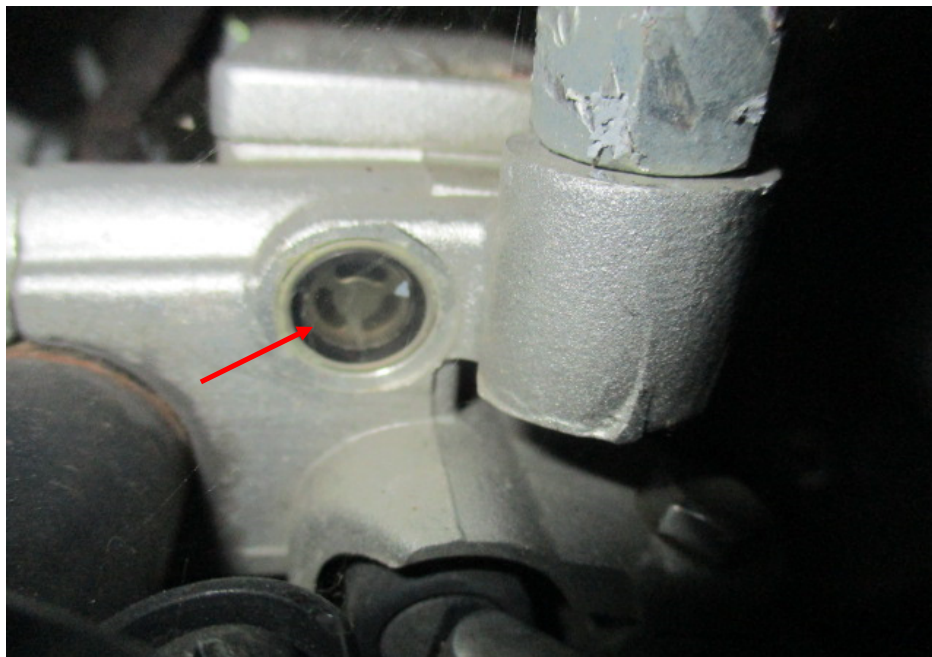
Photo 23 shows the brake fluid reservoir for the front brake of the Motorcycle. The brake fluid was observed to be of sufficient level and without contamination for operational purposes (arrowed).

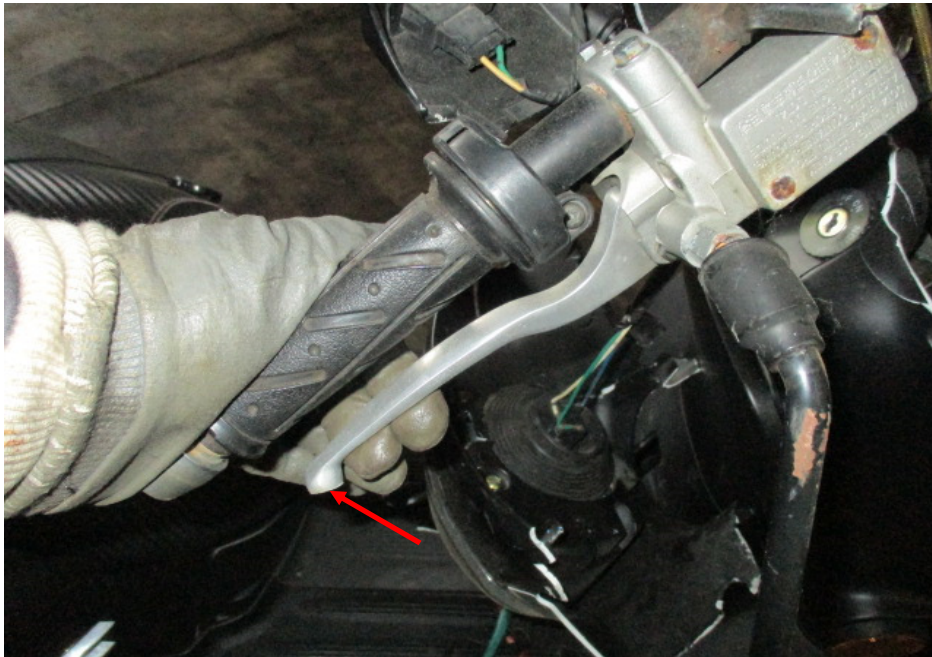
Photo 24 shows the front brake lever being depressed. There was some resistance felt (spongy like feel) upon pressing the front brake lever (arrowed). This would indicate that there is no leakage of pressure/vacuum in the brake system.

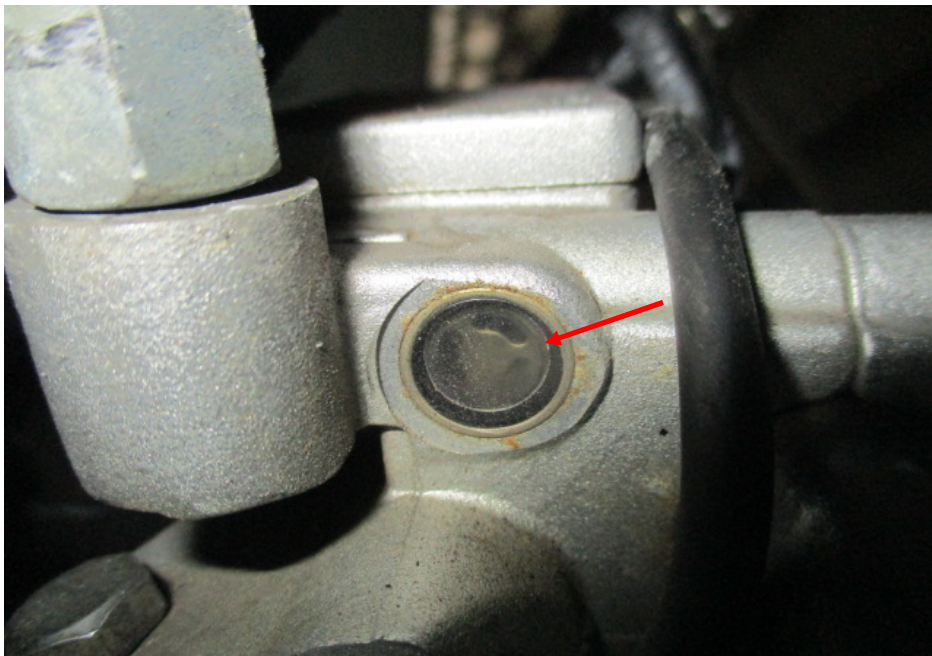
Photo 25 shows the brake fluid reservoir for the rear brake of the Motorcycle. The brake fluid was observed to be of sufficient level and without contamination for operational purposes (arrowed).

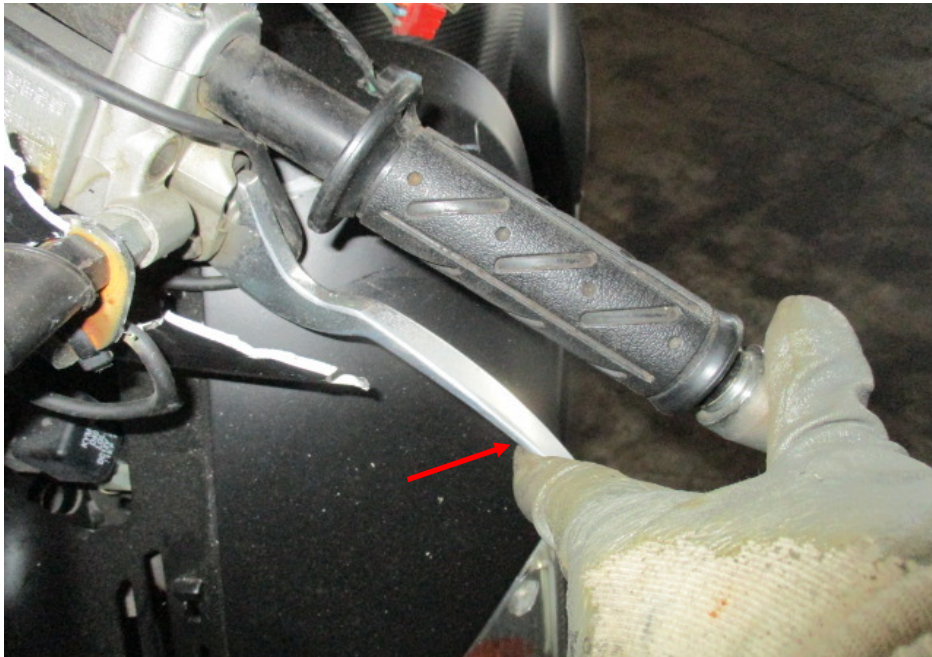
Photo 26 shows the rear brake lever being depressed. There was some resistance felt (spongy like feel) upon pressing the front brake lever (arrowed). This would indicate that there is no leakage of pressure/vacuum in the brake system.

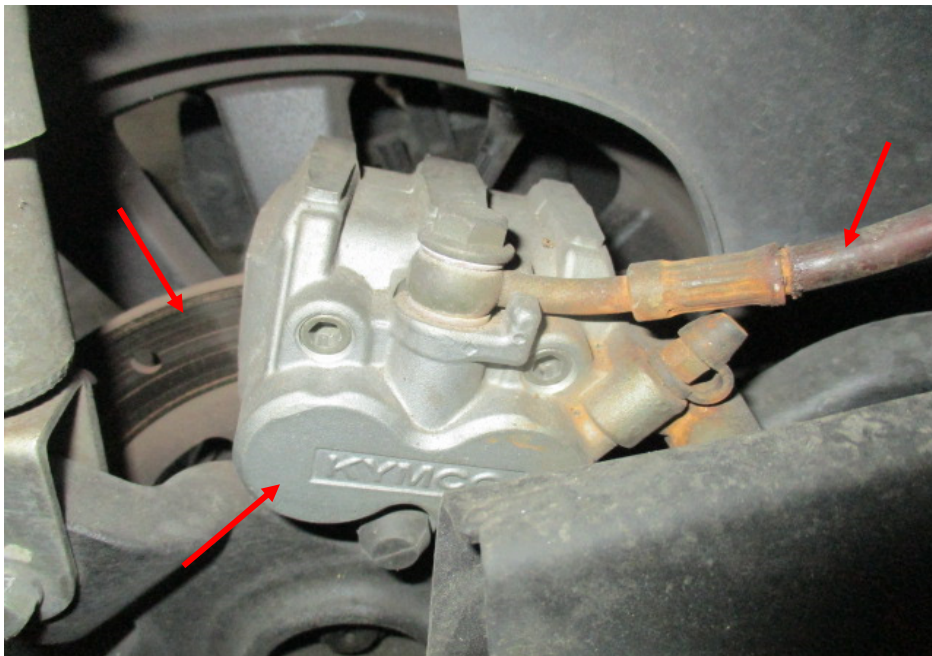
Photo 27 shows a close up view of the rear brake caliper, rear brake disc and rear brake hose (arrowed) of the Motorcycle, which are all part of the components in the hydraulic rear brake system of the Motorcycle. Our visual checks of these various components revealed all to be intact with no visible damage. No leakage of brake fluid was also observed.
