Your Ref: TP/IP/17661/2020  
Our Ref : CI/TPD20007960/N

27 July 2020

**INSPECTION REPORT OF MOTORCYCLE FBK 6836J**

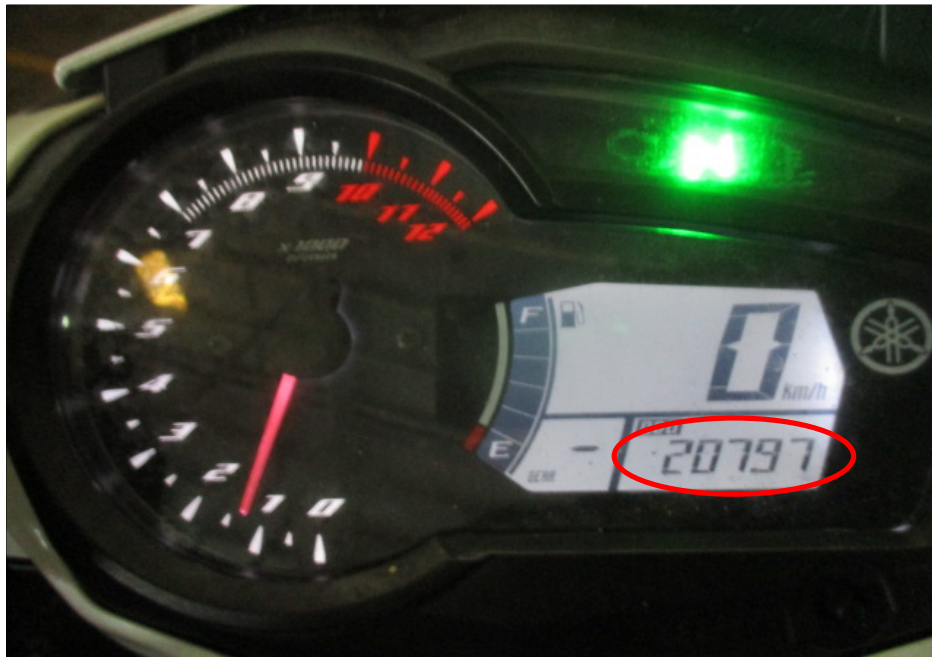
**Photo 1** shows the speedometer gauge of the Motorcycle. The mileage of the Motorcycle at the time of our inspection was 20, 797km (circled).

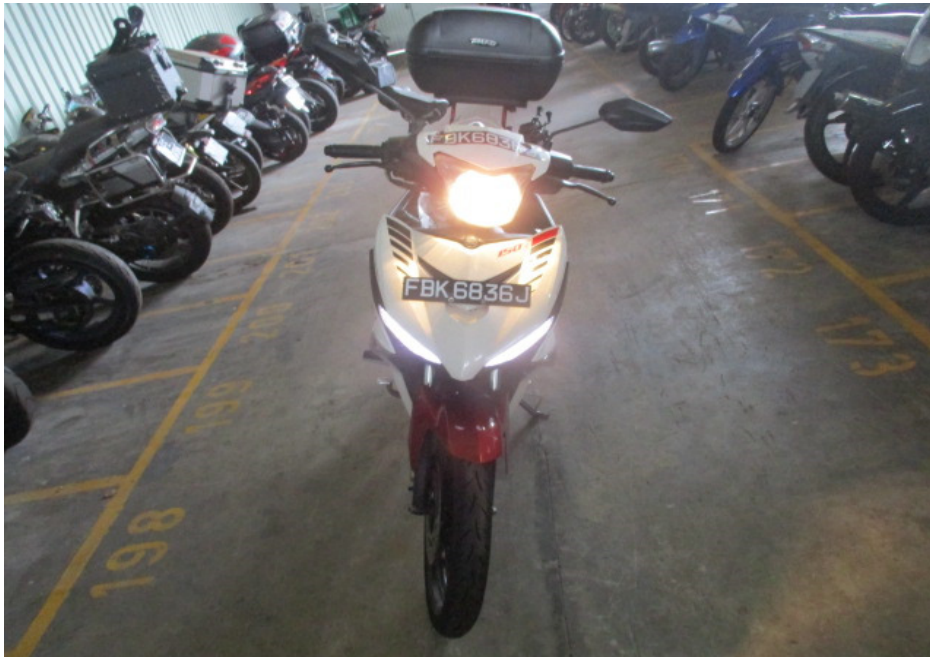
**Photo 2** shows a general view of the frontal portion of the Motorcycle at the time of our inspection. The Motorcycle was observed to have sustained damages at its frontal portion and left body.

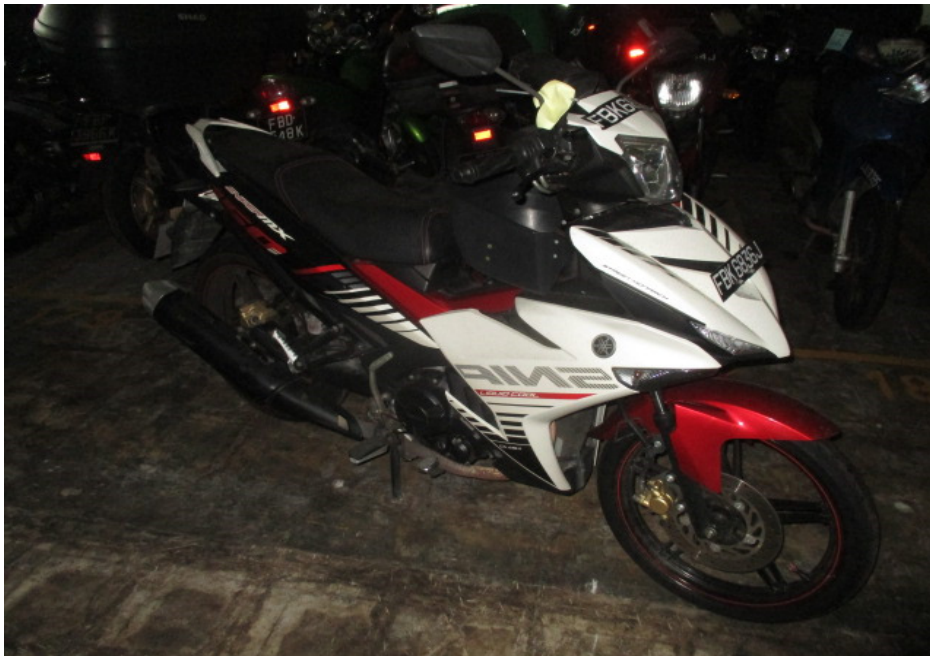
**Photo 3** shows a general view of the right body of the Motorcycle at the time of our inspection. The Motorcycle was observed to have sustained damages at its frontal portion and left body.

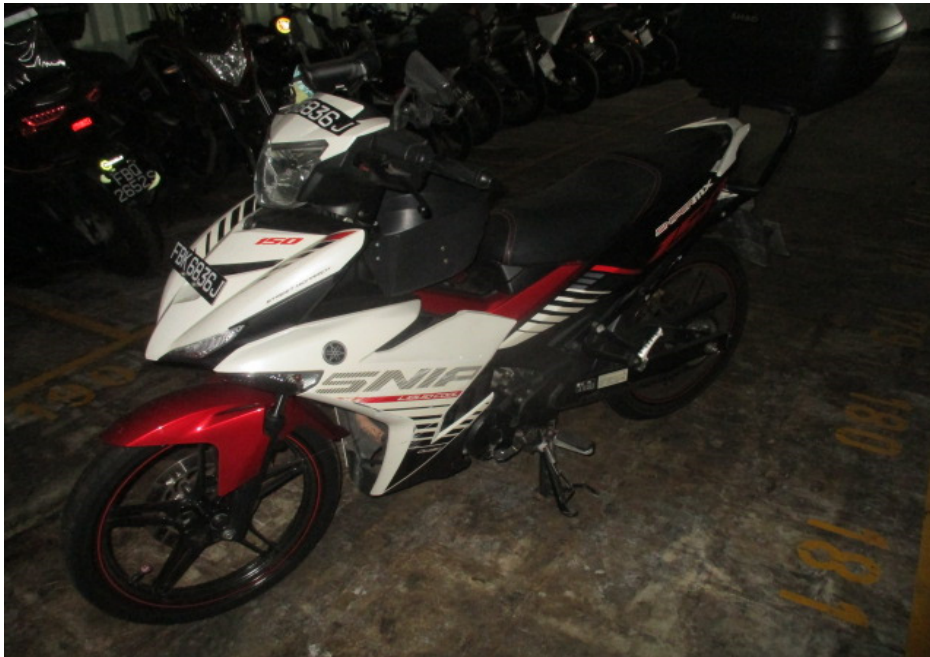
4. The mileage of the Motorcycle at the time of our inspection was 20, 797km.
5. The Motorcycle was observed to have sustained damages at its frontal portion and left body. The body parts that were found to have been damaged include its left cowling, front mudguard, clutch lever, left side mirror, left handlebar end, gear shift pedal, left front footrest, left rear side cover, top box rack and top box, amongst others.

**Photo 4** shows a general view of the left body of the Motorcycle at the time of our inspection. The Motorcycle was observed to have sustained damages at its frontal portion and left body. Amongst the body parts that were found to have been damaged include its left cowling, front mudguard, clutch lever, left side mirror, left handlebar end, gear shift pedal, left front footrest, left rear side cover, top box rack and top box, amongst others.

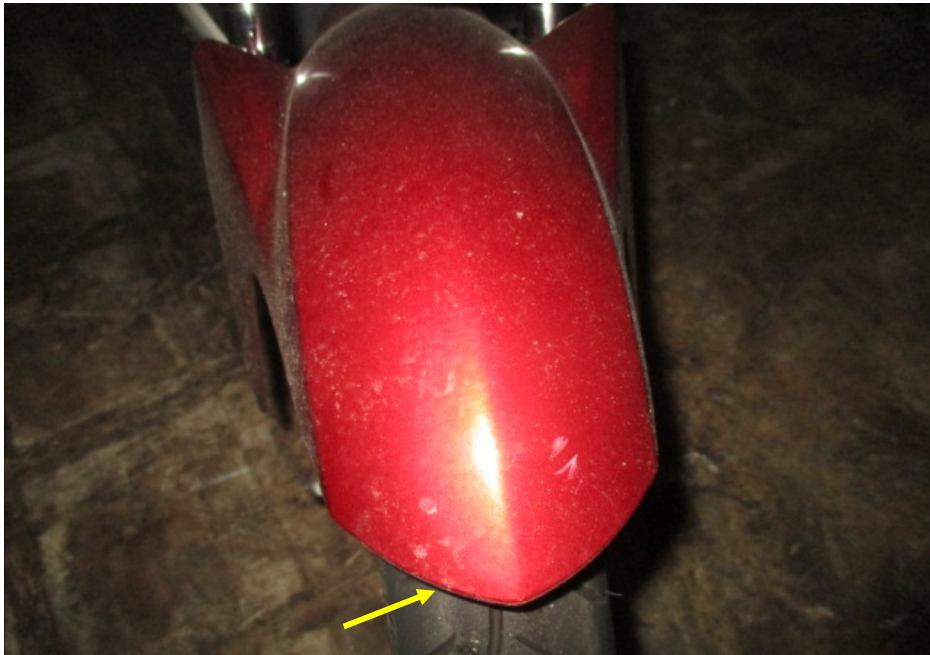
**Photo 5** shows a closer view of the front mudguard which was amongst the body parts at the front body of the Motorcycle that had sustained damage as a result of the accident (arrowed).

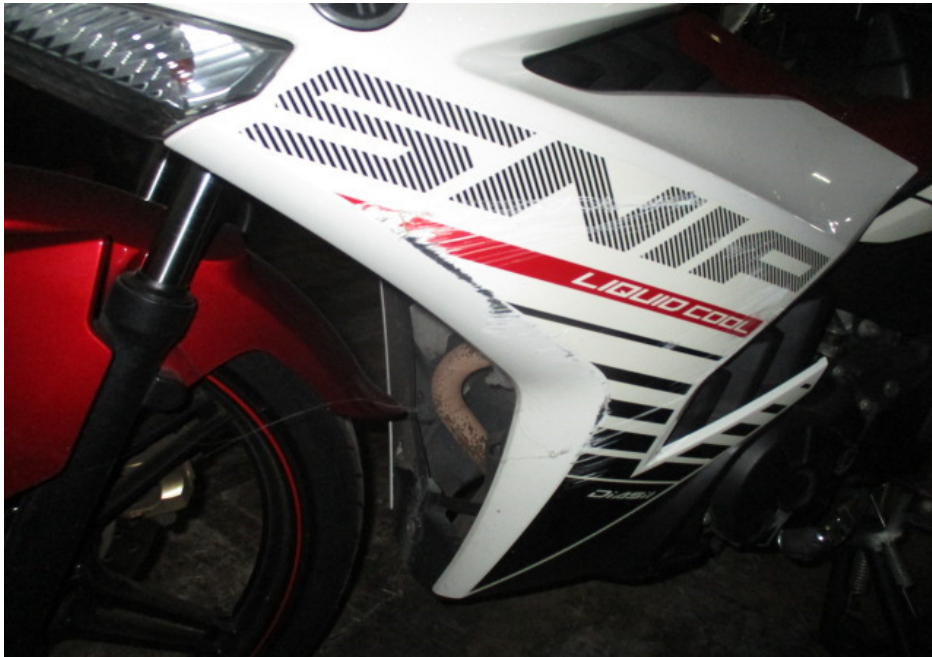
**Photo 6** shows a closer view of the left cowling which was amongst the body parts of the Motorcycle that had sustained damage as a result of the accident.

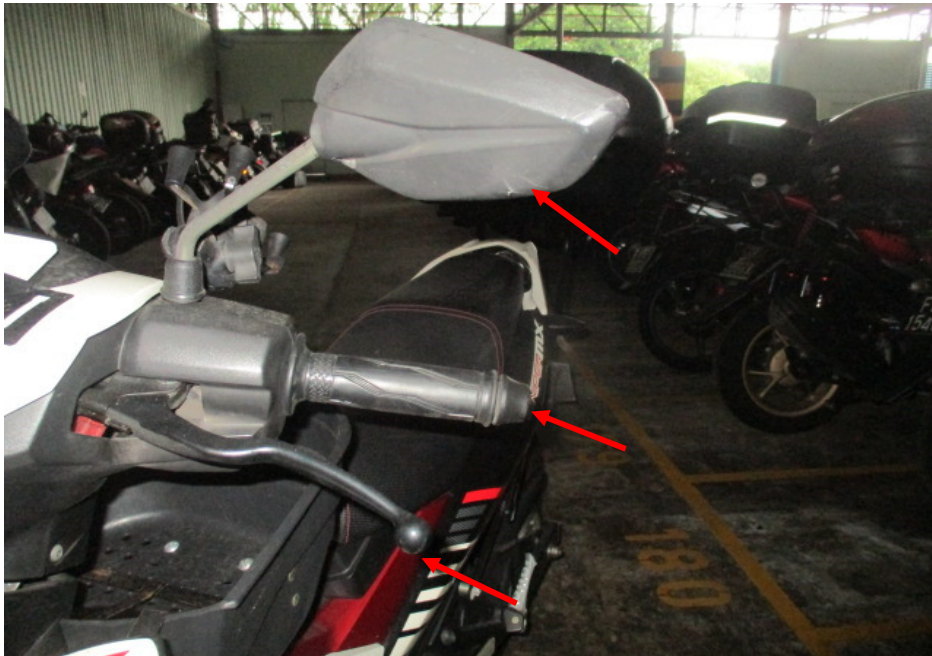
**Photo 7** shows the clutch lever, left handlebar end and left side mirror (arrowed), which were amongst the body parts of the Motorcycle that had sustained damage as a result of the accident.

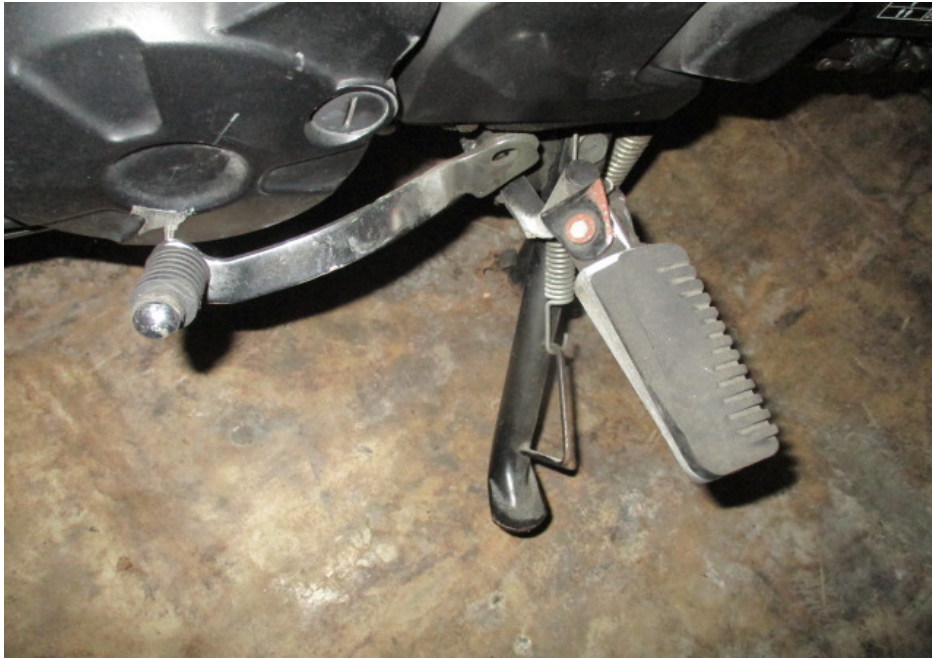
**Photo 8** shows a closer view of the bent gear shift pedal and left front footrest which were amongst the body parts of the Motorcycle that had sustained damage as a result of the accident.

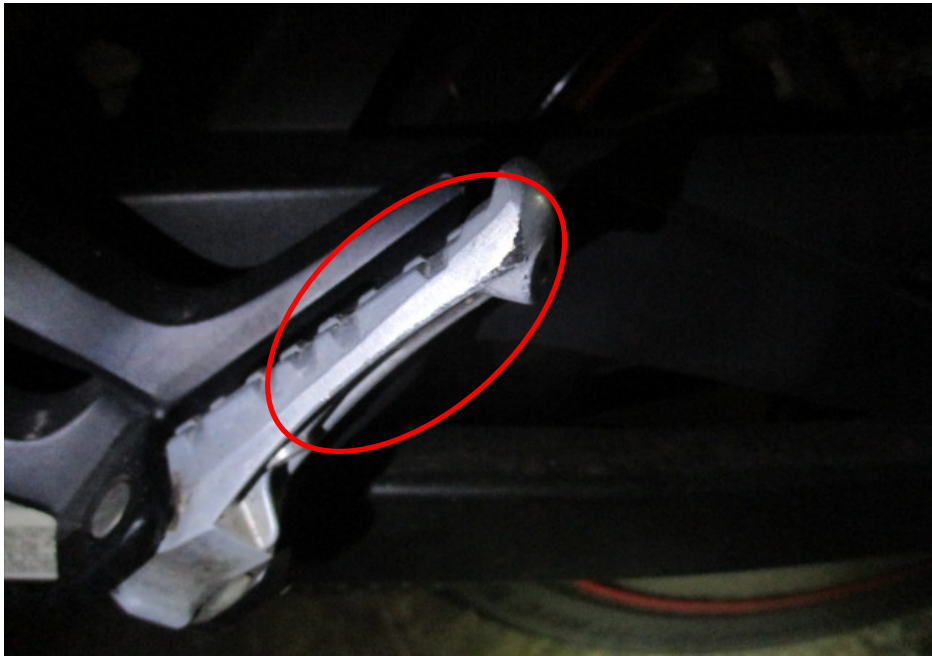
**Photo 9** shows a closer view of the left pillion foot peg (circled) which was amongst the body parts of the Motorcycle that had sustained damage as a result of the accident.

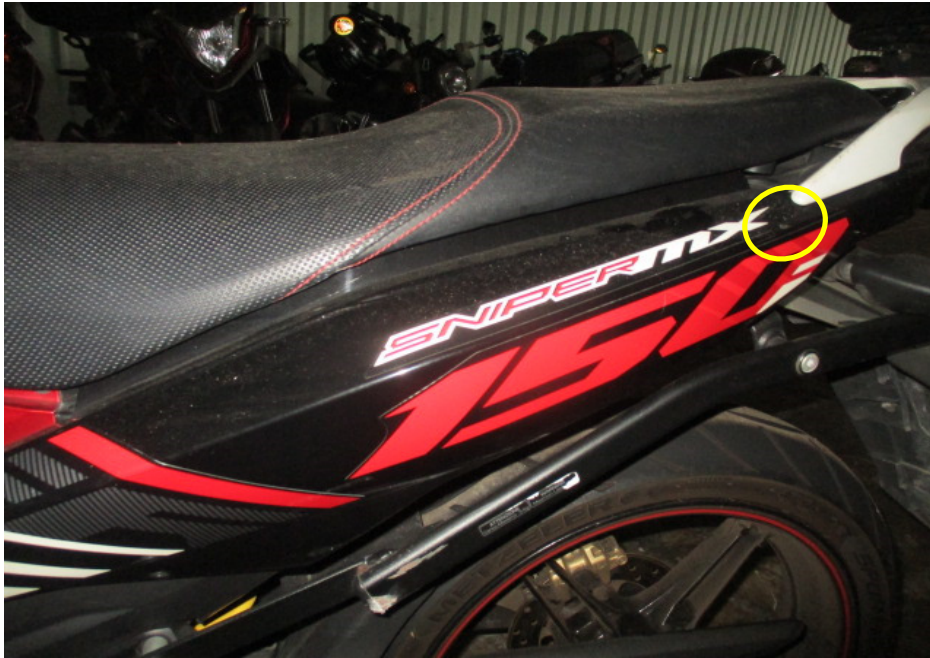
**Photo 10** shows a closer view of the left rear side cover (circled) which was amongst the body parts of the Motorcycle that had sustained damage as a result of the accident.

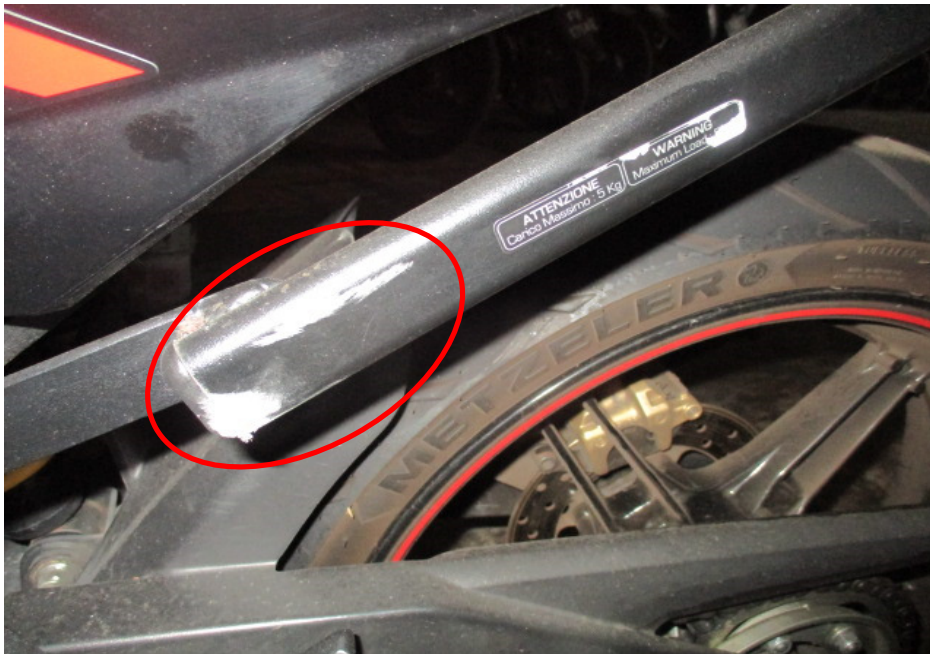
**Photo 11** shows the top box rack (circled) of the Motorcycle that had sustained damage as a result of the accident.

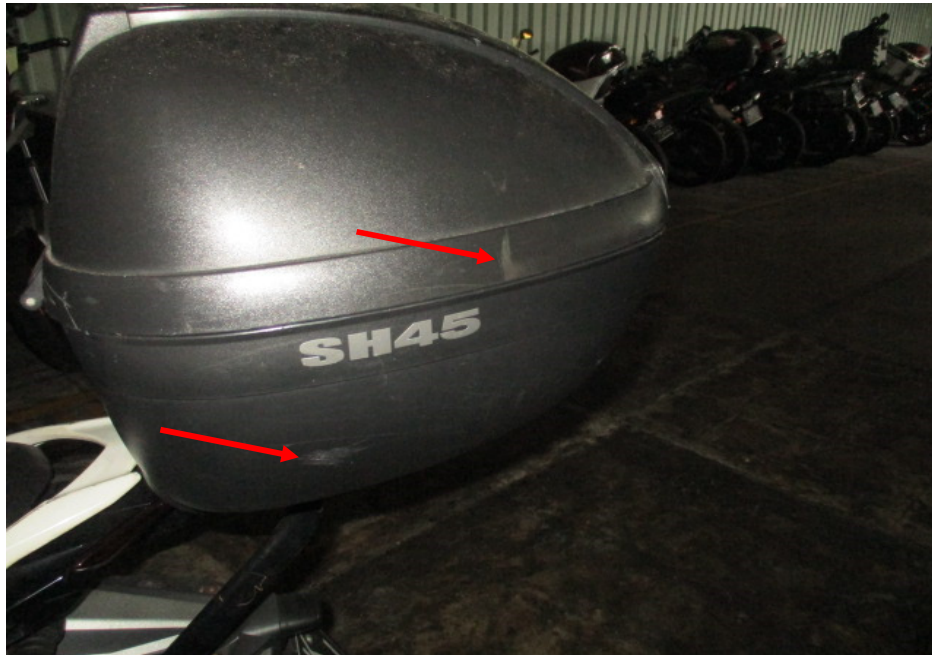
**Photo 12** shows the top box of the Motorcycle which sustained damages of grazing nature as a result of the accident (arrowed).

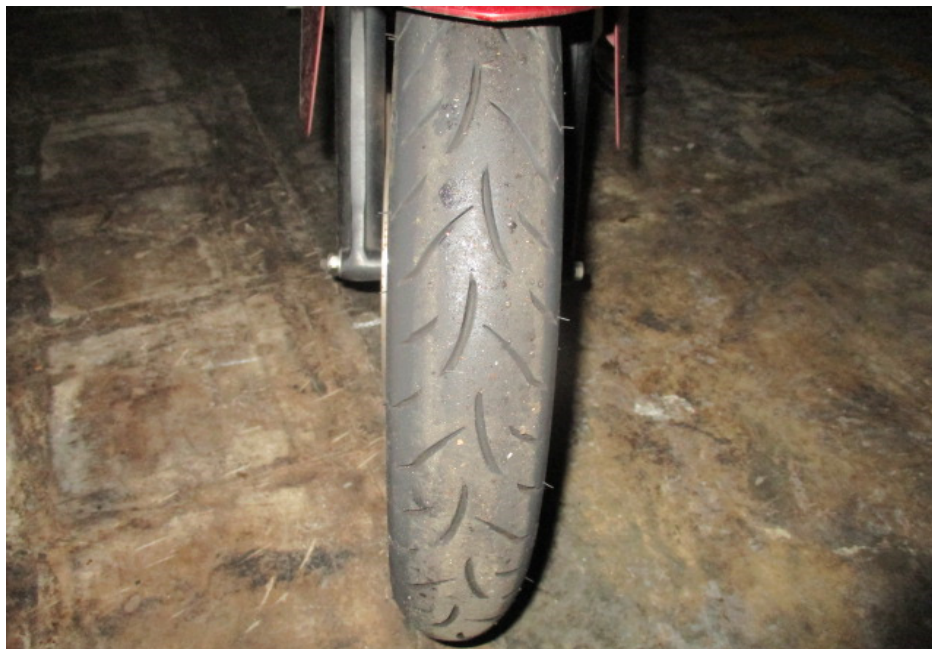
**Photo 13** shows the front tyre of the Motorcycle at the time of our inspection. The front tyre was observed to be in serviceable condition with remaining tread depth of approximately 3mm. The pattern of the tread was also clearly visible. There was no tear, burst mark(s) and/or punctured hole(s) on the sidewalls as well as across the tread of the front tyre.

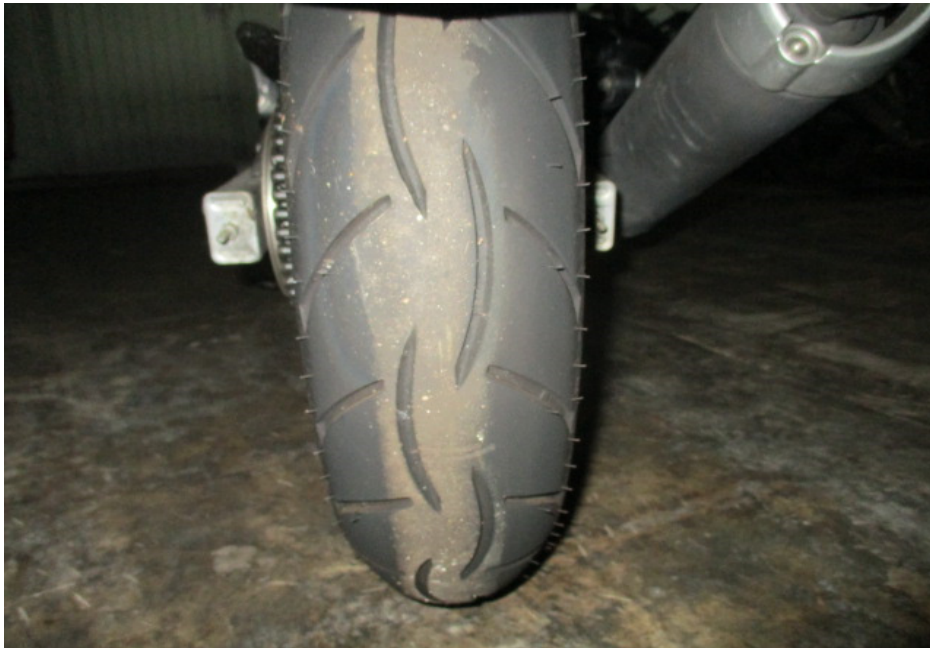
**Photo 14** shows the condition of the Motorcycle's rear tyre. The rear tyre was observed to be in serviceable condition with remaining tread depth of approximately 4mm. The tyre was also observed to be sufficiently inflated for vehicular operation. We did not observe any tear, burst mark(s) and/or punctured hole(s) on the sidewalls as well as across the tread of the rear tyre.

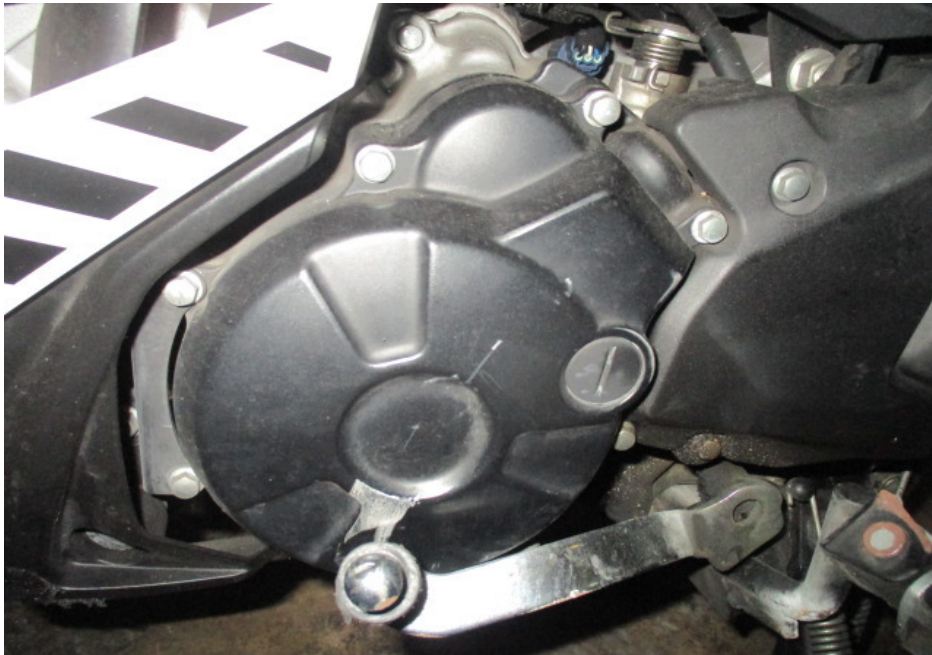
**Photo 15** shows the left side of the engine of the Motorcycle at the time of our inspection. The various engine related parts and components were found to be intact with no visible damage. There was also no sign(s) or indication(s) of fluid leak observed around the left engine area of the Motorcycle.

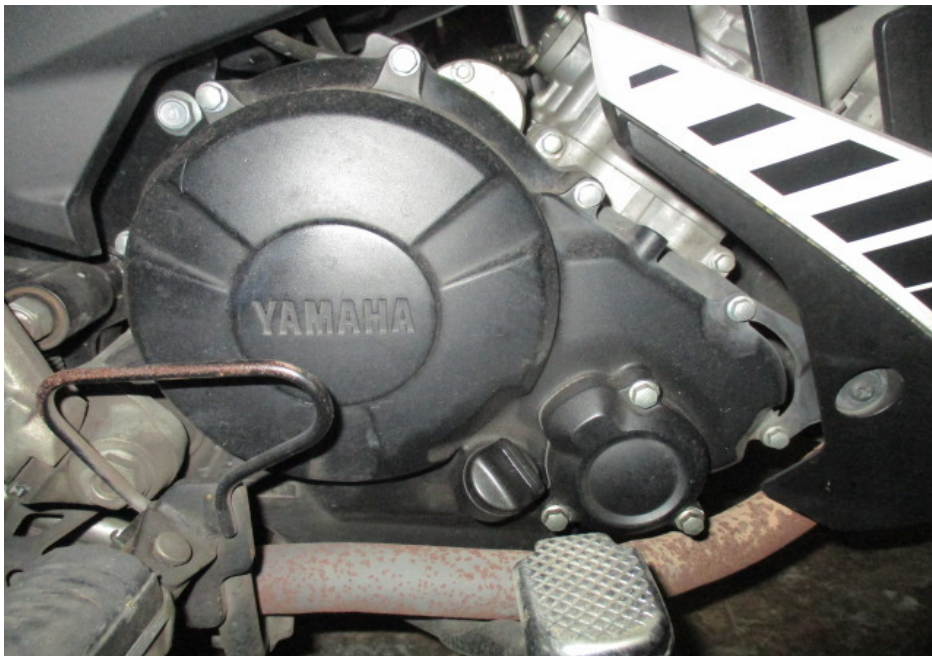
**Photo 16** shows the right side of the engine of the Motorcycle at the time of our inspection. The various engine related parts and components were found to be intact with no visible damage. There was also no sign(s) or indication(s) of fluid leak observed around the right engine area of the Motorcycle.

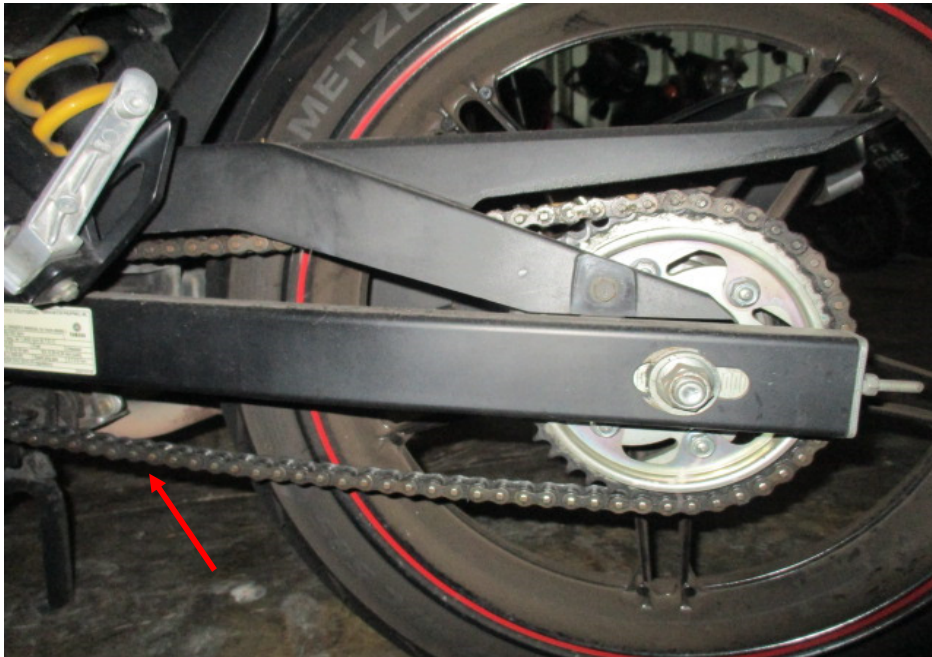
**Photo 17** shows the general view of the gear train (arrowed) of the Motorcycle, which was observed to be intact with no misalignment. It was also adequately lubricated for operating purposes.

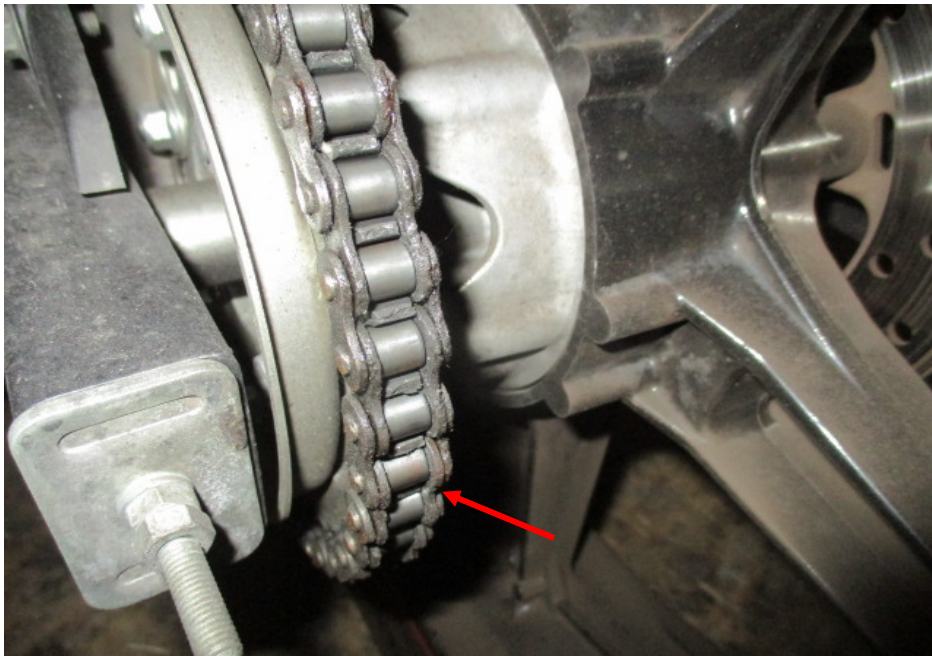
**Photo 18** shows a closer view of the gear train (arrowed) of the Motorcycle, which was observed to be intact with no misalignment. It was also adequately lubricated for operating purposes.

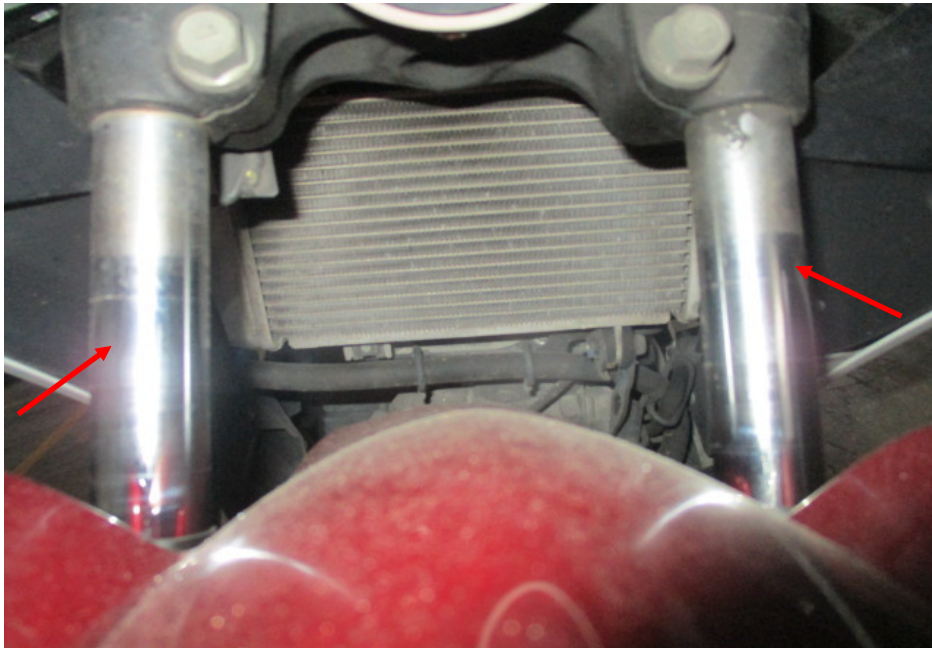
**Photo 19** shows the front fork (arrowed) of the Motorcycle. The front fork and fork bracket of the Motorcycle were both found to be intact and undamaged. Turning the Motorcycle's handle bar towards the left and right did not produce any abnormal free play. The steering system of the Motorcycle was in serviceable condition at the time of our inspection.

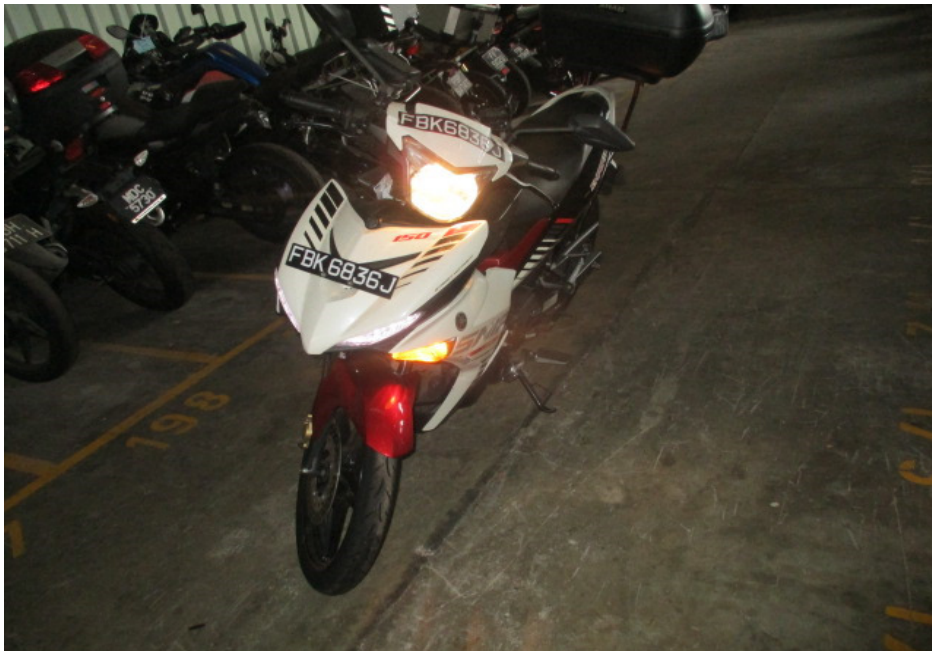
**Photo 20** shows the front wheel of the Motorcycle turned towards its full left. Turning the Motorcycle's handle bar towards the left did not produce any abnormal free play and/or resistance. This would indicate that the steering system of the Motorcycle was in serviceable condition at the time of our inspection.

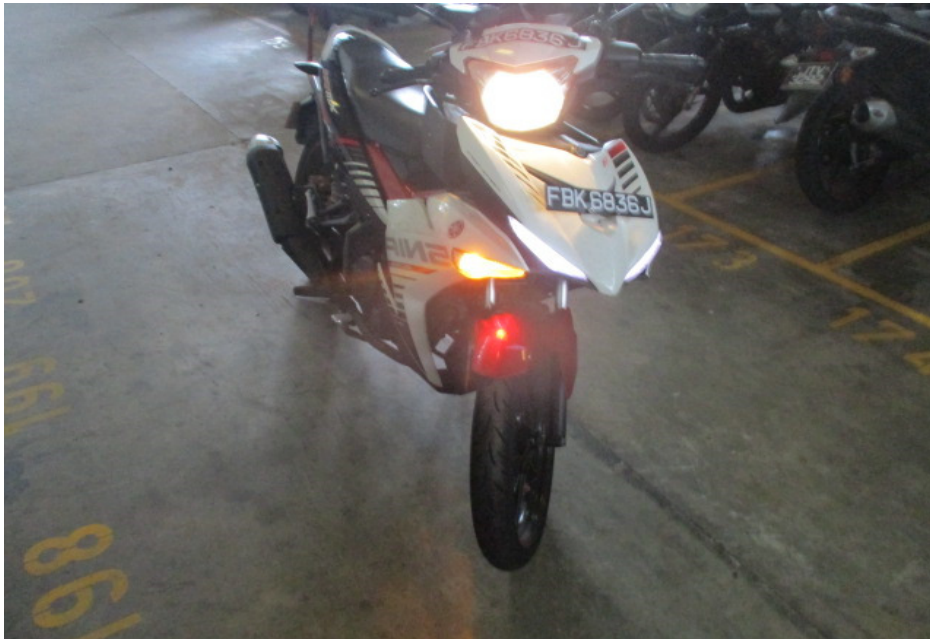
**Photo 21** shows the front wheel of the Motorcycle turned towards its full right. Turning the Motorcycle's handle bar towards the right did not produce any abnormal free play and/or resistance. This would indicate that the steering system of the Motorcycle was in serviceable condition at the time of our inspection.

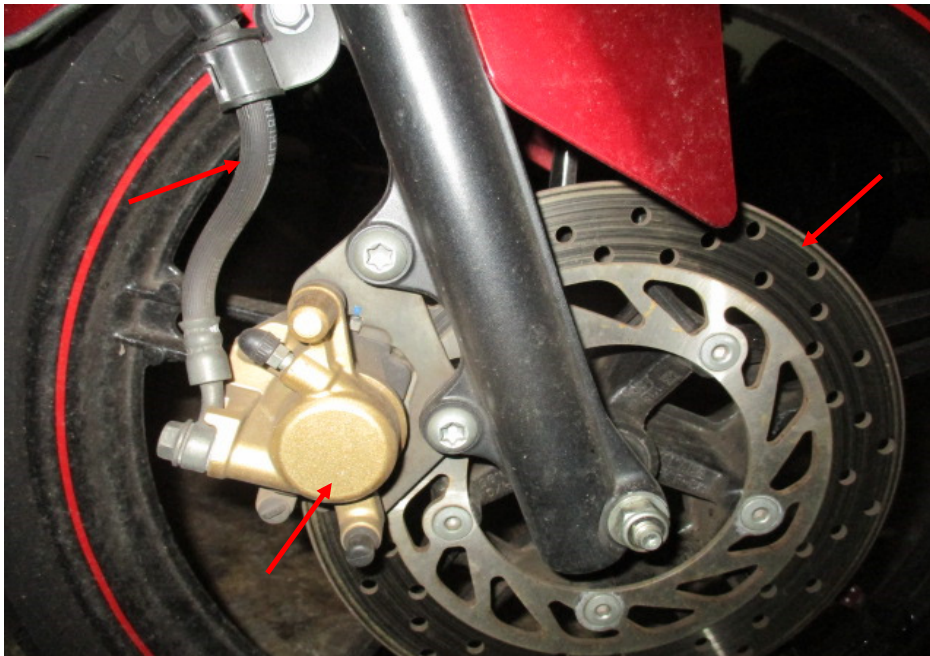
**Photo 22** shows a close up view of the front brake caliper, front brake disc and front brake hose (arrowed) of the Motorcycle, which are all part of the components in the hydraulic front brake system of the Motorcycle. Our visual checks of these various components had revealed all to be intact with no visible damage. No leakage of brake fluid was also observed.

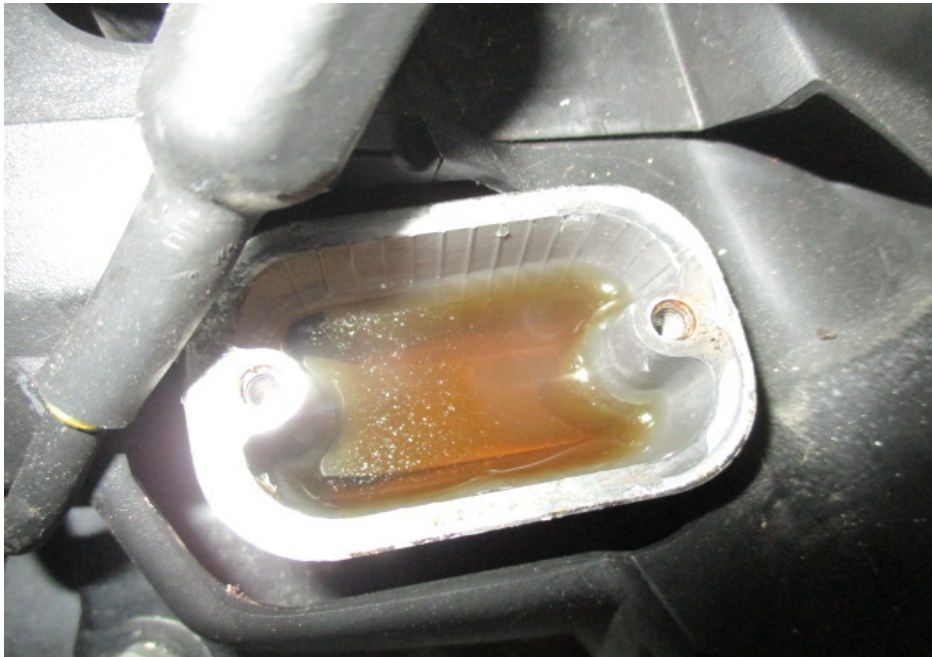
**Photo 23** shows the brake fluid reservoir for the front brake of the Motorcycle. The brake fluid was observed to be of sufficient level and without contamination for operational purposes.

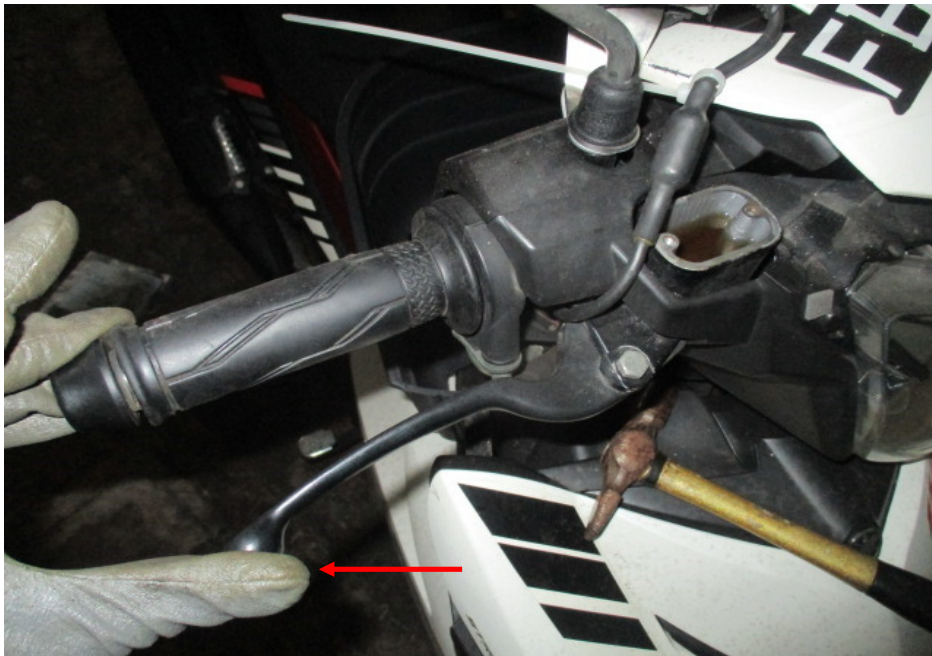
**Photo 24** shows the front brake lever being depressed. There was some resistance felt (spongy like feel) upon pressing the front brake lever (arrowed). This would indicate that there is no leakage of pressure/vacuum in the brake system.

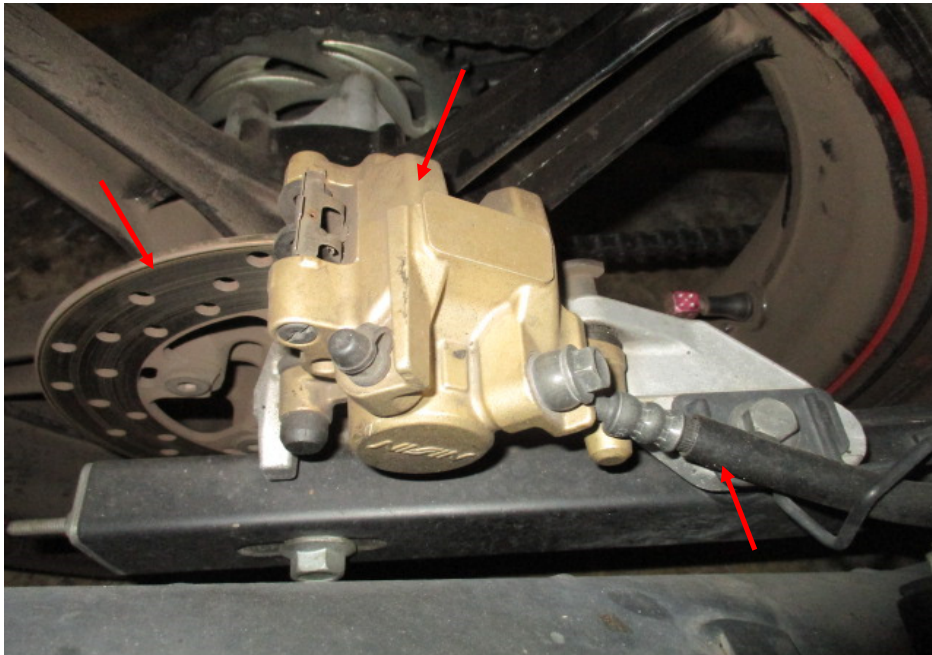
**Photo 25** shows a close up view of the rear brake caliper, rear brake disc and rear brake hose (arrowed) of the Motorcycle, which are all part of the components in the hydraulic rear brake system of the Motorcycle. Our visual checks of these various components had revealed all to be intact with no visible damage. No leakage of brake fluid was also observed.

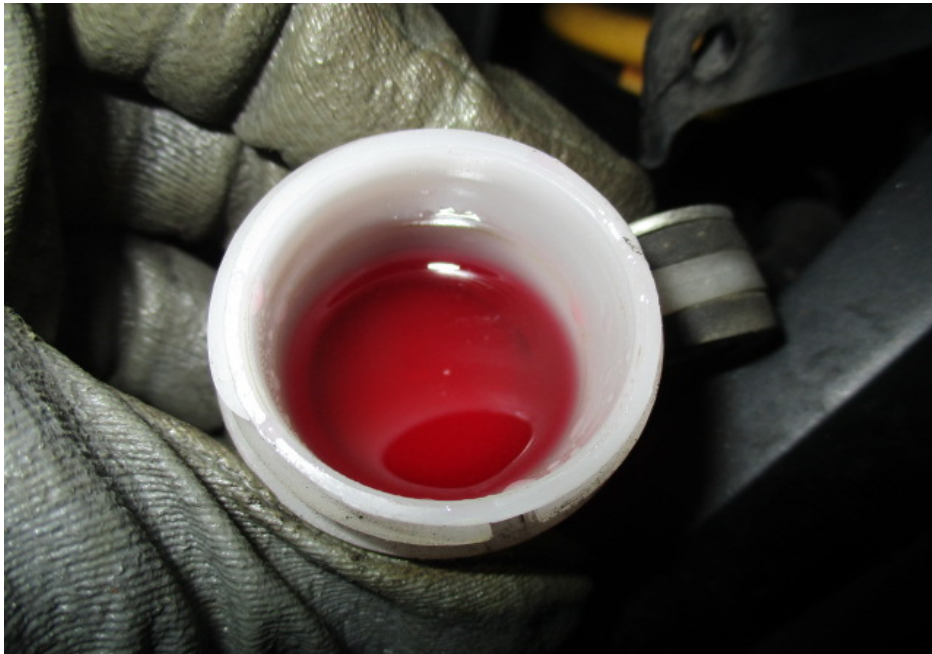
**Photo 26** shows the brake fluid reservoir for the rear brake of the Motorcycle. The brake fluid was observed to be of sufficient level and without contamination for operational purposes.
