27 July 2020

**Fatal Accident Investigation Team**

**INSPECTION REPORT OF MOTORCYCLE FBG 2618U**

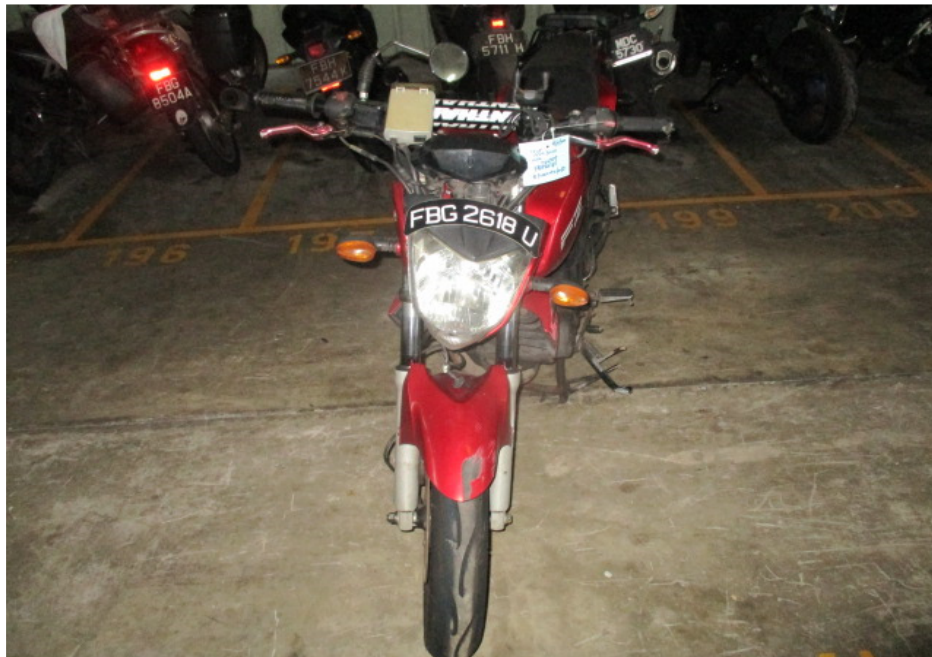
**Photo 2** shows a general view of the frontal portion of the Motorcycle at the time of our inspection. The Motorcycle was observed to have sustained damages all around.

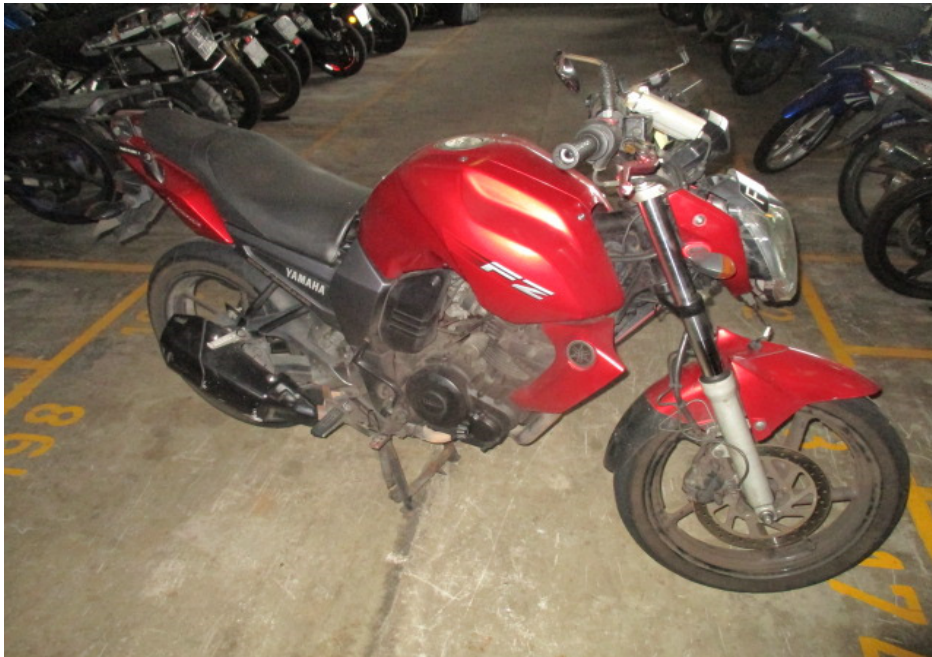
**Photo 2** shows a general view of the right body of the Motorcycle at the time of our inspection. The Motorcycle was observed to have sustained damages all around.

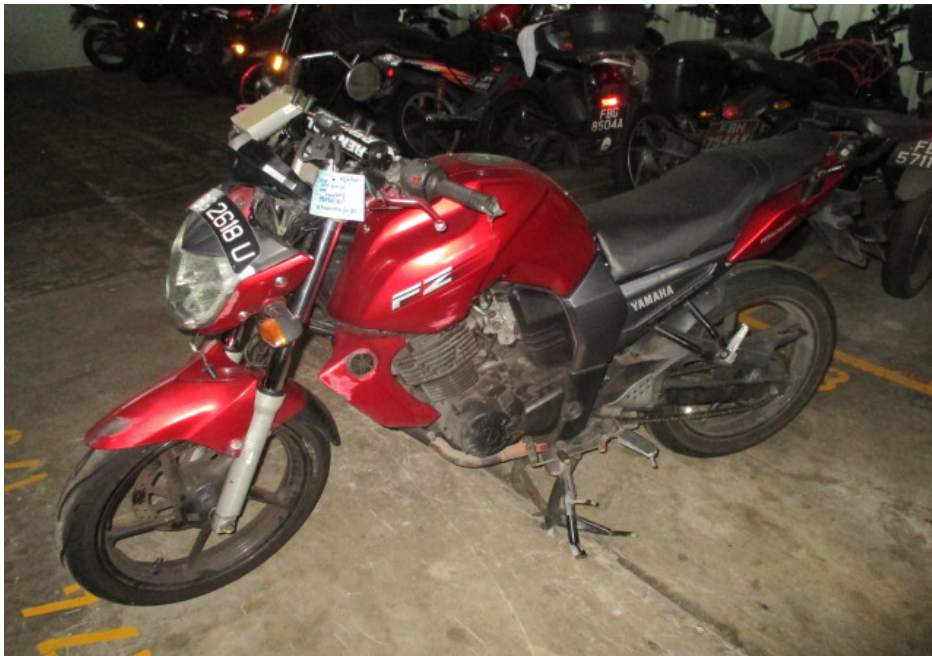
**Photo 3** shows a general view of the left body of the Motorcycle at the time of our inspection. The Motorcycle was observed to have sustained damages all around. The body parts that were found to have been damaged include its front cowlings, headlight assembly, front mudguard, left side mirror, handlebar ends, front brake lever, clutch lever, gear shift pedal, left front footrest, left pillion foot peg, left radiator cover, petrol tank cover and top box rack, amongst others.

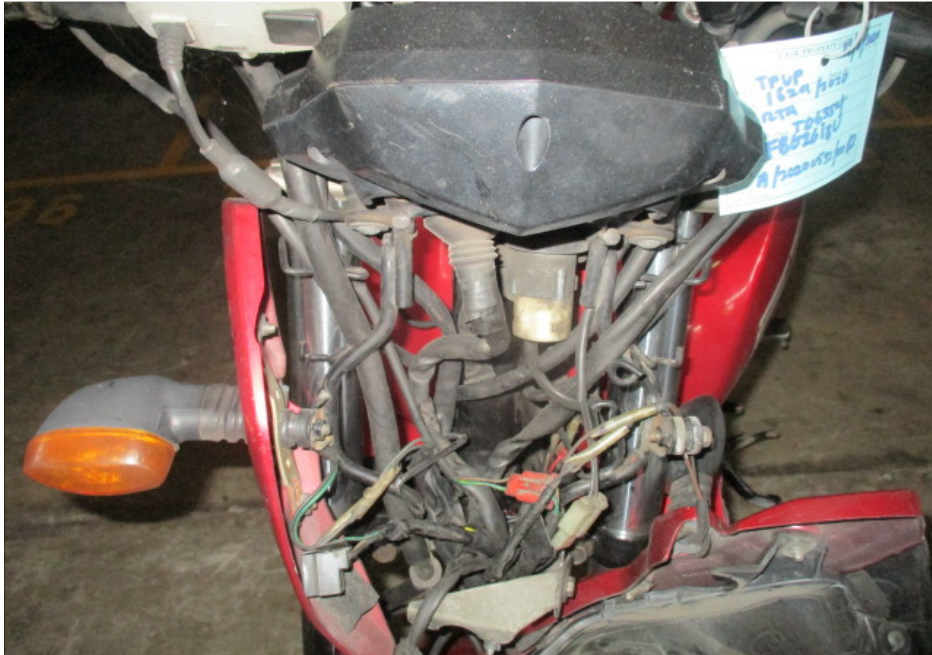
**Photo 4** shows a close up view of the headlight assembly which was amongst the body parts at the front of the Motorcycle that had sustained damage as a result of the accident.

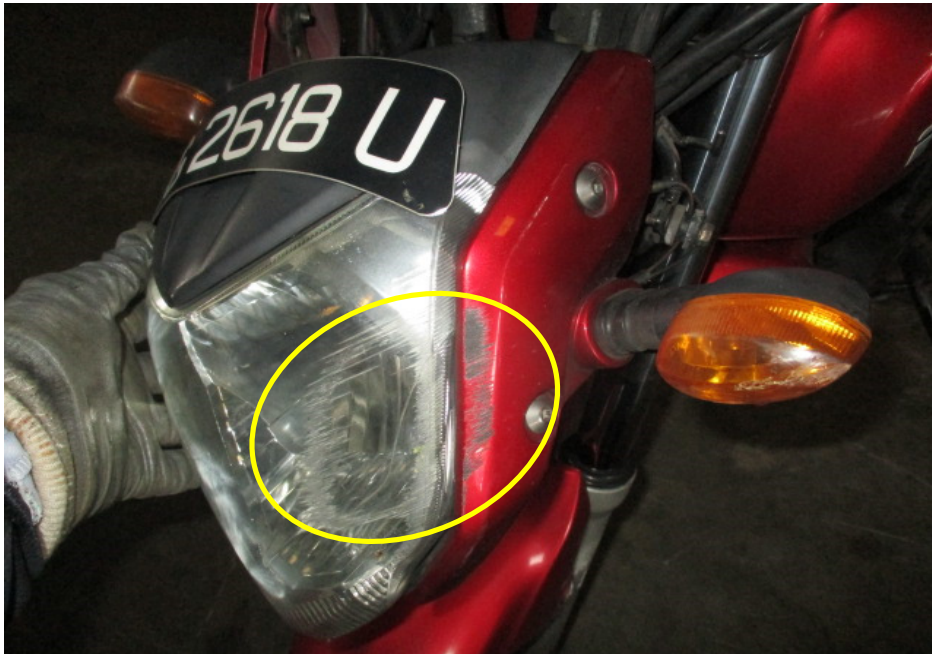
**Photo 5** shows a closer view of the headlight and front cowling (circled) which was amongst the body parts of the Motorcycle that had sustained damage as a result of the accident.

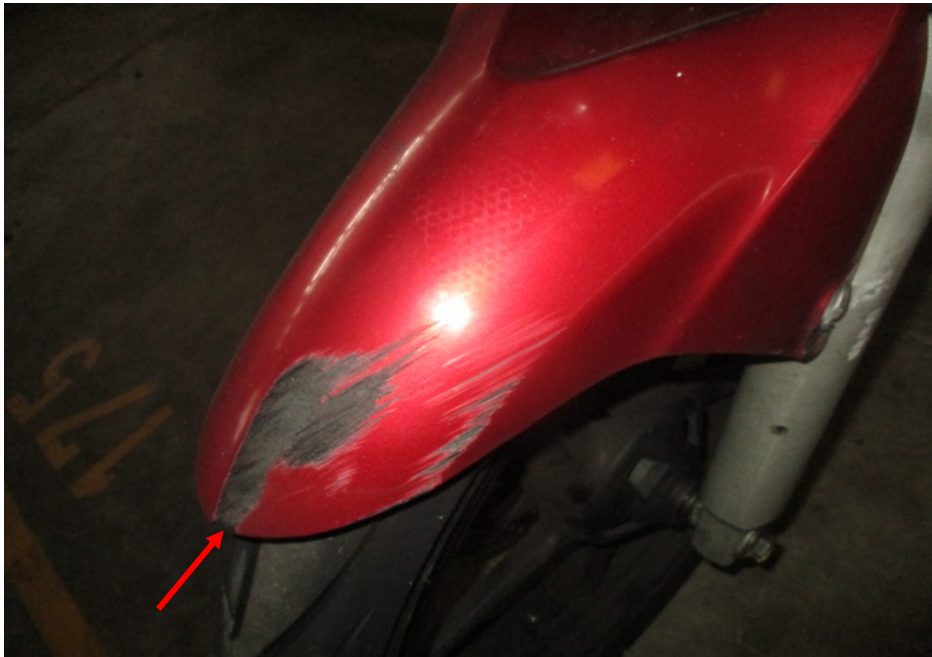
**Photo 6** shows a closer view of the front mudguard (arrowed) which was amongst the body parts of the Motorcycle that had sustained damage as a result of the accident.

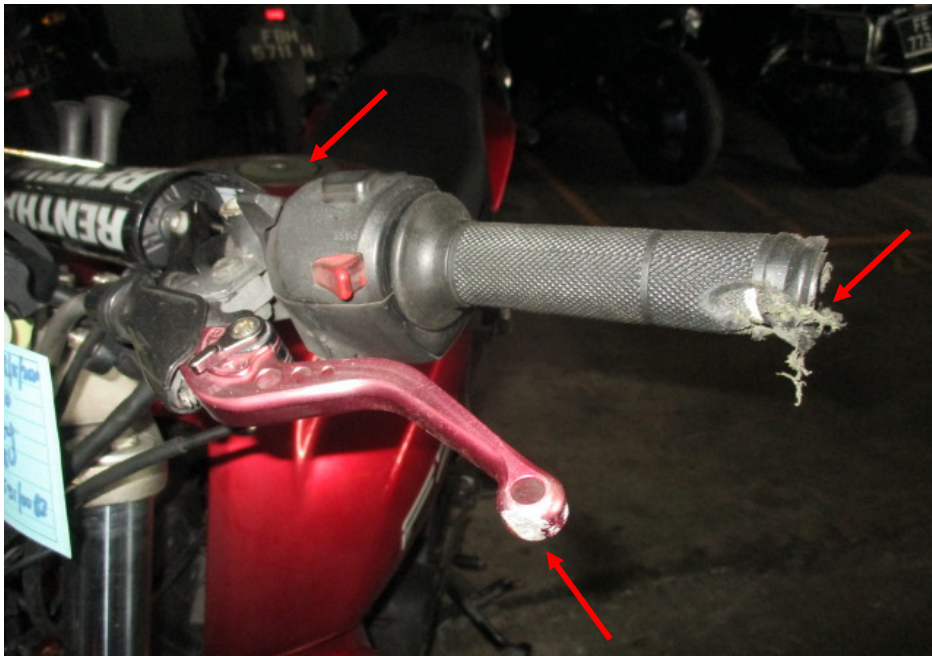
**Photo 7** shows the left handlebar end, left side mirror and clutch lever (arrowed), which were amongst the body parts of the Motorcycle that had sustained damage as a result of the accident.

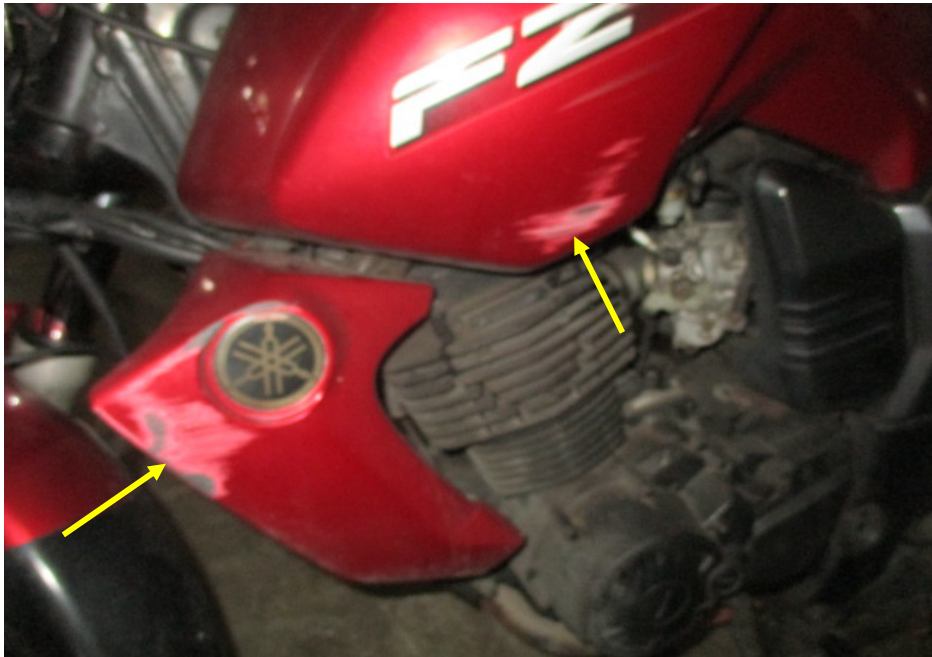
**Photo 8** shows the left radiator cover and petrol tank cover (arrowed), which were amongst the body parts of the Motorcycle that had sustained damage as a result of the accident.

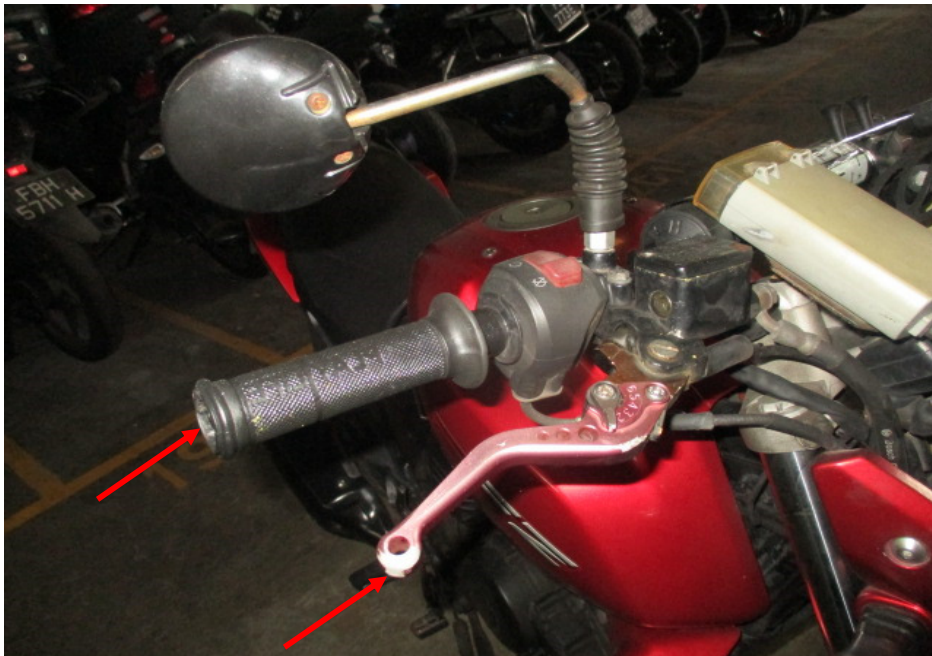
**Photo 9** shows the right handlebar end and front brake lever (arrowed), which were amongst the body parts of the Motorcycle that had sustained damage as a result of the accident.

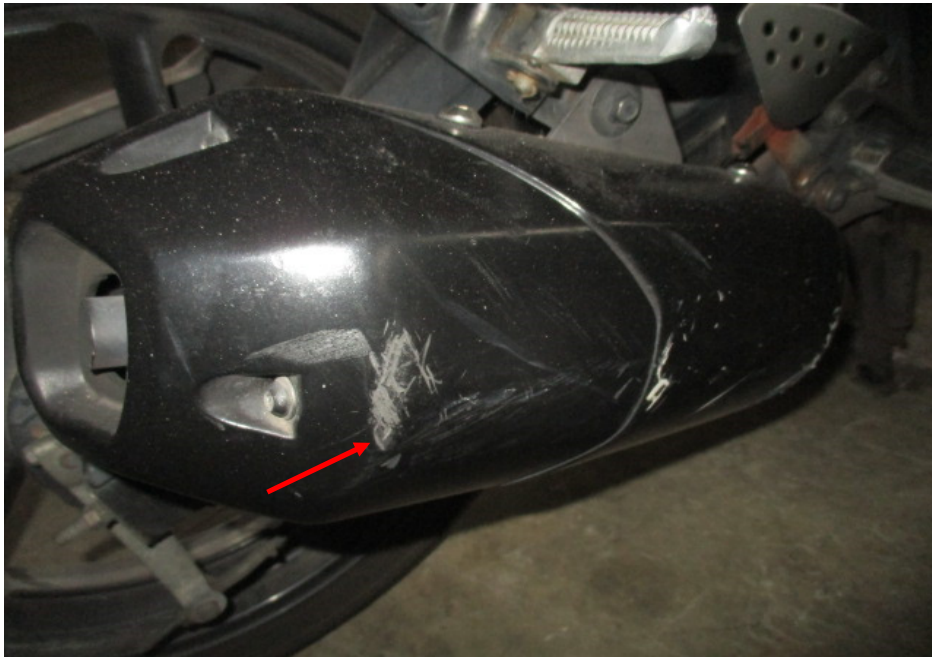
**Photo 10** shows a closer view of the exhaust muffler which was amongst the body parts of the Motorcycle that had sustained damages of grazing nature as a result of the accident (arrowed).

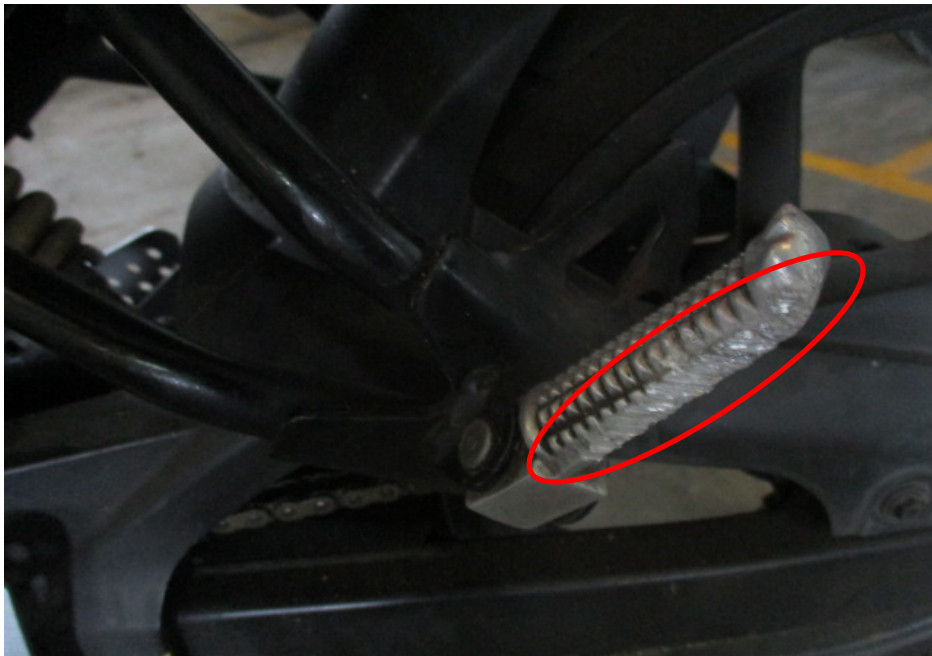
**Photo 11** shows a closer view of the left pillion foot peg which was amongst the body parts of the Motorcycle that had sustained damages of grazing nature as a result of the accident (circled).

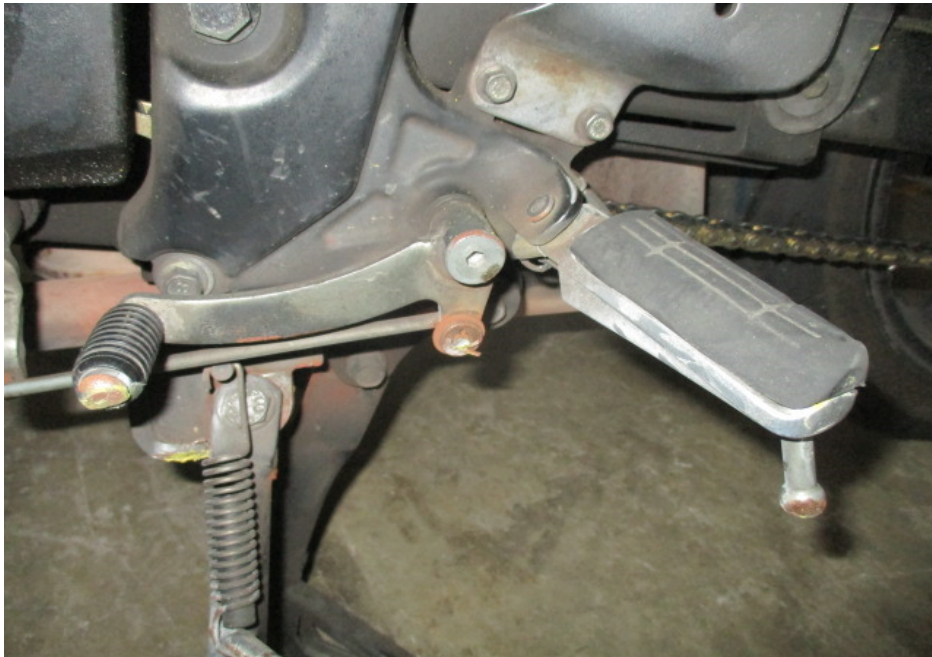
**Photo 12** shows the bent gear shift pedal and left front footrest of the Motorcycle as a result of the accident.

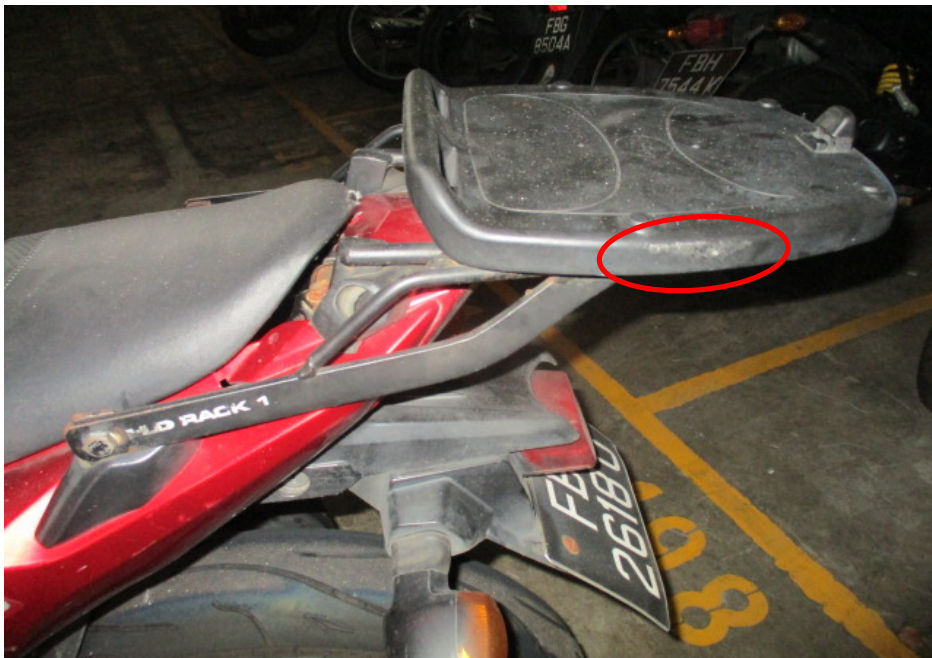
**Photo 13** shows the top box rack of the Motorcycle that had sustained damage as a result of the accident (circled).

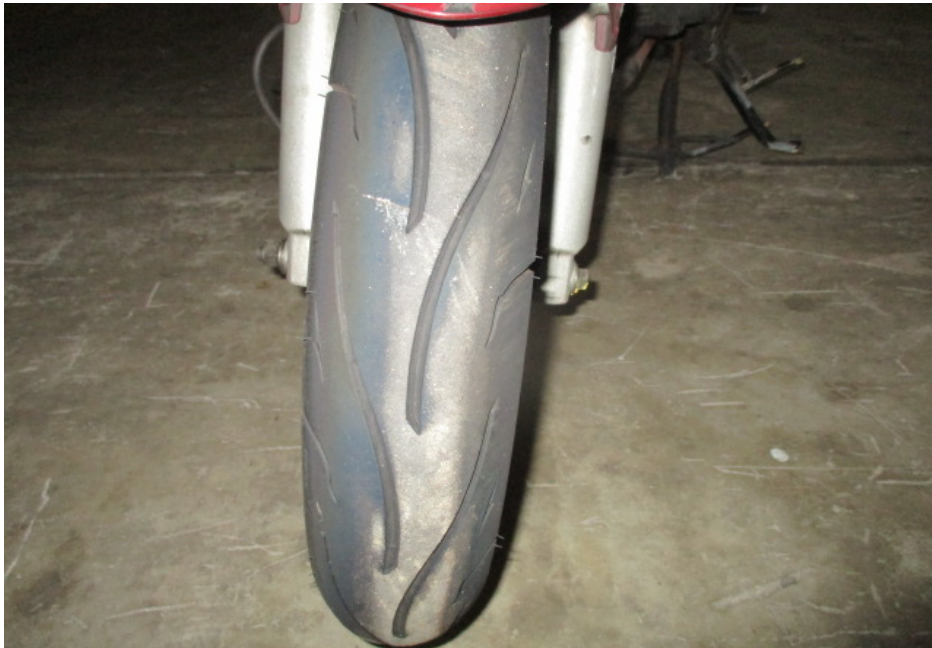
**Photo 14** shows the front tyre of the Motorcycle at the time of our inspection. The front tyre was observed to be in serviceable condition with remaining tread depth of approximately 4mm. The pattern of the tread was also clearly visible. There was no tear, burst mark(s) and/or punctured hole(s) on the sidewalls as well as across the tread of the front tyre.

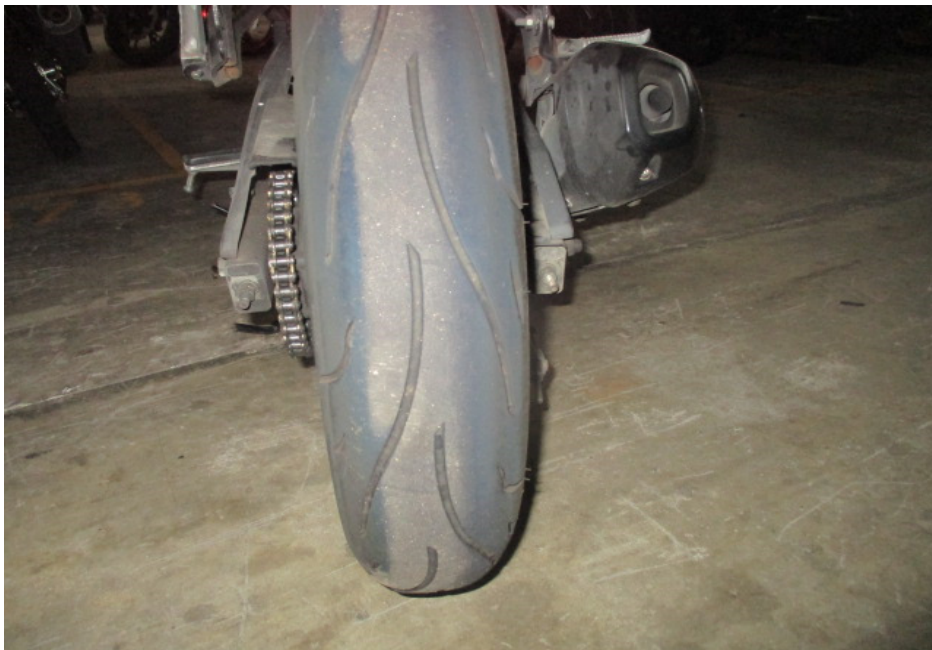
**Photo 15** shows the condition of the Motorcycle's rear tyre. The rear tyre was observed to be in serviceable condition with remaining tread depth of approximately 3mm. The tyre was also observed to be sufficiently inflated for vehicular operation. We did not observe any tear, burst mark(s) and/or punctured hole(s) on the sidewalls as well as across the tread of the rear tyre.

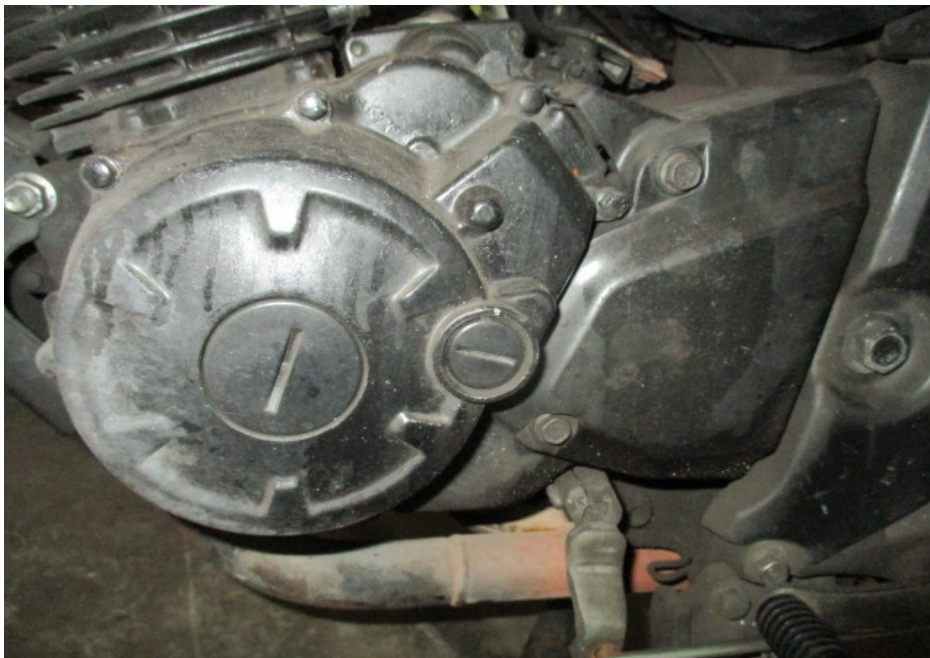
**Photo 16** shows the left side of the engine of the Motorcycle at the time of our inspection. The various engine related parts and components were found to be intact with no visible damage. There was also no sign(s) or indication(s) of fluid leak observed around the left engine area of the Motorcycle.

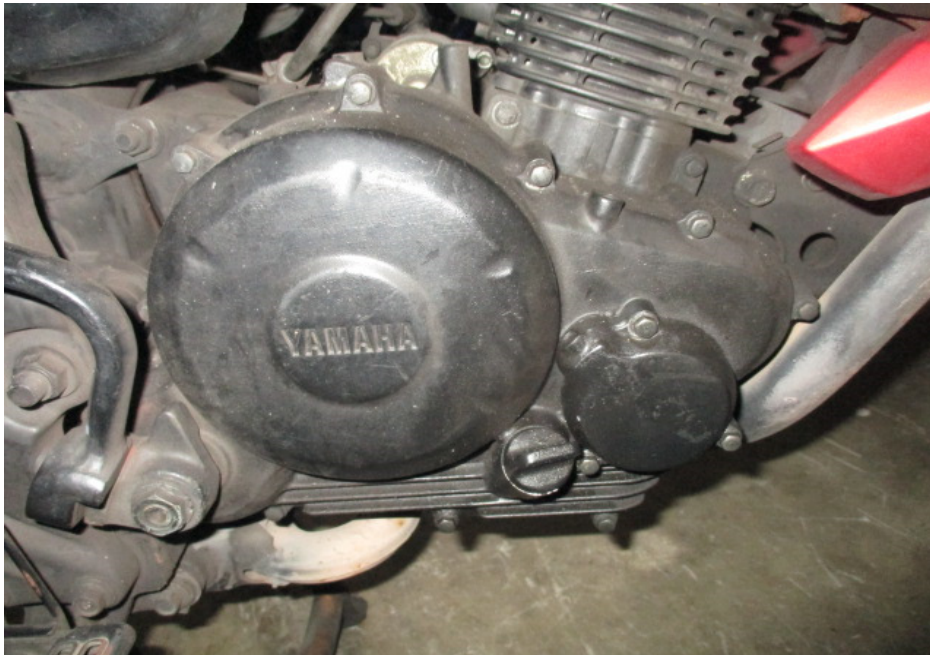
**Photo 17** shows the right side of the engine of the Motorcycle at the time of our inspection. The various engine related parts and components were found to be intact with no visible damage. There was also no sign(s) or indication(s) of fluid leak observed around the right engine area of the Motorcycle.

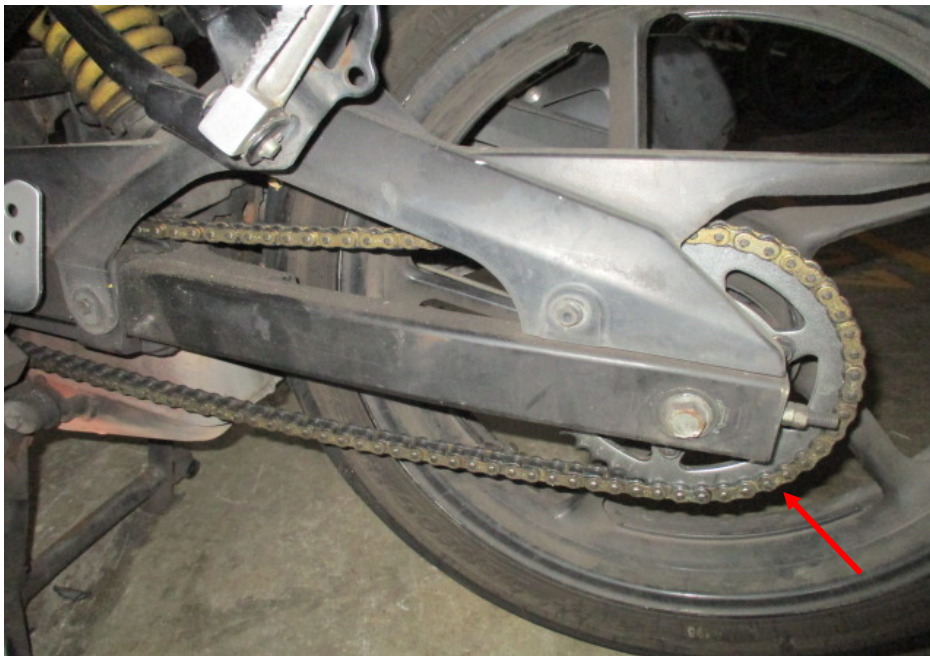
**Photo 18** shows the general view of the gear train (arrowed) of the Motorcycle, which was observed to be intact with no misalignment. It was also adequately lubricated for operating purposes.

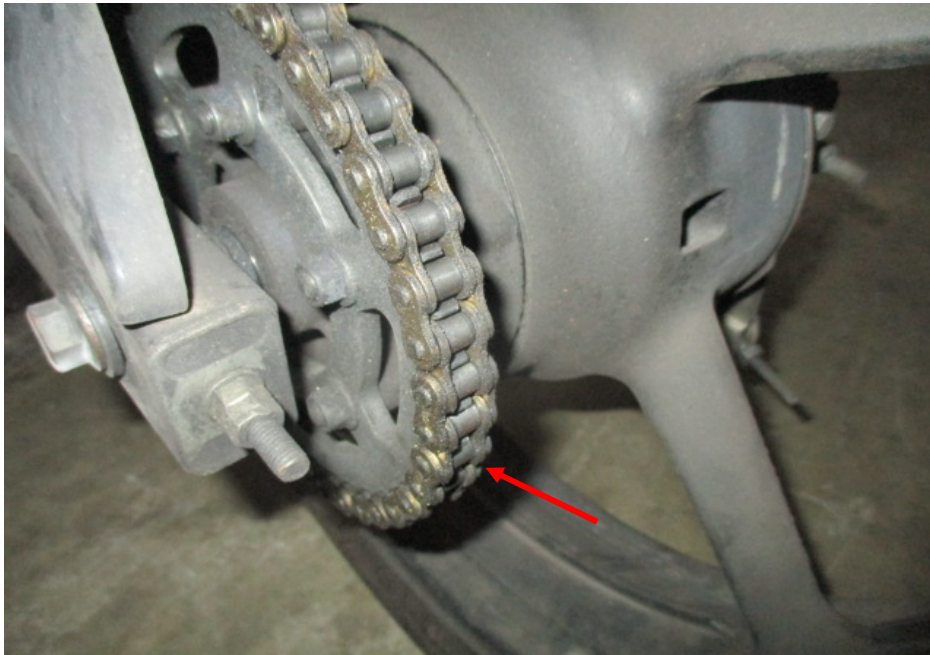
**Photo 19** shows a closer view of the gear train (arrowed) of the Motorcycle, which was observed to be intact with no misalignment. It was also adequately lubricated for operating purposes.

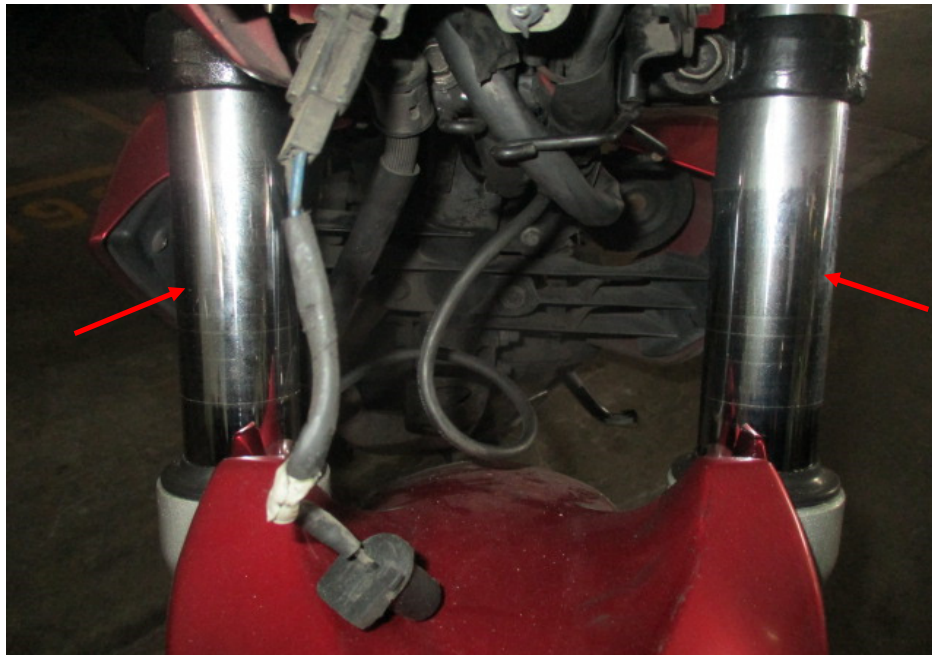
**Photo 20** shows the front fork (arrowed) of the Motorcycle. The front fork and fork bracket of the Motorcycle were both found to be intact and undamaged. Turning the Motorcycle's handle bar towards the left and right did not produce any abnormal free play. The steering system of the Motorcycle was in serviceable condition at the time of our inspection.

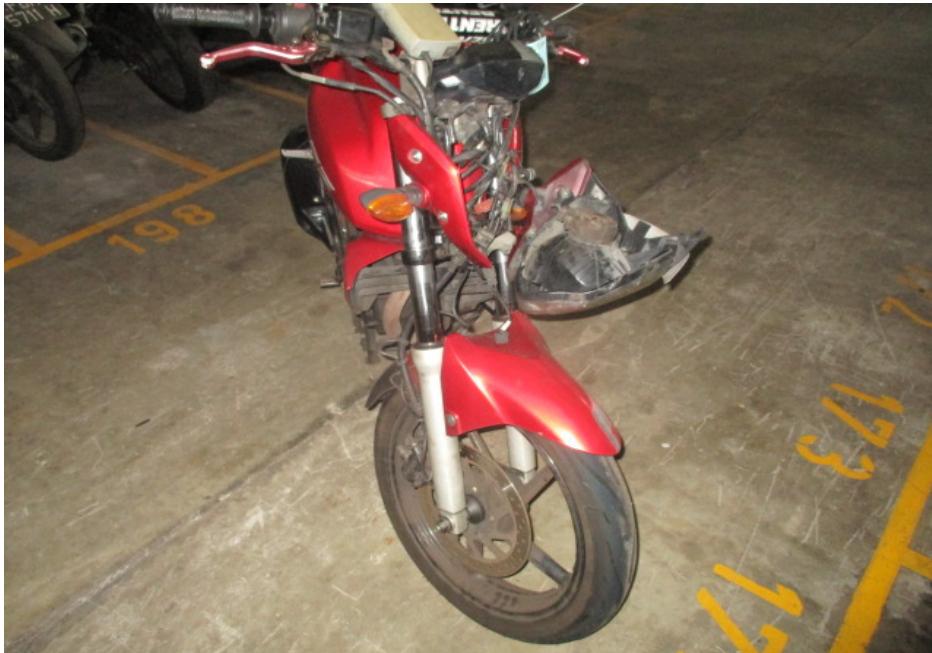
**Photo 21** shows the front wheel of the Motorcycle turned towards its full left. Turning the Motorcycle's handle bar towards the left did not produce any abnormal free play and/or resistance. This would indicate that the steering system of the Motorcycle was in serviceable condition at the time of our inspection.

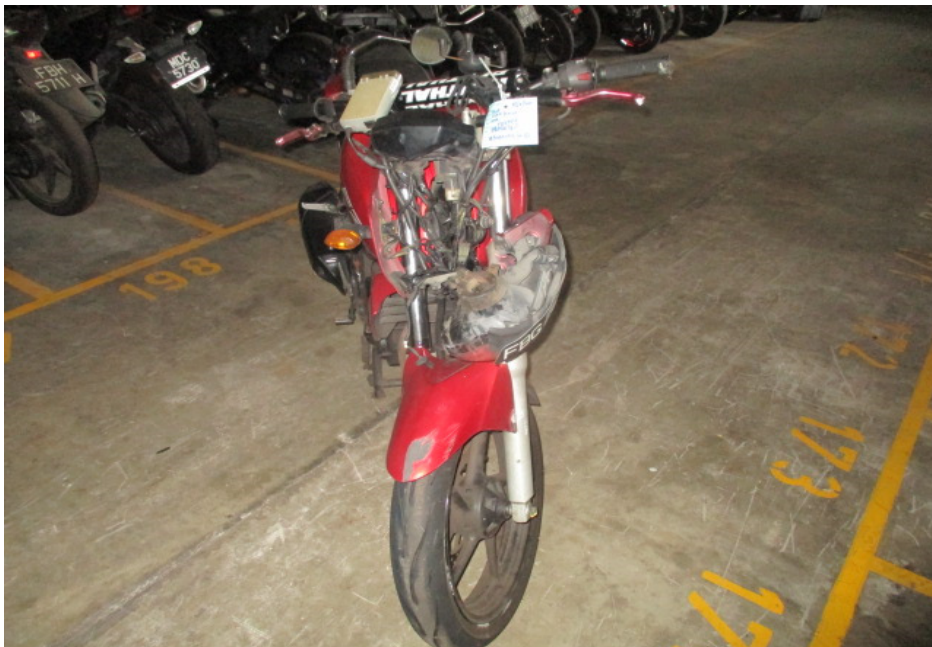
**Photo 22** shows the front wheel of the Motorcycle turned towards its full right. Turning the Motorcycle's handle bar towards the right did not produce any abnormal free play and/or resistance. This would indicate that the steering system of the Motorcycle was in serviceable condition at the time of our inspection.

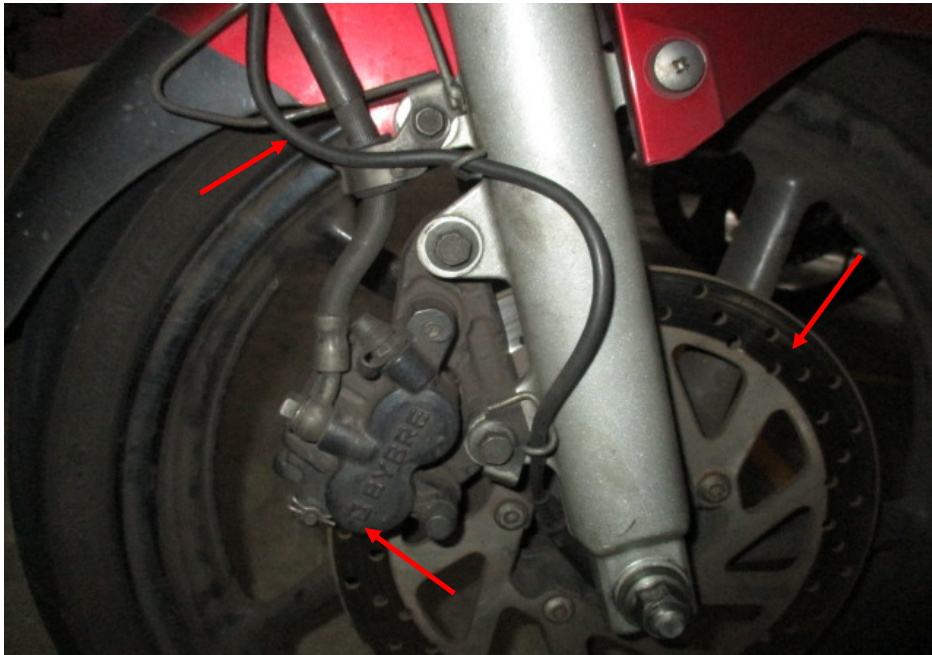
**Photo 23** shows a close up view of the front brake caliper, front brake disc and front brake hose (arrowed) of the Motorcycle, which are all part of the components in the hydraulic front brake system of the Motorcycle. Our visual checks of these various components had revealed all to be intact with no visible damage. No leakage of brake fluid was also observed.

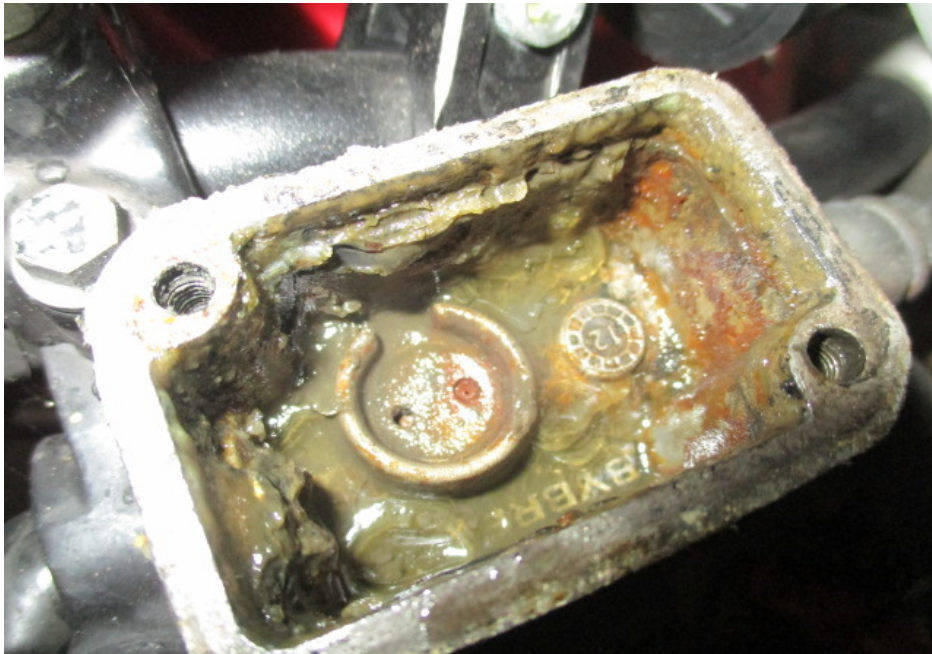
12. The brake system of the Motorcycle was of a semi-hydraulic type, where hydraulic (brake fluid) pressure controls the brake for the front wheel while the brake for the rear wheel is controlled by mechanical means (cables and springs). Our visual examination of the various components in the brake system, like the brake disc, brake caliper, drum, brake lever and brake foot pedal, revealed all to be intact and without damage. There was also no leakage of brake fluid observed along the front brake hose. This was from the respective front brake fluid reservoir to the front brake caliper of the Motorcycle. However the brake fluid reservoir for the front brake was found to be empty and contaminated. There was no visible tear or cut observed on the connecting hoses and cables.

**Photo 24** shows the brake fluid reservoir for the front brake of the Motorcycle. The brake fluid reservoir was found to be empty and contaminated.

15. Basing on our physical inspection of the Motorcycle, it appears that the steering system and rear braking system of the Motorcycle were all in serviceable condition. The front braking system of the Motorcycle was found not to be in serviceable condition.
16. The 2 tyres of the Motorcycle were found to be in serviceable condition. There was no tear, cut or burst mark(s) on the outer and the inner sidewalls as well as across the tread of the 2 tyres. The 2 tyres were sufficiently inflated for vehicular operation with remaining tread depth of approximately 4mm and 3mm each.

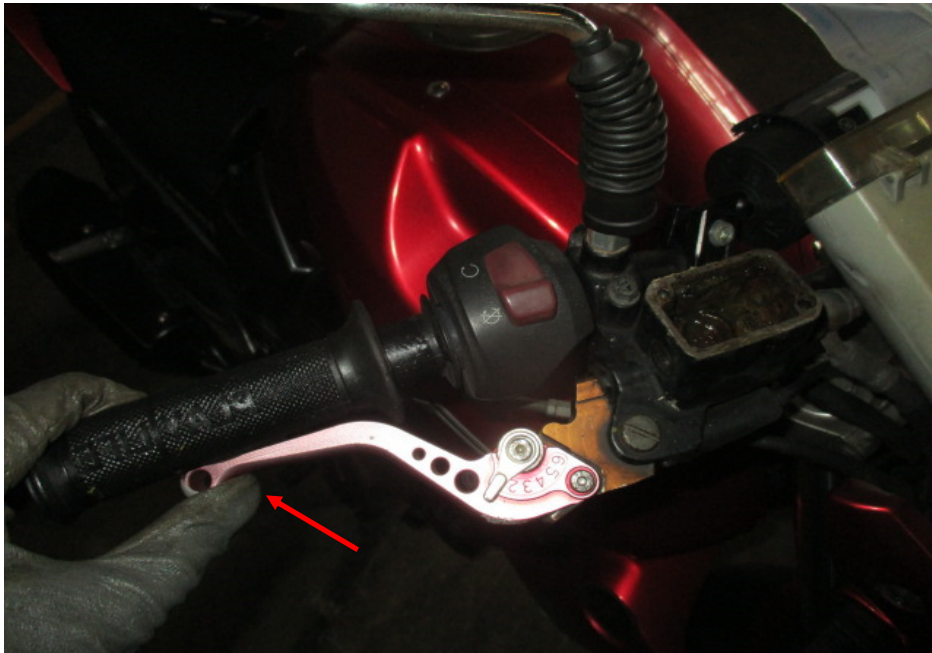
13. Static brake tests conducted on the Motorcycle had appeared to indicate that the front brake system of the Motorcycle was not in serviceable condition. There was no resistance felt (spongy like feel) upon pressing the front brake lever. This would indicate that there may be a leakage of pressure/vacuum in the front brake system.

14. We subsequently carried out an operational test of the Motorcycle's braking system. This was done by manually pushing the Motorcycle forward and backward, simulating the Motorcycle in motion, and thereafter engaging the front brake and rear brake of the Motorcycle. At the end of the short operational test, we did not observe any abnormal behaviour of the Motorcycle's rear braking system. The rear wheel of the Motorcycle was able to stop rotating immediately upon stepping on the brake pedal. However the front wheel of the Motorcycle was unable to stop rotating immediately upon depressing the brake lever. See photos 20 – 26 below.

**Photo 25** shows the front brake lever being depressed. There was no resistance felt (spongy like feel) upon pressing the front brake lever (arrowed). This would indicate that there may be a leakage of pressure/vacuum in the brake system.

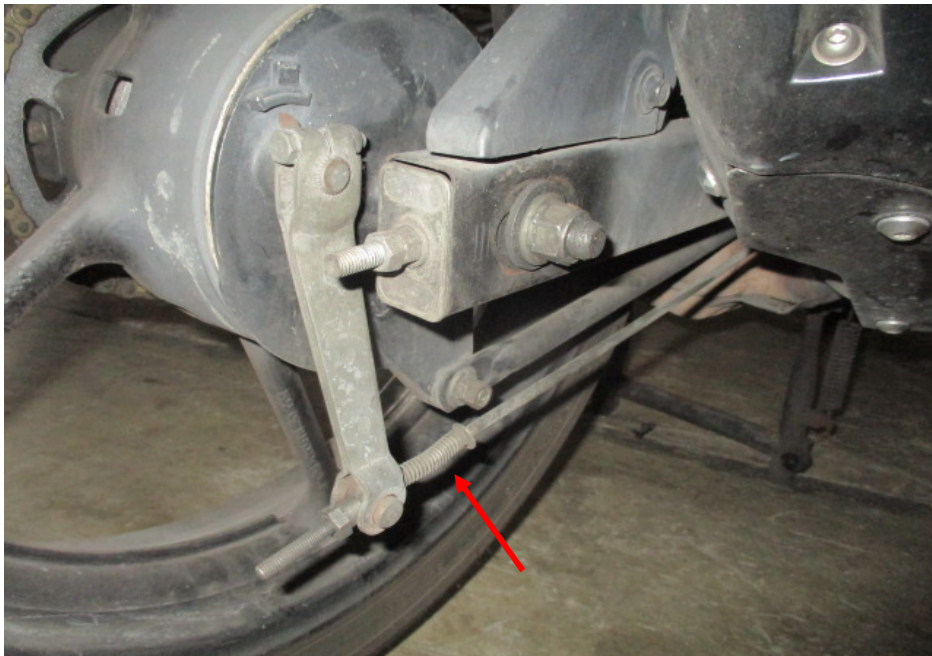
**Photo 26** shows the rear wheel of the Motorcycle. The type of brake system for the rear wheel was of a mechanical type, controlled by the brake foot pedal of the Motorcycle. Our checks of the cable (arrowed), spring and drum which are all part of the components in the rear brake system of the Motorcycle reveal all to be intact and without damage.
