# LKK Auto Consultants Pte Ltd

### ADJUSTMENT ON REPAIR COST FOR VEHICLE NO. SHF 557J

PHOTOGRAPHS FOR VEHICLE NO. SHF 557J

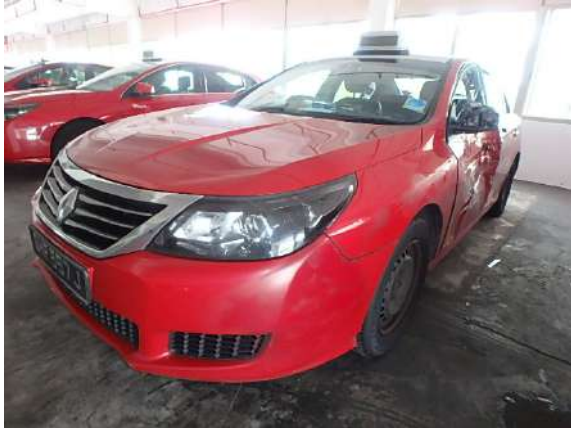
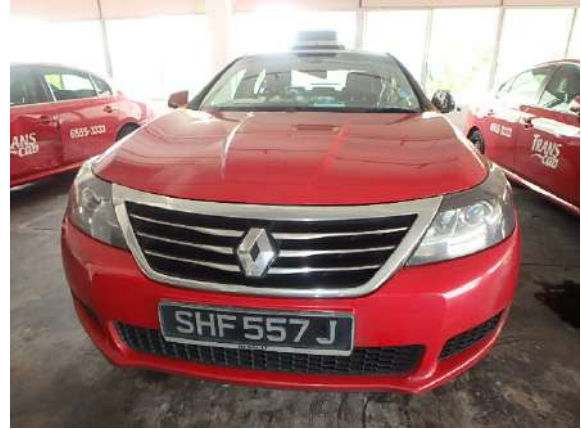
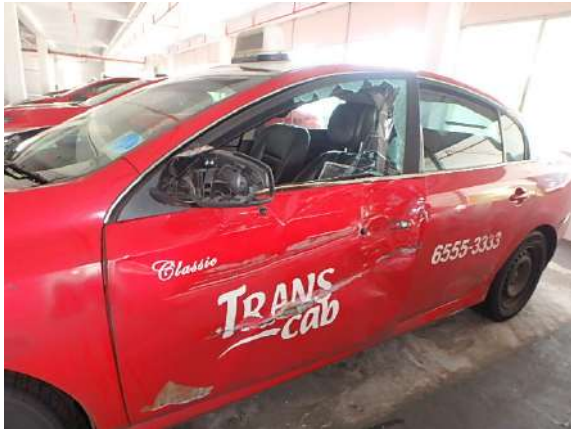
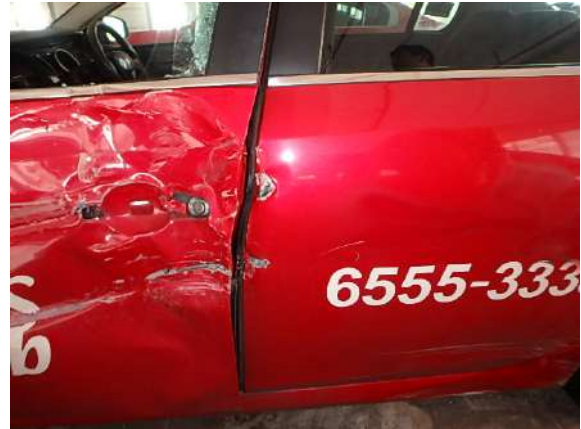
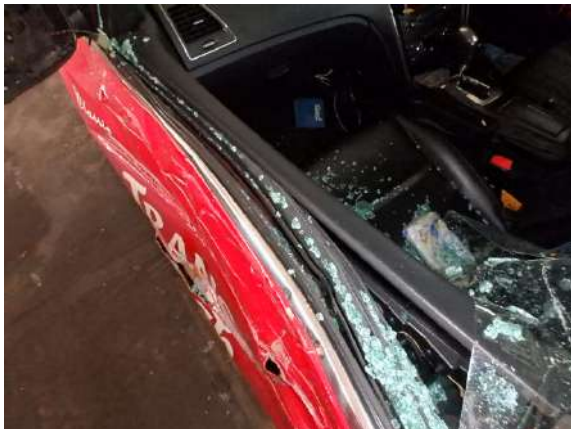
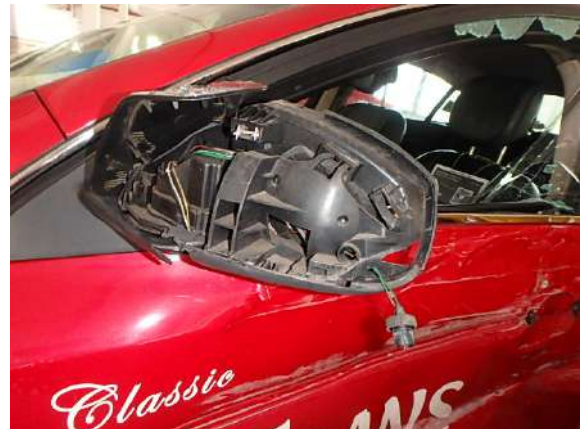
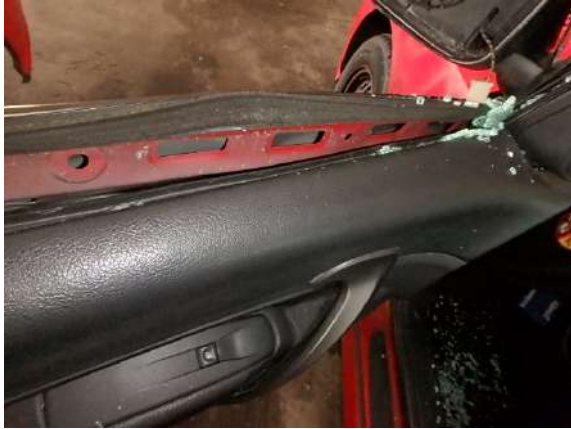
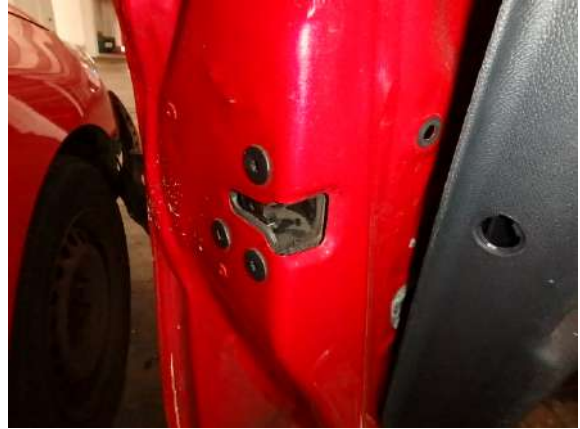
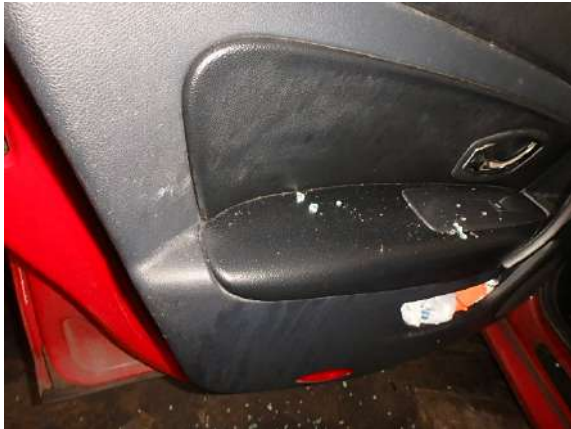
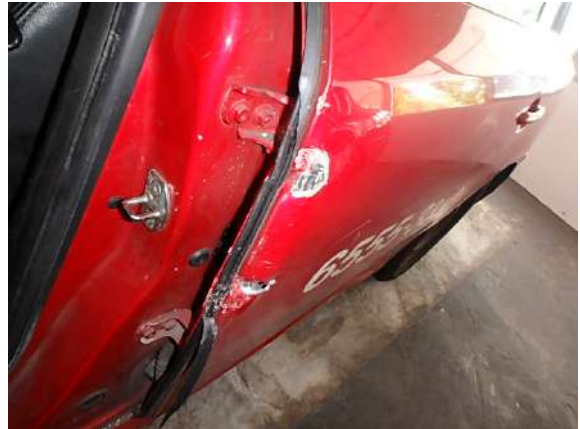
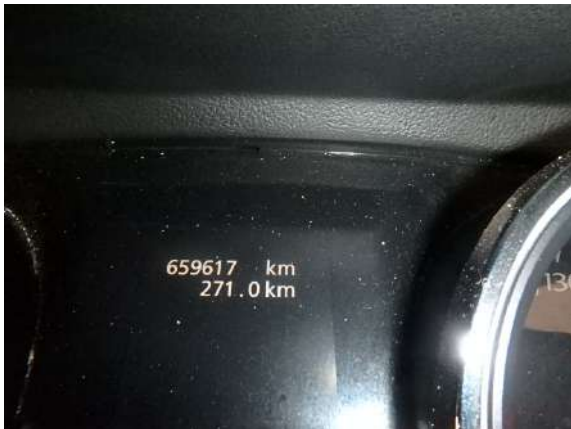
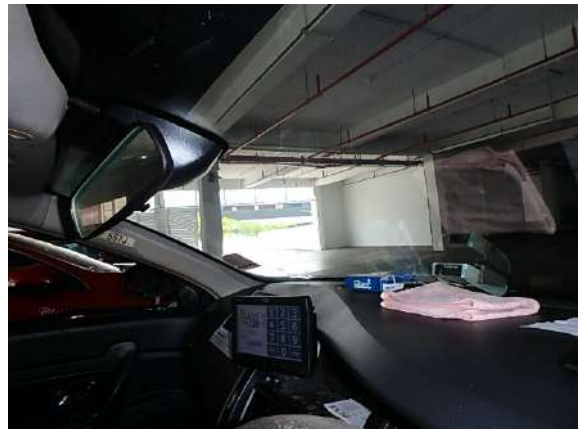
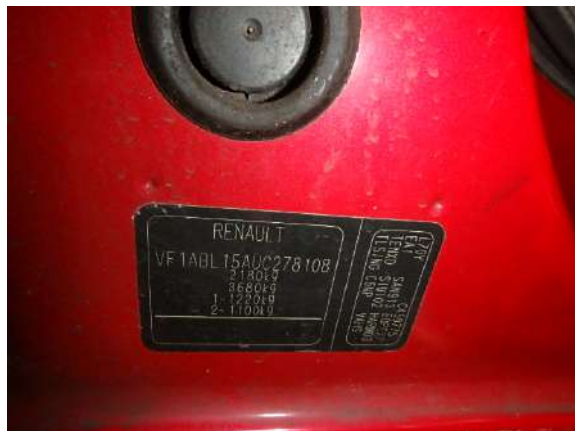
| Affiliated to Federation Internationale Des Experts En Automobile | | | | |
|---|---|---|---|---|
| | THE VEHICLE SUSTAINED DAMAGES AT THE N/S BODY.<br>DAMAGES SEE DETAILS. | | | |

| <b>RECOMMENDED COST OF LUMP SUM REPAIRS (TO ITS PRE-ACCIDENT CONDITION)</b> | | | <b>8,100.00</b> |
