LKK Auto Consultants Pte Ltd

Vehicle No. SGW 2770T
Insured Veh. SH 9490S
Claim No. D20003060MFSH/1
Policy No. D-20094922MFSH
Accident Date 31/07/2020
Inspection Date 04/08/2020

ADJUSTMENT ON REPAIR COST FOR VEHICLE NO. SGW 2770T

PHOTOGRAPHS FOR VEHICLE NO. SGW 2770T

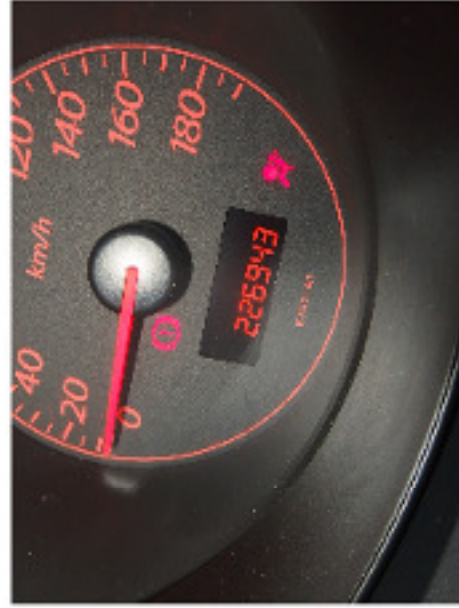
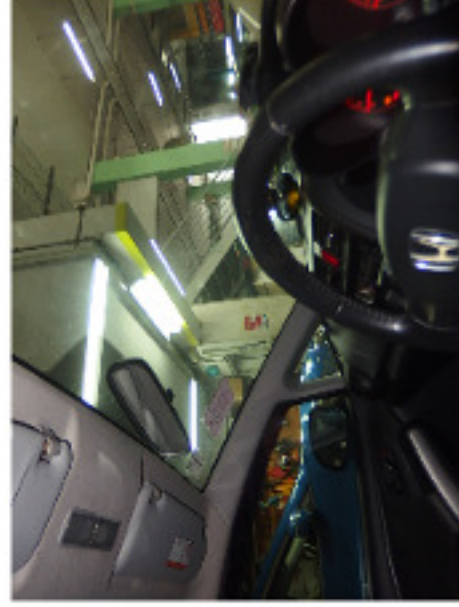
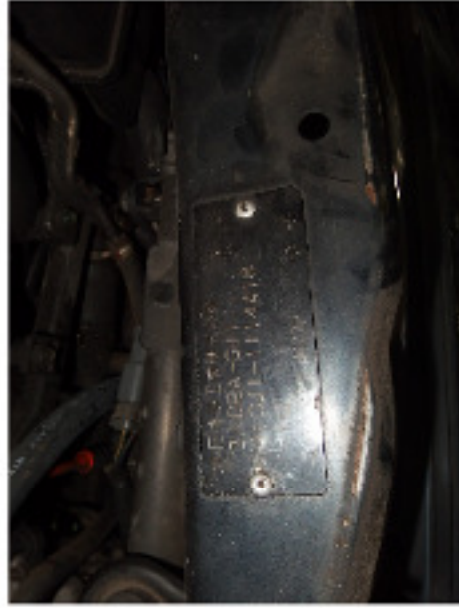
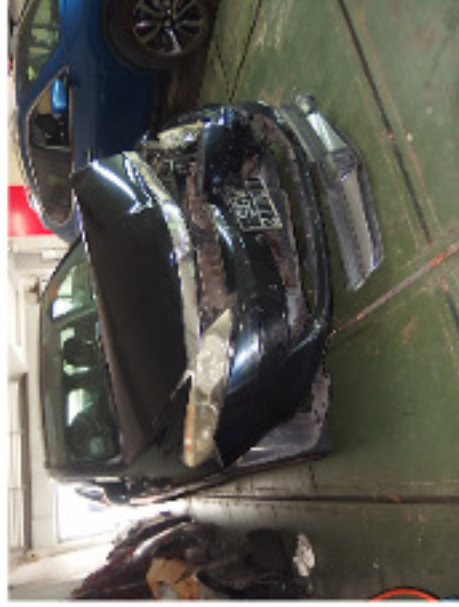
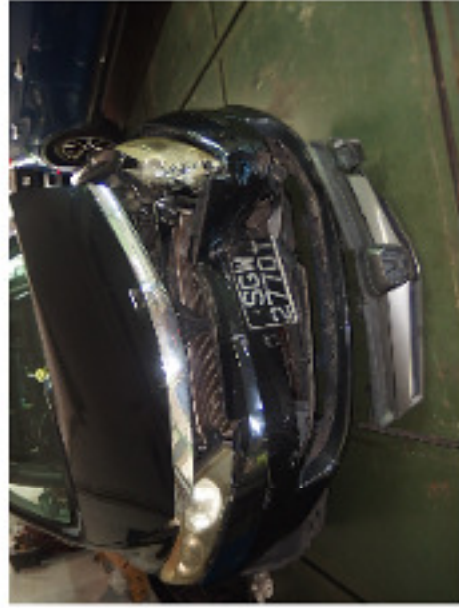
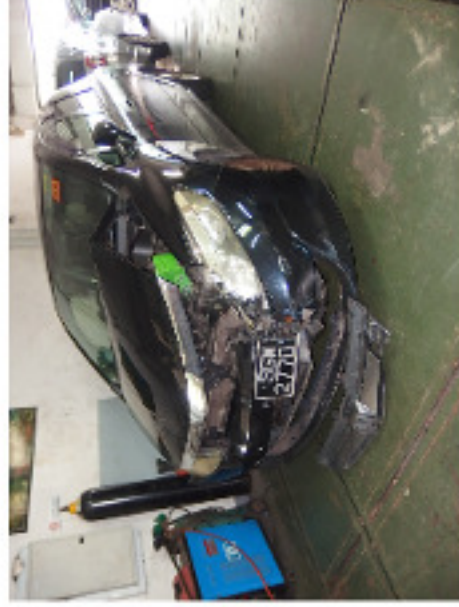
4. Description of Damages				
THE VEHICLE SUSTAINED DAMAGES AT THE FRONT PORTION.THE CHASSIS FRAME AFFECTED DUE TO COLLISION. DAMAGES SEE DETAILS.				
5. General Information				
Accident Date	31/07/2020	Inspection Date	04/08/2020	
Survey held at	QUAN DE MOTOR TRADING BLK 1 KAKI BUKIT AVENUE 6 #01-67 AUTOBAY SINGAPORE 417883			
5a. Remarks				
A)THE INSPECTION WAS CONDUCTED ON A"WITHOUT PREJUDICE" BASIS. B)IN ACCORDANCE TO YOUR INSTRUCTIONS, WE HAVE NOT AUTHORISED REPAIRS.				
5b. Estimate Days of Repair				
ESTIMATED NORMAL PERIOD FOR REPAIR:		10 Working Days
