## VEHICLE APPRAISAL REPORT

Our Reference: **TP20-028023**  
 Your Reference: **-**  
 Vehicle Number: **SLN7845S**

Assessment of Vehicle No: **SLN7845S**  
 Date of Accident: **9-Feb-20**  
 Date of Inspection: **11-Feb-20**

| Reg date: | 2017 | Model: | CX-3 SKYACTIV-G 2.0 6AT |

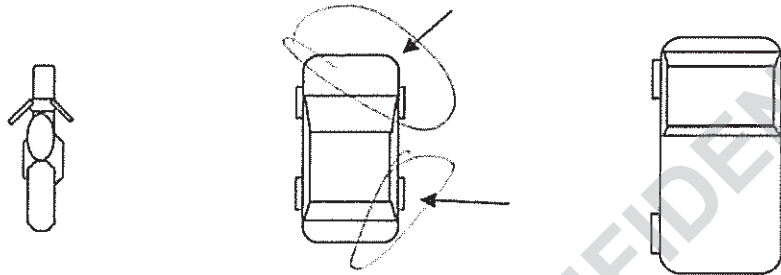
At the time of inspection, this vehicle sustained damages to the **Frontal and Right side portion**. Please see attached scheduled details.
