LKK Auto Consultants Pte Ltd

Vehicle No. SMM 4765C
Insured Veh. SHC 1608E
Claim No. D20003011MFSH
Policy No. D-20094922MFSH
Accident Date 28/07/2020
Inspection Date 11/08/2020

ADJUSTMENT ON REPAIR COST FOR VEHICLE NO. SMM 4765C

PHOTOGRAPHS FOR VEHICLE NO. SMM 4765C

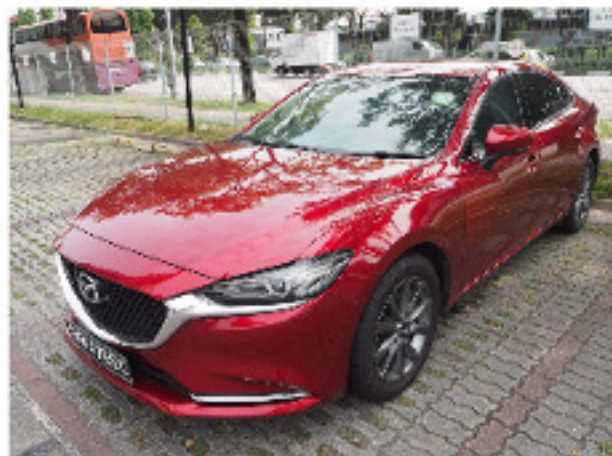
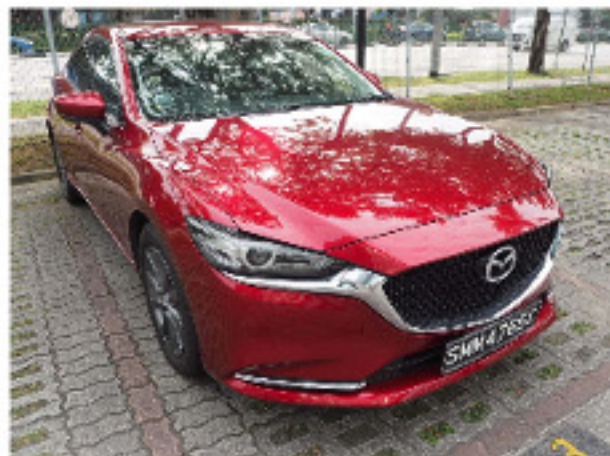
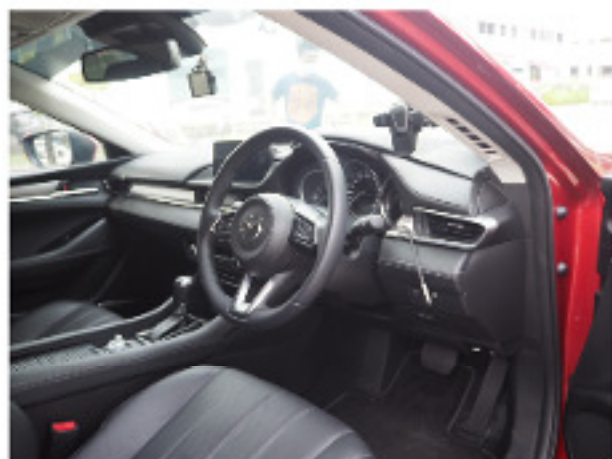
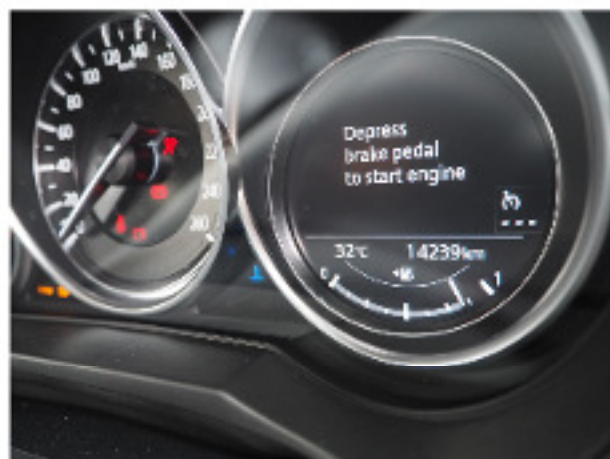
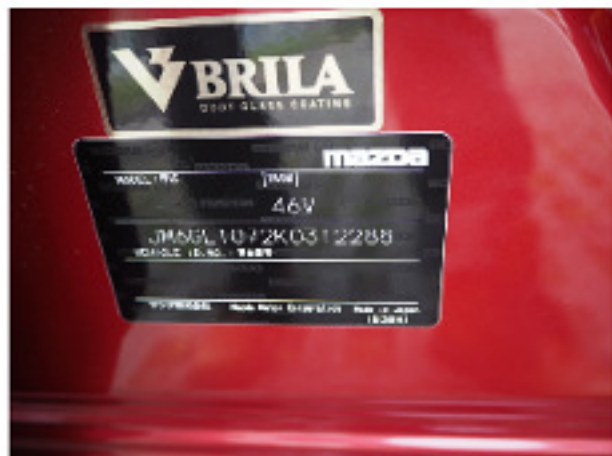
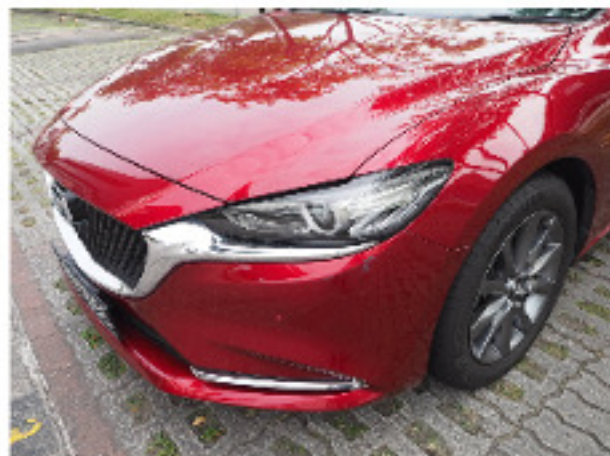
INSPECTION

THE VEHICLE SUSTAINED DAMAGES AT THE FRONT N/S PORTION. DAMAGES SEE DETAILS.

6,928.60	5,862.40
<u>SPECIAL NETT ITEMS</u>				
1	SUNDRIES (SN)	NECESSARY	100.00	20.00
			100.00	20.00
<u>LABOUR</u>				
TO REPLACE FRONT BUMPER AND FRONT FENDER LH .REPAIR ALL AREAS AFFECTED BY THE ACCIDENT .			1,650.00	660.00
TO RESPRAY FRONT BUMPER AND FRONT FENDER LH .			1,575.00	630.00
TO TRANSFER FRONT PEDESTRIAN SENSORS .			330.00	200.00
TO CHECK ELECTRICAL SYSTEM FOR PROPER FUNCTIONING.			250.00	120.00
