**VEHICLE DAMAGE INSPECTION REPORT**

Our Ref: 196/TP/2019

Date of loss: 14/3/2019  
Claimant: Chen Tian Furniture

| Reg No: | GW1756S | Make & | Nissan |

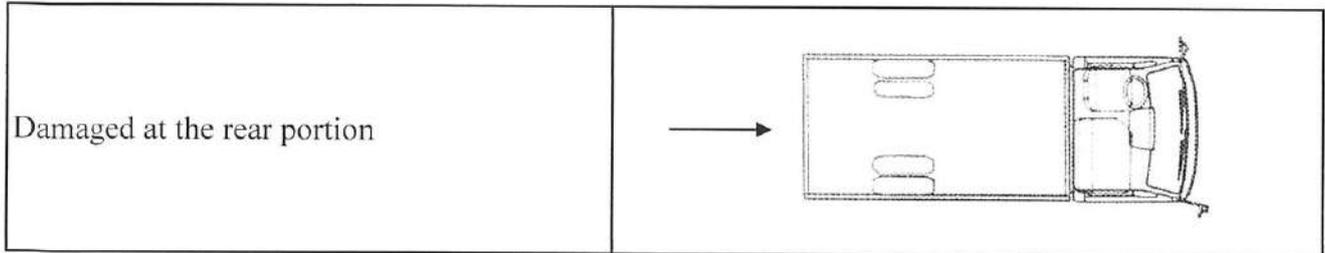
## POINT OF IMPACT

Our visual inspection of the vehicle revealed that the damages noted are at the rear portion.
