LKK Auto Consultants Pte Ltd

Vehicle No. SHD 413B
Insured Veh. SME 4727E
Claim No. C10006916
Policy No.
Accident Date 04/08/2020
Inspection Date 05/08/2020

ADJUSTMENT ON REPAIR COST FOR VEHICLE NO. SHD 413B

PHOTOGRAPHS FOR VEHICLE NO. SHD 413B

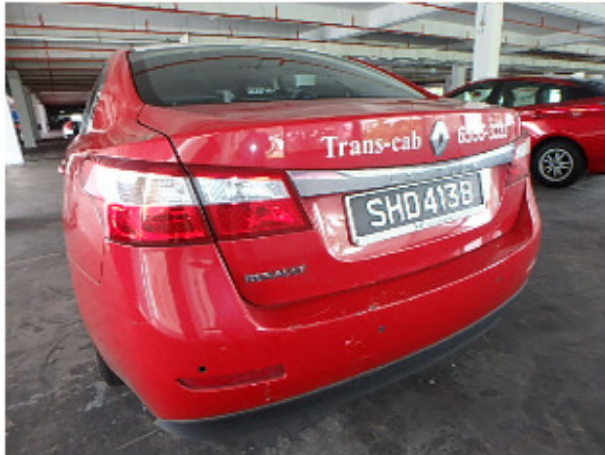
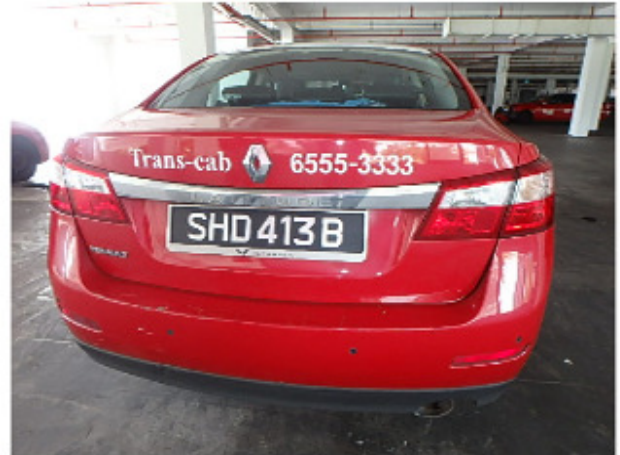
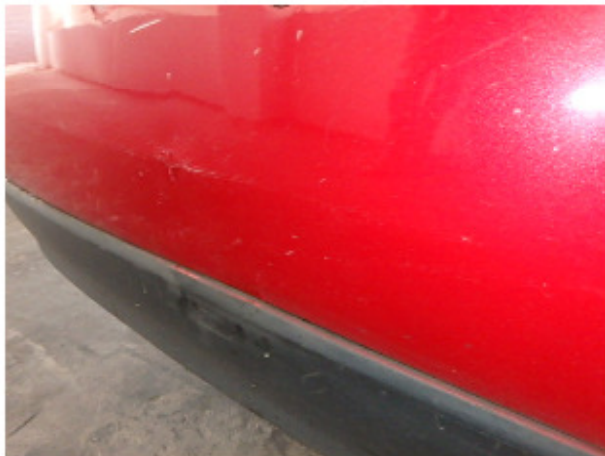
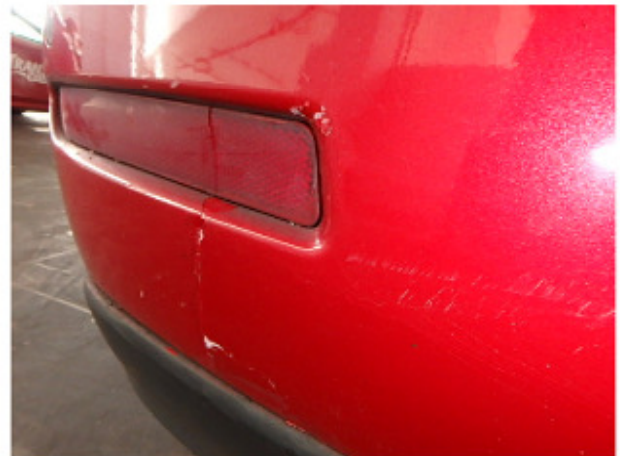
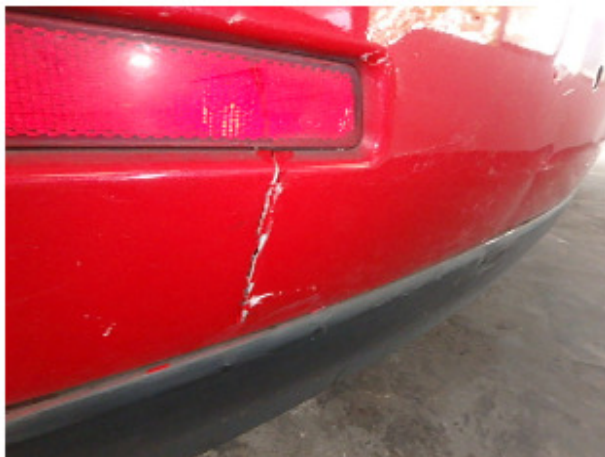
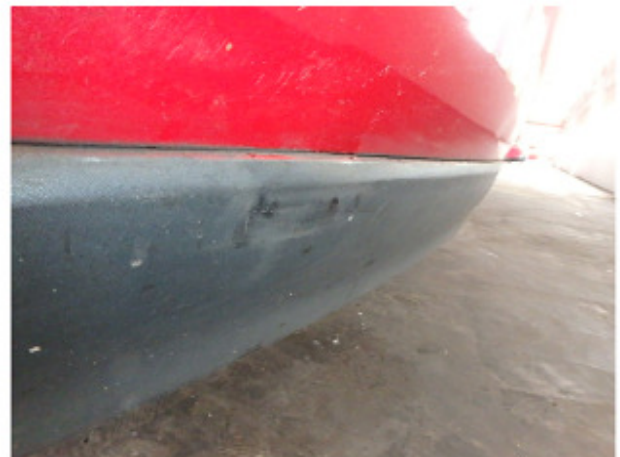
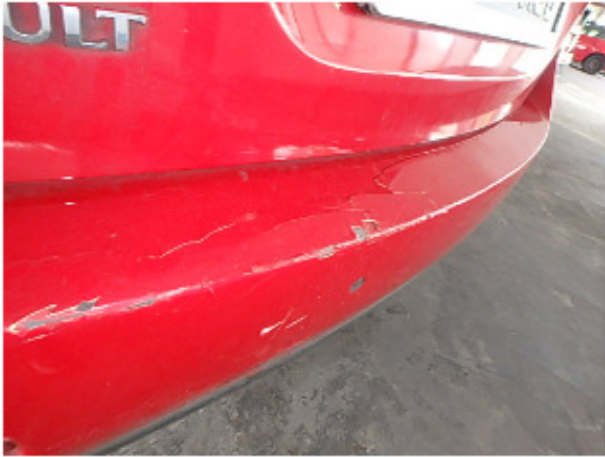
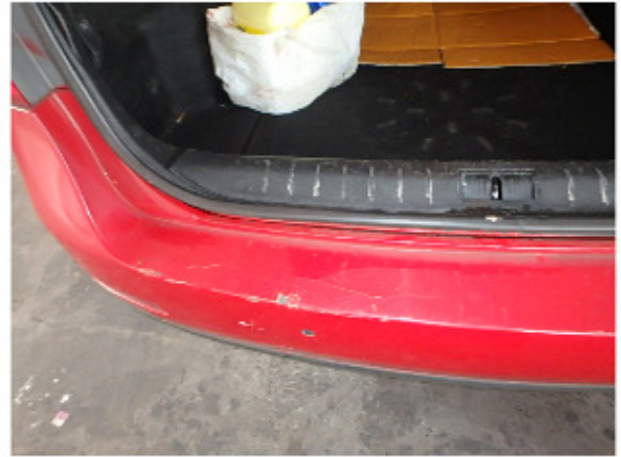
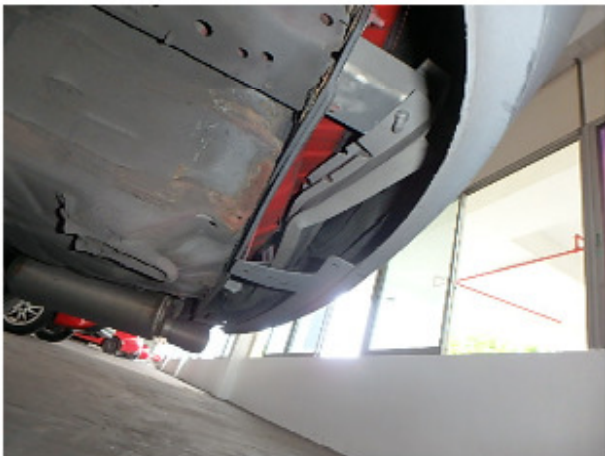
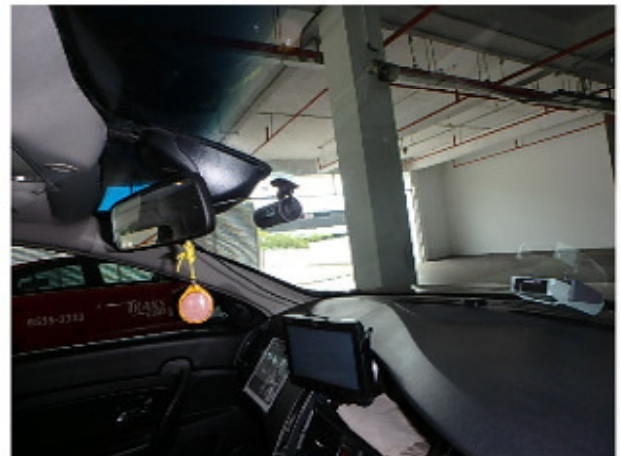
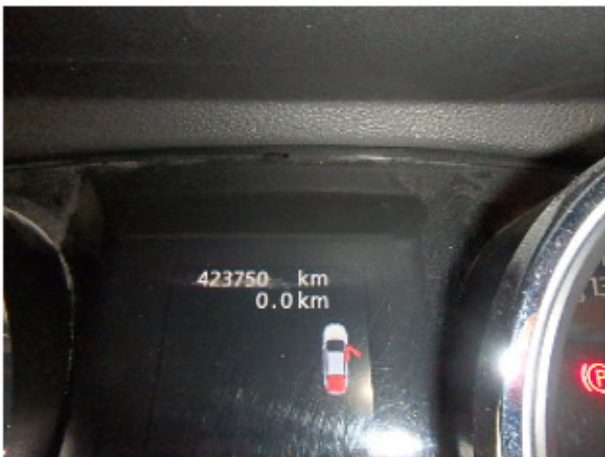
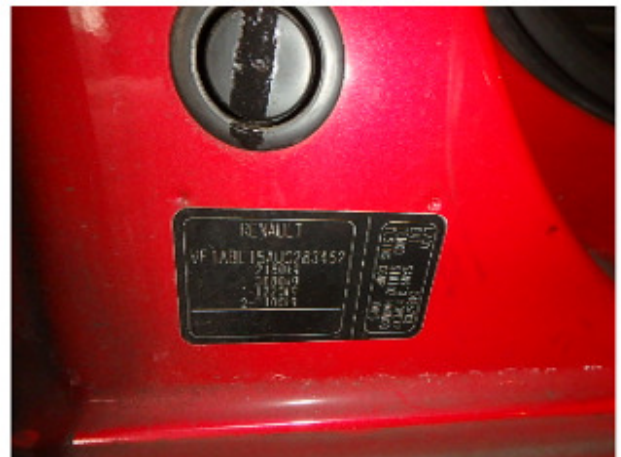
THE VEHICLE SUSTAINED DAMAGES AT THE REAR N/S PORTION. DAMAGES SEE DETAILS.
--

Qty	Description of Parts	Condition	Estimate By Workshop (\$)	Our Adjusted (\$)
	<u>REPLACEMENT OF PARTS</u>			
1	BUMPER COVER REAR	CRACKED / BUCKLED	561.70	561.70
1	BUMPER LOWER REAR	DENTED	411.90	411.90
1	BUMPER BRACKET CTR REAR	SERVICEABLE	98.10	-
1	BUMPER BRACKET SIDE LH REAR	SERVICEABLE	80.80	-
1	BUMPER RETAINER LH REAR	SERVICEABLE	54.20	-
1	BUMPER REFLECTOR REAR LH	CRACKED	16.60	16.60
1	BUMPER BEAM REAR	BENT	547.80	547.80
1	BUMPER BEAM BRACKET LH REAR	TO REPAIR SEE LABOUR	114.50	-
1	BUMPER BEAM BRACKET RH REAR	TO REPAIR SEE LABOUR	114.50	-
1	OUTER PANEL REAR (END PANEL)	TO REPAIR SEE LABOUR	745.80	-
1	OUTER PANEL REAR (END PANEL) TRIM	SERVICEABLE	404.56	-
1	TAIL-LAMP	SERVICEABLE	401.40	-
1	BOOT REAR	TO REPAIR SEE LABOUR	1,677.20	-
1	BOOT FINISHER	SERVICEABLE	344.70	-
1	BOOT WEATHERSTRIP	SERVICEABLE	178.20	-
1	BOOT REFLECTOR LAMP LH	SERVICEABLE	277.70	-
1	BOOT REFLECTOR LAMP RH	SERVICEABLE	277.70	-
1	BOOT BADGE "RENAULT"	NOT NECESSARY	82.40	-

RECOMMENDED COST OF LUMP SUM REPAIRS (TO ITS PRE-ACCIDENT CONDITION)				1,600.00
---	--	--	--	-----------------
