Your Ref : 9395714805SG
Our Ref : CC3/AIG20008090/N

M/s AIG Asia Pacific Insurance Pte. Ltd.

**AUTOMOBILE TECHNICAL INVESTIGATION REPORT OF ACCIDENT
INVOLVING SHB 621C AND SKE 8878A ON 30 JULY 2020**

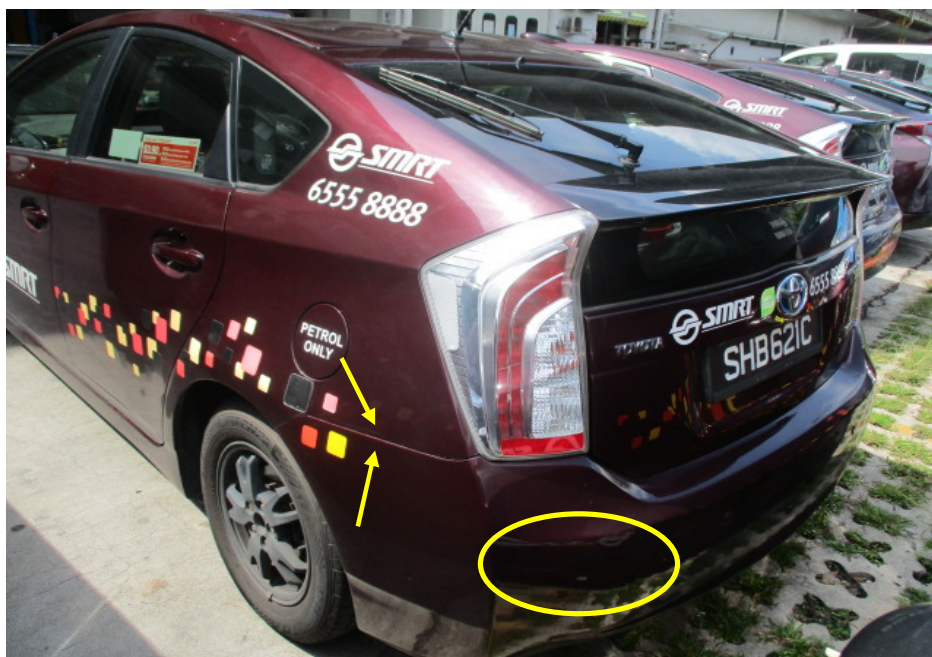
9. From our examination of the photographs taken during the Pre- Repair Survey conducted by LKK Auto Consultants Pte. Ltd. about 4 days after the accident, we observed whitish marks as well as a slight rectangular indentation around the left lower portion of the rear bumper of the Taxi. We also noted that the rear bumper was slightly misaligned at its left corner edge. See photos 1 - 5 below.

Photo 1 shows a rear view of the Taxi at the time of the Pre- Repair Survey conducted by LKK Auto Consultants Pte. Ltd. which was taken about 4 days after the accident. We observed whitish marks as well as a rectangular indentation around the left lower portion of the rear bumper of the Taxi (circled). We also noted that the rear bumper was slightly misaligned at its left corner edge (yellow arrows).

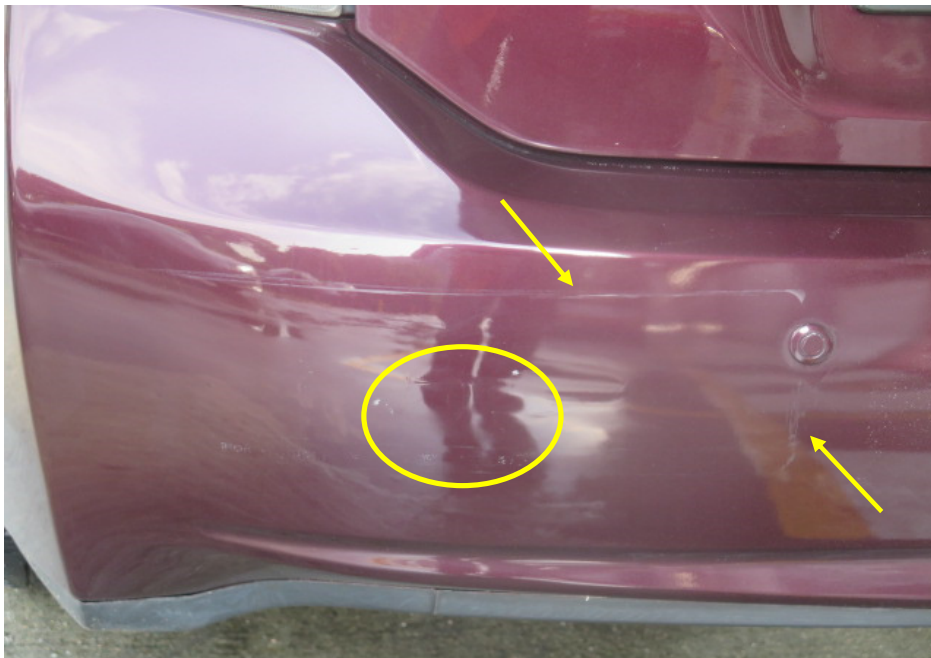
Photo 2 shows a closer view of the left lower portion of the rear bumper of the Taxi. We observed whitish marks (circled) as well as a rectangular indentation (yellow arrows) around the left lower portion of the rear bumper of the Taxi.

- a) the shape of the slight rectangular indentation on the rear lower left portion of the Taxi's rear bumper had corresponded to the shape of the Lexus's front number plate frame;

20. Upon contact, the front number plate frame of the Lexus had compressed against the rear bumper of the Taxi, creating the permanent slight rectangular indentation on the left lower portion of the rear bumper of the Taxi.

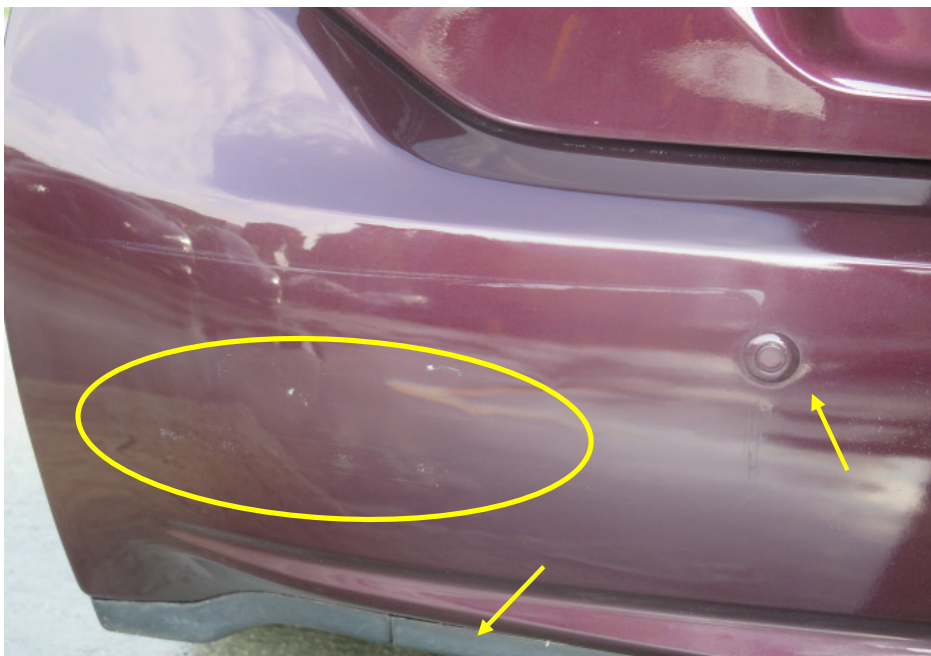
Photo 3 shows a close up view of the whitish marks (circled) at the left lower portion of the rear right bumper of the Taxi.

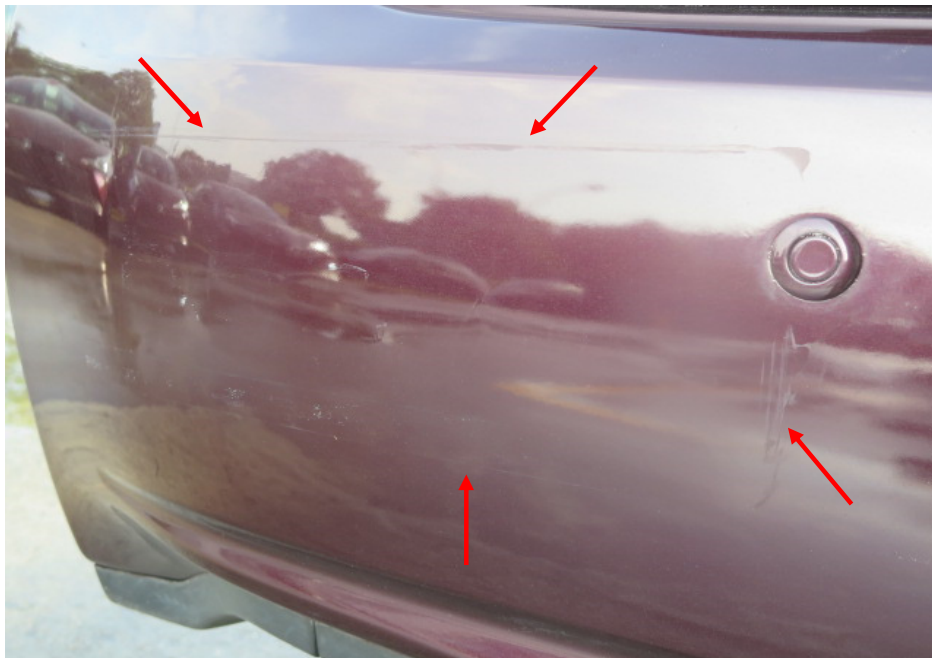
Photo 4 shows a close up view of the rectangular indentation (red arrows) around the left lower portion of the rear bumper of the Taxi.

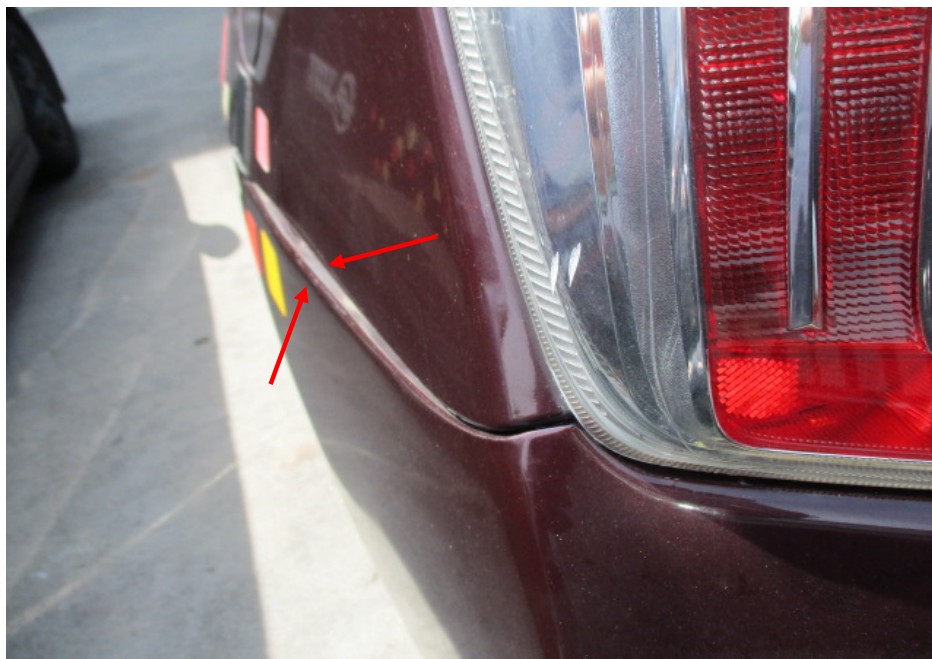
Photo 5 shows a close up view of the left corner edge of the rear bumper of the Taxi. We observed a slight misalignment at the corner edges (red arrows).

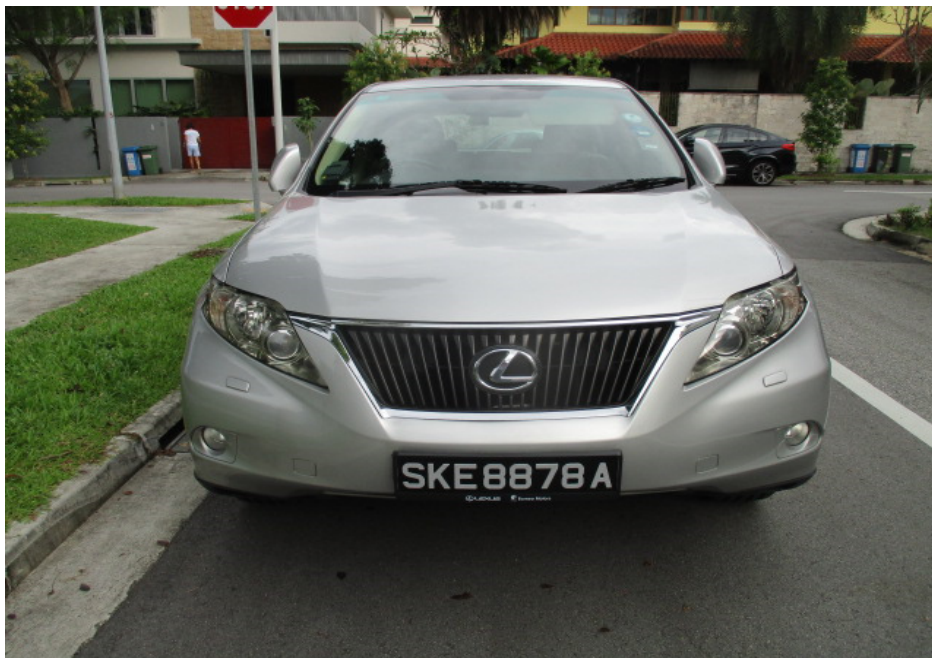
Photo 6 shows the general view of the frontal portion of the Lexus at the time of our inspection.

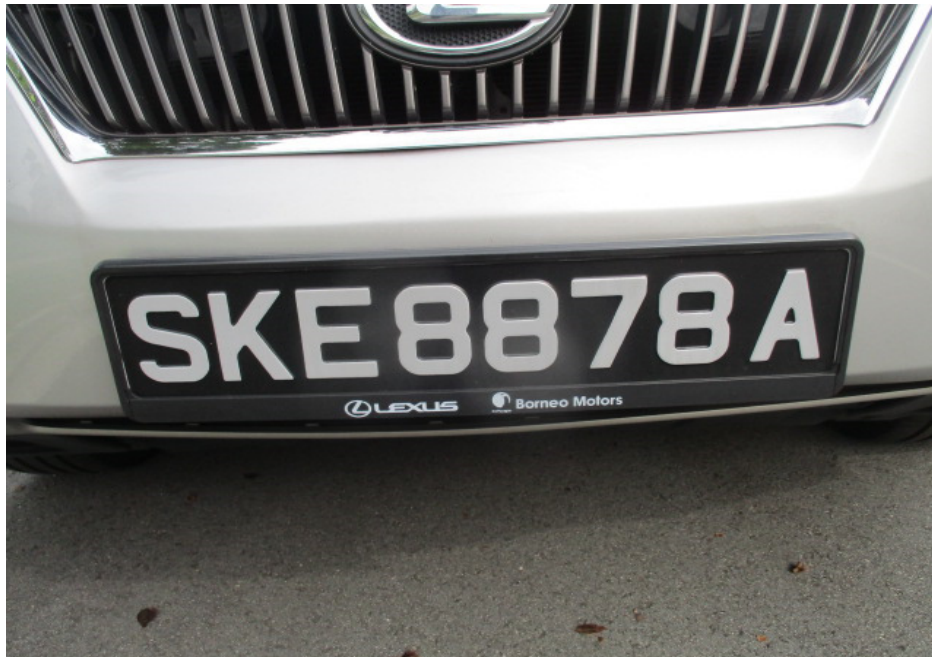
Photo 7 shows a closer view of the front number plate and front number plate frame at the time of our inspection. Mrs Lim mentioned to us that she had replaced the front number plate and front number plate frame shortly after the accident.

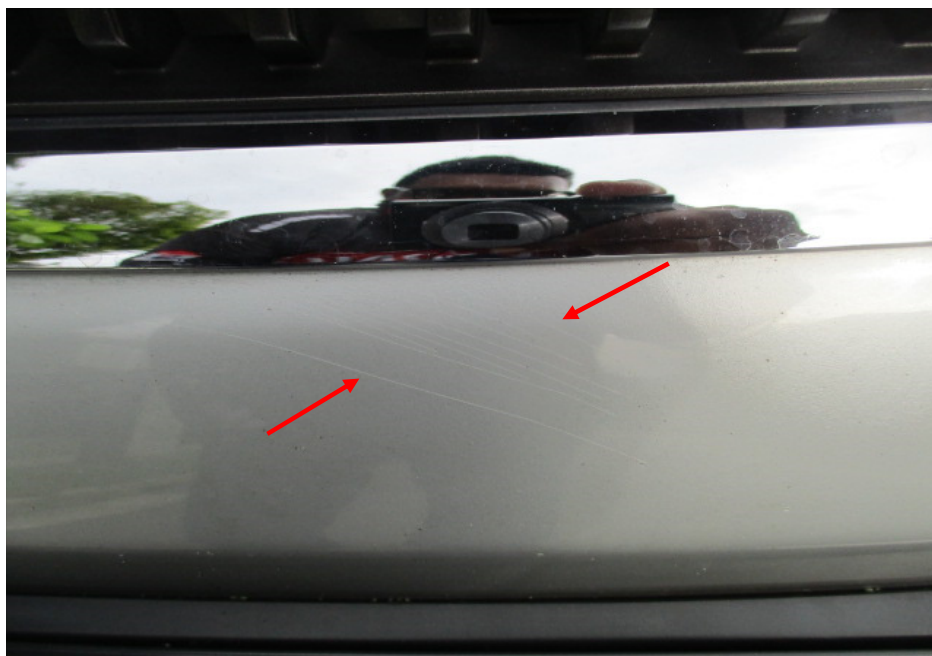
Photo 8 shows a closer view of the paint cracks found above the front number plate frame of the Lexus (red arrows) but Mrs Lim mentioned us that it was not related to the accident. She informed us that sometime before our physical inspection, the Lexus was parked near her home premises when it was hit by a van, causing the paint cracks.

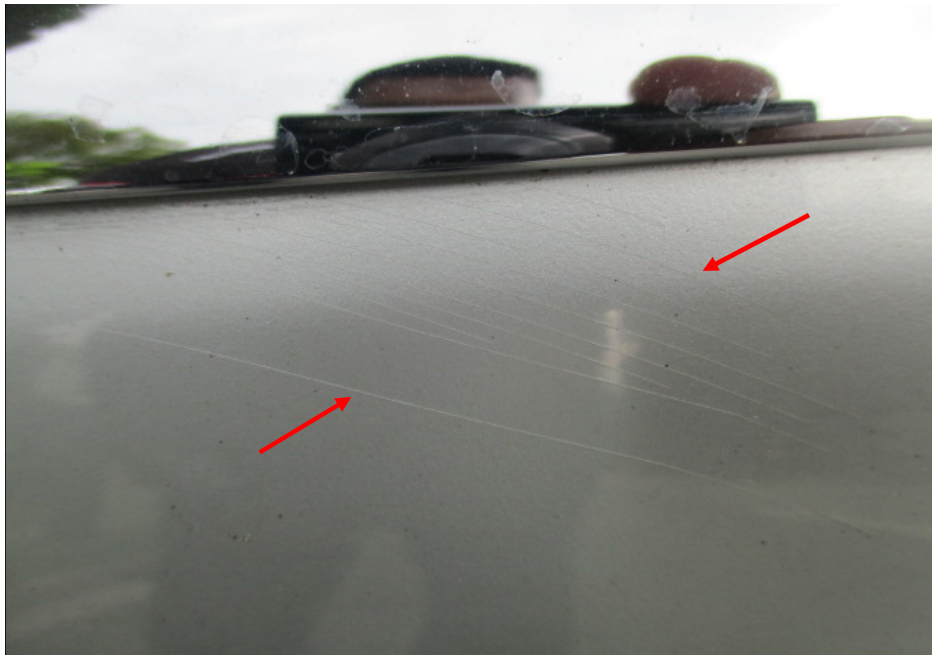
Photo 9 shows a close up view of the paint cracks found above the front number plate frame of the Lexus at the time of our inspection (red arrows).

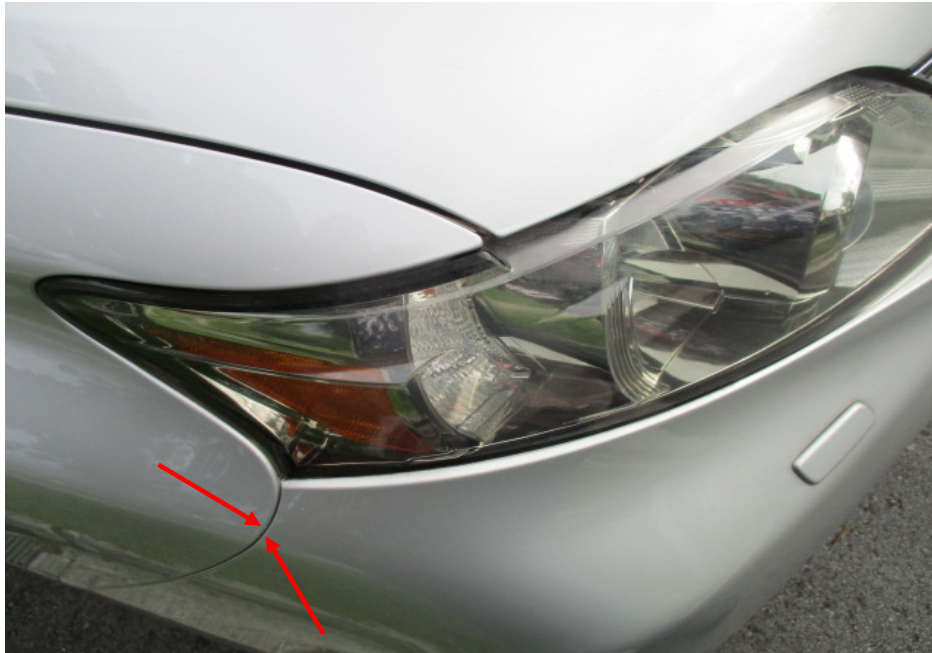
Photo 10 shows a closer view of the right corner edge of the front bumper of the Lexus. We observed that there was no misalignment at the corner edges (arrowed).

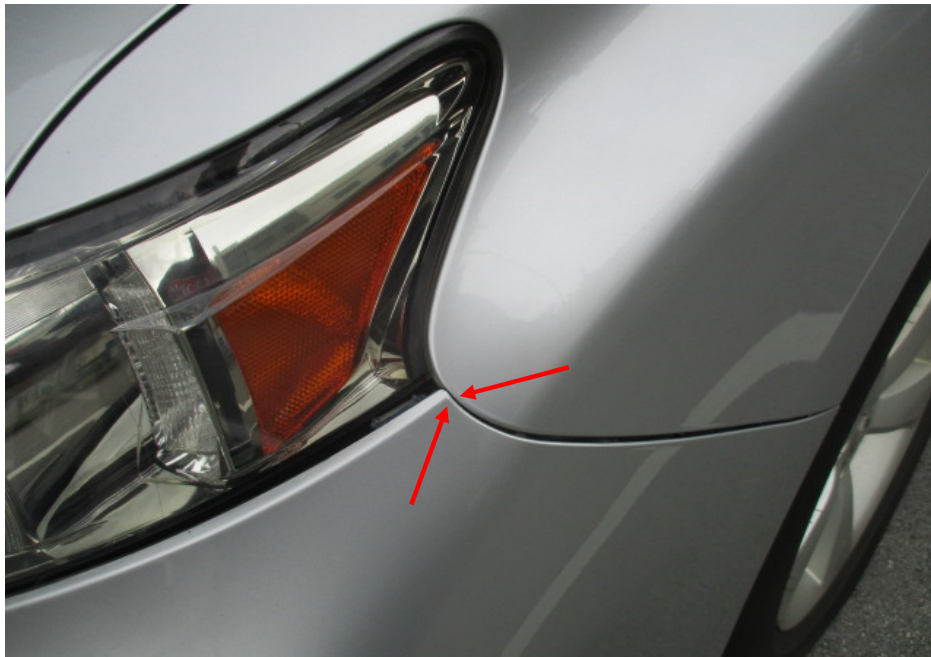
Photo 11 shows a closer view of the left corner edge of the front bumper of the Lexus. We observed that there was a slight misalignment at the corner edges (arrowed).

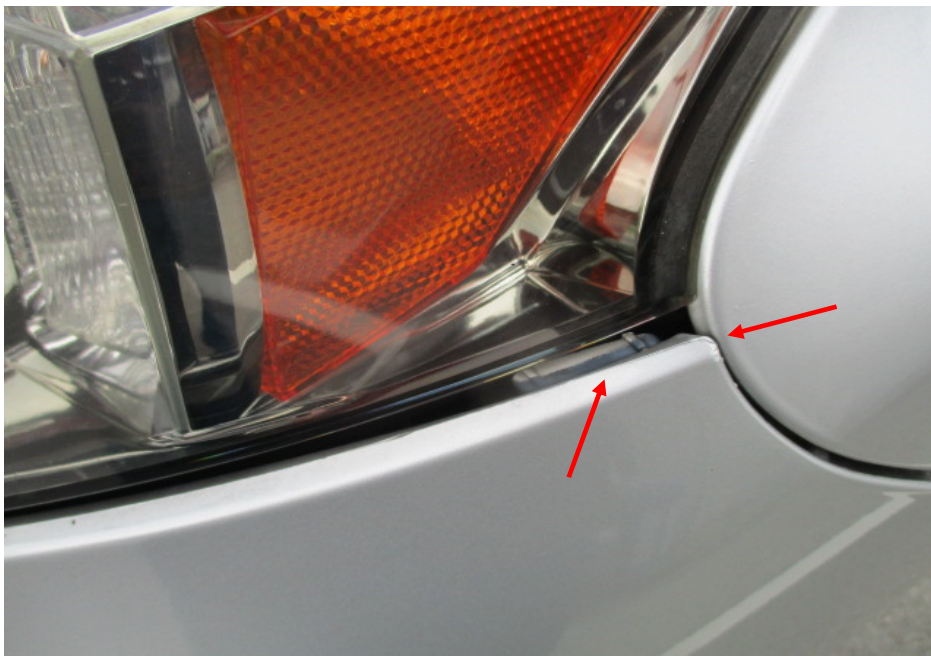
Photo 12 shows a close up view of the misaligned left corner edge of the front bumper of the Lexus (arrowed). Mrs Lim again mentioned that this damage was not related to the accident.

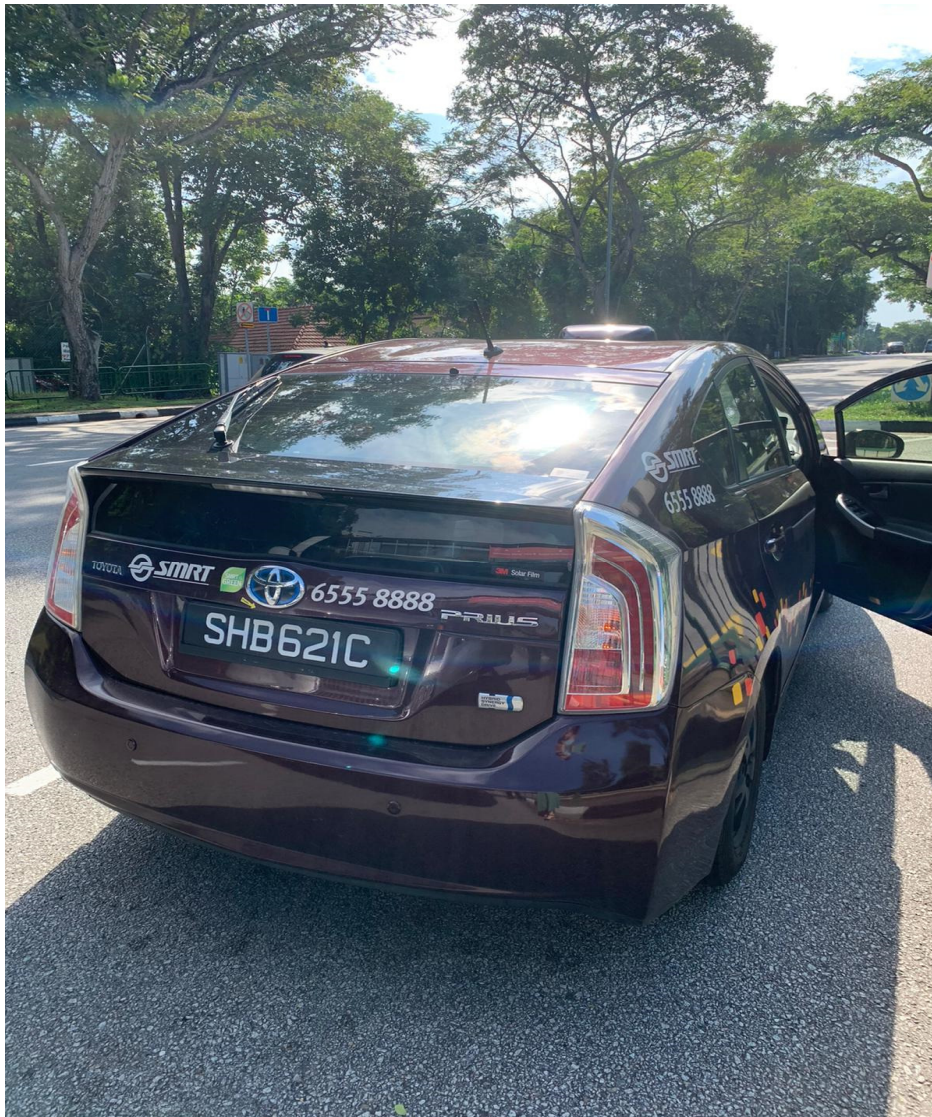
Photo 13 shows the rear portion of the Taxi post- accident.

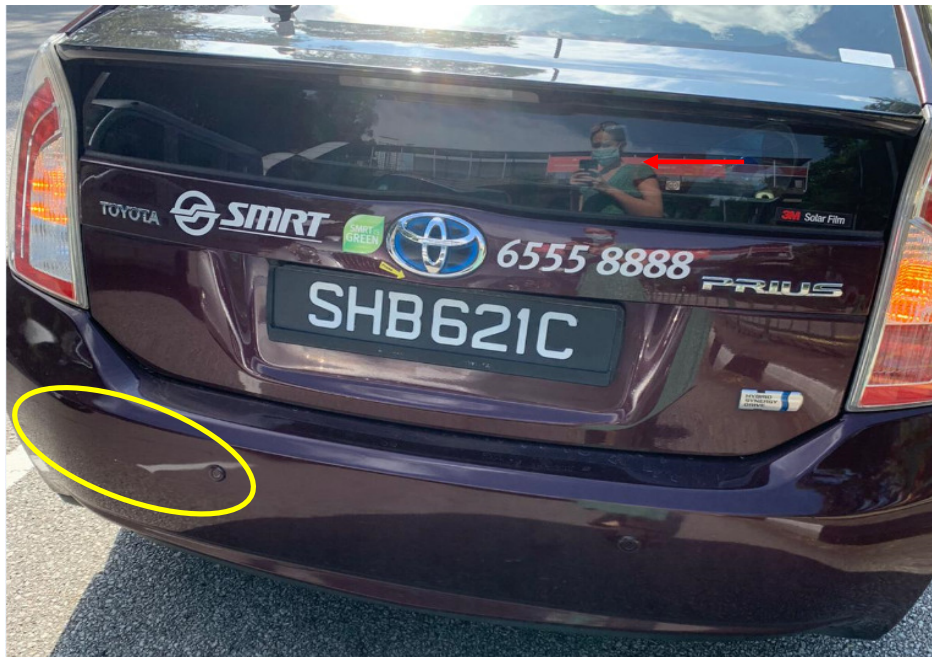
Photo 14 shows upon closer examination of this photograph, we observed the rectangular indentation on the left lower portion of the Taxi's rear bumper (circled).

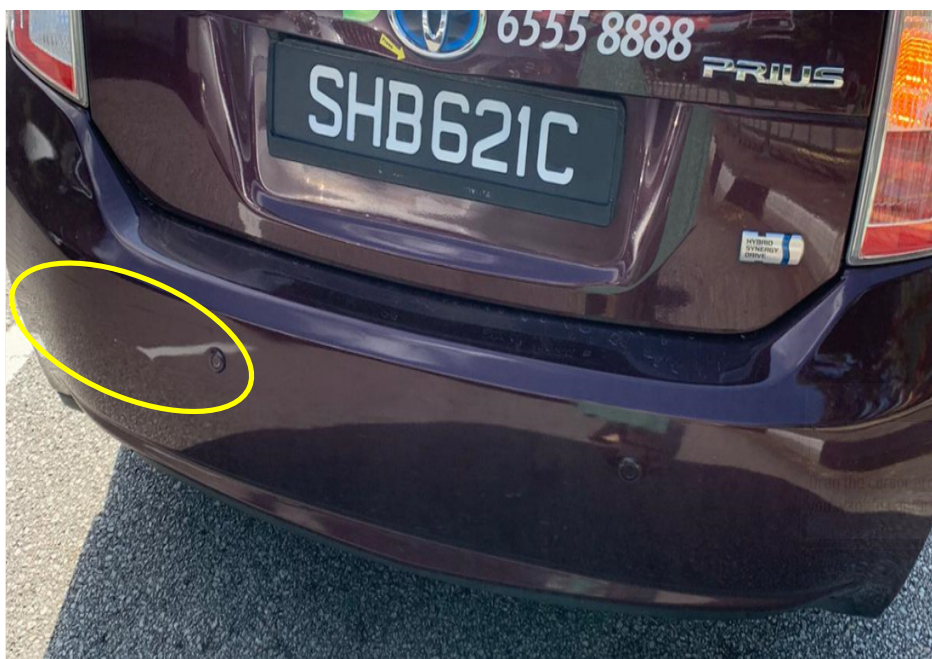
Photo 15 shows a close up view of the rectangular indentation on the left lower portion of the Taxi's rear bumper (circled).

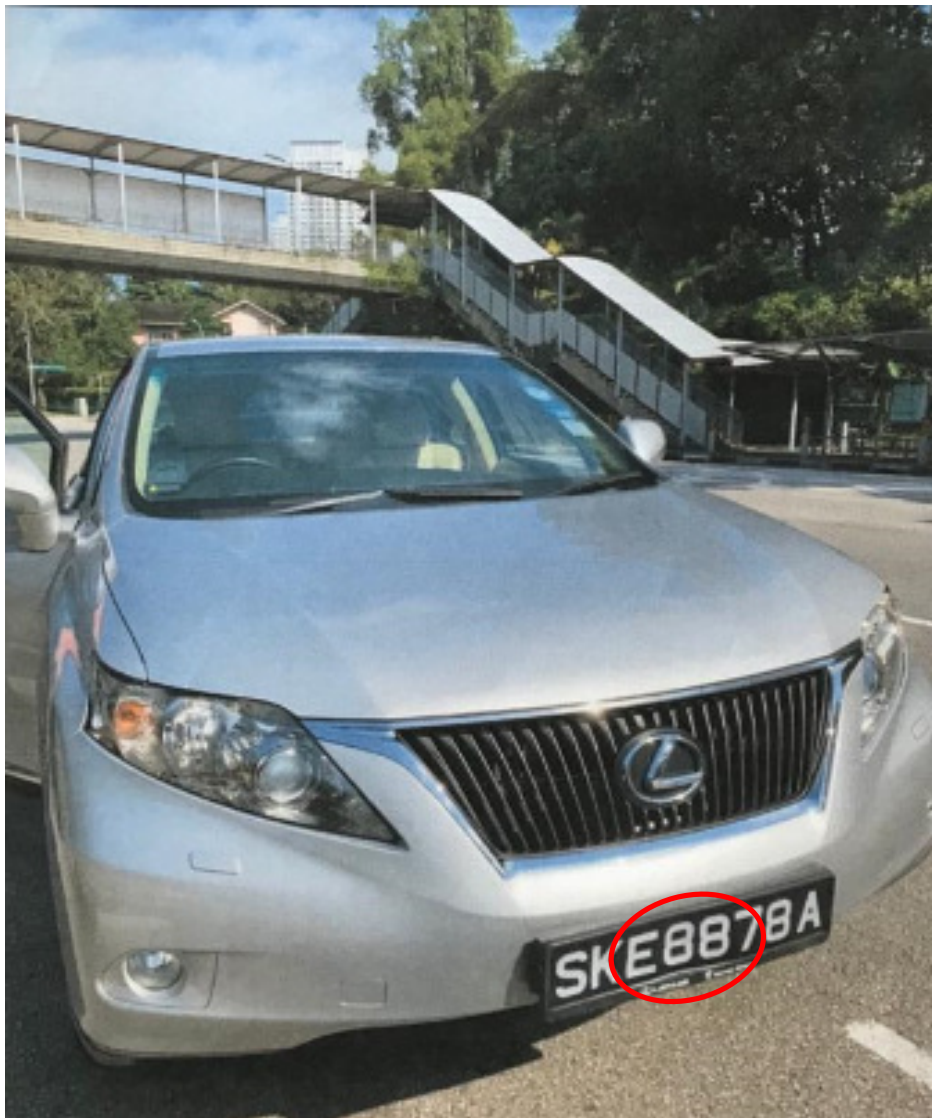
Photo 16 shows the frontal portion of the Lexus post- accident. We observed a dent on the centre portion of the front number plate and distortion of the front number plate frame (circled).

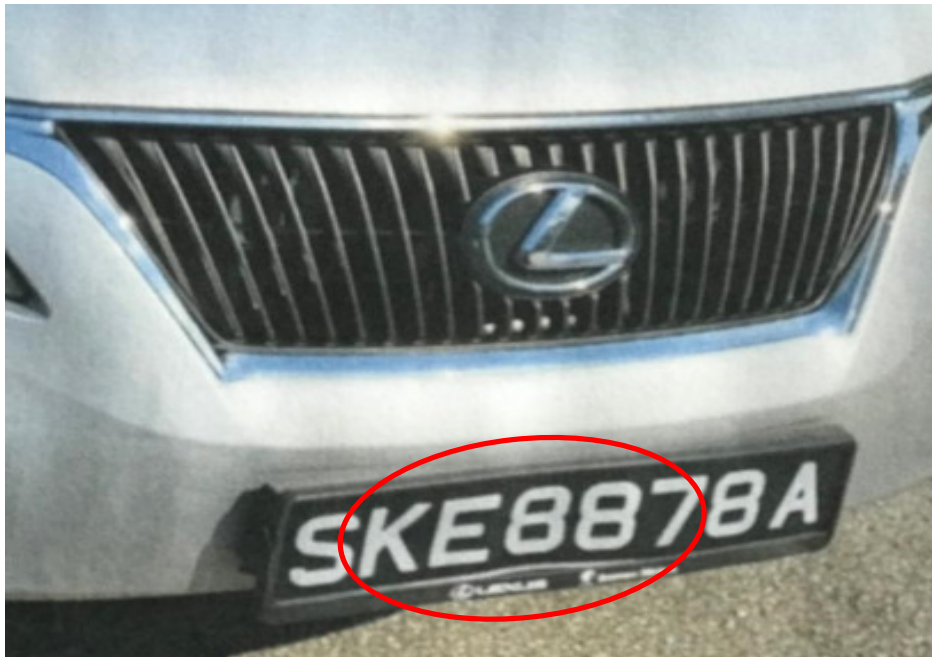
Photo 17 shows a close up view of the dented front number plate and distorted front number plate frame of the Lexus post- accident (circled).

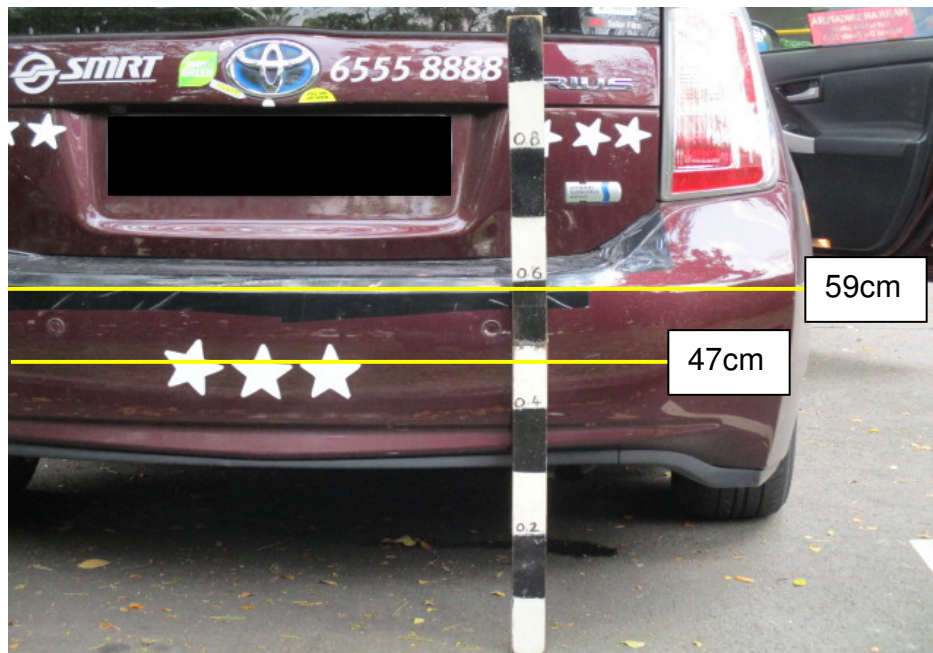
Photo 18 shows the height measurement being conducted on the rear portion of the Taxi (using a similar make and model). The height range of the rectangular indentation and whitish marks found on the lower left portion of the Taxi's rear bumper was between 47cm to 59cm above ground level.

b) the height above ground level of the damages to the left lower portion of the Taxi's rear bumper was within the height above ground of the front number plate and rectangular shaped front number plate frame of the Lexus.

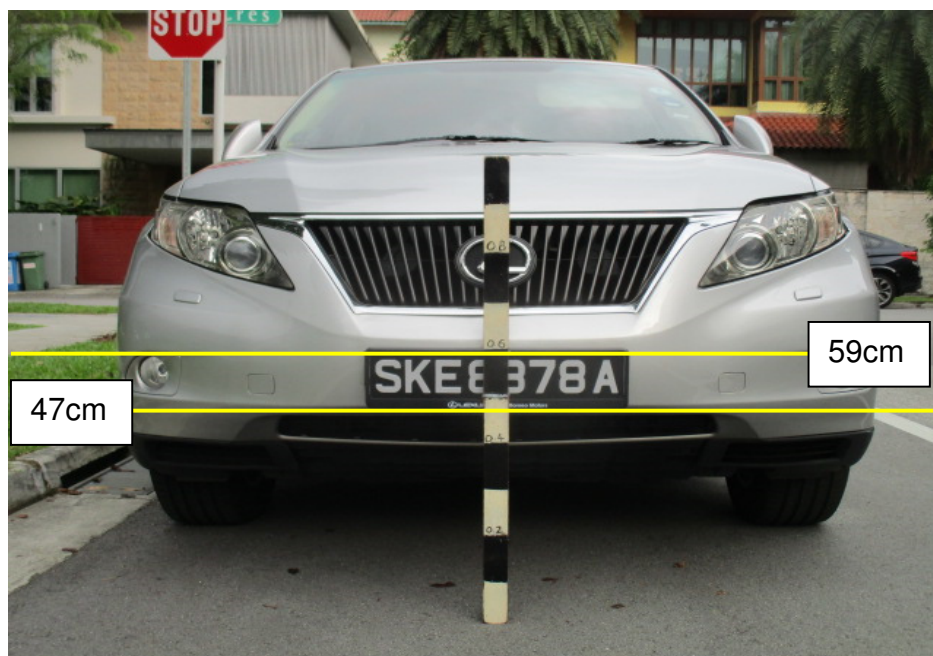
Photo 19 shows the height measurement being conducted on the front portion of the Lexus. The dented front number plate and distorted front number plate frame of the Lexus are within the 47cm to 59cm height range.
