Your Ref: C10006910/JM
Our Ref : CI/AGI20008175/P

**TECHNICAL INVESTIGATION REPORT OF FIRE INCIDENT INVOLVING THE
INSURED VEHICLE SKZ 6102H ON 21st JULY 2020**

Vehicle Registration No.	: SKZ 6102H
Make / Model	: BMW 116D 5DR HATCHBACK DSC LED
Chassis No	: WBA1V720805C07041
Year of Registration	: January 2016
Mileage	: 125,576KM

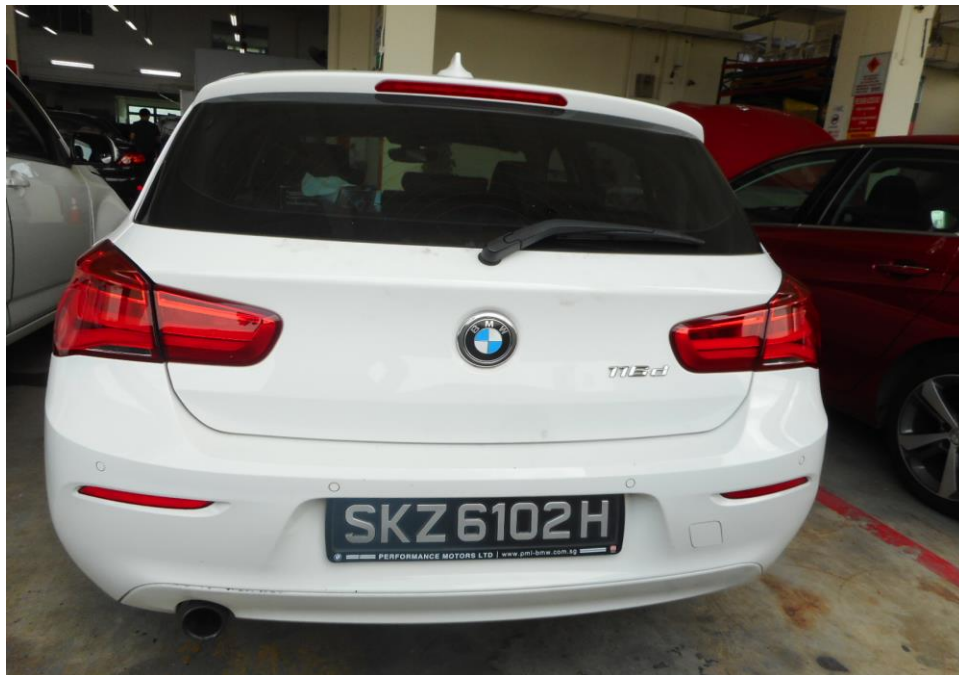
Photo 1 shows the rear portion of the Insured Vehicle, which was observed to be unaffected by the fire.

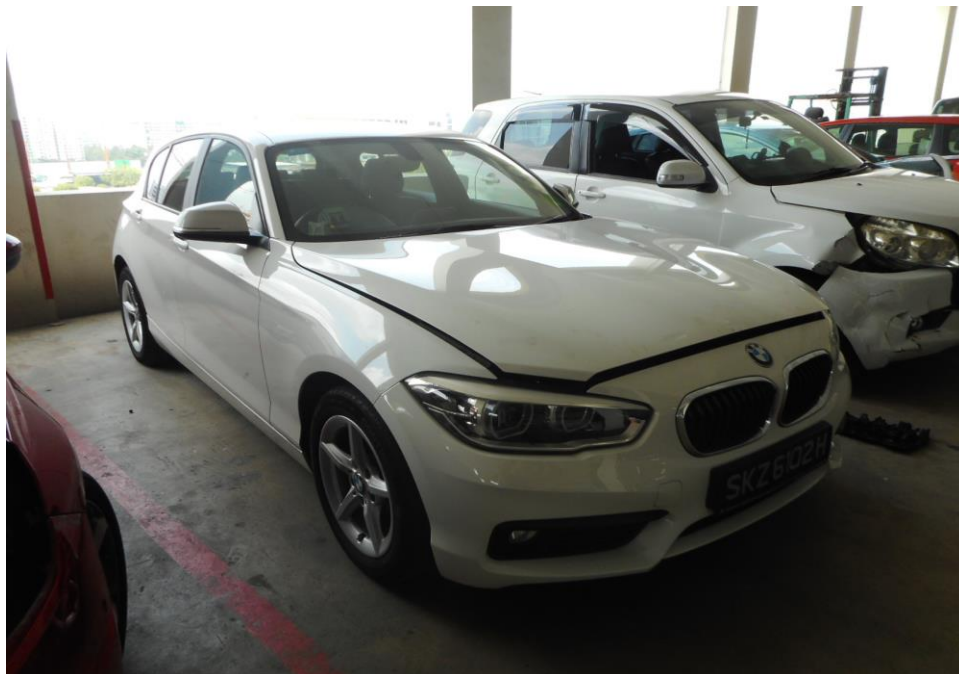
Photo 2 shows the right body of the Insured Vehicle, which was observed to be unaffected by the fire.

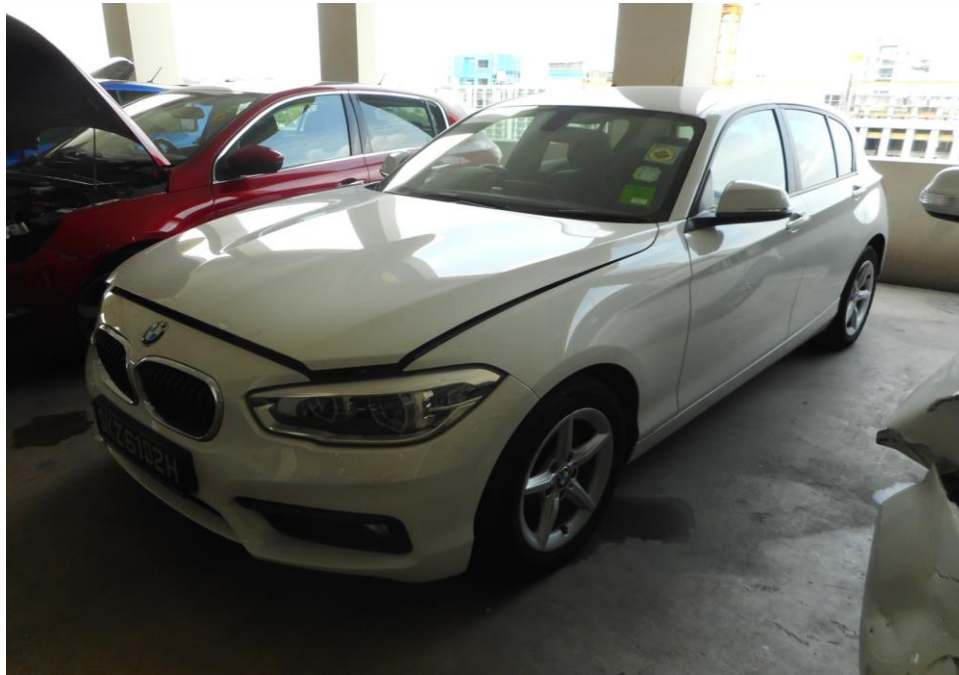
Photo 3 shows the left body of the Insured Vehicle, which was observed to be unaffected by the fire.

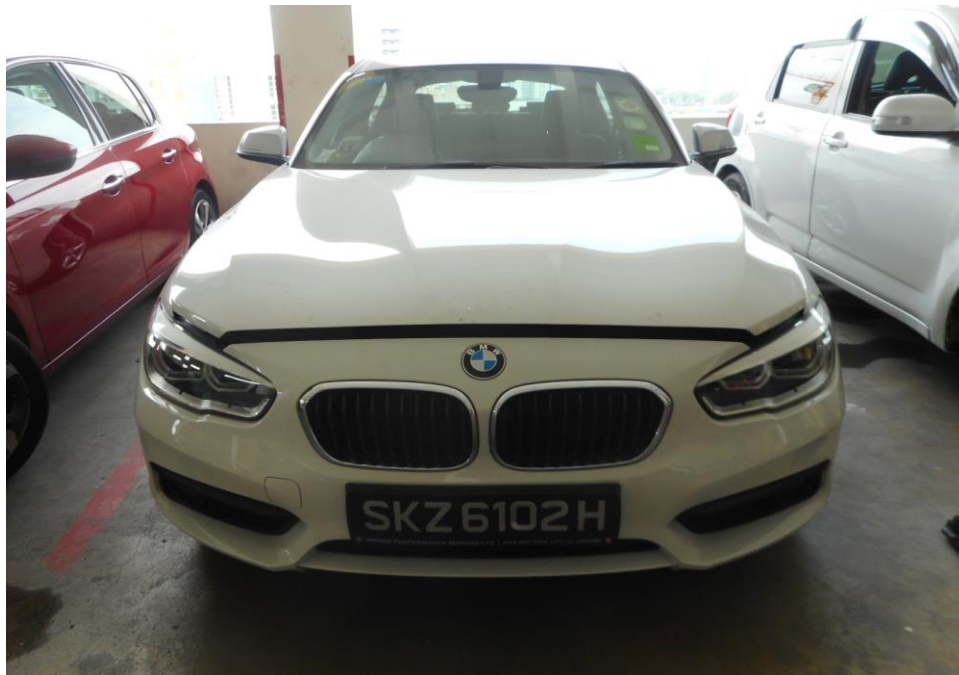
Photo 4 shows the front portion of the Insured Vehicle, which was observed to be unaffected by the fire.

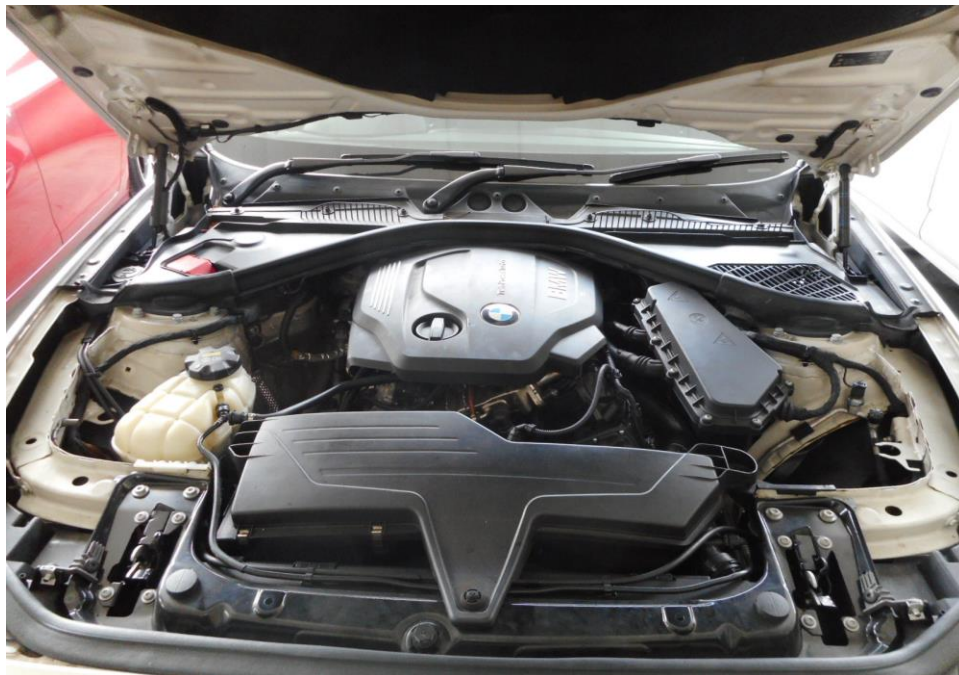
5. The Insured Vehicle was observed to have sustained minor fire damage confined only to its engine compartment in the front, the engine cover, electrical wirings and components was damaged as a result of the fire. The other parts of the Insured Vehicle was not affected by the fire See photos 1 – 8 below.

Photo 5 shows the general view of the front engine compartment of the Insured Vehicle at the time of our inspection. The Insured Vehicle was observed to have sustained minor fire damage confined only to its engine compartment in the front, the engine cover, electrical wirings and components was damaged as a result of the fire.

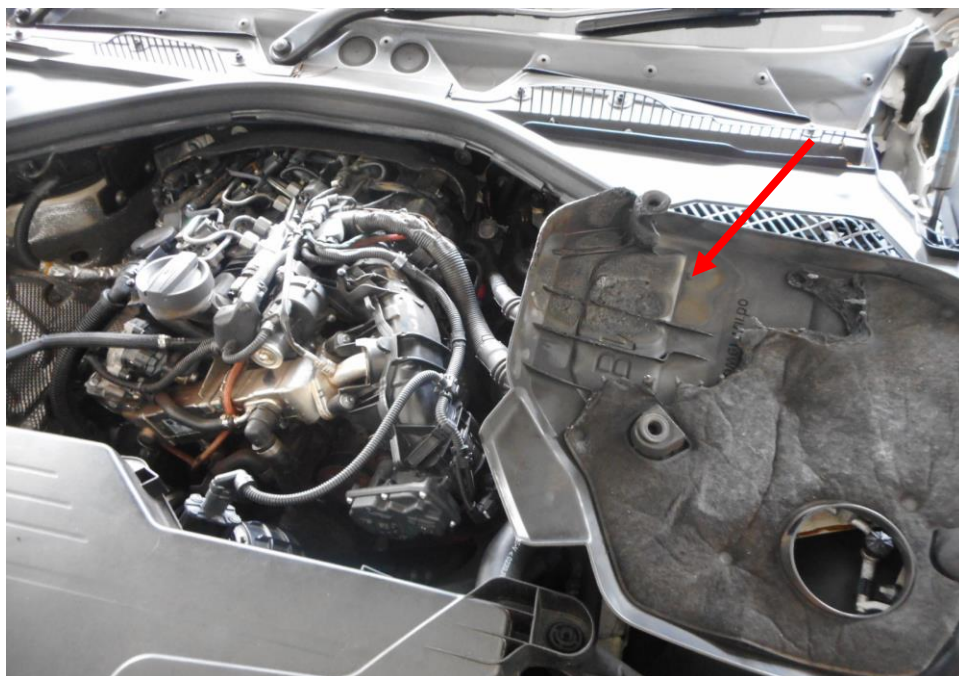
Photo 6 shows the engine compartment of the Insured Vehicle at the time of our inspection with the engine cover removed. The Insured Vehicle was observed to have sustained minor fire damage to its engine cover (arrowed) was damaged as a result of the fire.

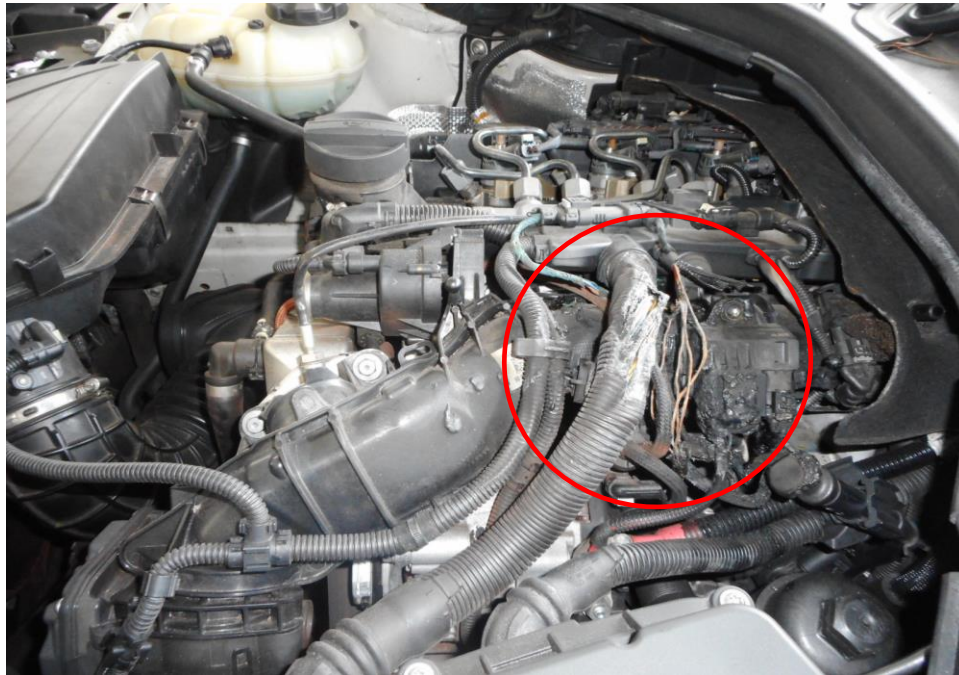
Photo 7 shows the engine compartment of the Insured Vehicle at the time of our inspection with the engine cover removed. The Insured Vehicle was observed to have sustained minor fire damage to its electrical wirings and components (circled) and was damaged as a result of the fire.

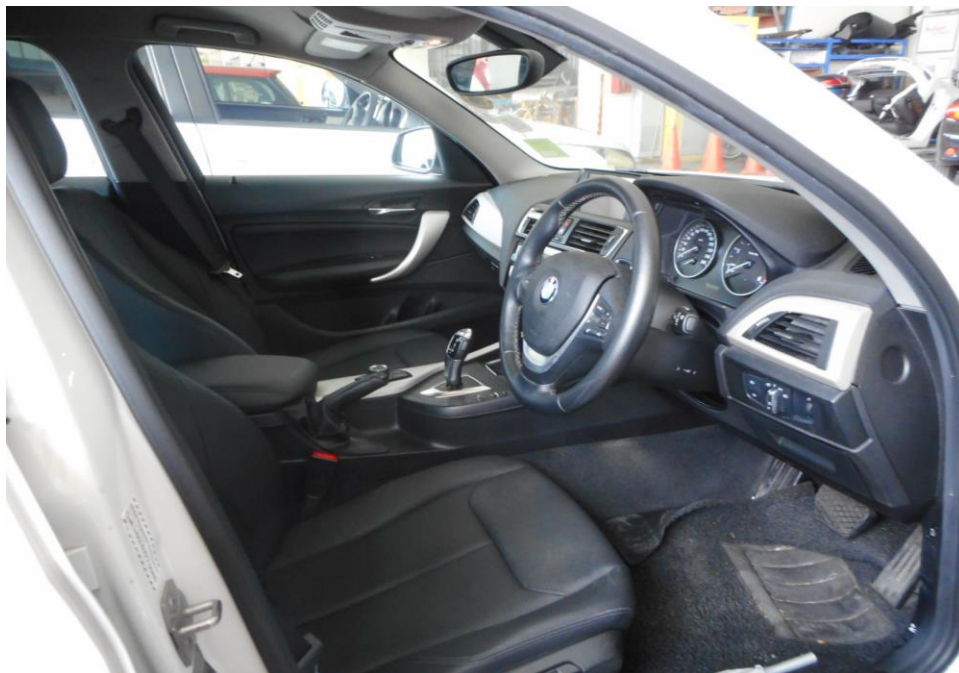
Photo 8 shows the interior view from the right side of the Insured Vehicle at the time of our inspection. The right side of the Insured Vehicle was observed to be unaffected by the fire.

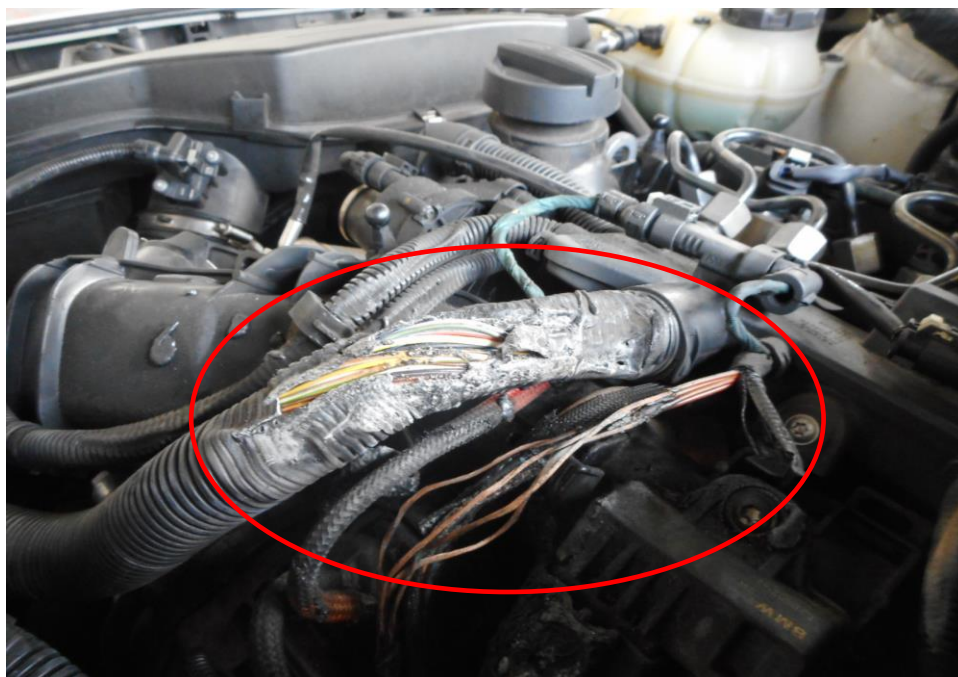
7. For this particular case, the fire appears to have originated from the engine wirings of the engine compartment on the Insured Vehicle. This can be determined from the burn pattern of the various components in the engine compartment, which were observed to have been partly melted and burn from the high heat intensity and the exposure of bare copper wirings. See photo 9 & 10 below.

Photo 9 shows the close up view of the engine of the Insured Vehicle at the time of our inspection. The burn pattern of the various components which were observed to be partly melted and burn from the high heat intensity and exposure of bare copper wirings (circled) indicates that the fire had originated from the wirings of the engine portion of the Insured Vehicle.

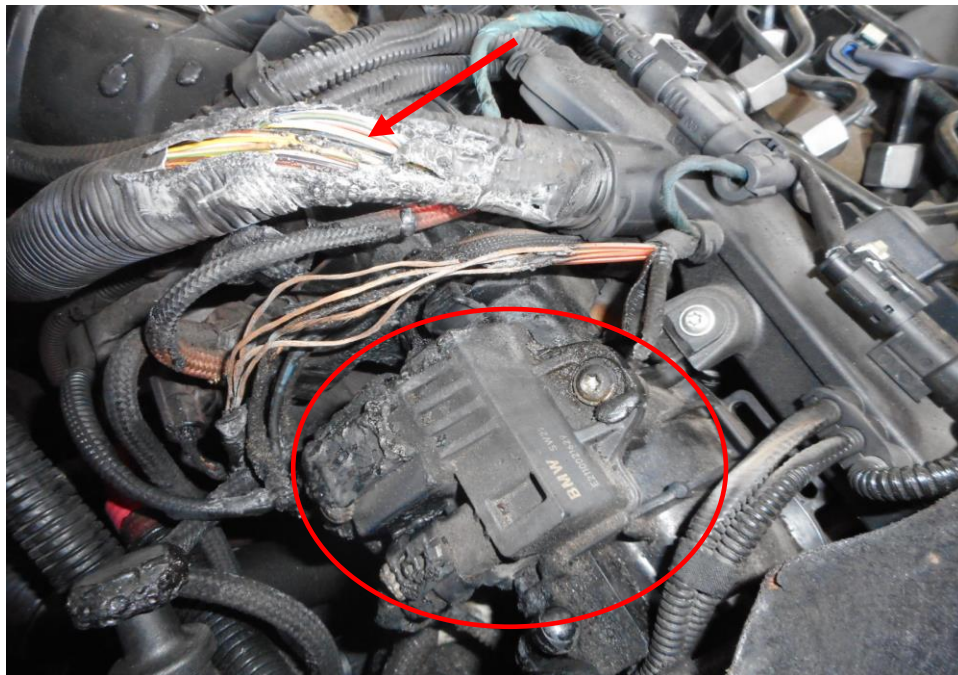
Photo 10 shows the close up view of the engine of the Insured Vehicle at the time of our inspection. The heat from the fire had also damaged the components in the engine compartment. Its glow plug relay (circled) and original wiring harness (arrowed) were the various components which were observed to be partly melted and burn from the high heat intensity indicates that the fire had originated from the area of the engine portion of the Insured Vehicle.

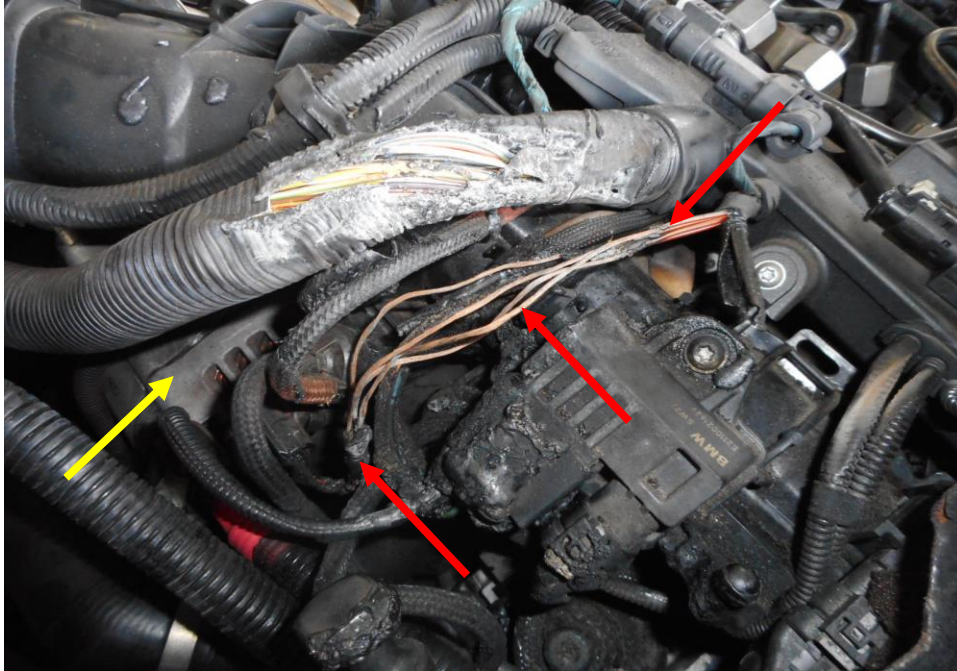
8. Upon closer examination of the engine compartment of the Insured Vehicle which was where the fire had started, we had found traces of greenish residue on the original wirings leading from the alternator. The wirings were original wirings fitting from manufacturer. The presence of greenish residue indicates internal heating of copper wires, a sign of an electrical short circuit occurring. The greenish residue is normally left behind from the oxidation as a result of chemical reaction involving the copper wires. This physical evidence would then appear to suggest that the cause of fire to the Insured Vehicle could have possibly been due to electrical in nature. See photos 11 & 12 below.

Photo 11 shows the general view of the front right engine compartment portion of the Insured Vehicle at the time of our inspection. Observed that the fire had likely started from the original wiring harnesses (red arrow) leading out from the alternator (yellow arrow) as there was greenish residue on the surface. The presence of greenish residue indicates internal heating of copper wires, a sign of an electrical short circuit occurring. The greenish residue is normally left behind from oxidation as a result of chemical reaction involving the copper wires.

20. The possibility of the fire being due to electrical in nature would then seem more likely given that engine overheating and external factors would both seem unlikely. The fire being due to electrical nature is also supported by the condition of the wirings that were found leading from the alternator to the original wirings on the Insured Vehicle, which was earlier discussed in paragraph 9 above.

22. Having investigated and technically analysed the damages of burnt nature to the Insured Vehicle, we are of the view that the cause of fire to the Insured Vehicle was of electrical nature. For this particular case, the fire had originated along the original manufacturer wirings leading to the alternator of the Insured Vehicle.
23. We did not find any evidence which had suggested that the cause of fire to the Insured Vehicle was due to poor maintenance and/or recurring electrical problem.

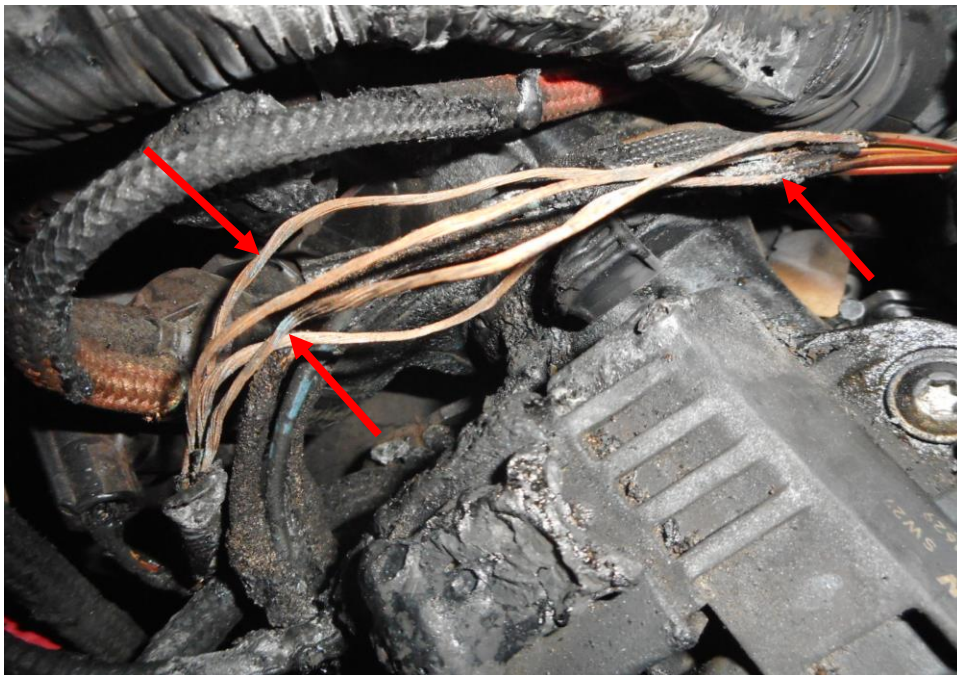
Photo 12 shows a close up view of the original wiring harness in the engine compartment. The original wiring harness (arrowed) was observed with greenish residue on the surface. The presence of greenish residue indicates internal heating of copper wires, a sign of an electrical short circuit occurring. The greenish residue is normally left behind from oxidation as a result of chemical reaction involving the copper wires.
