# LKK Auto Consultants Pte Ltd

## ADJUSTMENT ON REPAIR COST FOR VEHICLE NO. SMR 4220G

### PHOTOGRAPHS FOR VEHICLE NO. SMR 4220G

### INSPECTION

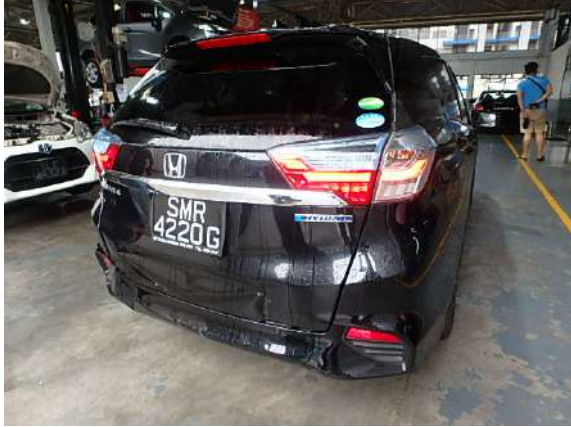
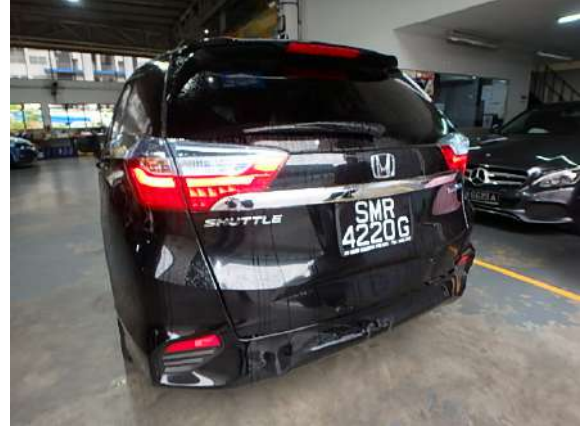
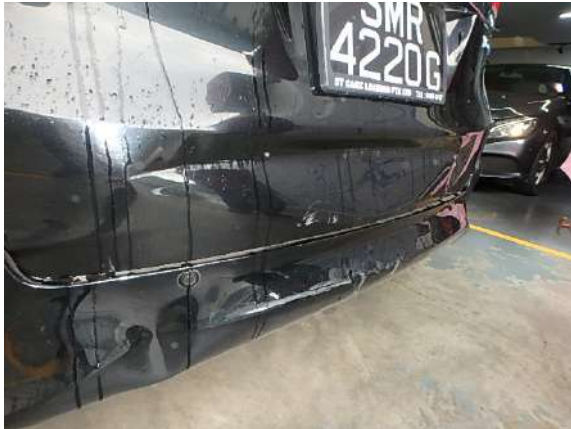
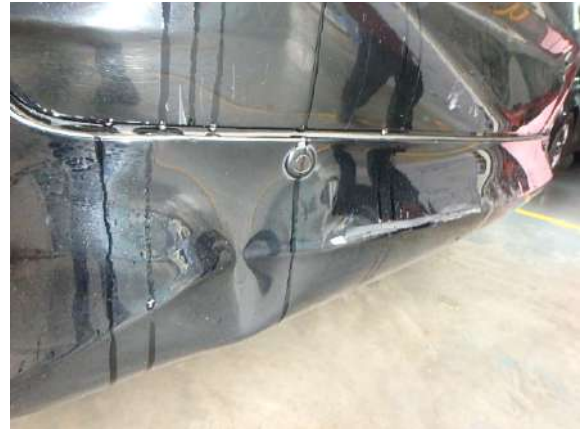
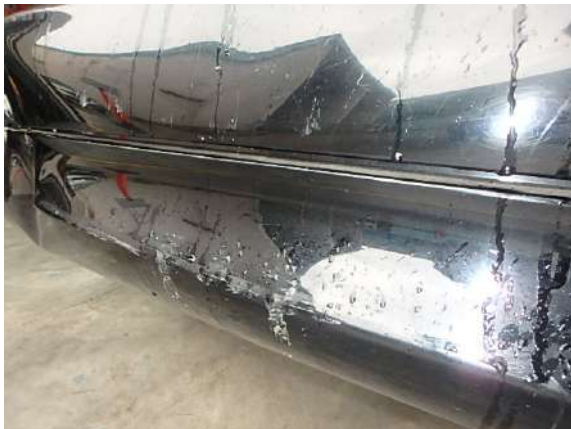
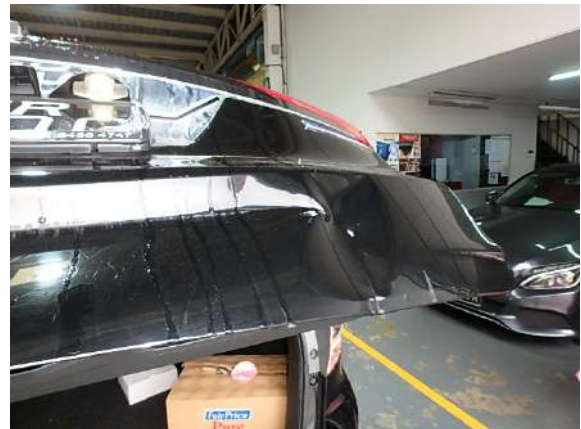
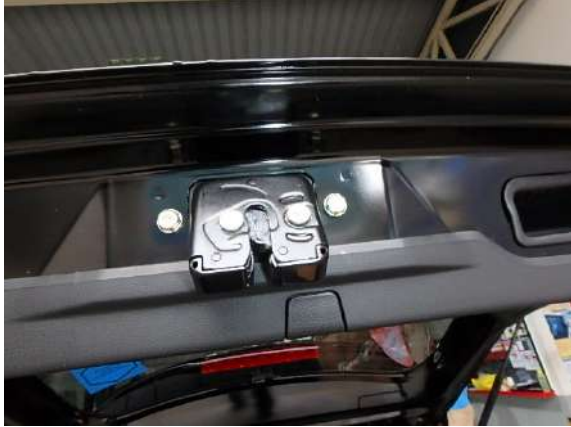
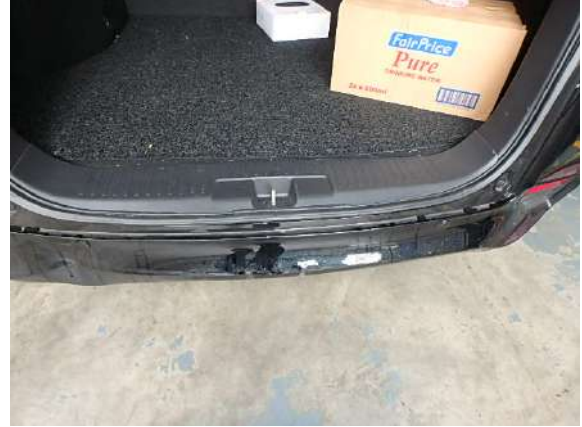
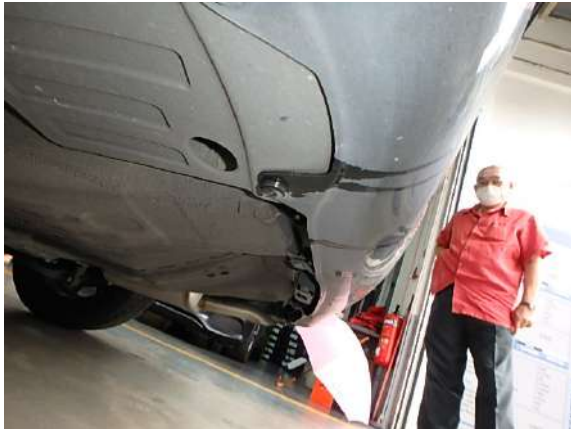
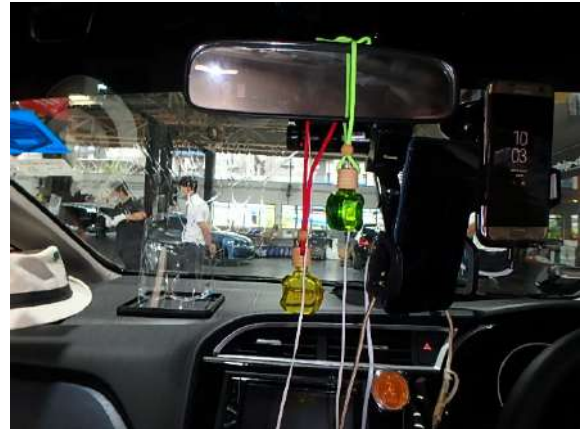
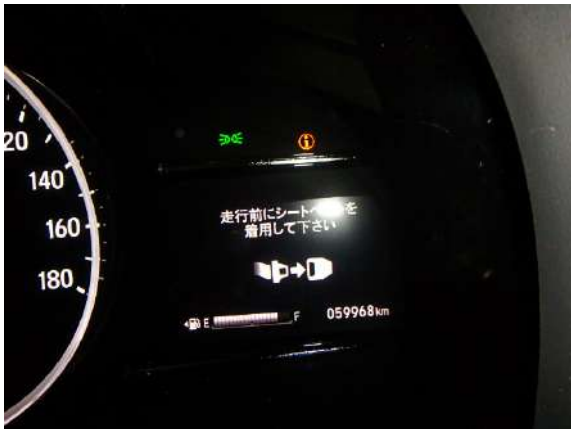
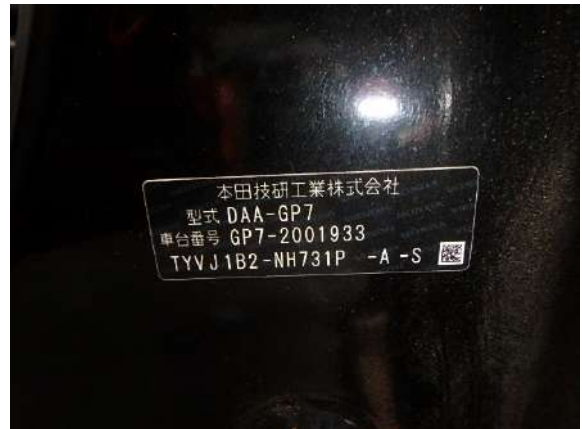
<b>4. Description of Damages</b>				
THE VEHICLE SUSTAINED DAMAGES AT THE REAR PORTION. DAMAGES SEE DETAILS.				
<b>5. General Information</b>				
Accident Date	10/08/2020		Inspection Date	12/08/2020
Survey held at	OPTIMA WERKZ PTE LTD 6, KUNG CHONG ROAD SINGAPORE 159143			
<b>5a. Remarks</b>				
A)THE INSPECTION WAS CONDUCTED ON A"WITHOUT PREJUDICE" BASIS. B)IN ACCORDANCE TO YOUR INSTRUCTIONS, WE HAVE NOT AUTHORISED REPAIRS.				
<b>5b. Estimate Days of Repair</b>				
ESTIMATED NORMAL PERIOD FOR REPAIR:			<b>4 Working Days</b>

Qty	Description of Parts	Condition	Estimate By Workshop (\$)	Our Adjusted (\$)
<b><u>REPLACEMENT OF PARTS</u></b>				
1	REAR TAILGATE	BENT	986.90	986.90
1	REAR TAILGATE "SHUTTLE" EMBLEM	NECESSARY	46.60	46.60
1	REAR TAILGATE "HYBRID" EMBLEM	NECESSARY	56.20	56.20
8	REAR TAILGATE INNER TRIM CLIPS @\$5.50	NOT NECESSARY	44.00	-
1	REAR WINDSCREEN MOULDING	NECESSARY	68.70	68.70
1	REAR BUMPER	BUCKLED	783.70	783.70
8	REAR BUMPER CLIPS @\$5.80	NECESSARY	46.40	46.40
1	REAR TAILLAMP RH (CRACKED)	NOT CONSISTENT WITH THE IMPACT	580.20	-
1	REAR END PANEL (NPA)	TO REPAIR SEE LABOUR	-	-
	LESS 20% DISCOUNT		-522.54	-397.70
			2,090.16	1,590.80
<b><u>SPECIAL NETT ITEMS</u></b>				
1	REAR WINDSCREEN SEALANT (SN)	NECESSARY	60.00	40.00
2	REAR WINDSCREEN STOPPER @\$15.00 (SN)	NECESSARY	30.00	30.00
1	REAR BUMPER REVERSE SENSOR (SN)	DENTED	350.00	200.00
