# PRECISION APPRAISAL SERVICES

## AUTOMOBILE INSPECTION REPORT

Assigned By : As above  
Accident Date : 06 October 2019  
Assignment Date : 07 October 2019  
Inspection Date : 07 October 2019  
Our Reference No. : PAS/LYM/191214/TP

| Registration No. | : GBB 6911 Y | Mileage | : 281272 | Km/h |

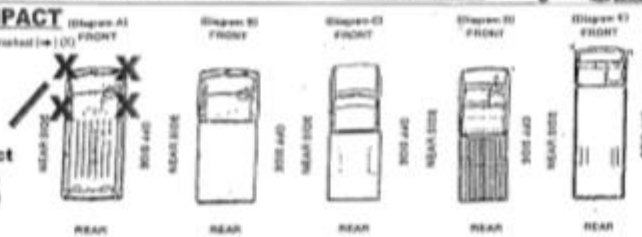
The vehicle sustained impact on its N/s Front. (see Diagram A)

Both front doors and pillars and step panel, front bumper and inner member, both front corner panels and chassis, front centre panel and grille were dented.
