Your Ref : D20003185MFSH  
Our Ref : CS4/FCI20008373/N

14 August 2020

**TECHNICAL INVESTIGATION REPORT OF FIRE INCIDENT INVOLVING THE  
INSURED VEHICLE SHC 3097R ON 10 AUGUST 2020**

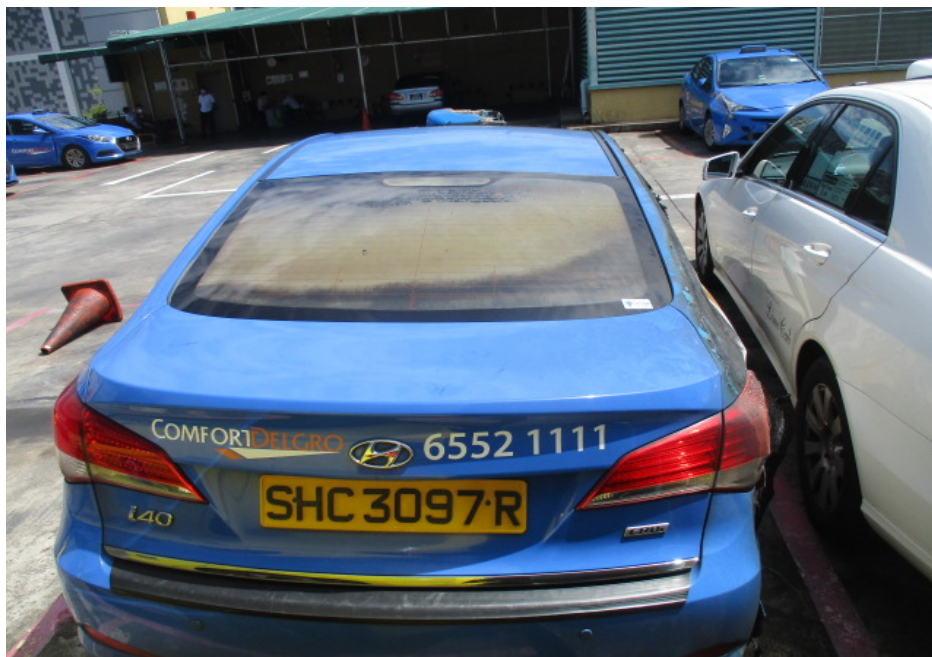
**Photo 1** shows the general view of the rear portion of the Insured Vehicle at the time of our inspection. The rear portion of the Insured Vehicle was relatively unaffected by the fire.

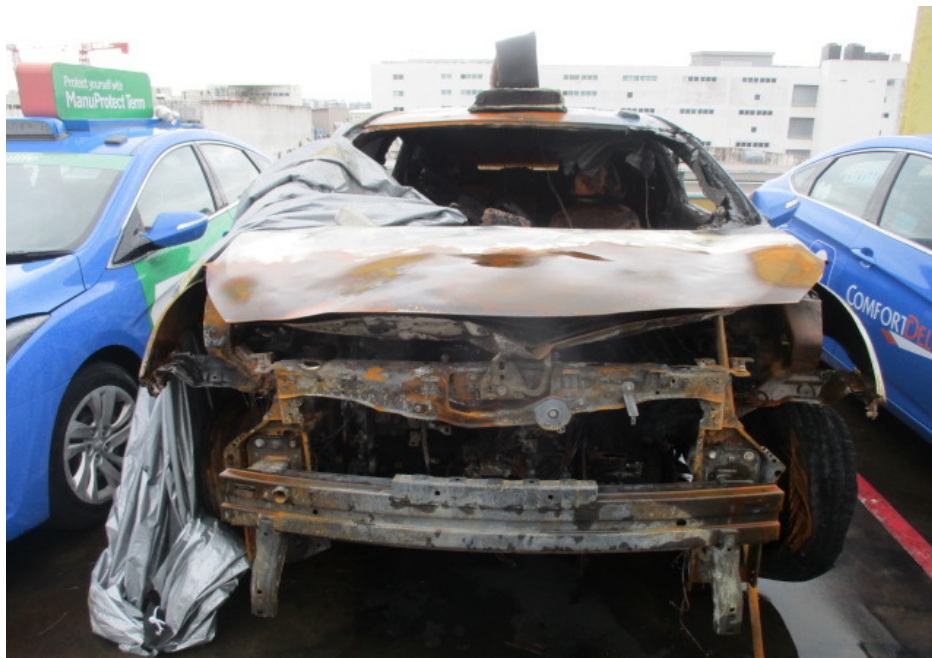
4. The Insured Vehicle was noted to have sustained fire damage that was confined to its frontal portion and right body. The entire engine compartment of the Insured Vehicle was observed to be severely burnt while the interior compartment was observed to be severely affected by the fire.
5. The fire had resulted in the body parts at the frontal portion and right body of the Insured Vehicle to be burnt. This had included its front bumper, front bonnet, front support panel, front grille, front headlamps, front windscreen, right rims, right body and right tyres amongst others. See photos 1 – 6 below.

**Photo 2** shows the general view of the frontal portion of the Insured Vehicle at the time of our inspection. The fire damage to the Insured Vehicle was confined to its frontal portion and right body. The entire engine compartment of the Insured Vehicle was observed to be severely burnt while the interior compartment was observed to be severely affected by the fire.

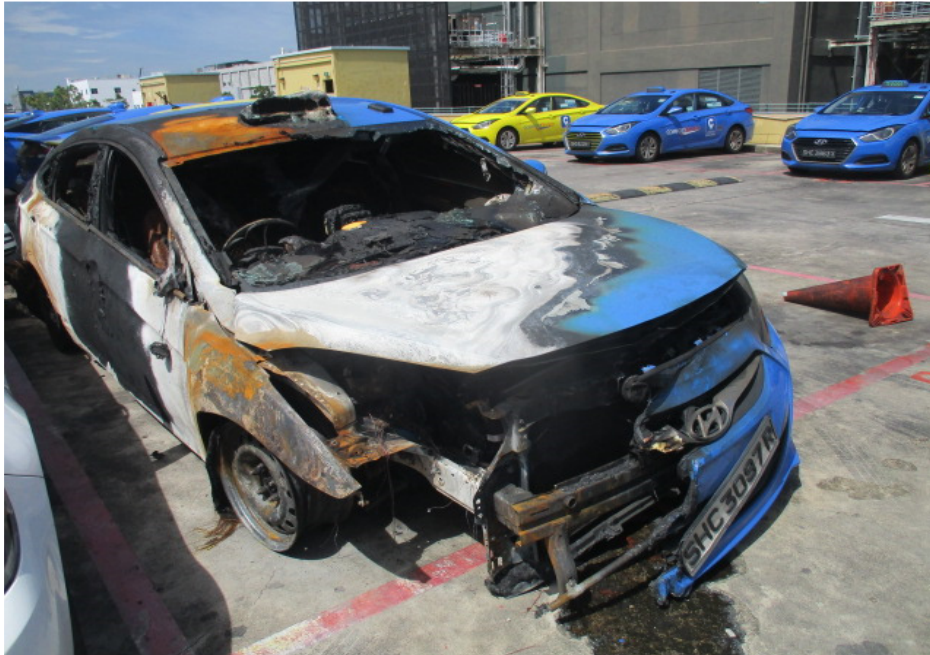
**Photo 3** shows the closer view of the right front body of the Insured Vehicle at the time of our inspection. The fire damage to the Insured Vehicle was confined to its frontal portion and right body. Its front bumper, front bonnet, front support panel, front grille, front headlamps, front windscreen, right rims, right body and right tyres were amongst the body parts that were found to have been affected by the fire.

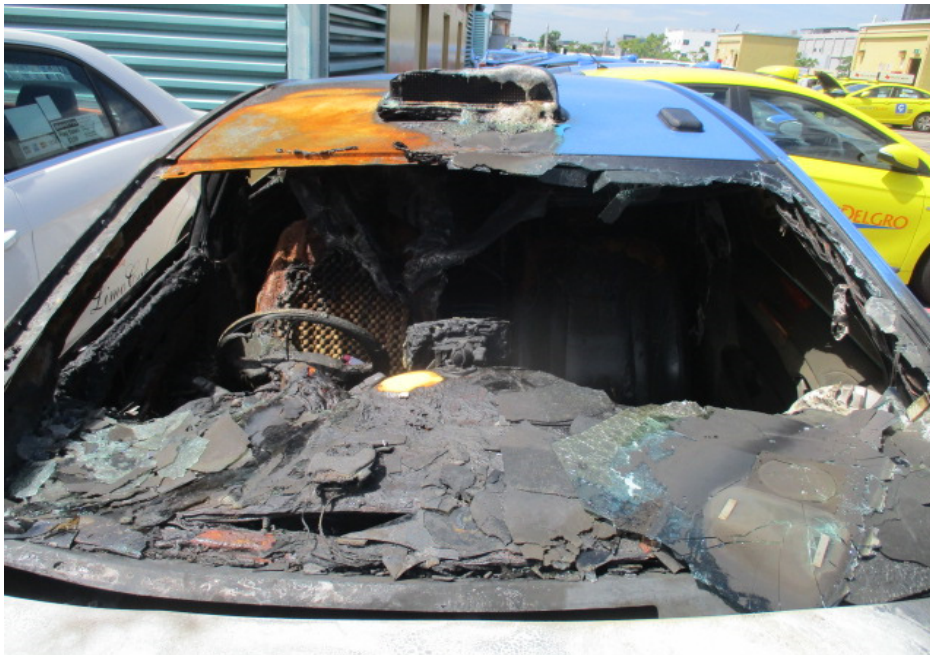
**Photo 4** shows the general view of the front windscreen of the Insured Vehicle at the time of our inspection. The fire damage to the windscreen was extensive.

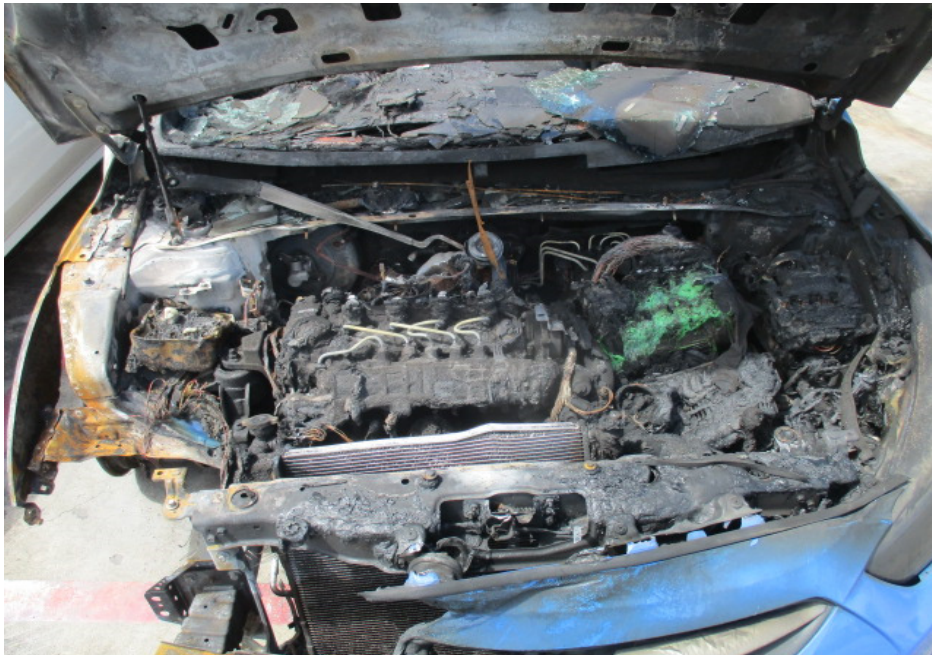
**Photo 5** shows the engine compartment of the Insured Vehicle at the time of our inspection. The entire engine compartment of the Insured Vehicle was observed to be severely burnt. Most of the parts inside the engine compartment were found to be burnt and/or melted as a result of the fire.

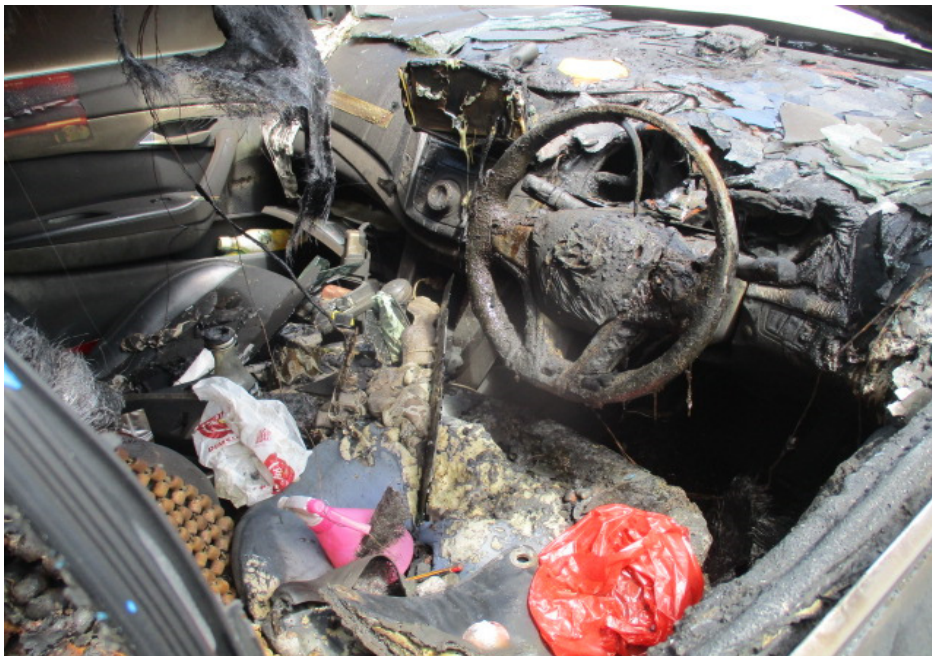
**Photo 6** shows the interior compartment of the Insured Vehicle, which was severely affected by the fire.

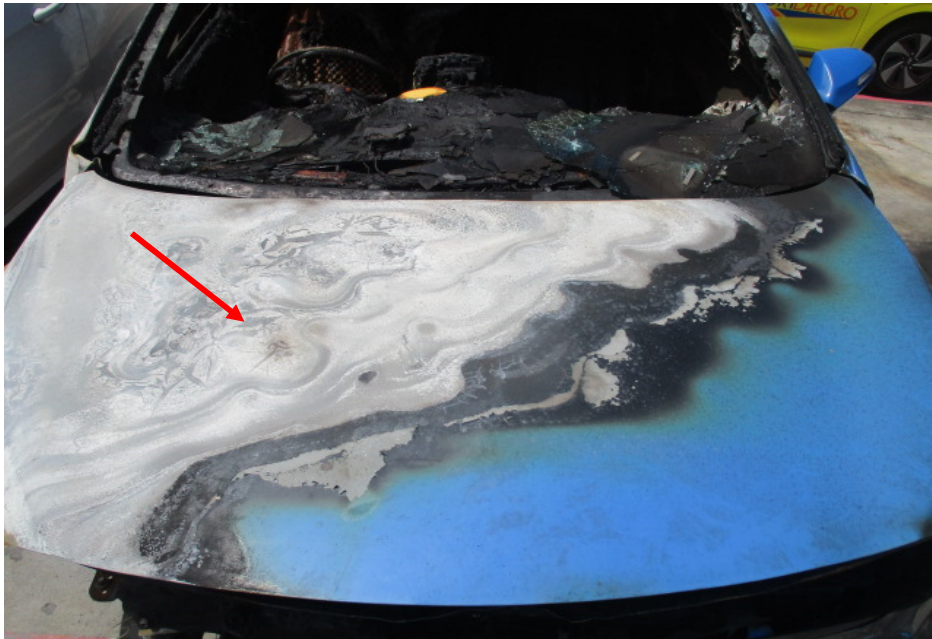
7. For this particular case, the fire appears to have originated within the engine compartment of the Insured Vehicle, somewhere around the right portion of the engine compartment. This can be determined due to the nature of the fire damage which was more extensive at the right portion, the burn pattern and the high heat intensity burn marks (whitish burn marks) found on the right portion of the front bonnet of the Insured Vehicle and also the rust that had developed on the underside of the front bonnet, at the right portion.

8. The whitish burn marks are a result of exposure to prolonged heat intensity. Rust would normally start to develop around these areas soon after a fire as prolonged exposure to high heat intensity usually causes steel/metal material body parts to be exposed to natural environmental condition. The rust that had developed on the underside of the front bonnet, around the right portion, is an indication that the right portion of the engine compartment had sustained exposure to prolonged high heat intensity. See photos 7 & 8 below.

**Photo 7** shows the burn pattern and whitish burn marks that were found on the right portion of the front bonnet of the Insured Vehicle (arrowed). Such whitish burn marks are a result of exposure to prolonged heat intensity, which may indicate where the fire had started. Rust would also begin to develop on these areas soon after the fire.

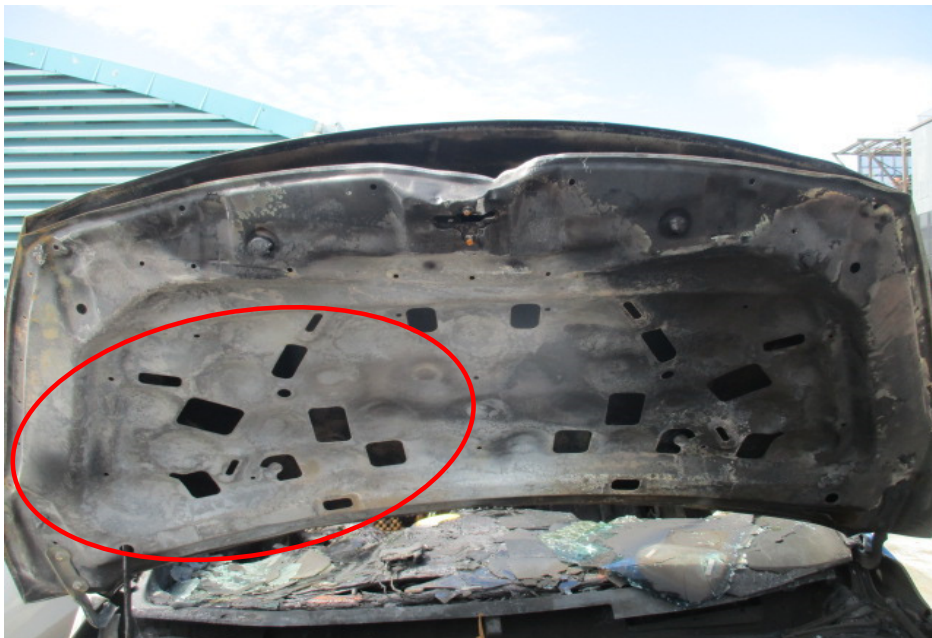
**Photo 8** shows the rust that had developed on the underside of the front bonnet, around the right portion (circled). The development of rust is an indication that this area was subjected to prolonged exposure to high heat intensity, which had caused the steel/metal material of the front bonnet to be exposed to natural environmental condition. Hence the fire to the Insured Vehicle can be determined to have originated towards the right portion of the engine compartment.

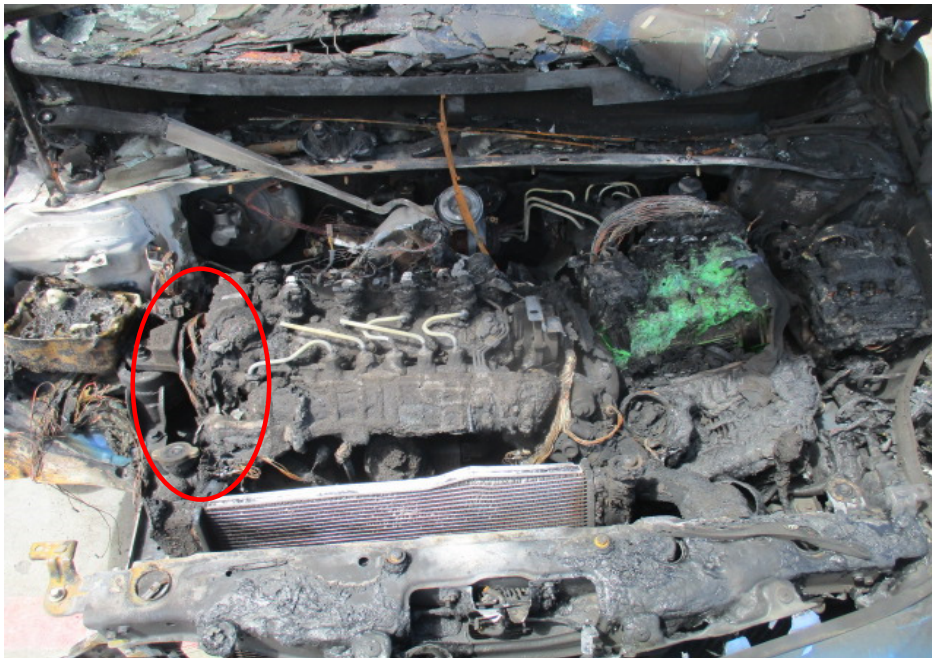
9. Upon closer examination of the right portion of the engine compartment, which was where the fire to the Insured Vehicle had likely started, we had found greenish residue on several burnt stretches of original factory fitted wirings around the centre right portion of the engine compartment. The presence of such greenish residue indicates internal heating of copper wires, a sign of an electrical short circuit occurring. The greenish residue is normally left behind from oxidation as a result of chemical reaction involving the copper wires. This physical evidence would then appear to suggest that the cause of fire to the Insured Vehicle could have possibly been due to electrical in nature. See photos 9 - 12 below.

**Photo 9** shows the original factory fitted wirings around the right portion of the engine compartment, which is in the immediate vicinity where the fire to the Insured Vehicle had likely started. We had found greenish residue on several burnt stretches of these wirings (circled). The presence of such greenish residue indicates internal heating of copper wires, a sign of an electrical short circuit occurring. The greenish residue is normally left behind from oxidation as a result of chemical reaction involving the copper wires.

27. Having investigated and technically analysed the damages of burnt nature to the Insured Vehicle, we are of the view that the cause of fire to the Insured Vehicle was of electrical in nature. For this particular case, the fire had originated along the original factory fitted wirings inside the engine compartment, somewhere around the right portion of the engine compartment.
28. We did not find any evidence which had suggested that the cause of fire to the Insured Vehicle was due to poor maintenance and/or recurring electrical problem.

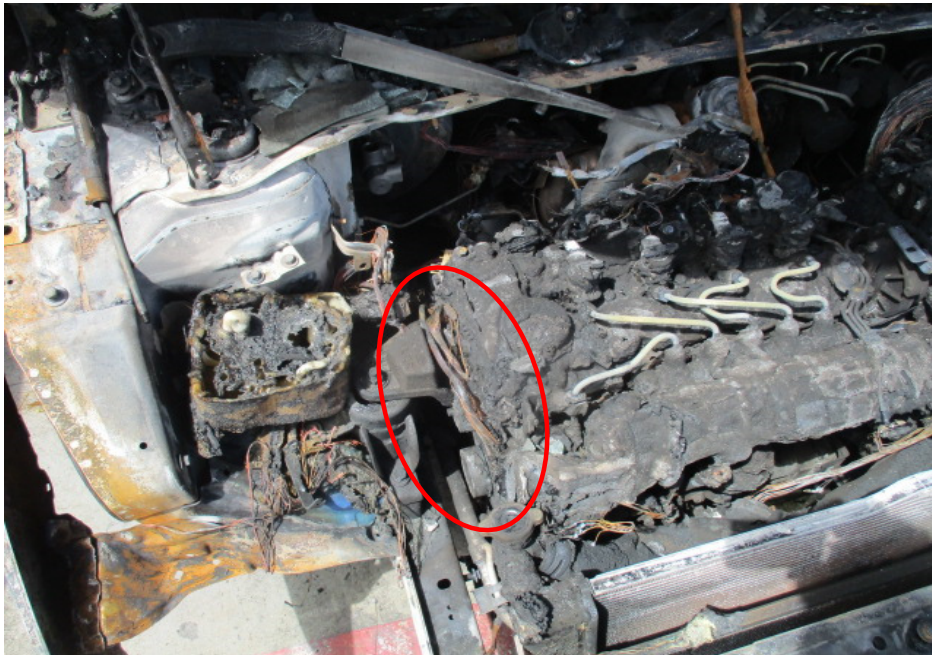
**Photo 10** shows a closer view of the greenish residue found on some of the burnt stretches of original factory fitted wirings (arrowed). The presence of such greenish residue suggests occurrence of an electrical short circuit.

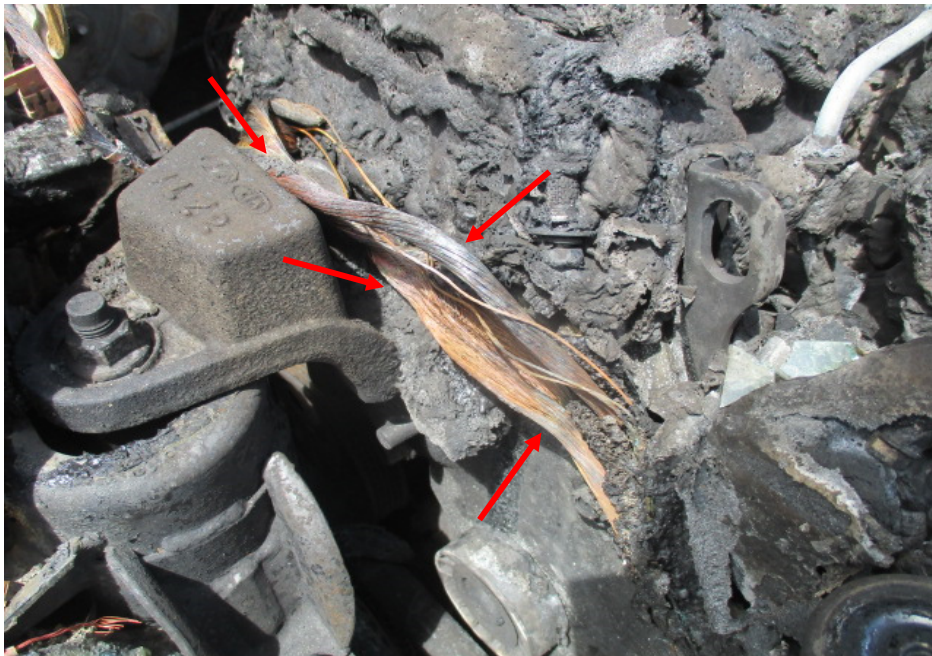
**Photo 11** shows a closer view of the greenish residue found on some of the burnt stretches of original factory fitted wirings (arrowed). The presence of such greenish residue suggests occurrence of an electrical short circuit.

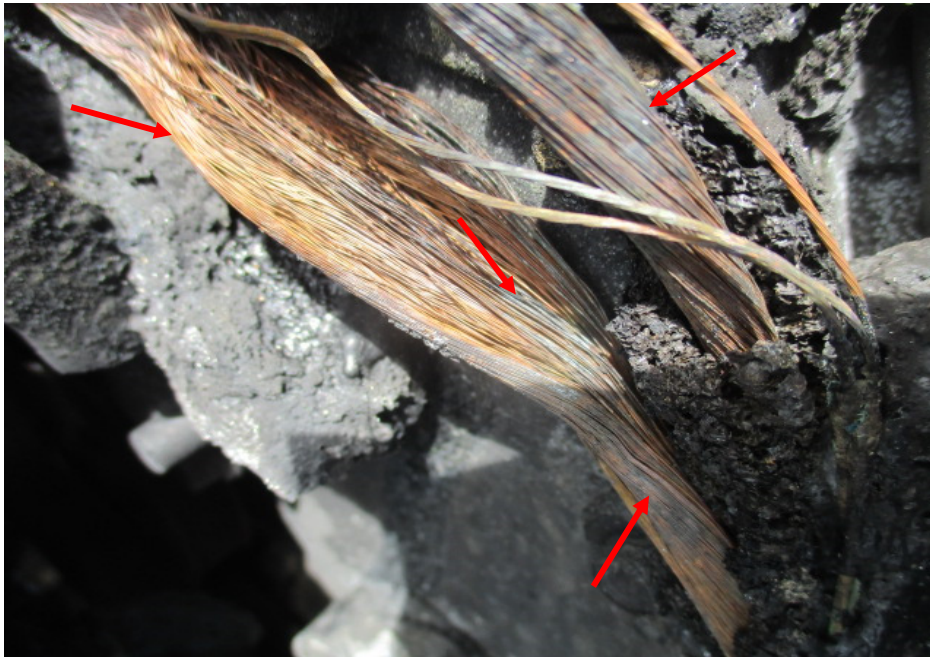
**Photo 12** shows a close up view of the greenish residue found on some of the burnt stretches of original factory fitted wirings (arrowed). The presence of such greenish residue suggests occurrence of an electrical short circuit.

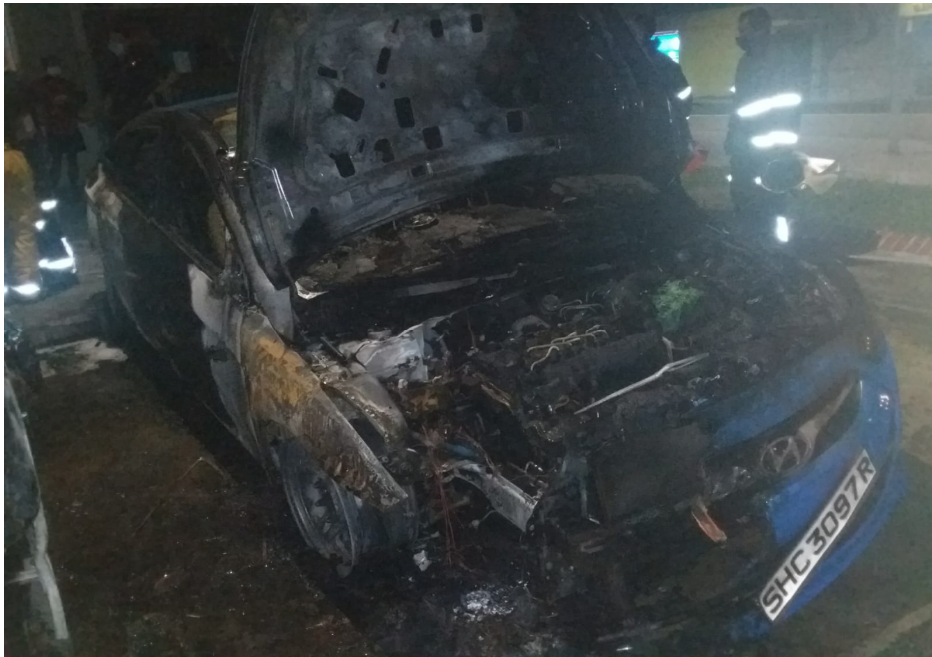
**Photo 13** shows the Insured Vehicle after the fire was extinguished by the SCDF.

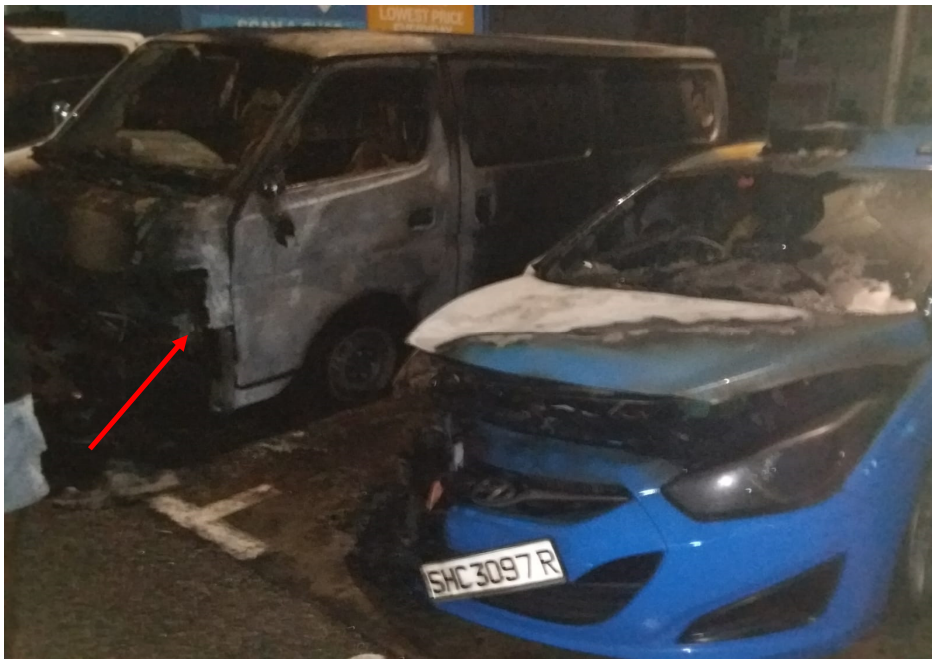
**Photo 14** shows Insured Vehicle after the fire was extinguished. A motor van parked on the right side of the Insured Vehicle had sustained damage of heat nature at its left side (arrowed).
