Date of accident : 07/08/2020

Vehicle number : GBH8242A

Vehicle mark / model : TOYOTA HIACE 2.8 MANUAL

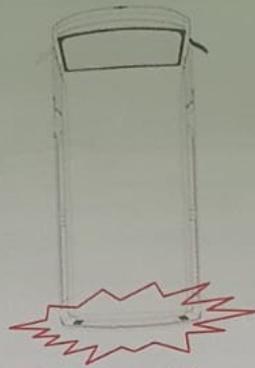
This vehicle GBH8242A in our workshop repair was sustain at the **REAR CENTRE PORTION SIDE** damage .

NO	LABOUR DISCRPTION	LABOUR PRICE
1	Labour for dismantle, panel beating, reshape and replacement tailgate assy, rear end panel, rear bumper and all affected areas	\$ <del>600</del> 750.00 700
2	Labour for spray paint tailgate, end panel and all affected areas	\$ 500.00
3	Labour for replace and distance testing reverse sensor	\$ 60 <del>80.00</del>
4	Labour for remove and replace rear windscreen and conduct water leaking test	\$ 120 <del>180.00</del>
5	Labour for perform anti - rust treatment on affected areas	\$ 80 <del>180.00</del>
Total labour		\$ 1,690.00
Parts + labour		\$ 9,121.50
Total amount		\$ 10,811.50
