Your Ref: TP/IP/27739/2020  
Our Ref : CI/TPD20008422/P

13<sup>th</sup> August 2020

### **Fatal Accident Investigation Team**

### **MECHANICAL INSPECTION REPORT OF MOTOR TAXI SHB 585Z**

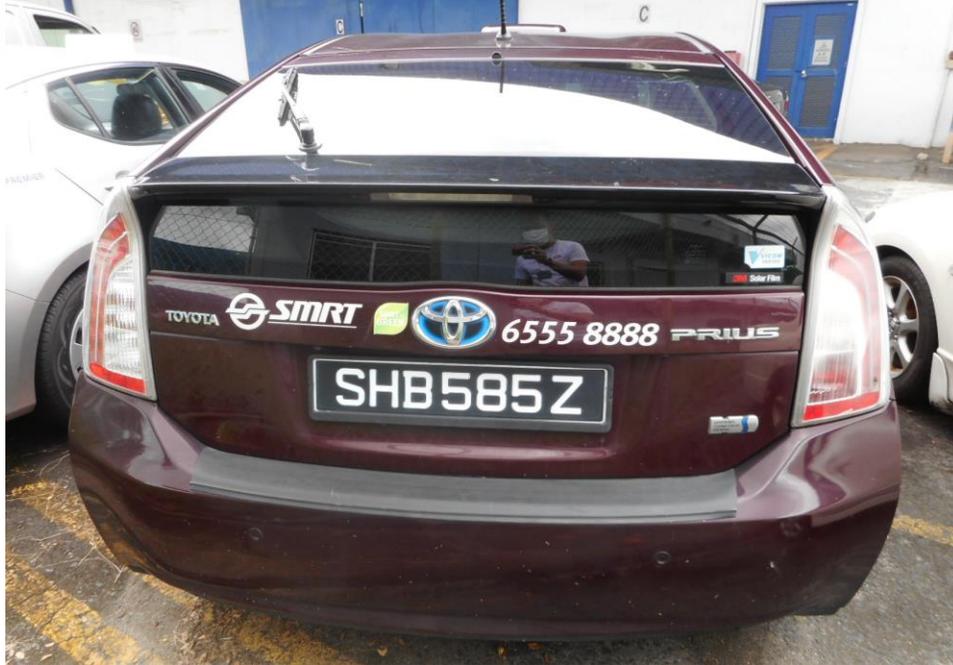
**Photo 1** shows a general view of the Motor Taxi's rear body at the time of my inspection. The rear portion of the Motor Taxi was observed to have been undamaged by the accident.

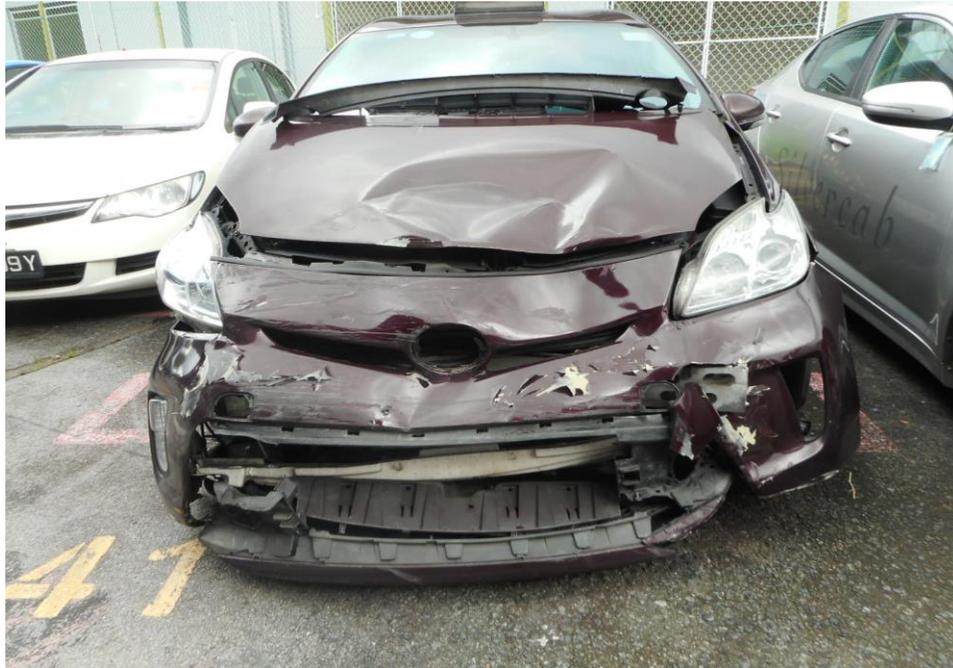
4. The mileage of the Motor Taxi was not recorded due to damage to the ignition system and engine system as a result of the accident.
5. The Motor Taxi was observed to have sustained damage at its front portion. Its front bonnet, front bumper, front left fender, front left and right headlamp was amongst the body parts and various components in the engine compartments were also damaged as a result of the accident.

**Photo 2** shows a general view of the Motor Taxi's front body at the time of my inspection. The Motor Taxi was observed to have sustained damage at its front portion. Its front bonnet, front bumper, front left fender, front left and right headlamp was amongst the body parts and various components in the engine compartments were also damaged as a result of the accident.

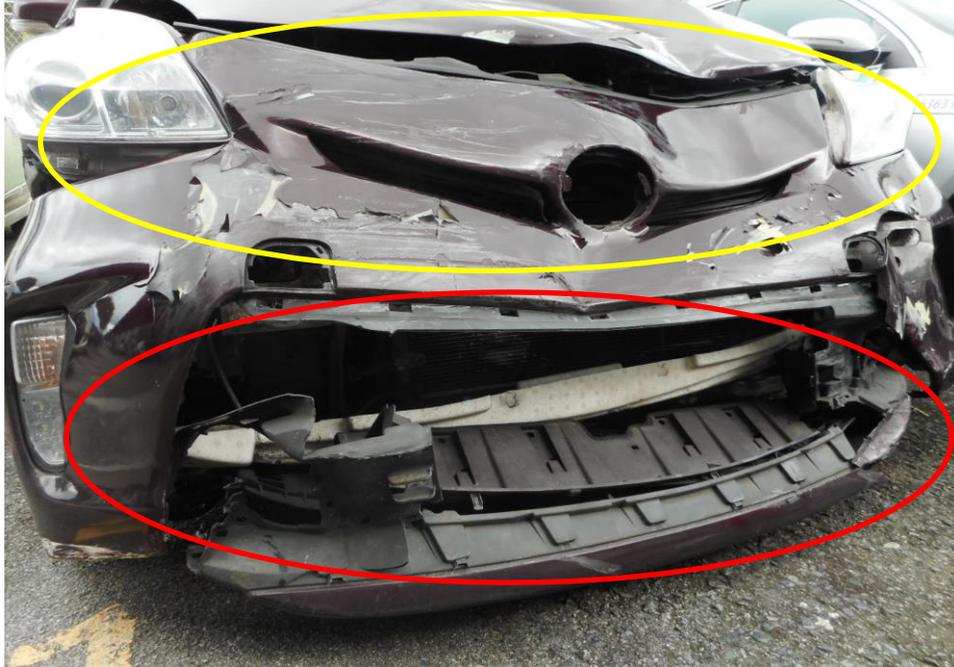
**Photo 3** shows the close up view of the Motor Taxi's front body at the time of my inspection. The Motor Taxi was observed to have sustained damage at its front portion. Its front bonnet (yellow circle) and front bumper (red circle) was amongst the body parts and various components in the engine compartments were also damaged as a result of the accident.

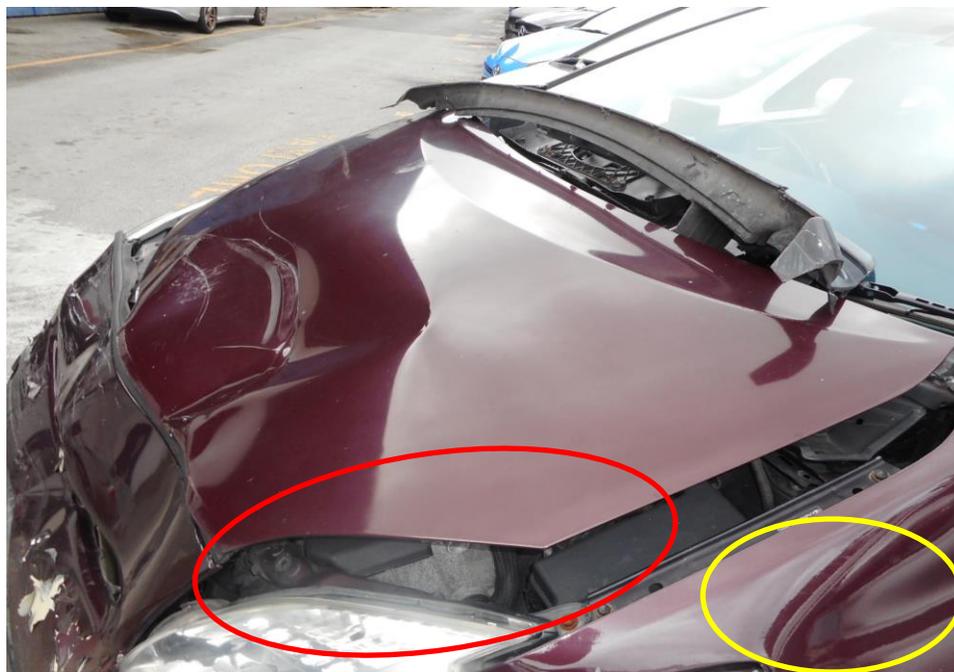
**Photo 4** shows a general view of the Motor Taxi's engine compartment at the time of my inspection. The Motor Taxi was observed to have sustained damage at its front portion. Its front left fender (yellow circle) was amongst the body parts and various components (red circle) in the engine compartments were also damaged as a result of the accident.

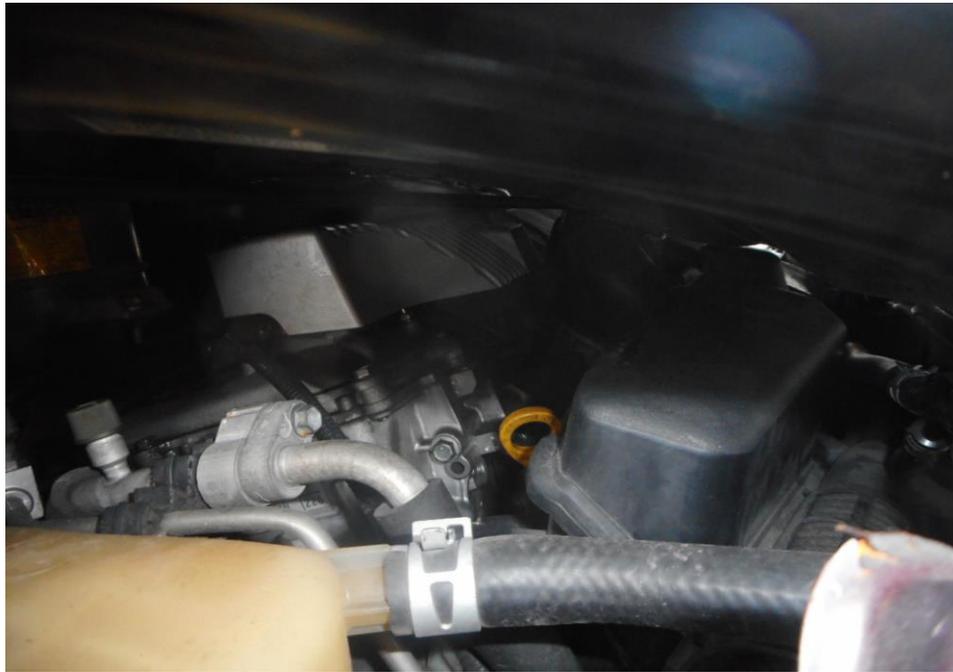
**Photo 5** shows a close up view of the Motor Taxi's engine compartment at the time of my inspection. The Motor Taxi was observed to have sustained damage at its front portion. Various components in the engine compartments were also damaged as a result of the accident.

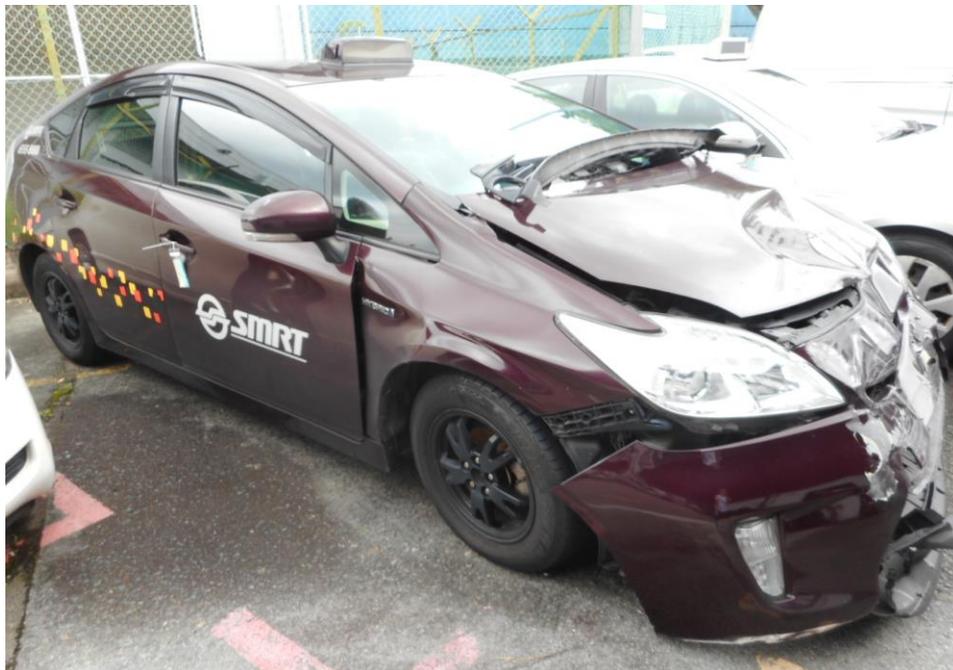
**Photo 6** shows a general view of the Motor Taxi's right body at the time of my inspection. The rear right portion of the Motor Taxi was observed to have been undamaged by the accident.

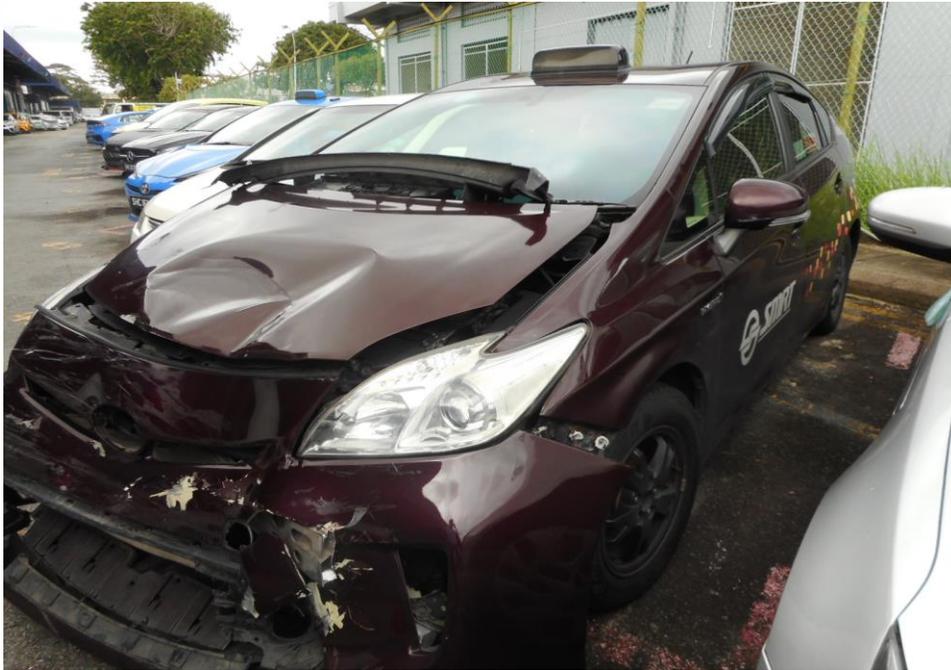
**Photo 7** shows a general view of the Motor Taxi's left body at the time of my inspection. The rear left portion of the Motor Taxi was observed to have been undamaged by the accident.

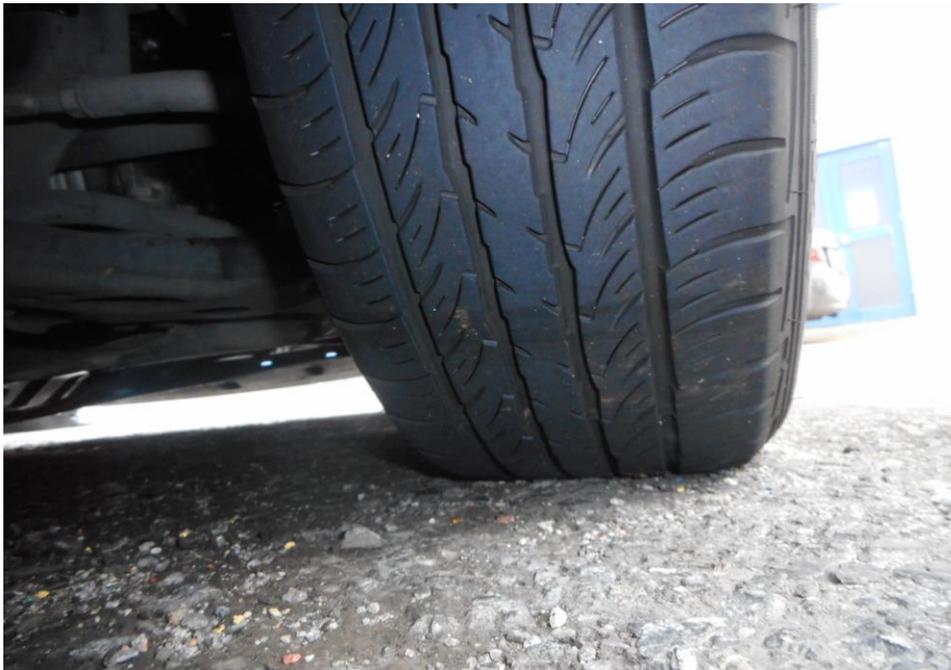
**Photo 8** shows the condition of the front right tyre of the Motor Taxi, which was observed to be in serviceable condition with remaining tread depth of approximately 5.5mm. The tyre, which was wrapped around alloy wheel rim, was also observed to be sufficiently inflated for vehicular operation.

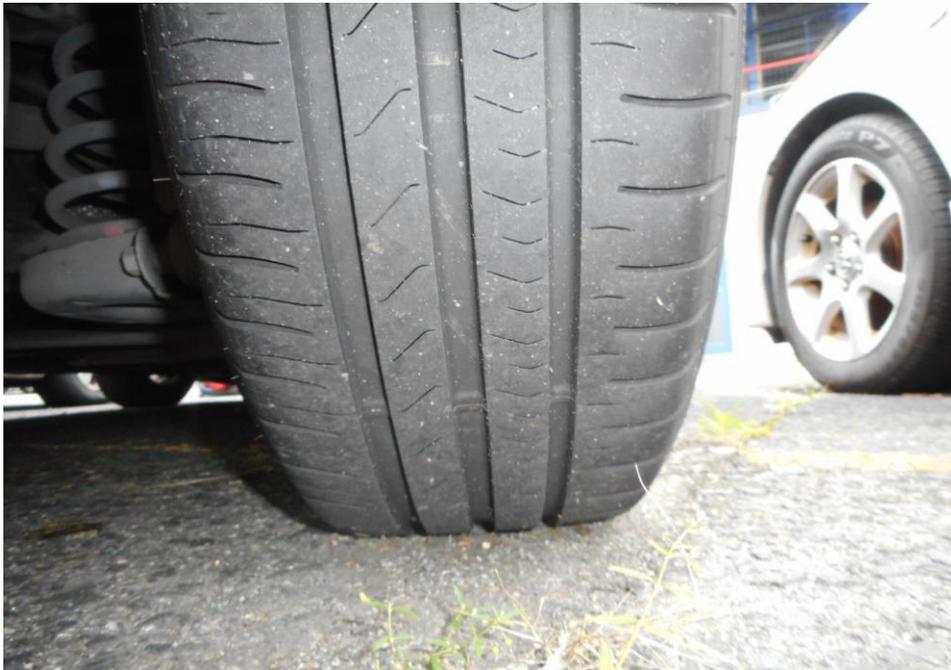
**Photo 9** shows the condition of the rear right tyre of the Motor Taxi, which was observed to be in serviceable condition with remaining tread depth of approximately 5.4mm. The tyre was also observed to be sufficiently inflated for vehicular operation with no tear, cut or burst mark(s).

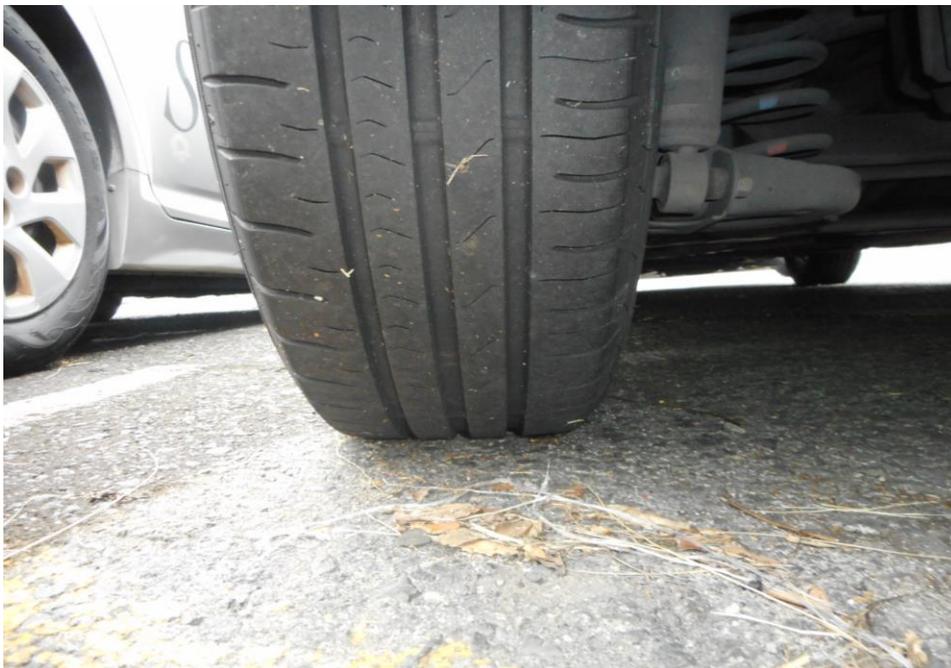
**Photo 10** shows the condition of the rear left tyre of the Motor Taxi, which was observed to be in serviceable condition with remaining tread depth of approximately 4.9mm. The tyre was also observed to be sufficiently inflated for vehicular operation with no tear, cut or burst mark(s).

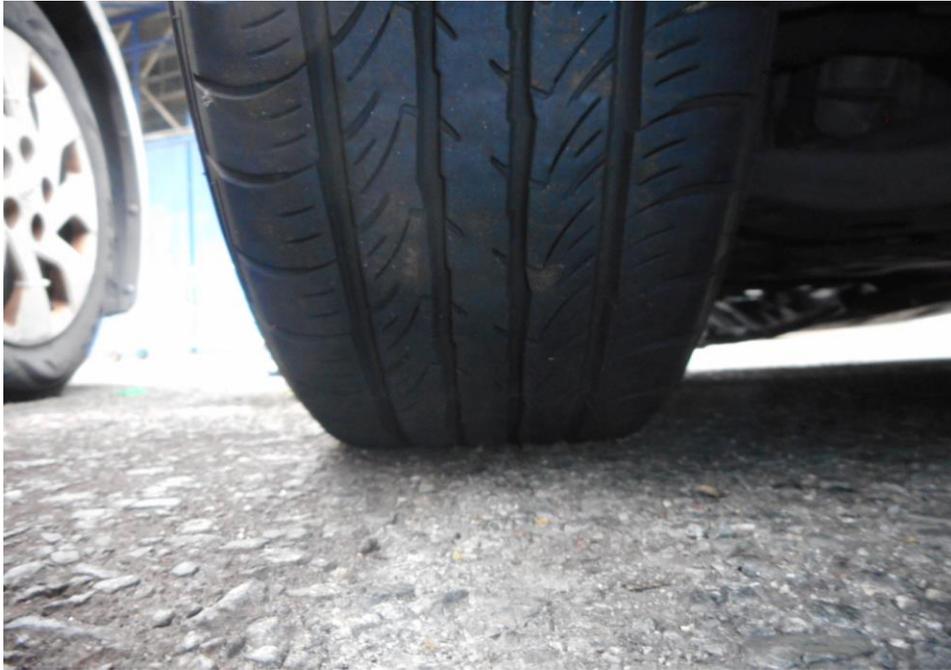
**Photo 11** shows the condition of the front left tyre of the Motor Taxi, which was observed to be in serviceable condition with remaining tread depth of approximately 5.2mm. The tyre was also observed to be sufficiently inflated for vehicular operation with no tear, cut or burst mark(s).

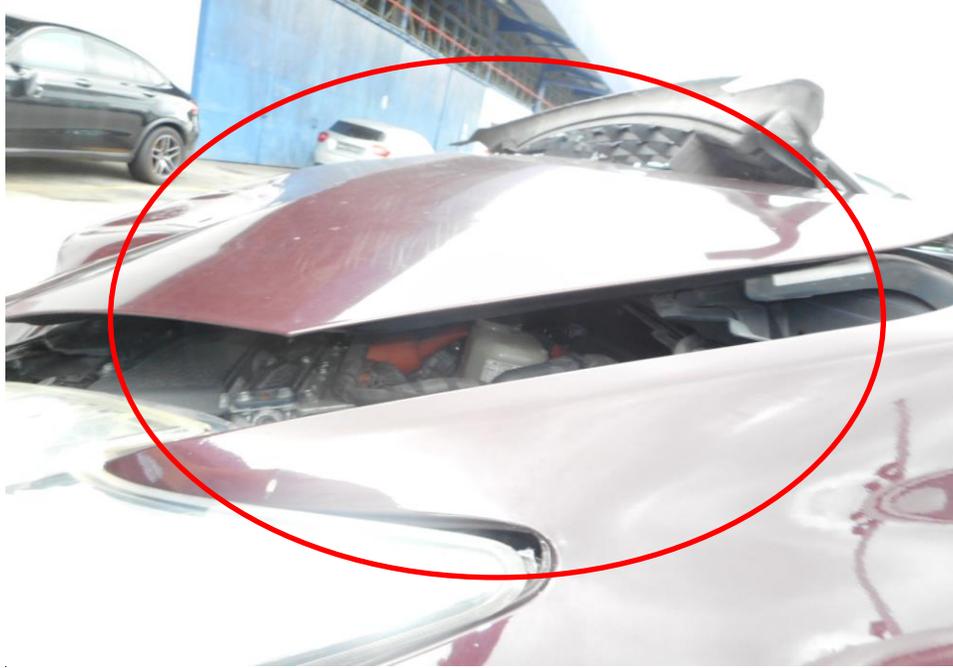
8. We were unable to raise the front bonnet of the Motor Taxi to conduct the examination of the Motor Taxi's engine compartment because the damage caused by the accident had resulted in the damages to the lock mechanism of the bonnet and the structure of the engine compartment. (unable to open)  
See photo 12 below

**Photo 12** shows a close up view of the damaged front bonnet lock mechanism and the structure of the engine compartment of the Motor Taxi at the time of my inspection resulting it unable to open a result of the accident (circled) (Unable to open)

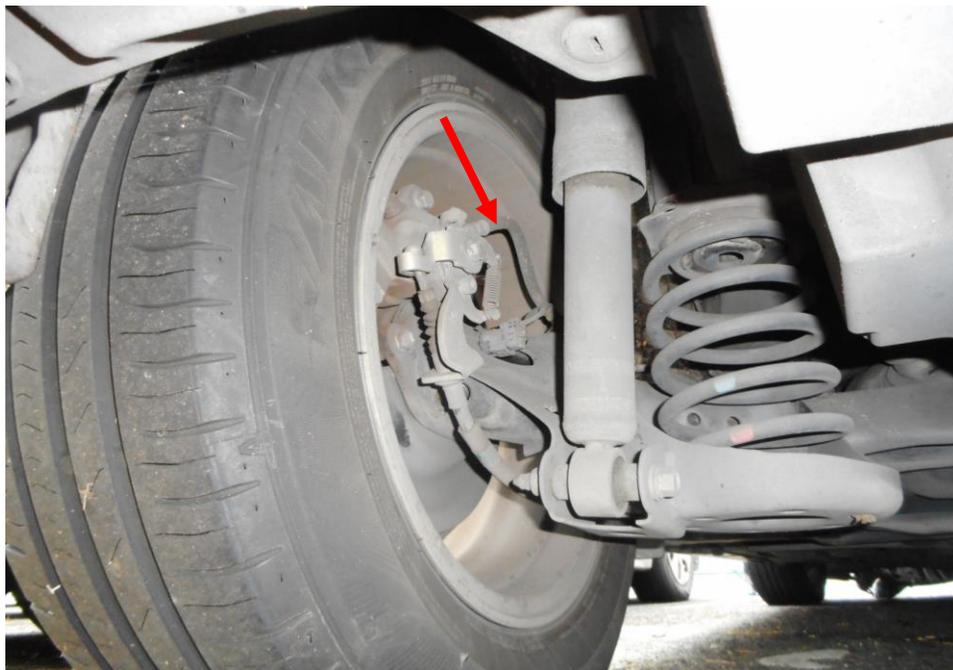
**Photo 13** shows the brake hose/pipe (arrowed) at the rear left wheel of the Motor Taxi. No leakage of brake fluid was observed. Visual examination of the various components of the braking system like the drum brake, brake booster, brake pedal etc. had revealed all to be intact and without visible damage.

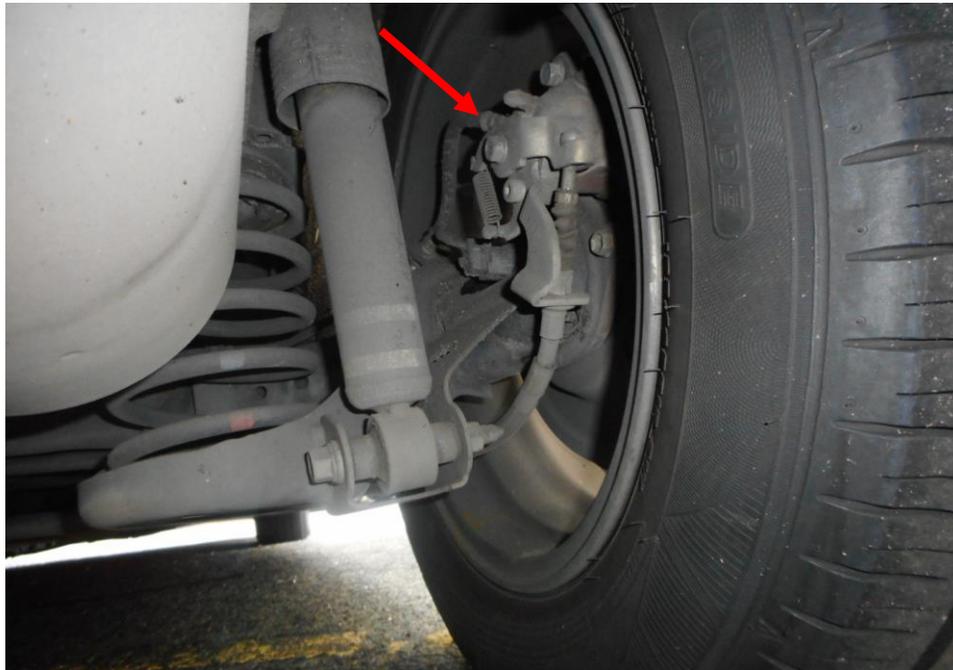
**Photo 14** shows the brake hose/pipe (arrowed) at the rear right wheel of the Motor Taxi. No leakage of brake fluid was observed. Visual examination of the various components of the braking system like the drum brake, brake booster, brake pedal etc. had revealed all to be intact and without visible damage.

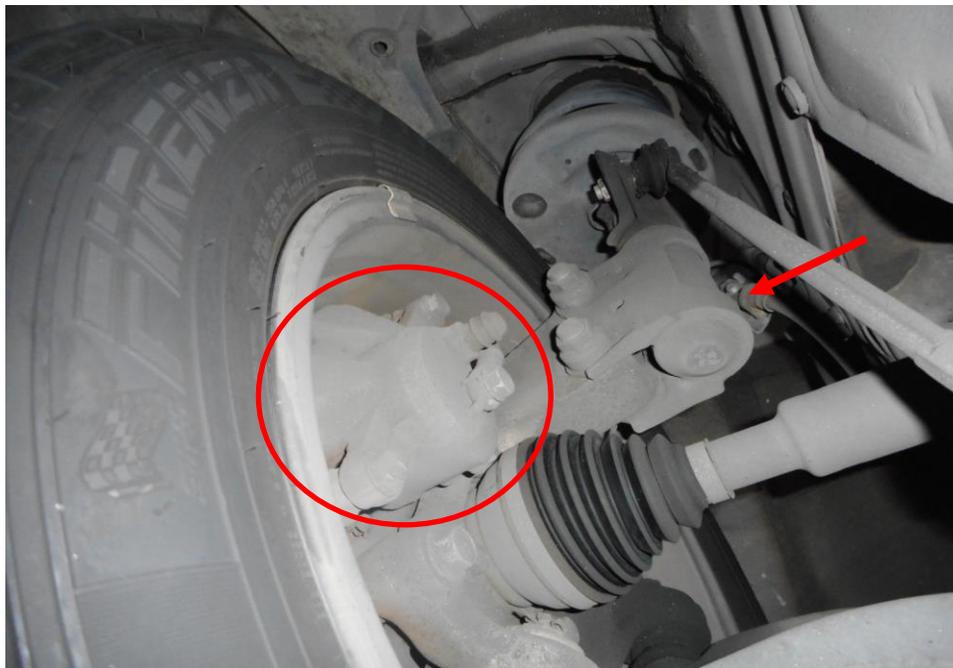
**Photo 15** shows the brake hose/pipe (arrowed) at the front right wheel of the Motor Taxi. No leakage of brake fluid was observed. Visual examination of the various components of the braking system like the brake caliper (circled), brake booster, brake pedal etc had revealed all to be intact and without visible damage at the time of accident. There was also no sign of fluid stain(s) observed on the various undercarriage components.

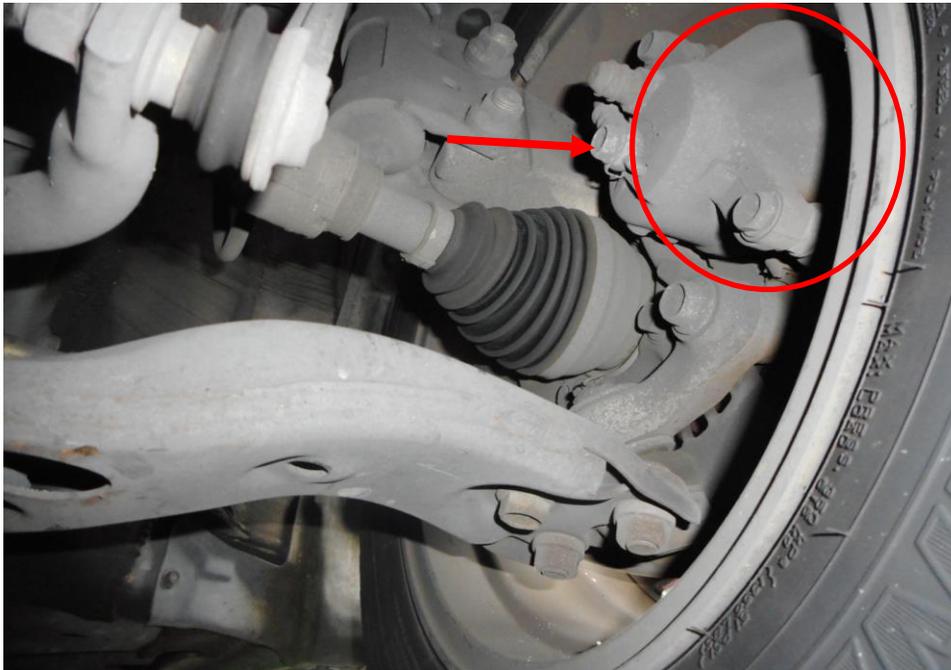
**Photo 16** shows the brake hose/pipe (arrowed) at the front left wheel of the Motor Taxi. No leakage of brake fluid was observed. Visual examination of the various components of the braking system like the brake caliper (circled), brake booster, brake pedal etc had revealed all to be intact and without visible damage at the time of accident. There was also no sign of fluid stain(s) observed on the various undercarriage components.

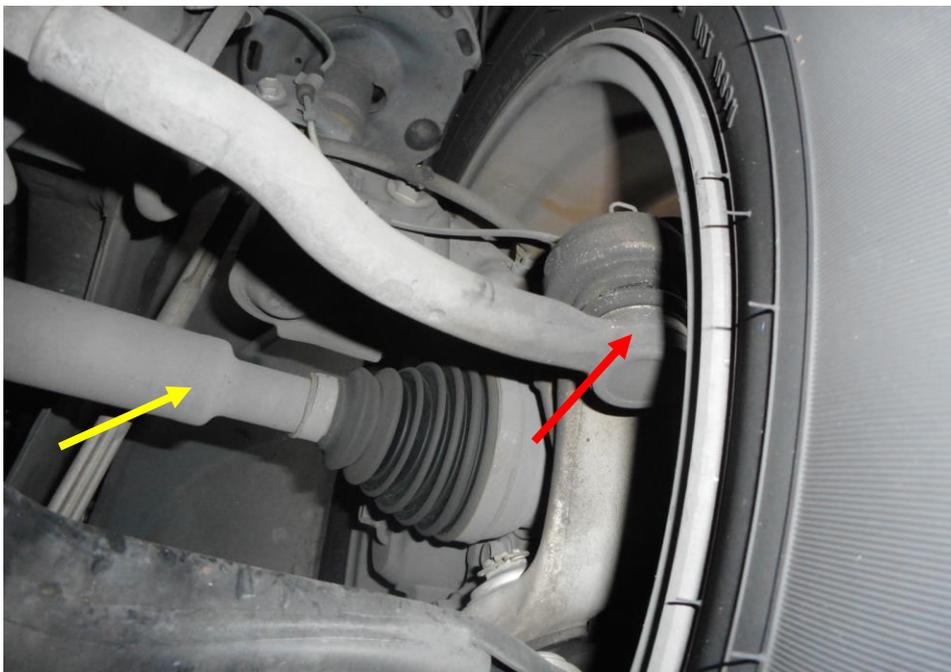
**Photo 17** shows the various undercarriage components at the front right wheel of the Motor Taxi, in particular the steering tie rod end (arrowed) and drive shaft (yellow arrow). The various steering components were all found to be intact, suggesting that the steering system of the Motor Taxi was likely to be in serviceable condition at the material time of accident. There was also no sign of fluid stain(s) observed on the various undercarriage components.

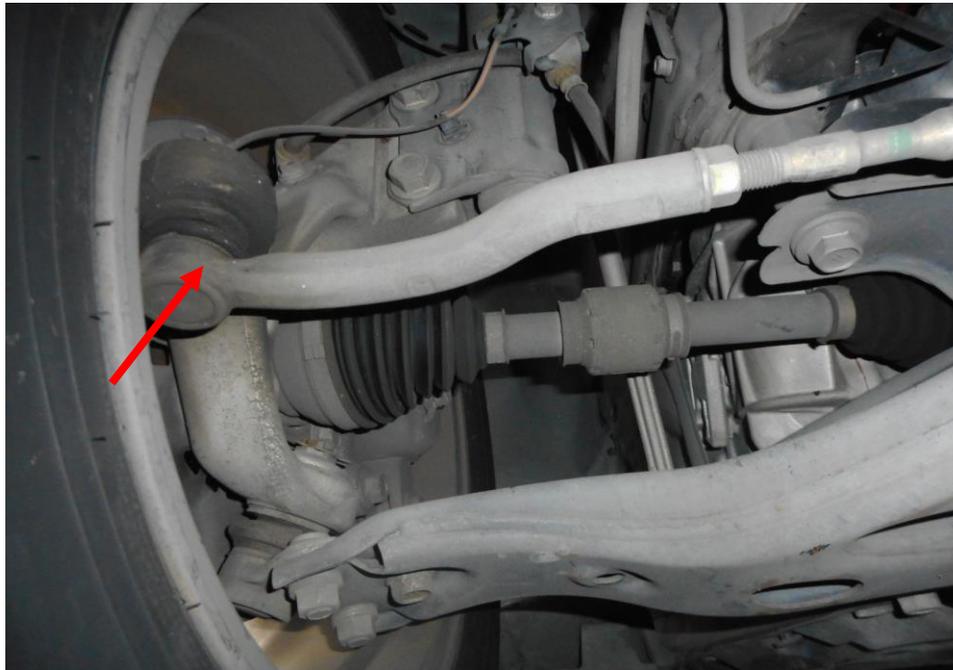
**Photo 18** shows the various undercarriage components at the front left wheel of the Motor Taxi, in particular the steering tie rod end (arrowed). The various Undercarriage components of the Motor Taxi were all found to be intact without any visible damage. There was also no sign of fluid stain(s) observed on the various undercarriage components.
