Your Ref: TP/IP/25603/2020  
Our Ref : CI/TPD20008423/P

**Fatal Accident Investigation Team**

**MECHANICAL INSPECTION REPORT OF MOTOR TRAILER XB 8044B**

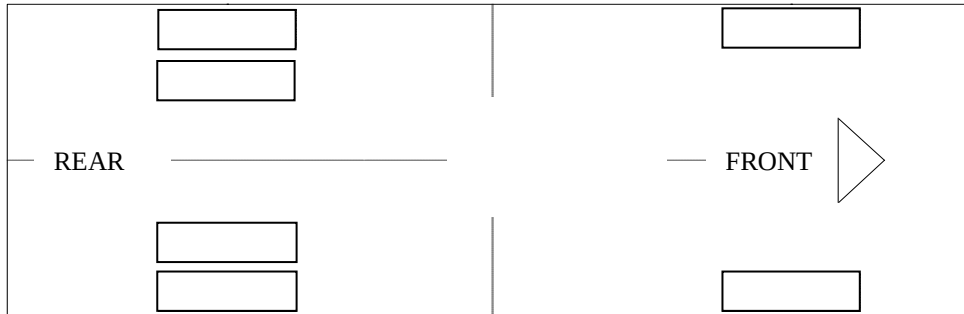
Fronway 295/80 R22.5 (10.3mm)

Greatwall 295/80 R22.5 (8.7mm)

Goldencrown 295/80 R22.5 (4.7mm)

Greatwall 295/80 R22.5 (8.5mm)

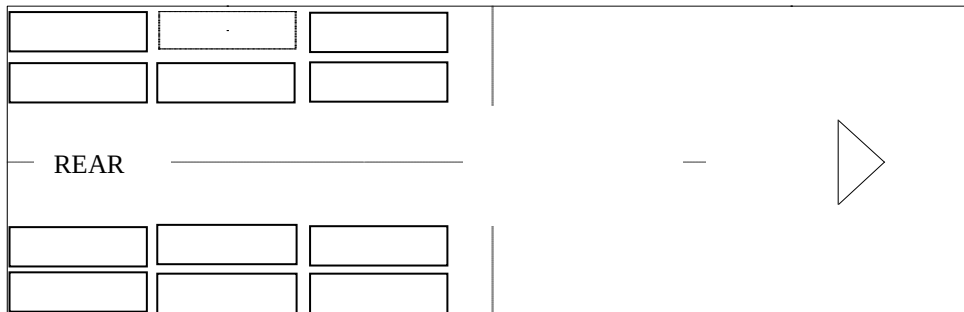
Linglong 10.00/ R15 (13.3mm)

Linglong 10.00/ R15 (9.9mm)

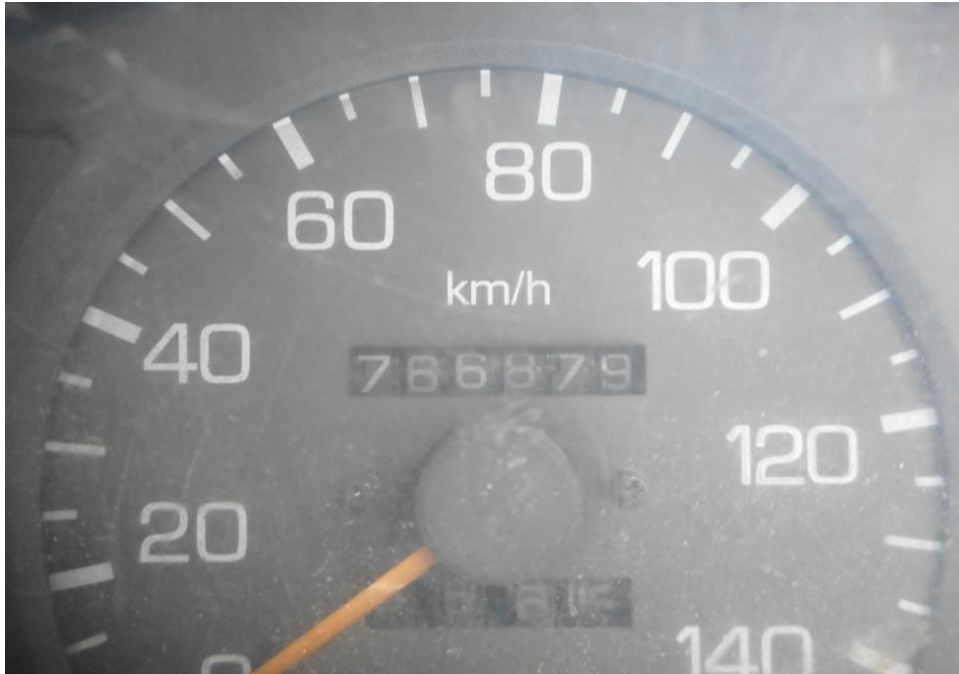
**Photo 1** shows a general view of the instrument cluster of the Motor Trailer at the time of my inspection. The mileage of the Motor Trailer was 766,879km

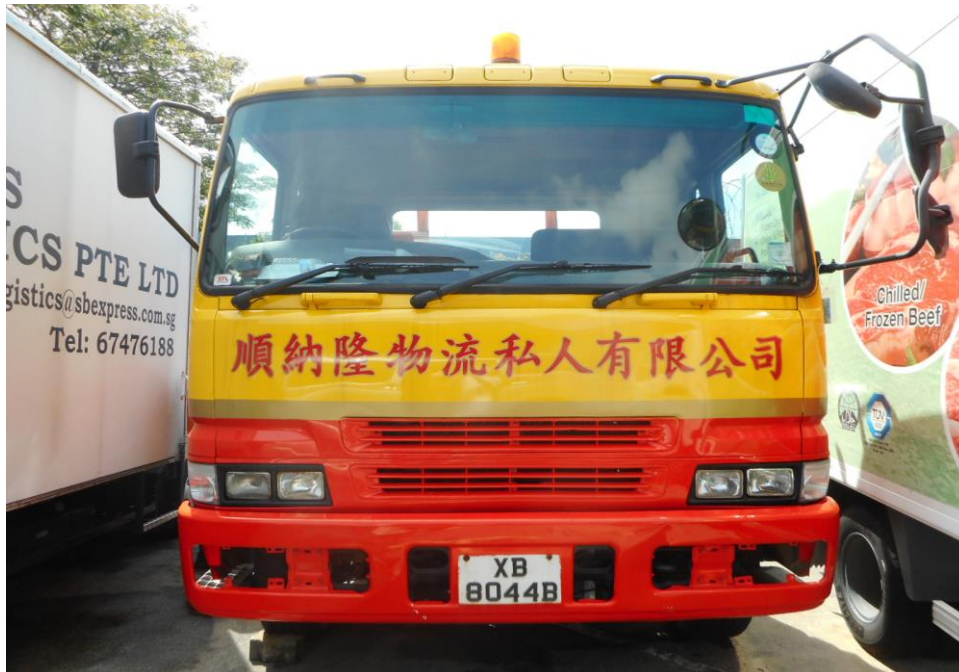
**Photo 2** shows a general view of the front body of the Motor Trailer at the time of my inspection. The Motor Trailer was observed to be intact and unaffected by the accident.

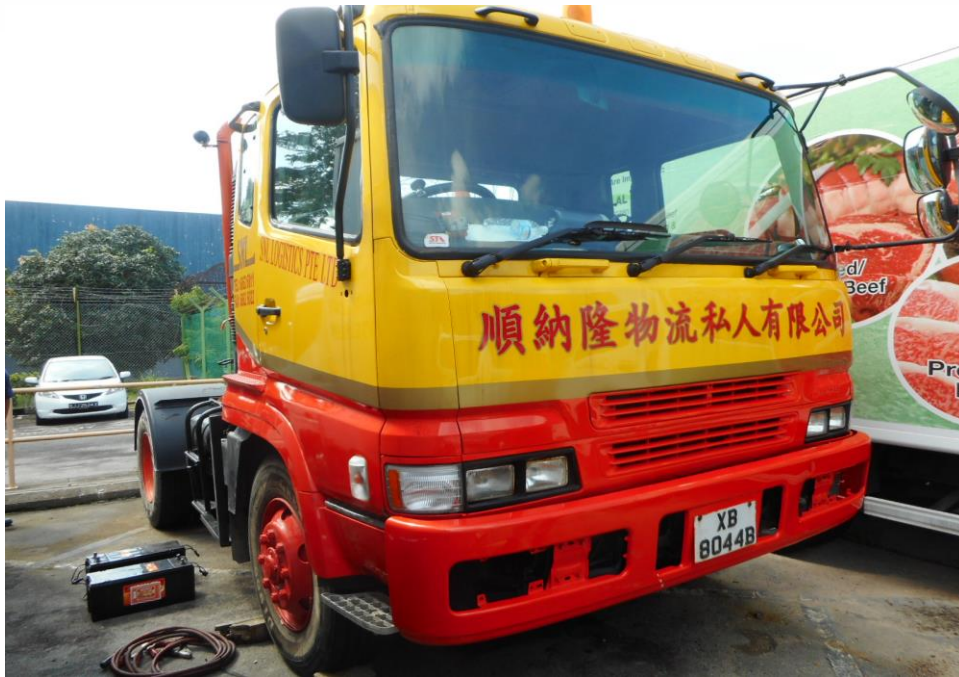
**Photo 3** shows a general view of the front right body of the Motor Trailer at the time of my inspection. The Motor Trailer was observed to be intact and unaffected by the accident.

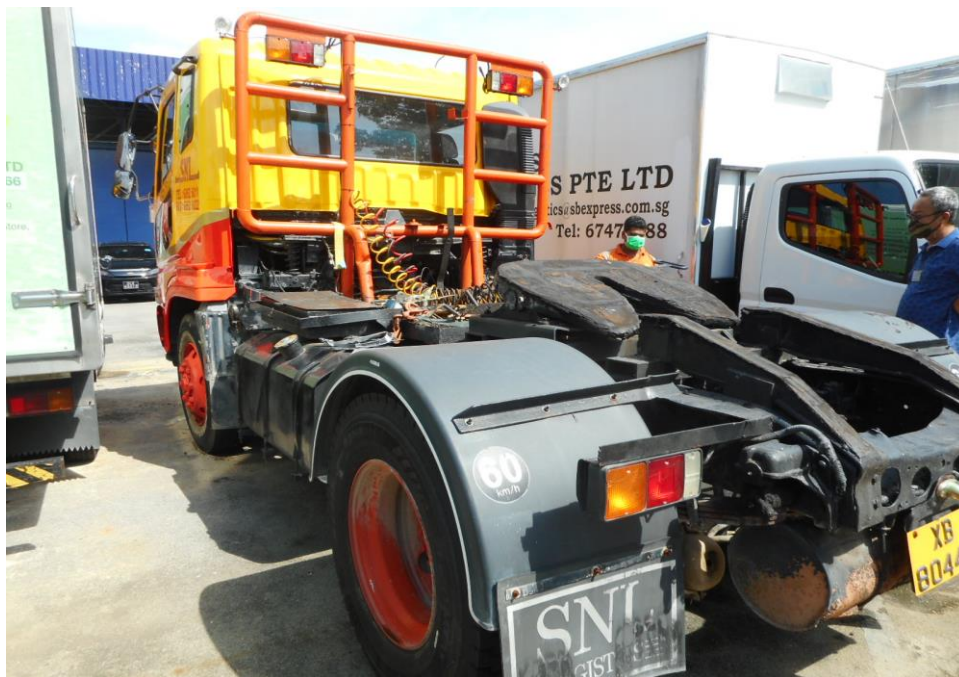
**Photo 4** shows a general view of the front left body of the Motor Trailer at the time of my inspection. The Motor Trailer was observed to be intact and unaffected by the accident.

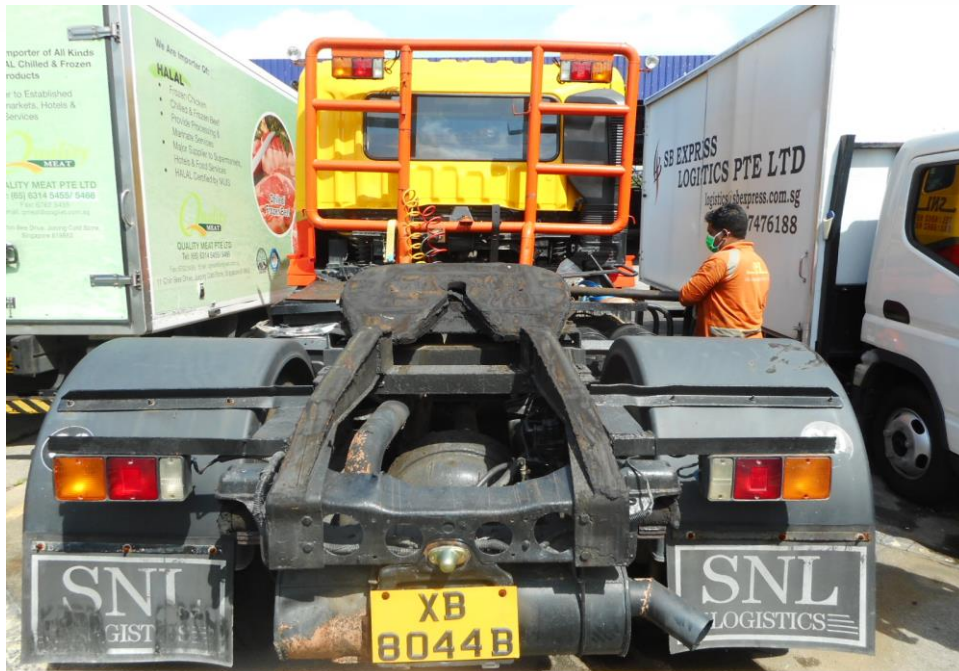
**Photo 5** shows a general view of the Motor Trailer's rear body at the time of my inspection. The Motor Trailer was observed to be intact and unaffected by the accident.

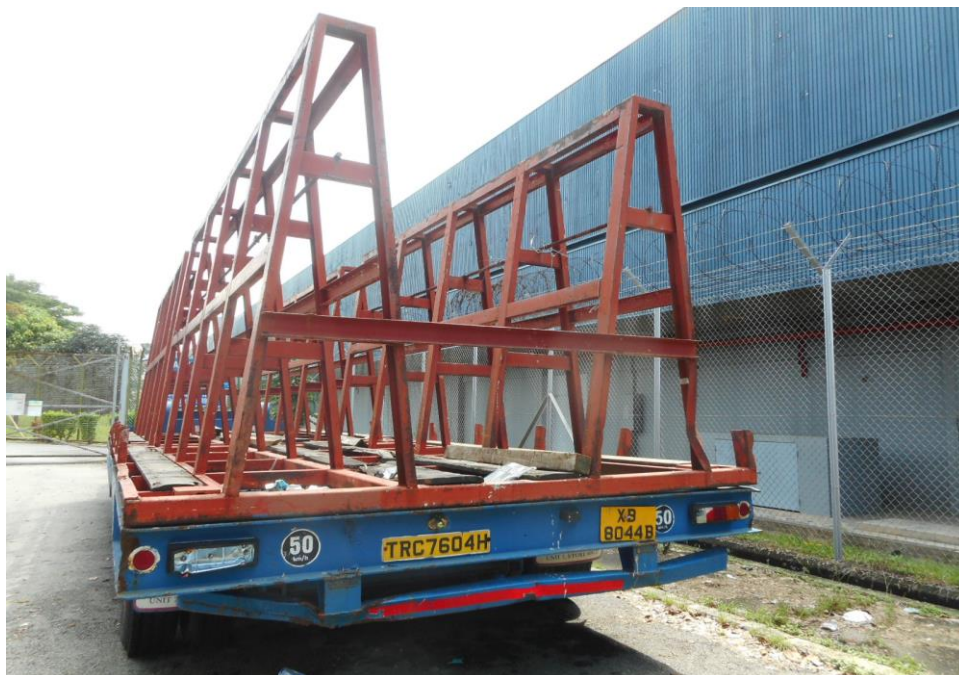
4. The mileage of the Motor Trailer at the time of my inspection was 766,879km.
5. The Motor Trailer was observed to have sustained damage at its rear left trailer. Its rear left brake light & body panel was damaged as a result of the accident.

**Photo 6** shows a general view of the front body of the trailer at the time of my inspection. The Motor Trailer was observed to sustained damage at its rear left portion. Its rear left brake lamp & body panel was damaged as a result of the accident.

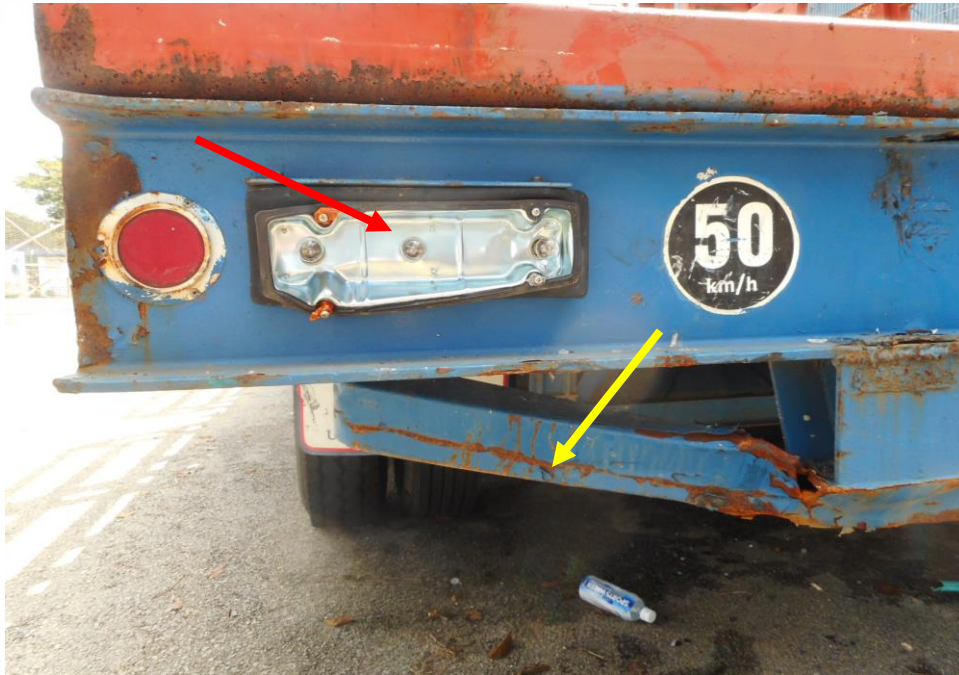
**Photo 7** shows a close up view of the front body of the trailer at the time of my inspection. The Motor Trailer was observed to sustained damage at its rear left portion. Its rear left brake lamp (red arrow) & body panel (yellow arrow) was damaged as a result of the accident.

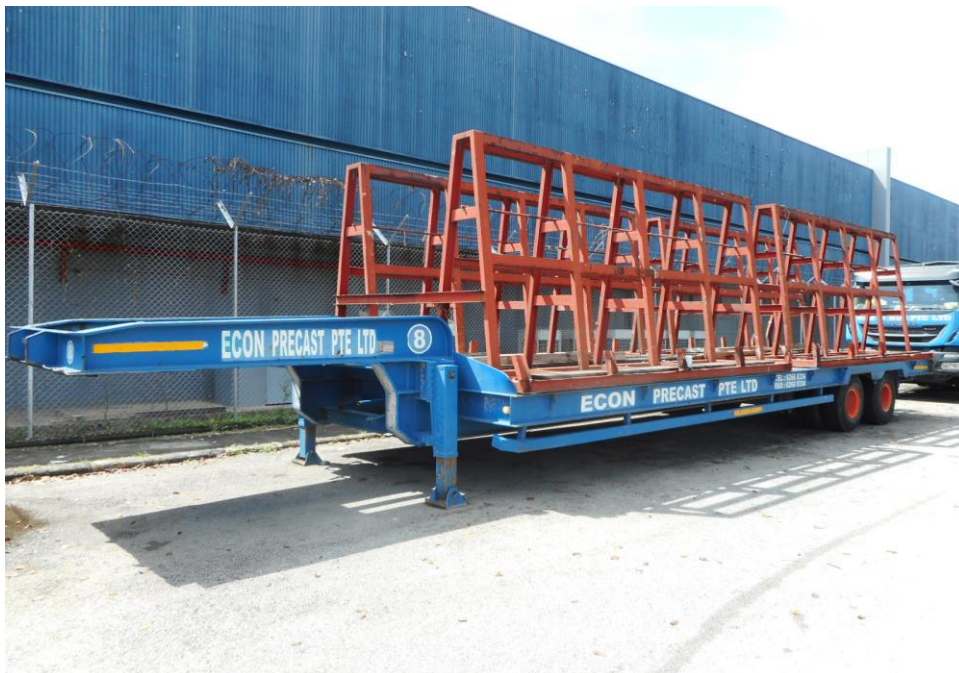
**Photo 8** shows a general view of the trailer's left body at the time of my inspection. The Motor Trailer was observed to be intact and unaffected by the accident.

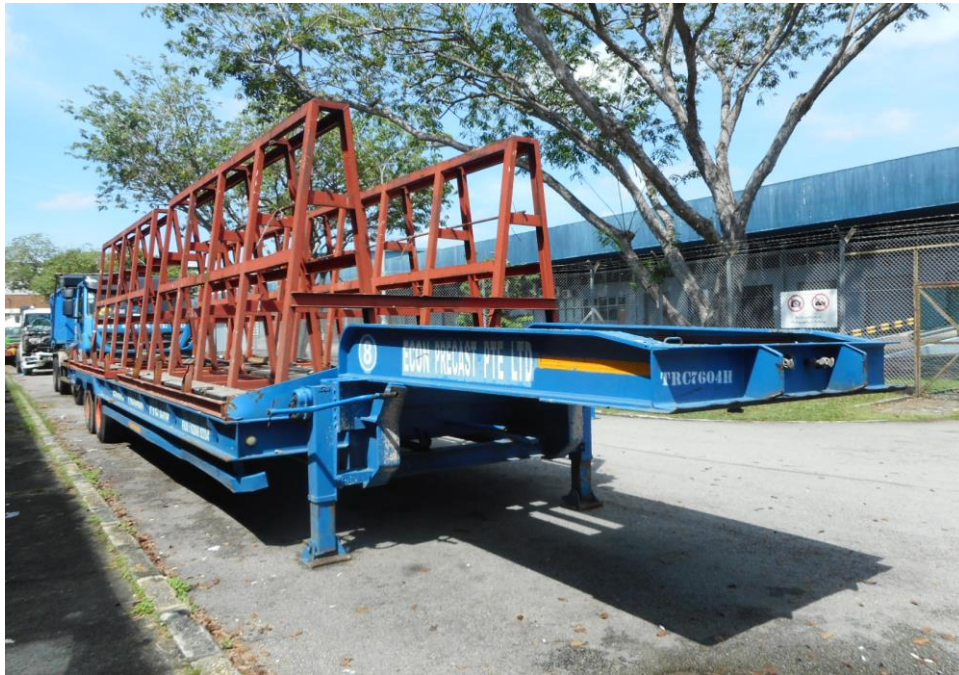
**Photo 9** shows a general view of the trailer's right body at the time of my inspection. The Motor Trailer was observed to be intact and unaffected by the accident.

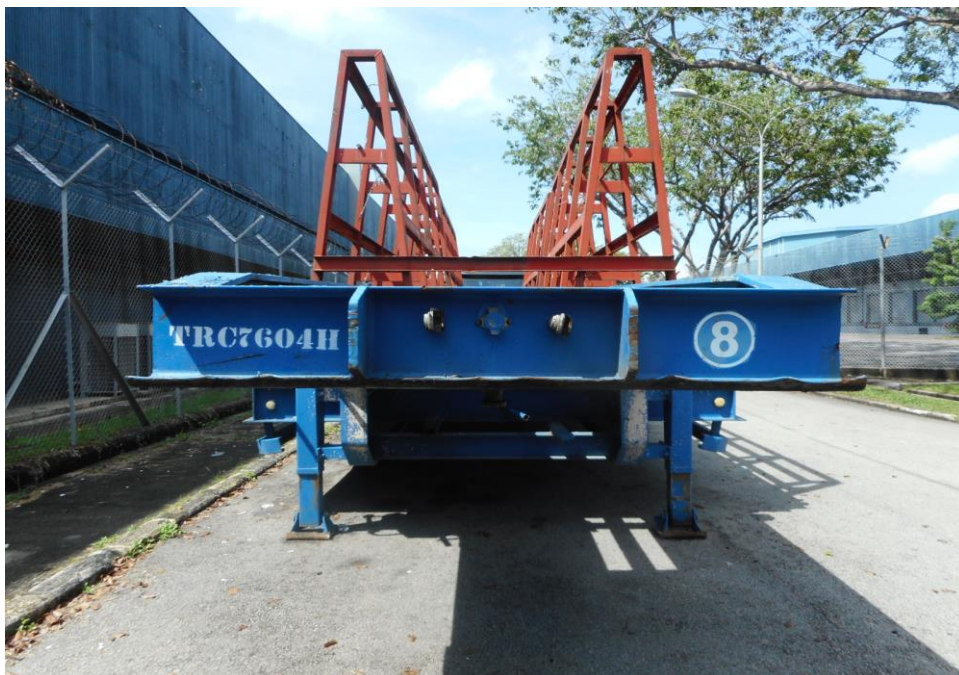
**Photo 10** shows a general view of the trailer's front body at the time of my inspection. The Motor Trailer was observed to be intact.

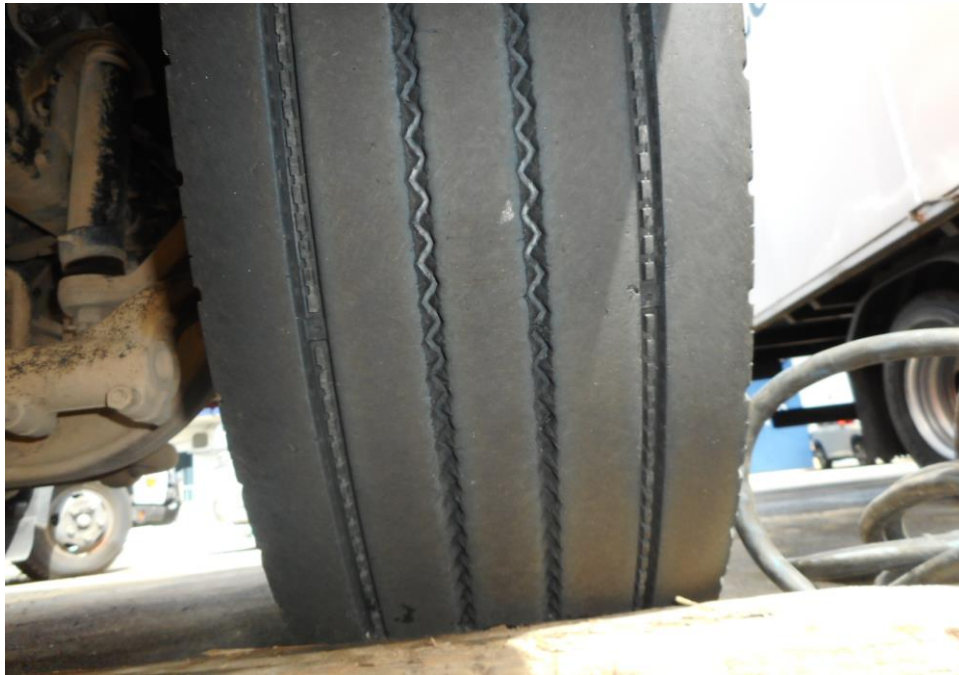
**Photo 11** shows the condition of the front right tyre of the Motor Trailer, which was observed to be in serviceable condition with remaining tread depth of approximately 8.5 mm. The tyre, which was wrapped around standard steel wheel rim, was also observed to be sufficiently inflated for vehicular operation. There was no tear, cut or burst mark(s) on the outer and the inner sidewalls as well as across the tread of the 6 tyres that were fitted on the Motor Trailer.

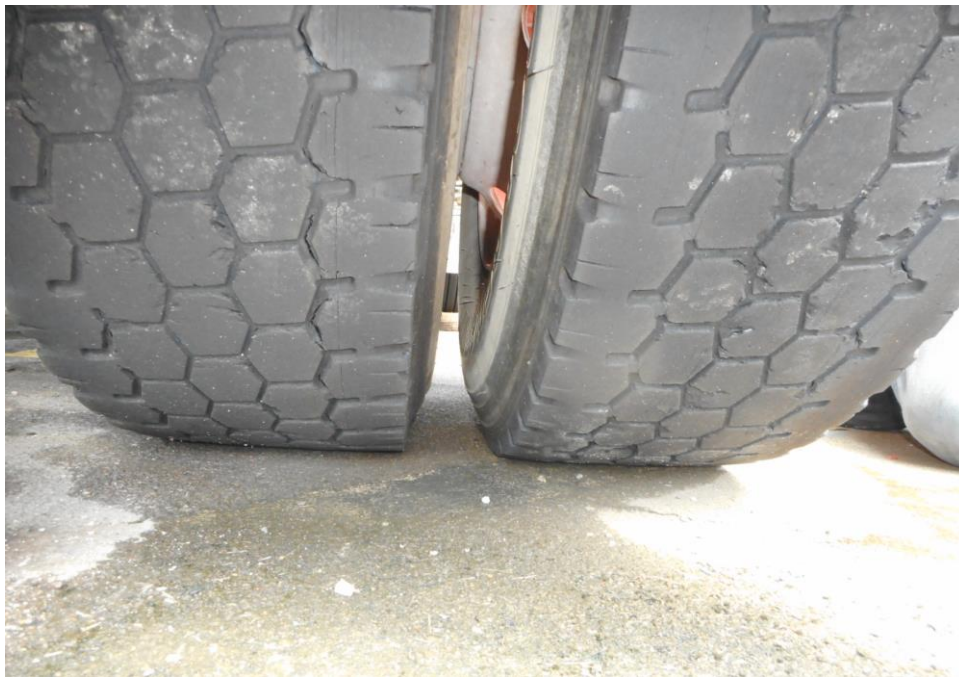
**Photo 12** shows the condition of the rear right tyre of the Motor Trailer, which was observed to be in serviceable condition with remaining tread depth of approximately 4.7mm. The tyre, which was wrapped around standard steel wheel rim, was also observed to be sufficiently inflated for vehicular operation.

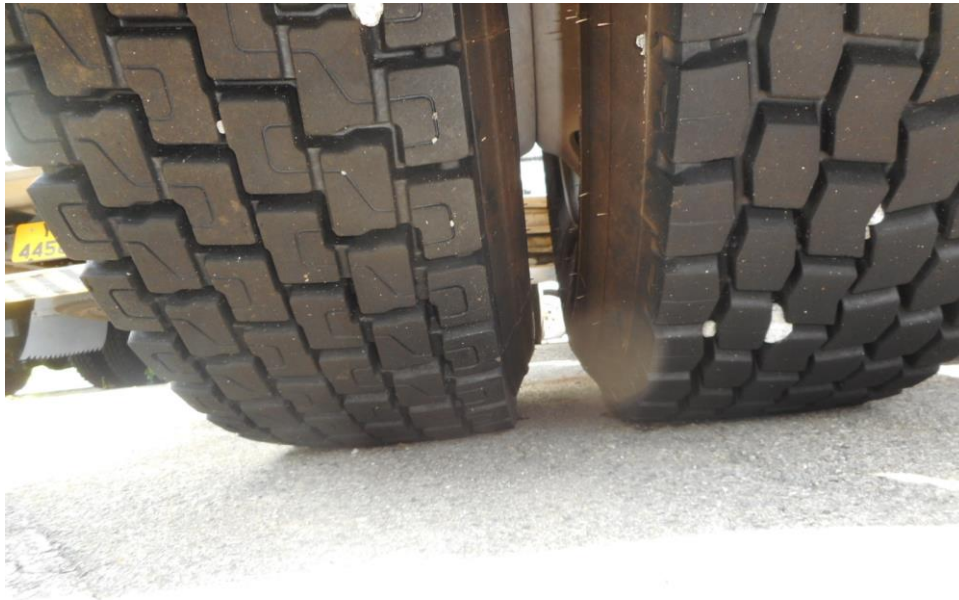
**Photo 13** shows the condition of the rear left tyres of the Motor Trailer, which was observed to be in serviceable condition with remaining tread depth of approximately 10.3mm. The tyres, which were wrapped around standard steel wheel rim, were also observed to be sufficiently inflated for vehicular operation. There was also no damage found on all 6 steel wheel rims of the Motor Trailer.

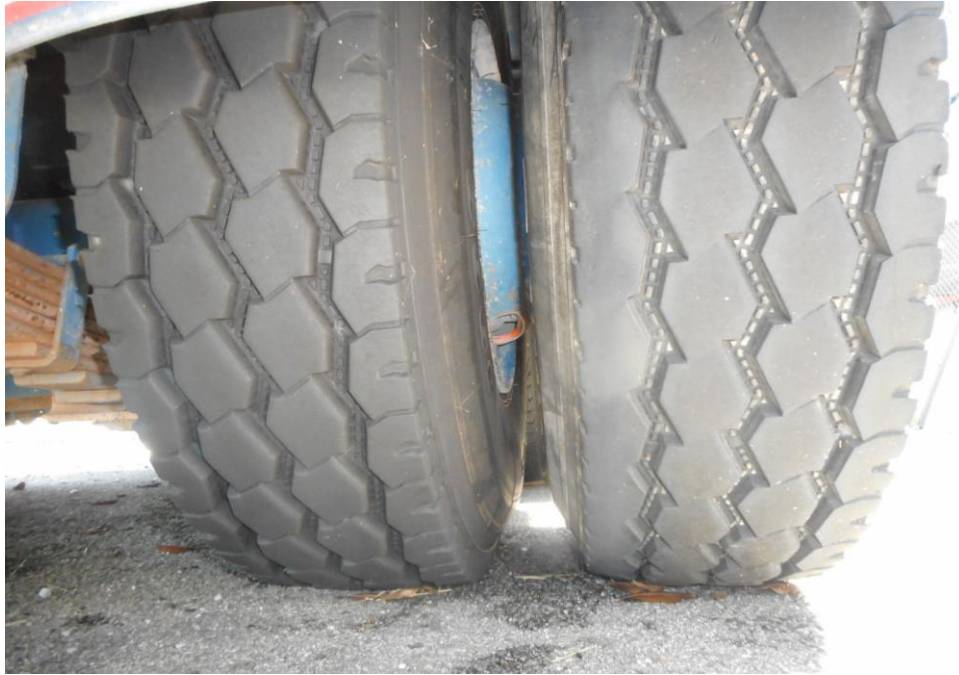
**Photo 15** shows the condition of the right tyres of the trailer, which was observed to be in serviceable condition with remaining tread depth of approximately 9.9mm. The tyre, which was wrapped around standard steel wheel rim, was also observed to be sufficiently inflated for vehicular operation.

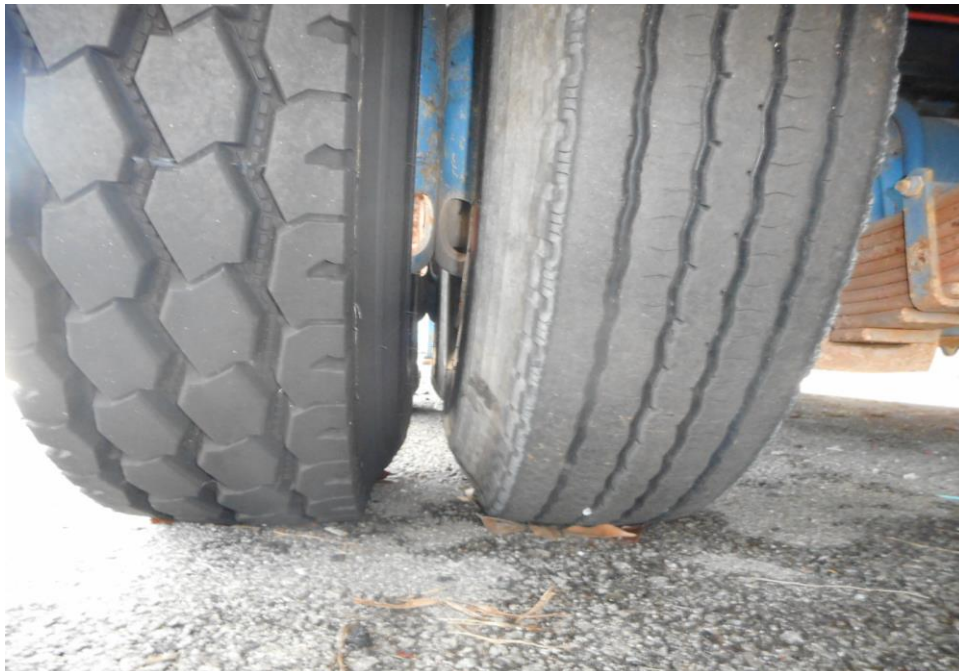
**Photo 16** shows the condition of the left tyres of the trailer, which was observed to be in serviceable condition with remaining tread depth of approximately 13.3mm. The tyres, which were wrapped around standard steel wheel rim, were also observed to be sufficiently inflated for vehicular operation. There was also no damage found on all 6 steel wheel rims of the Motor Trailer.

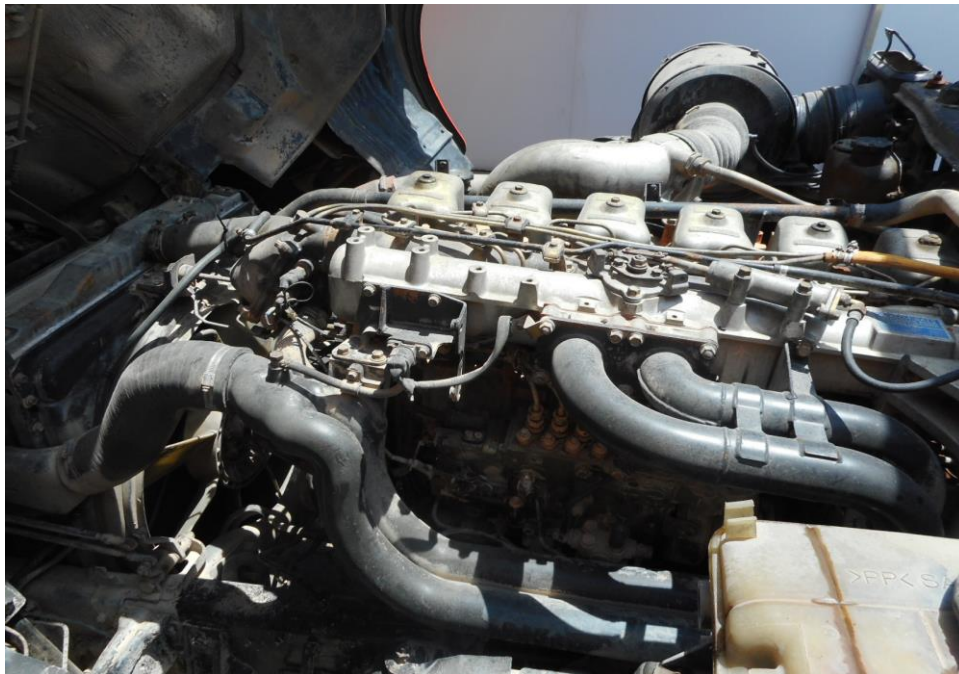
**Photo 17** shows a general view of the Motor Trailer's engine compartment, which was accessed by lifting the front cabin of the Motor Trailer. The various parts and components inside the engine compartment were unaffected by the accident. There was also no sign(s) or indication(s) of fresh fluid leakage and/or fluid stain within the engine compartment

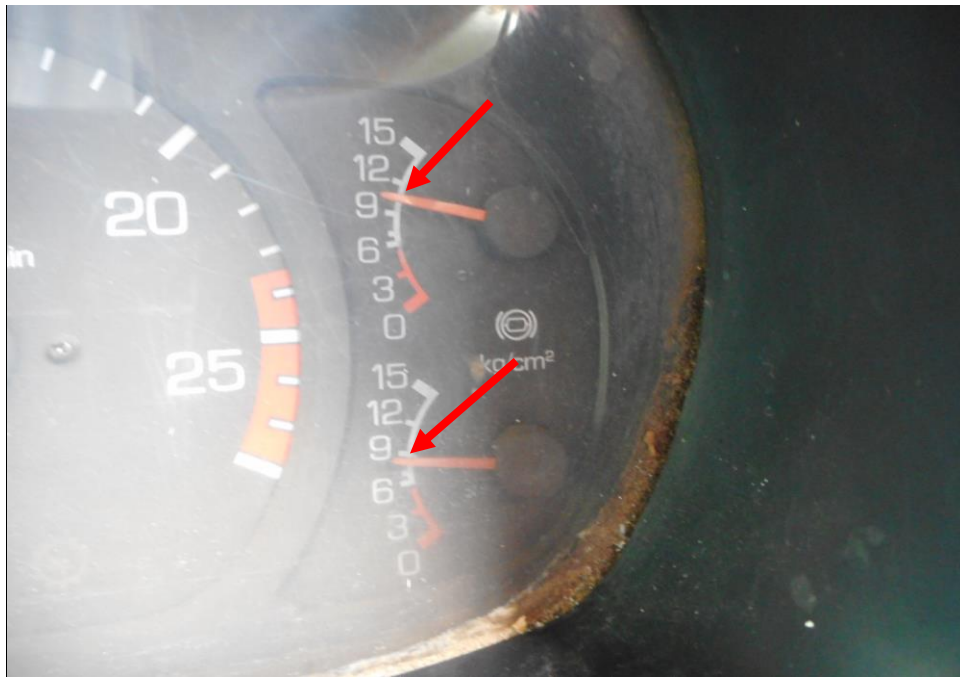
**Photo 18** shows the air in the air brake cylinders of the Motor Trailer at the time of my inspection. The air in the cylinder was observed to be of sufficient level & serviceable at the time of the accident.

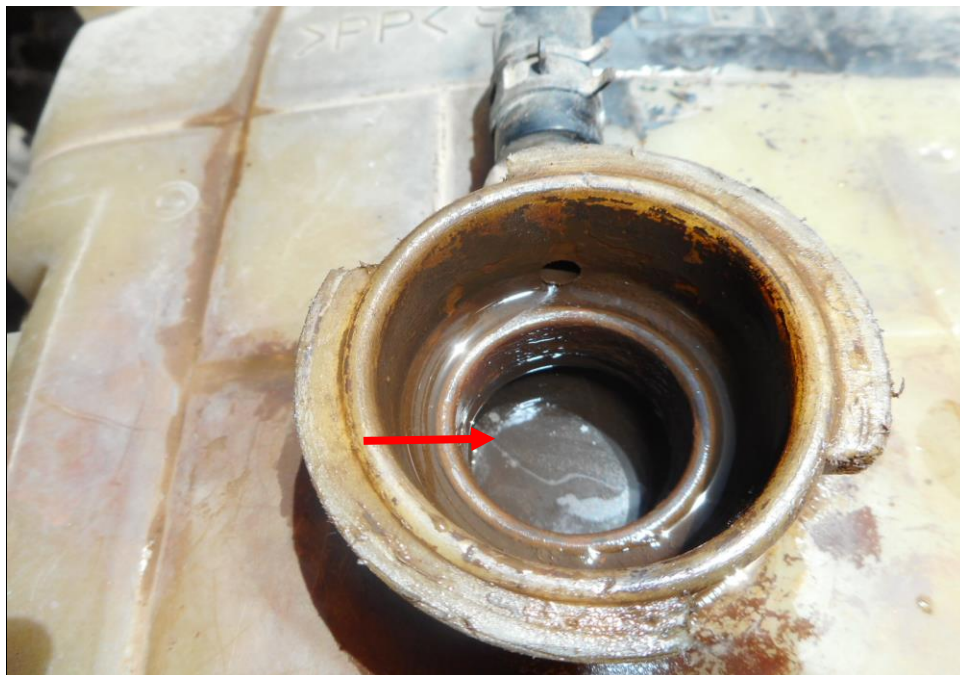
**Photo 19** shows the engine coolant reservoir of the Motor Trailer at the time of my inspection. The engine coolant was observed to be of sufficient level (arrowed) and without any visible contamination.

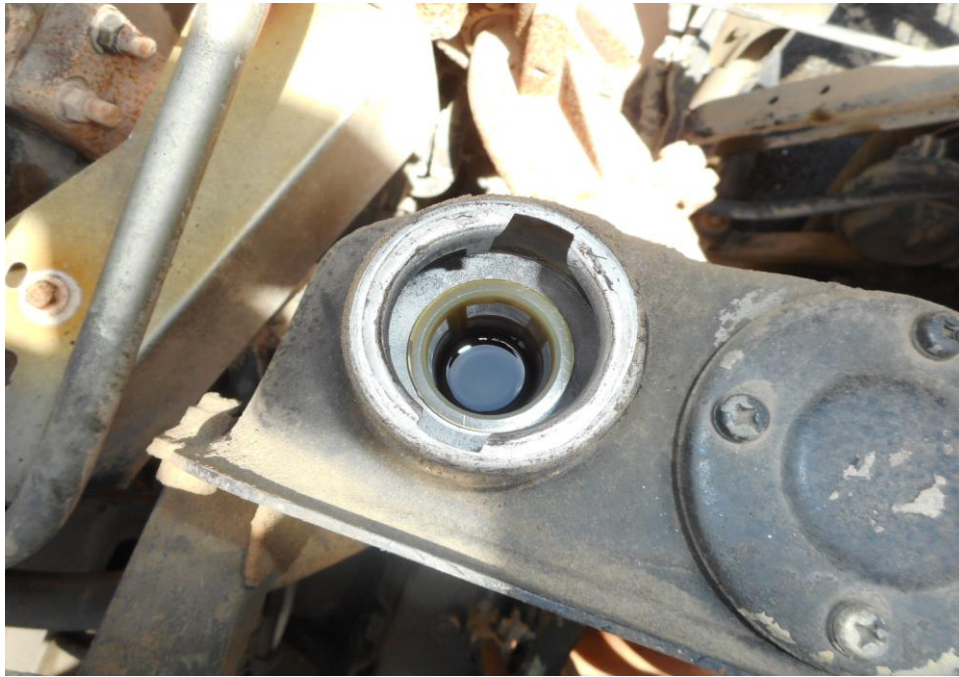
**Photo 20** shows the power steering fluid reservoir of the Motor Trailer at the time of my inspection. The power steering fluid was observed to be of sufficient level and without any visible contamination.

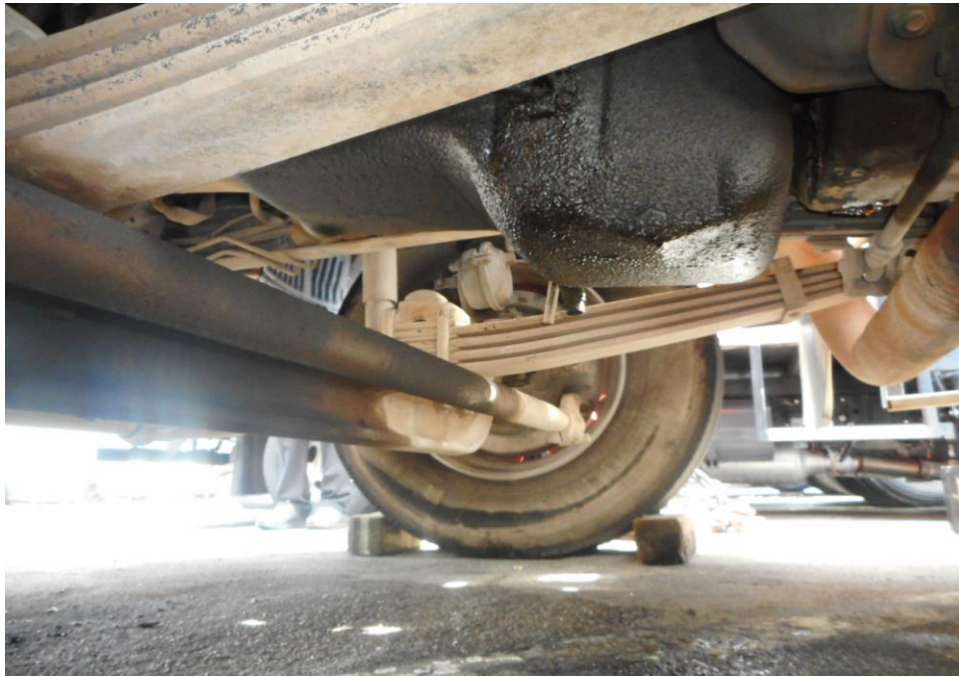
**Photo 22** shows the undercarriage of the Motor Trailer, at the area where the engine housing located. I did not find any sign(s) or indication(s) of fluid leak, however old fluid stain(s) was observed on the underside of the Motor Trailer.

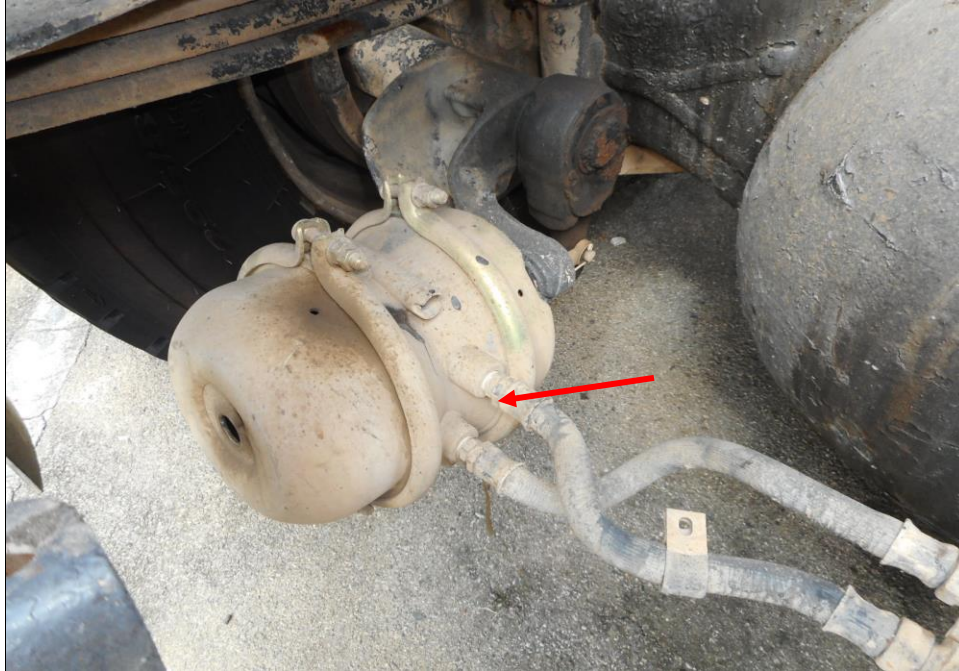
**Photo 23** shows the brake pipe (arrowed) at the rear right wheel of the Motor Trailer. I did not observe any leakage of brake fluid at the time of my inspection of the Motor Trailer. My static tests of the Motor Trailer's braking system, along with my visual examination of the various mechanical components in the braking system, had indicated that there was no internal leakage of pressure/vacuum. Hence the braking system of the Motor Trailer was likely to be in serviceable condition at the material time of accident.

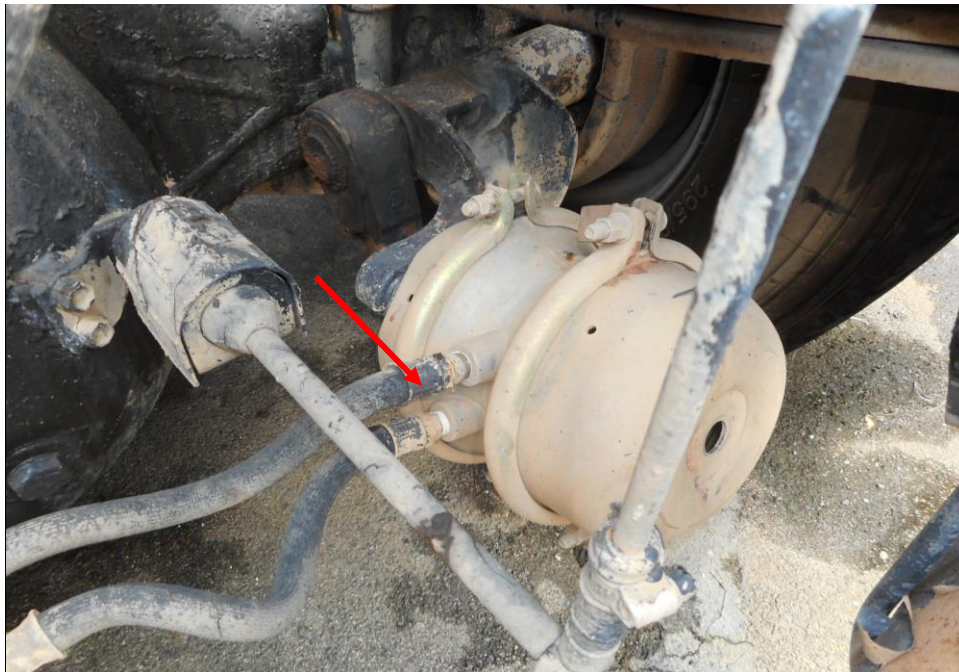
**Photo 24** shows the brake pipe (arrowed) at the rear left wheel of the Motor Trailer. I did not observe any leakage of brake fluid at the time of my inspection of the Motor Trailer. My static tests of the Motor Trailer's braking system, along with my visual examination of the various mechanical components in the braking system, had indicated that there was no internal leakage of pressure/vacuum. Hence the braking system of the Motor Trailer was likely to be in serviceable condition at the material time of accident.

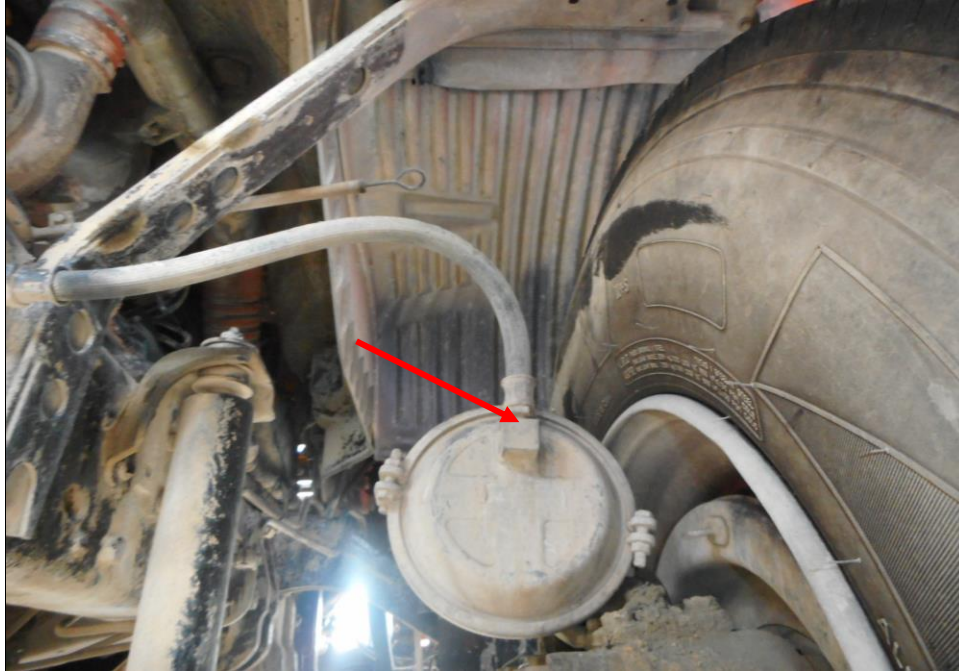
**Photo 25** shows the brake pipe (arrowed) at the front right wheel of the Motor Trailer. I did not observe any leakage of brake fluid at the time of my inspection of the Motor Trailer. My static tests of the Motor Trailer's braking system, along with my visual examination of the various mechanical components in the braking system, had indicated that there was no internal leakage of pressure/vacuum. Hence the braking system of the Motor Trailer was likely to be in serviceable condition at the material time of accident.

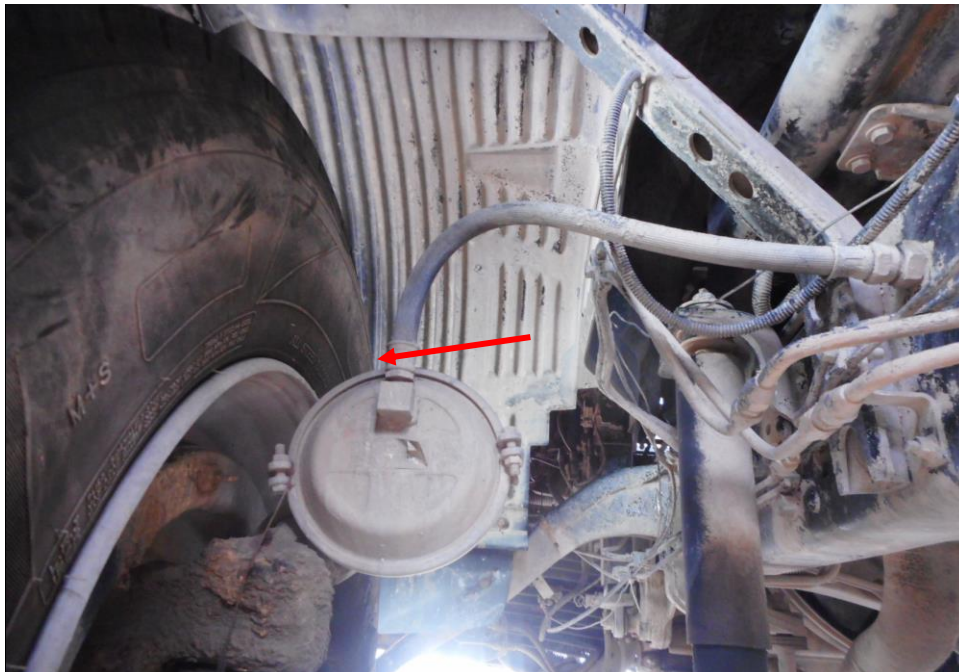
**Photo 26** shows the brake pipe (arrowed) at the front left wheel of the Motor Trailer. I did not observe any leakage of brake fluid at the time of my inspection of the Motor Trailer. My static tests of the Motor Trailer's braking system, along with my visual examination of the various mechanical components in the braking system had indicated that there was no internal leakage of pressure/vacuum. Hence the braking system of the Motor Trailer was likely to be in serviceable condition at the material time of accident.

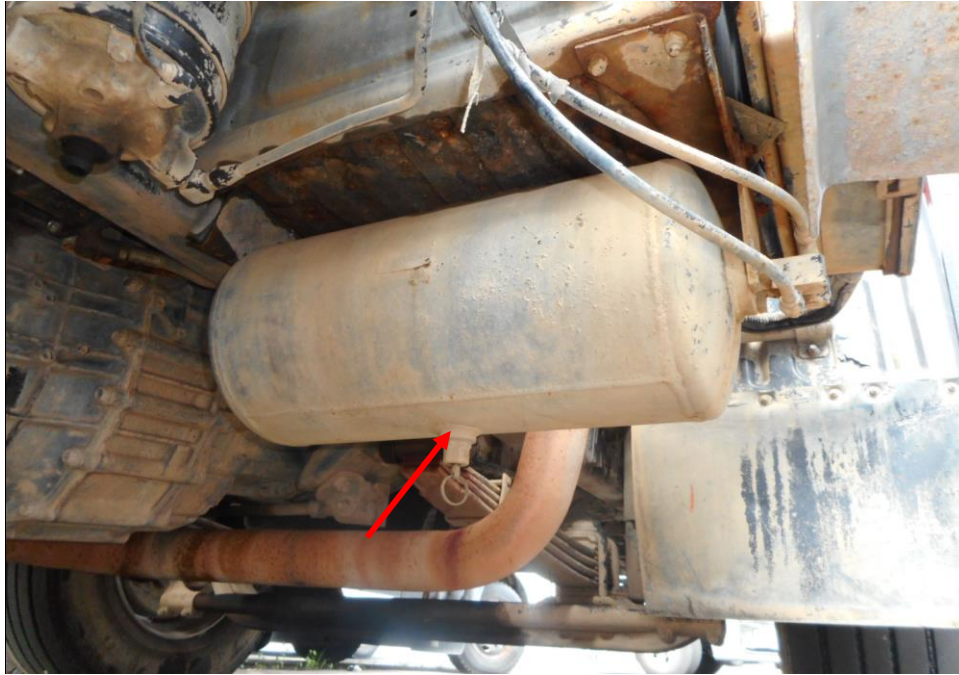
**Photo 27** shows the air brake cylinders (arrowed) at the undercarriage of the Motor Trailer. I did not observe any leakage of air brake fluid at the time of my inspection of the Motor Trailer. My static tests of the Motor Trailer's braking system, along with my visual examination of the various mechanical components in the braking system had indicated that there was no internal leakage of pressure/vacuum. Hence the braking system of the Motor Trailer was likely to be in serviceable condition at the material time of accident.

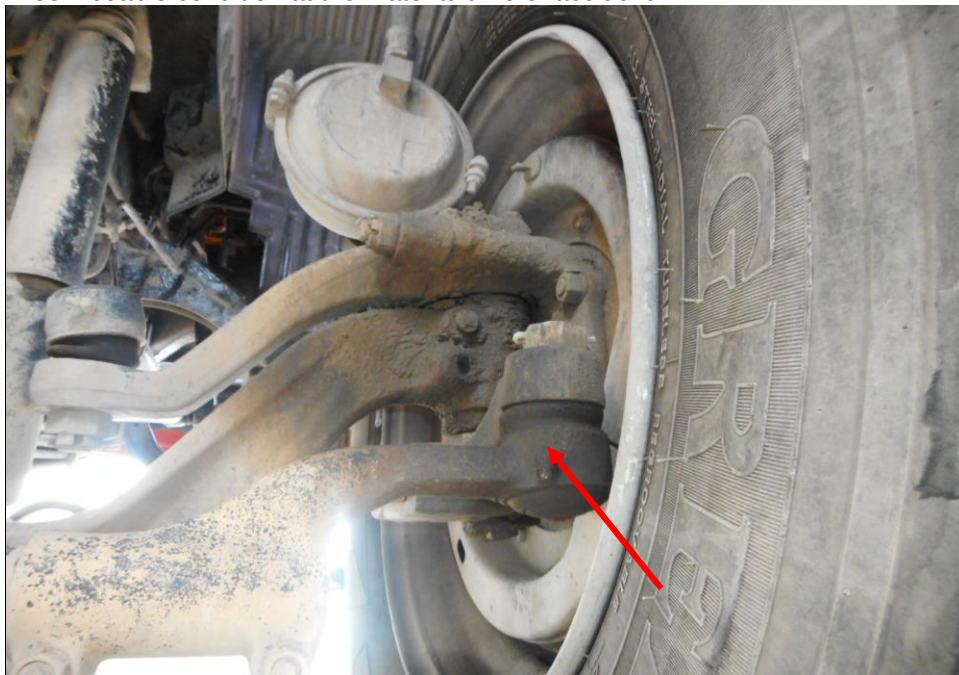
**Photo 28** shows the various undercarriage components at the front right wheel of the Motor Trailer, in particular the steering tie rod end (arrowed). The various steering components were all found to be intact, suggesting that the steering system of the Motor Trailer was likely to be in serviceable condition at the material time of accident. There was also no sign of fluid stain(s) observed on the various undercarriage components.

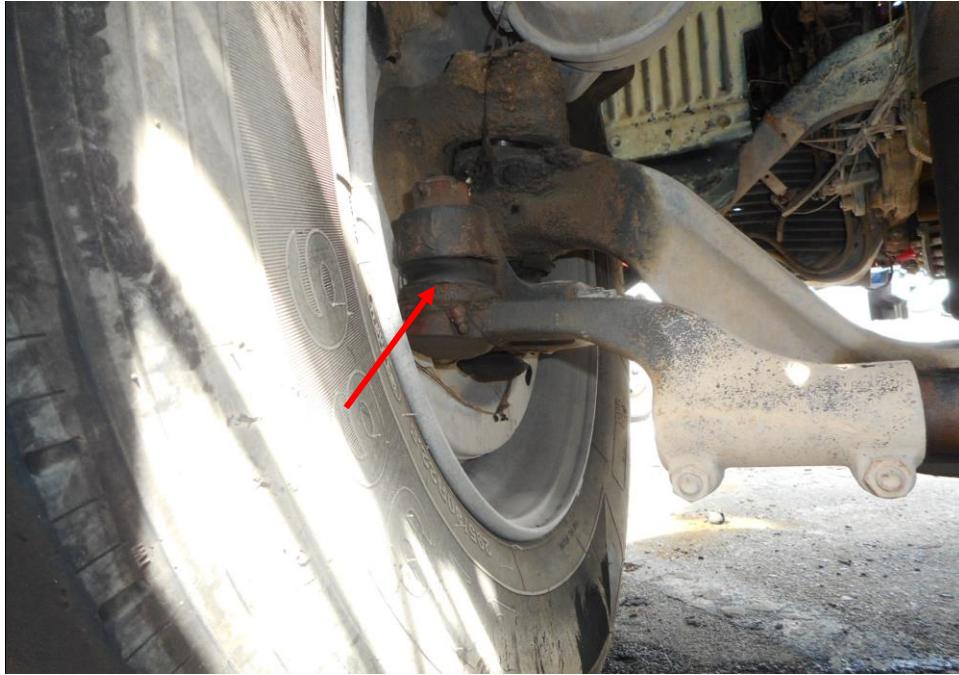
**Photo 29** shows the various undercarriage components at the front left wheel of the Motor Trailer, in particular the steering tie rod end (arrowed). The various undercarriage components of the Motor Trailer were all found to be intact without any visible damage. There was also no sign of fluid stain(s) observed on the various undercarriage components.

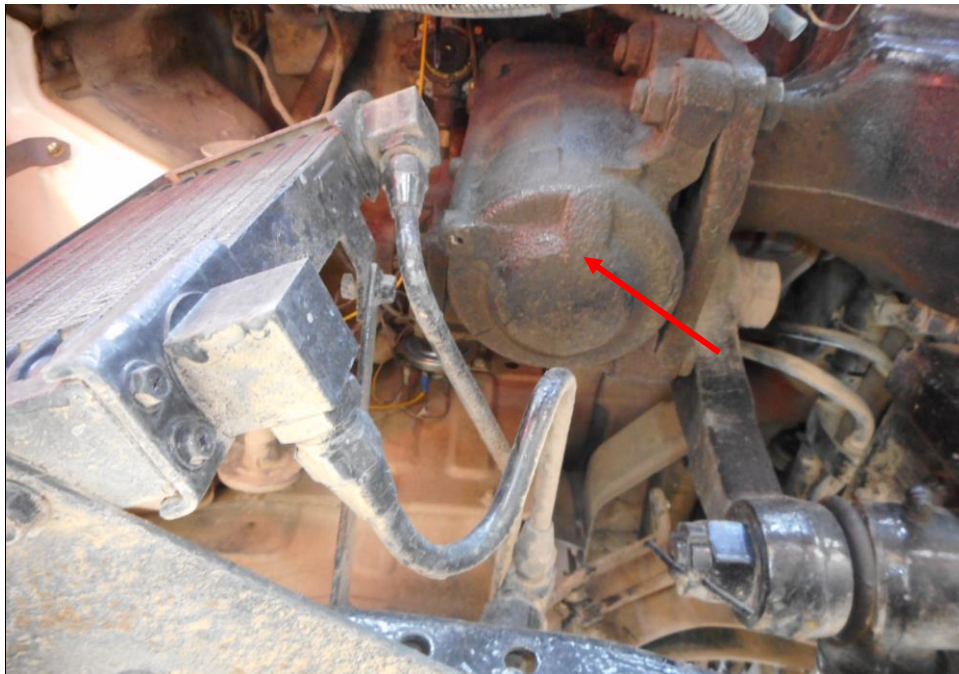
**Photo 30** shows the steering box component (arrowed) at the undercarriage of the Motor Trailer was found to be intact without any visible damage. There was also no sign of fluid stain(s) observed on the various undercarriage components.

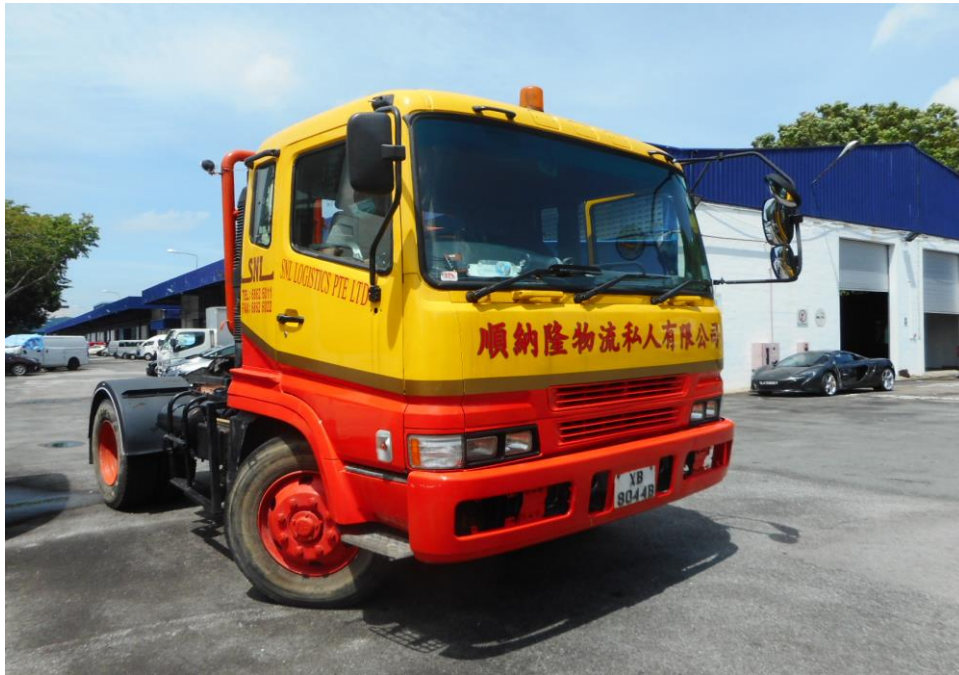
**Photo 31** shows the front right wheel of the Motor Trailer turned to its full left. During my steering system test, I did not experience any abnormal free play and/or resistance when I had turned the steering wheel towards full left and full right. This would suggest that the steering system of the Motor Trailer was likely to be in serviceable condition at the material time of accident.
