Your Ref: TP/IP/ 31609 /2019  
Our Ref : CI/TPD20008424/P

18<sup>th</sup> August 2020

**General Investigation Team**

**MECHANICAL INSPECTION REPORT OF POLICE UNMARKED MOTOR CAR  
QX 982M / SKM 5497T**

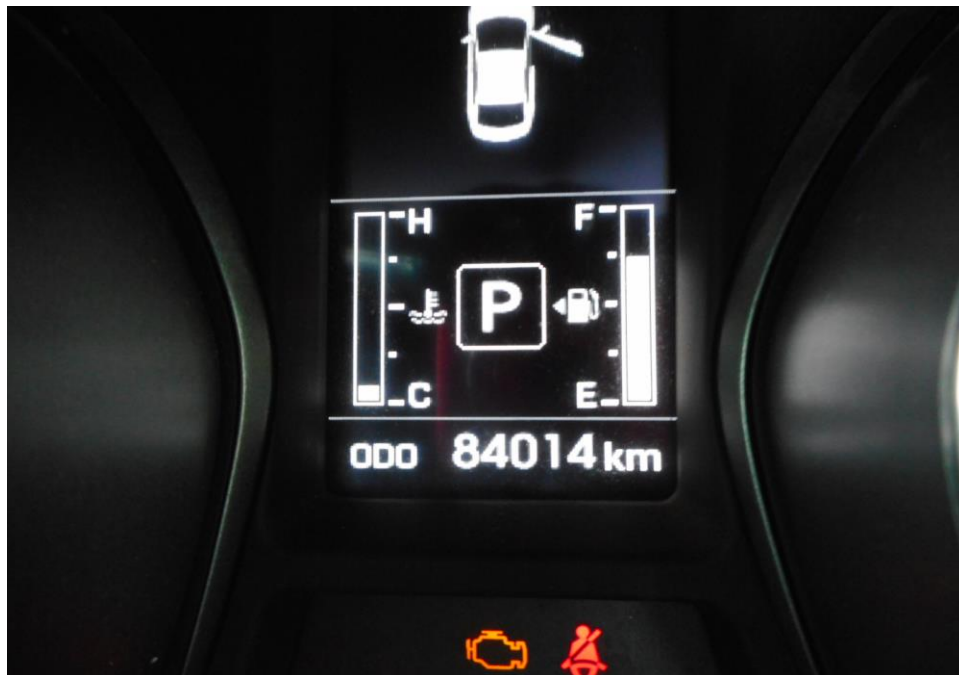
**Photo 1** shows the mileage of the Motor Car at the time of my inspection. The mileage observed was 84,014km.

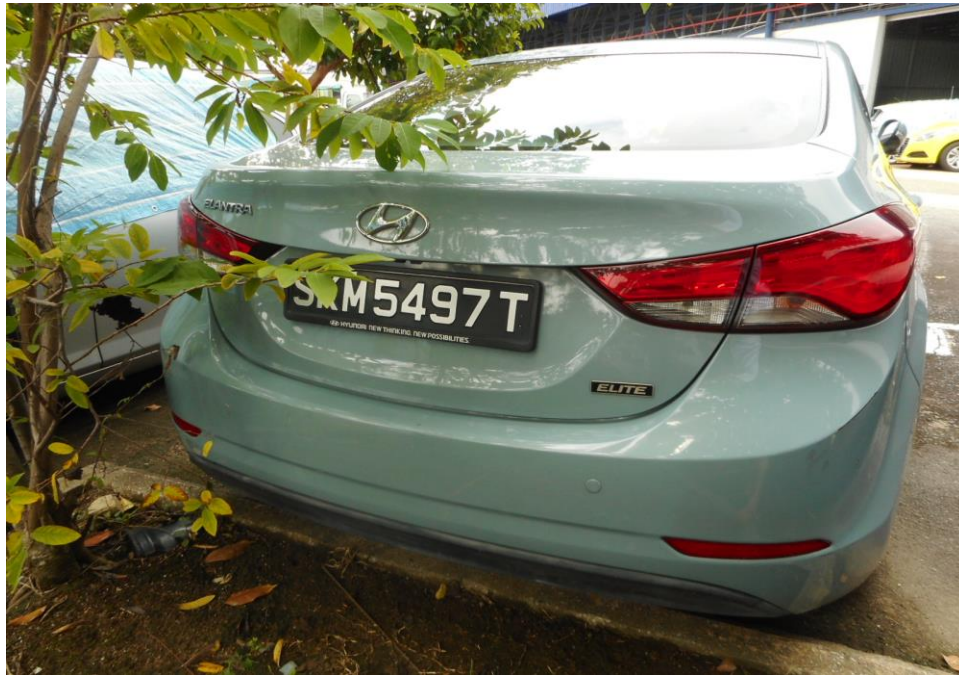
**Photo 2** shows the general view of the Motor Car's rear body at the time of my inspection. The Motor Car rear was observed to be unaffected by the accident.

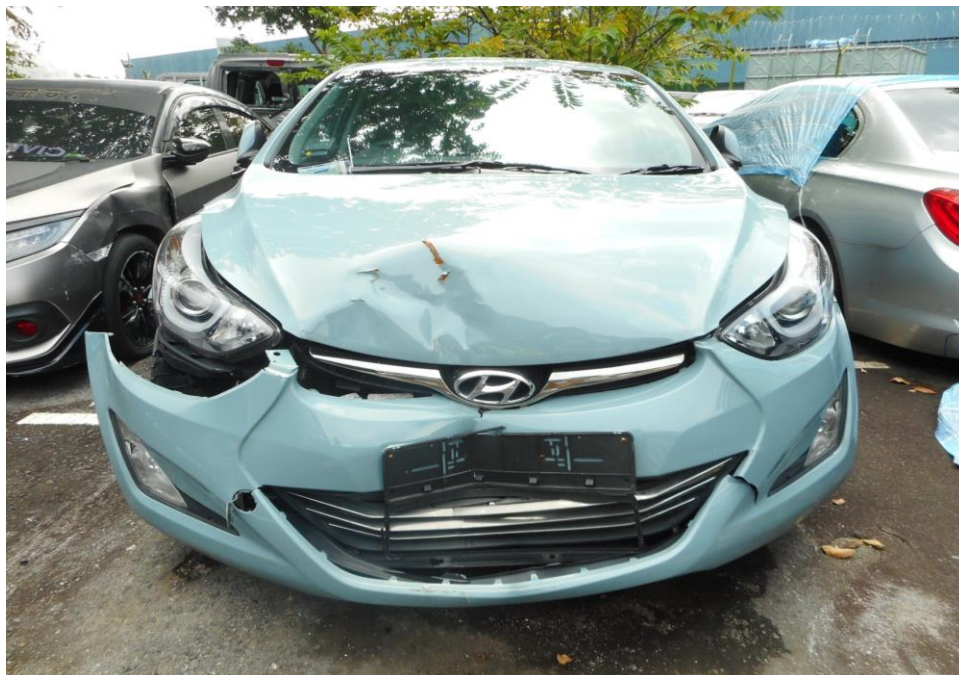
4. The mileage of the Motor Car at the time of my inspection was 84,014km.
5. The Motor Car was observed to have sustained damage at its front portion. Its front bonnet, front bumper and its radiator were amongst the body parts that were damaged as a result of the accident.

**Photo 3** shows a general view of the Motor Car's front body at the time of my inspection. The Motor Car was observed to have sustained damage at its front portion. Its front bonnet, front bumper and its radiator were amongst the body parts that were damaged as a result of the accident.

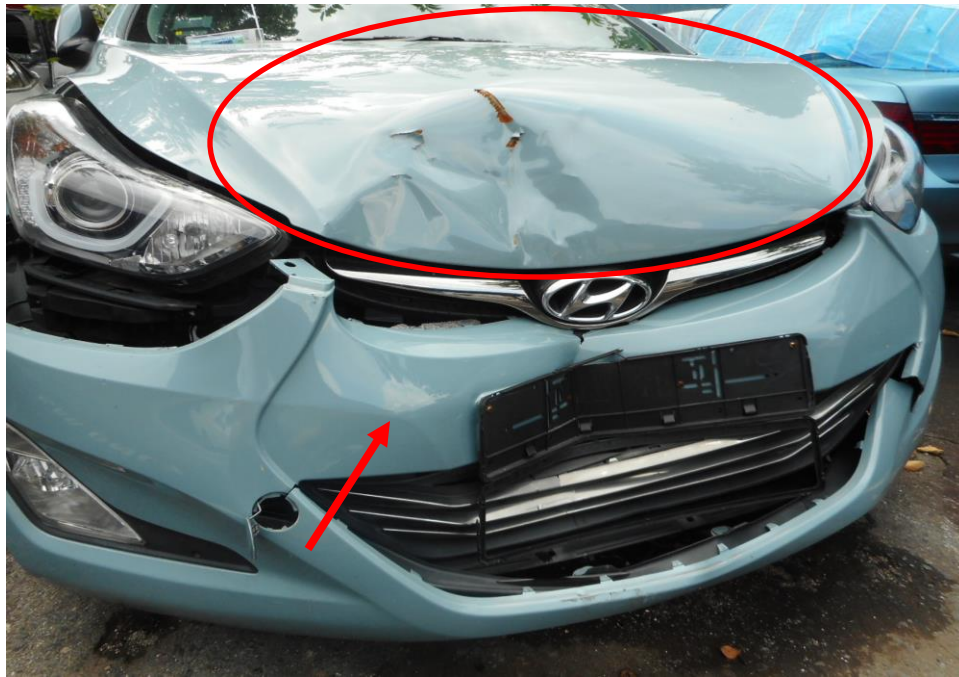
**Photo 4** shows the close up view of the Motor Car's front body at the time of my inspection. The Motor Car was observed to have sustained damage at its front portion. Its front bonnet (circled), front bumper (arrowed) were amongst the body parts that were damaged as a result of the accident.

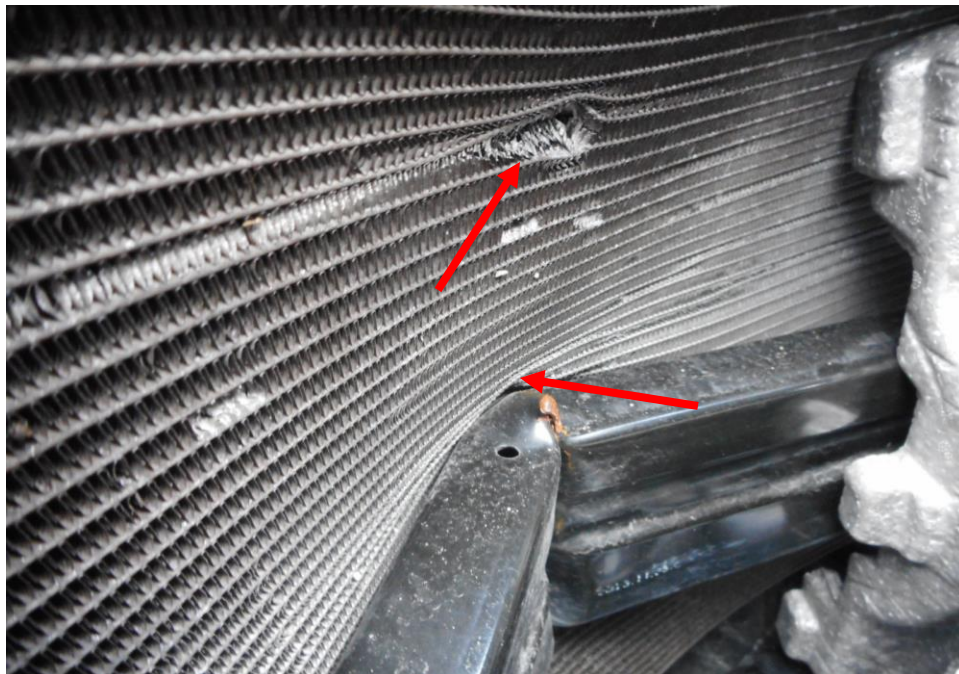
**Photo 5** shows the close up view of the Motor Car's front body at the time of my inspection. The Motor Car was observed to have sustained damage at its front portion. Its radiator (arrowed) were amongst the body parts that were damaged as a result of the accident.

8. Upon examination of the engine compartment of the Motor Car, I had observed all the parts and components inside the engine compartment to be intact and unaffected by the accident. The brake fluid and engine oil were all found to be of sufficient level for operating purposes. Visually, there was also no contamination found to these fluids. However, the engine coolant was found to be insufficient due to the punctured to the radiator which had caused the coolant to flow out as a result of the accident. Refer photo 5 above.

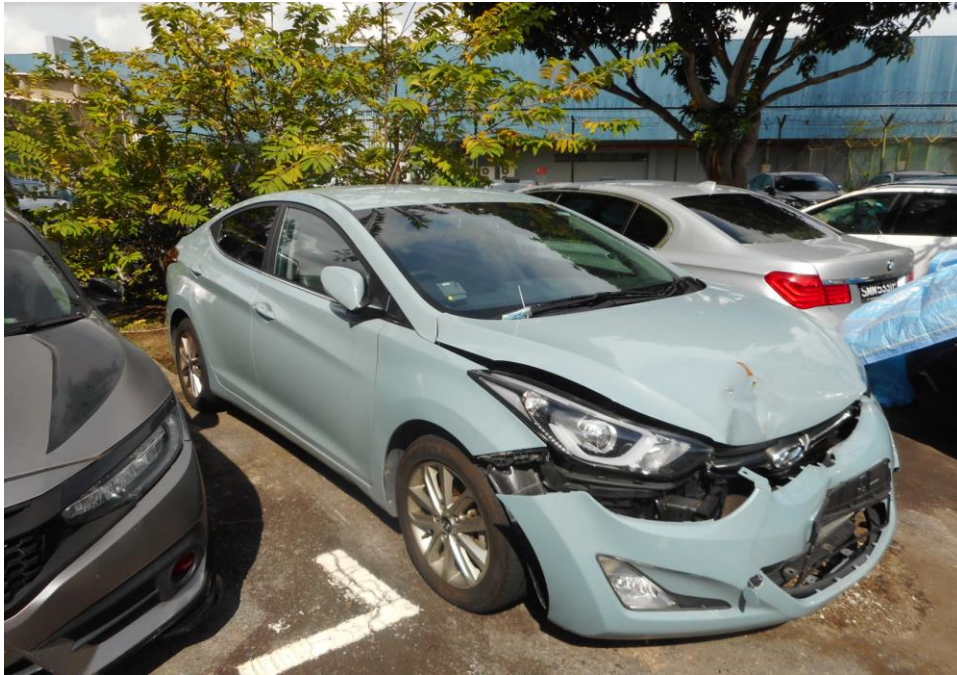
**Photo 6** shows a general view of the Motor Car's right body at the time of my inspection. The right portion of the Motor Car was observed to have been unaffected by the accident.

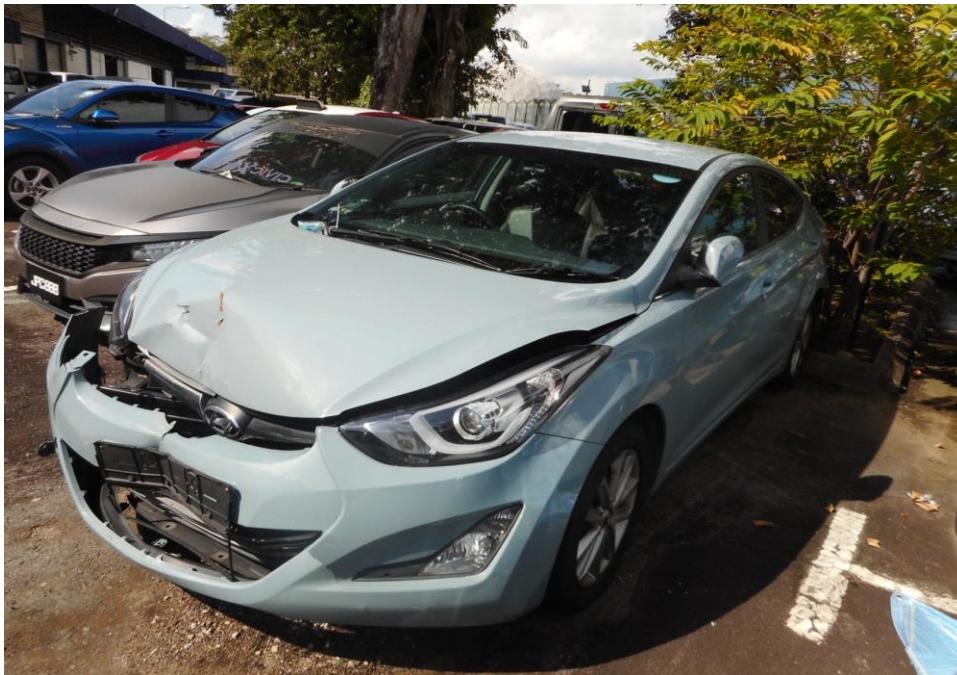
**Photo 7** shows a general view of the Motor Car's left body at the time of my inspection. The left portion of the Motor Car was observed to have been unaffected by the accident.

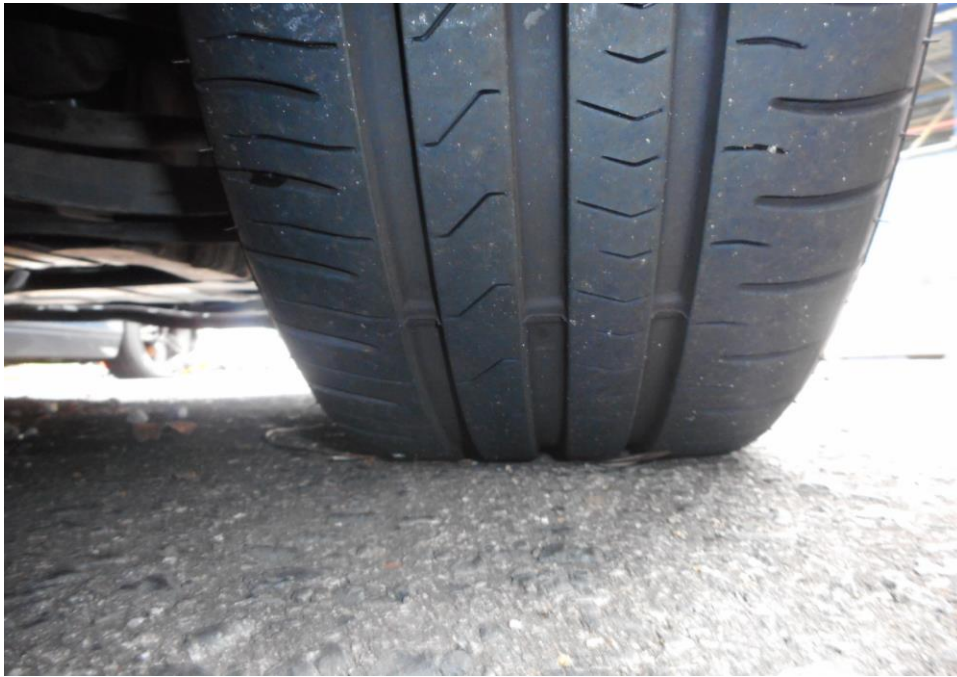
**Photo 8** shows the condition of the front right tyre of the Motor Car, which was observed to be in serviceable condition with remaining tread depth of approximately 4.8mm. The tyre was sufficiently inflated for vehicular operation with no tear, cut or burst mark(s) on the outer and the inner sidewalls as well as across the tread. The 4 tyres of the Motor Car were wrapped around standard steel wheel rims without any damage.

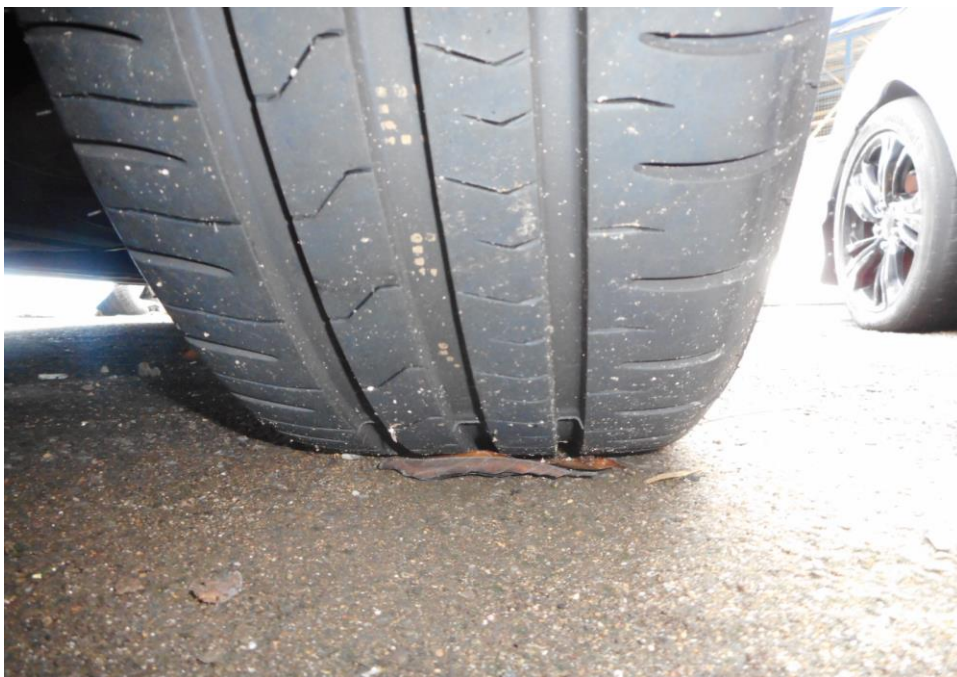
**Photo 9** shows the condition of the rear right tyre of the Motor Car, which was observed to be in serviceable condition with remaining tread depth of approximately 6.8mm. The tyre was also observed to be sufficiently inflated for vehicular operation with no tear, cut or burst mark(s).

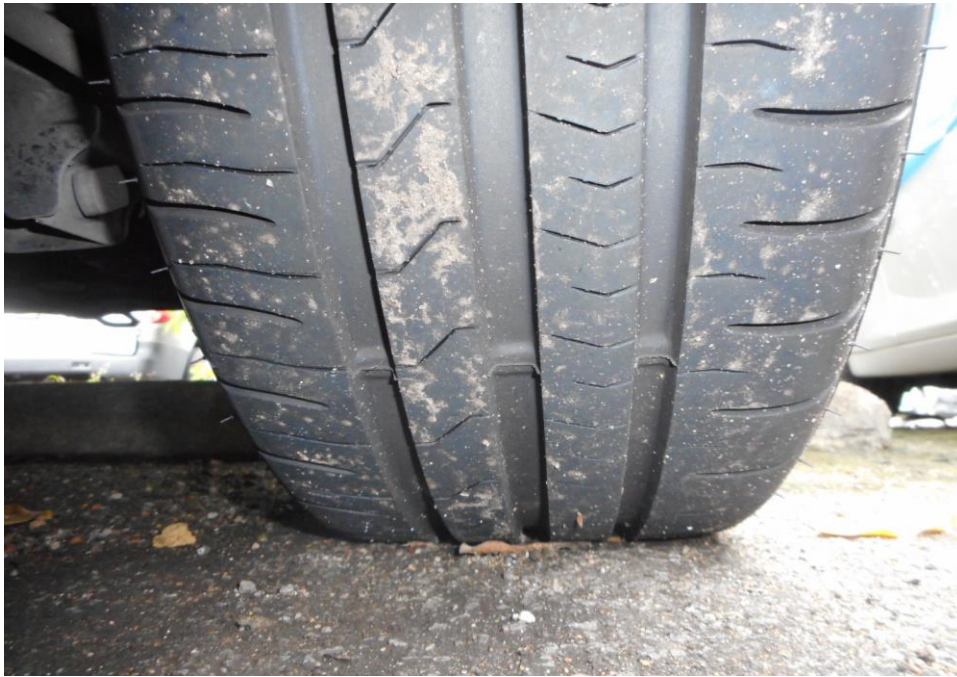
**Photo 10** shows the condition of the rear left tyre of the Motor Car, which was observed to be in serviceable condition with remaining tread depth of approximately 6.6mm. The tyre, which was wrapped around steel wheel rim, was also observed to be sufficiently inflated for vehicular operation. The 4 tyres of the Motor Car were wrapped around standard steel wheel rims.

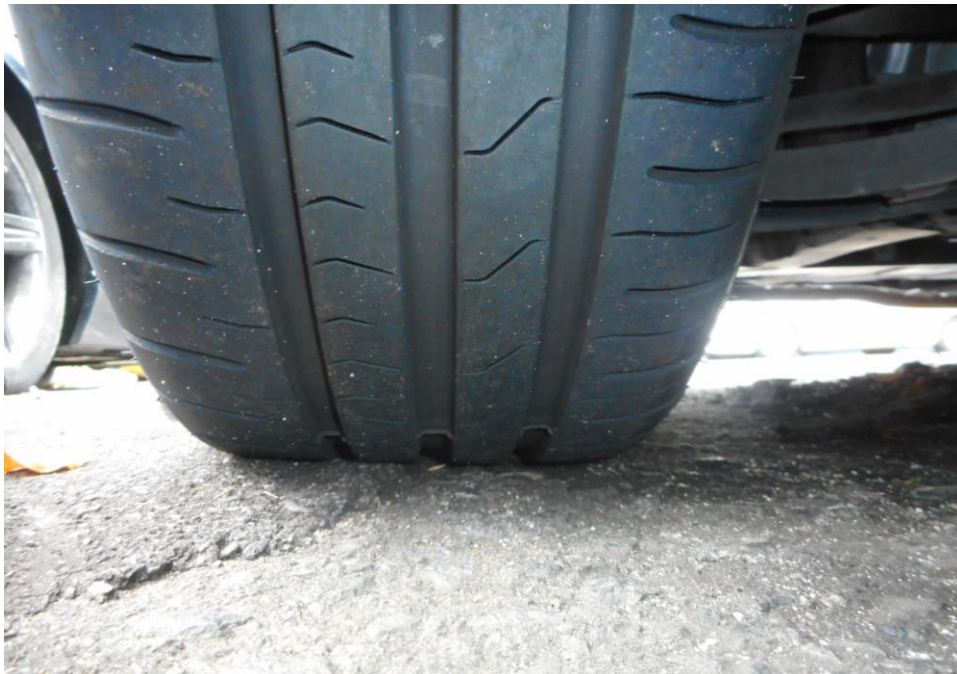
**Photo 11** shows the condition of the front left tyre of the Motor Car, which was observed to be in serviceable condition with remaining tread depth of approximately 6.2mm. There was also no tear, cut or burst mark(s) on the outer and the inner sidewalls as well as across the tread of the Motor Car's 4 tyres.

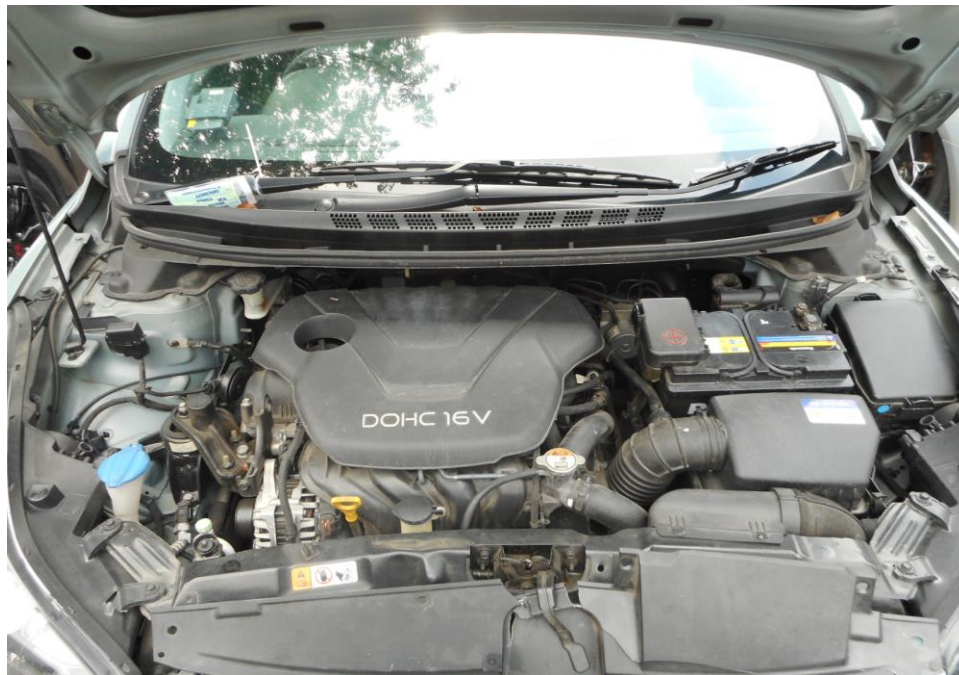
**Photo 12** shows a general view of the Motor Car's engine compartment. The various parts and components inside the engine compartment were unaffected by the accident. There was also no sign(s) or indication(s) of fluid leakage and/or fluid stain within the engine compartment.

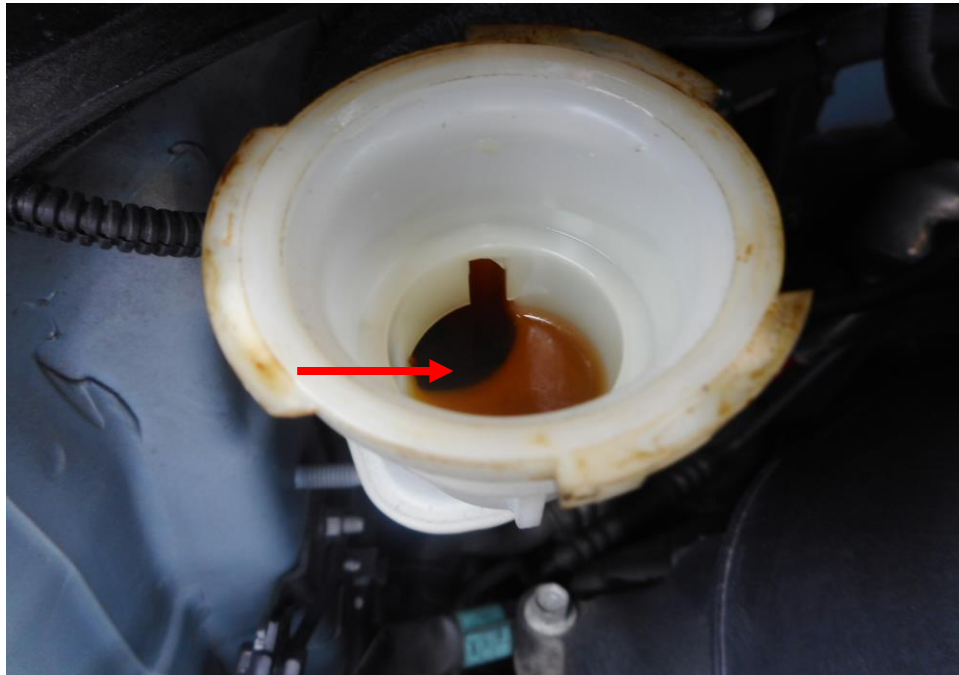
**Photo 13** shows the brake fluid reservoir of the Motor Car at the time of my inspection. The brake fluid was observed to be of sufficient level (arrowed) and without any visible contamination.

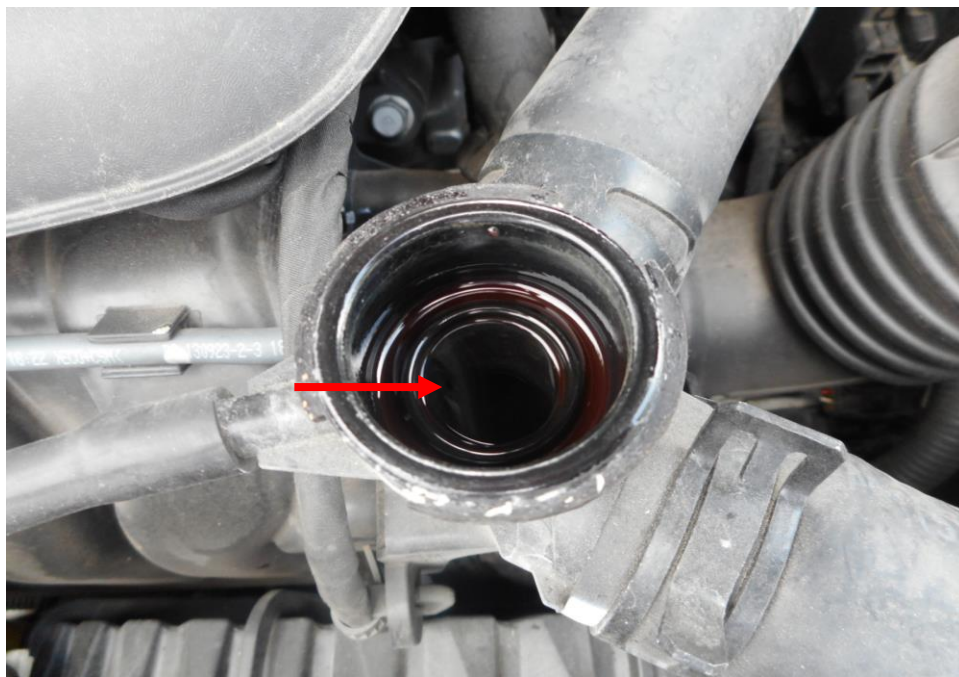
**Photo 14** shows checks being carried out to the engine coolant of the Motor Car at the time of my inspection. The engine coolant was observed to be insufficient level (arrowed) due to the damaged the radiator which caused the coolant to flow out.

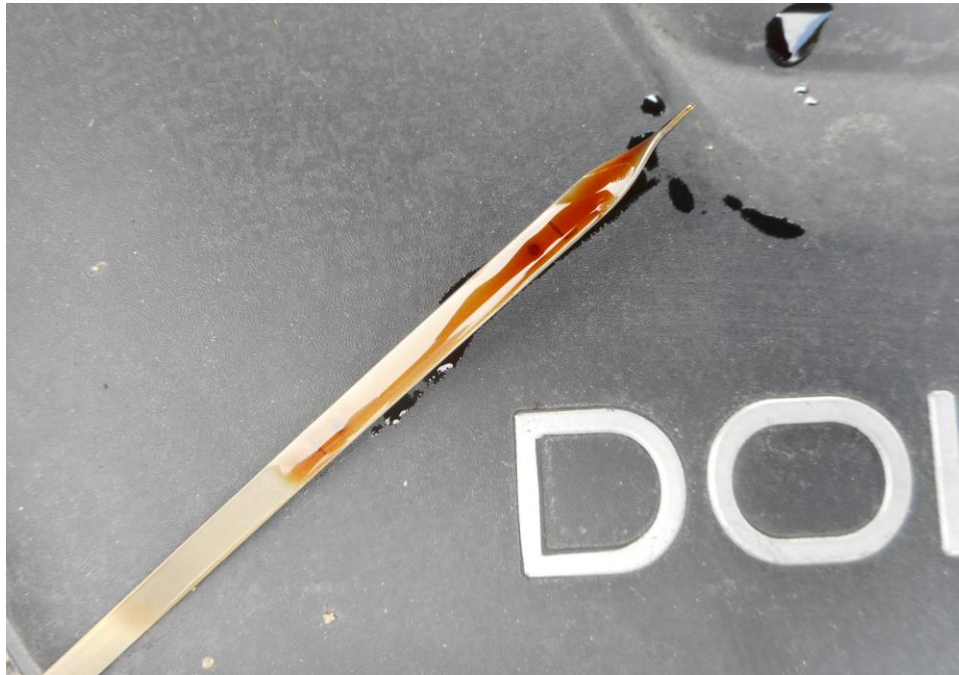
**Photo 15** shows the engine oil dip stick of the Motor Car at the time of my inspection. The engine oil was observed to be of sufficient level and without any visible contamination.

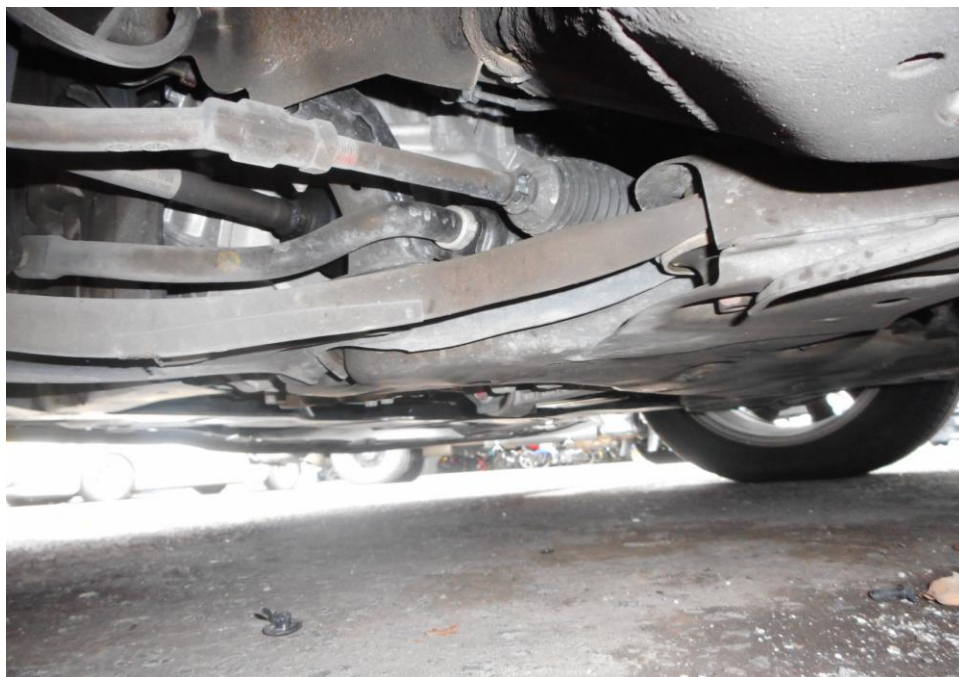
**Photo 16** shows the undercarriage of the Motor Car, at the area where the engine housing and transmission housing are located. I did not find any sign(s) or indication(s) of fluid leak and/or fluid stain(s) on the underside of the Motor Car.

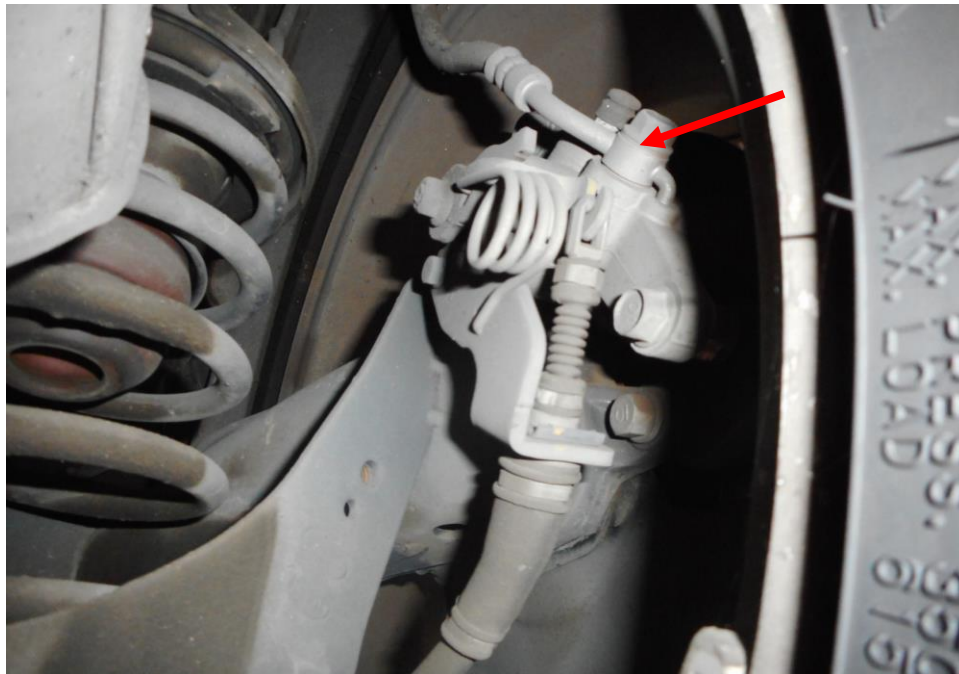
**Photo 17** shows the brake hose/pipe (arrowed) at the rear right wheel of the Motor Car. No leakage of brake fluid was observed. Visual examination of the various components of the braking system like the drum brake, brake booster, brake pedal etc. had revealed all to be intact and without visible damage.

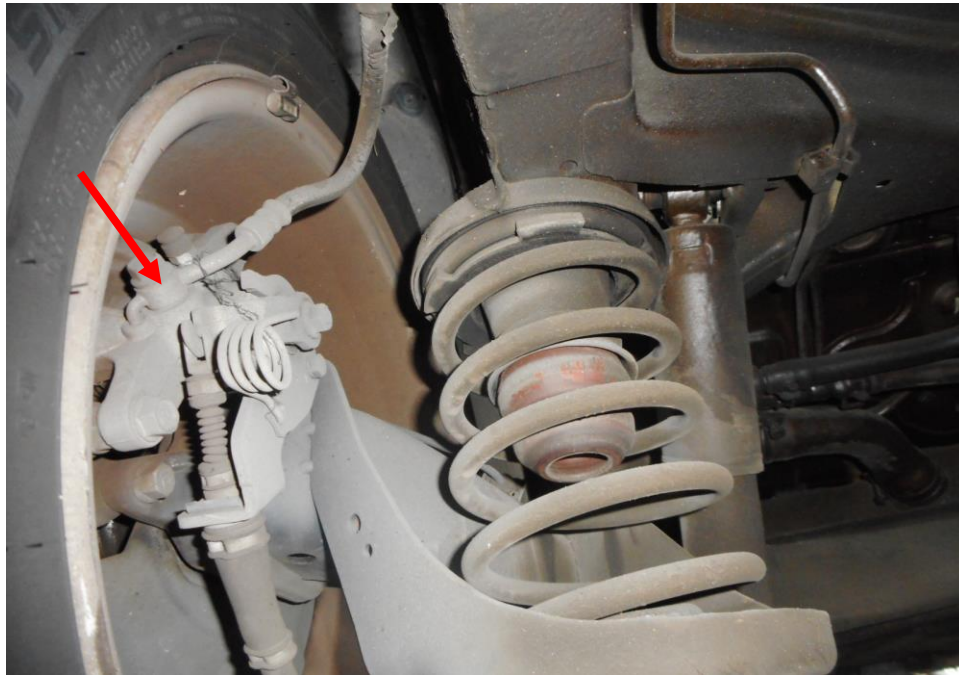
**Photo 18** shows the brake hose/pipe (arrowed) at the rear left wheel of the Motor Car. I did not observe any leakage of brake fluid at the time of my inspection of the Motor Car. Static tests of the Motor Car's braking system had indicated that there was no internal leakage of pressure/vacuum. The undercarriage components of the Motor Car were also all found to be intact and without any visible damage.

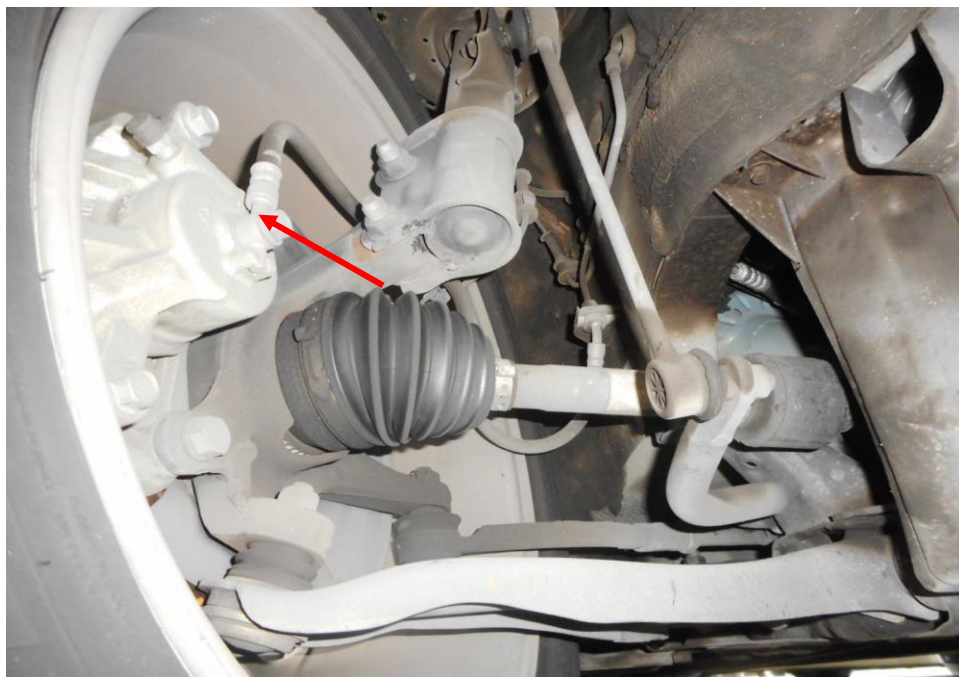
**Photo 19** shows the brake hose/pipe (arrowed) at the front right wheel of the Motor Car. I did not observe any leakage of brake fluid at the time of my inspection of the Motor Car. Static tests of the Motor Car's braking system had indicated that there was no internal leakage of pressure/vacuum. The undercarriage components of the Motor Car were also all found to be intact and without any visible damage.

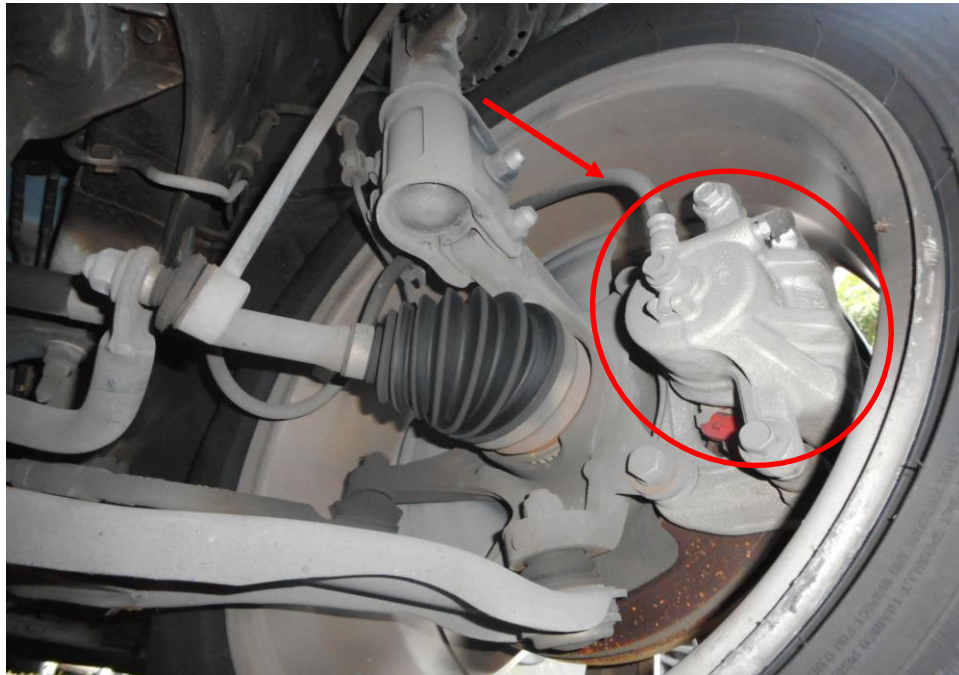
**Photo 20** shows the brake hose/pipe (arrowed) at the front left wheel of the Motor Car. No leakage of brake fluid was observed. Visual examination of the various components of the braking system like the brake caliper (circled), brake booster, brake pedal etc had revealed all to be intact and without visible damage.

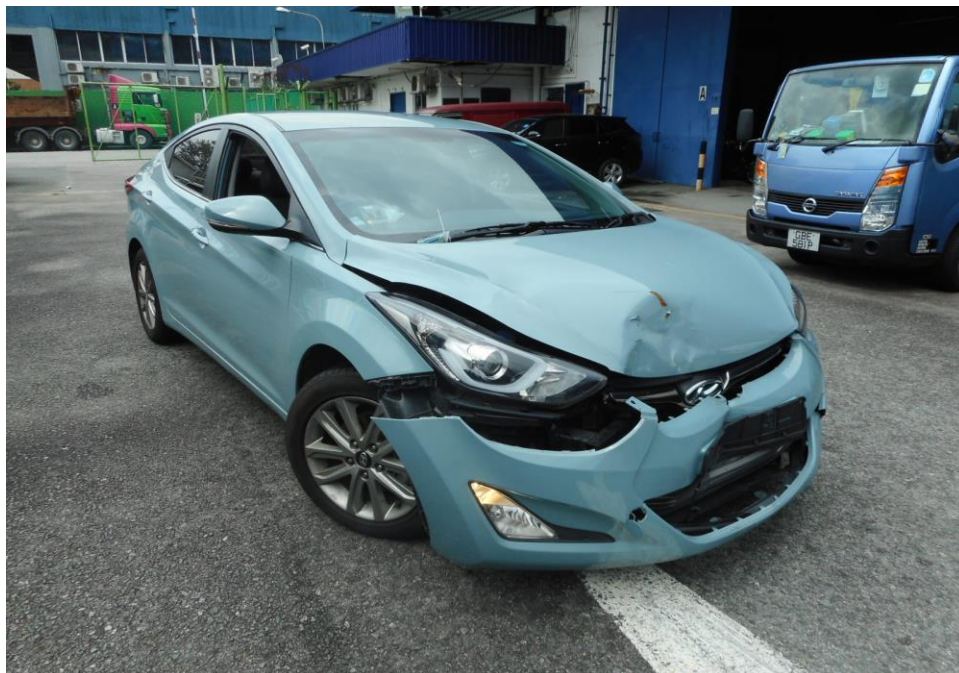
**Photo 21** shows the front right wheel of the Motor Car turned to its full left. During my steering system test, I did not experience any abnormal free play and/or resistance when I had turned the steering wheel towards the left and right. This would suggest that the steering system of the Motor Car was likely to be in serviceable condition at the material time of accident.

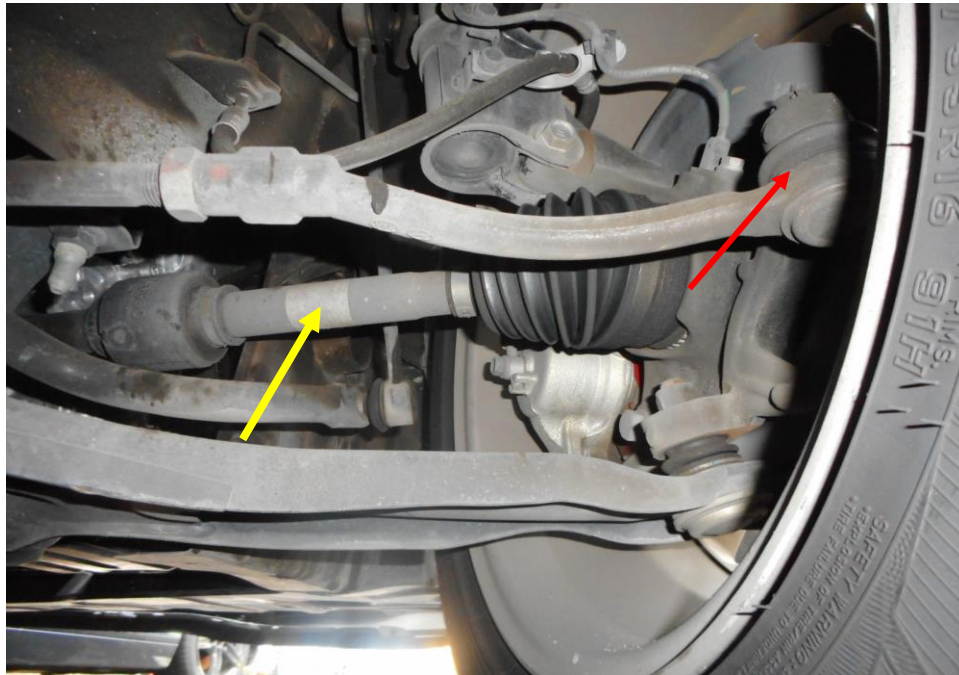
**Photo 22** shows the various undercarriage components at the front right wheel of the Motor Car, in particular the steering tie rod (red arrow) and drive shaft (yellow arrow). The various steering components were all found to be intact, suggesting that the steering system of the Motor Car was likely to be in serviceable condition at the material time of accident. There was also no sign of fluid stain observed on the various undercarriage components at the front right wheel of the Motor Car.

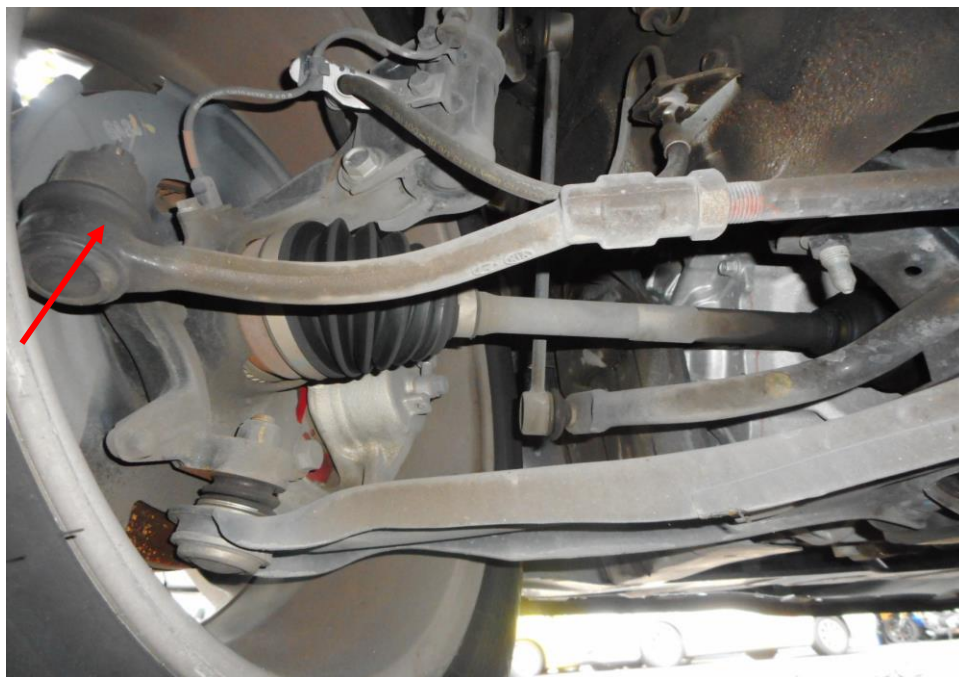
**Photo 23** shows the various undercarriage components at the front left wheel of the Motor Car, which had included the steering tie rod (red arrow). The various undercarriage components of the Motor Car were all found to be intact without any visible damage.

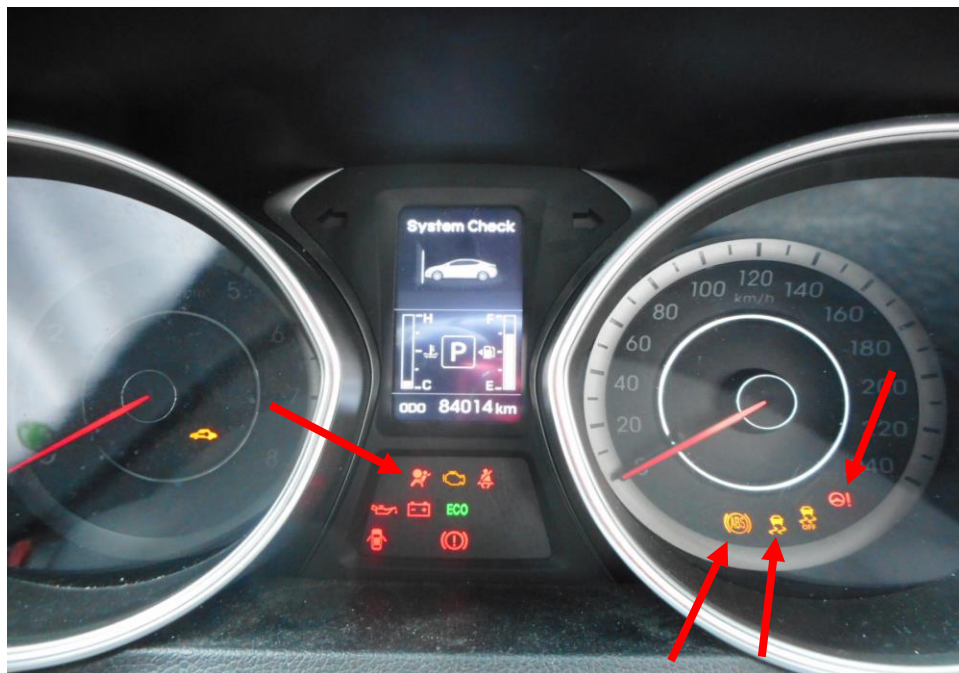
**Photo 24** shows the warning light for Anti-Lock Brake System (ABS), Power Steering System (EPS), Traction Control System (TC) and Supplemental Restraint System (SRS) (arrowed) appearing on the instrument panel of the Motor Car during the self-test of its various electronic operating systems when its engine was cranked.

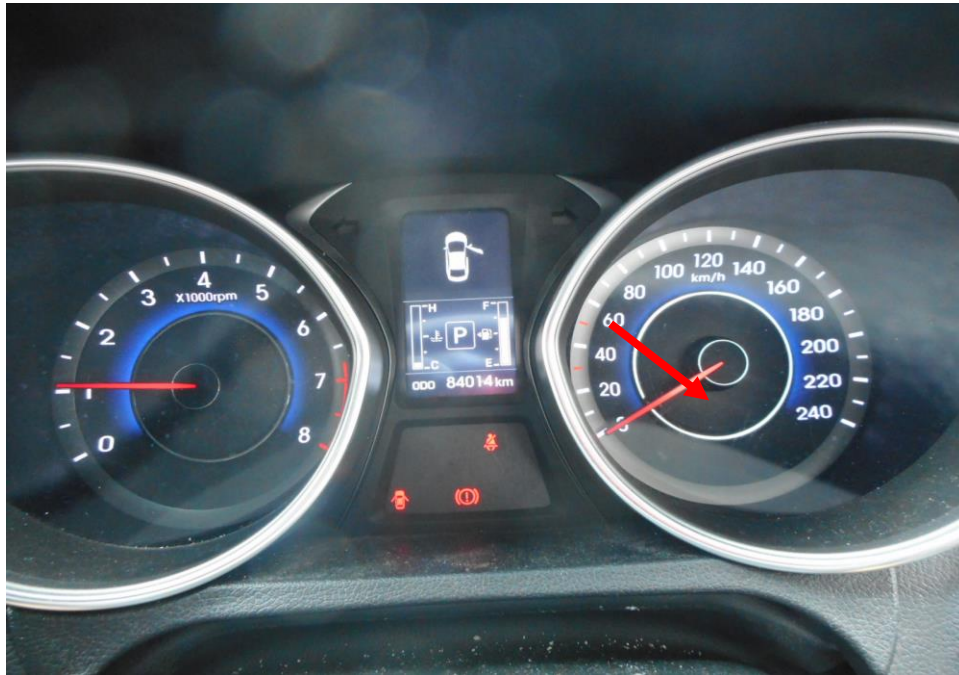
**Photo 25** shows no warning lights illuminated on the instrument panel of the Motor Car after the engine was cranked. This would suggest that there was no abnormality to the electronic operating system of the Motor Car, like the ABS, EPS, TC and SRS etc.
