Your Ref: TP/IP/27739/2020
Our Ref : CI/TPD20008426/P

17th August 2020

MECHANICAL INSPECTION REPORT OF MOTOR CAR SKD 6335T

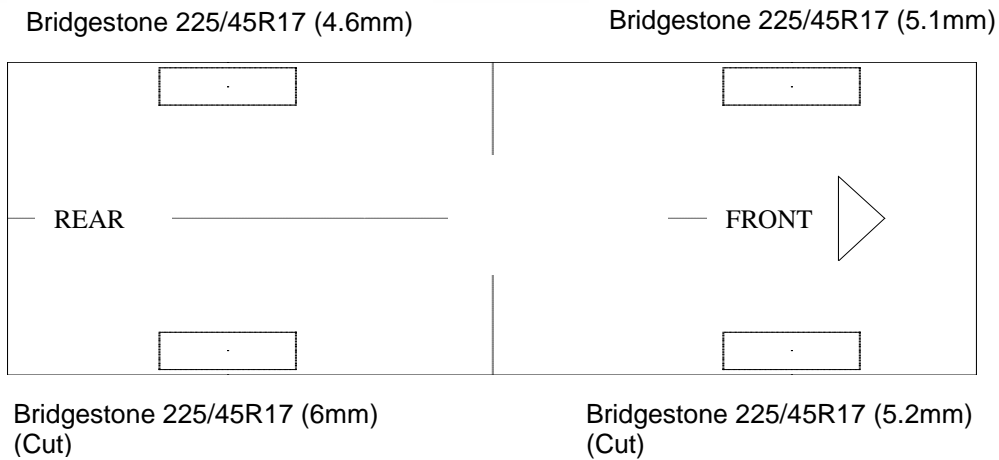
6. Both right front and rear tyres and rims was observed to be damaged. However, the condition of the Motor Car's 2 other tyres was observed to be in serviceable condition. I did not find any tear, cut or burst mark(s) on the outer and the inner sidewalls as well as across the tread of the 2 tyres. The 2 tyres were also observed to be sufficiently inflated for vehicular operation. The tyre brand, tyre size and remaining tread depth of the 4 tyres were recorded as follows:-

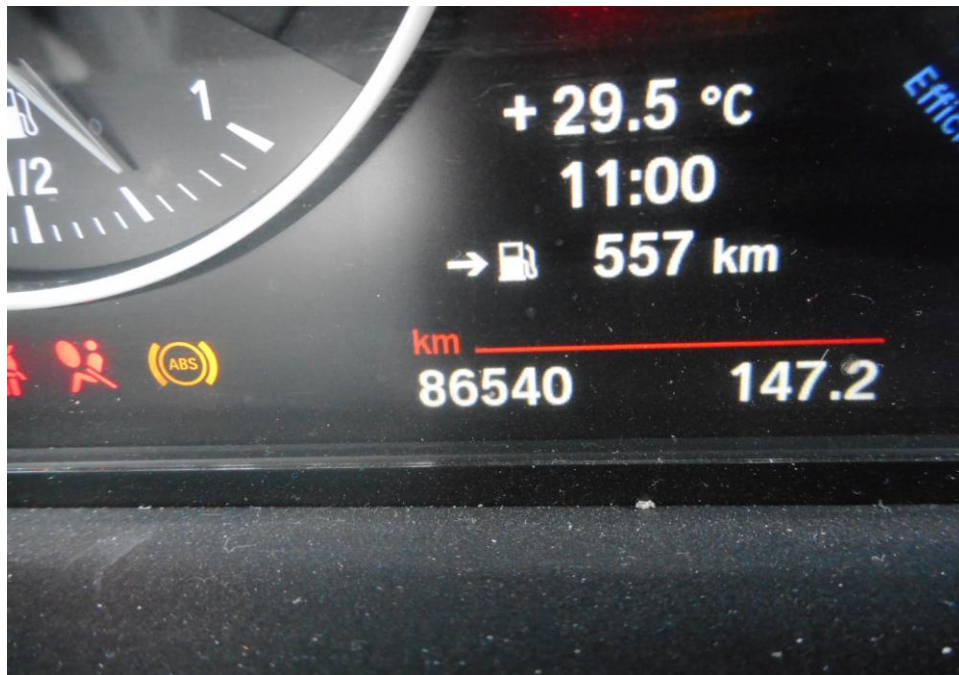
Photo 1 shows the mileage of the Motor Car at the time of my inspection. The mileage observed was 86,540km.

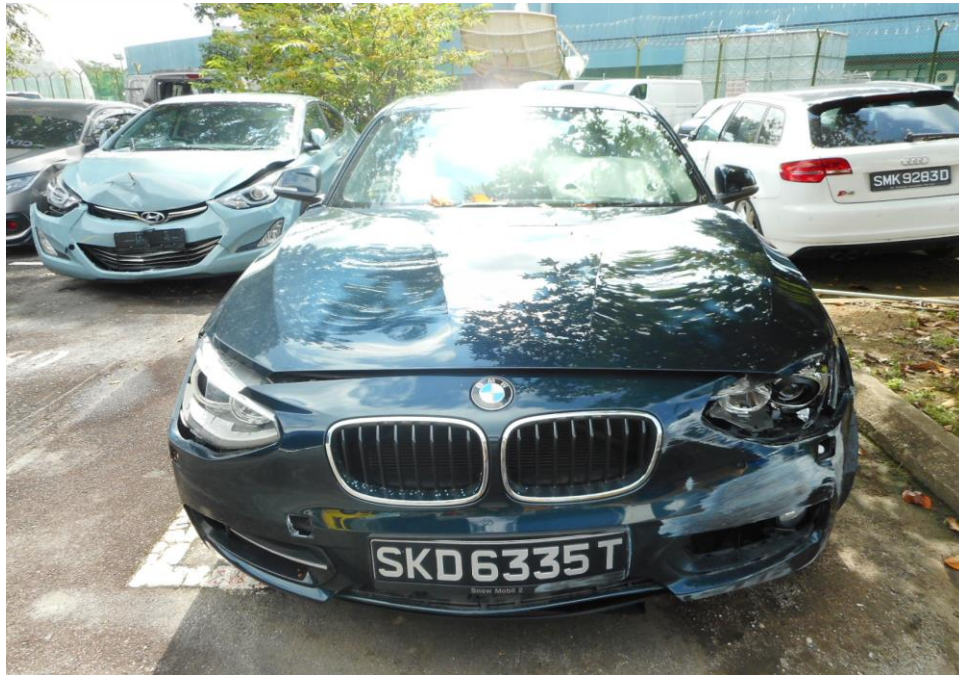
Photo 2 shows a general view of the Motor Car's front body at the time of my inspection. The Motor Car was observed to have sustained damage all around. Its front bonnet, front bumper, both front headlamps, its left and right body panels, its rear windscreen, both rear tail lamps and rear bumper were amongst the body parts that were damaged as a result of the accident. The Supplemental Restraint System (SRS) was activated as a result of the accident.

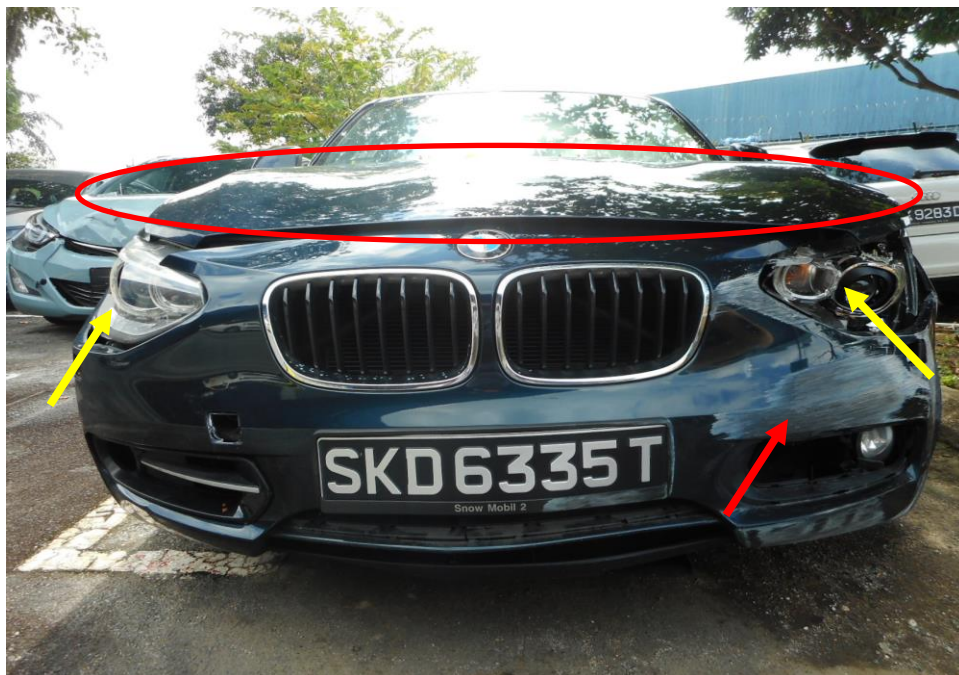
Photo 2 shows a close up view of the Motor Car's front body at the time of my inspection. Its front bonnet (circled), front bumper (red arrow), both front headlamps (yellow arrow) were amongst the body parts that were damaged as a result of the accident.

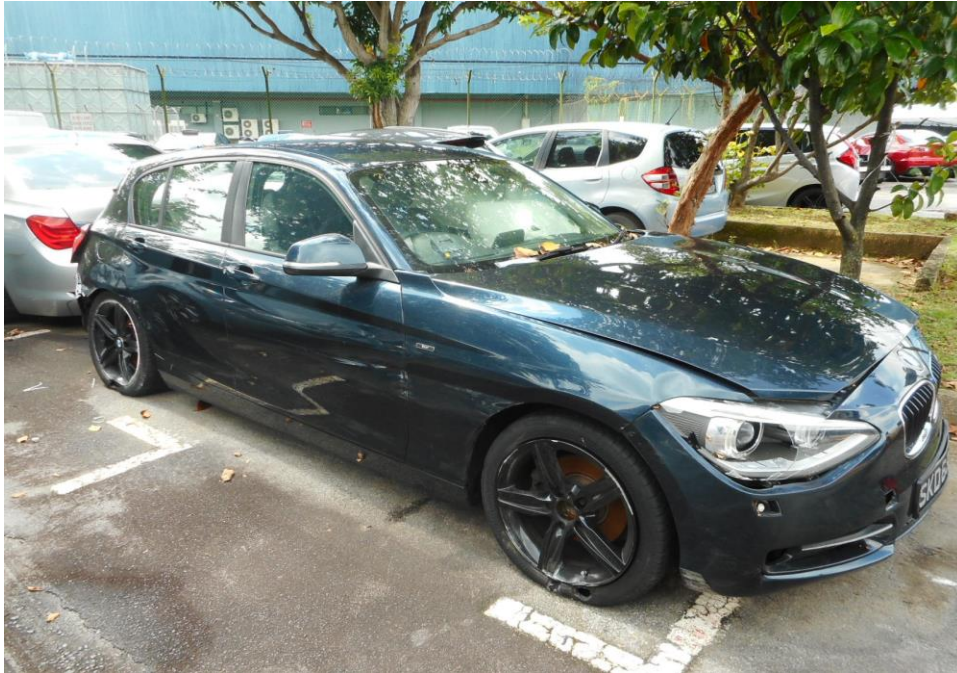
Photo 3 shows the general view of the Motor Car's right body at the time of my inspection. The Motor Car was observed to have sustained damage on its right body panels were amongst the body parts that were damaged as a result of the accident.

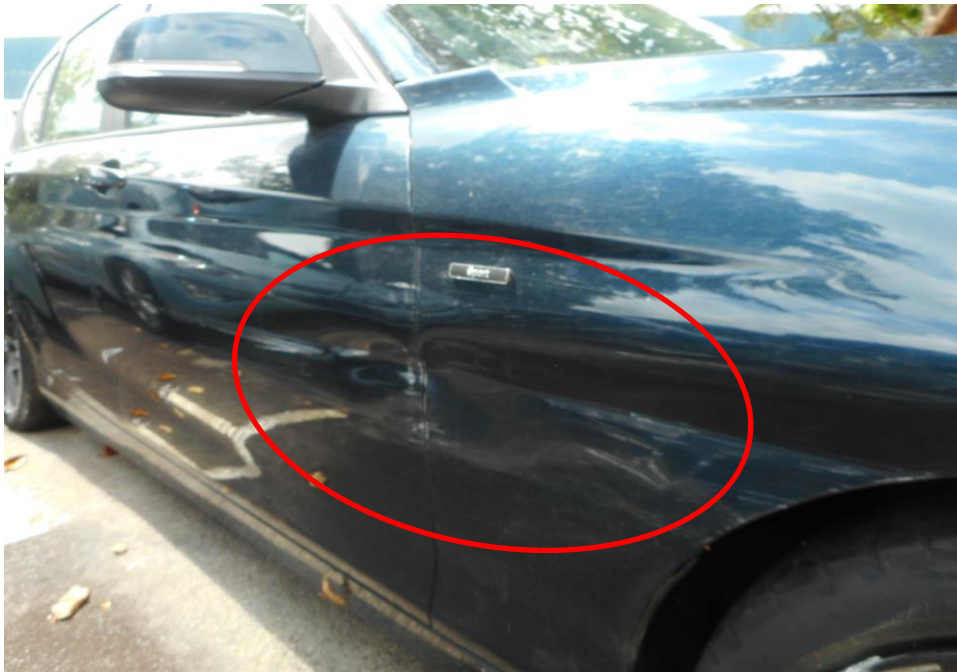
Photo 4 shows the close view of the Motor Car's right body at the time of my inspection. The Motor Car was observed to have sustained damage on its right body panels (circled) were amongst the body parts that were damaged as a result of the accident.

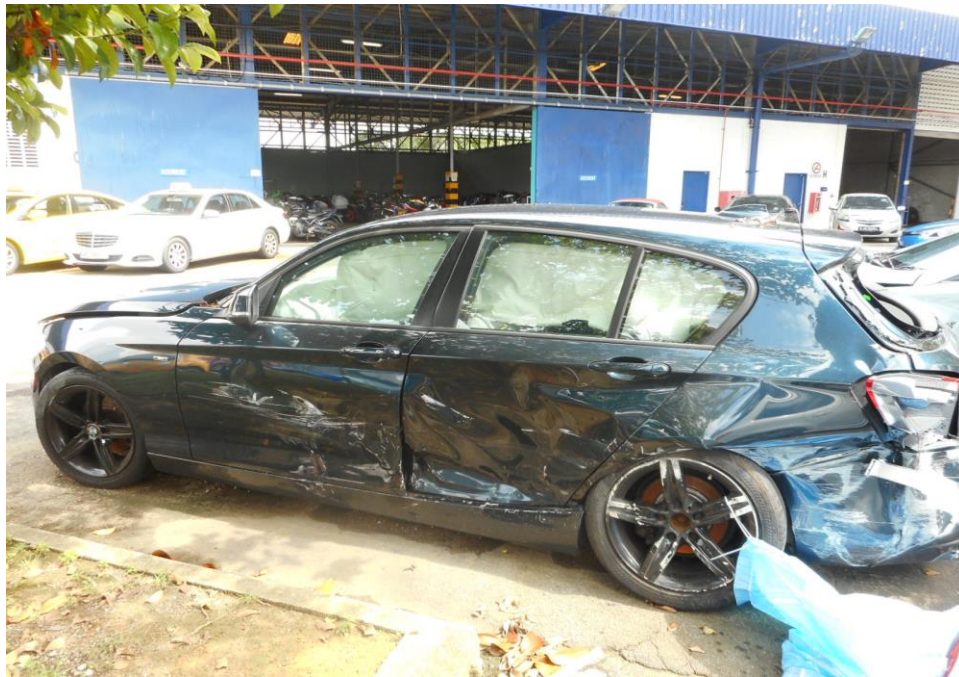
Photo 5 shows the general view of the Motor Car's left body at the time of my inspection. The Motor Car was observed to have sustained damage on its right body panels were amongst the body parts that were damaged as a result of the accident.

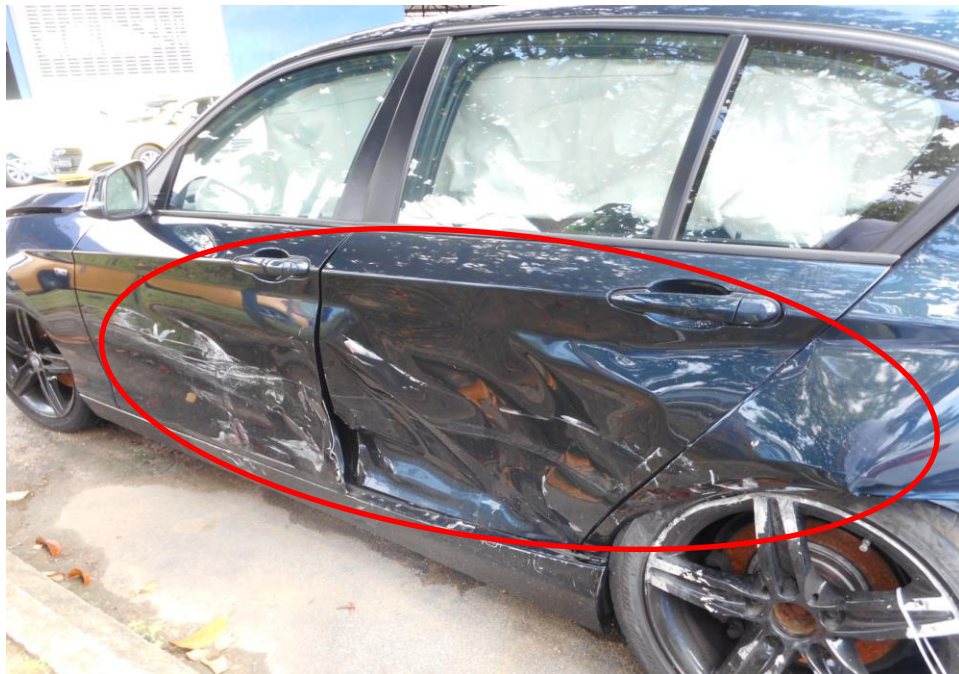
Photo 6 shows the close view of the Motor Car's left body at the time of my inspection. The Motor Car was observed to have sustained damage on its right body panels (circled) were amongst the body parts that were damaged as a result of the accident.

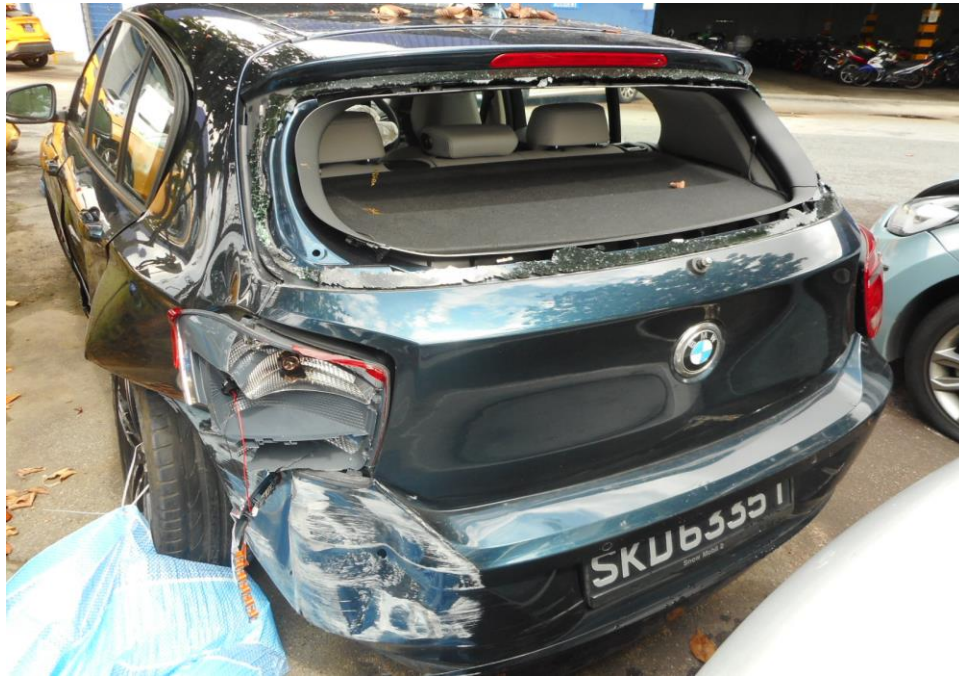
Photo 7 shows the general view of the Motor Car's rear body at the time of my inspection, its rear windscreen, both rear tail lamps and rear bumper were amongst the body parts that were damaged as a result of the accident.

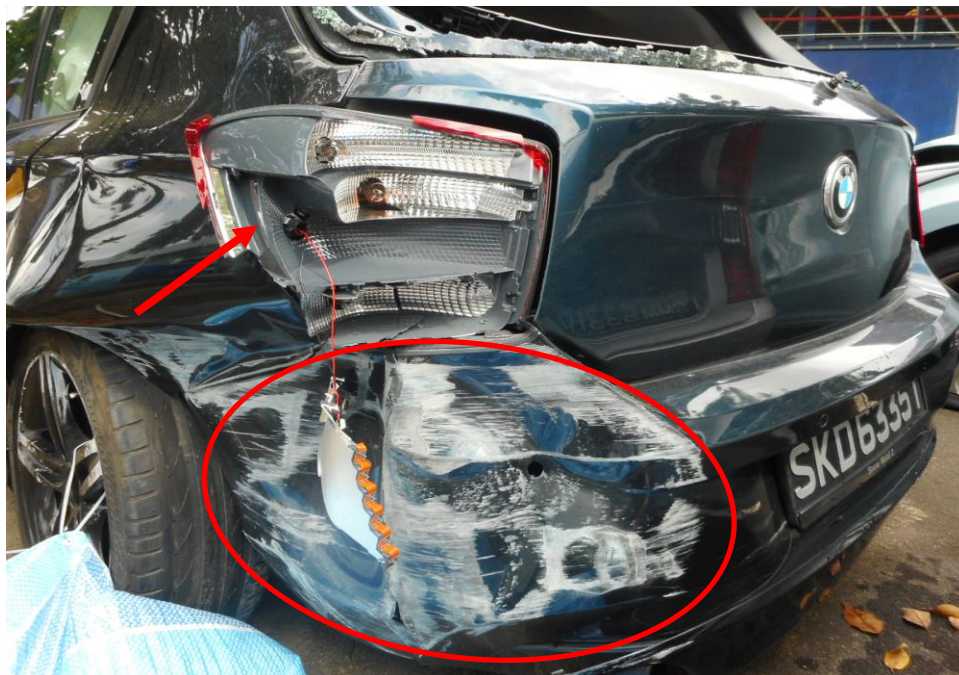
Photo 8 shows the close up view of the Motor Car's rear body at the time of my inspection, its rear left tail lamp (arrowed) and rear bumper (circled) were amongst the body parts that were damaged as a result of the accident.

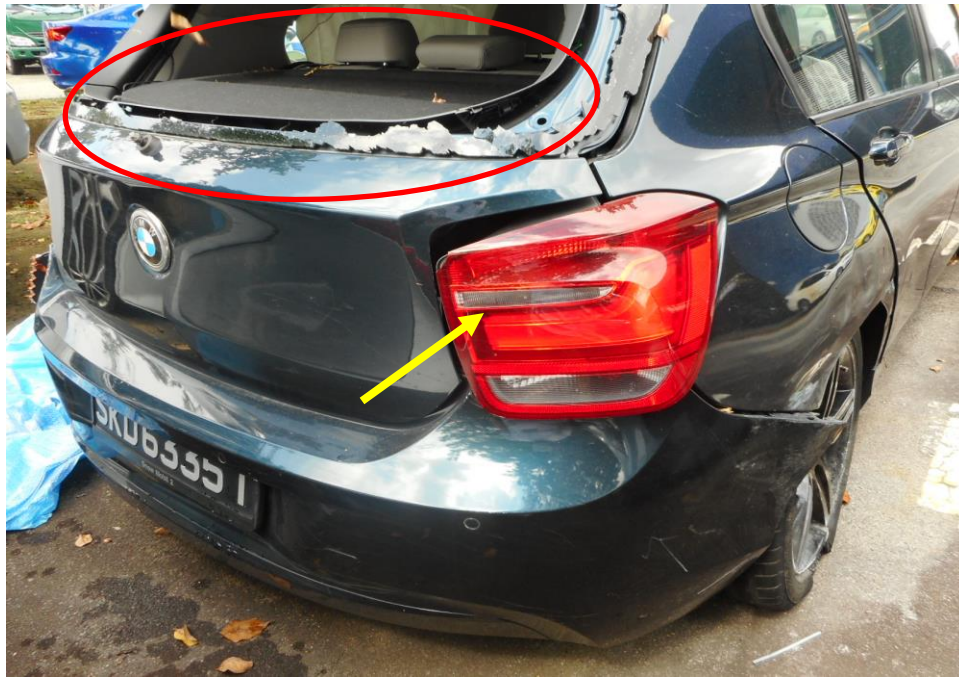
Photo 9 shows the general view of the Motor Car's rear body at the time of my inspection, its rear windscreen (circled) and rear right tail lamp (arrowed) were amongst the body parts that were damaged as a result of the accident.

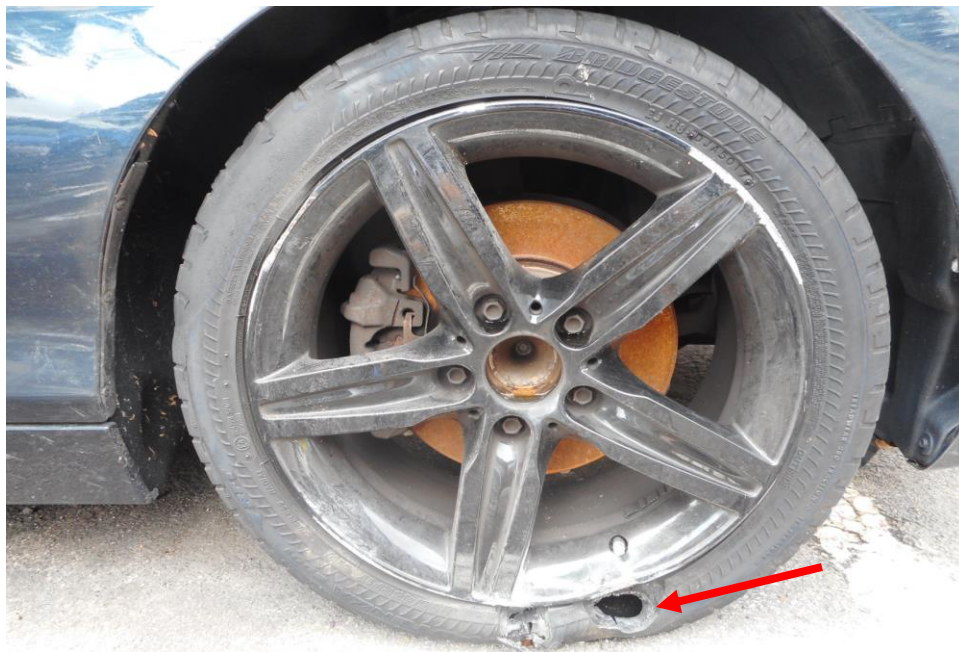
Photo 10 shows the condition of the front right tyre of the Motor Car, which was observed to be in unserviceable condition as it was damaged (arrowed) as a result of the accident with remaining tread depth of approximately 5.2mm.

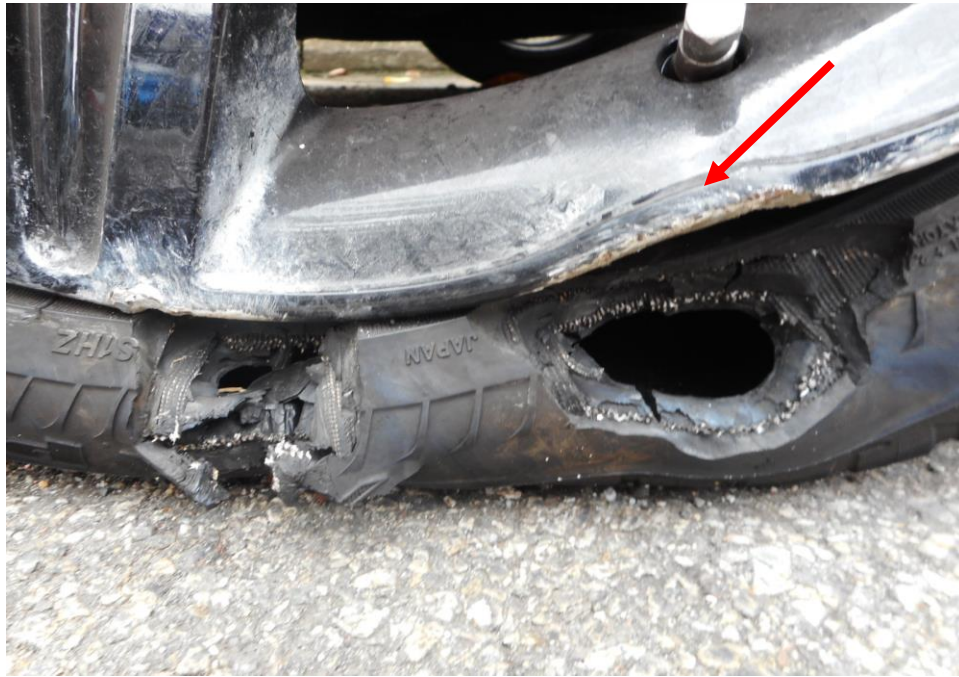
Photo 11 shows the close up condition of the front right tyre and rim of the Motor Car, which was observed that rim (arrowed) had likely caused cut on the tyre in the midst of the accident due to the impact it sustained from the collision.

17. The damaged to the front right and rear right tyres of the Motor Car were observed to be caused by the rims of Motor Car itself due to the impact sustained from the collision which caused the rims to cut through the tyre wall as a result of the accident. Refer to photo 11 & 13 above.

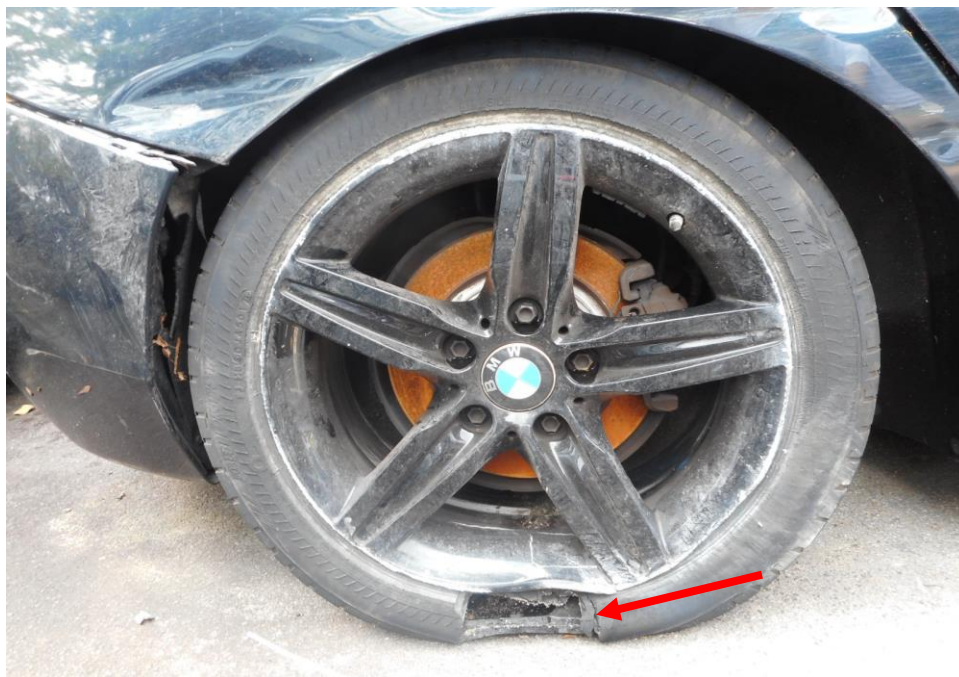
Photo 12 shows the condition of the rear right tyre of the Motor Car, which was observed to be in unserviceable condition as it was damaged (arrowed) as a result of the accident with remaining tread depth of approximately 6mm.

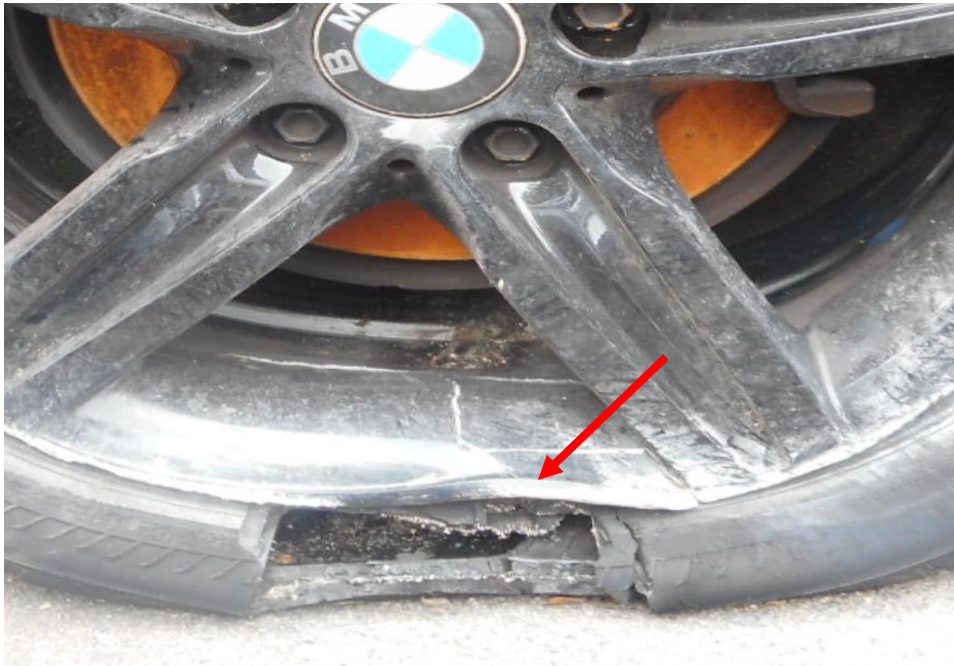
Photo 13 shows the close up condition of the rear right tyre and rim of the Motor Car, which was observed that rim (arrowed) had likely caused cut on the tyre in the midst of the accident due to the impact it sustained from the collision.

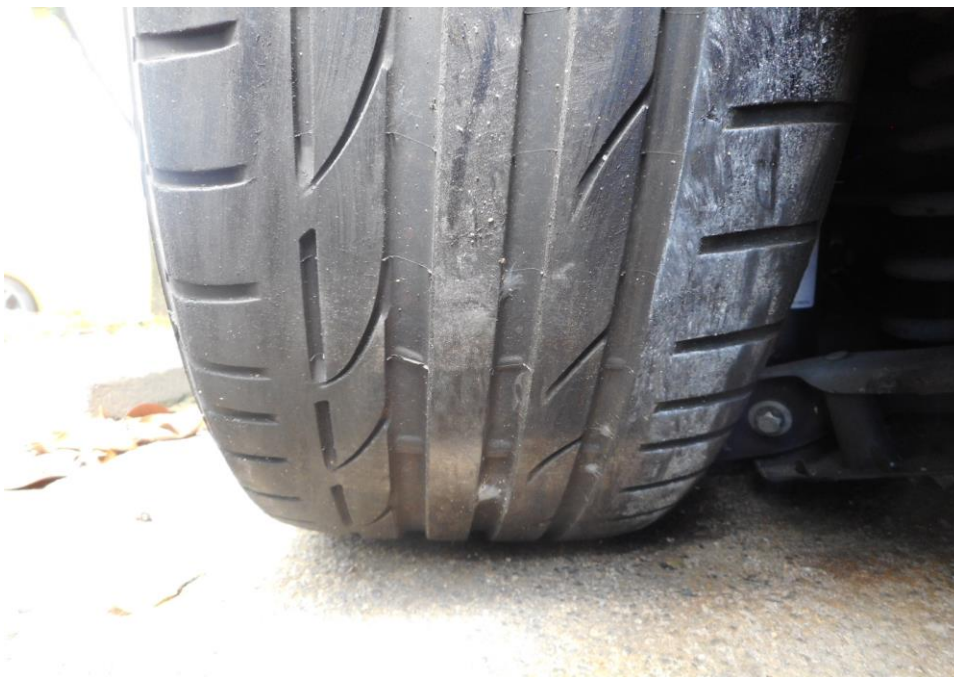
Photo 14 shows the condition of the rear left tyre of the Motor Car, which was observed to be in serviceable condition with remaining tread depth of approximately 4.6mm. There was also no tear, cut or burst mark(s) on the outer and the inner sidewalls as well as across the tread of the Motor Car's 2 left tyres.

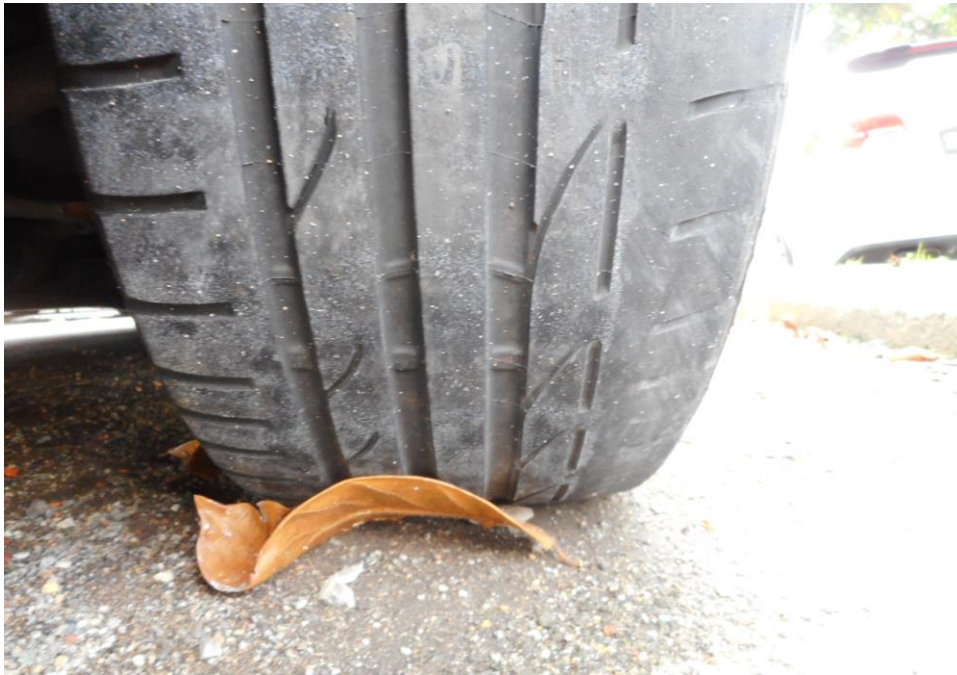
Photo 15 shows the condition of the front left tyre of the Motor Car, which was observed to be in serviceable condition with remaining tread depth of approximately 5.1mm. There was also no tear, cut or burst mark(s) on the outer and the inner sidewalls as well as across the tread of the Motor Car's 2 left tyres.

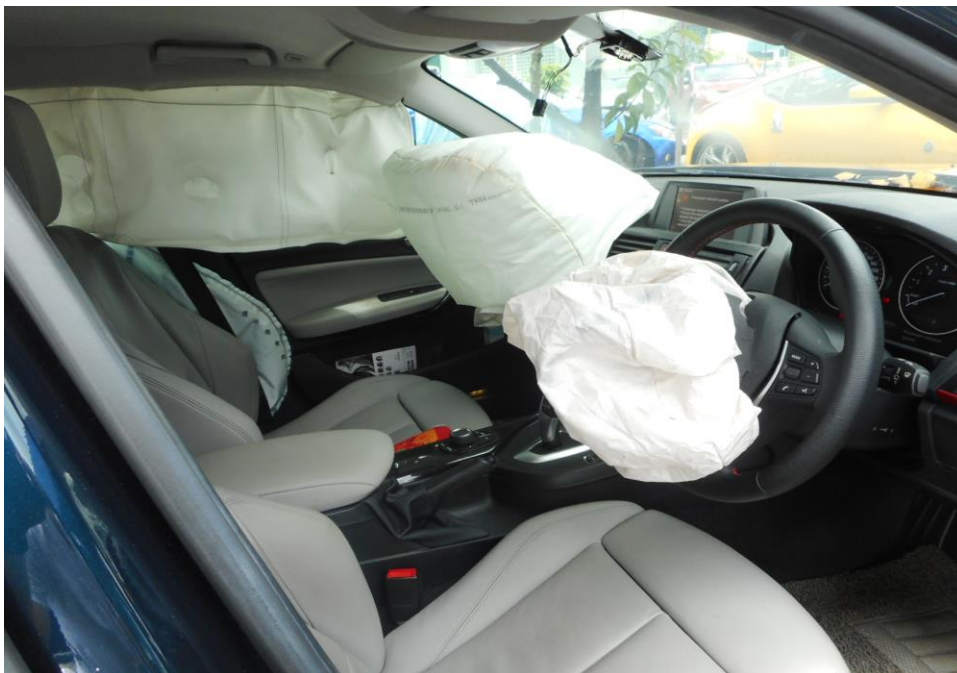
Photo 16 shows the deployment of the Supplemental Restraint System (SRS) airbag in the Motor Car as a result of the accident.

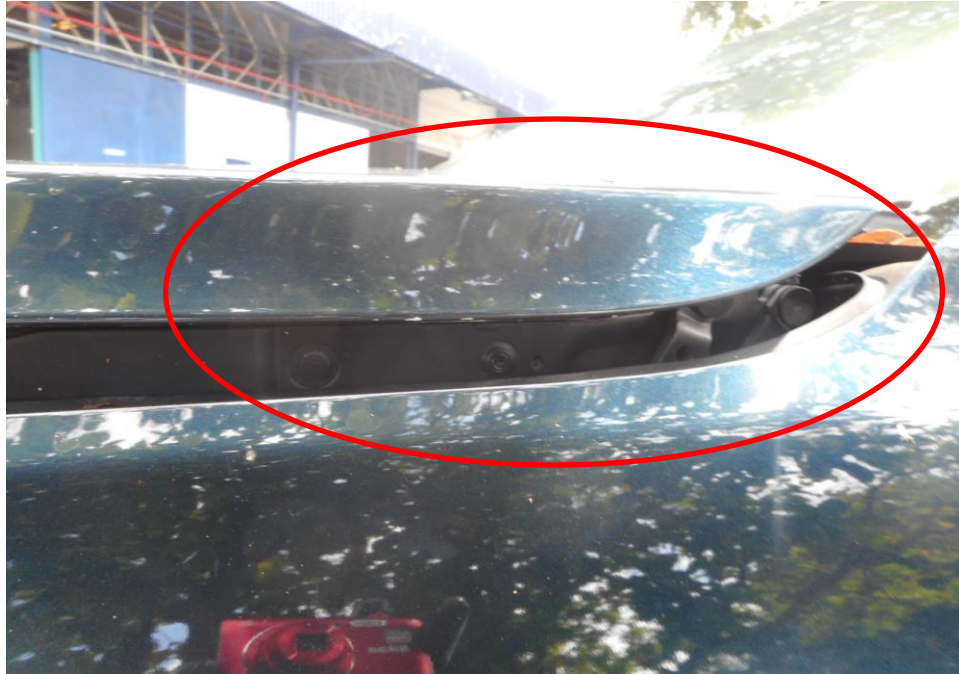
8. We were unable to raise the front bonnet of the Motor car to conduct the examination of the Motor Car's engine compartment because the damage caused by the accident had resulted in the damages to the lock mechanism of the bonnet and the structure of the engine compartment. (unable to open)
See photo 17 below

Photo 17 shows a close up view of the damaged front bonnet lock mechanism and the structure of the engine compartment of the Motor Car at the time of my inspection resulting it unable to open a result of the accident. (circled) (Unable to open)

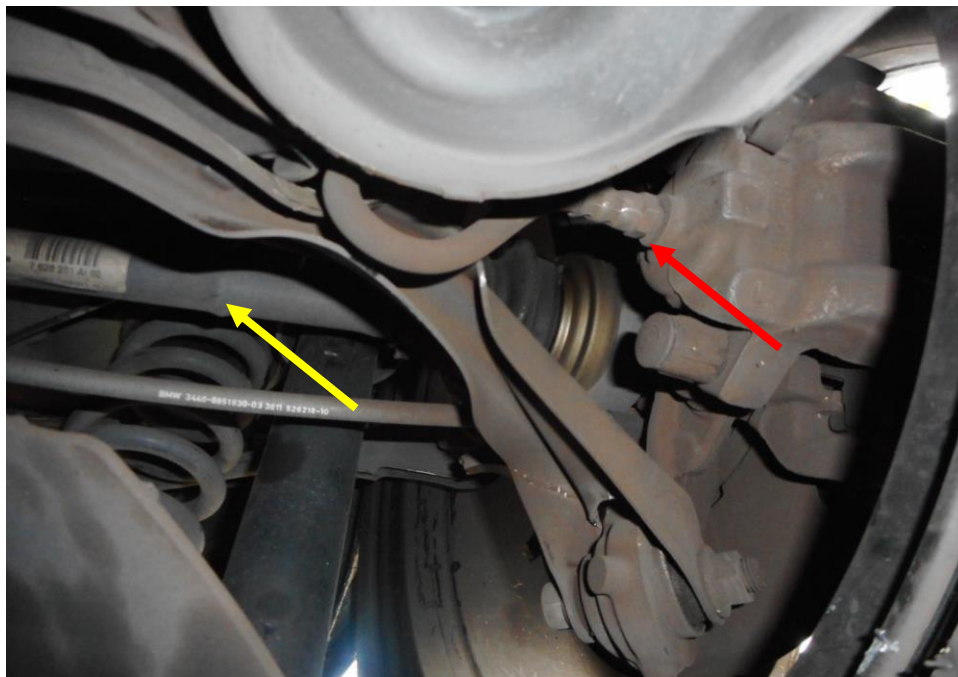
Photo 18 shows the brake hose/pipe (arrowed) at the rear right wheel of the Motor Car. No leakage of brake fluid was observed and drive shaft (yellow arrow) Visual examination of the various components of the braking system like the drum brake, brake booster, brake pedal, drive shaft etc. had revealed all to be intact and without visible damage.

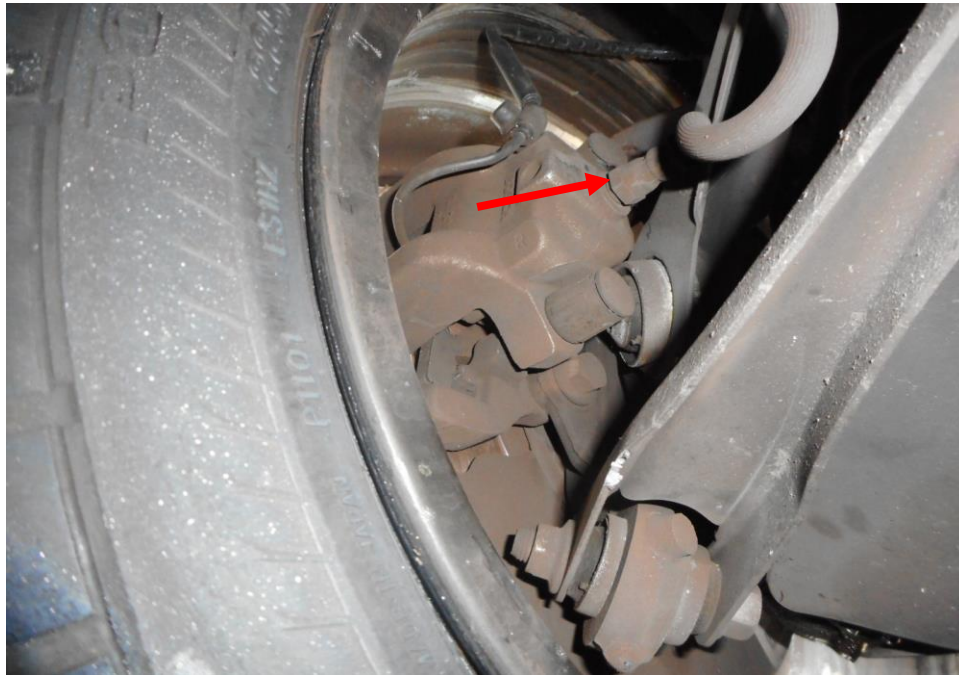
Photo 19 shows the brake hose/pipe (arrowed) at the rear left wheel of the Motor Car. I did not observe any leakage of brake fluid at the time of my inspection of the Motor Car. Static tests of the Motor Car's braking system had indicated that there was no internal leakage of pressure/vacuum. The undercarriage components of the Motor Car were also all found to be intact and without any visible damage.

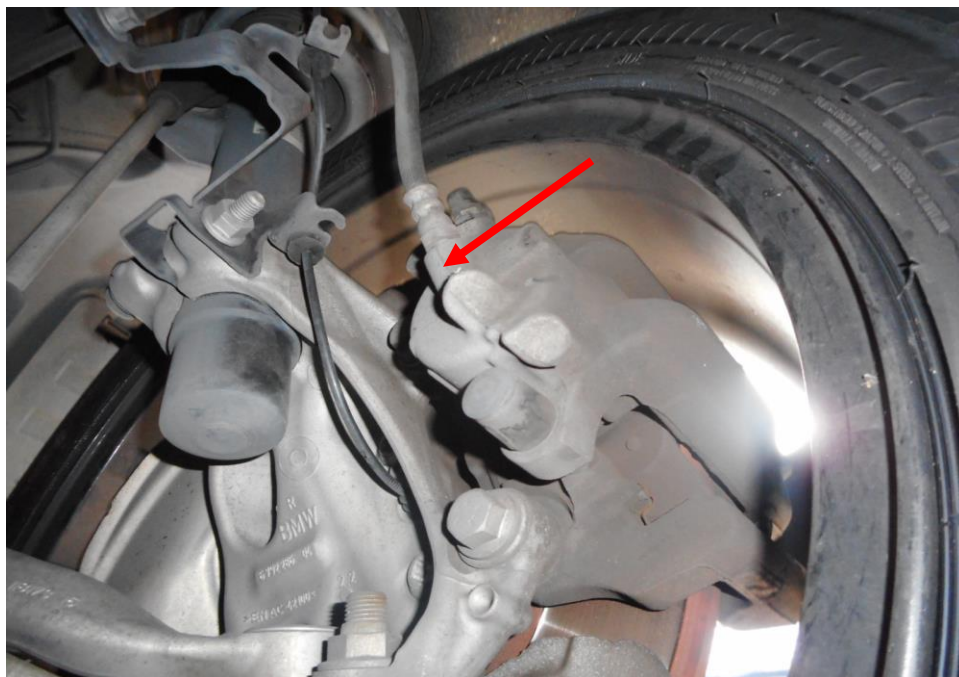
Photo 20 shows the brake hose/pipe (arrowed) at the front right wheel of the Motor Car. I did not observe any leakage of brake fluid at the time of my inspection of the Motor Car. Static tests of the Motor Car's braking system had indicated that there was no internal leakage of pressure/vacuum. The undercarriage components of the Motor Car were also all found to be intact and without any visible damage.

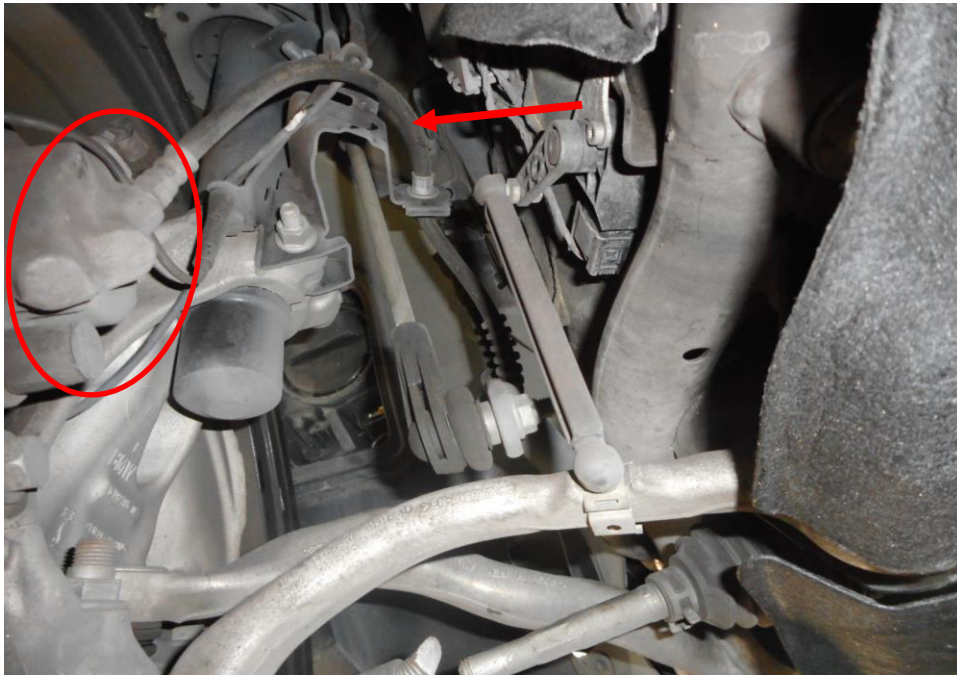
Photo 21 shows the brake hose/pipe (arrowed) at the front left wheel of the Motor Car. No leakage of brake fluid was observed. Visual examination of the various components of the braking system like the brake caliper (circled), brake booster, brake pedal etc had revealed all to be intact and without visible damage.

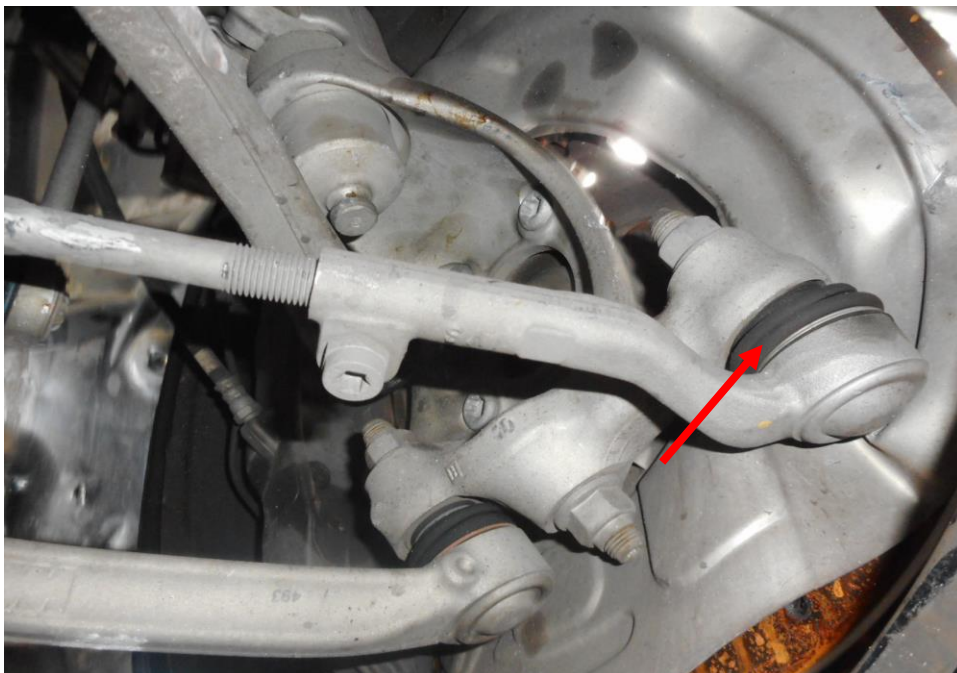
Photo 22 shows the various undercarriage components at the front right wheel of the Motor Car, in particular the steering tie rod (red arrow). The various steering components were all found to be intact, suggesting that the steering system of the Motor Car was likely to be in serviceable condition at the material time of accident. There was also no sign of fluid stain observed on the various undercarriage components at the front left wheel of the Motor Car.

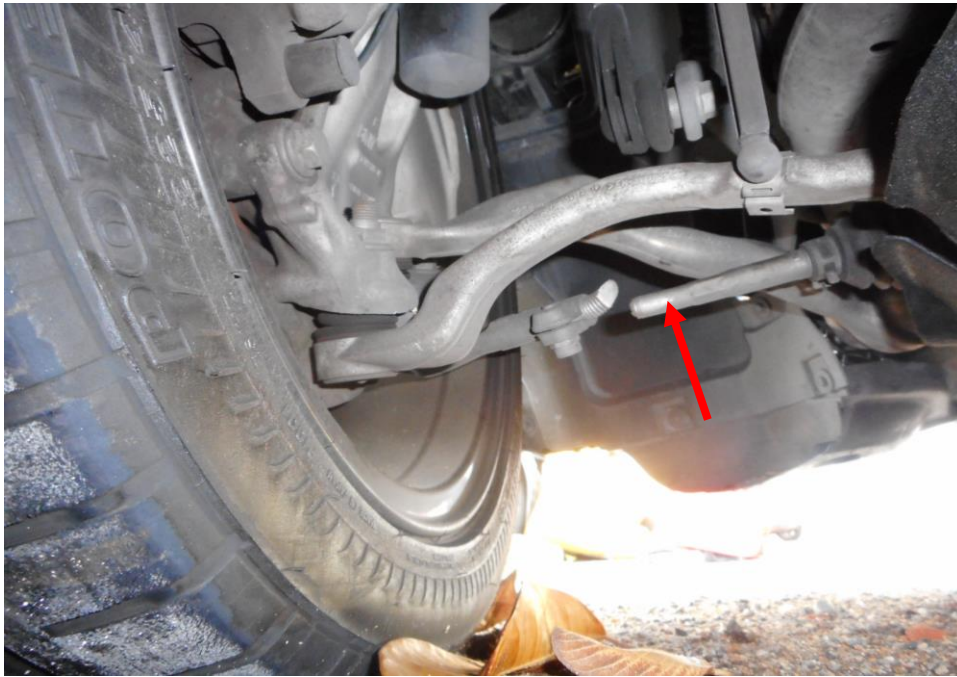
Photo 23 shows the various undercarriage components at the front left wheel of the Motor Car, the steering tie rod (red arrow) was observed to be damaged as a result of the accident.

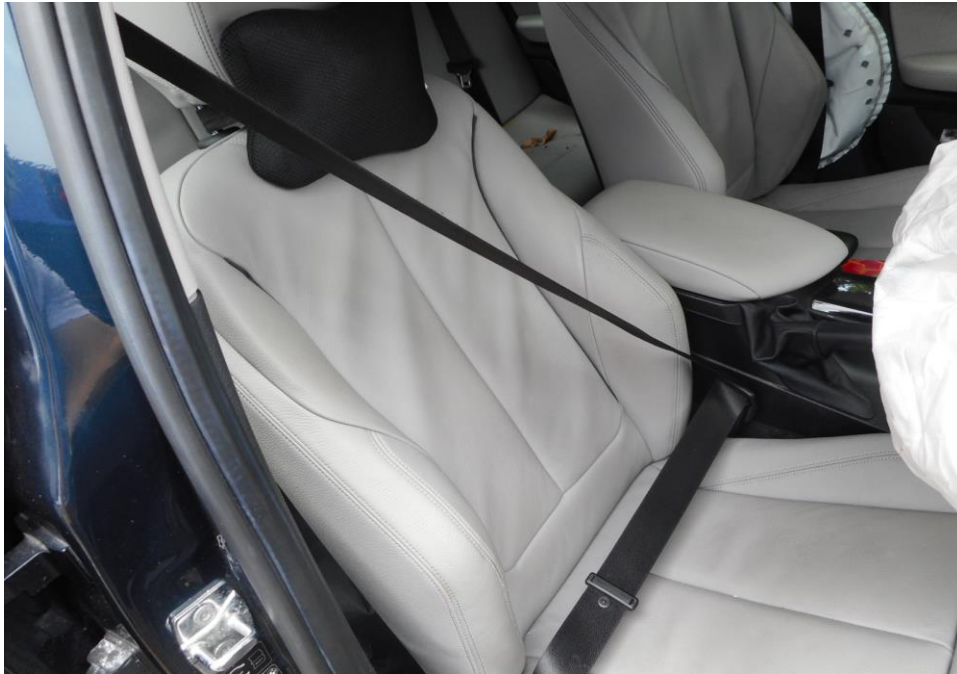
Photo 24 shows that the seat belt on the right seat were able to be fastened securely into the respective pre-tensioners that were fitted at the sides of each seat.

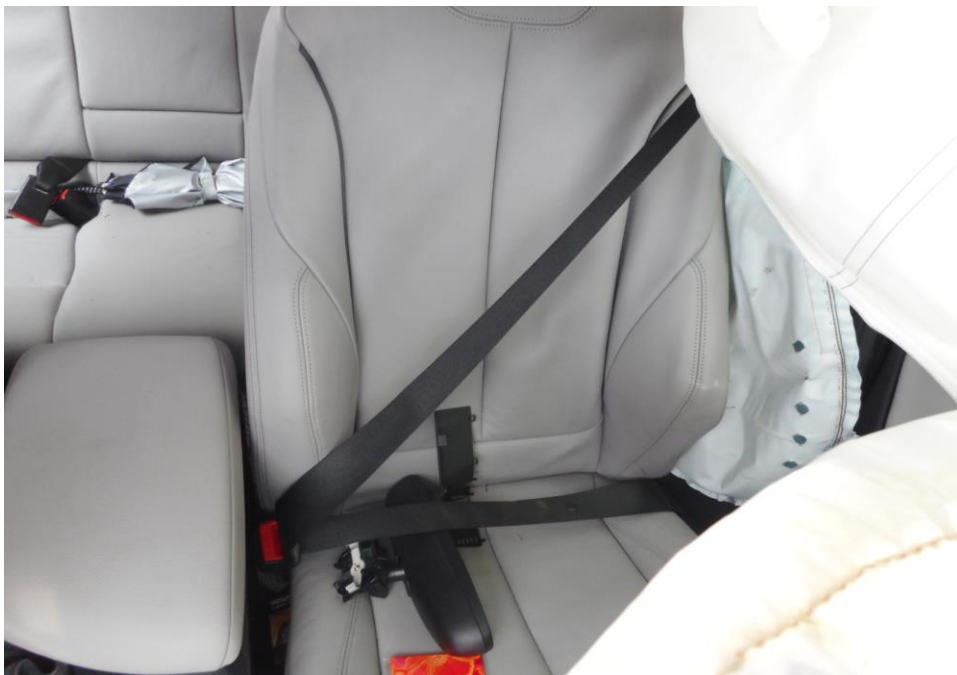
Photo 25 shows that the seat belt on the left seat were able to be fastened securely into the respective pre-tensioners that were fitted at the sides of each seat.
