## ESTIMATE

DATE : 21/2/2020  
ACC DATE : 20/2/2020  
POLICY NO : DMC919001459

RE: VEHICLE NO: XE4589Y MITSUBISHI FUSO/ CHENG HENG LEE PTE LTD

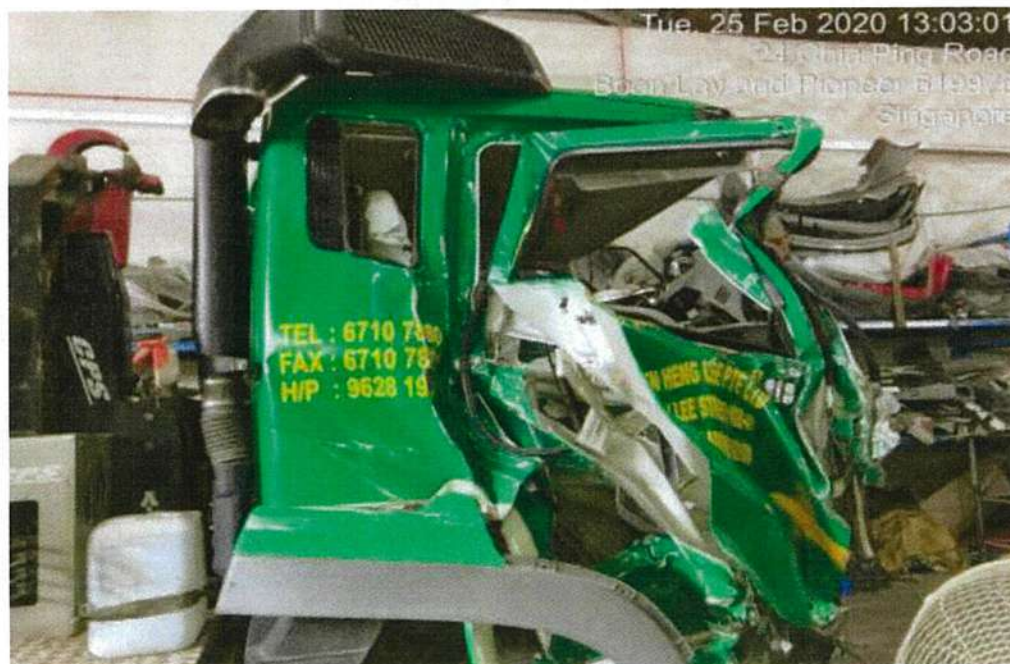
| S/NO | QTY | DESCRIPTION | UNIT PRICE \$ | AMOUNT \$ |
|---|---|---|---|---|
| 1 | 1 | FRONT CABIN HEAD - sheared / deformed | | 85,000.00 |

Photo 6 CRUSHED RH SIDE OF CABIN

| S/NO | QTY | LABOUR & MISCELLANEOUS | AMOUNT \$ |
|---|---|---|---|
| 3 | | Remove & Refit Front Cabin | 1,800.00 |

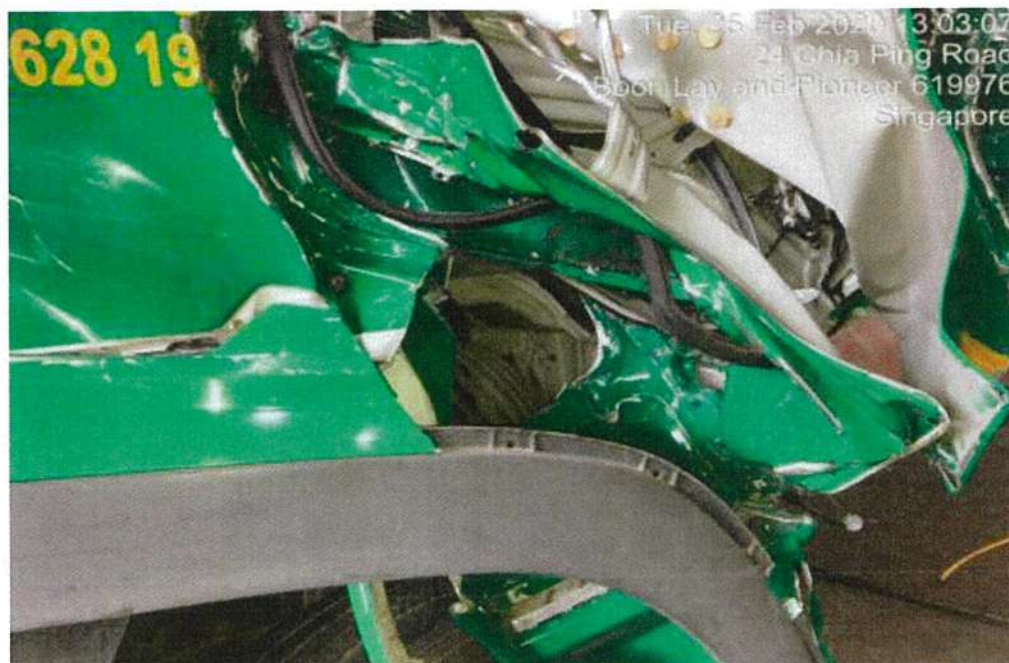
Photo 8 CRUSHED DOOR & DOOR COMPONENTS

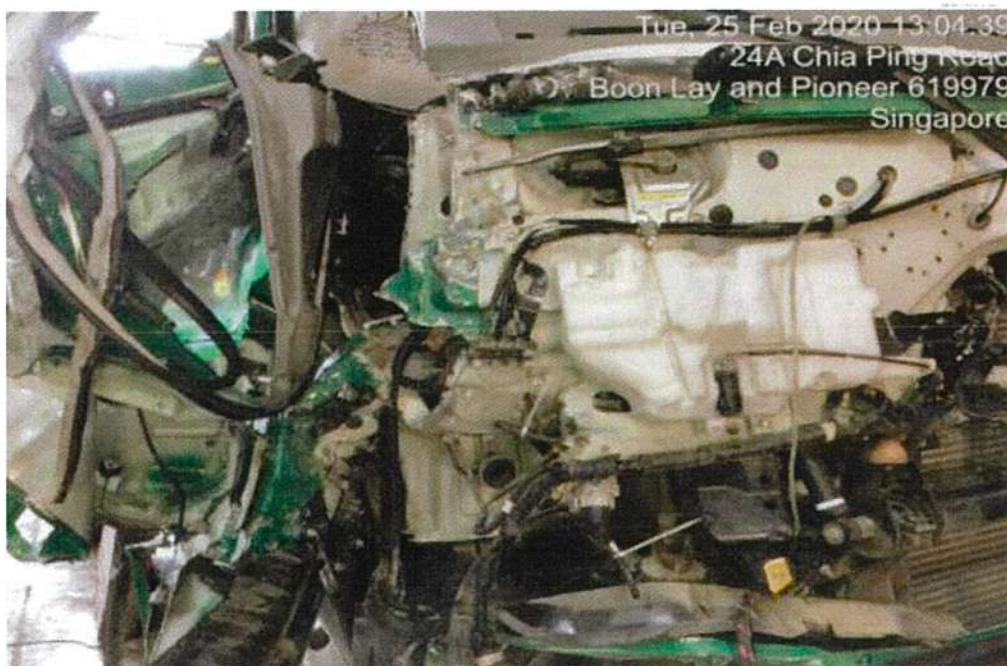
Photo 13 SNAPPED WIPER LINKAGE

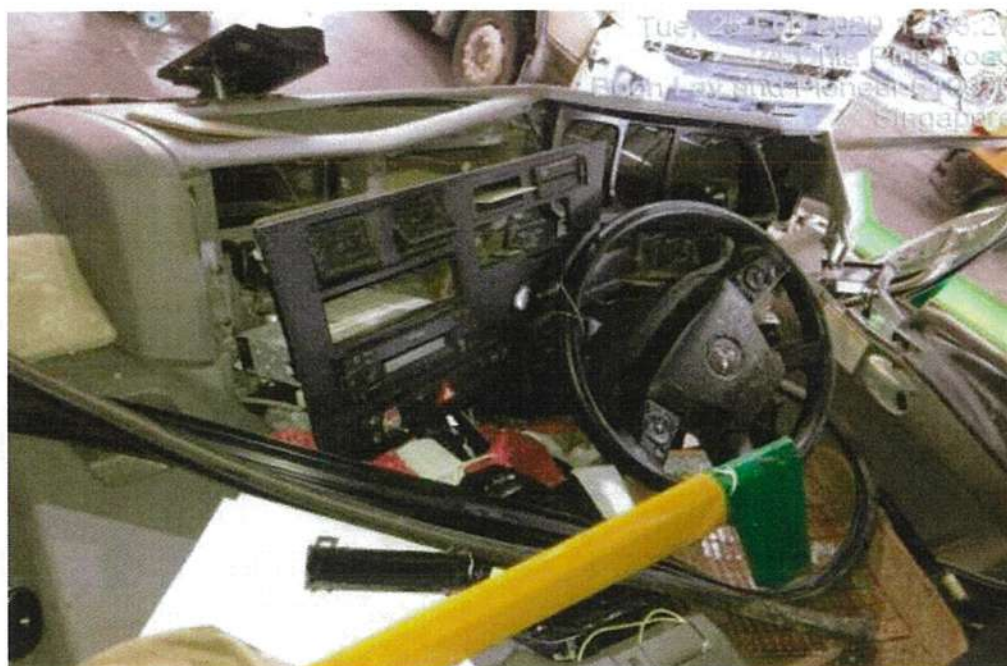
Photo 14 BROKEN DASHBOARD & COVERINGS

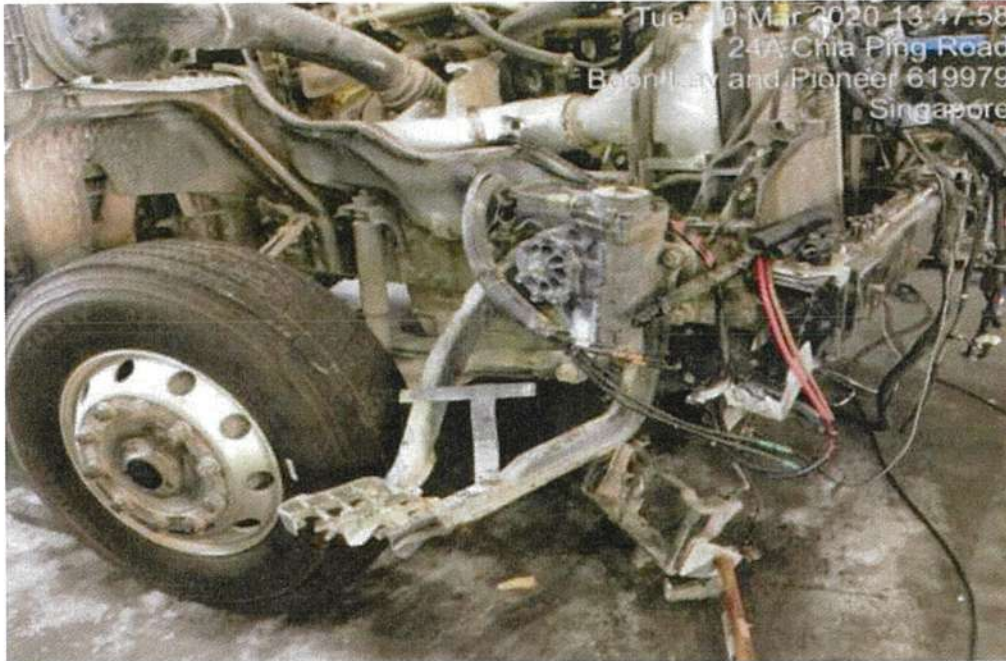
Photo 21 SNAPPED WIRE HARNESS & BENT LOWER STEPS

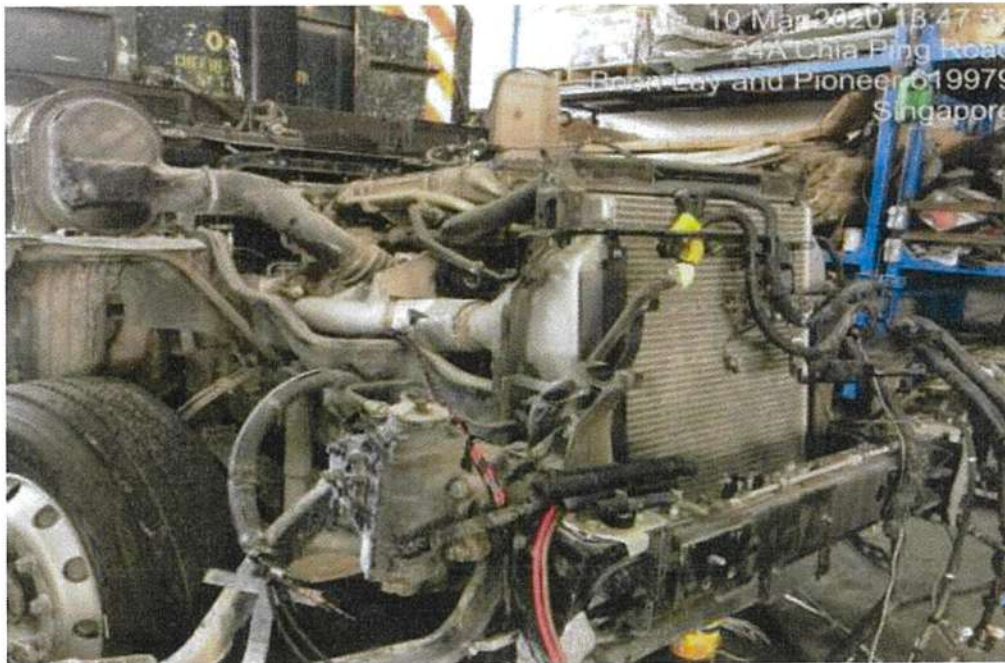
Photo 22 BROKEN AIR FILTER HOUSING

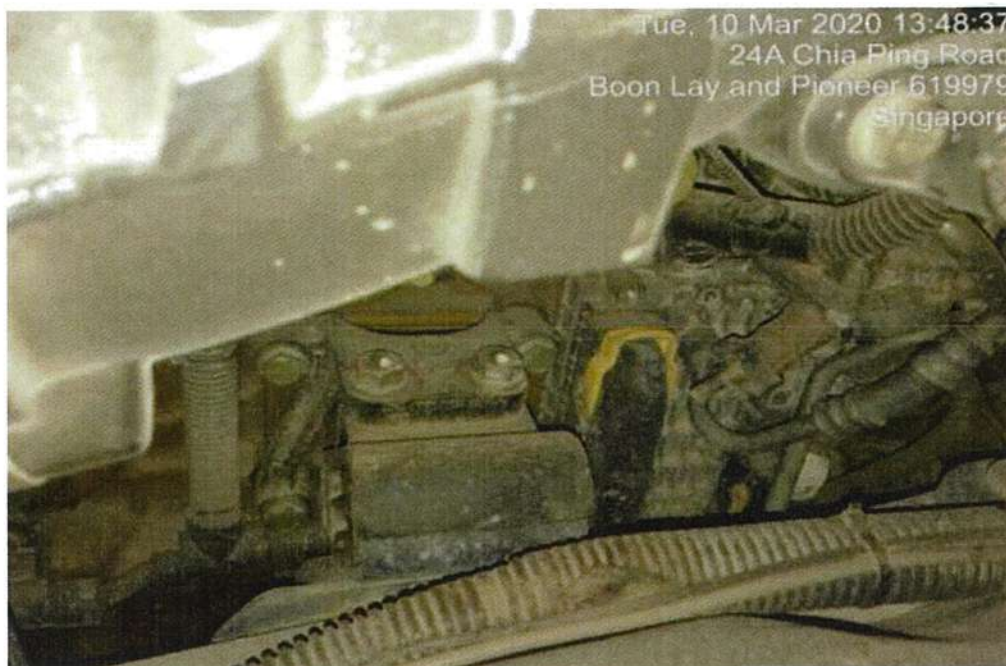
Photo 25 INTACT ENGINE MOUNTING
