RE: VEHICLE NO.:XE4599Y MITSUBISHI/FUSO/ CHENG HENG LEE PTE LTD

## ESTIMATE

DATE : 24/2/2020  
ACC DATE : 20/02/2020  
POLICY NO : DMC618001459

Attention: Motor Claim Department

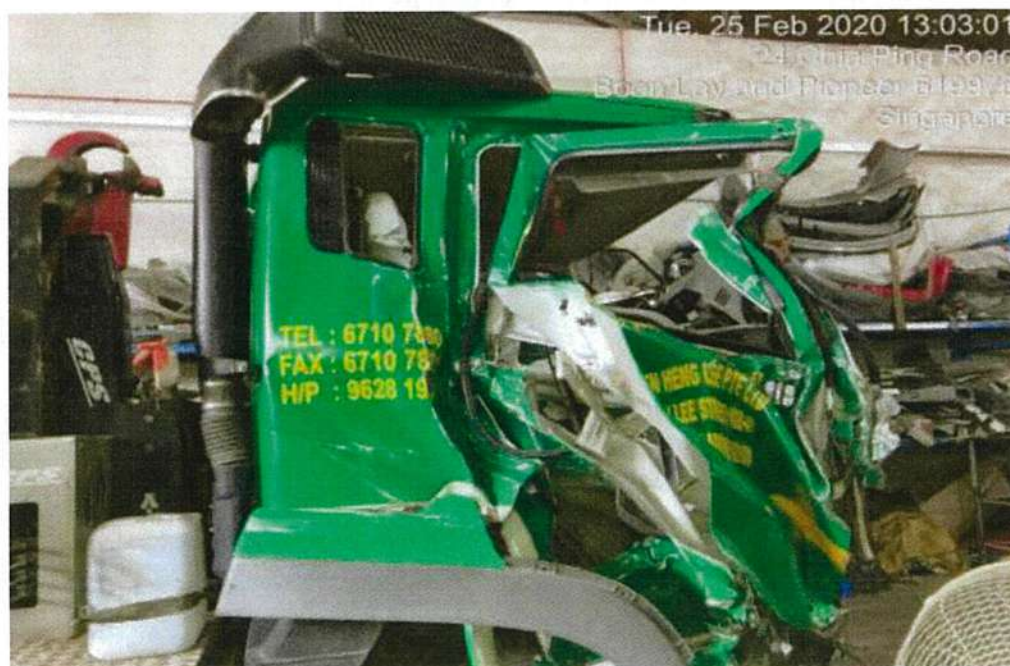
Photo 6 CRUSHED RH SIDE OF CABIN

| S/NO | QTY | LABOUR & MISCELLANEOUS | AMOUNT \$ |
|---|---|---|---|
| 3 | | Remove & Refit Front Cabin | 1,800.00 |

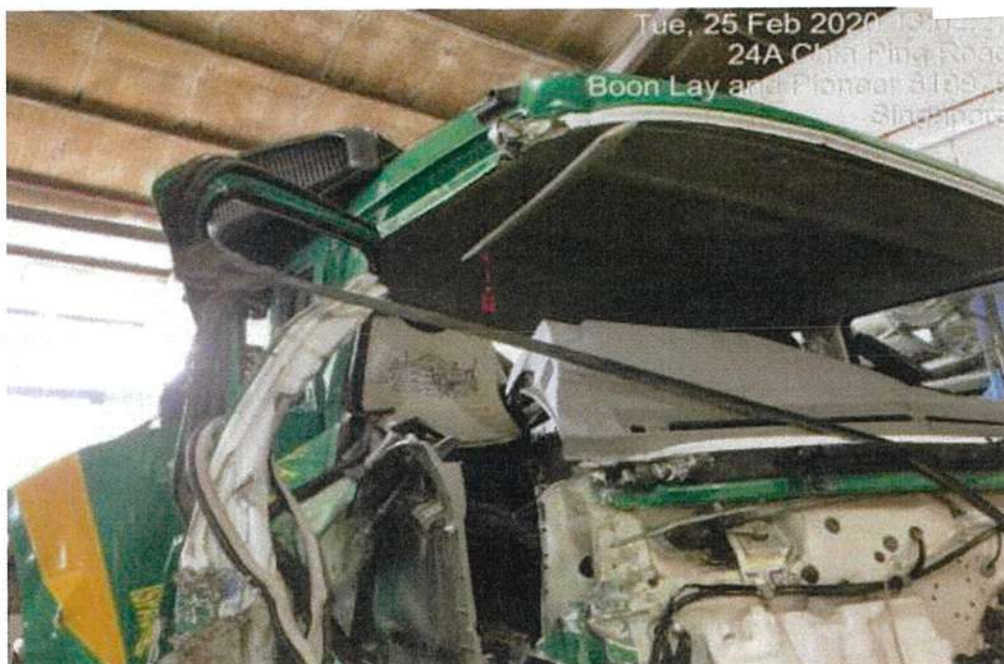
Photo 7 SHEARED RH PILLAR & FIREWALL

| S/NO | QTY | LABOUR & MISCELLANEOUS | AMOUNT \$ |
|---|---|---|---|
| 1 | | To remove damaged body panel with all necessary components/attachments apply hot-works where necessary straighten affected area, repair/reshape body dented panels in accordance with factory specifications replace new parts refit and align into position refit all necessary components / attachments | 2,600.00 |

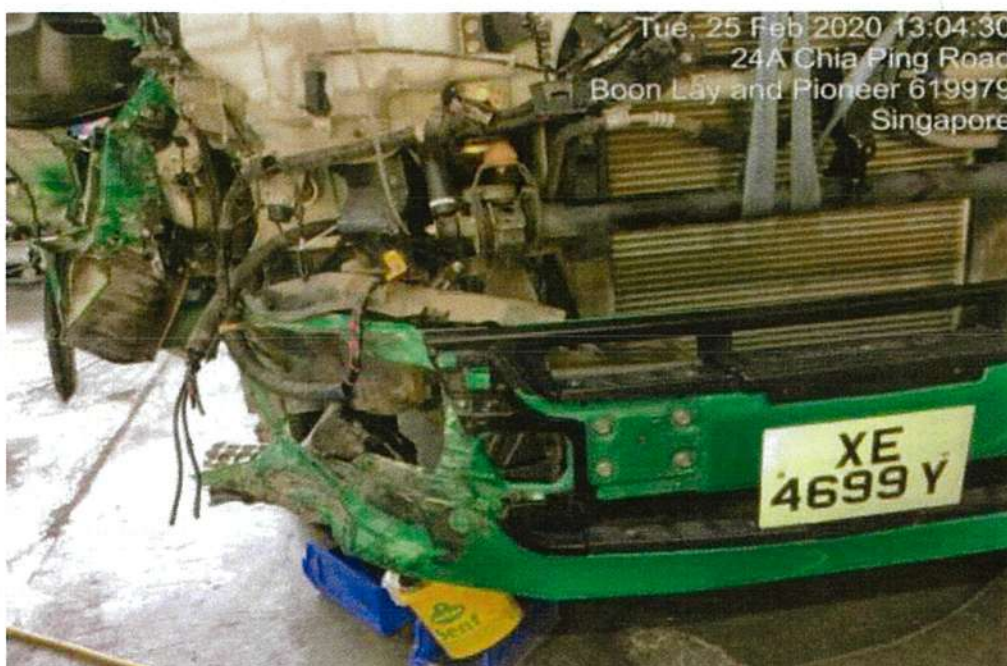
Photo 9 DENTED RH BUMPER / BROKEN RH LAMPS

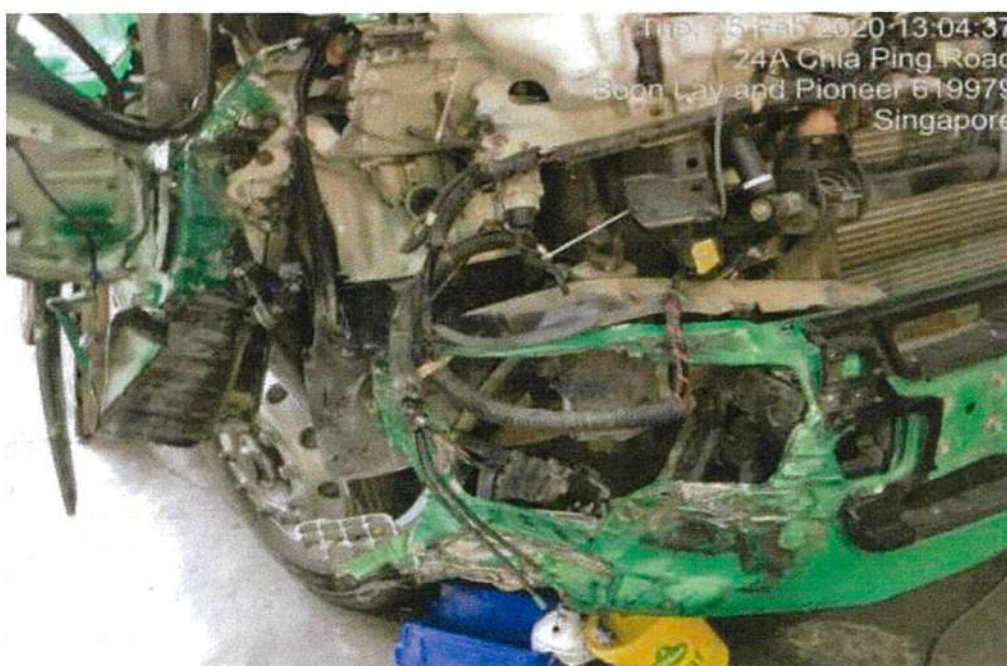
Photo 10 SNAPPED & BURST WIRE HARNESS & AIR PIPING

| S/NO | QTY | LABOUR & MISCELLANEOUS | AMOUNT \$ |
|---|---|---|---|
| 4 | | Check & reconnect Wire Harness system & diagnosis fault code | 3,200.00 |

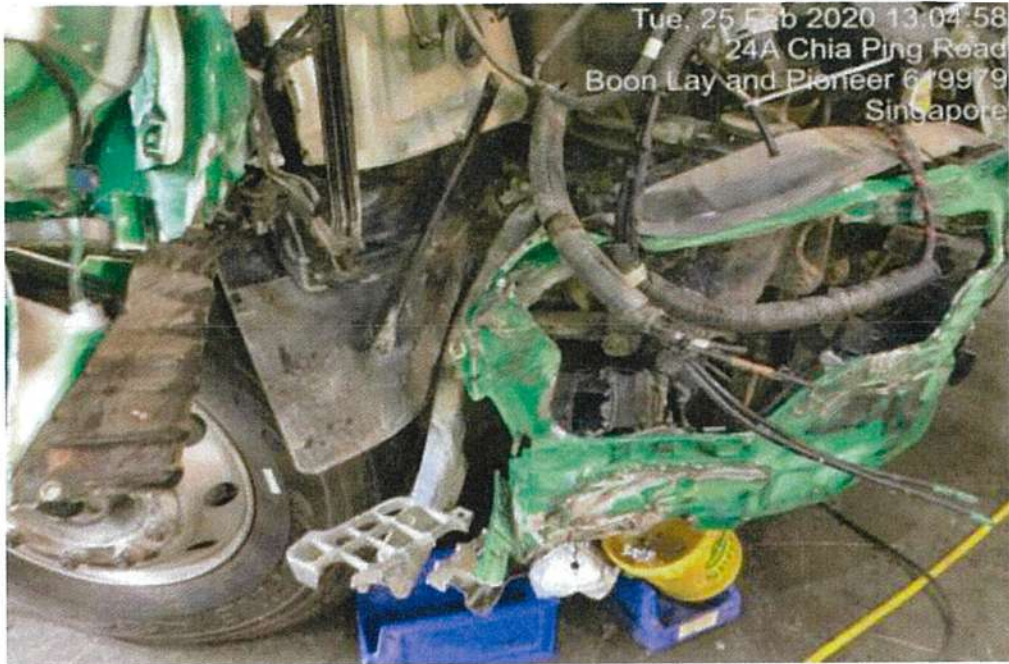
Photo 11 SNAPPED RH LOWER STEPS

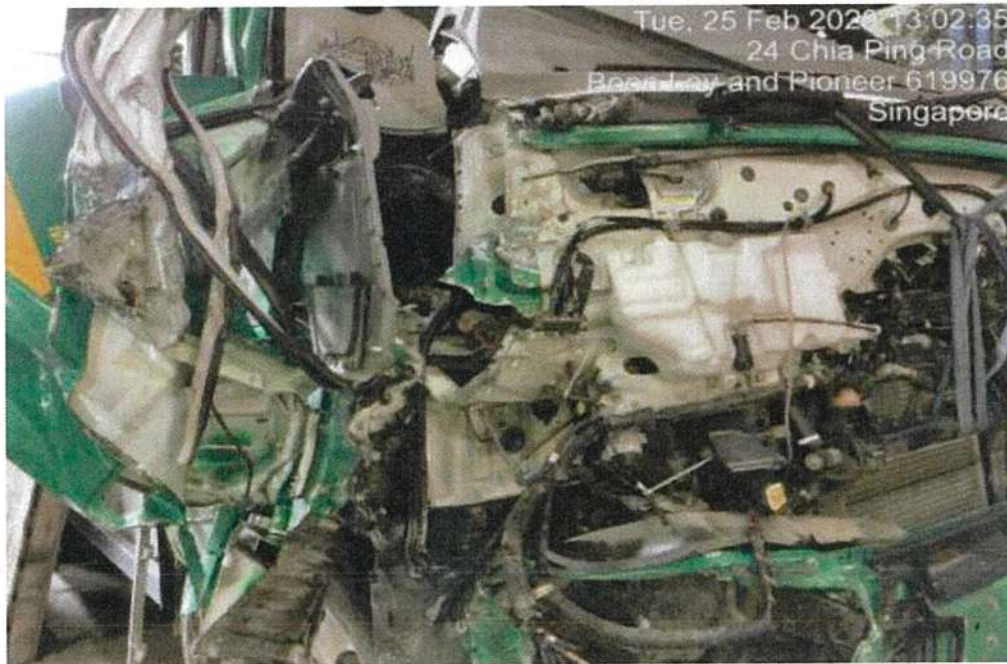
Photo 12 SHEARED FIRE WALL & DEFORMED DASHBOARD

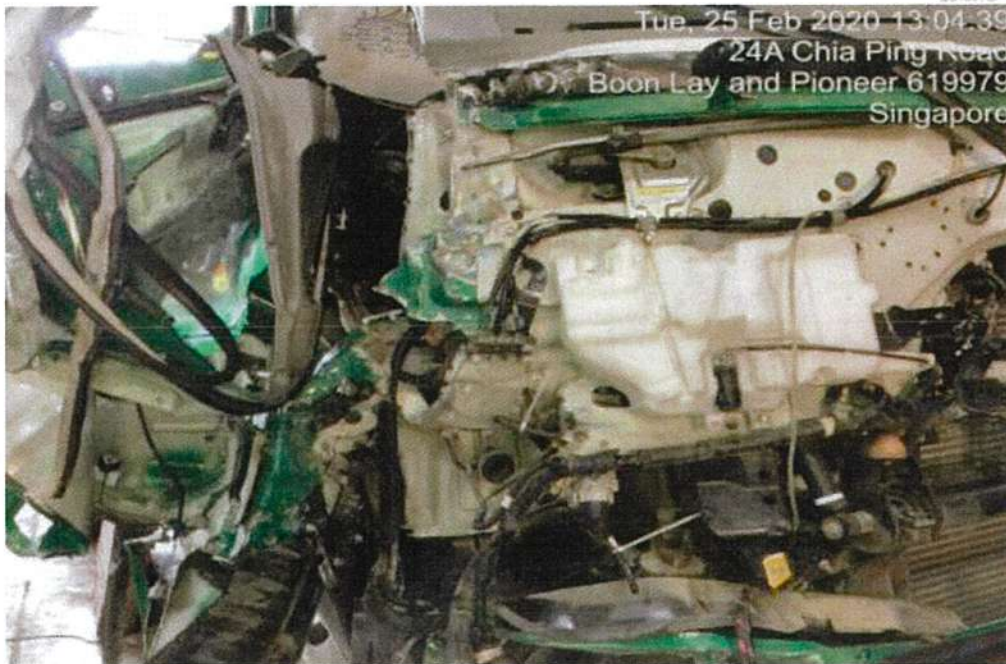
Photo 13 SNAPPED WIPER LINKAGE

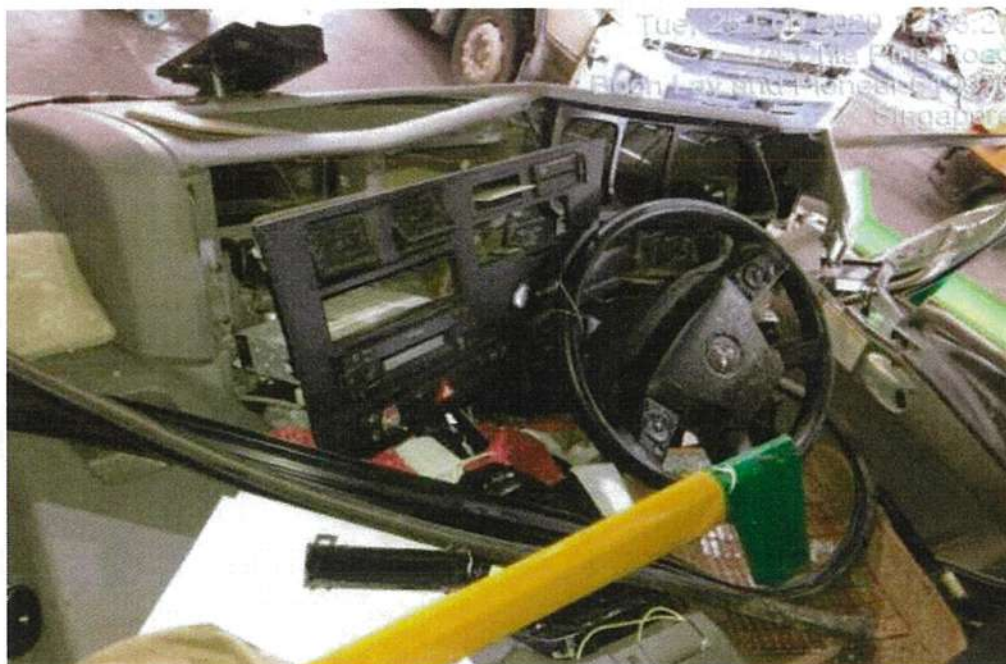
Photo 14 BROKEN DASHBOARD & COVERINGS

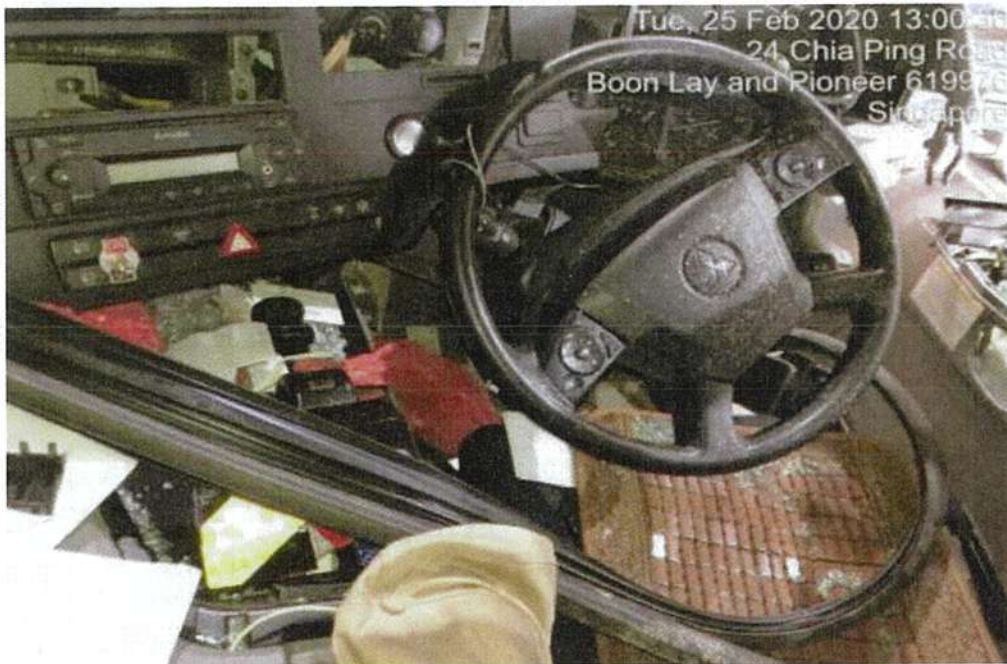
Photo 15 DEFORMED STEERING COLUMN

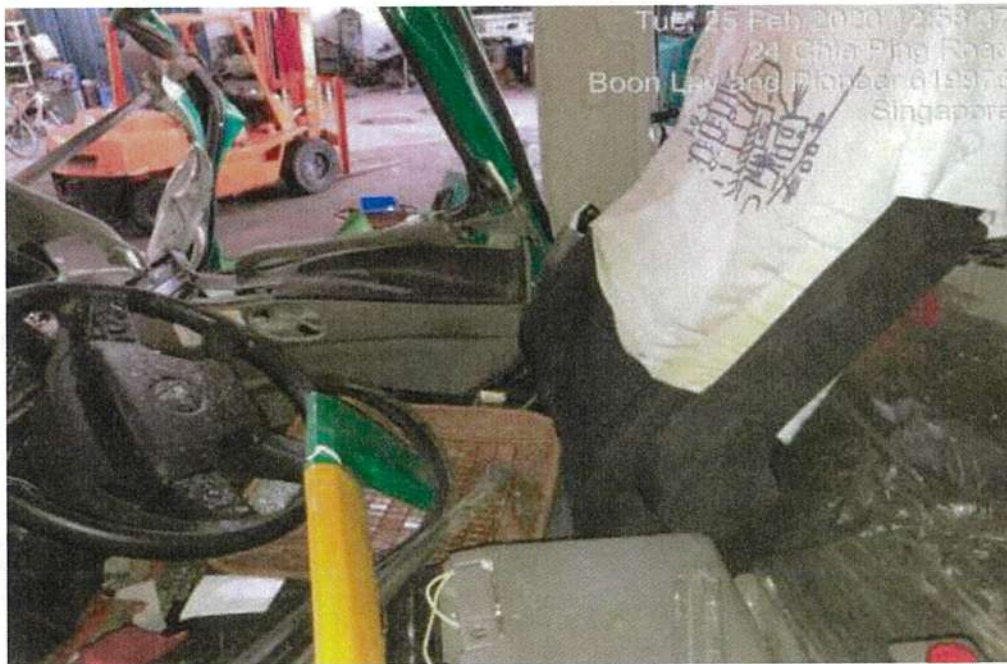
Photo 16 DISTORTED DRIVER'S SEAT

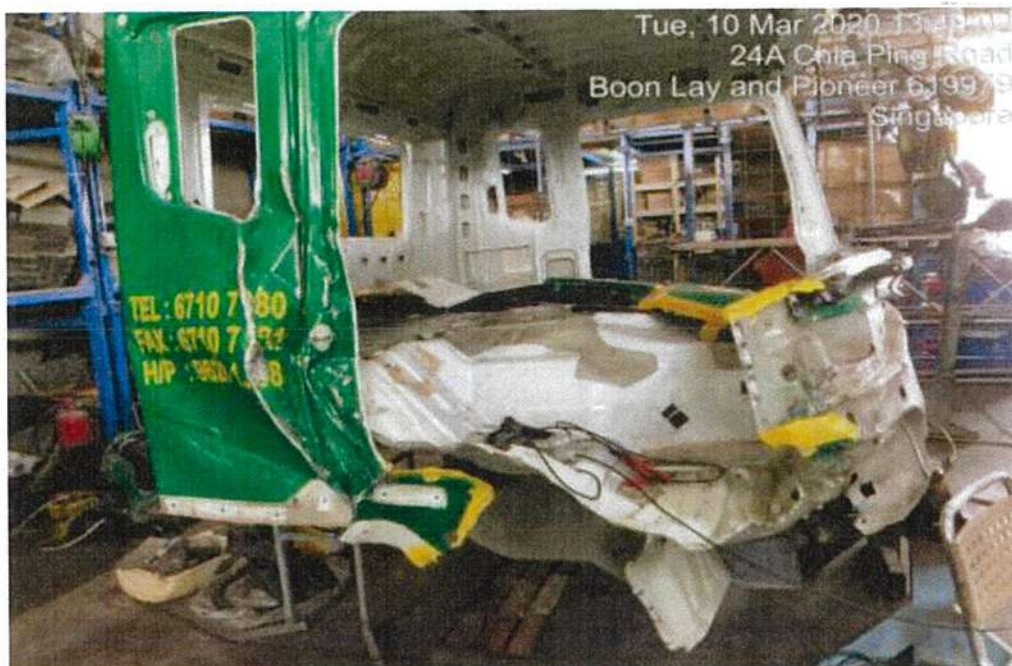
Photo 19 SHEARED CABIN

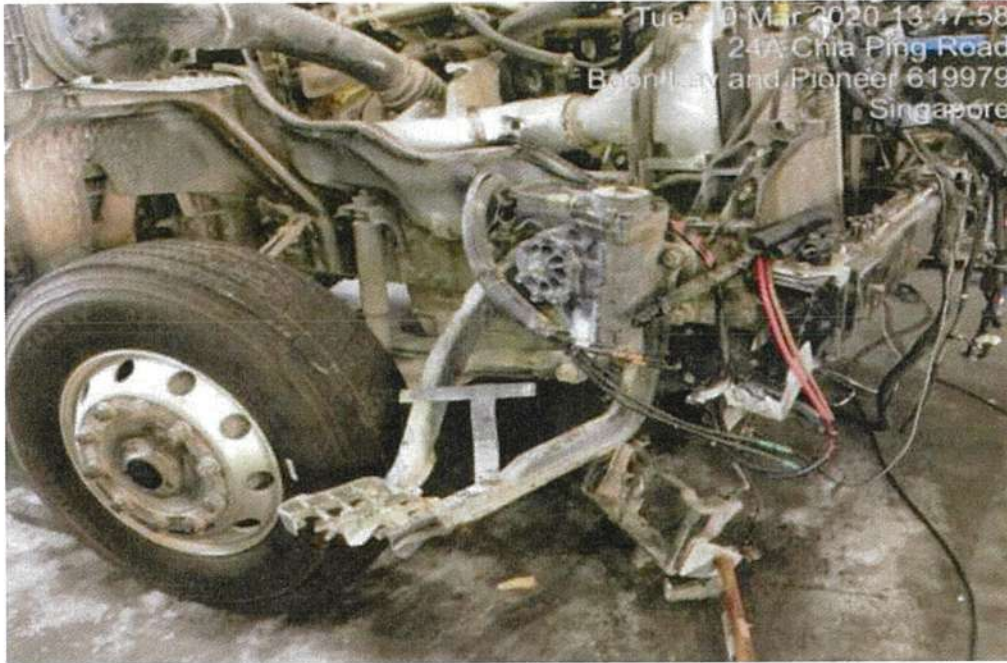
Photo 21 SNAPPED WIRE HARNESS & BENT LOWER STEPS

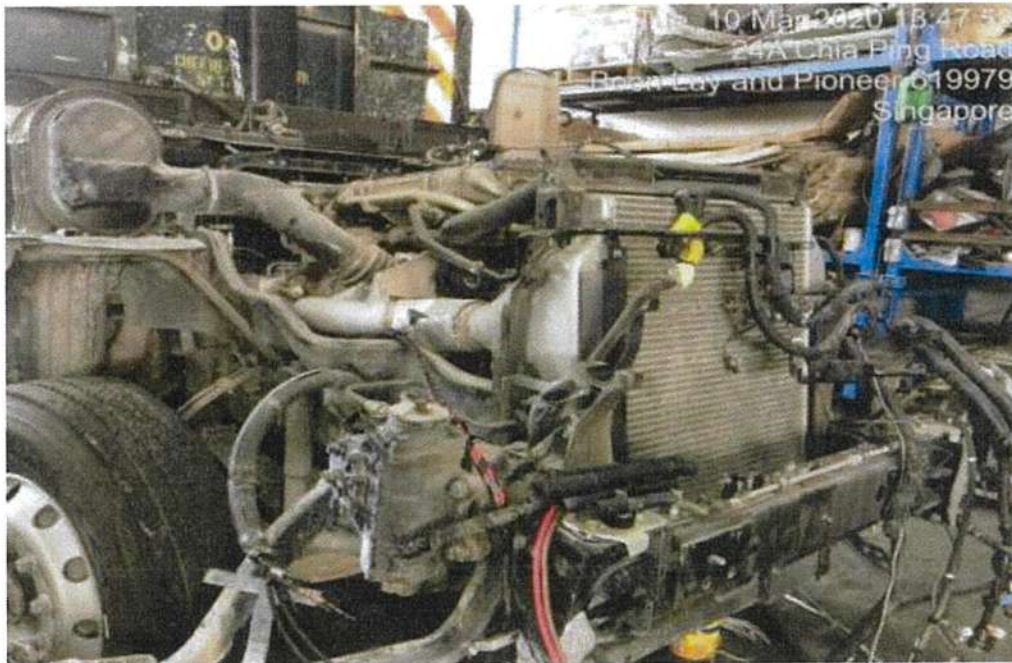
Photo 22 BROKEN AIR FILTER HOUSING

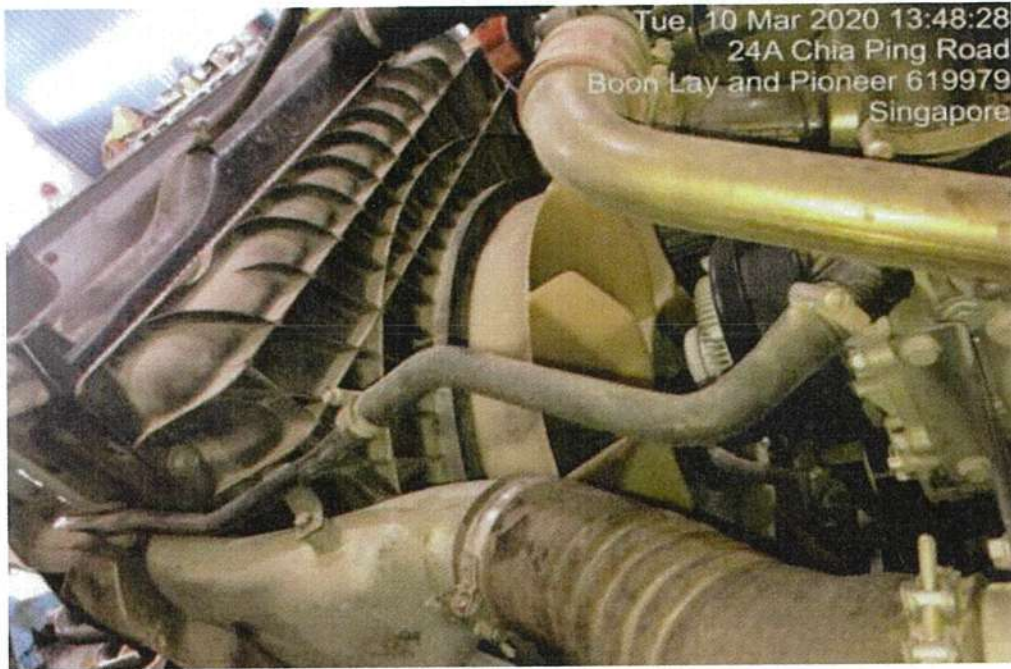
Photo 23 INTACT RADIATOR FAN BLADE

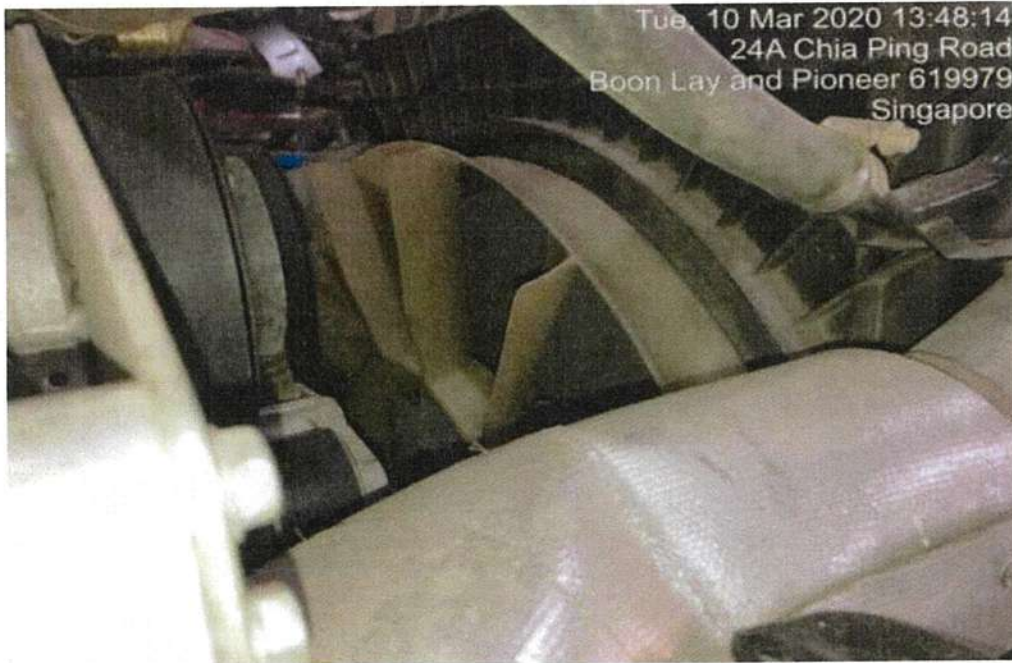
Photo 24 INTACT RADIATOR
