Your Ref: S0M02SCU
Our Ref : CI/ASM20008668/P

26th August 2020

**TECHNICAL INVESTIGATION REPORT OF INSURED VEHICLE SGC 4334L
INVOLVED IN AN ACCIDENT ON 14 AUGUST 2020**

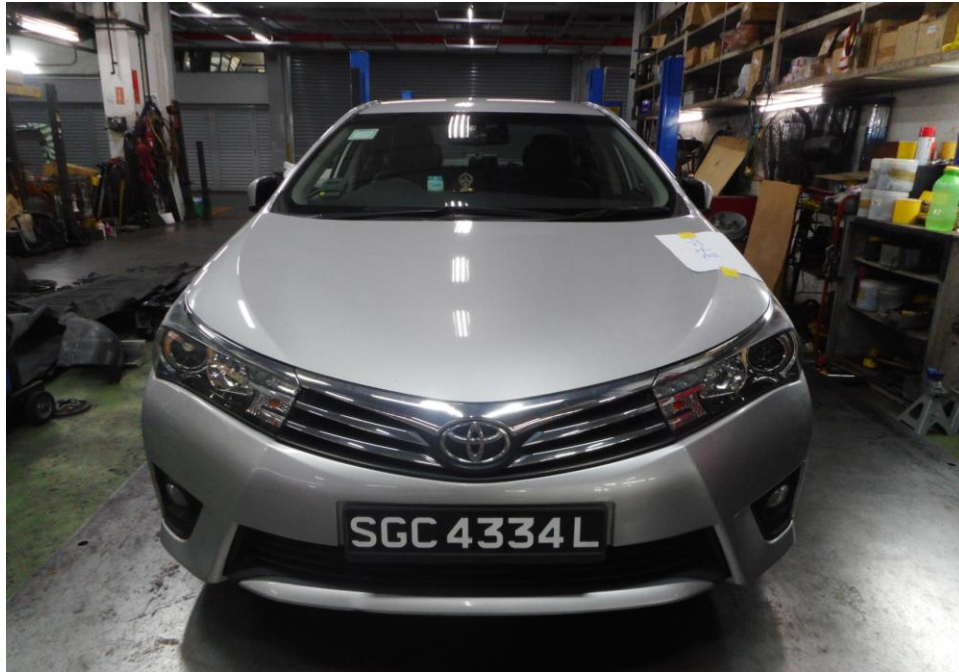
Photo 1 shows the general view of the front portion of the insured vehicle at the time of my inspection its unaffected by the accident.

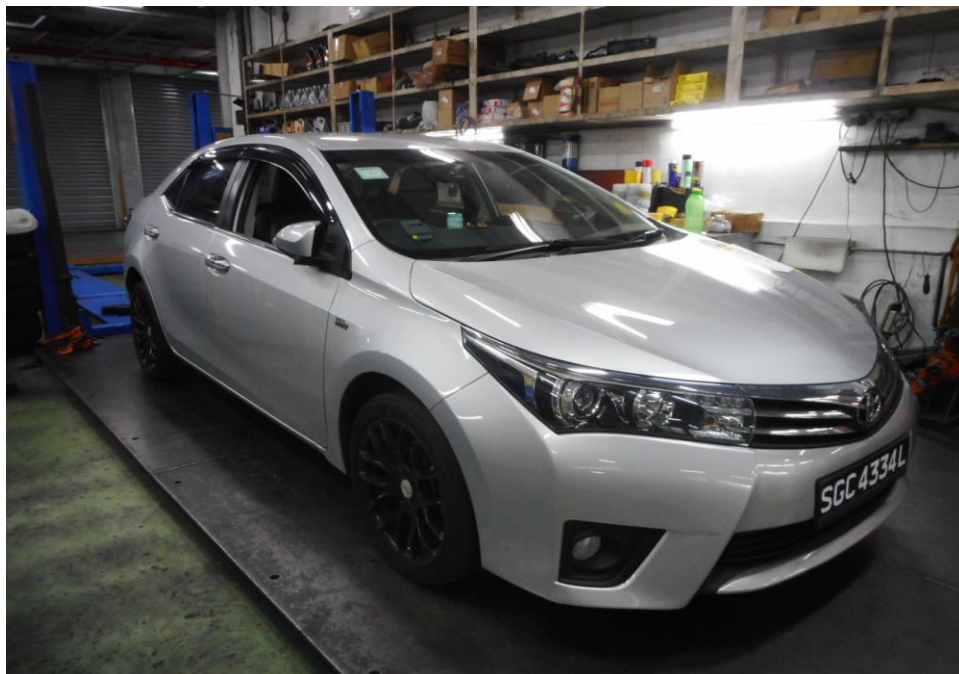
Photo 2 shows the general view of the right portion of the insured vehicle at the time of my inspection its unaffected by the accident.

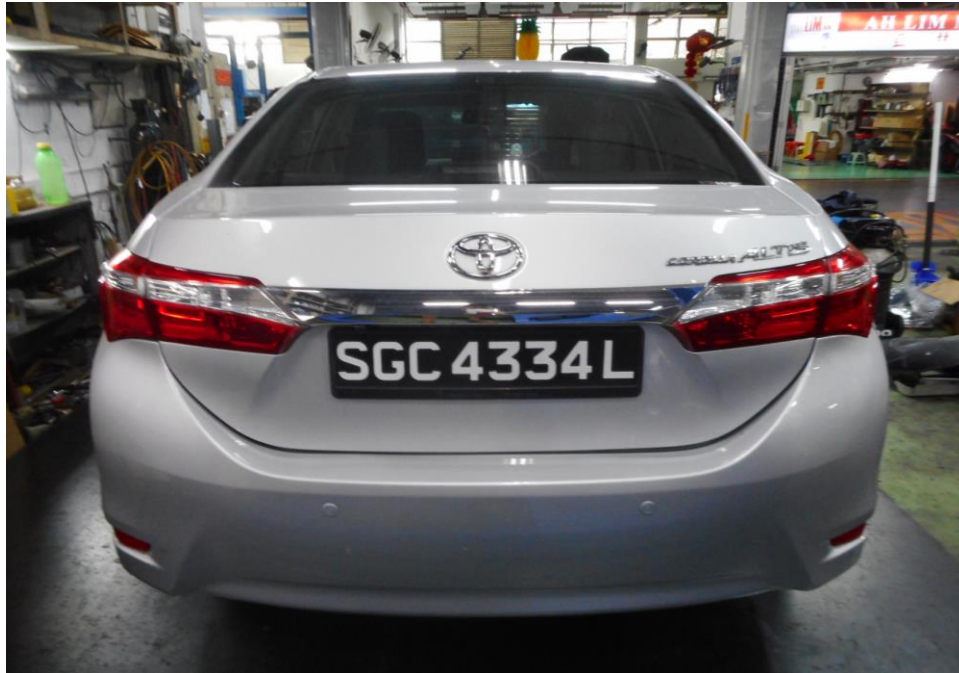
Photo 3 shows the general view of the rear portion of the insured vehicle at the time of my inspection its unaffected by the accident.

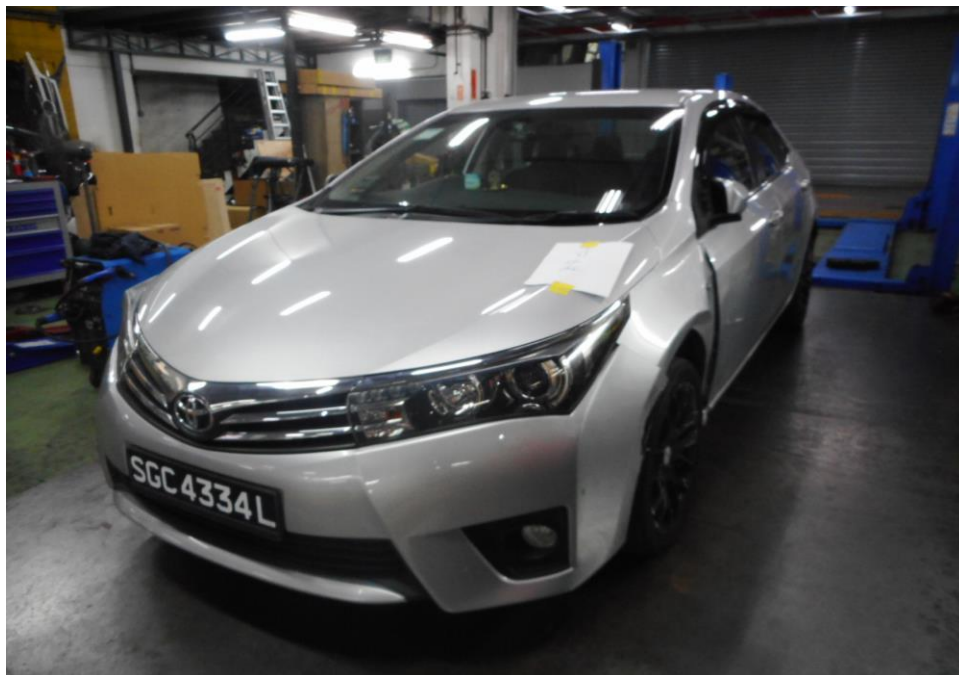
Photo 4 shows the general view of the front right portion of the insured vehicle at the time of my inspection.

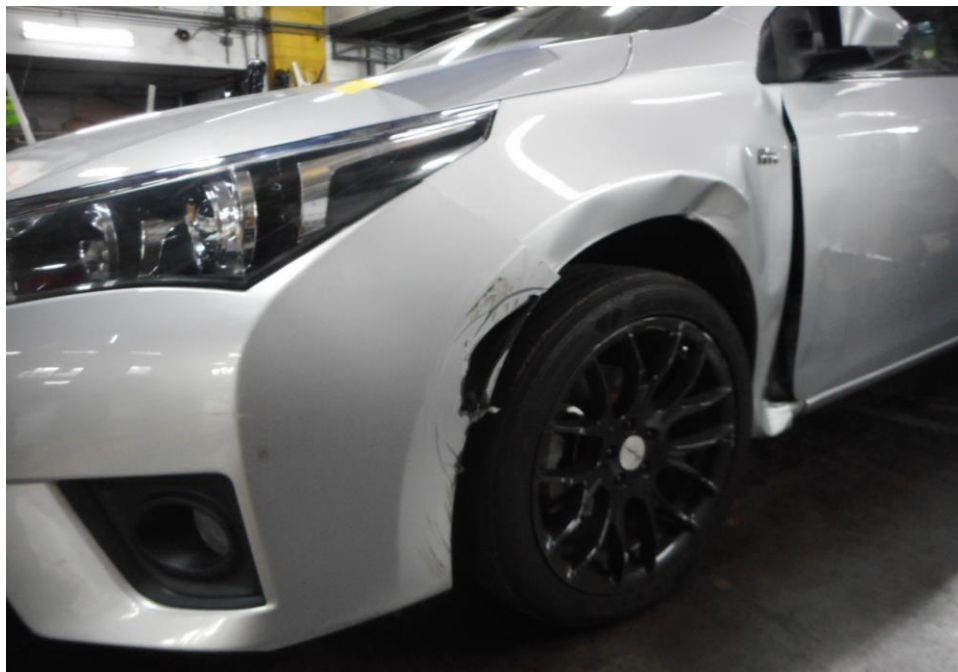
Photo 5 shows the close up view of the left front portion of the insured vehicle at the time of my inspection. Its bumper, body panel, fender and rims was observed to be damaged as a result of the accident.

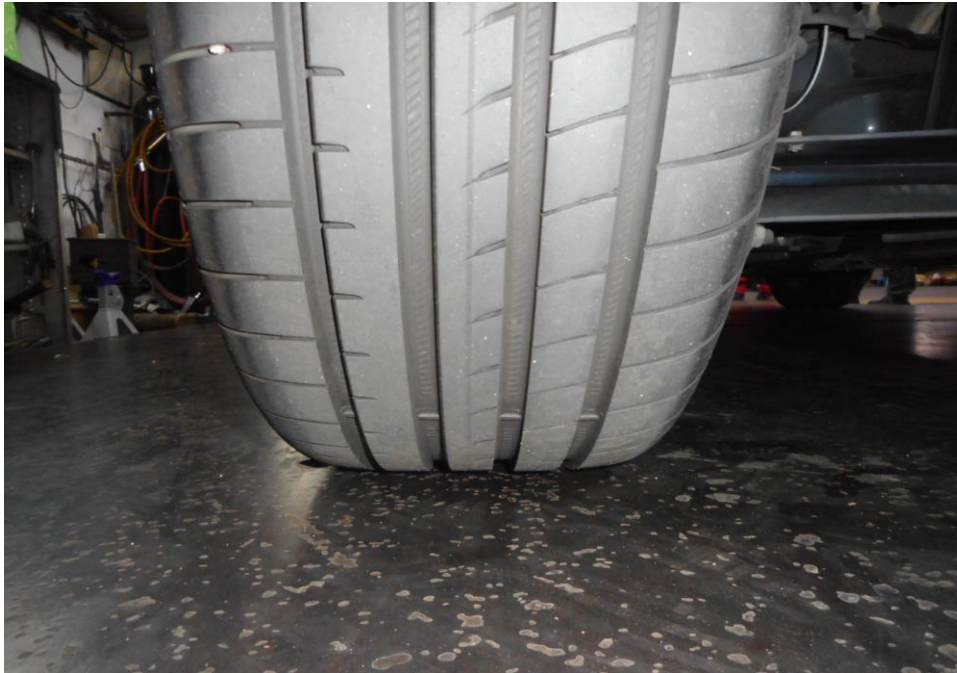
Photo 7 shows the rear left tyre of the insured vehicle at the time of my inspection. The rear left tyre of the insured vehicle was observed to be in serviceable condition.

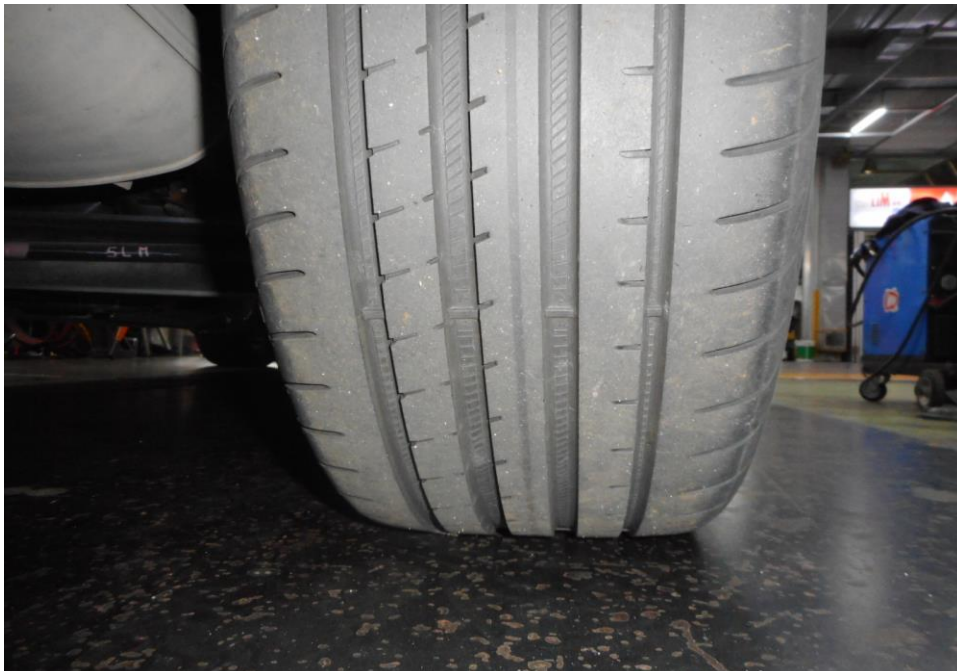
Photo 8 shows the rear right tyre of the insured vehicle at the time of my inspection. The rear right tyre of the insured vehicle was observed to be in serviceable condition.

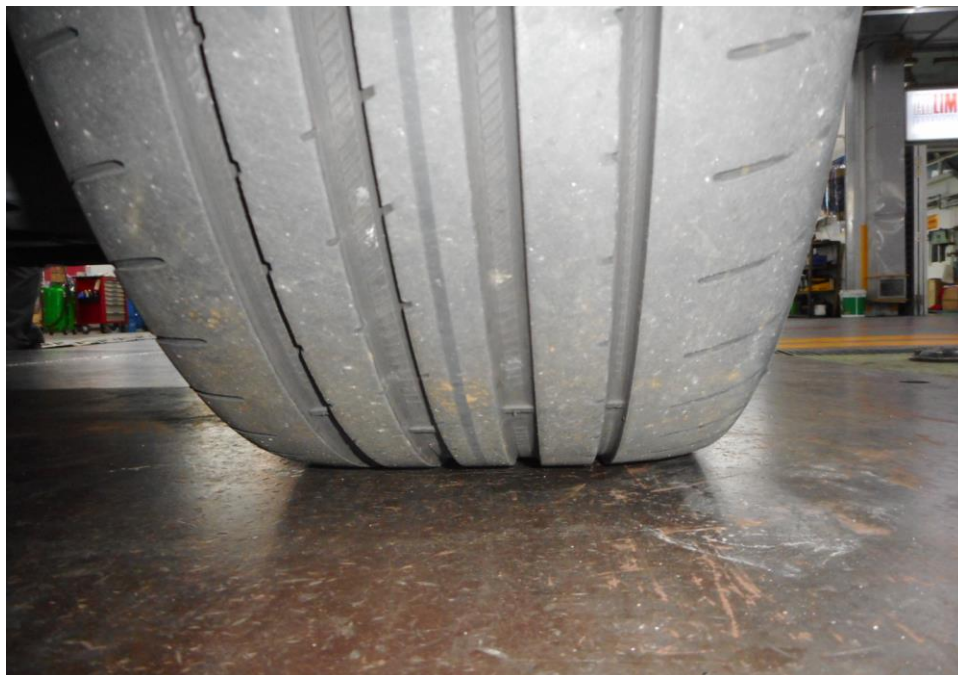
Photo 9 shows the front right tyre of the insured vehicle at the time of my inspection. The front right tyre of the insured vehicle was observed to be in serviceable condition.

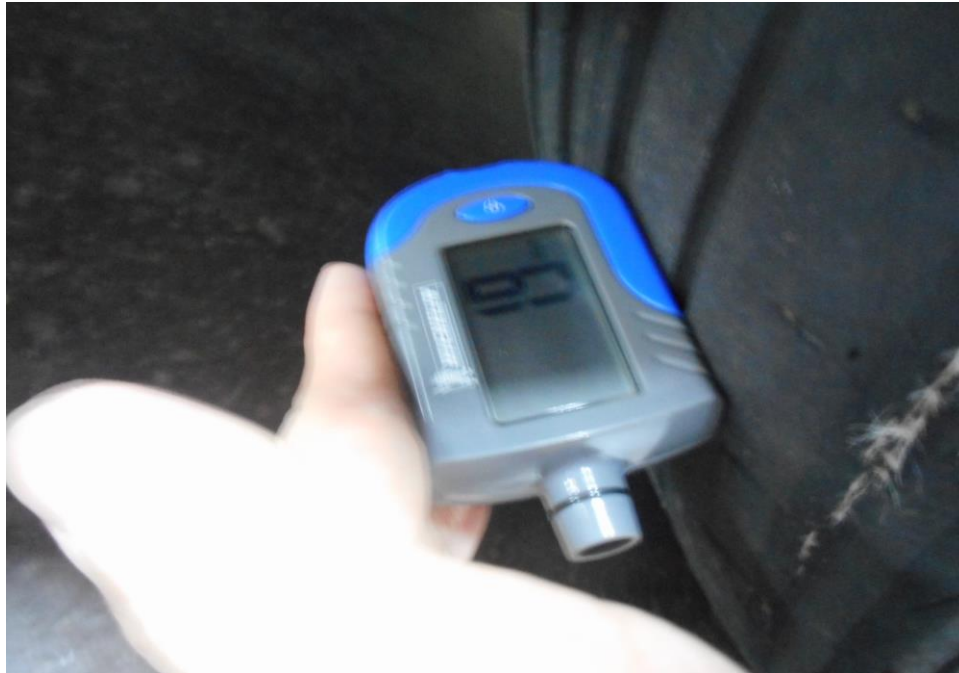
7. Upon examination of the front left tyre of the insured vehicle, the remaining thread depth was at minimum 1.9mm, which was within the LTA requirements. However, the rubber compound at the outer side of the tyre was completely worn, exposing the reinforcing belts that are found within the tyre. The same extent of worn condition was also observed around the entire circumference of the tyre. See photo 10 - 12 below.

Photo 10 shows the tread depth of the front left tyre on the insured vehicle at the time of my inspection. The remaining tread depth is 1.9mm which is within the LTA requirements.

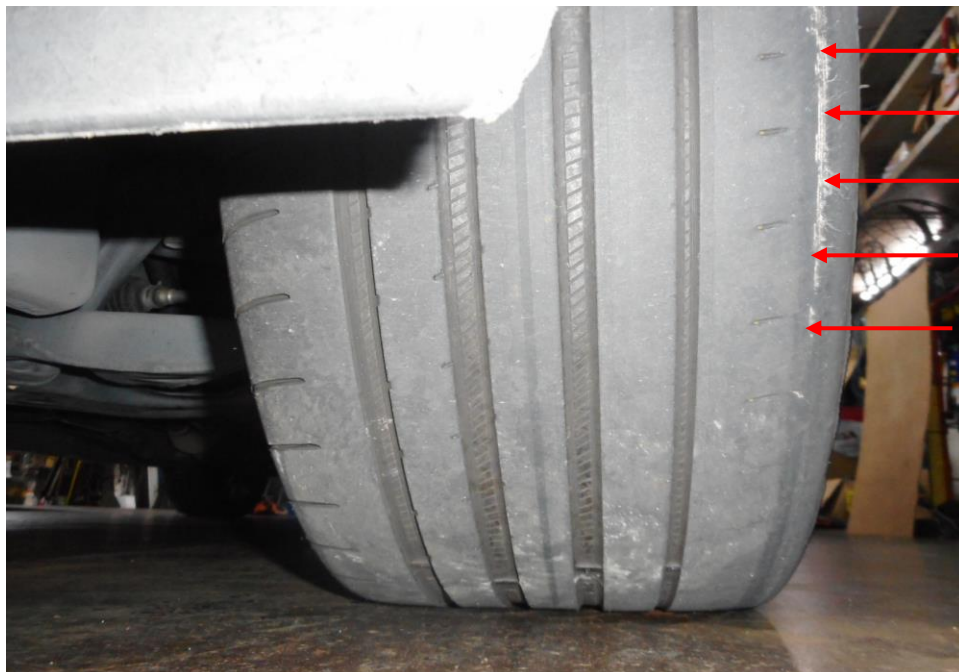
Photo 11 shows the front left tyre of the insured vehicle at the time of my inspection. The rubber compound at the inner side of the tyre, around its entire circumference, was observed to be completely worn, exposing the reinforcing belts (arrowed) that are found within the mentioned tyre.

8. The condition of the front left tyre of the insured vehicle, where the reinforcing belts that are found within the tyre were exposed, due to completely worn rubber, do not comply with SECTION 109(e) CAP 276 of THE ROAD TRAFFIC ACT, ROAD TRAFFIC (MOTOR VEHICLES, CONSTRUCTION AND USE) RULES. Under this section it states that “no person shall use, or cause or permit to be used on a road any motor vehicle or trailer, a wheel of which is fitted with a pneumatic tyre, if the tyre has any portion of the ply or cord structure exposed”.

9. The condition of the front left tyre of the insured vehicle would have also likely affected the road worthiness of the insured vehicle as the traction/frictional grip between the insured vehicle and the road surface would have been significantly lessen, especially during wet weather condition, when travelling at high speed or cruising speed, cornering and braking amongst others.

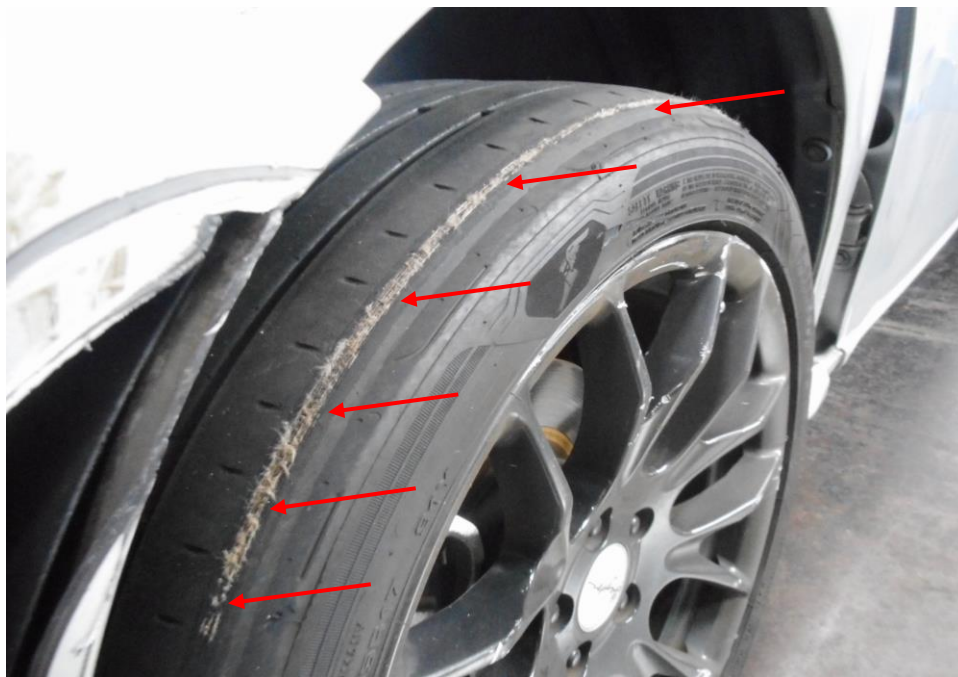
Photo 12 shows the front left tyre of the insured vehicle at the time of my inspection. The rubber compound at the outer side of the tread, around its entire circumference, was observed to be completely worn, exposing the reinforcing belts (arrowed) that are found within the mentioned tyre.
