Affiliated to Federation Internationale Des Experts En Automobile				
SOMPO INSURANCE SINGAPORE PL		Ref : CS/SMO20008729/Utf3n2		
50 RAFFLES PLACE #05-01/06 SINGAPORE LAND TOWERSINGAPORE 048623		Date : 28-08-2020

ADJUSTMENT ON REPAIR COST FOR VEHICLE NO. GBA 3761M

PHOTOGRAPHS FOR VEHICLE NO. GBA 3761M

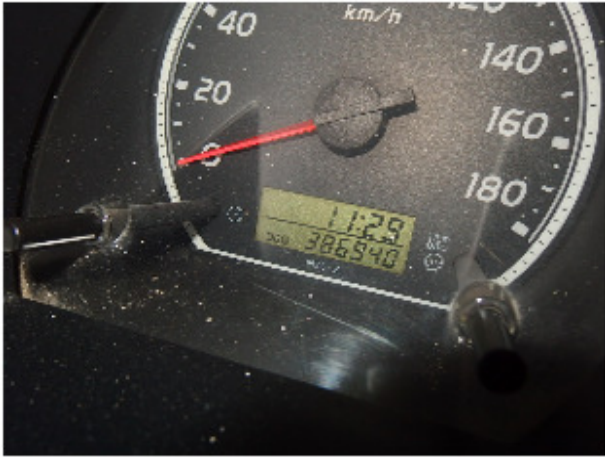
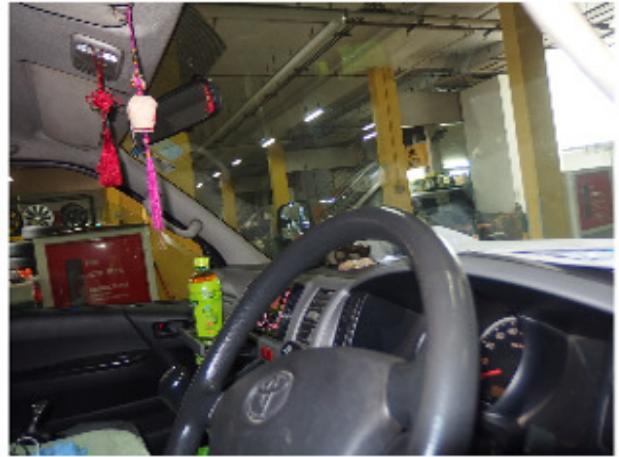
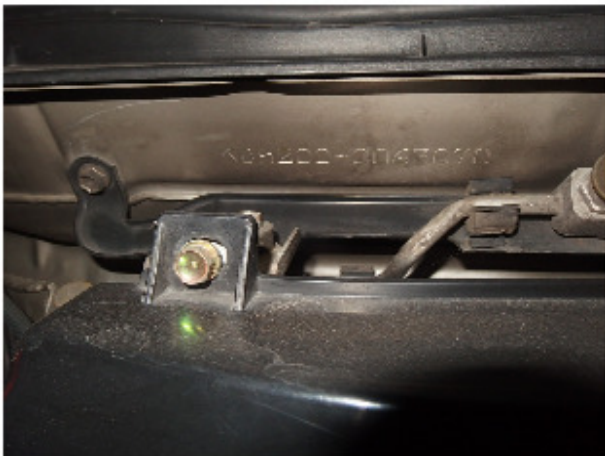
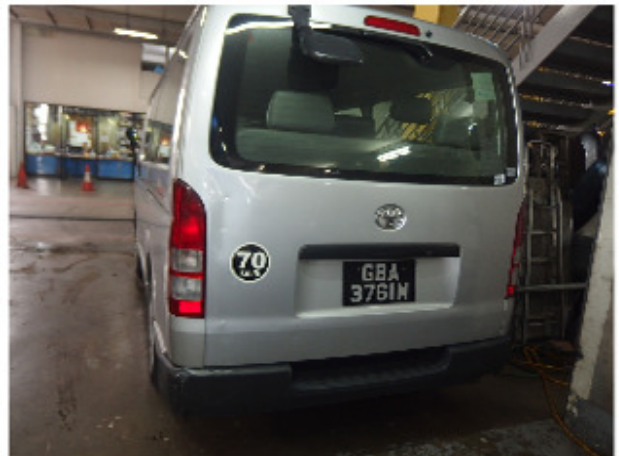
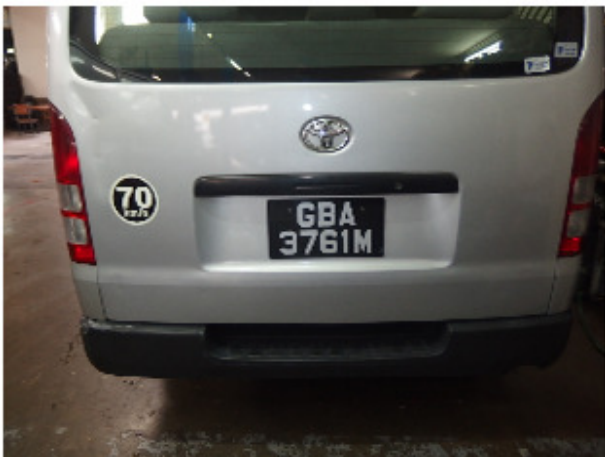
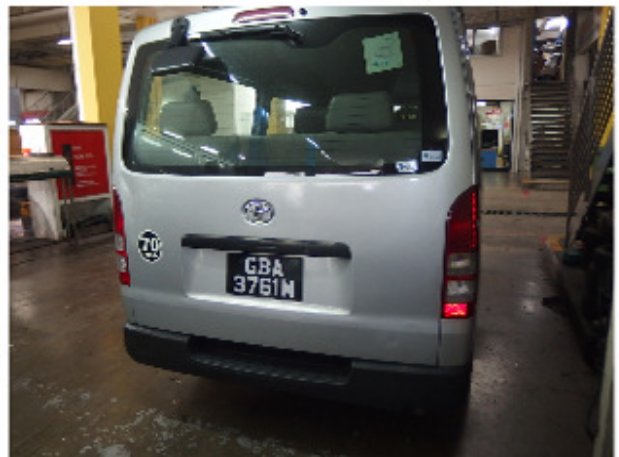
4. Description of Damages				
THE VEHICLE SUSTAINED DAMAGES AT THE REAR N/S PORTION. DAMAGES SEE DETAILS.				
5. General Information				
Accident Date	15/08/2020	Inspection Date	20/08/2020	
Survey held at	CHENG MOTOR WORK CO. NO.1 KAKI BUKIT AVE 6 #01-83 SINGAPORE 417883			
5a. Remarks				
A)THE INSPECTION WAS CONDUCTED ON A"WITHOUT PREJUDICE" BASIS. B)IN ACCORDANCE TO YOUR INSTRUCTIONS, WE HAVE NOT AUTHORISED REPAIRS.				
5b. Estimate Days of Repair				
ESTIMATED NORMAL PERIOD FOR REPAIR:		3 Working Days

Qty	Description of Parts	Condition	Estimate By Workshop (\$)	Our Adjusted (\$)
	<u>REPLACEMENT OF PARTS</u>			
1	TAILGATE	BADLY DENTED	1,817.30	1,817.30
2	TAILGATE ABSORBER @\$378.20	NOT NECESSARY	756.40	-
1	TAILGATE EMBLEM LOGO	NECESSARY	61.30	61.30
1	TAILLAMP L/H	NOT NECESSARY	378.20	-
1	CONNER PANEL L/H	TO REPAIR SEE LABOUR	178.30	-
	LESS 25% DISCOUNT		-	-469.65
			3,191.50	1,408.95
	<u>SPECIAL NETT ITEMS</u>			
1	REAR BUMPER (50%)(SN)	DEFORMED	380.10	190.05
1	REAR WINDSCREEN SEALANT (SN)	NECESSARY	60.00	40.00
1	70KM STICKER (SN)	NECESSARY	20.00	10.00
1	REVERSE SENSOR (SN)	NOT FITTED	280.00	-

740.10	240.05
	<u>LABOUR</u>			
	LABOR FOR KNOCKING,CUTTING,WELDING ,REPLACE OF PARTS.INCLUSIVE OF THE REPAIR OF CONNER PANEL L/H.		800.00	300.00
	TO SPRAY PAINT ON DAMAGE PORTION.		1,000.00	300.00
	TO APPLY RUST-PROOFING ON THE REPLACED PORTION.		80.00	30.00
	TO RENEW REAR WINDSCREEN GLASS.		150.00	120.00
	TO REMOVE/TRANSFER TAILGATE COMPONENTS.		150.00	50.00
	TO DISMANTLE/RENEW REVERSE SENSOR.	NOT NECESSARY	100.00	-

-		-	-
	-		-	-
	-		-	-
			2,280.00	800.00
	GRAND TOTAL		6,211.60	2,449.00
	RECOMMENDED COST OF LUMP SUM REPAIRS (TO ITS PRE-ACCIDENT CONDITION)			1,950.00
