LKK Auto Consultants Pte Ltd

Vehicle No. SKX 8326B
Insured Veh. SH 9370E
Claim No. D20003272MFSH
Policy No. D-18088937MFSH
Accident Date 15/08/2020
Inspection Date 21/09/2020

ADJUSTMENT ON REPAIR COST FOR VEHICLE NO. SKX 8326B

PHOTOGRAPHS FOR VEHICLE NO. SKX 8326B

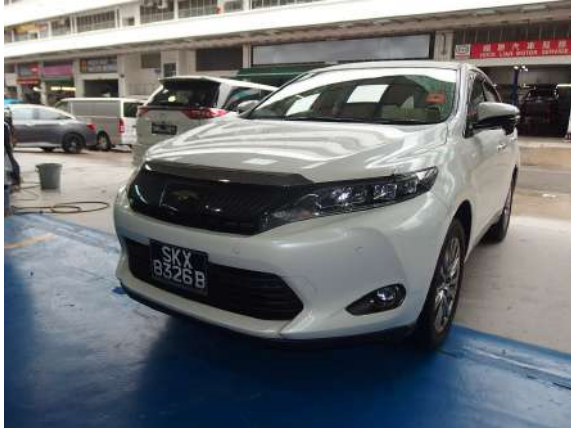
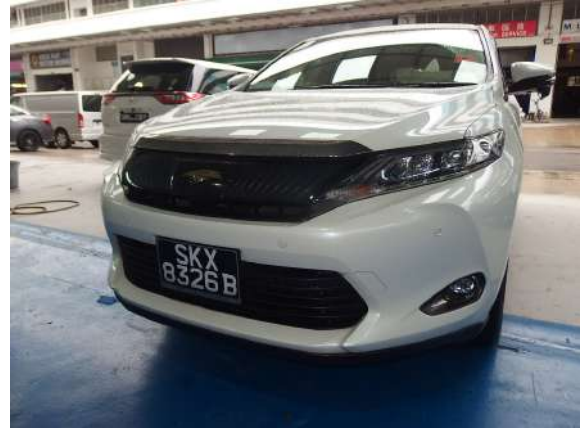
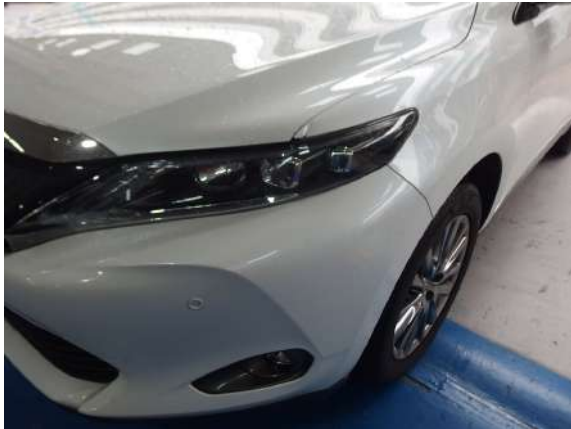
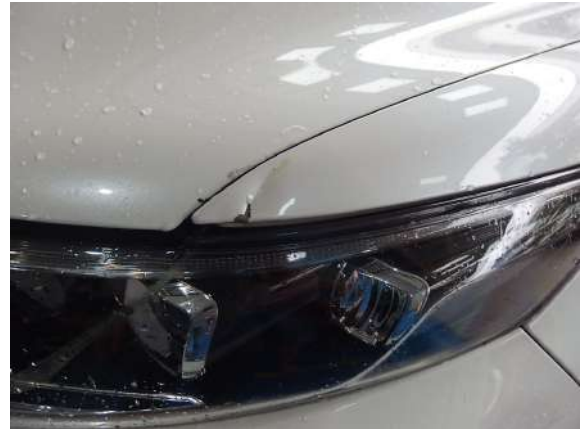
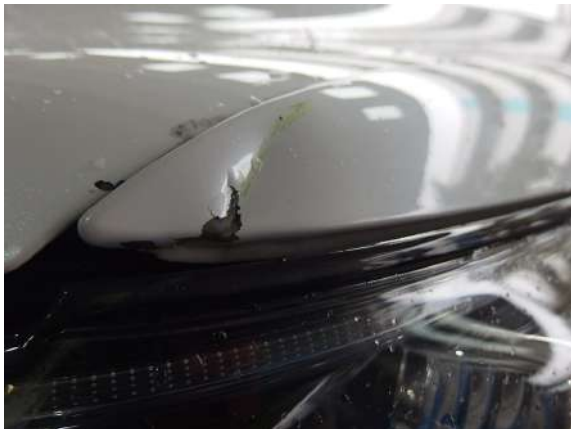
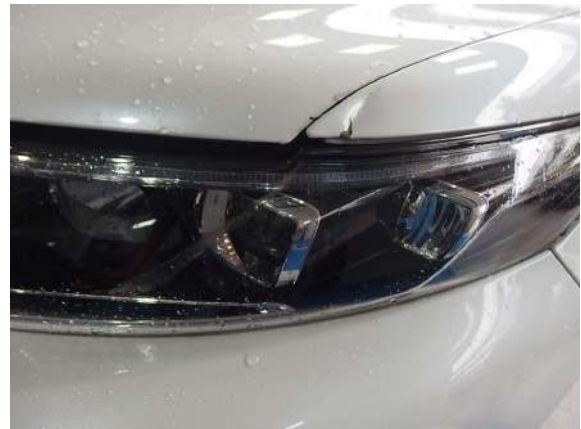
4. Description of Damages				
THE VEHICLE SUSTAINED DAMAGES AT THE N/S FRONT PORTION AND N/S BODY. DAMAGES SEE DETAILS.				
5. General Information				
Accident Date	15/08/2020	Inspection Date	21/09/2020	
Survey held at	HOCK WAH MOTOR WORKSHOP PTE LTD 3011 BEDOK INDUSTRIAL PARK E #01-2008 SINGAPORE 489977			
5a. Remarks				
A)THE INSPECTION WAS CONDUCTED ON A"WITHOUT PREJUDICE" BASIS. B)IN ACCORDANCE TO YOUR INSTRUCTIONS, WE HAVE NOT AUTHORISED REPAIRS.				
5b. Estimate Days of Repair				
ESTIMATED NORMAL PERIOD FOR REPAIR:			3 Working Days
