Your Ref: TP/IP/33657/2020  
Our Ref : CI/TPD20008771/P

**MECHANICAL INSPECTION REPORT OF MOTOR CAR SLB 5250J**

1. I refer to your request on 19<sup>th</sup> August 2020 to conduct a physical inspection of a Motor Car bearing registration number SLB 5250J (herein referred to as "**Motor Car**"), which was involved in a road traffic accident on 10<sup>th</sup> August 2020.
2. The objective of the inspection is to determine if there was any possible mechanical failure to the Motor Car that may have contributed to the accident.
3. Following the request, I had carried out a physical inspection of the Motor Car on 2<sup>nd</sup> September 2020 at the premises of Traffic Police vehicle pound, 517 Airport Road Singapore 539942. I now set out below my observations and comments with respect to this inspection.

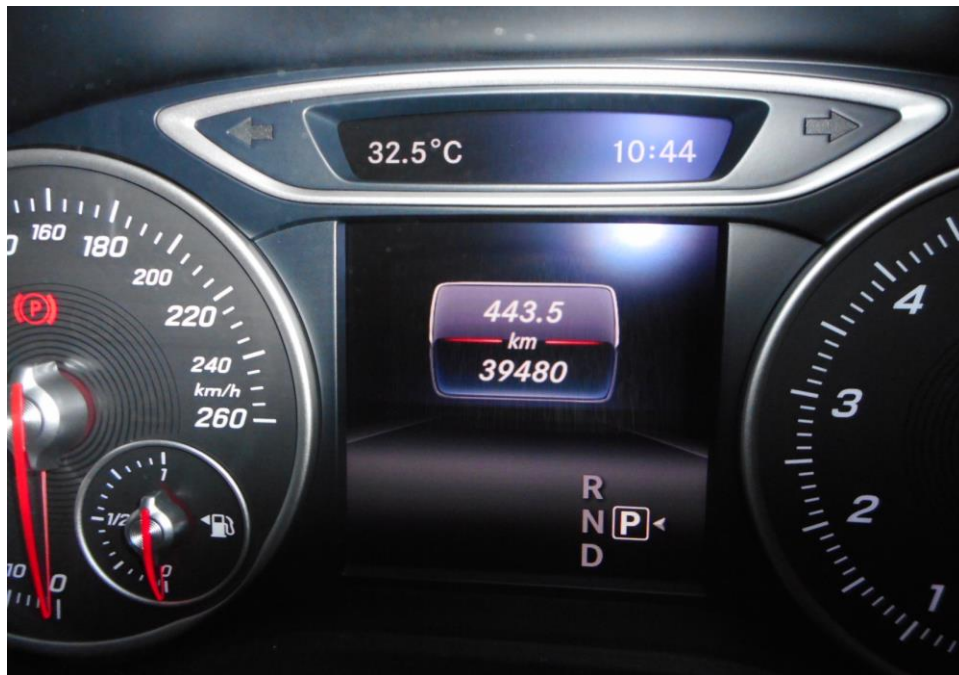
4. The mileage of the Motor Car at the time of my inspection was 39,480km.
5. The Motor Car was observed to have sustained damage at its front portion. Its front bonnet, front bumper, its front right fender and rear bumper were amongst the body parts that were damaged as a result of the accident.

**Photo 1** shows the mileage of the Motor Car at the time of my inspection. The mileage observed was 39,480km.

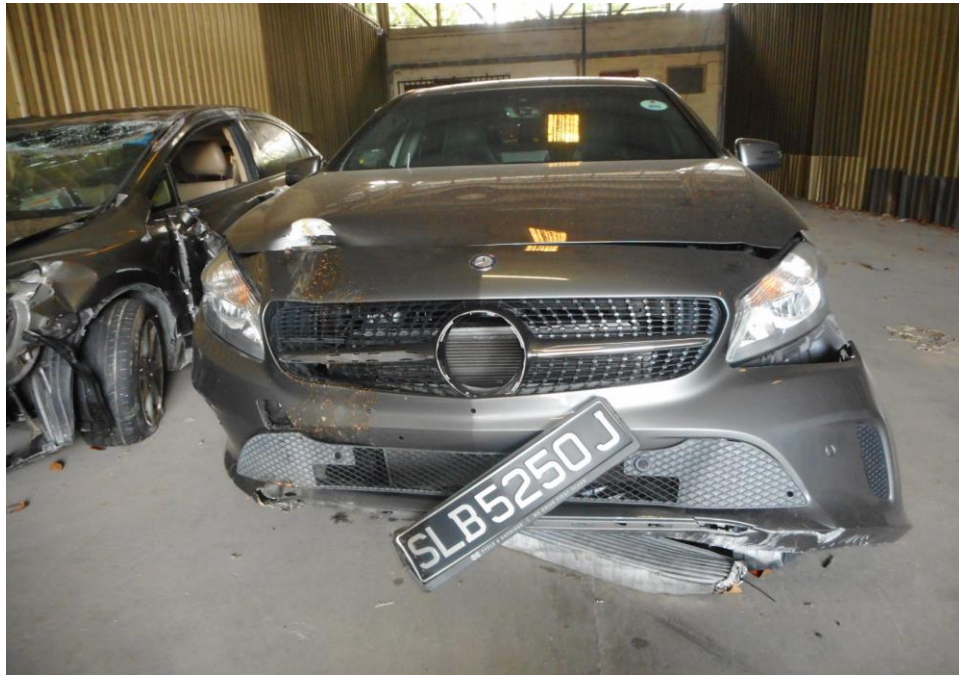
**Photo 2** shows a general view of the Motor Car's front body at the time of my inspection. The Motor Car was observed to have sustained damage at its front portion. Its front bonnet, front bumper, front fender and its rear bumper were amongst the body parts that were damaged as a result of the accident.

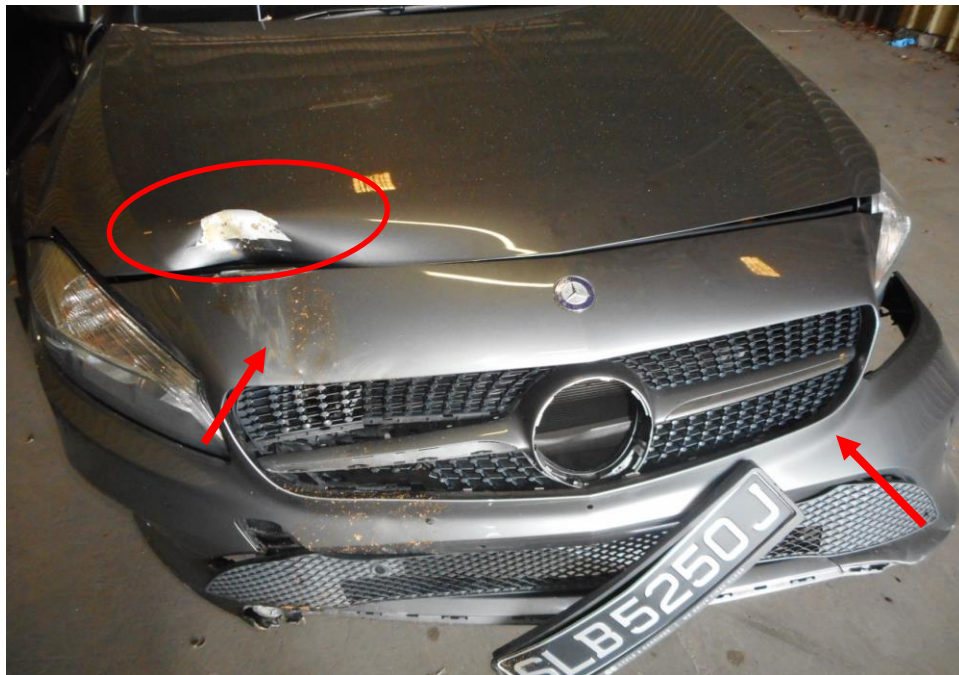
**Photo 3** shows a close up view of the Motor Car's front body at the time of my inspection. Its front bonnet (circled), front bumper (arrowed), were amongst the body parts that were damaged as a result of the accident.

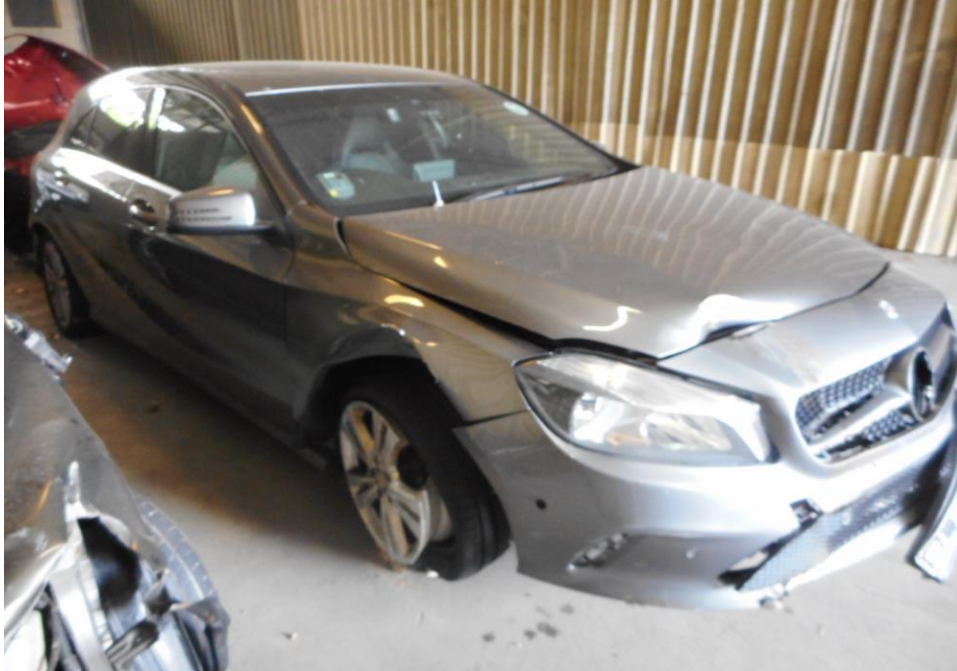
**Photo 4** shows the general view of the Motor Car's right body at the time of my inspection. The Motor Car was observed to have sustained damage on its right front fender were amongst the body parts that were damaged as a result of the accident.

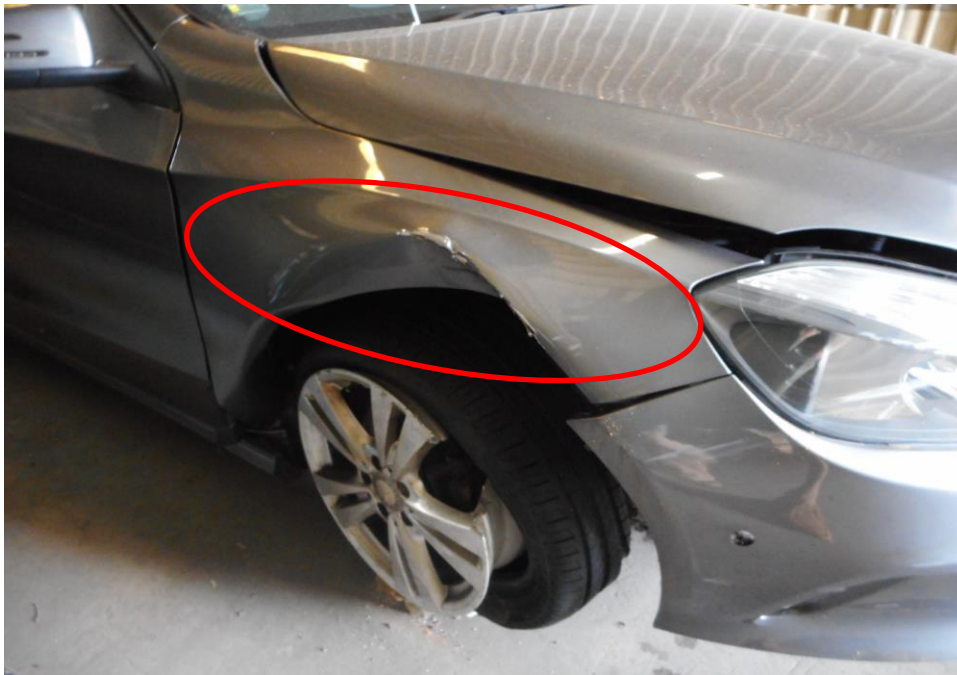
**Photo 5** shows the close view of the Motor Car's right body at the time of my inspection. The Motor Car was observed to have sustained damage on its right front fender (circled) were amongst the body parts that were damaged as a result of the accident.

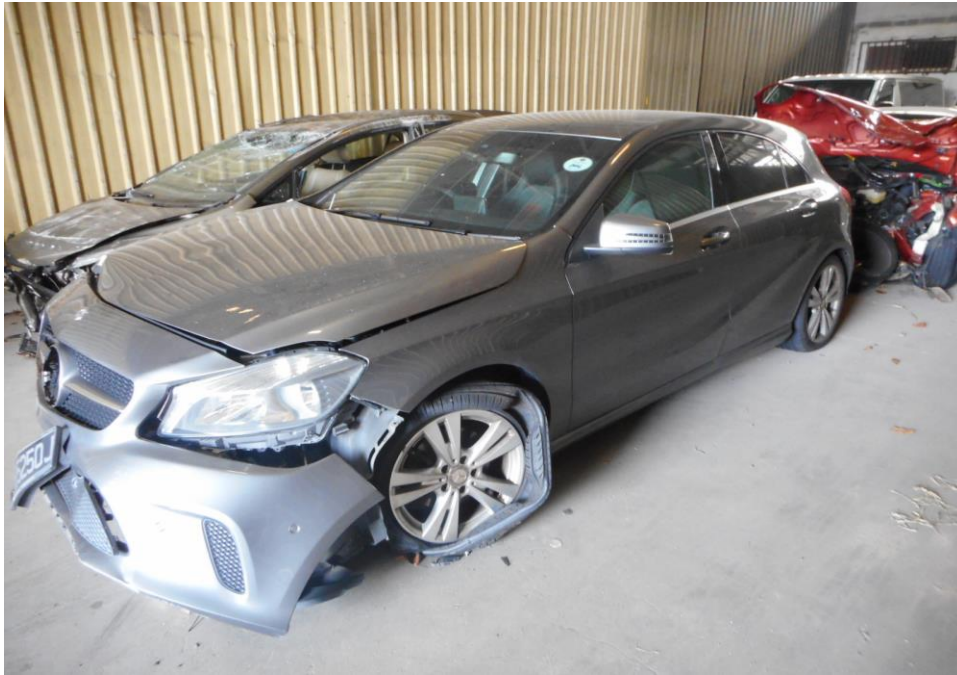
**Photo 6** shows a general view of the Motor Car's left body at the time of my inspection. The left portion of the Motor Car was observed to have been unaffected by the accident.

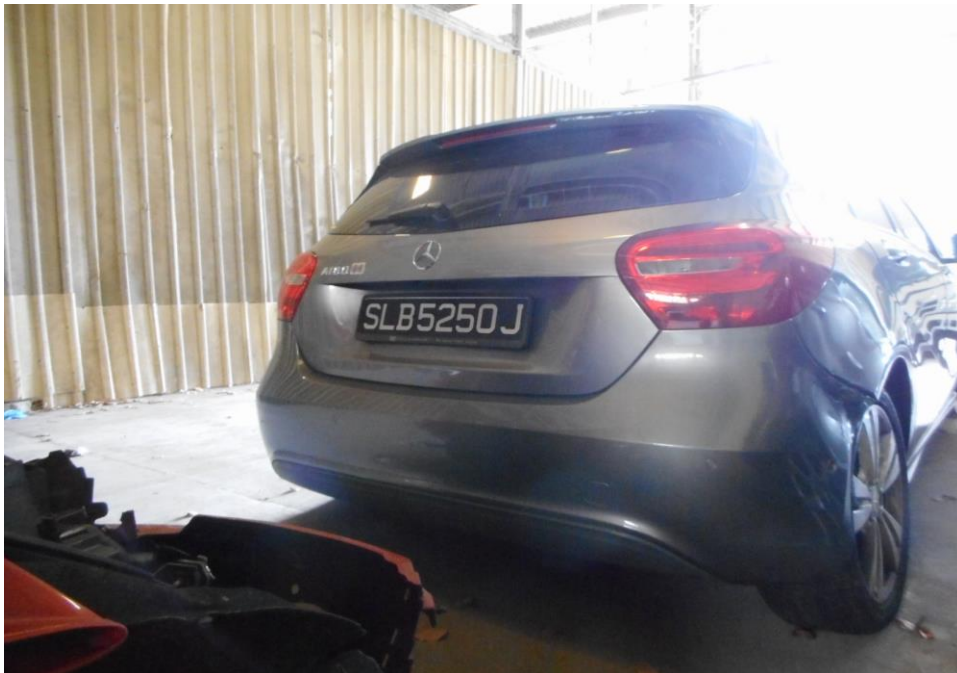
**Photo 7** shows the general view of the Motor Car's rear body at the time of my inspection, its rear bumper were amongst the body parts that were damaged as a result of the accident.

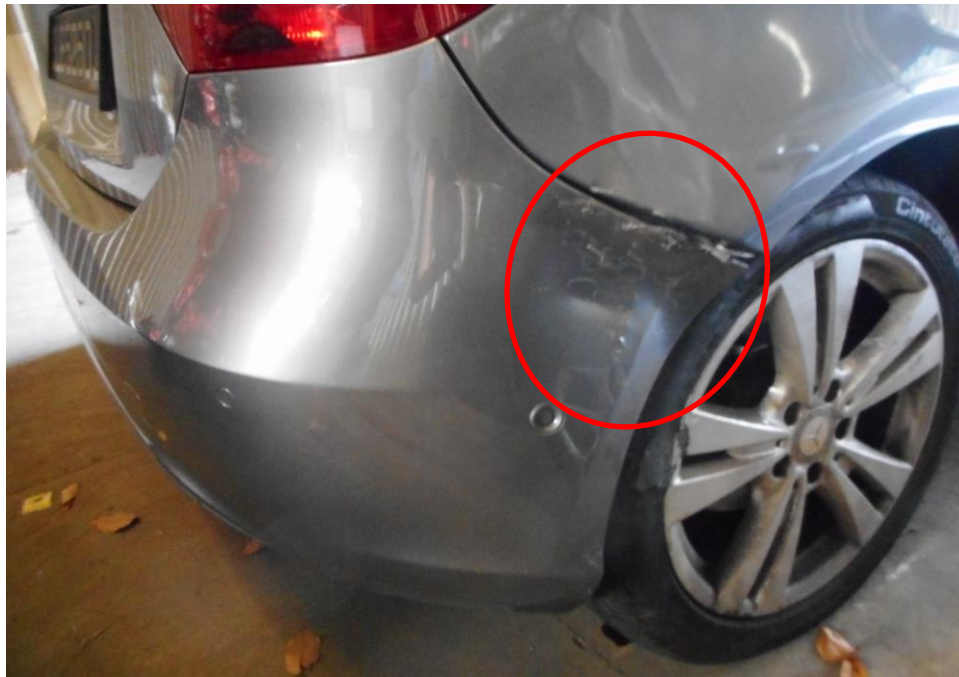
**Photo 8** shows the close up view of the Motor Car's rear body at the time of my inspection, its rear bumper (circled) were amongst the body parts that were damaged as a result of the accident.

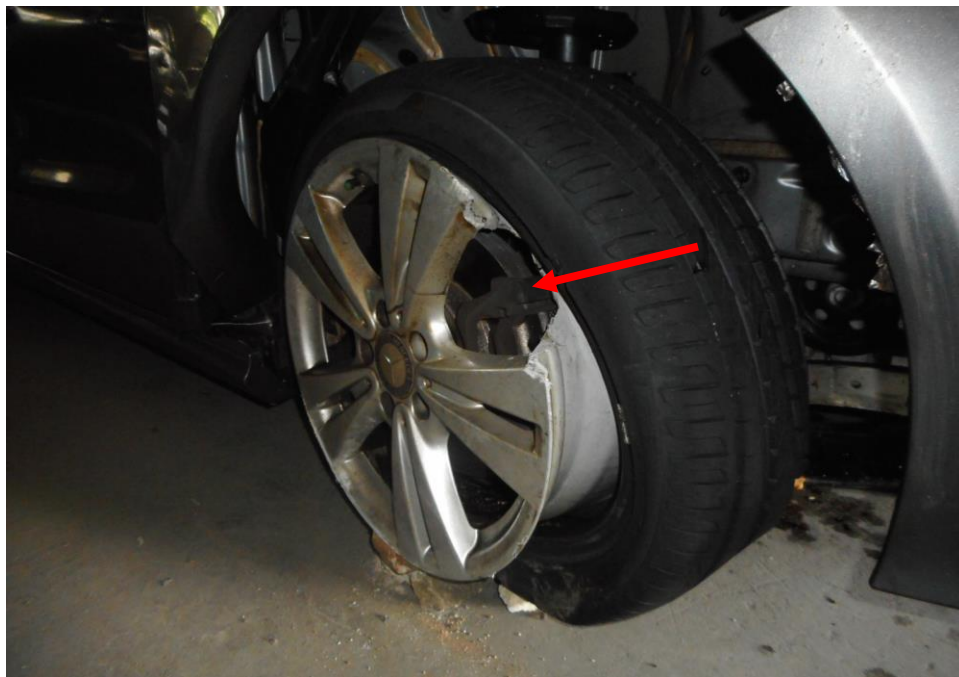
**Photo 9** shows the condition of the front right tyre of the Motor Car, which was observed to be in unserviceable condition as it was damaged (arrowed) as a result of the accident with remaining tread depth of approximately 8.1mm.

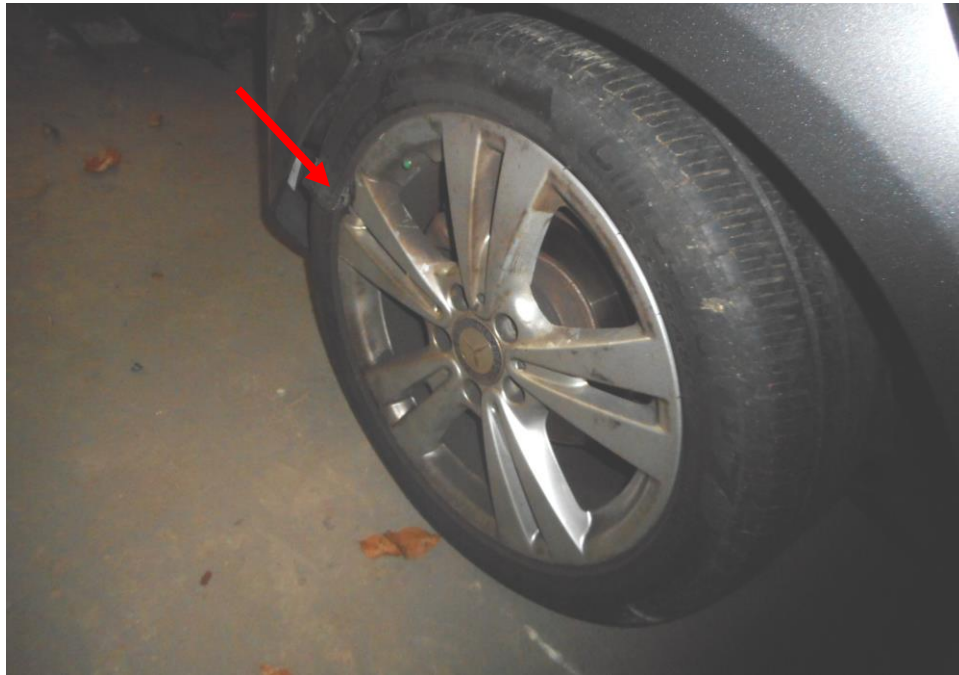
**Photo 10** shows the condition of the rear right tyre of the Motor Car, which was observed to be in unserviceable condition as it was damaged (arrowed) as a result of the accident with remaining tread depth of approximately 4.3mm.

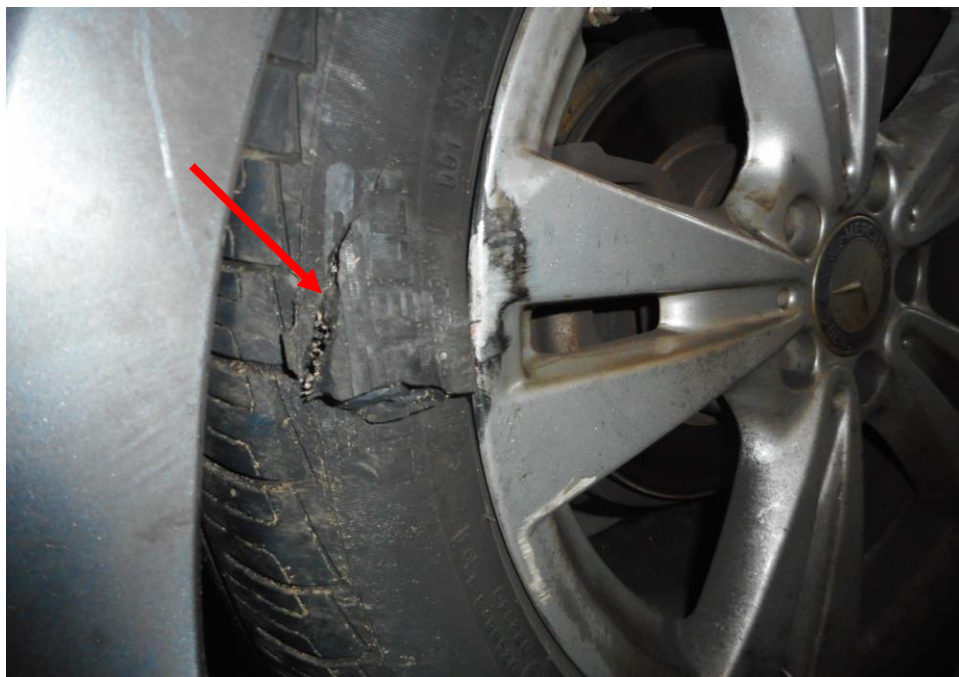
**Photo 11** shows the close up condition of the rear right tyre and rim of the Motor Car, which was observed that rim (arrowed) had likely caused cut on the tyre in the midst of the accident due to the impact it sustained from the collision.

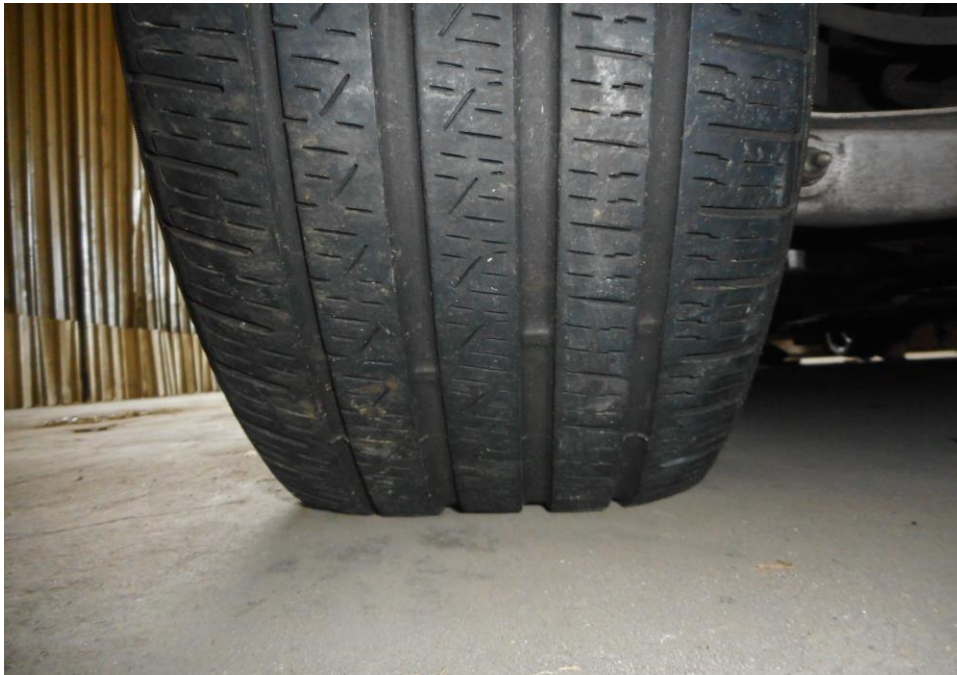
**Photo 12** shows the condition of the rear left tyre of the Motor Car, which was observed to be in serviceable condition with remaining tread depth of approximately 4.4mm. There was also no tear, cut or burst mark(s) on the outer and the inner sidewalls as well as across the tread of the Motor Car's rear left tyre.

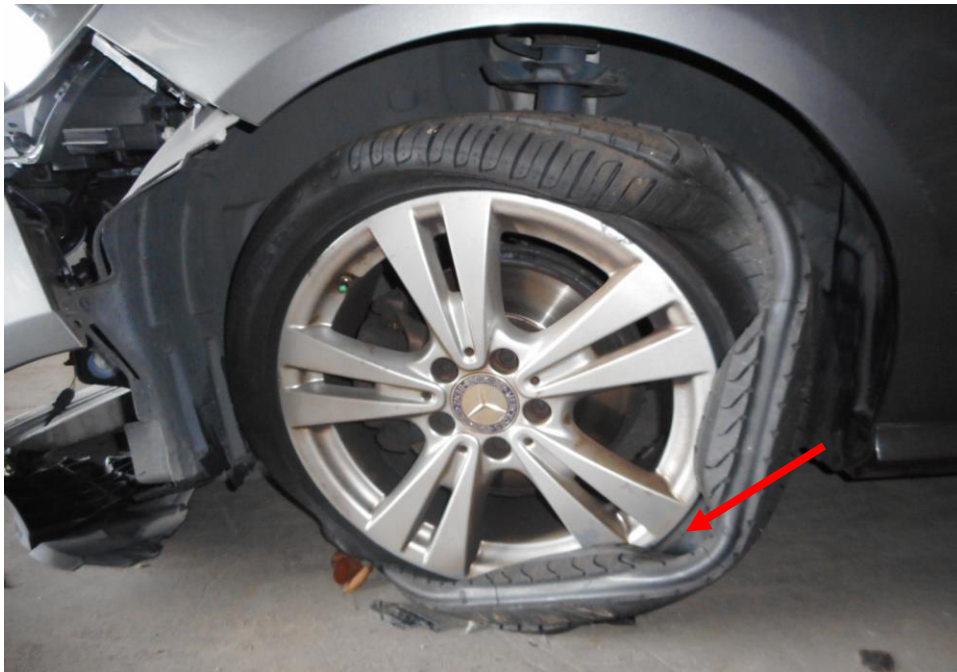
**Photo 13** shows the condition of the front left tyre of the Motor Car, which was observed to be in unserviceable condition as it was damaged (arrowed) as a result of the accident with remaining tread depth of approximately 8.2mm.

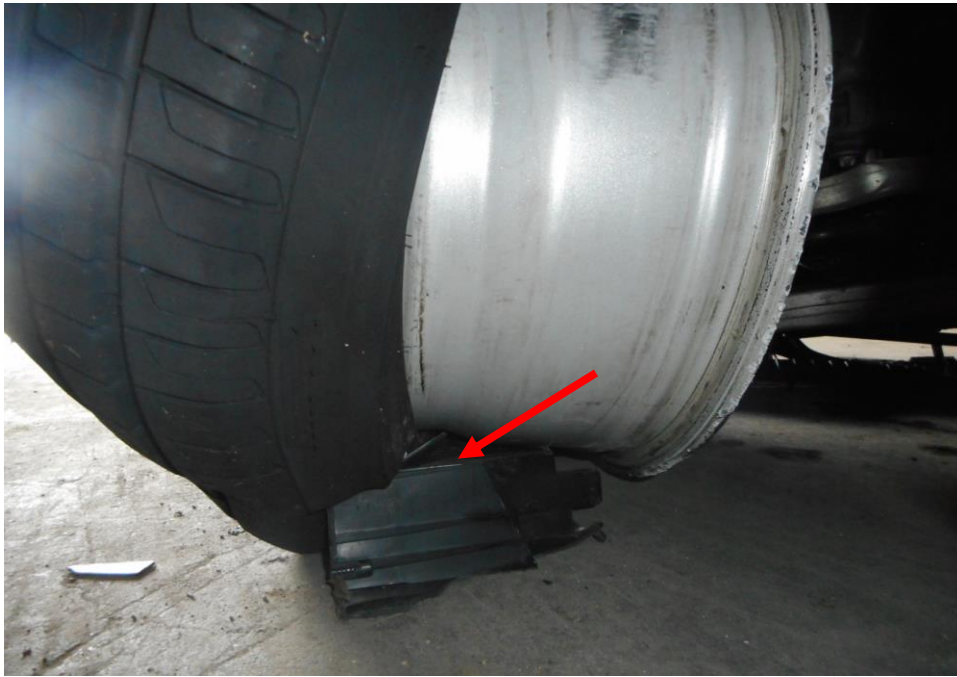
**Photo 14** shows the condition of the front left tyre and rim of the Motor Car, which was observed that rim (arrowed) had likely caused cut on the tyre in the midst of the accident due to the impact it sustained from the collision.

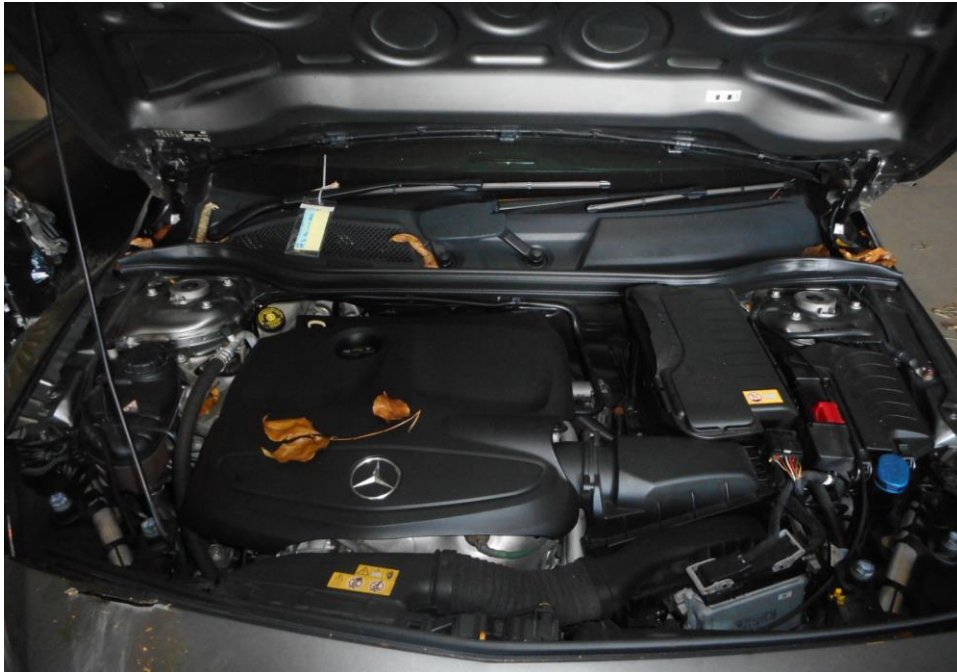
8. Upon examination of the engine compartment of the Motor Car, I had observed the brake fluid and engine coolant were all found to be of sufficient level for operating purposes. Visually, there was also no contamination found to these fluids. However, the engine oil was found to be insufficient due to the damaged to the undercarriage oil sump which had caused the engine oil to flow out as a result of the accident. See photo 15 – 19 below.

**Photo 15** shows a general view of the Motor Car's engine compartment. I had observed the brake fluid and engine coolant were all found to be of sufficient level for operating purposes. Visually, there was also no contamination found to these fluids. However, the engine oil was found to be insufficient due to the damaged to the undercarriage oil sump which had caused the engine oil to flow out as a result of the accident.

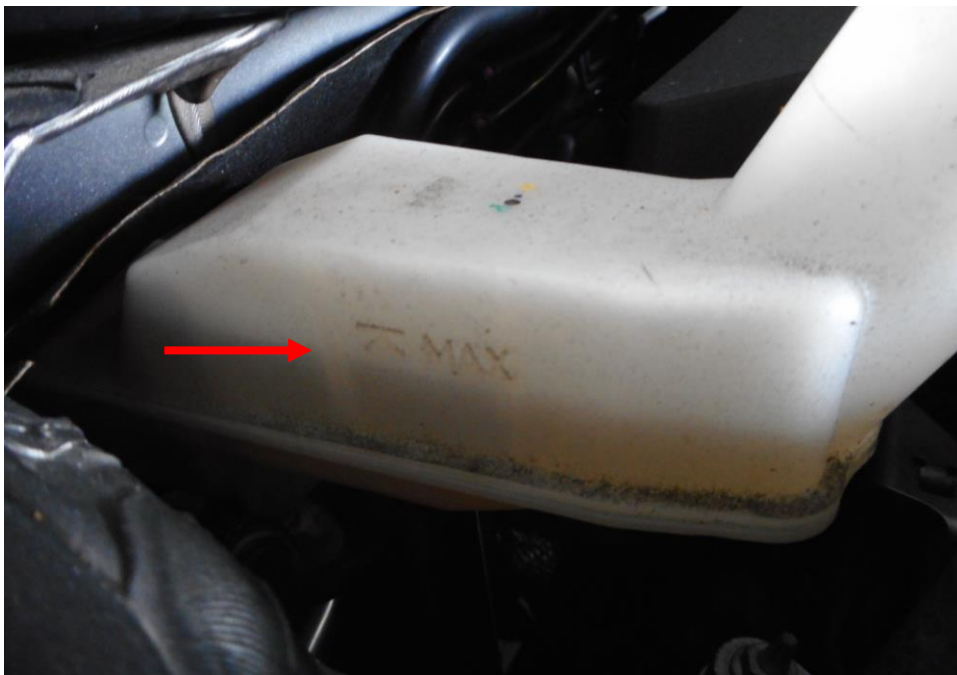
**Photo 16** shows the brake fluid reservoir of the Motor Car at the time of my inspection. The brake fluid was observed to be of sufficient level (arrowed) and without any visible contamination.

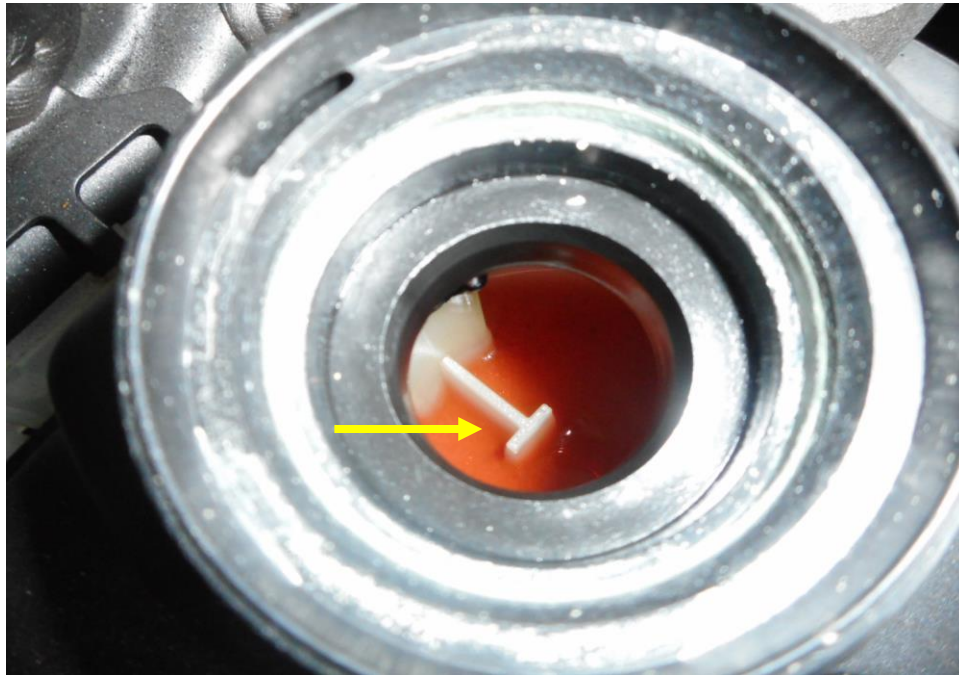
**Photo 17** shows checks being carried out to the engine coolant of the Motor Car at the time of my inspection. The engine coolant was observed to be sufficient level (arrowed) without any visible contamination.

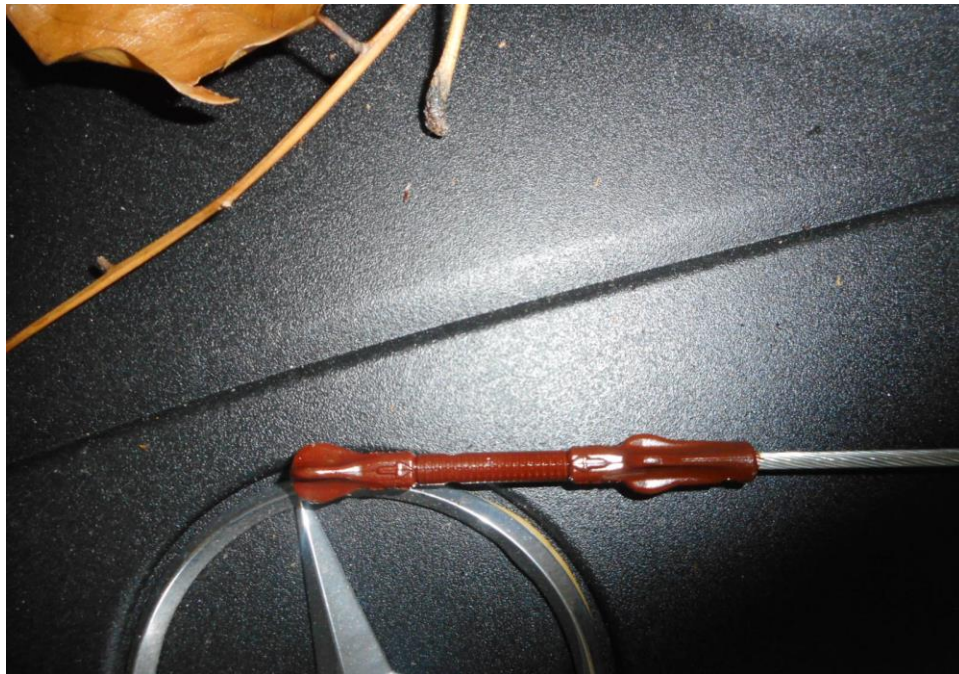
**Photo 18** shows the engine oil dip stick of the Motor Car at the time of my inspection. The engine oil was observed to be of insufficient level due to the damaged the undercarriage engine oil sump which caused the coolant to flow out.

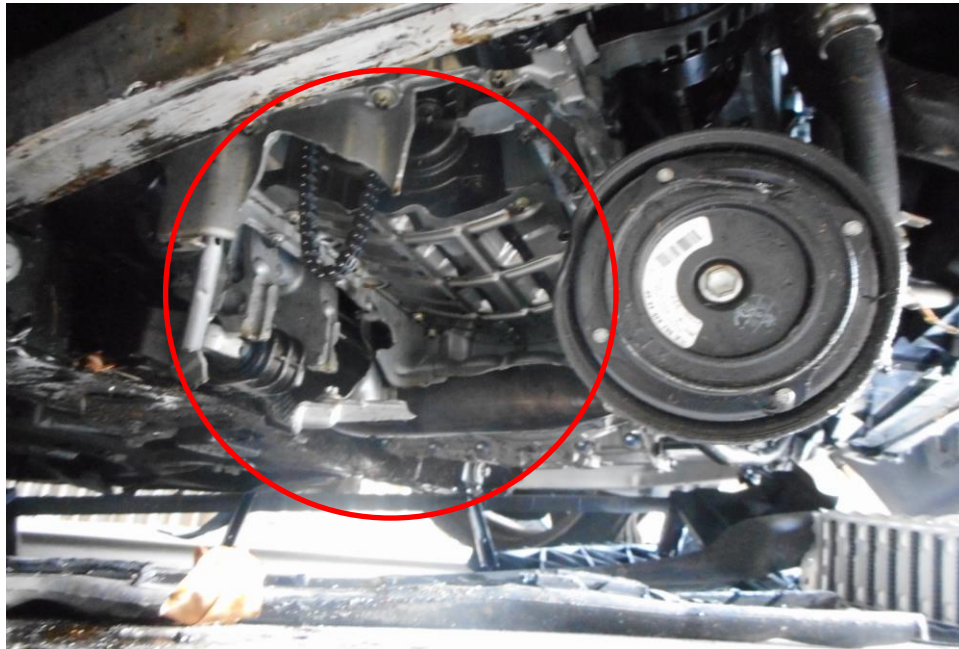
**Photo 19** shows the undercarriage of the Motor Car, at the area where the engine housing and transmission housing are located. I did find any sign(s) or indication(s) of fluid leak and/or fluid stain(s) due to the damaged to the undercarriage engine oil sump (circled) on the underside of the Motor Car as a result of the accident.

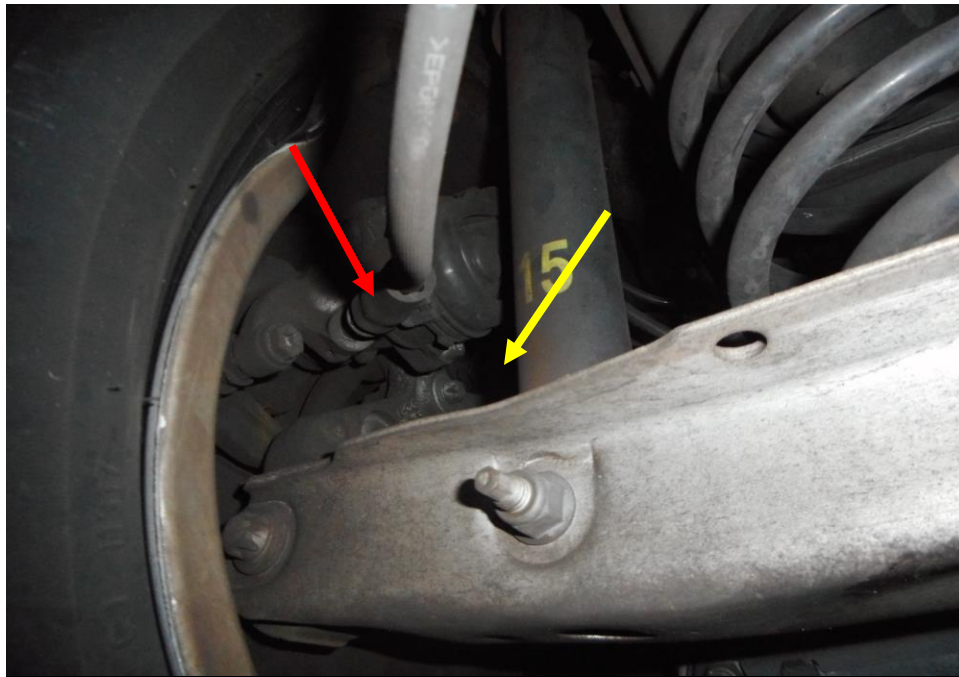
**Photo 20** shows the brake hose/pipe (arrowed) at the rear right wheel of the Motor Car. No leakage of brake fluid was observed. Visual examination of the various components of the braking system like the drum brake, brake booster, brake pedal etc. had revealed all to be intact and without visible damage.

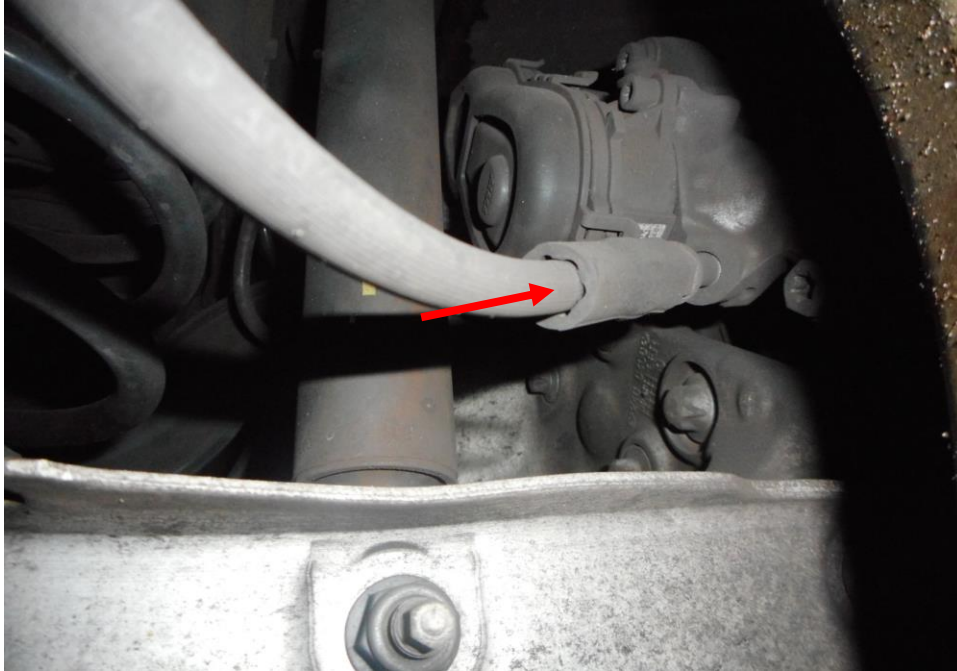
**Photo 21** shows the brake hose/pipe (arrowed) at the rear left wheel of the Motor Car. I did not observe any leakage of brake fluid at the time of my inspection of the Motor Car. Static tests of the Motor Car's braking system had indicated that there was no internal leakage of pressure/vacuum. The undercarriage components of the Motor Car were also all found to be intact and without any visible damage.

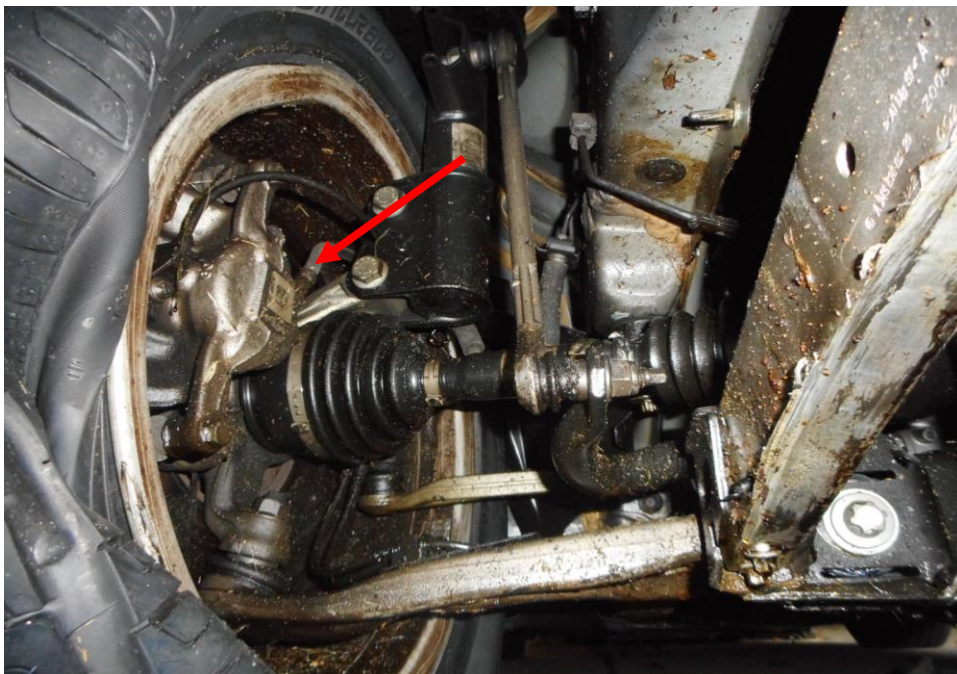
**Photo 22** shows the brake hose/pipe (arrowed) at the front right wheel of the Motor Car. I did not observe any leakage of brake fluid at the time of my inspection of the Motor Car. Static tests of the Motor Car's braking system had indicated that there was no internal leakage of pressure/vacuum. The undercarriage components of the Motor Car were also all found to be intact and without any visible damage. The components in this area was cover in engine oil due to the damaged engine oil as a result of the accident.

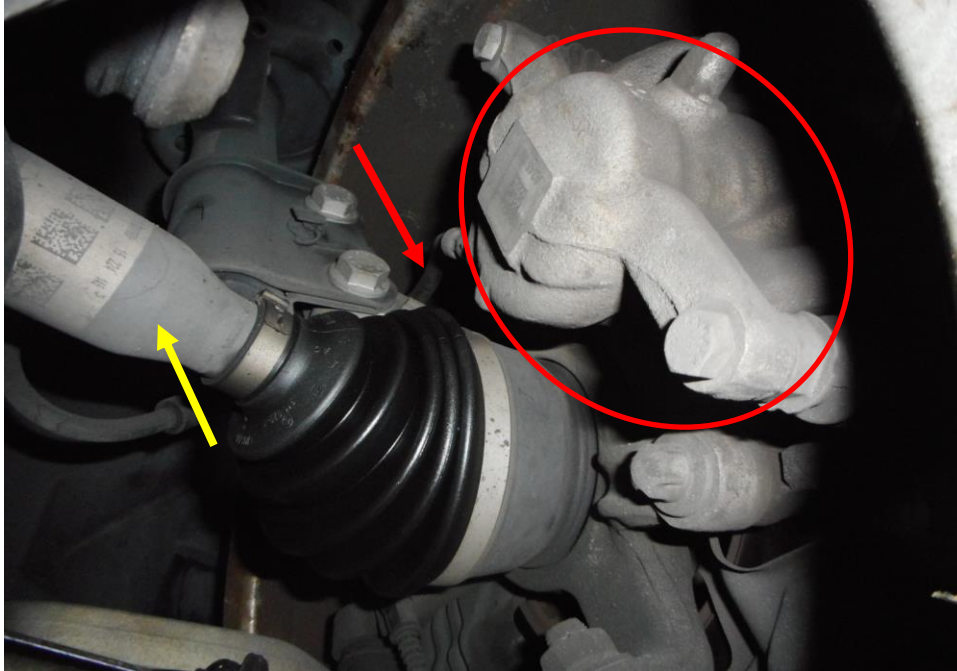
**Photo 23** shows the brake hose/pipe (red arrow) at the front left wheel of the Motor Car. No leakage of brake fluid was observed. Visual examination of the various components of the braking system like the brake caliper (circled) and drive shaft (yellow arrow), brake booster, brake pedal, drive shaft etc had revealed all to be intact and without visible damage.

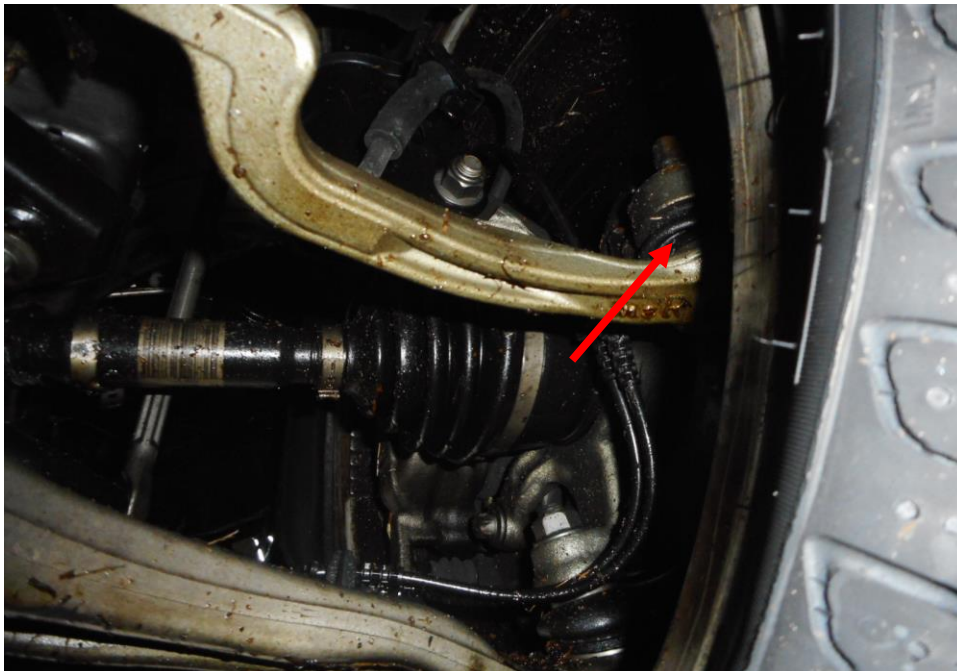
**Photo 24** shows the various undercarriage components at the front right wheel of the Motor Car, in particular the steering tie rod (red arrow). The various steering components were all found to be intact, suggesting that the steering system of the Motor Car was likely to be in serviceable condition at the material time of accident. There was also no sign of fluid stain observed on the various undercarriage components at the front left wheel of the Motor Car. The components in this area was cover in engine oil due to the damaged engine oil as a result of the accident.

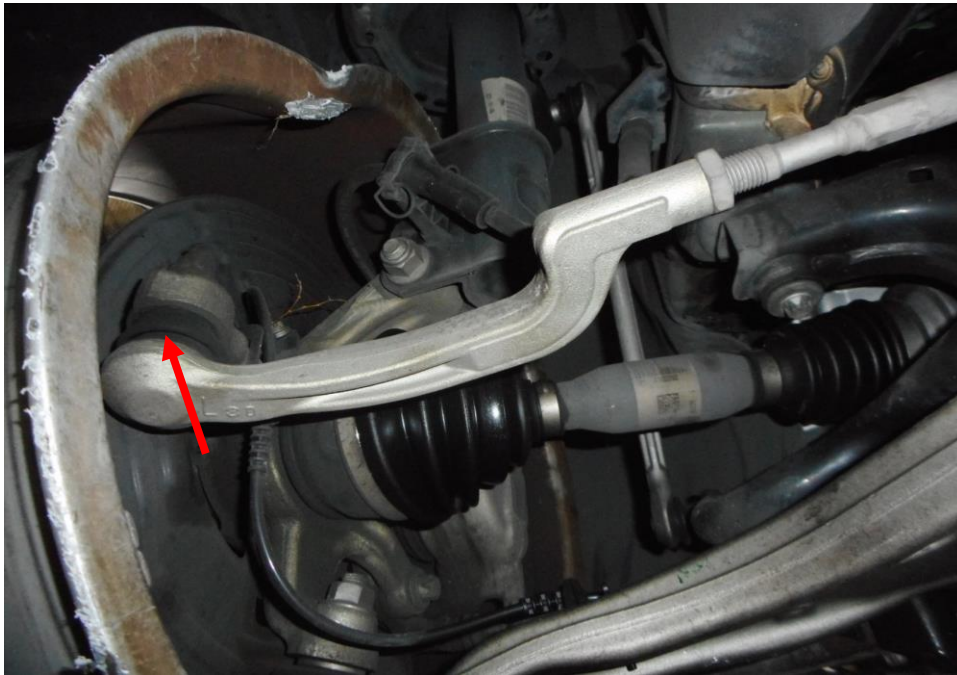
**Photo 25** shows the various undercarriage components at the front left wheel of the Motor Car, the steering tie rod (red arrow) the various steering components were all found to be intact, suggesting that the steering system of the Motor Car was likely to be in serviceable condition at the material time of accident. There was also no sign of fluid stain observed on the various undercarriage components at the front left wheel of the Motor Car.
