Your Ref: TP/IP/29993/2020
Our Ref : CI/TPD20008772/P

7th October 2020

MECHANICAL INSPECTION REPORT OF PRIME MOVER XE 2046U

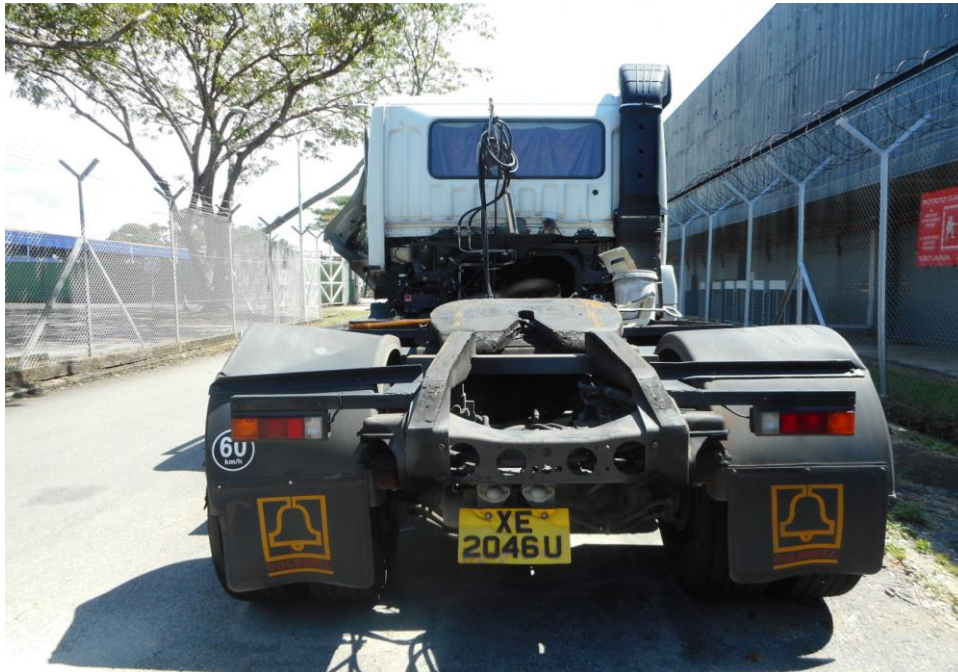
Photo 1 shows a general view of the Prime Mover's rear body at the time of my inspection. There was no damage found to the rear portion of the Prime Mover.

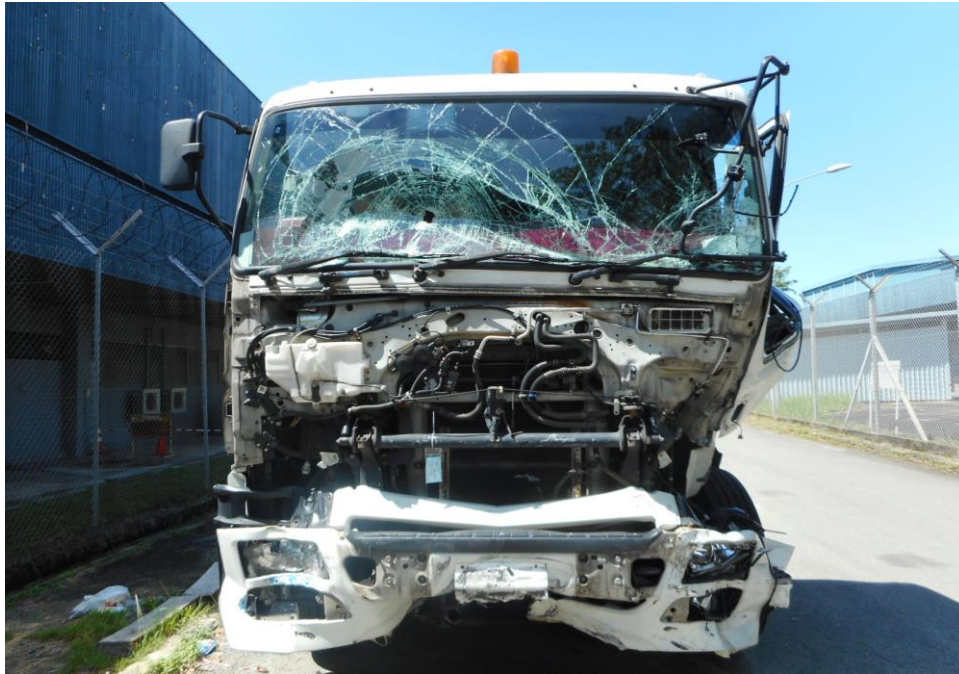
Photo 2 shows a general view of the front body of the Prime Mover at the time of my inspection. The Prime Mover was observed to have sustained damage at its frontal portion. Its front windscreen, front body panel and engine components were amongst the body parts that were damaged as a result of the accident.

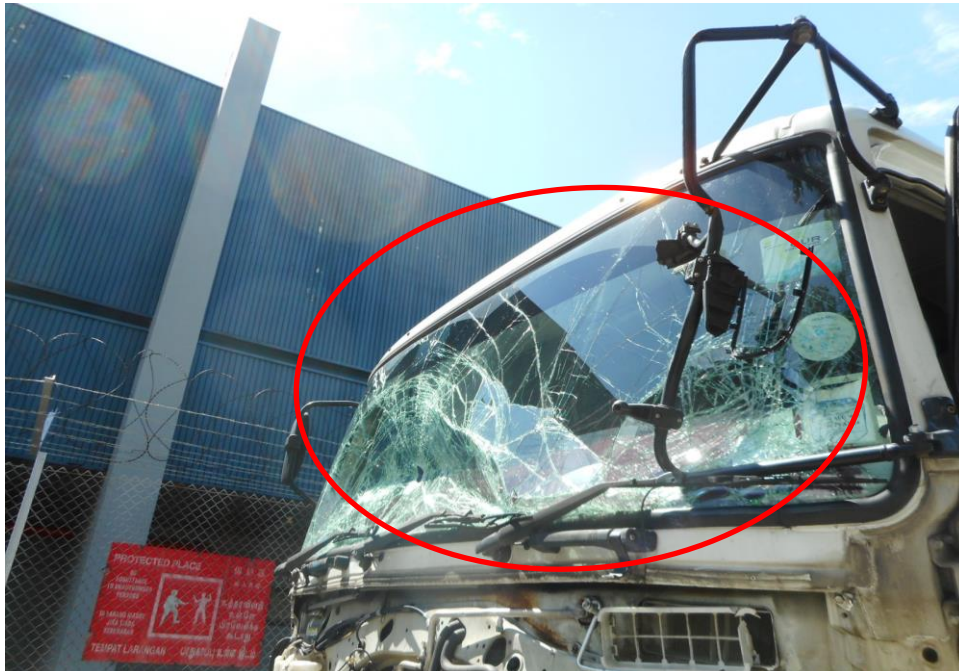
Photo 3 shows the close up view of the Prime Mover front body at the time of my inspection. The Prime Mover was observed to have sustained damage at its front windscreen (circled), as a result of the accident.

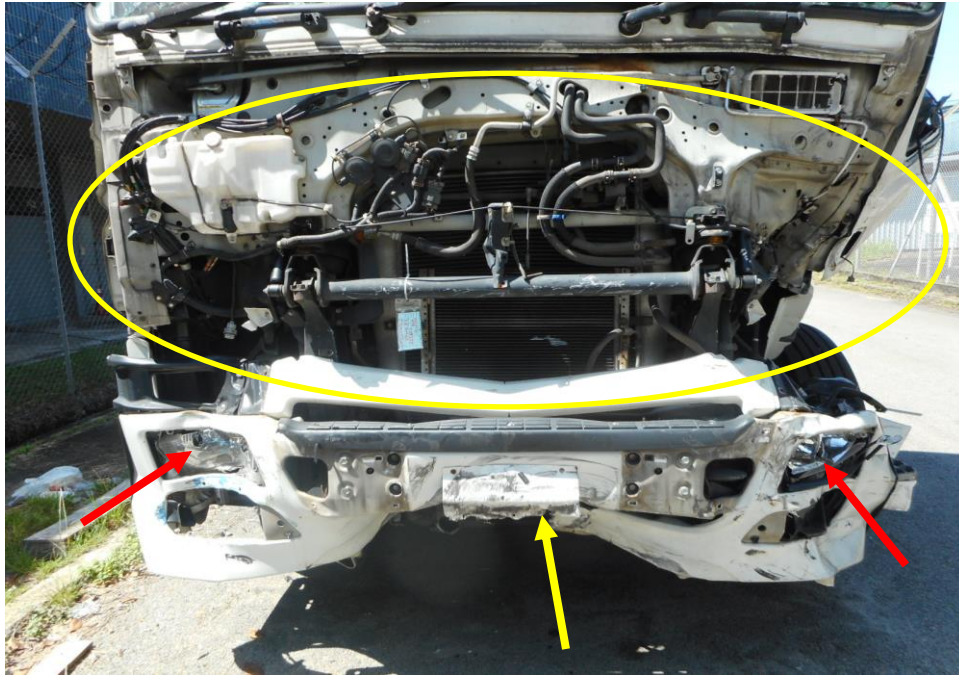
Photo 4 shows the close up view of the Prime Mover front body at the time of my inspection. The Prime Mover was observed to have sustained damage at its front body panel (circled), it's both front headlamps (red arrow) and front bumper (yellow arrow) was also damaged as a result of the accident.

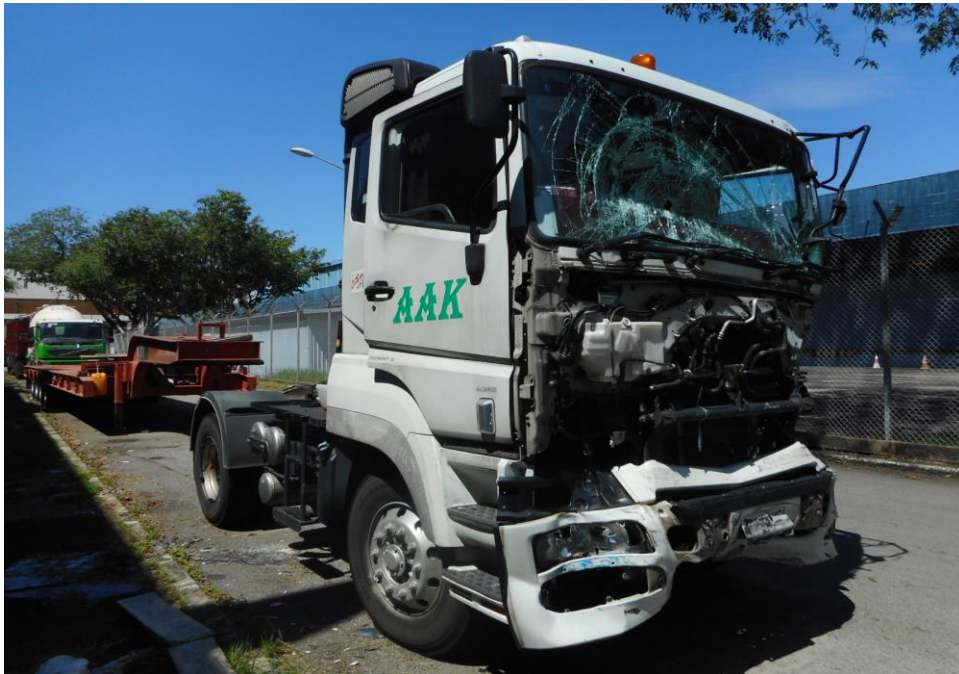
Photo 5 shows a general view of the front right body of the Prime Mover at the time of my inspection, it was observed to have been unaffected by the accident.

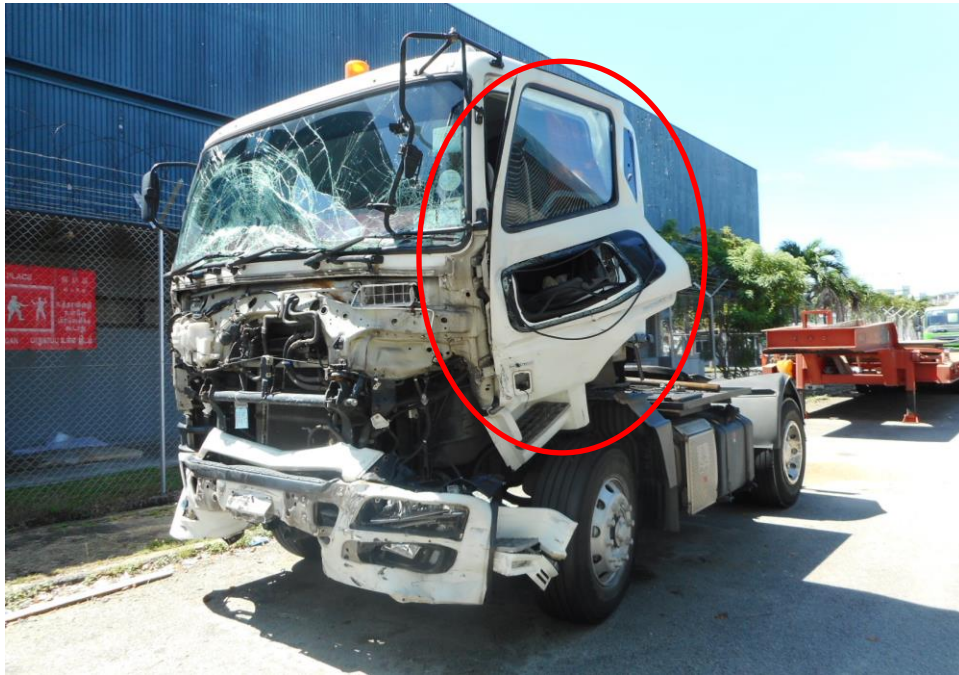
Photo 6 shows a general view of the front right body of the Prime Mover at the time of my inspection, the right door (circled) was observed to have been damaged by the accident.

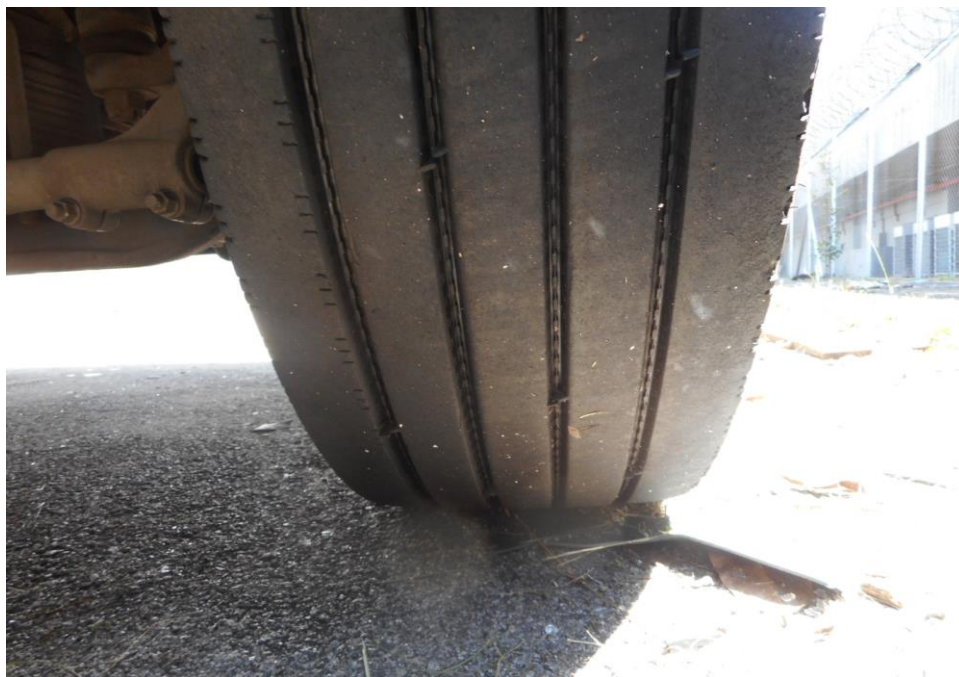
Photo 7 shows the condition of the front right tyre of the Prime Mover, which was observed to be in serviceable condition with remaining tread depth of approximately 7.2 mm. The tyre, which was wrapped around standard steel wheel rim, was also observed to be sufficiently inflated for vehicular operation. There was no tear, cut or burst mark(s) on the outer and the inner sidewalls as well as across the tread of the 10 tyres that were fitted on the Prime Mover.

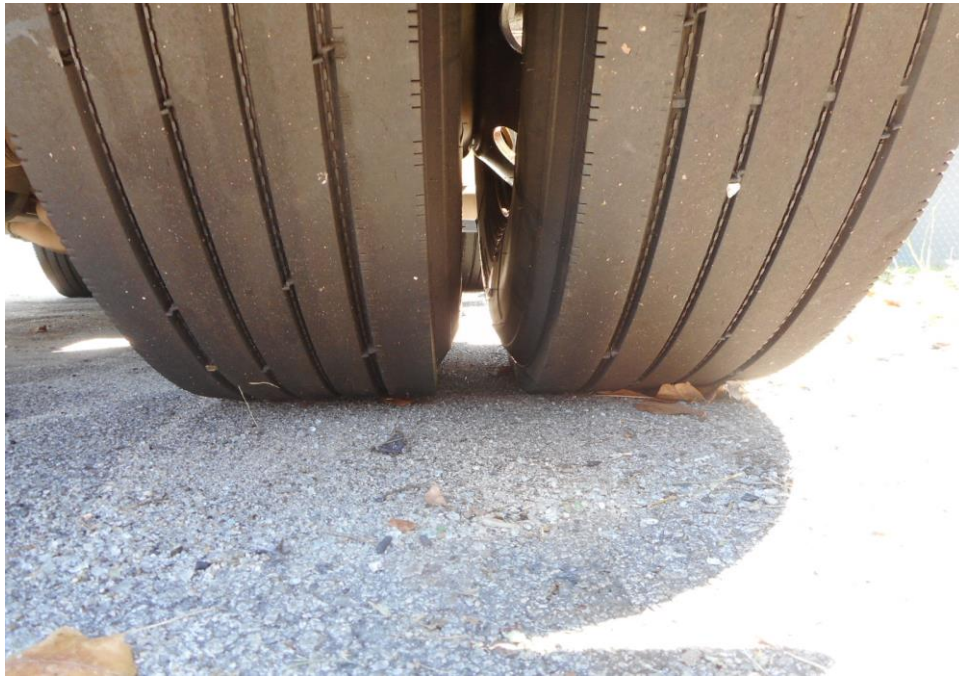
Photo 8 shows the condition of the rear right tyre of the Prime Mover, which was observed to be in serviceable condition with remaining tread depth of approximately 4.3mm. The tyre, which was wrapped around standard steel wheel rim, was also observed to be sufficiently inflated for vehicular operation.

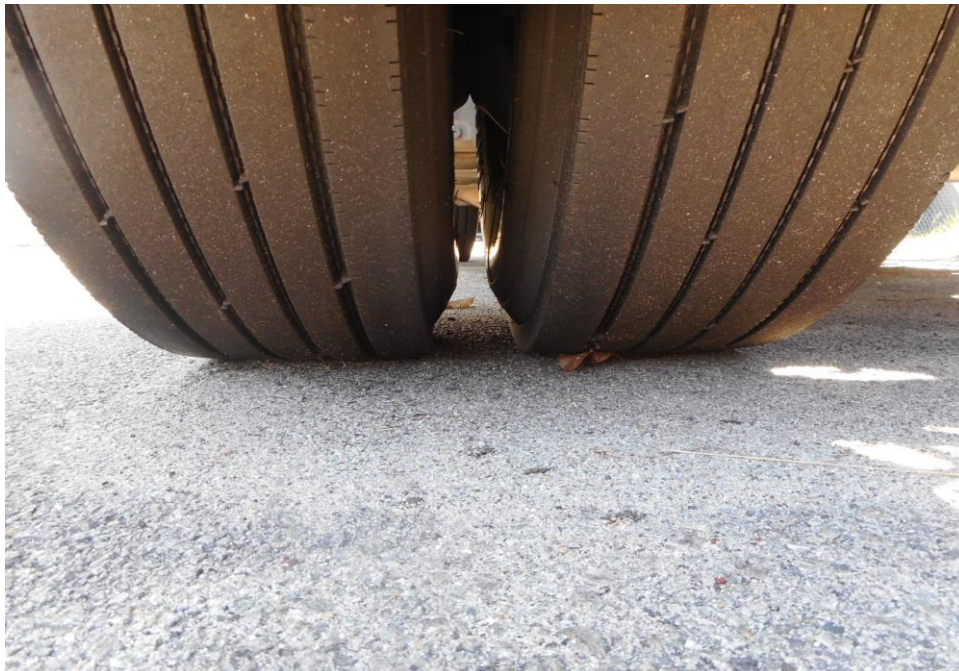
Photo 9 shows the condition of the rear left tyres of the Prime Mover, which was observed to be in serviceable condition with remaining tread depth of approximately 5.4mm. The tyres, which were wrapped around standard steel wheel rim, were also observed to be sufficiently inflated for vehicular operation. There was also no damage found on all 10 steel wheel rims of the Prime Mover.

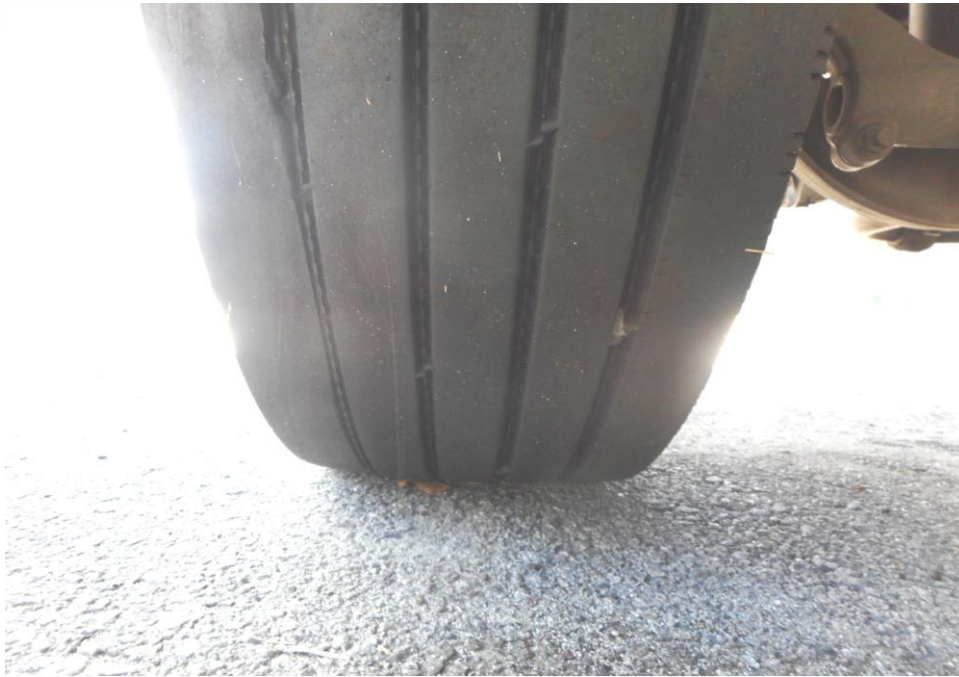
Photo 10 shows the condition of the front left tyres of the Prime Mover, which were observed to be in serviceable condition with remaining tread depth of approximately 6.4mm. There was also no tear, cut or burst mark(s) on the outer and the inner sidewalls as well as across the tread of the 10 tyres that were fitted on the Prime Mover.

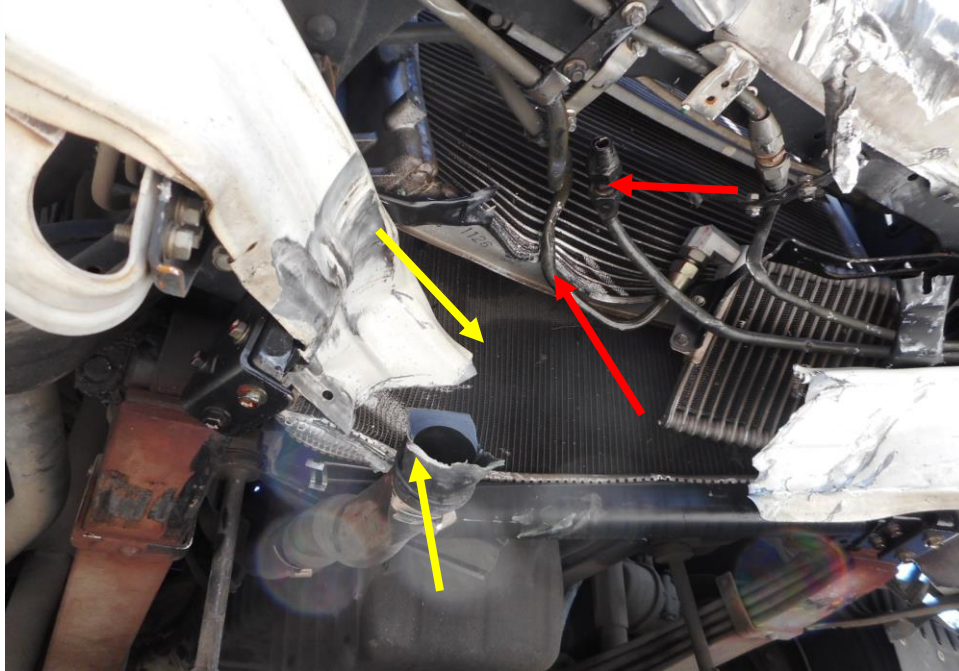
8. The engine compartment of the Prime Mover was located below the front cabin of the Prime Mover. I was not able to carry out any checks on the engine compartment as the cabin of the Prime Mover was not able to be lifted to the engine compartment as it requires the battery powered. The various operating fluids were also not able to be checked.
9. However, further examination of the engine compartment revealed, that the components in the engine compartment of the Prime Mover had sustained damaged as a result of the accident. See photo 11 below.

Photo 11 shows the close up view of the Prime Mover front underside at the time of my inspection. The Prime Mover was observed to have sustained damage at its engine, its oil hoses (red arrow) and radiator (yellow arrow) was also damaged as a result of the accident.

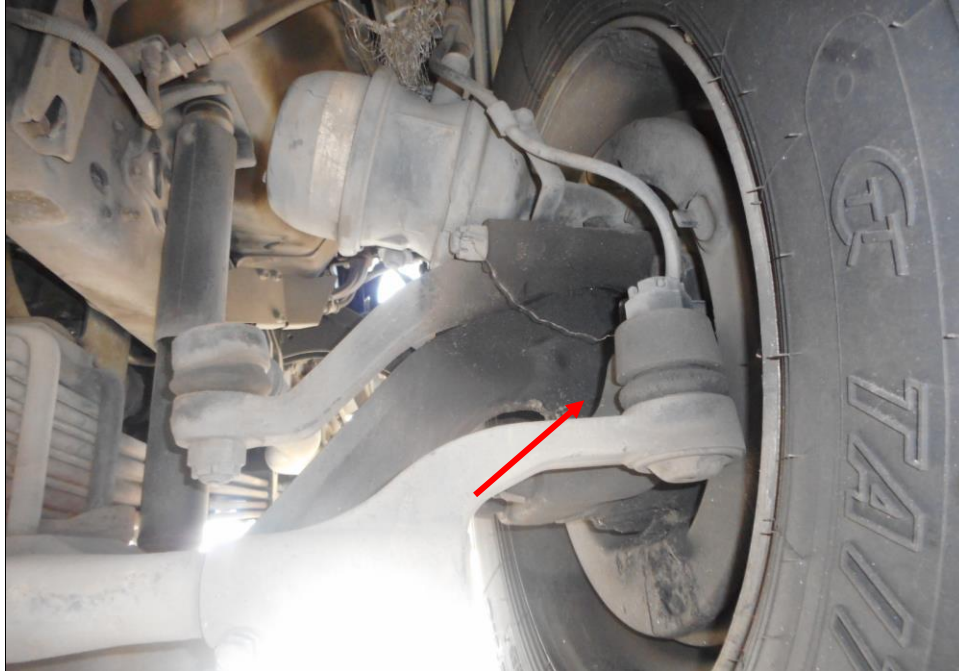
Photo 12 shows the various undercarriage components at the front right wheel of the Prime Mover, in particular the steering tie rod end (arrowed). The various steering components were all found to be intact, suggesting that the steering system of the Prime Mover was likely to be in serviceable condition at the material time of accident. There was also no sign of fluid stain(s) observed on the various undercarriage components.

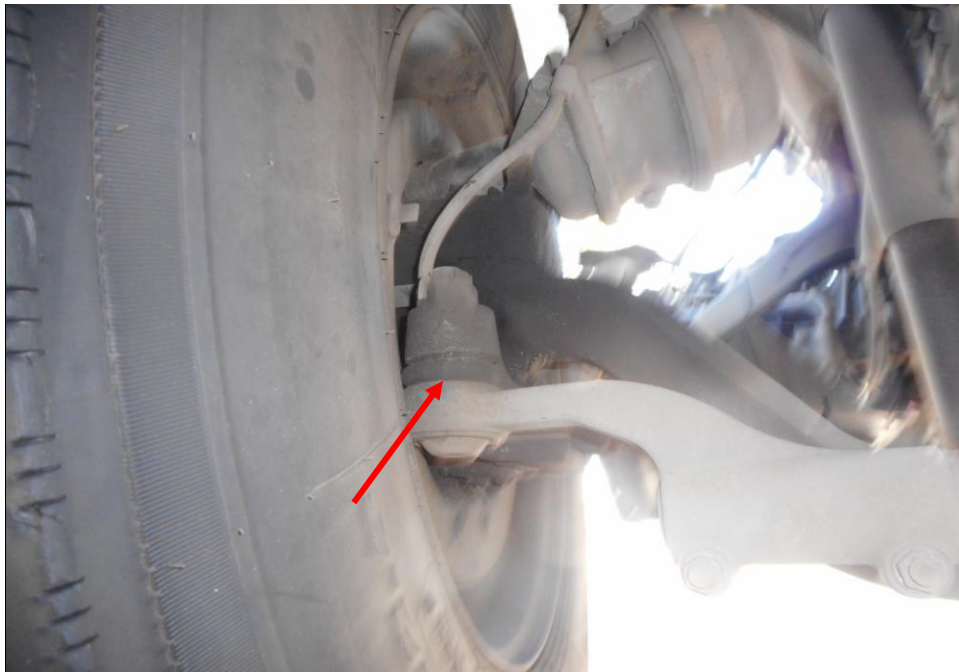
Photo 13 shows the various undercarriage components at the front left wheel of the Prime Mover, in particular the steering tie rod end (arrowed). The various undercarriage components of the Prime Mover were all found to be intact without any visible damage. There was also no sign of fluid stain(s) observed on the various undercarriage components.

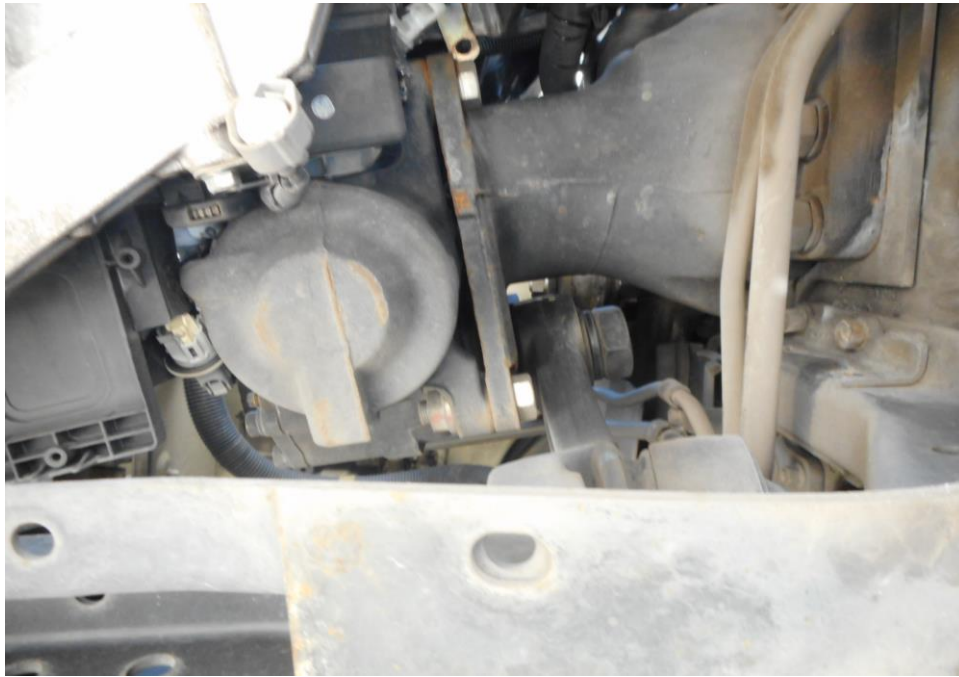
Photo 14 shows the steering box component (arrowed) at the undercarriage of the Prime Mover was found to be intact without any visible damage. There was also no sign of fluid stain(s) observed on the various undercarriage components.

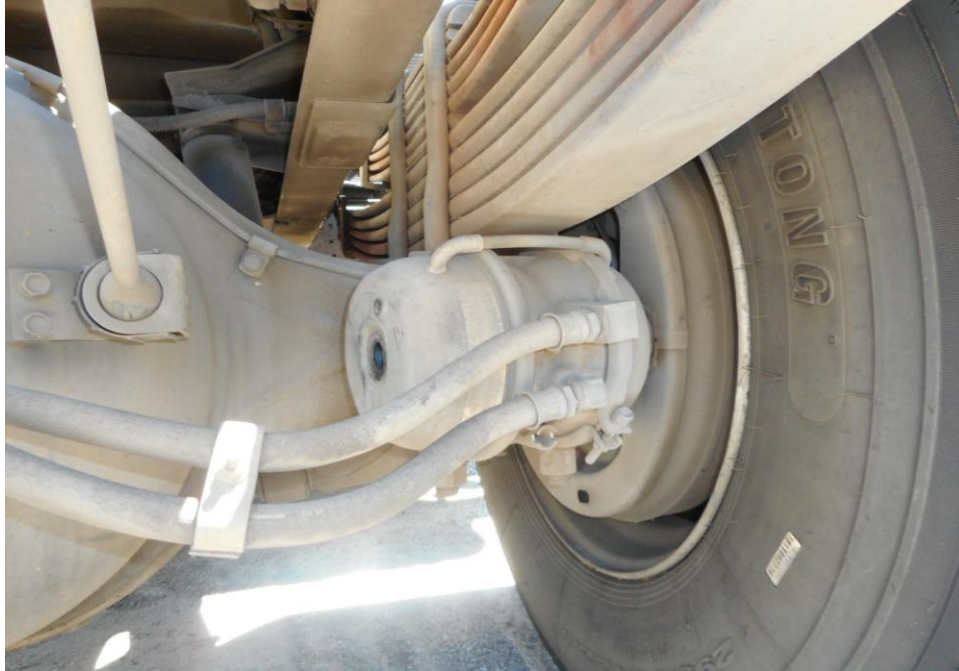
Photo 15 shows the brake pipe (arrowed) at the rear right wheel of the Prime Mover. I did not observe any leakage of brake fluid at the time of my inspection of the Prime Mover. My static tests of the Prime Mover's braking system, along with my visual examination of the various mechanical components in the braking system, had indicated that there was no internal leakage of pressure/vacuum. Hence the braking system of the Prime Mover was likely to be in serviceable condition at the material time of accident.

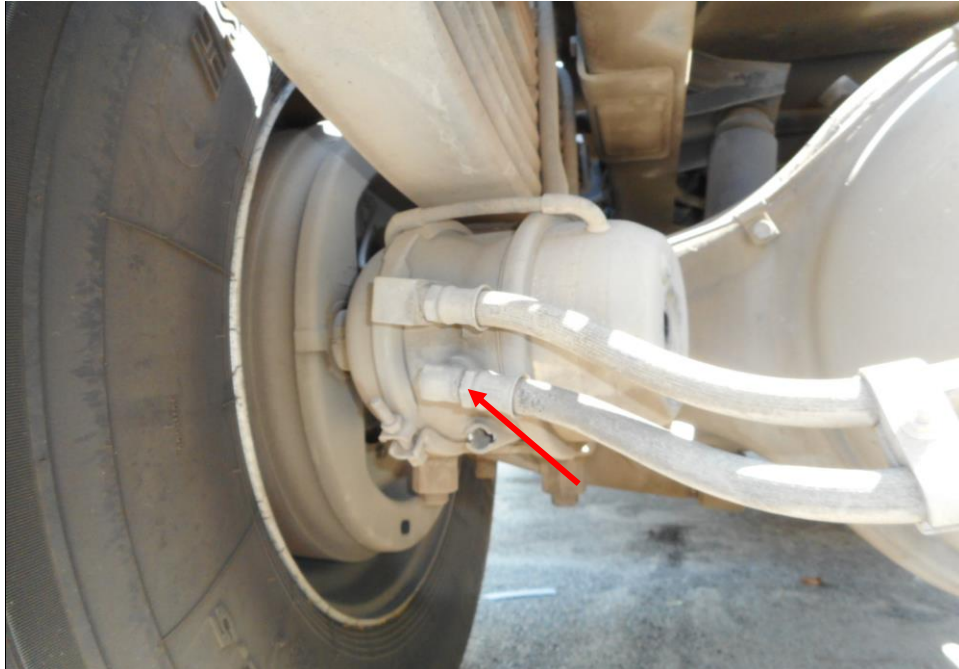
Photo 16 shows the brake pipe (arrowed) at the rear left wheel of the Prime Mover. I did not observe any leakage of brake fluid at the time of my inspection of the Prime Mover. My static tests of the Prime Mover's braking system, along with my visual examination of the various mechanical components in the braking system, had indicated that there was no internal leakage of pressure/vacuum. Hence the braking system of the Prime Mover was likely to be in serviceable condition at the material time of accident.

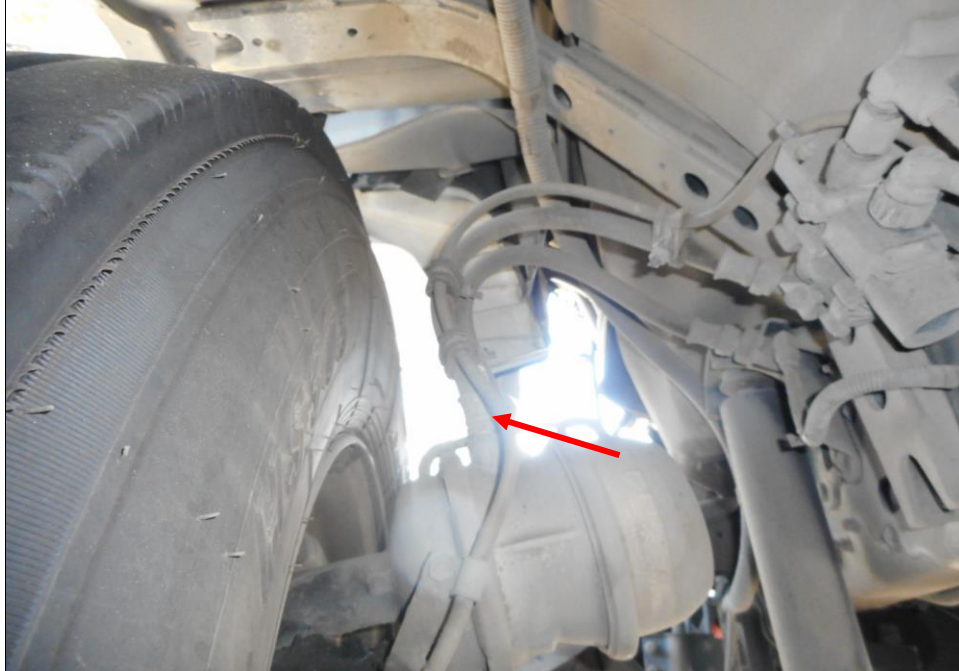
Photo 17 shows the brake pipe (arrowed) at the front left wheel of the Prime Mover. I did not observe any leakage of brake fluid at the time of my inspection of the Prime Mover. My static tests of the Prime Mover's braking system, along with my visual examination of the various mechanical components in the braking system, had indicated that there was no internal leakage of pressure/vacuum. Hence the braking system of the Prime Mover was likely to be in serviceable condition at the material time of accident.

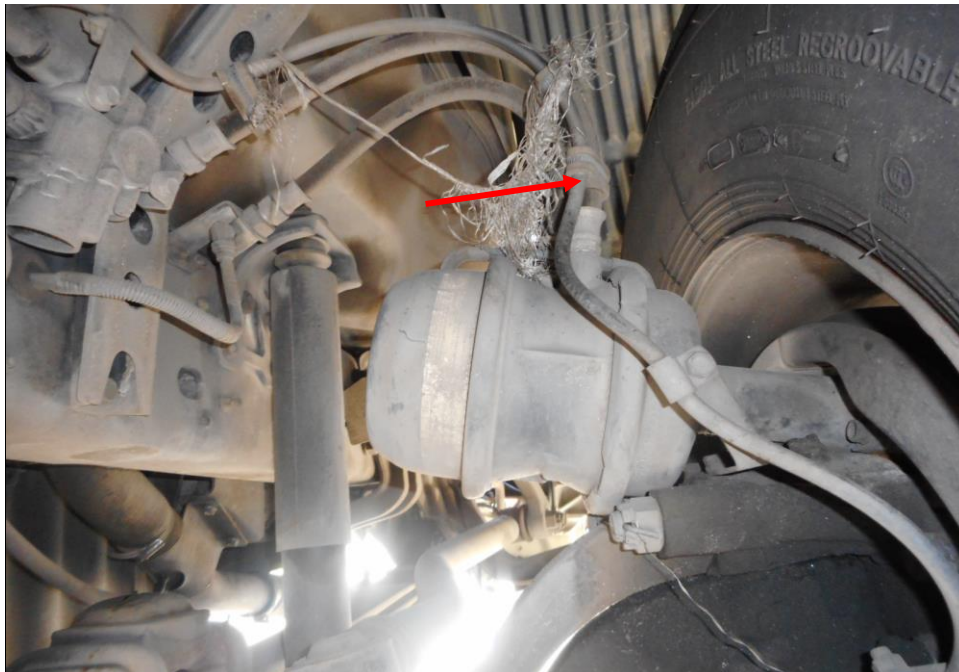
Photo 18 shows the brake pipe (arrowed) at the front right wheel of the Prime Mover. I did not observe any leakage of brake fluid at the time of my inspection of the Prime Mover. My static tests of the Prime Mover's braking system, along with my visual examination of the various mechanical components in the braking system had indicated that there was no internal leakage of pressure/vacuum. Hence the braking system of the Prime Mover was likely to be in serviceable condition at the material time of accident.

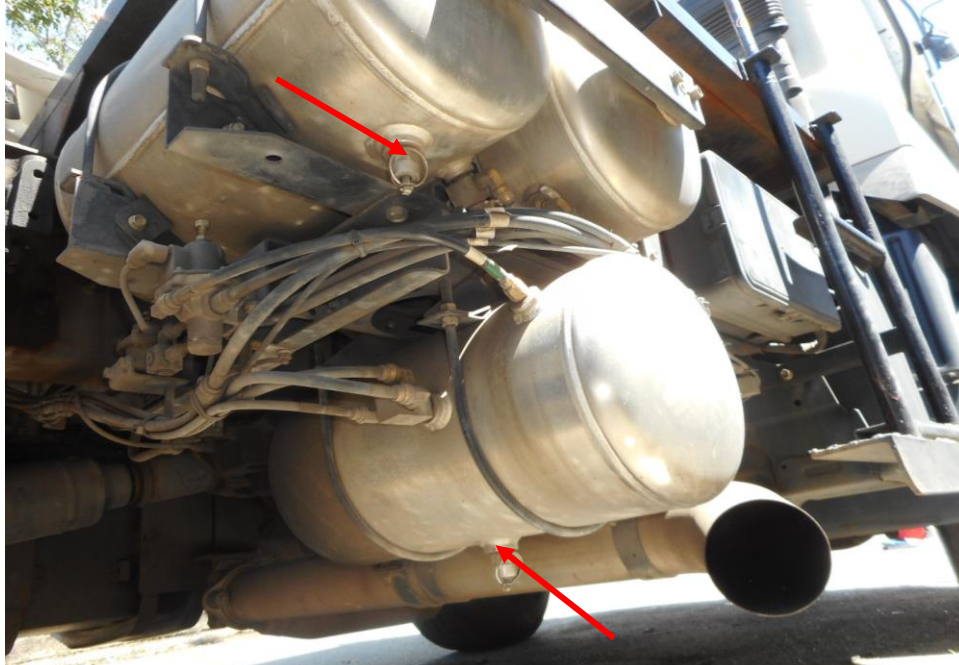
Photo 19 shows the air brake cylinders (arrowed) at the undercarriage of the Prime Mover. I did not observe any leakage of air brake fluid at the time of my inspection of the Prime Mover. My static tests of the Prime Mover's braking system, along with my visual examination of the various mechanical components in the braking system had indicated that there was no internal leakage of pressure/vacuum. Hence the braking system of the Prime Mover was likely to be in serviceable condition at the material time of accident.
