Your Ref: Porsche Macan  
(chassis number WP1ZZZ95ZKLB09452)  
Our Ref : CI/TP20008786/D

**INSPECTION REPORT OF AN UNREGISTERD PORSCHE MACAN MOTOR CAR WITH CHASSIS NUMBER WP1ZZZ95ZKLB09452**

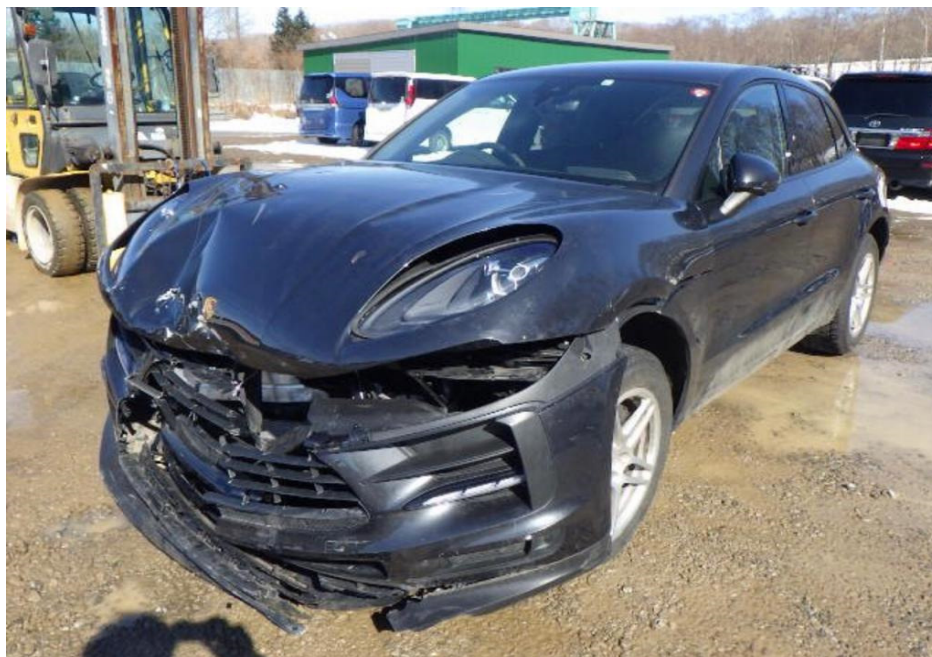
**Photo 1** shows the front left body of the Motor Car prior to any repairs being carried out (photograph provided to me). The Motor Car was observed to have sustained damages at its frontal portion. The body parts observed to be damaged had included the front bumper, front bonnet and front left headlamp amongst others.

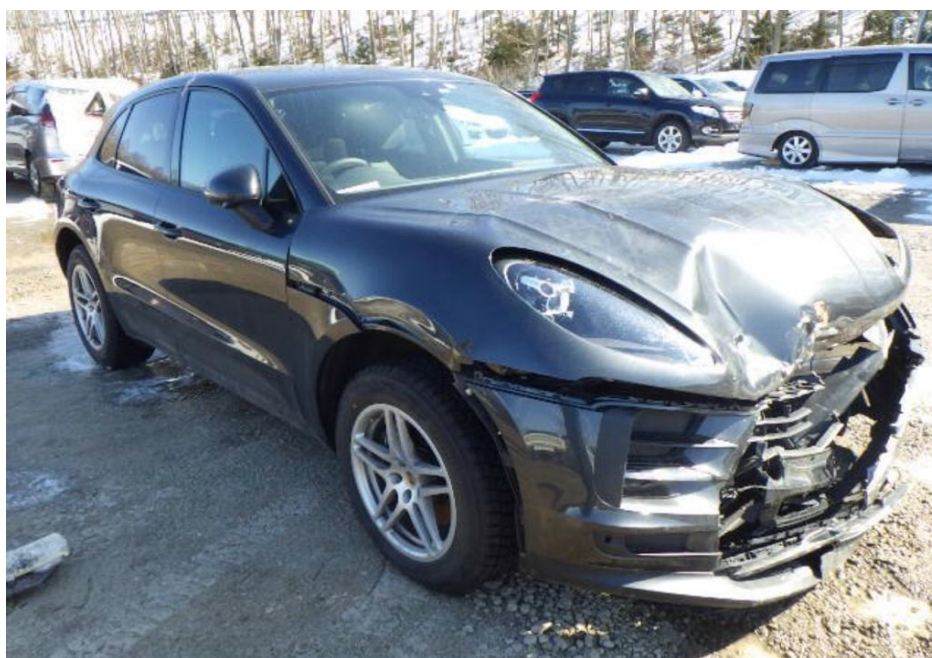
**Photo 2** shows the front right body of the Motor Car prior to any repairs being carried out (photograph provided to me). The Motor Car was observed to have sustained damages at its frontal portion. The body parts observed to be damaged had included the front bumper, front bonnet and front right headlamp amongst others.

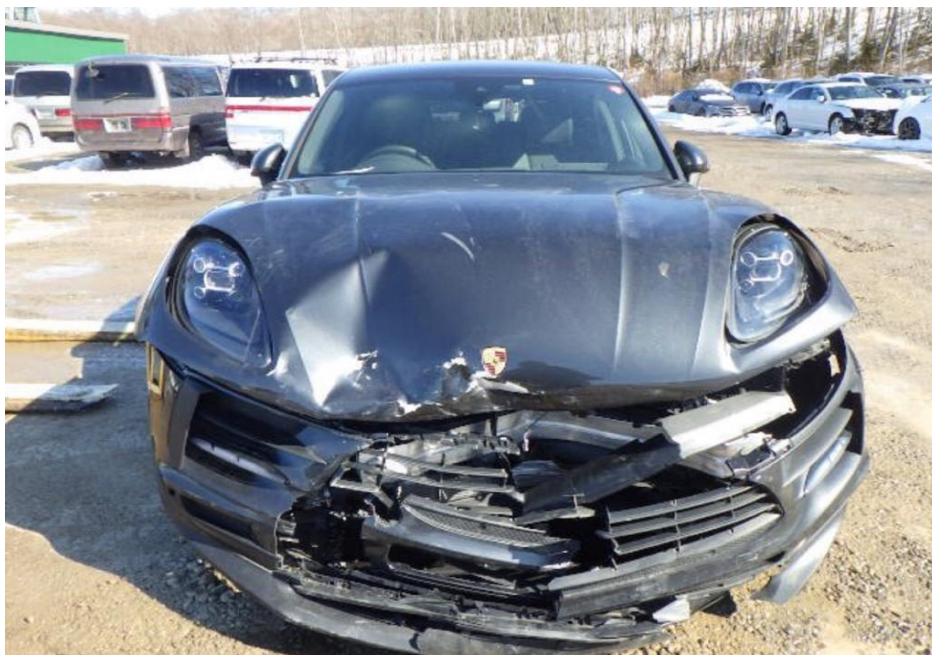
**Photo 3** shows the frontal portion of the Motor Car prior to any repairs being carried out (photograph provided to me). The front bonnet, front bumper, front bumper lower grille, front bumper reinforcement and front grille were amongst the body parts that were observed to have been damaged.

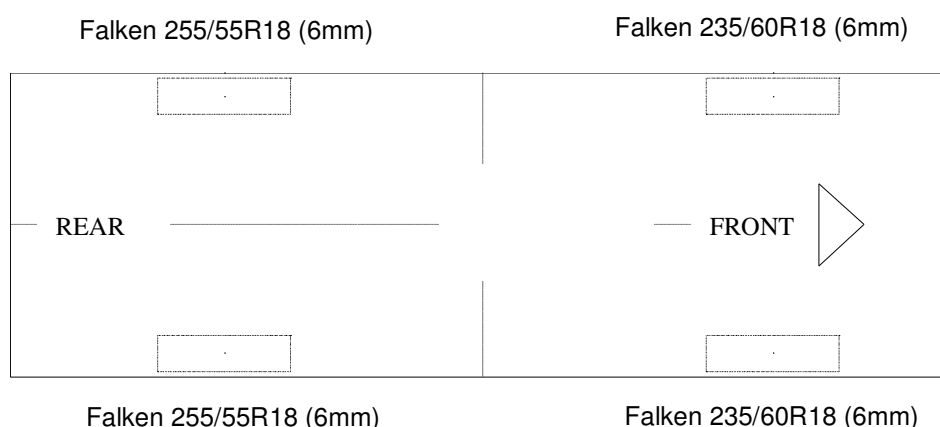
7. It was fitted with 18inch sport wheel rims that were wrapped with tyres that were observed to be of serviceable condition. The tyres were also sufficiently inflated for vehicular operation. The tyre brand, tyre size and approximate remaining tread depth of the 4 tyres of the Motor Car were recorded as follows: -

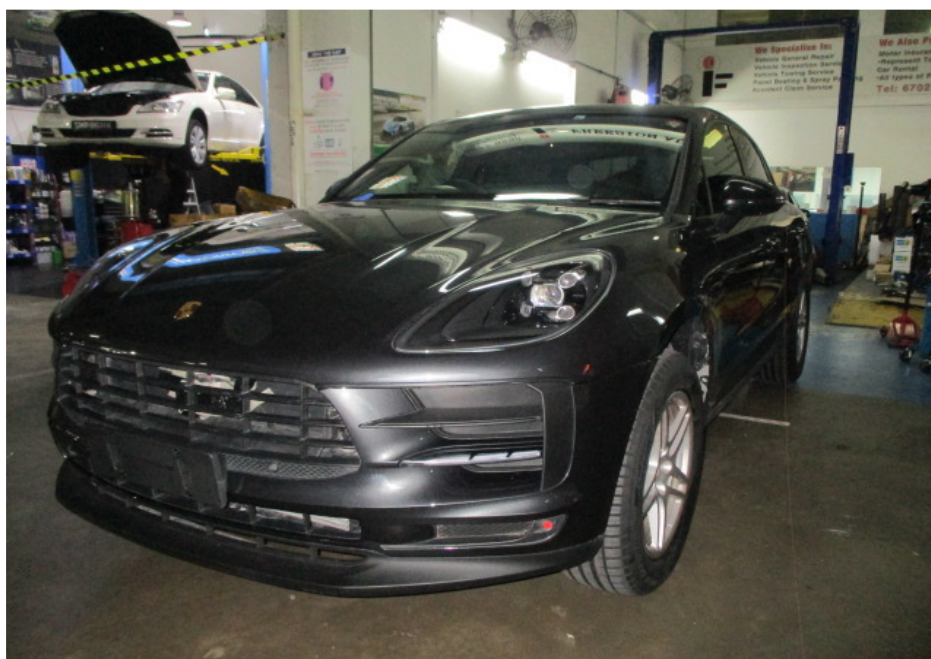
**Photo 4** shows a general view of the front left body of the Motor Car at the time of my inspection. The Motor Car was observed to be in relatively good general condition with no loose exterior fittings observed. The body parts at the frontal portion of the Motor Car were visually examined and it was observed that the repair/restoration works carried out to the damaged area of the Motor Car (refer to photograph 1 – 3 above) were reasonably adequate and in order.

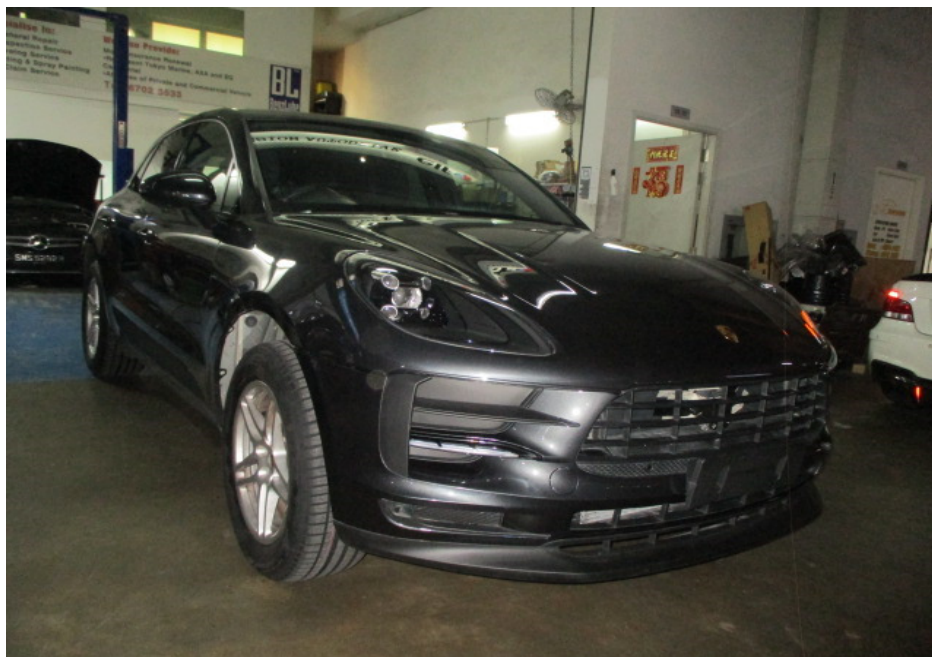
**Photo 5** shows a general view of the front right body of the Motor Car at the time of my inspection. The Motor Car was observed to be in relatively good general condition with no loose exterior fittings observed. The body parts at the frontal portion of the Motor Car were visually examined and it was observed that the repair/restoration works carried out to the damaged area of the Motor Car (refer to photograph 1 – 3 above) were reasonably adequate and in order.

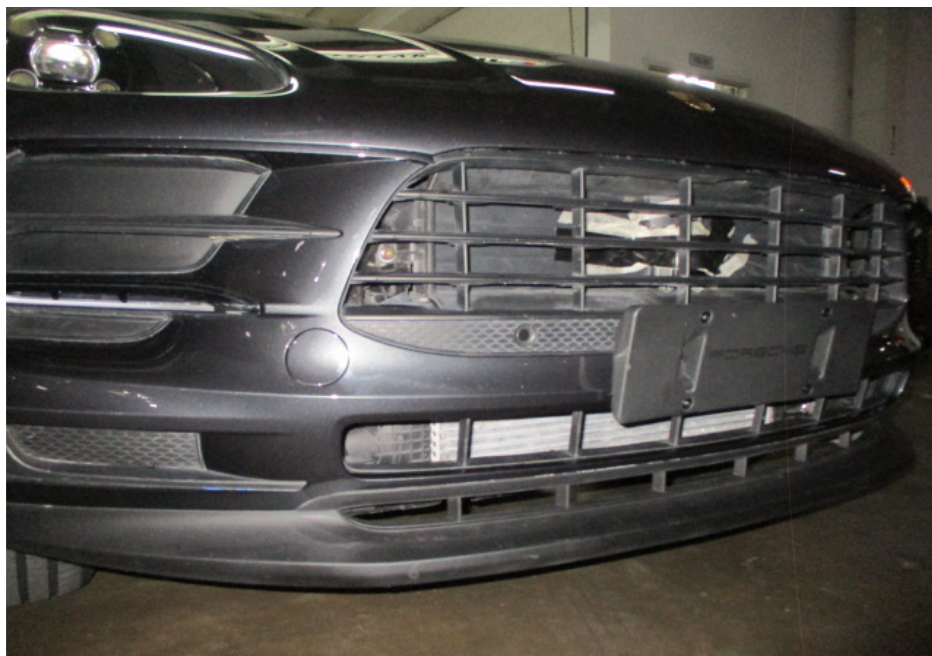
**Photo 6** shows a general view of the front lower portion of the Motor Car at the time of my inspection. The body parts at the frontal portion of the Motor Car were visually examined and it was observed that the repair/restoration works carried out to the damaged area of the Motor Car (refer to photograph 1 – 3 above) were reasonably adequate and in order.

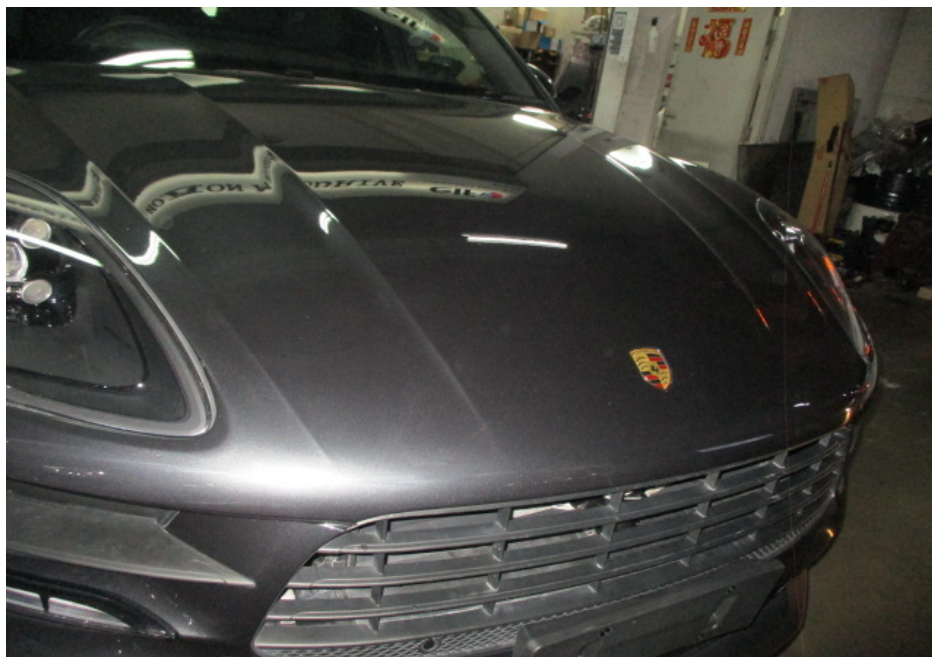
**Photo 7** shows the front bonnet and front grille of the Motor Car. The body parts at the frontal portion of the Motor Car were visually examined and it was observed that the repair/restoration works carried out to the damaged area of the Motor Car (refer to photograph 1 – 3 above) were reasonably adequate and in order.

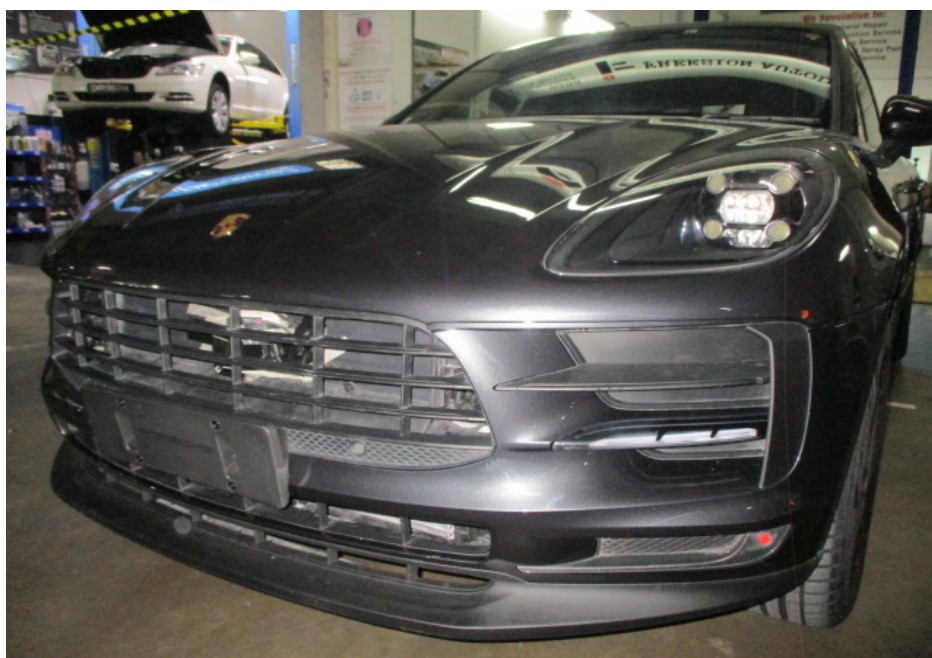
**Photo 8** shows a general view of the front lower portion of the Motor Car at the time of my inspection. The body parts at the frontal portion of the Motor Car were visually examined and it was observed that the repair/restoration works carried out to the damaged area of the Motor Car (refer to photograph 1 – 3 above) were reasonably adequate and in order.

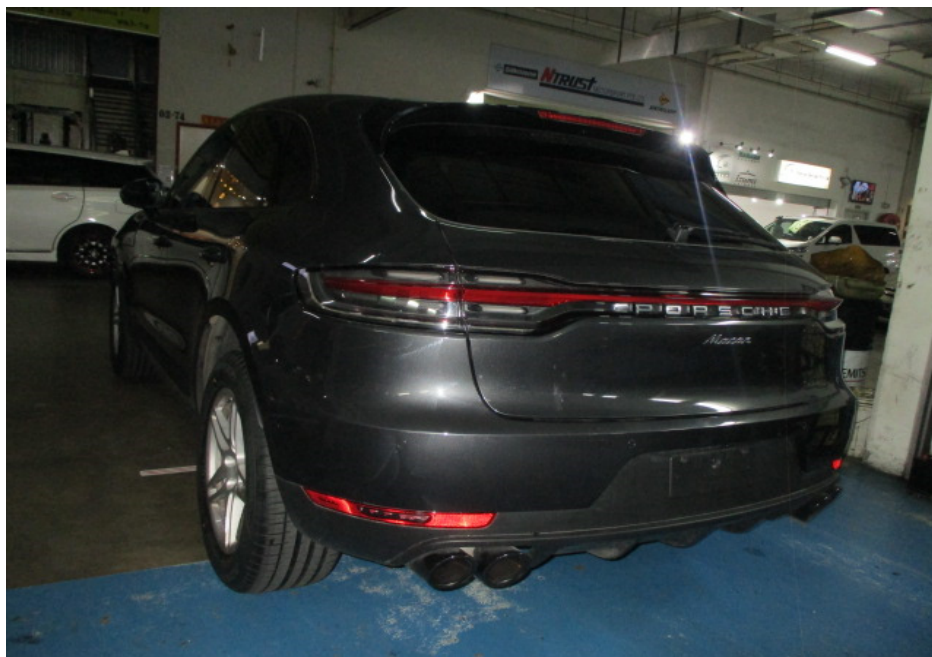
**Photo 9** shows a general view of the rear left body of the Motor Car at the time of my inspection. The Motor Car was observed to be in relatively good general condition with no loose exterior fittings observed. The mileage of the Motor Car recorded at the time of my inspection was 5,980km.

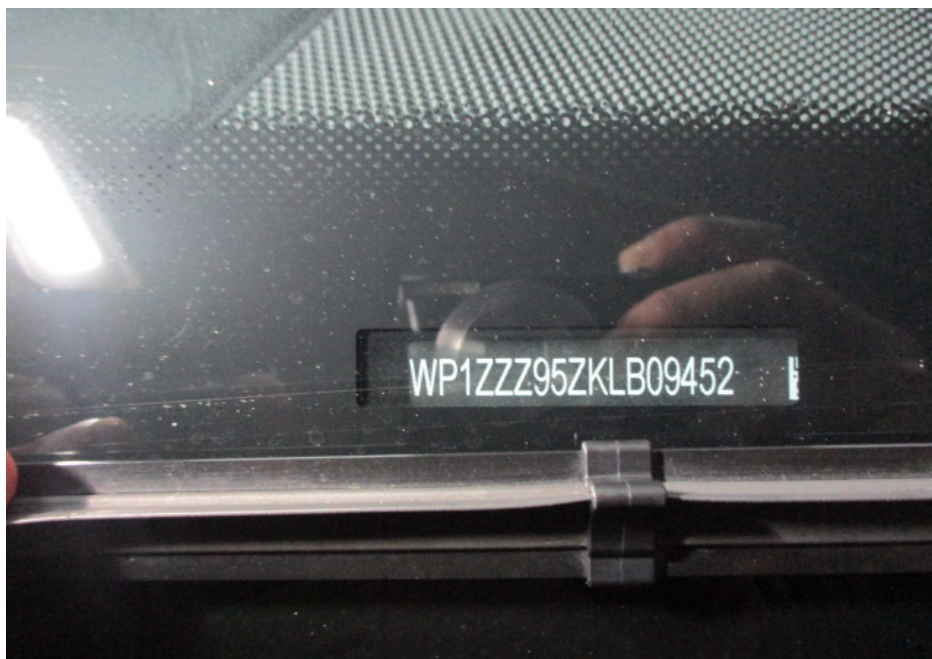
**Photo 10** shows the chassis number of the Motor Car. The chassis number recorded was WP1ZZZ95ZKLB09452.

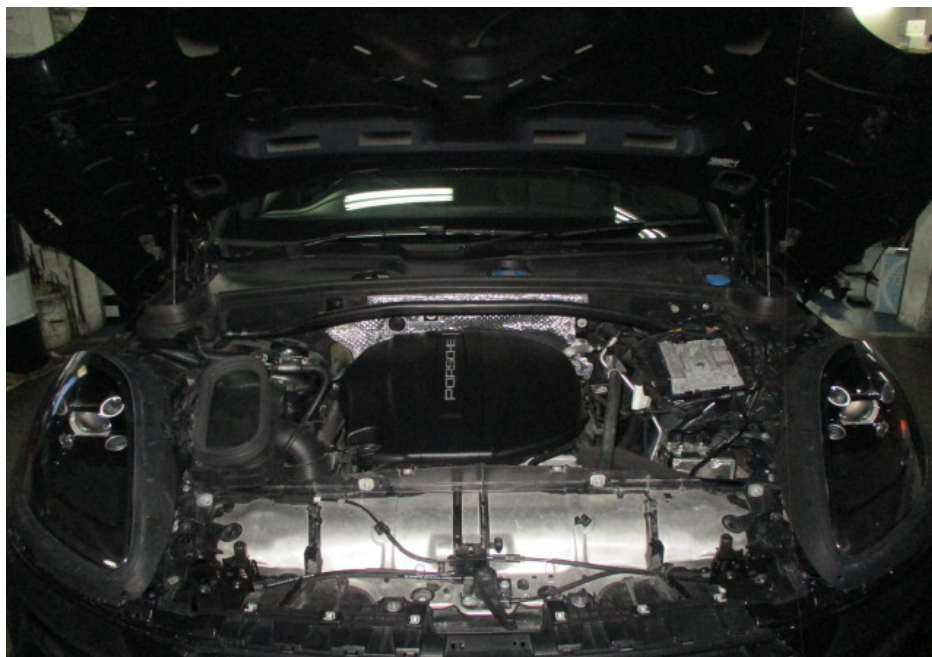
**Photo 11** shows a general view of the engine compartment of the Motor Car at the time of my inspection. The various parts and components inside the engine compartment were all observed to be intact and properly fitted. There was also no sign(s) or indication(s) of fluid leak and/or fluid stain found inside the engine compartment.

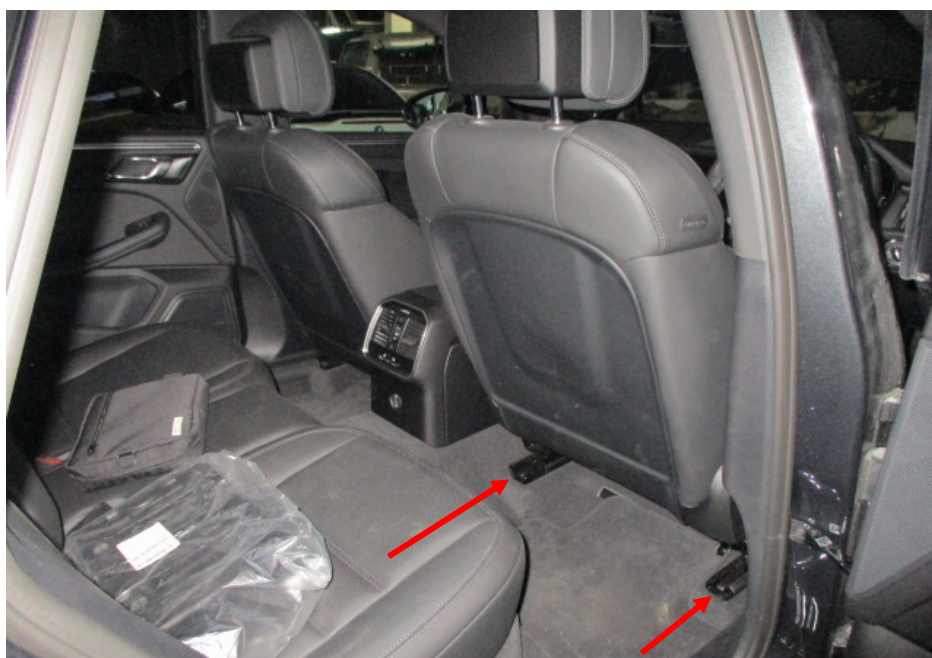
**Photo 12** shows the seats of the Motor Car, which were secured via seat rails (arrowed) to the floorboard. All the seats of the Motor Car were fitted with a retractable seat belt reel and pre-tensioner. The seat belts were also able to be fastened into the respective pre-tensions that were fitted on the side of each individual seat.

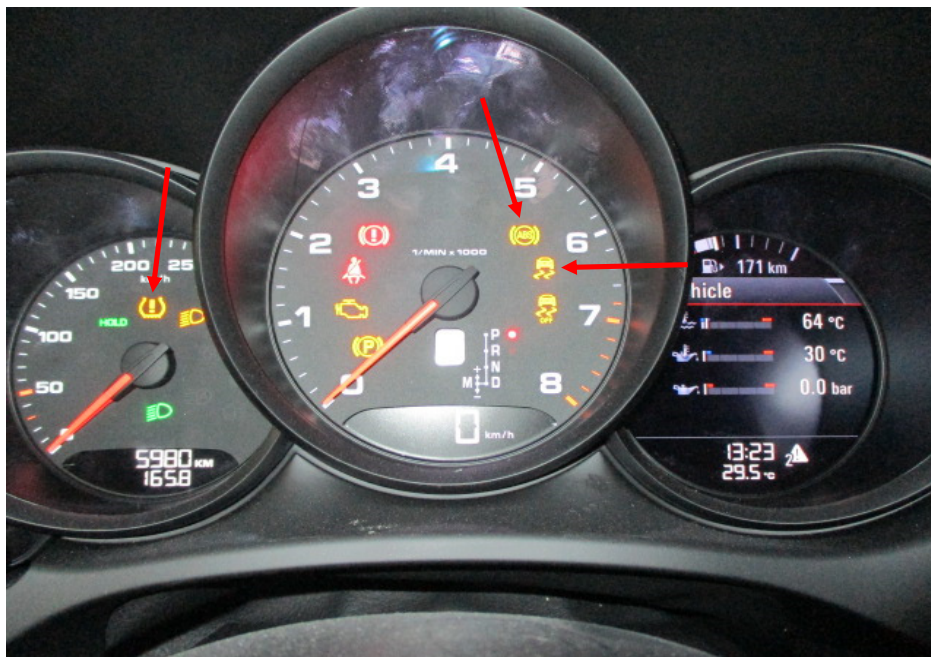
**Photo 13** shows the warning lights for the various electronic safety features appearing on the instrument panel of the Motor Car during its self-test when the engine is cranked, in particular the ABS, SRS, TPM and TCS lights (arrowed).

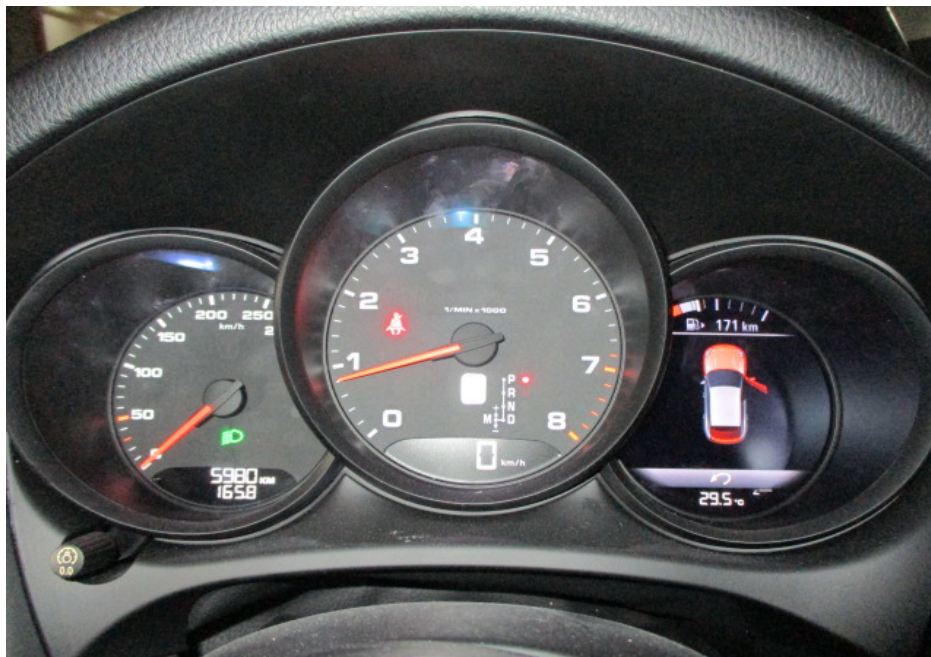
**Photo 14** shows the respective warning lights no longer illuminated after the engine was started, indicating that there was no fault detected to the ABS, SRS, TPM and TCS systems of the Motor Car during the self-test. These electronic systems were hence in working condition at the time of my inspection.

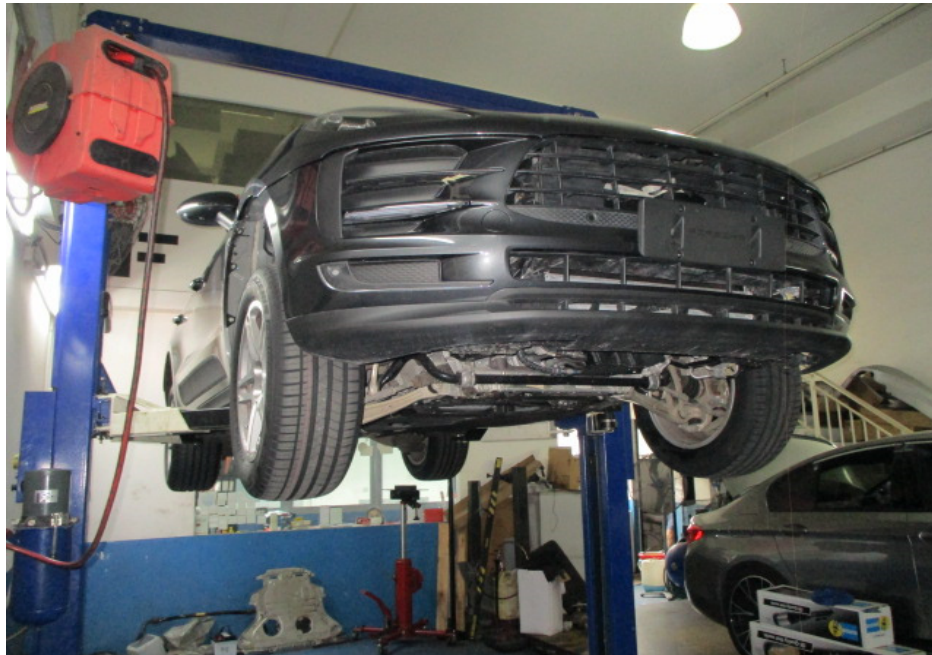
**Photo 15** shows the Motor Car hoisted up for checks on its undercarriage. There was no sign(s) or indication(s) of fluid leakage and/or fluid stain(s) on the underside of the Motor Car. The undercarriage components of the Motor Car were also all observed to be intact and secured in an appropriate manner.

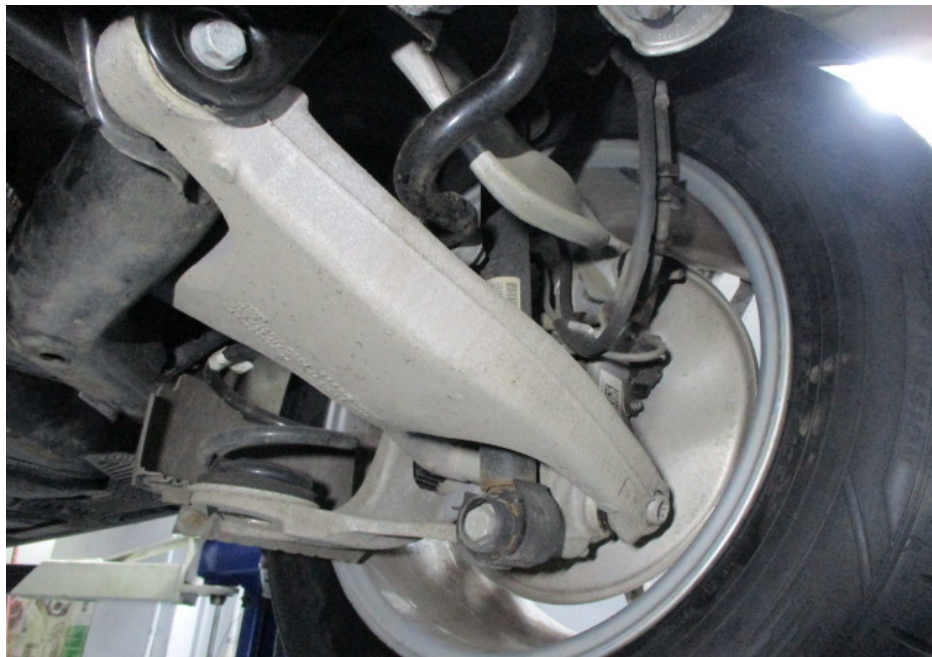
**Photo 16** shows a general view of the control arms and linkages at the rear right wheel of the Motor Car. I did not observe any fluid leak and/or fluid stain on the underside of the Motor Car. All of the Motor Car's undercarriage components were observed to be intact and secured in an appropriate manner.

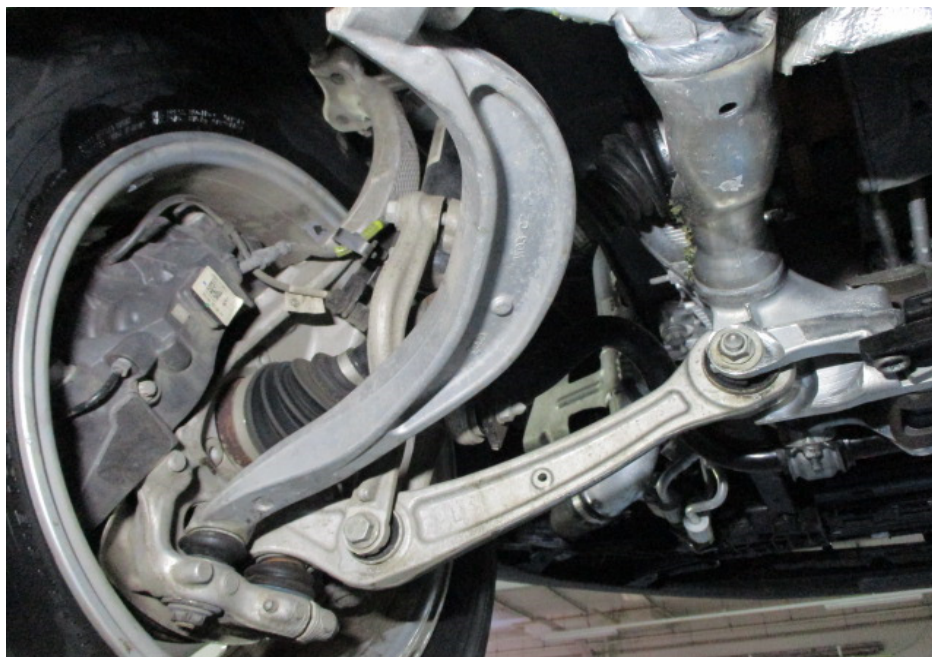
**Photo 17** shows the various undercarriage components at the front left wheel of the Motor Car. The mechanical components, control arms and linkages were all found to be intact and secured in an appropriate manner.

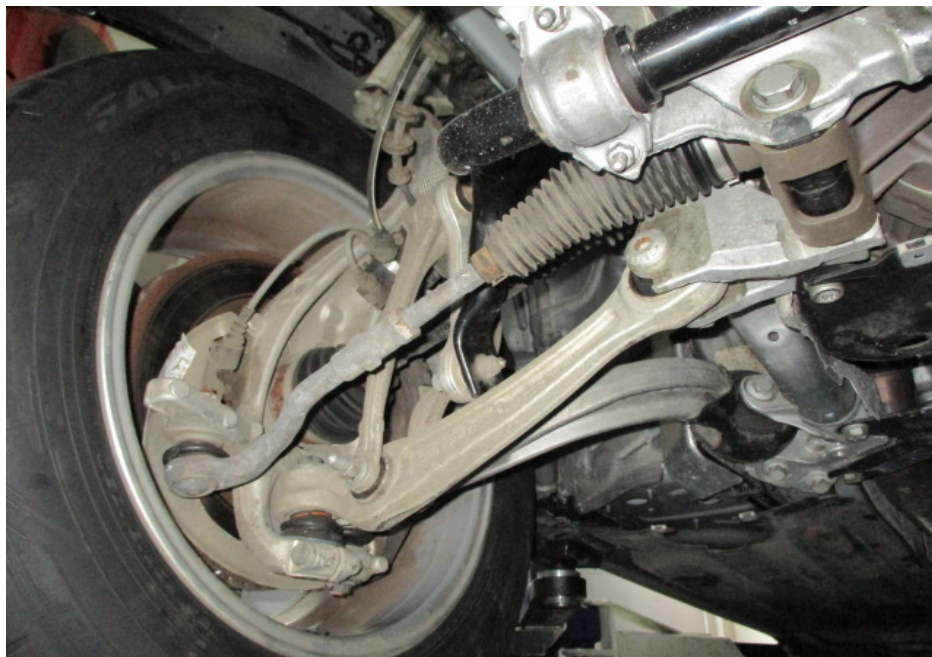
**Photo 18** shows the various undercarriage components at the front right wheel of the Motor Car. The mechanical components, control arms and linkages were all found to be intact and secured in an appropriate manner. I did not observe any fluid leak and/or fluid stain on the underside of the Motor Car.

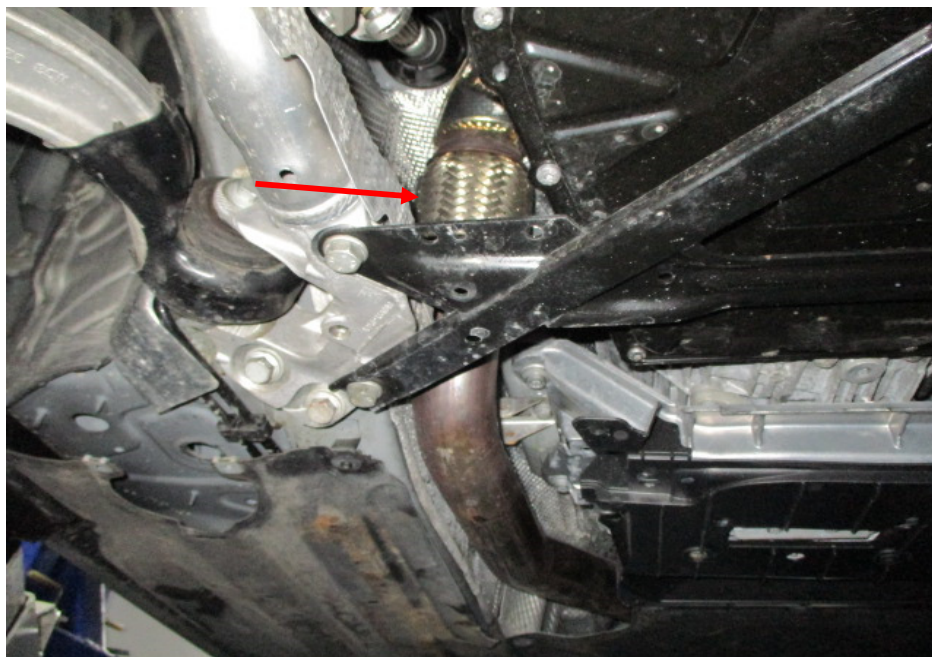
**Photo 19** shows the Motor Car's catalytic converter (arrowed). My examination of the Motor Car's exhaust system revealed no sign(s) or indication(s) of any cut or weld marks along its exhaust pipes and on its rear mufflers.

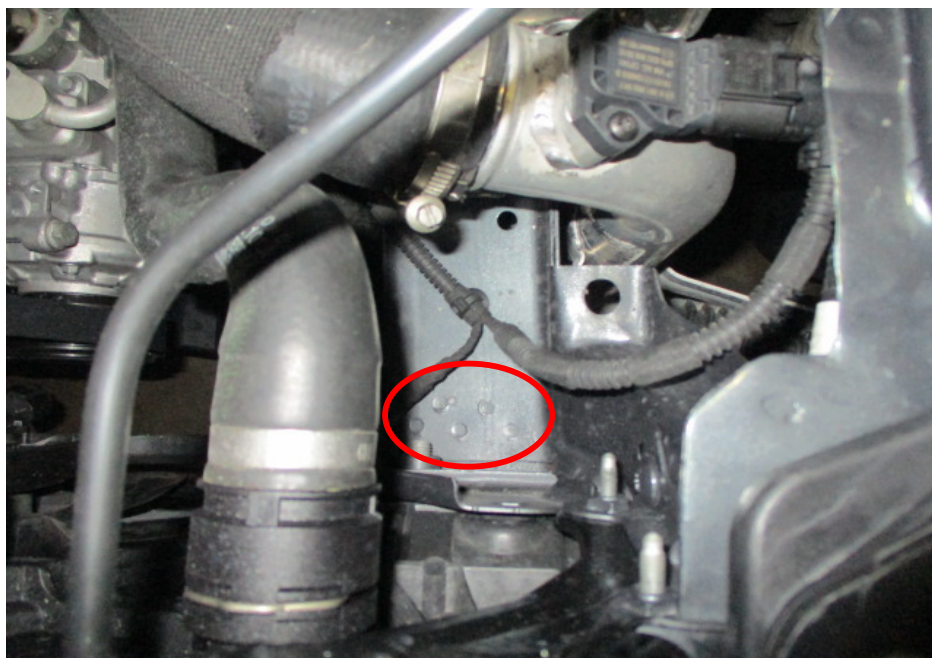
**Photo 20** shows the chassis/structural body at the front left of the Motor Car (as viewed from the engine compartment). This was at the section where the front left member joins the front left chassis. I did not find any weld marks other than original spot weld marks (circled) on the chassis/structural body of the Motor Car, indicating no work was done on the chassis/structural body of the Motor Car and that the chassis/structural body was originally fitted.

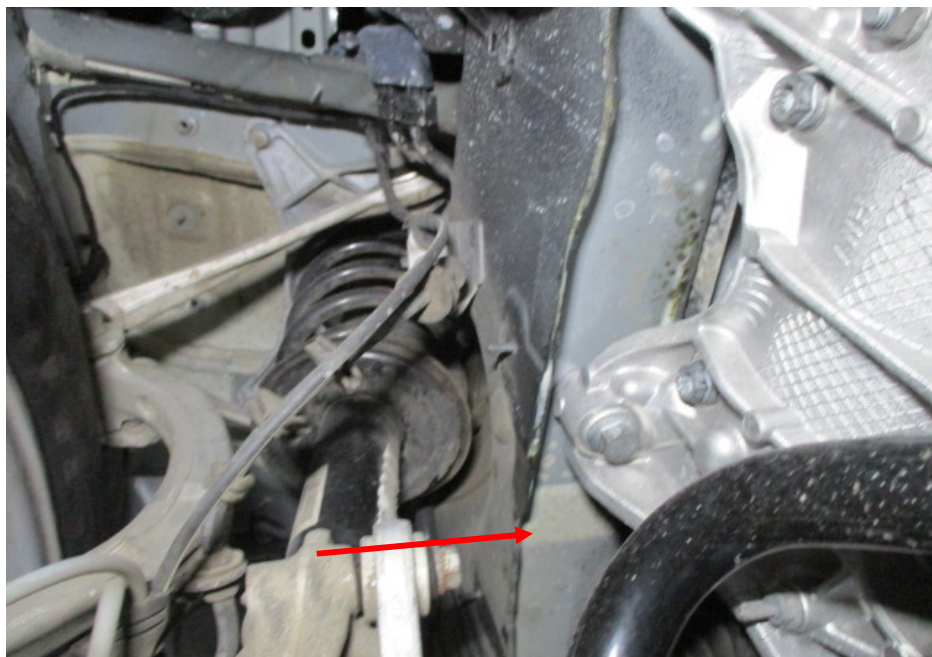
**Photo 21** shows the chassis/structural body at the underside front right of the Motor Car. Visually, I did not find any weld marks other than original spot weld marks on the chassis/structural body of the Motor Car. The original factory sealant (arrowed) at the joints along the chassis/structural body was also untouched, indicating no work was done on the chassis/structural body of the Motor Car and that the chassis/structural body was originally fitted.
