## LKK Auto Consultants Pte Ltd

Vehicle No. SLT 6619D  
Insured Veh. YN 477M  
Claim No. 19/20/20/VC00/023559  
Policy No. Z/19/VC00/104602  
Accident Date 20/08/2020  
Inspection Date 21/08/2020

## ADJUSTMENT ON REPAIR COST FOR VEHICLE NO. SLT 6619D

PHOTOGRAPHS FOR VEHICLE NO. SLT 6619D

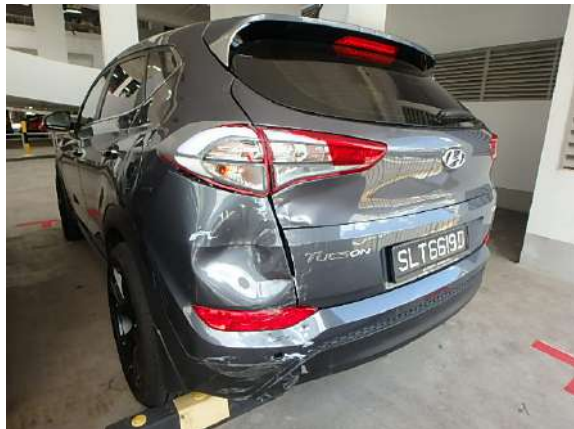
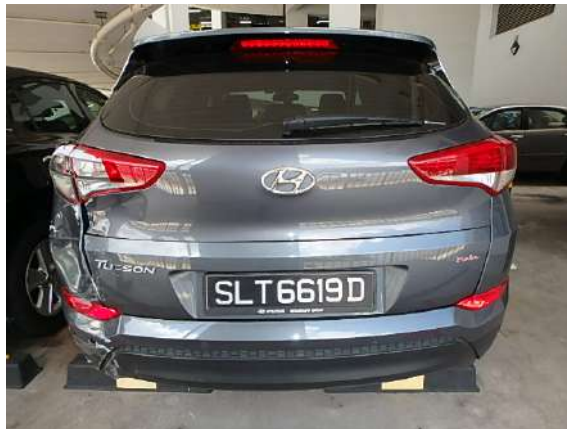
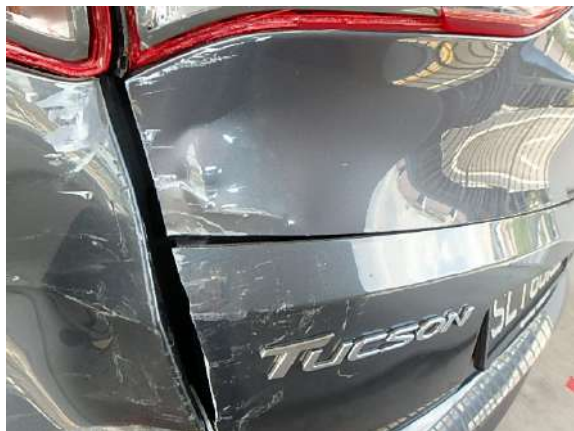
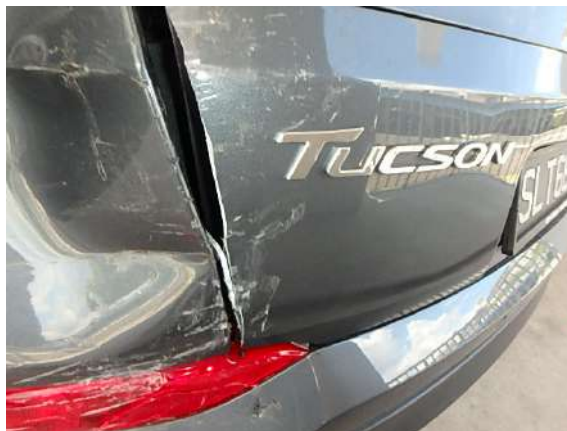
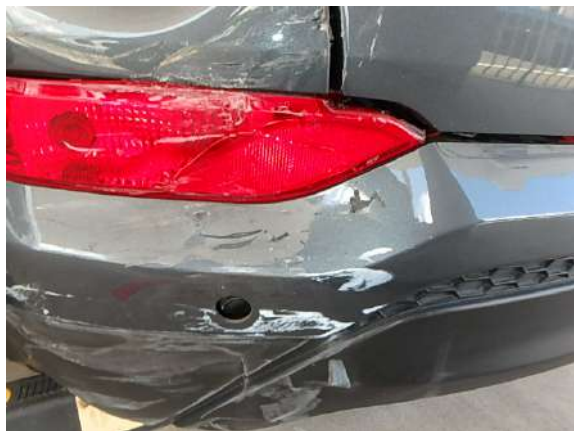
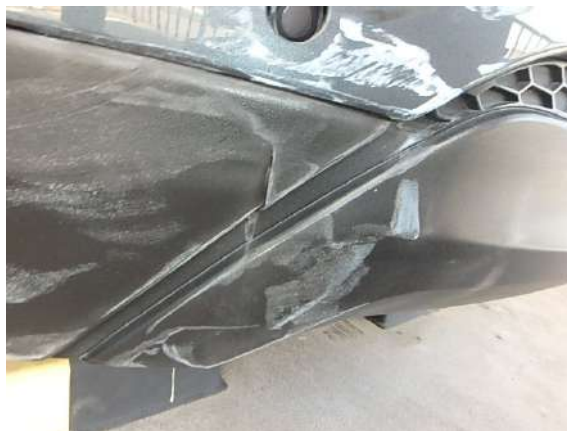
INSPECTION

| Affiliated to Federation Internationale Des Experts En Automobile | | | | |
|---|---|---|---|--|
| THE VEHICLE SUSTAINED DAMAGES AT THE REAR N/S PORTION.<br>DAMAGES SEE DETAILS. | | | | |
