### **ACCIDENT DAMAGED VEHICLE INSPECTION REPORT (WITHOUT PREJUDICE)**

| Registration Number | : SKA 7103 E | Mileage | : 164,980 km |
| Make & Model | : Toyota Wish 1.8X A | Chassis Number | : ZGE200008634 |

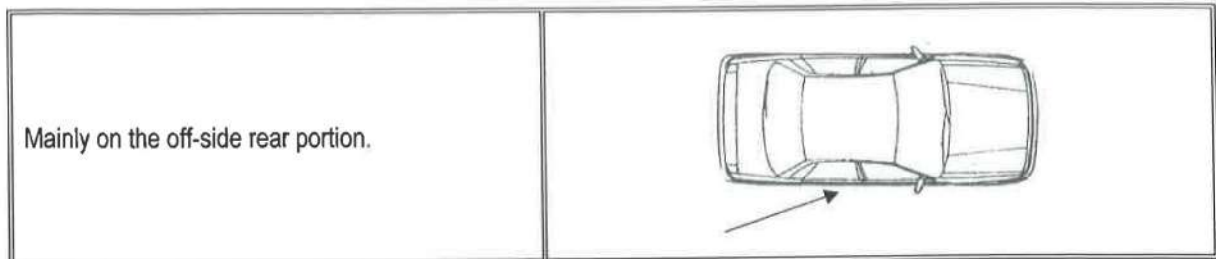
**(5) POINT OF IMPACT**

The impact of the collision has damaged/affected the right rear door, right rocker garnish and etc.
