Our Ref : 19/0019/TP
Your Ref : Not Advised

ACCIDENT DAMAGED VEHICLE INSPECTION REPORT (WITHOUT PREJUDICE)

Registration Number	: SKA 7103 E	Mileage	: 164,980 km
Make & Model	: Toyota Wish 1.8X A	Chassis Number	: ZGE200008634
Date of Registration	: 25 March 2011	Engine Number	: 2ZR0428472
Colour	: Black	Engine Capacity	: 1,797 cc

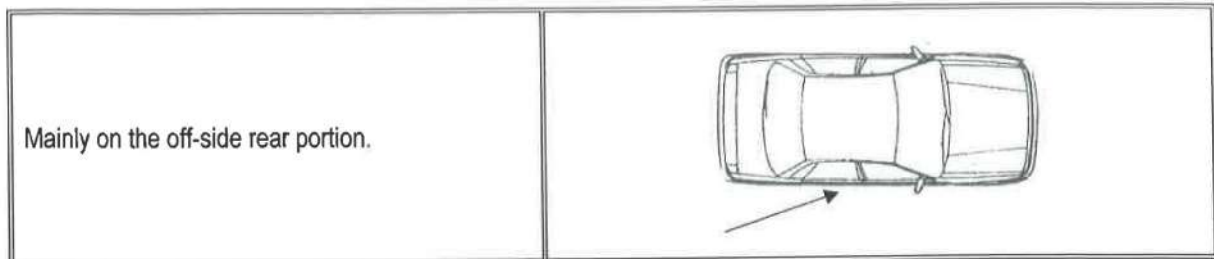
(5) POINT OF IMPACT

The impact of the collision has damaged/affected the right rear door, right rocker garnish and etc.
