LKK Auto Consultants Pte Ltd

Vehicle No. SMN 9822H
Insured Veh. SGW 1809Z
Claim No. DM20HO01230-JG
Policy No.
Accident Date 21/08/2020
Inspection Date 25/08/2020

ADJUSTMENT ON REPAIR COST FOR VEHICLE NO. SMN 9822H

PHOTOGRAPHS FOR VEHICLE NO. SMN 982ZH

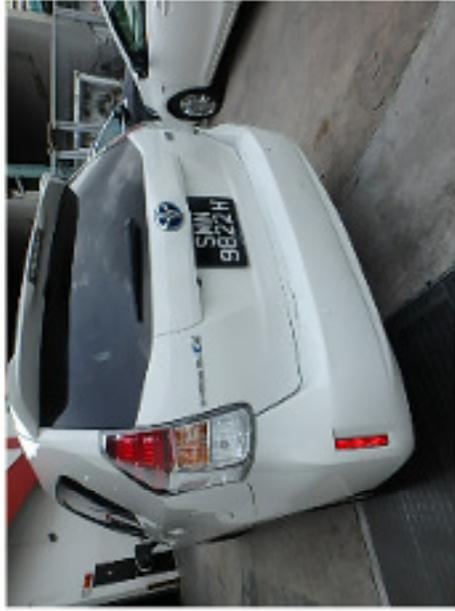
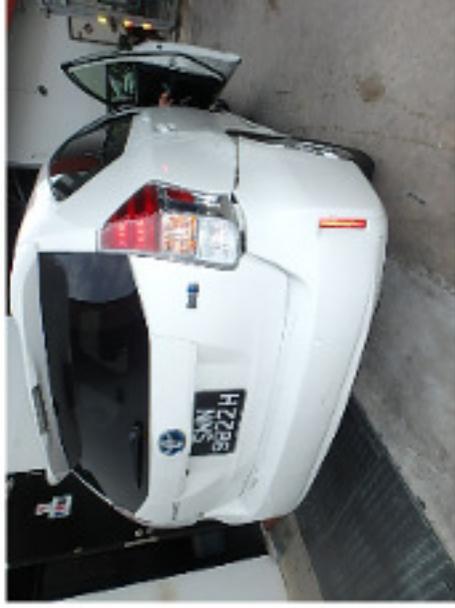
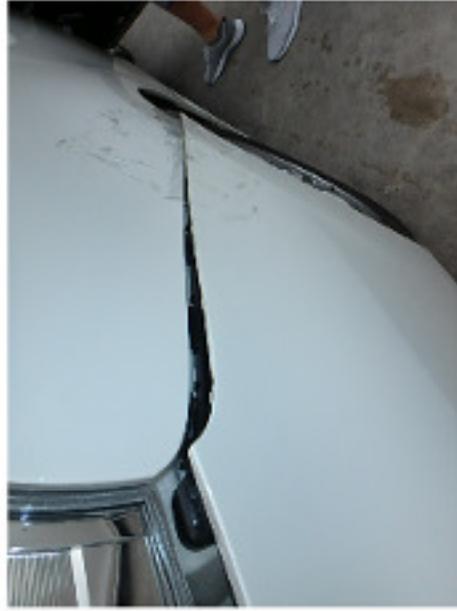
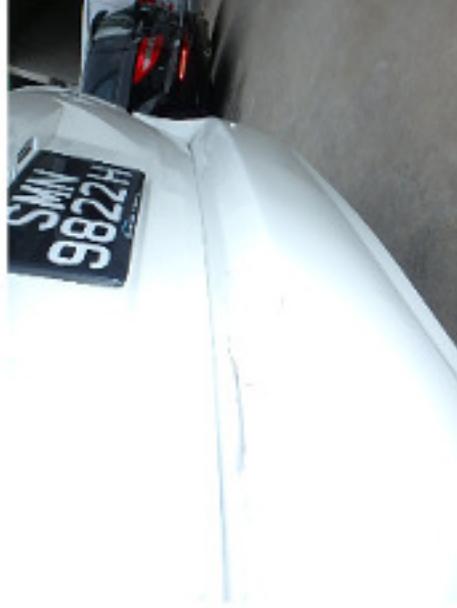
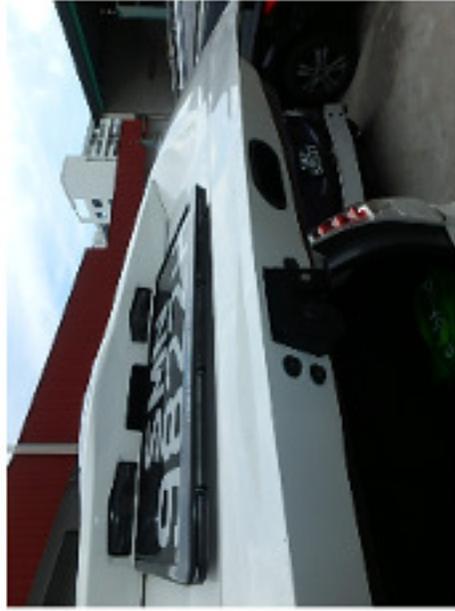
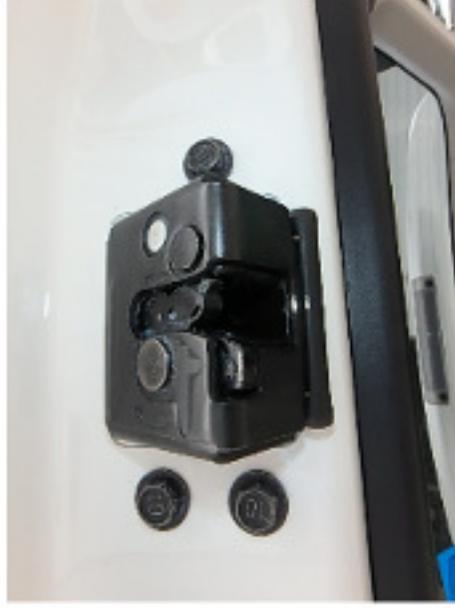
INSPECTION

THE VEHICLE SUSTAINED DAMAGES AT THE REAR PORTION.
DAMAGES SEE DETAILS.
