ASSIGNMENT

MT/1101115-003

SHA 5789A

REPAIR ESTIMATE

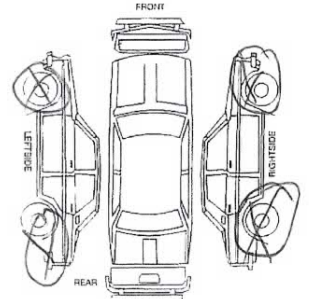
2. <input type="checkbox"/> New <input type="checkbox"/> SPARK Kakis Name of Customer : <u>Mr. Lim</u> Contact No. : <u>96971515</u> Vehicle No. : <u>SHA5789A</u> Make / Model / Colour : <u>i-40</u> Email :		5. Nature of Service: <input type="checkbox"/> Jumpstart <input type="checkbox"/> Recovery <input checked="" type="checkbox"/> Change Tyre / Battery	6. Parts Replaced/Remarks: <u>front / Rear Tyre puncture</u> <u>use Kdolly?</u>

: Cracked X : Dented
/ : Scatched O : Missing

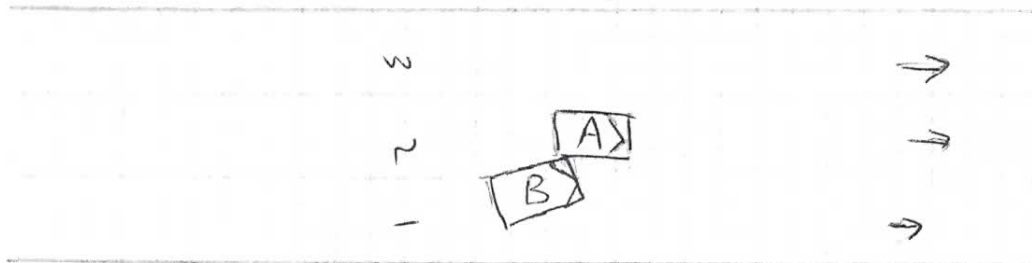
SKETCH PLAN

→ Stetant detached D

Somewhere after the Airport Rd exit, I suddenly felt a big impact from my right.

I went out and found out that a private car, B, had hit my taxi right rear side.

After that, my taxi lost control and my taxi right front was damaged too.
