Your Ref: TP/IP/35401/2020  
Our Ref : CI/TPD20009190/P

12<sup>th</sup> October 2020

**MECHANICAL INSPECTION REPORT OF MOTOR VAN GBB 236C**

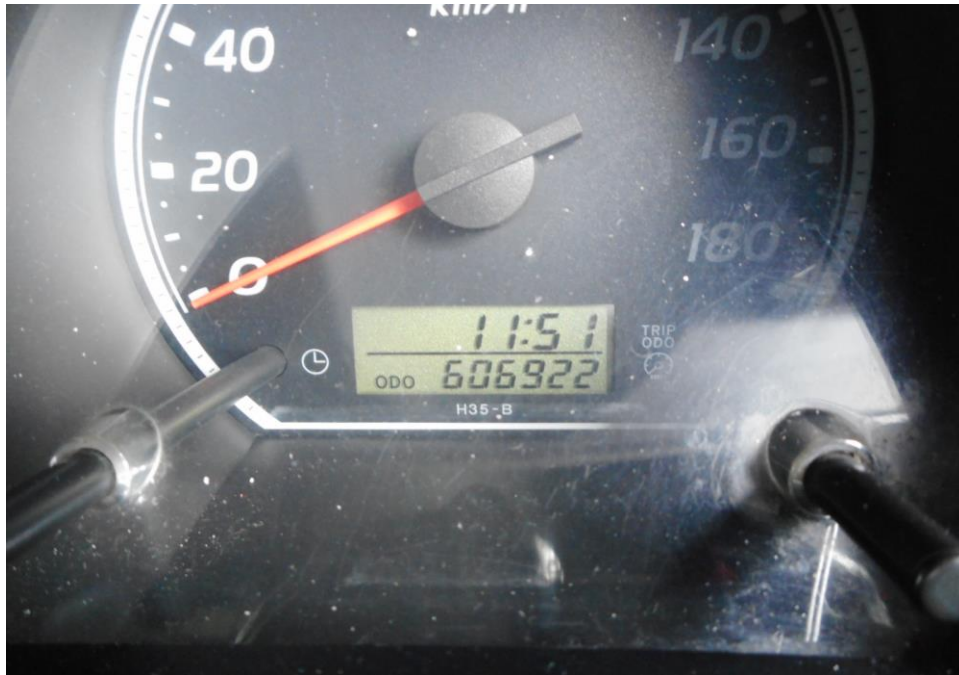
4. The mileage of the Motor Van at the time of my inspection was 606,922km.
5. The Motor Van appeared to have sustained damage at its rear portion. Its rear body panel and rear bumper were damaged at the time of my inspection.

**Photo 1** shows a general view of the instrument cluster of the Motor Van at the time of my inspection. The mileage of the Motor Van was 606,922km

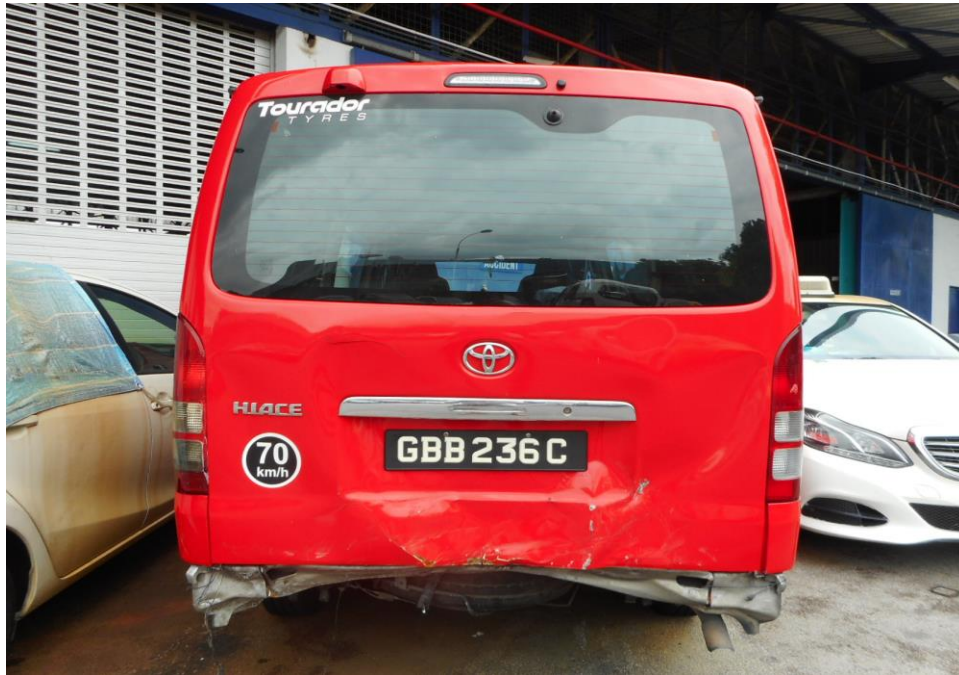
**Photo 2** shows a general view of the Motor Van's rear portion at the time of my inspection. It appeared to have sustained damage at its rear portion. Its rear body panel and rear bumper were damage at the time of my inspection.

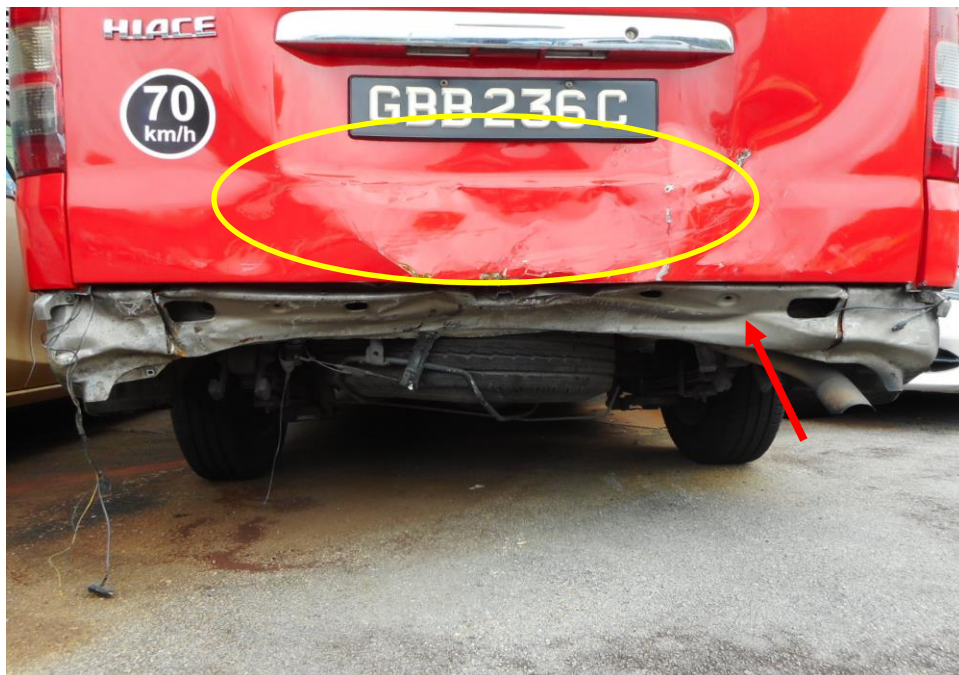
**Photo 3** shows a close up view of the Motor Van's rear portion at the time of my inspection. It appeared to have sustained damage at its rear portion. Its rear body panel (circled) and rear bumper (arrowed) was damage at the time of my inspection as a result of the accident.

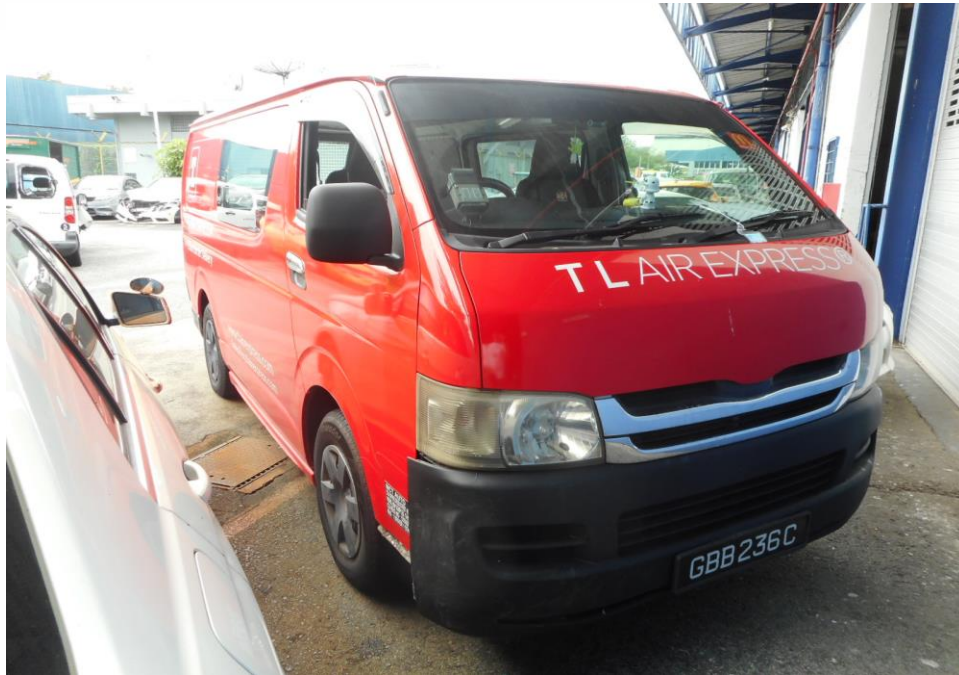
**Photo 4** shows a general view of the right body of the Motor Van at the time of my inspection. The Motor Van was observed to be intact and unaffected by the accident.

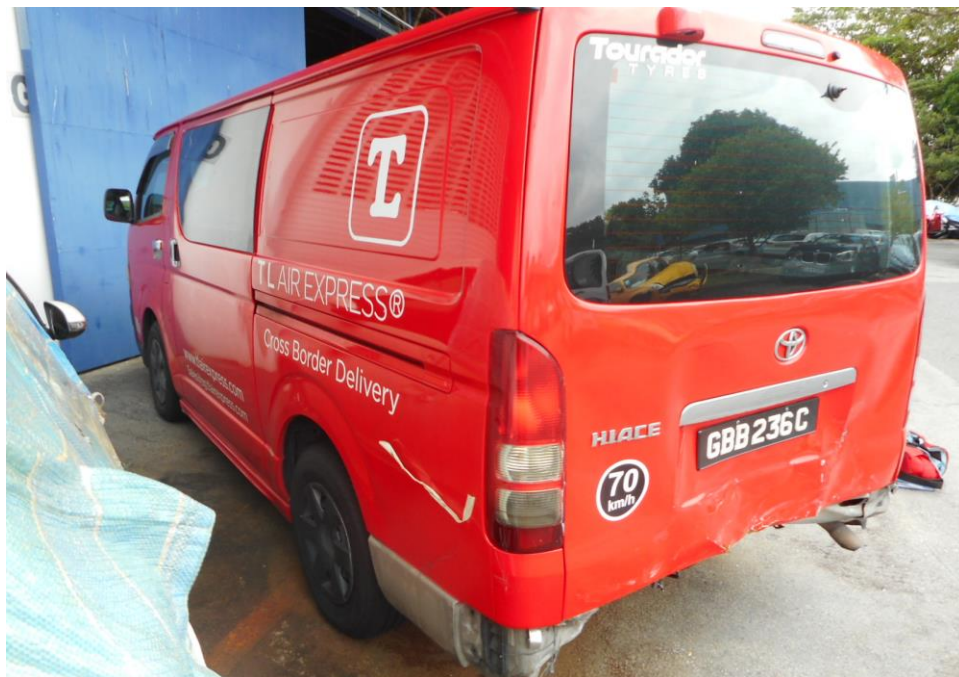
**Photo 5** shows a general view of the left body of the Motor Van at the time of my inspection. The Motor Van was observed to be intact and unaffected by the accident.

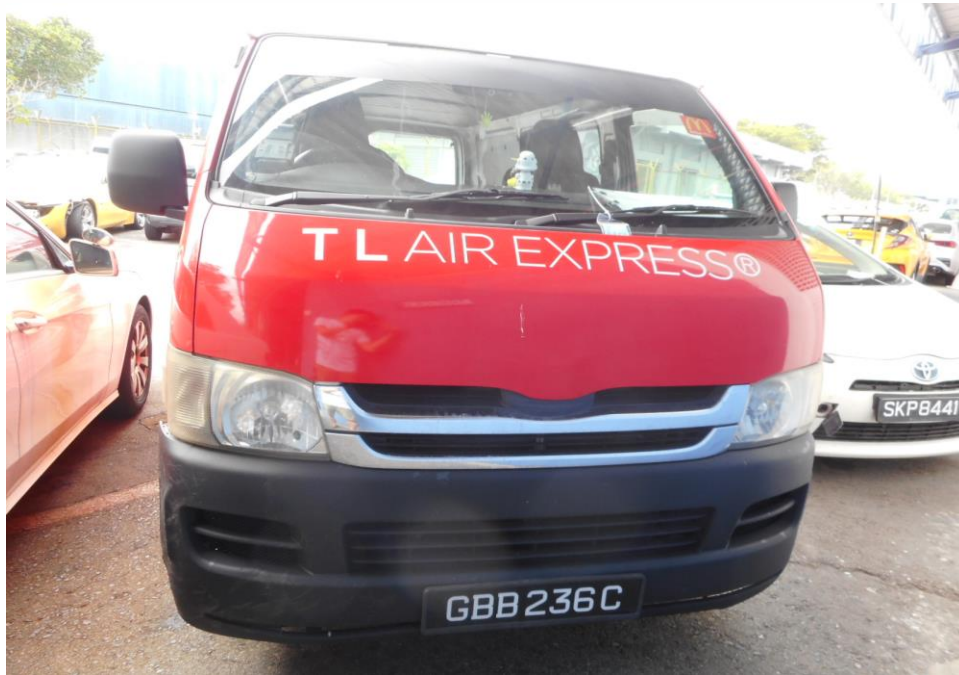
**Photo 6** shows a general view of the front body of the Motor Van at the time of my inspection. The Motor Van was observed to be intact and unaffected by the accident.

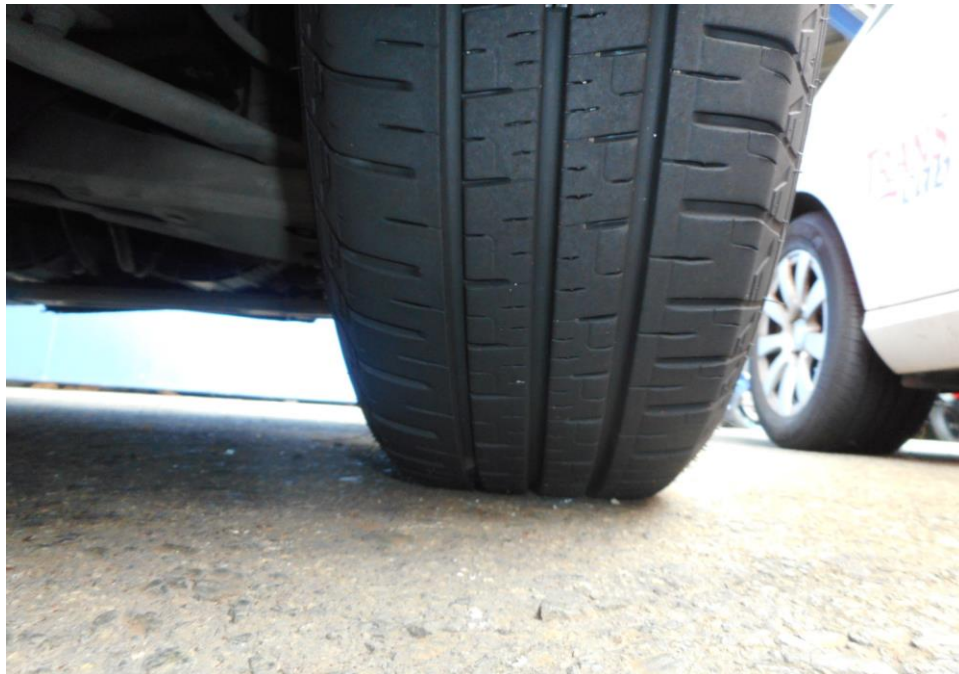
**Photo 7** shows the condition of the front right tyre of the Motor Van, which was observed to be in serviceable condition with remaining tread depth of approximately 6.4mm. The tyre, which was wrapped around standard steel wheel rim, was also observed to be sufficiently inflated for vehicular operation. There was no tear, cut or burst mark(s) on the outer and the inner sidewalls as well as across the tread of the 4 tyres that were fitted on the Motor Van.

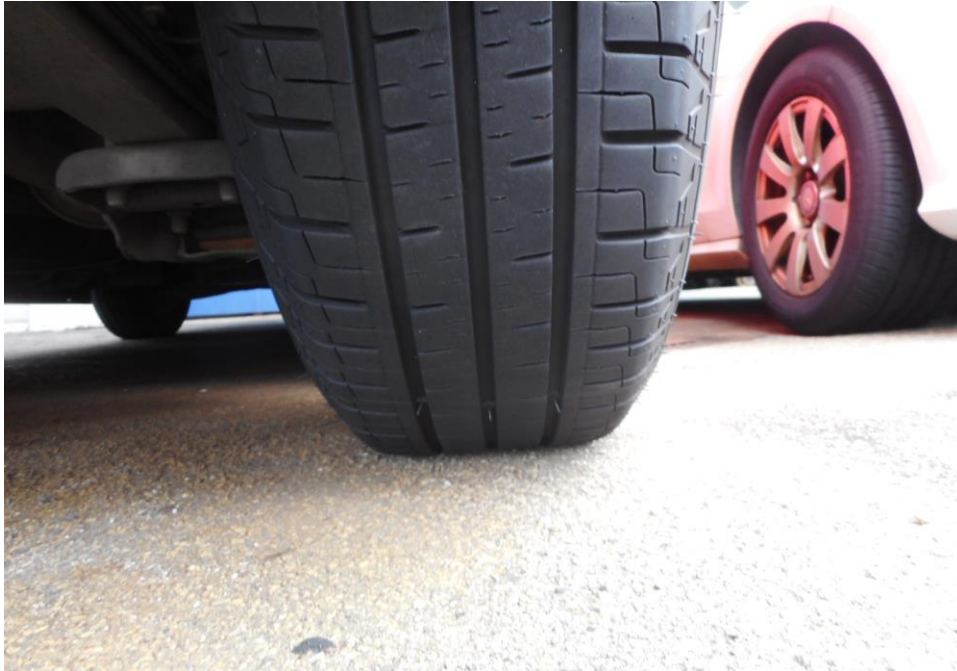
**Photo 8** shows the condition of the rear right tyre of the Motor Van, which was observed to be in serviceable condition with remaining tread depth of approximately 5mm. The tyre, which was wrapped around standard steel wheel rim, it was observed to be sufficiently inflated for vehicular operation.

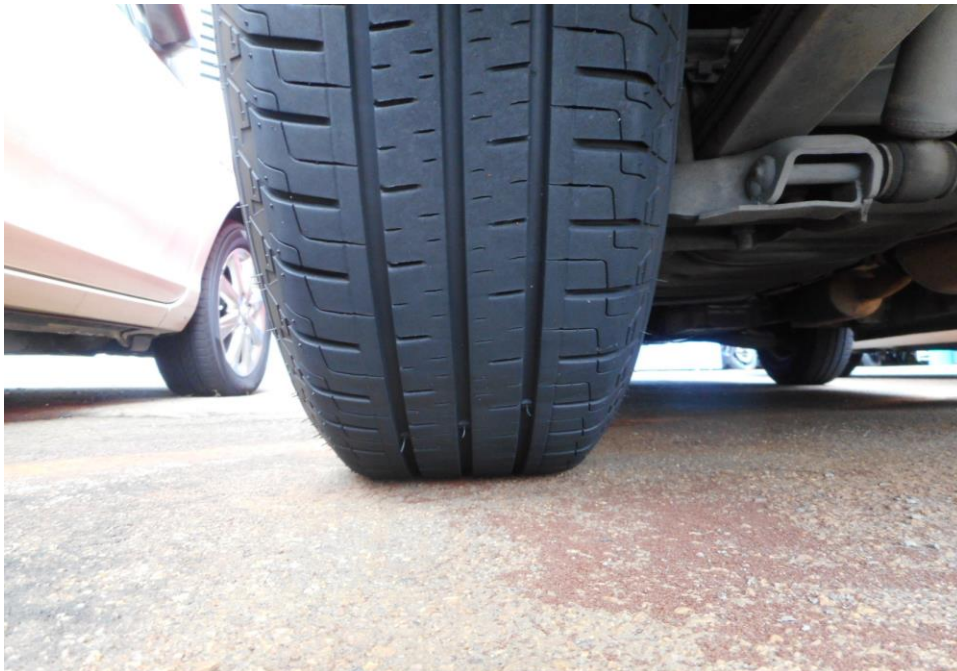
**Photo 9** shows the condition of the rear left tyres of the Motor Van, which was observed to be in serviceable condition with remaining tread depth of approximately 4.5mm. The tyres, which were wrapped around standard steel wheel rim, were also observed to be sufficiently inflated for vehicular operation. There was also no damage found on all 4 steel wheel rims of the Motor Van.

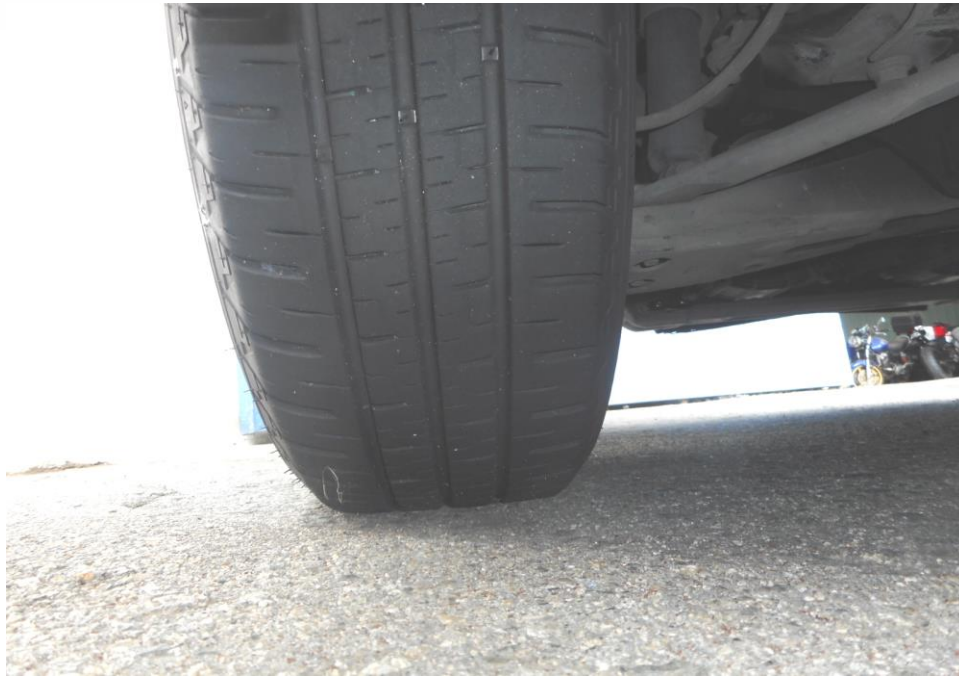
**Photo 10** shows the condition of the rear right tyres of the Motor Van, which were observed to be in serviceable condition with remaining, tread depth of approximately 6.2mm. There was also no tear, cut or burst mark(s) on the outer and the inner sidewalls as well as across the tread of the 4 tyres that were fitted on the Motor Van.

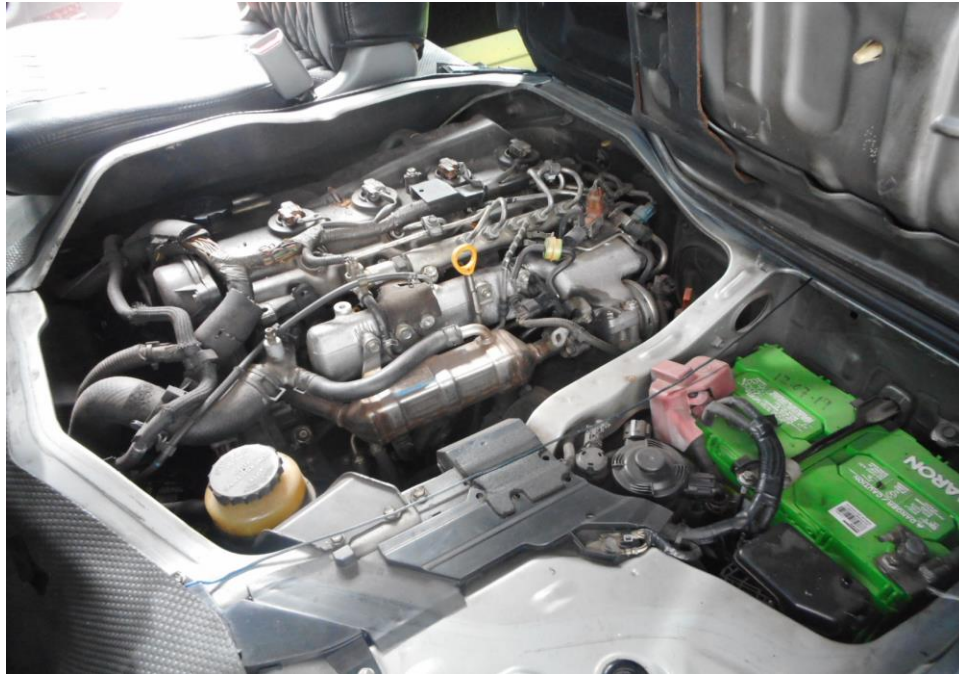
**Photo 11** shows a general view of the Motor Van's engine compartment, which was accessed by lifting the front cabin of the Motor Van. The various parts and components inside the engine compartment were unaffected by the accident. There was also no sign(s) or indication(s) of fresh fluid leakage and/or fluid stain within the engine compartment

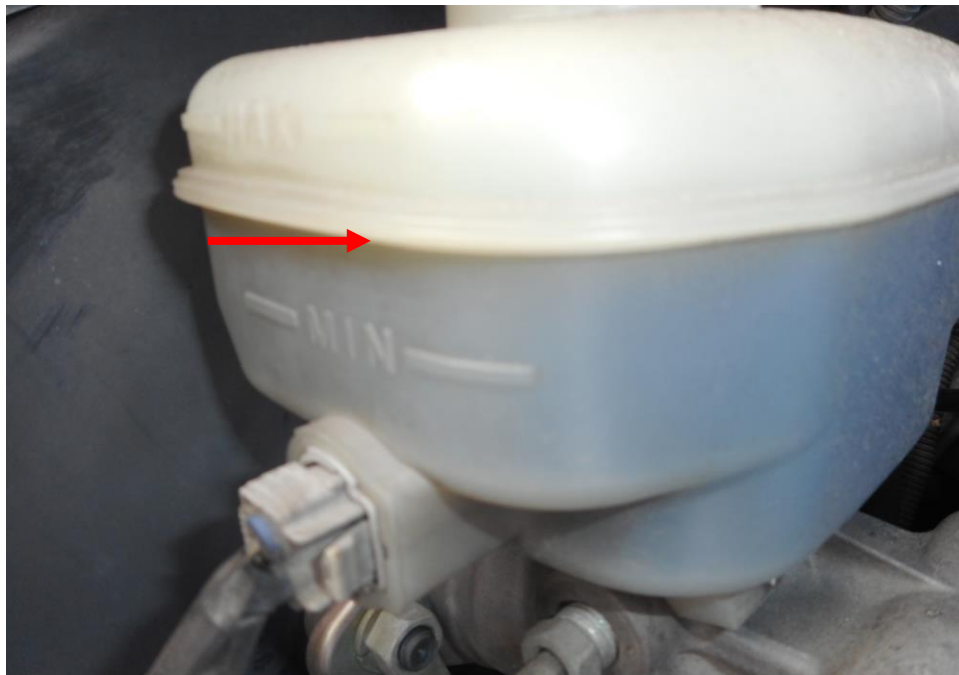
**Photo 12** shows the brake fluid reservoir of the Motor Van at the time of my inspection. The brake fluid was observed to be of sufficient level (arrowed) and without any visible contamination.

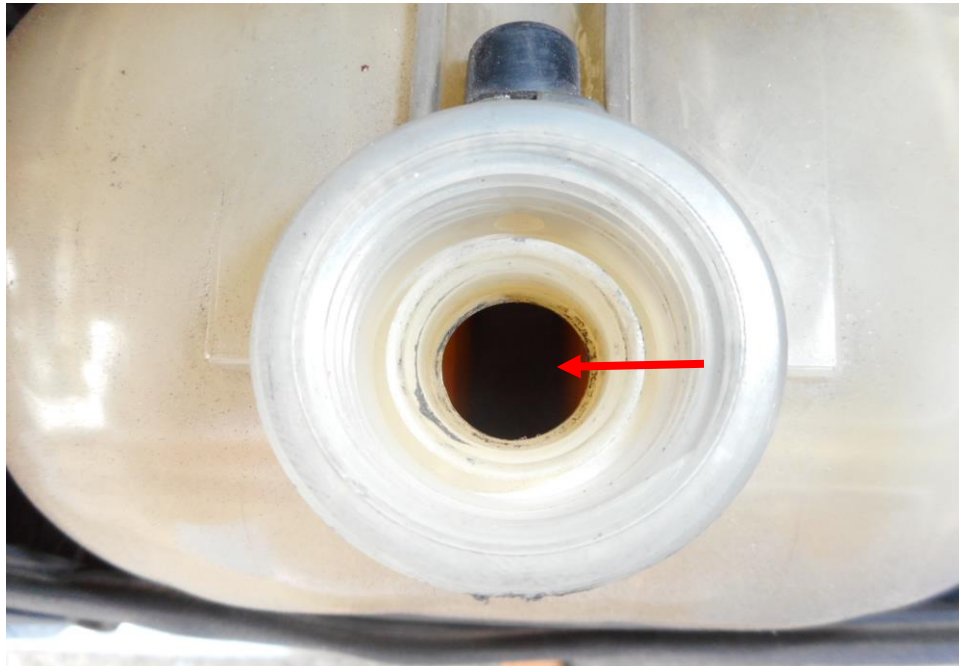
**Photo 13** shows the engine coolant reservoir of the Motor Van at the time of my inspection. The engine coolant was observed to be of sufficient level (arrowed) and without any visible contamination.

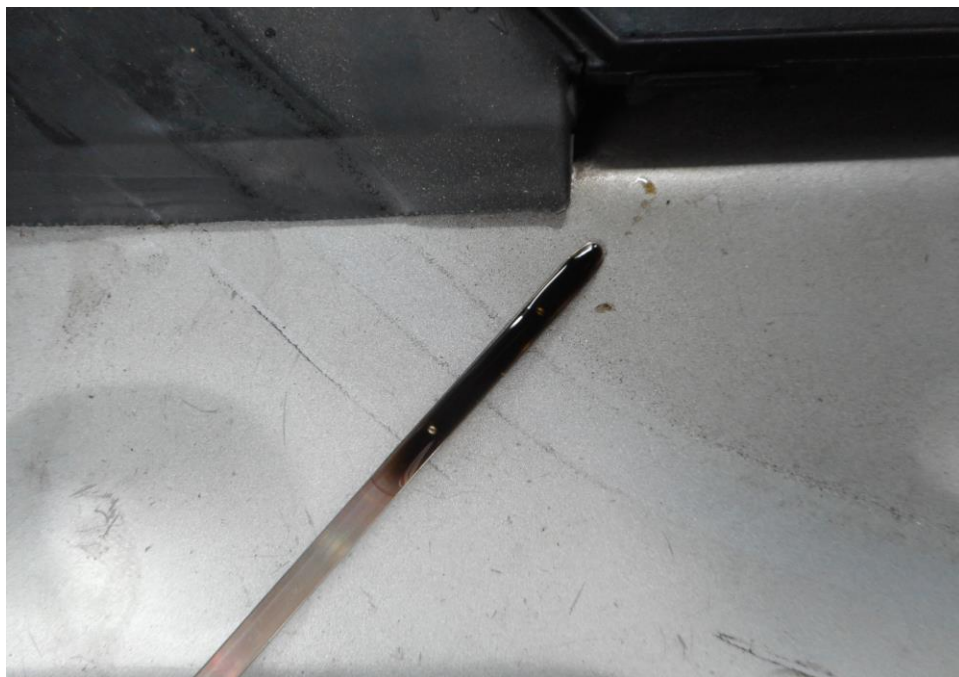
**Photo 14** shows the engine oil dip stick of the Motor Van at the time of my inspection. The engine oil was observed to be of sufficient level and without any visible contamination.

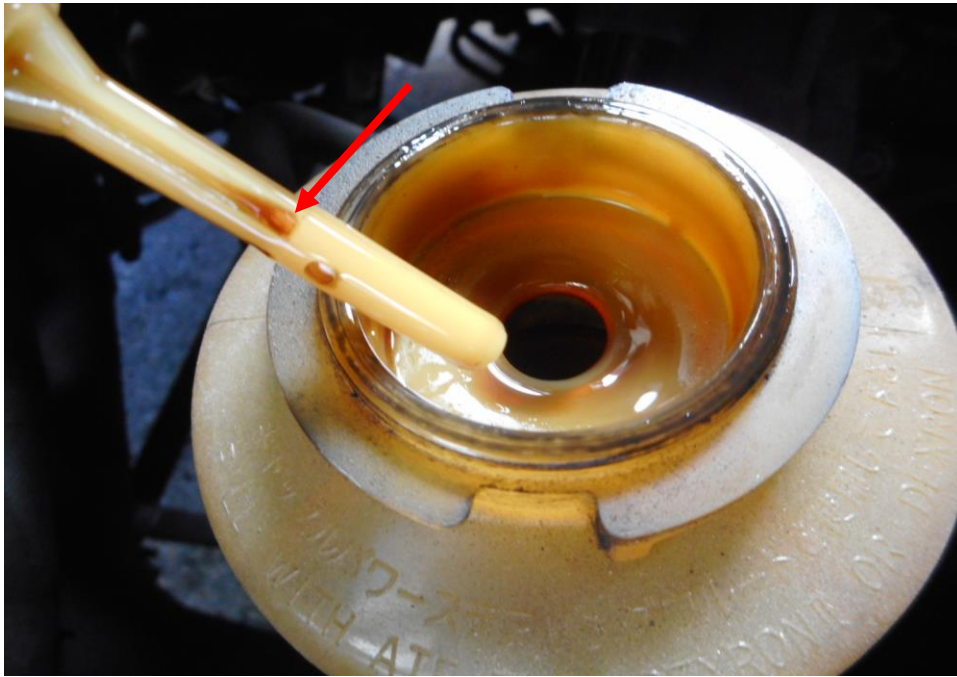
**Photo 15** shows the power steering fluid reservoir of the Motor Van at the time of my inspection. The steering fluid was observed to be of sufficient level (arrowed) and without any visible contamination.

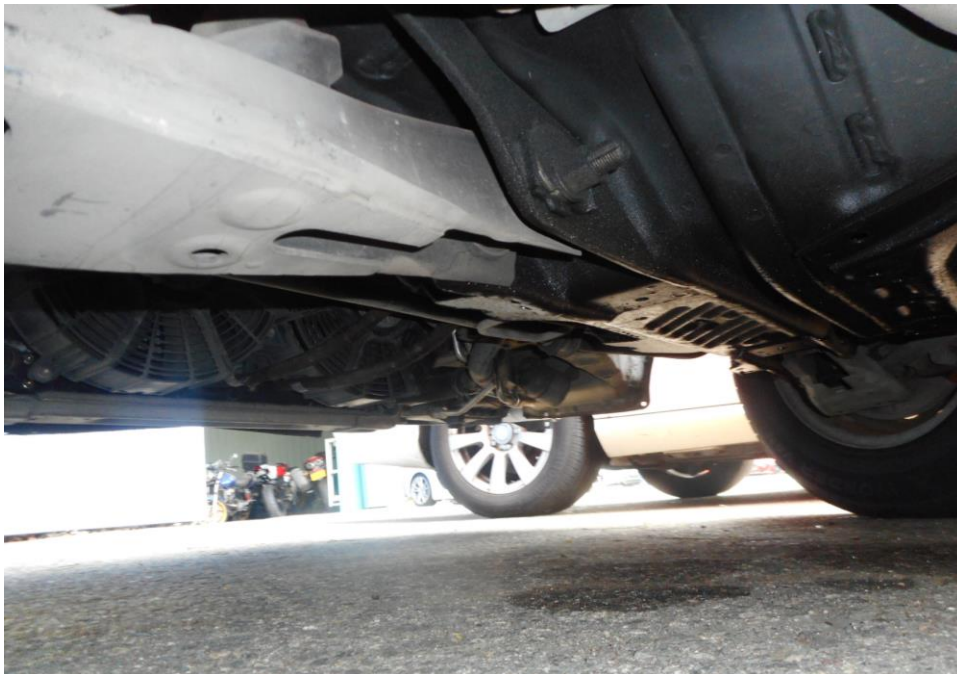
**Photo 16** shows the undercarriage of the Motor Van, at the area where the engine housing and transmission housing are located. . I did not find any sign(s) or indication(s) of fluid leak and/or fluid stain(s) on the underside of the Motor Van.

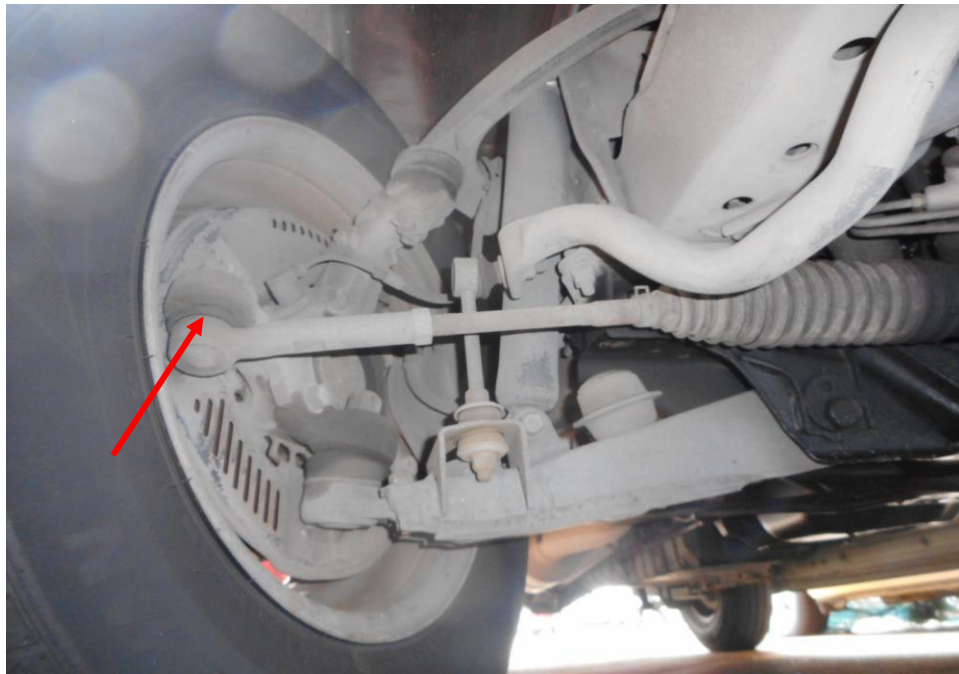
**Photo 17** shows the various undercarriage components at the front right wheel of the Motor Van, in particular the steering tie rod end (arrowed). The various steering components were all found to be intact, suggesting that the steering system of the Motor Van was likely to be in serviceable condition at the material time of accident. There was also no sign of fluid stain(s) observed on the various undercarriage components.

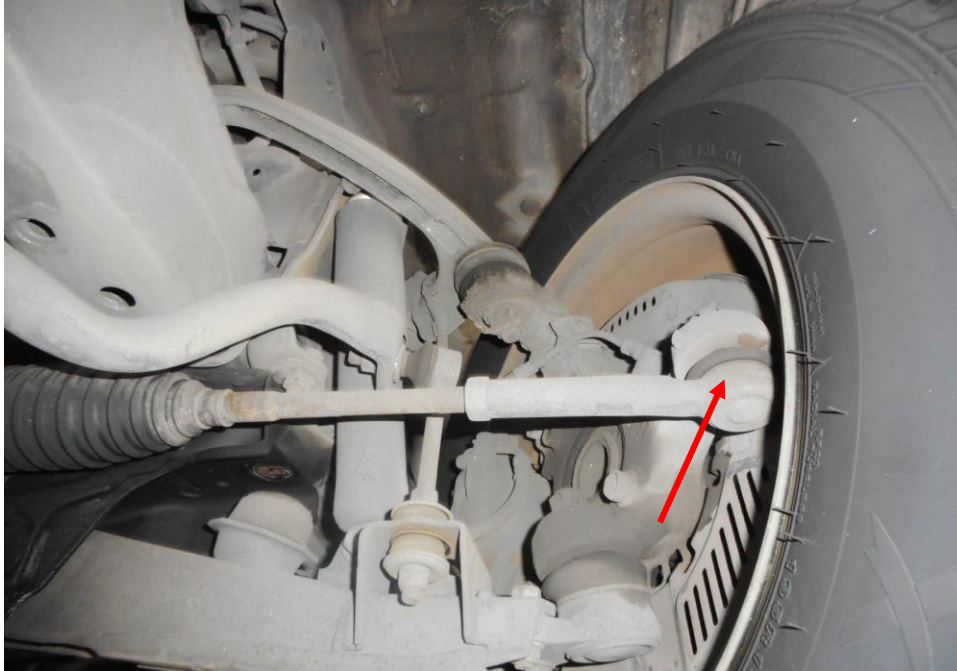
**Photo 18** shows the various undercarriage components at the front left wheel of the Motor Van, in particular the steering tie rod end (arrowed). The various undercarriage components of the Motor Van were all found to be intact without any visible damage. There was also no sign of fluid stain(s) observed on the various undercarriage components.

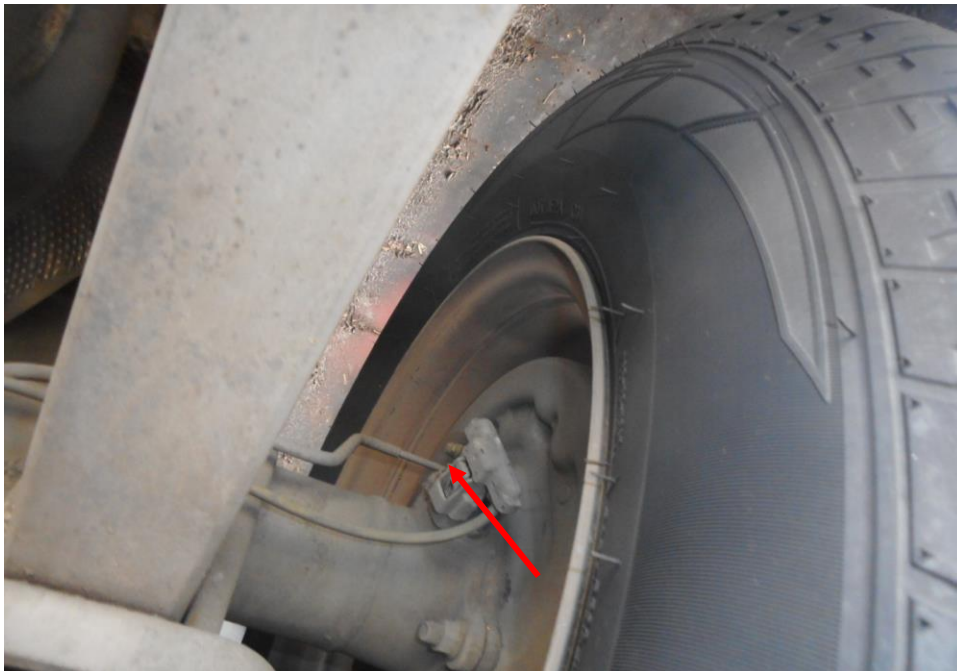
**Photo 19** shows the brake pipe (arrowed) at the rear right wheel of the Motor Van. I did not observe any leakage of brake fluid at the time of my inspection of the Motor Van. My static tests of the Motor Van's braking system, along with my visual examination of the various mechanical components in the braking system, had indicated that there was no internal leakage of pressure/vacuum. Hence the braking system of the Motor Van was likely to be in serviceable condition at the material time of accident.

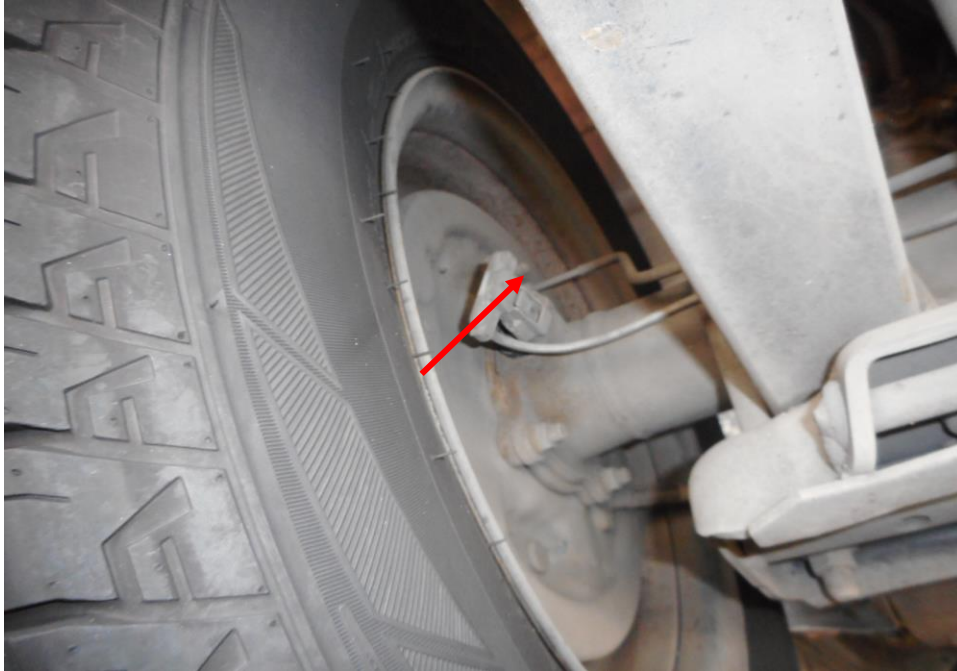
**Photo 20** shows the brake pipe (arrowed) at the rear left wheel of the Motor Van. I did not observe any leakage of brake fluid at the time of my inspection of the Motor Van. My static tests of the Motor Van's braking system, along with my visual examination of the various mechanical components in the braking system had indicated that there was no internal leakage of pressure/vacuum. Hence the braking system of the Motor Van was likely to be in serviceable condition at the material time of accident.

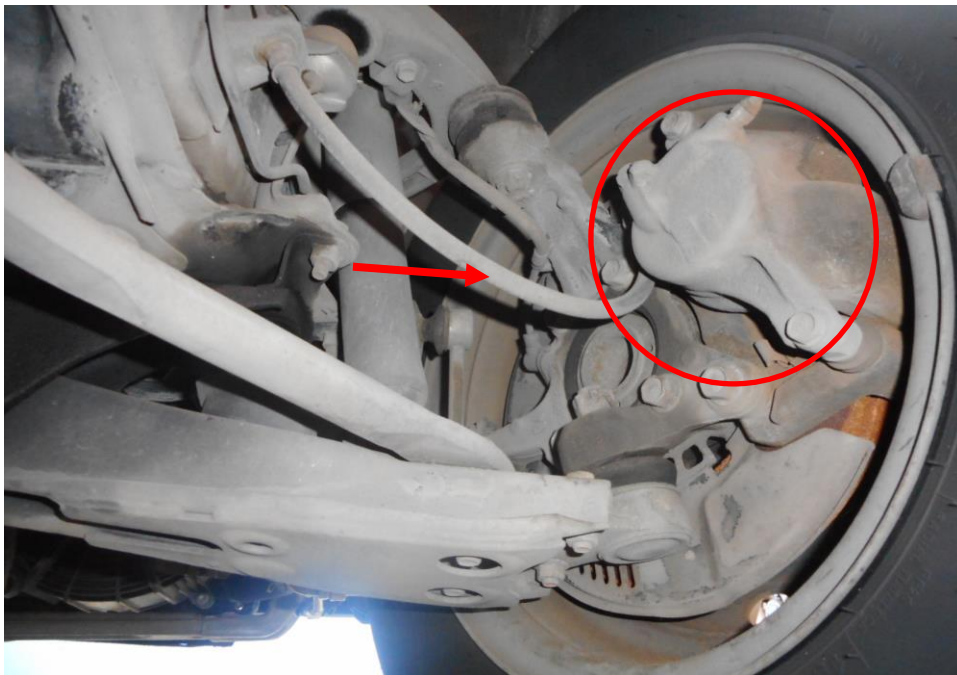
**Photo 21** shows the brake hose/pipe (arrowed) at the front right wheel of the Motor Van. No leakage of brake fluid was observed. Visual examination of the various components of the braking system like the brake caliper (circled), brake booster, brake pedal etc had revealed all to be intact and without visible damage at the time of accident. There was also no sign of fluid stain(s) observed on the various undercarriage components.

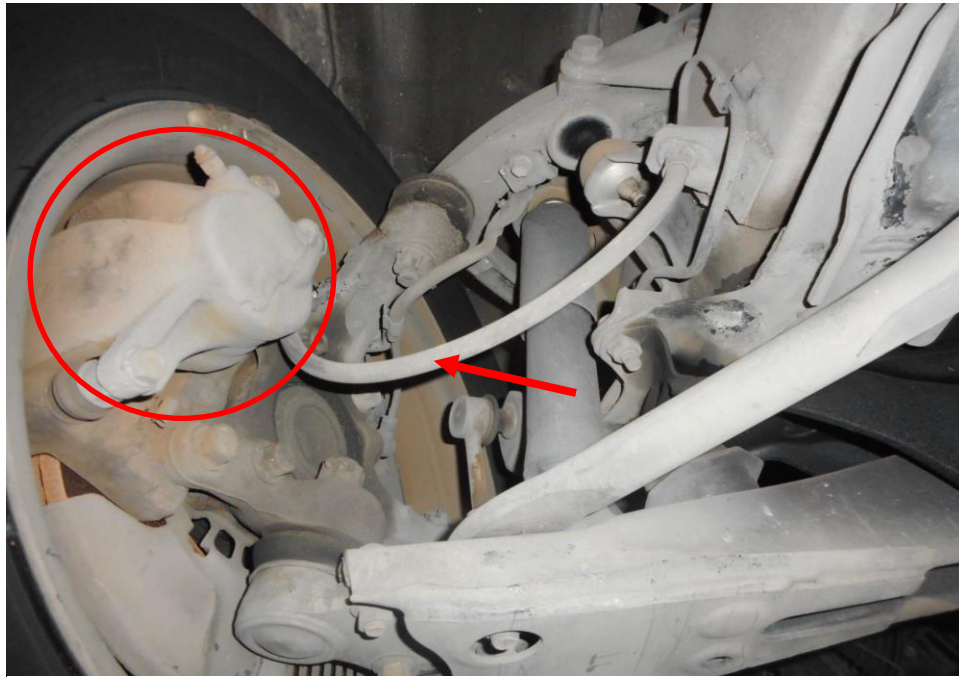
**Photo 22** shows the brake hose/pipe (arrowed) at the front left wheel of the Motor Van. No leakage of brake fluid was observed. Visual examination of the various components of the braking system like the brake caliper (circled), brake booster, brake pedal etc had revealed all to be intact and without visible damage at the time of accident. There was also no sign of fluid stain(s) observed on the various undercarriage components.

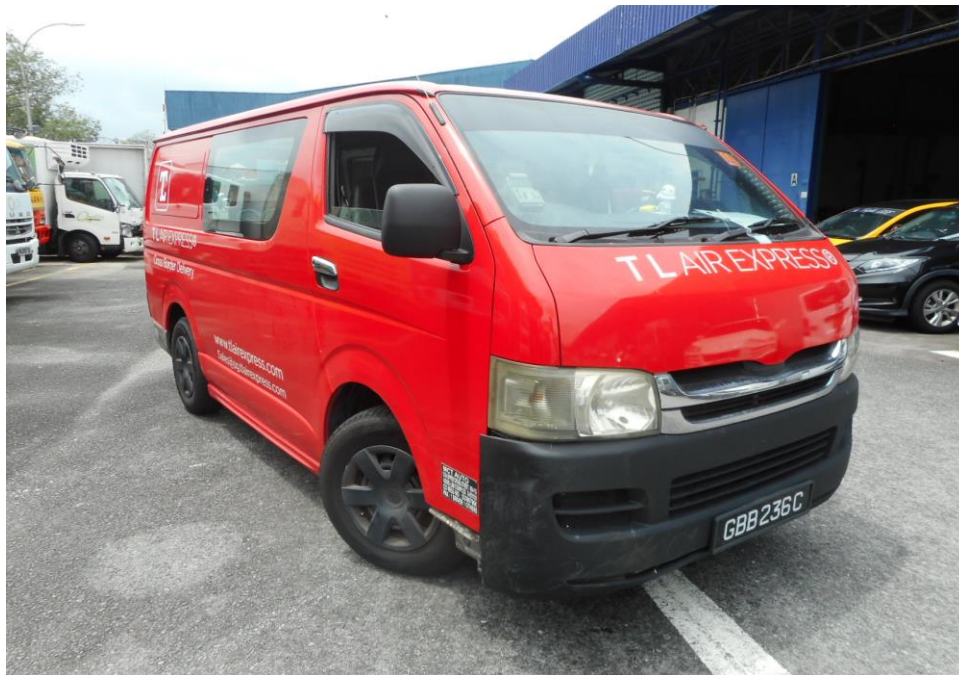
**Photo 23** shows the front right wheel of the Motor Van turned to its full left. During my steering system test, I did not experience any abnormal free play and/or resistance when I had turned the steering wheel towards full left and full right. This would suggest that the steering system of the Motor Van was likely to be in serviceable condition at the material time of accident.

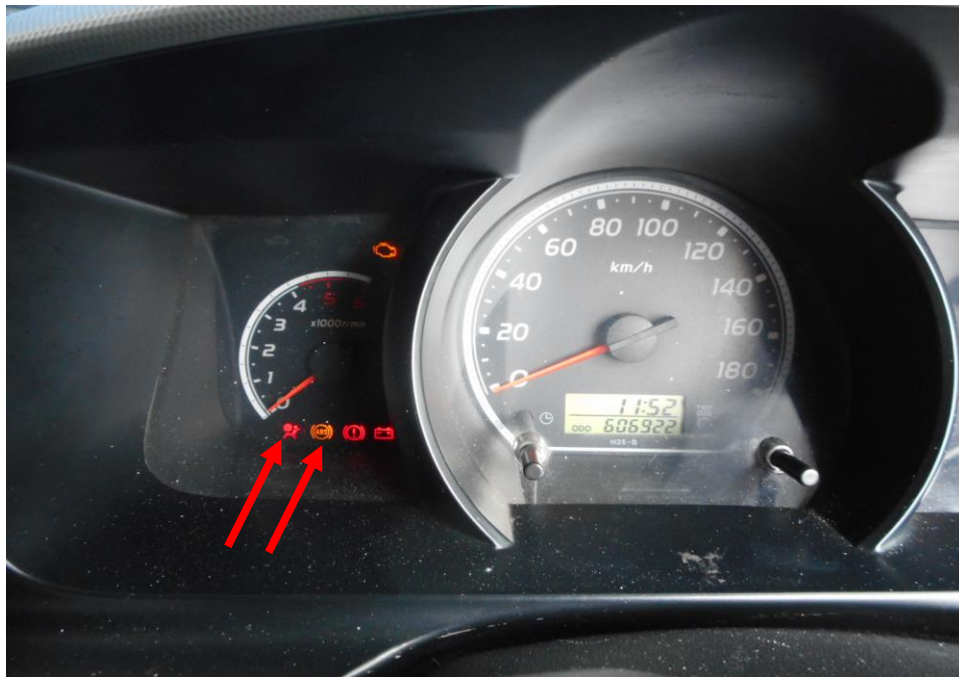
**Photo 24** shows the warning light for Anti-Lock Brake System (ABS) and Supplemental Restraint System (SRS) (arrowed) appearing on the instrument panel of the Motor Van during the self-test of its various electronic operating systems when its engine was cranked.

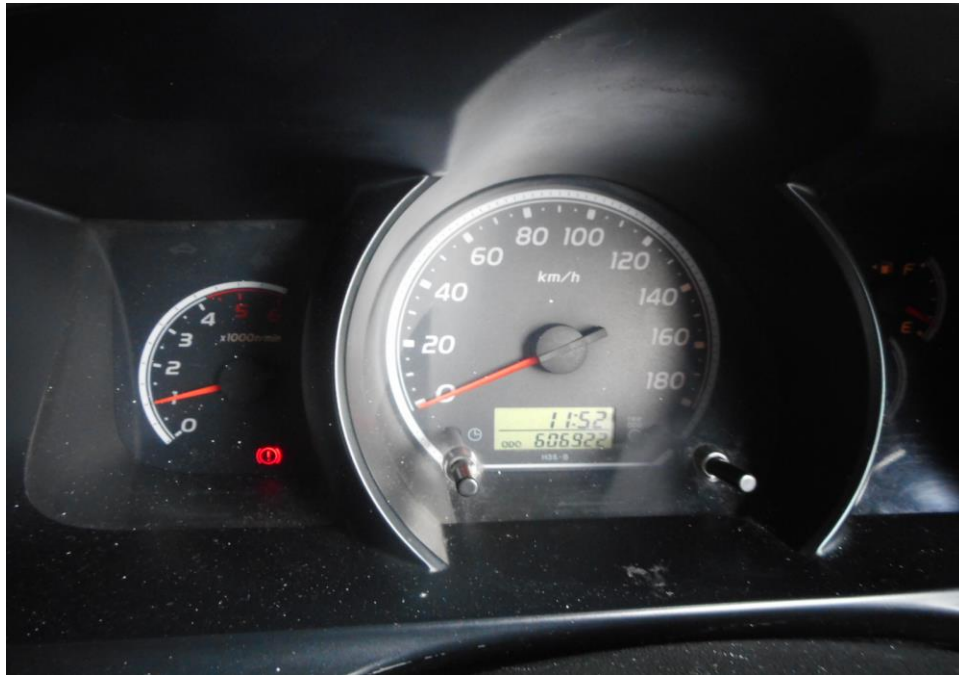
**Photo 25** shows no warning lights illuminated on the instrument panel of the Motor Van after the engine was cranked. This would suggest that there was no abnormality to the electronic operating system of the Motor Van, like the ABS and SRS etc.
