Your Ref: TP/IP/24953/2020
Our Ref : CI/TPD20009192/P

Fatal Accident Investigation Team

MECHANICAL INSPECTION REPORT OF MOTOR CAR SFL 7888A

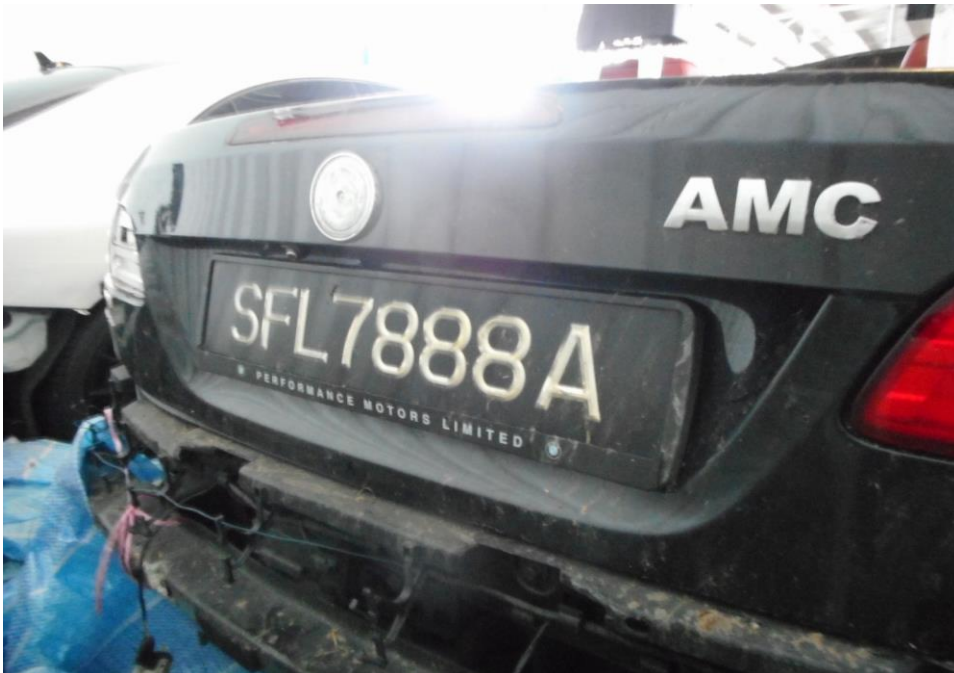
Photo 1 shows the VIN number on the Motor Car's rear body at the time of my inspection.

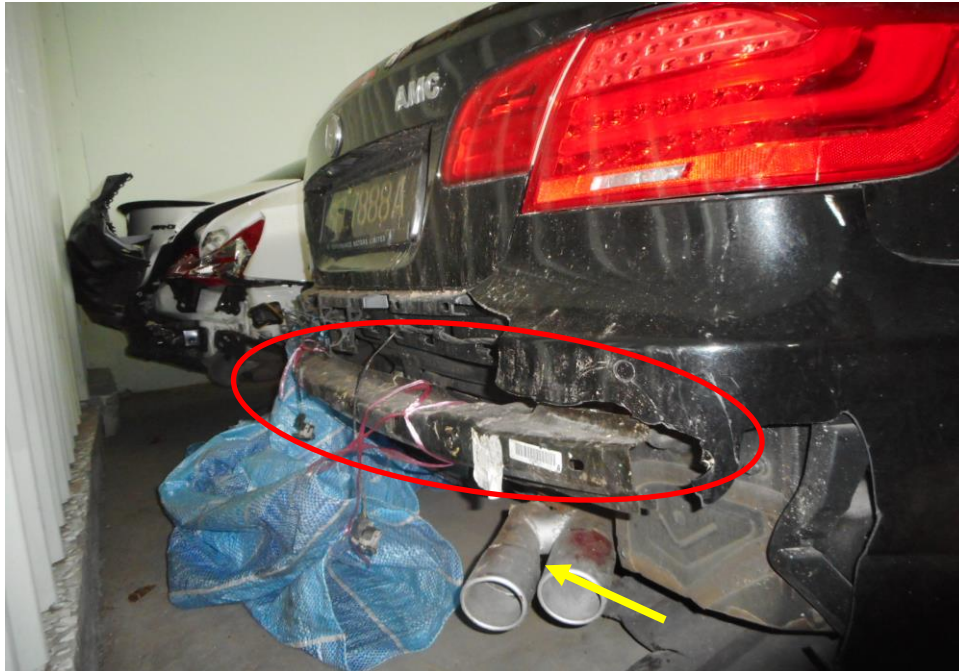
Photo 2 shows the general view of the Motor Car's rear body at the time of my inspection, its rear bumper (red arrow) and exhaust piping (yellow arrow) were amongst the body parts that were damaged as a result of the accident.

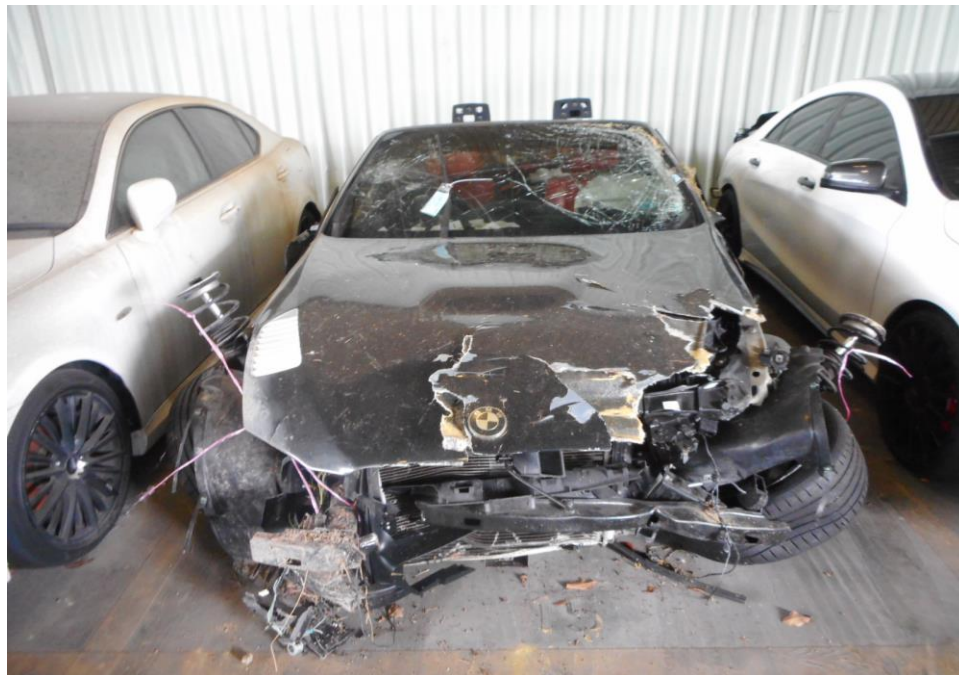
4. The mileage of the Motor Car at the time of my inspection was not recorded due to the damage the Motor Car various engine components had sustained.
5. The Motor Car was observed to have sustained damage all around. Its front windscreen, front bonnet, front bumper, both front headlamps, its left and right body panels and rear bumper were amongst the body parts that were damaged as a result of the accident. The Supplemental Restraint System (SRS) was activated as a result of the accident.

Photo 3 shows a general view of the Motor Car's front body at the time of my inspection. The Motor Car was observed to have sustained damage all around. Its front windscreen, front bonnet, front bumper, both front headlamps, its left and right body panels and rear bumper were amongst the body parts that were damaged as a result of the accident. The Supplemental Restraint System (SRS) was activated as a result of the accident.

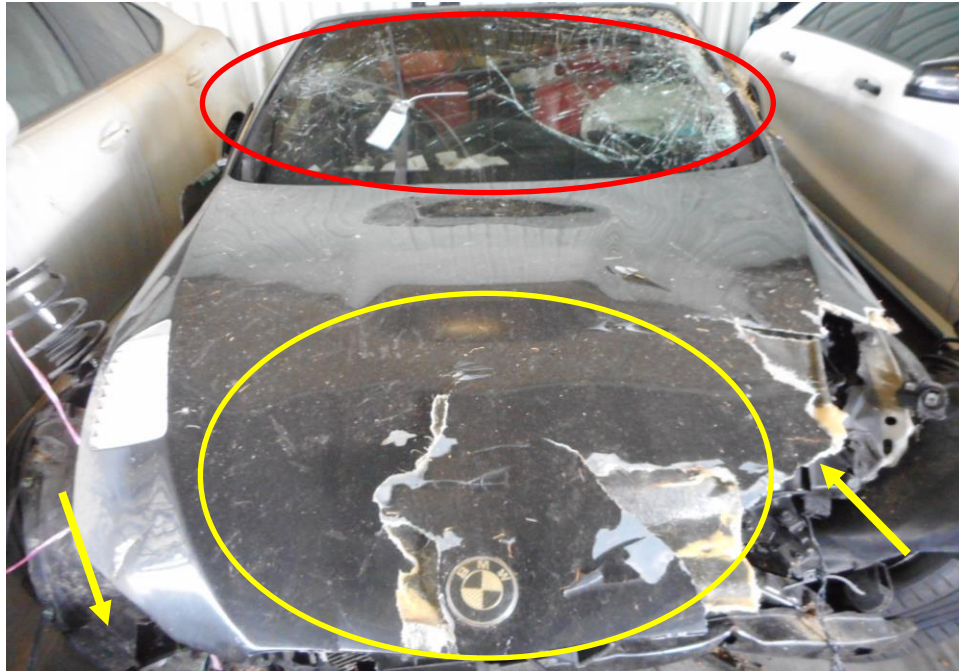
Photo 4 shows a close up view of the Motor Car's front body at the time of my inspection. Its front windscreen (red circle), front bonnet (yellow circle) and both front headlamps (yellow arrow) were amongst the body parts that were damaged as a result of the accident.

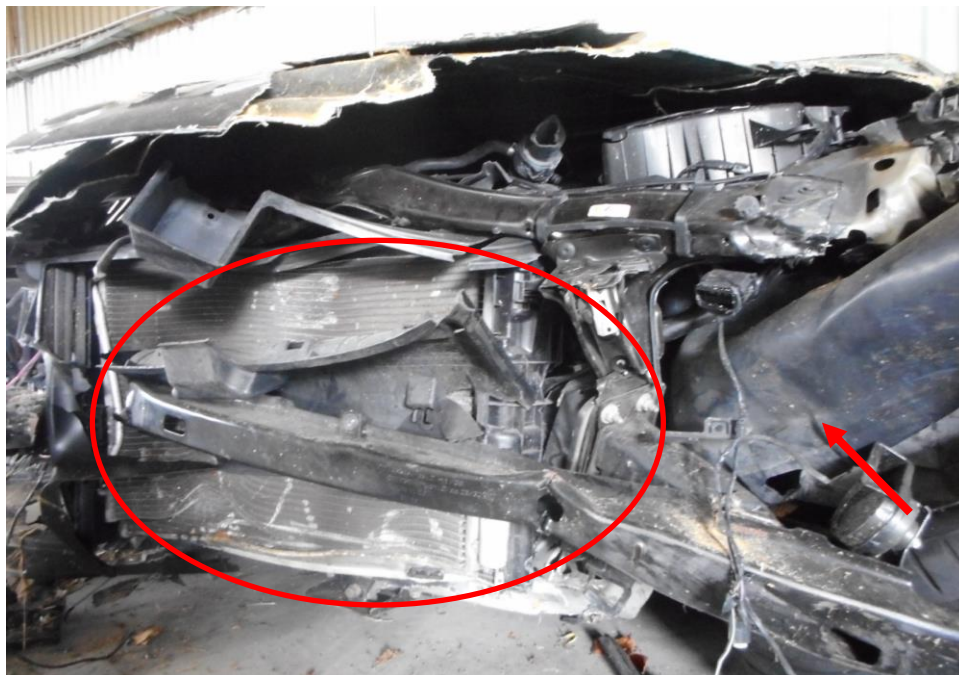
Photo 5 shows a close up view of the Motor Car's front body at the time of my inspection. Its front bumper (arrowed), radiator (circled) and various engine components were amongst the body parts that were damaged as a result of the accident.

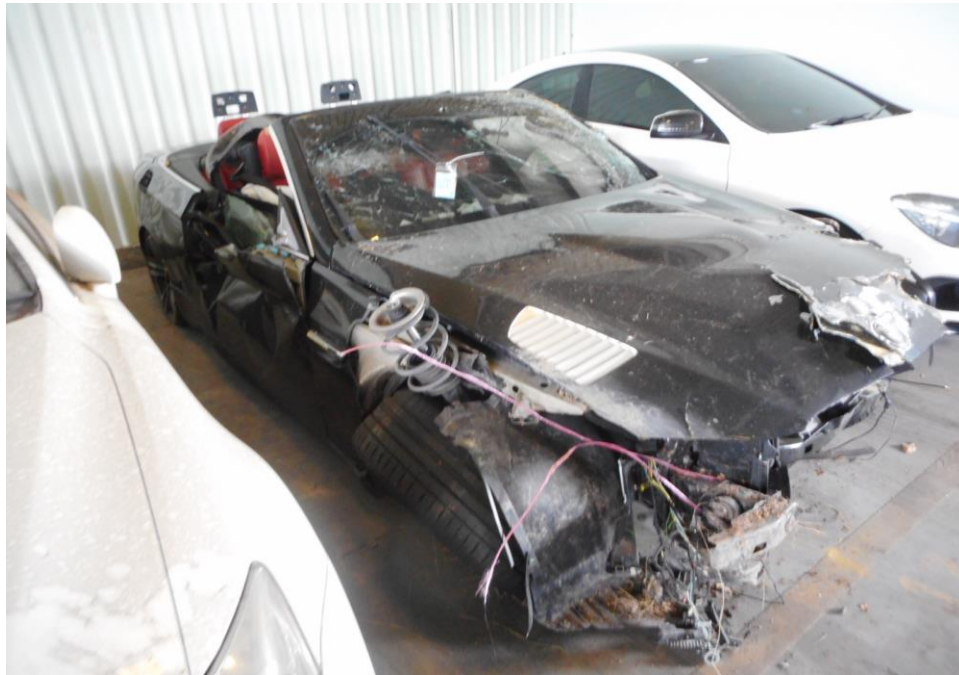
Photo 6 shows the general view of the Motor Car's right body at the time of my inspection. The Motor Car was observed to have sustained damage on its right body panels were amongst the body parts that were damaged as a result of the accident.

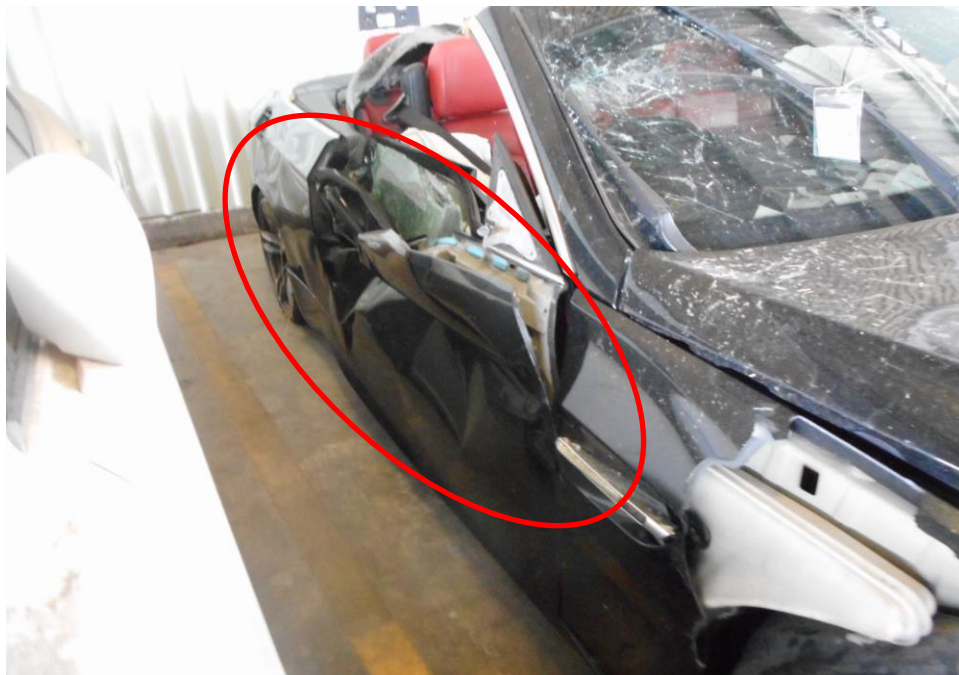
Photo 7 shows the close view of the Motor Car's right body at the time of my inspection. The Motor Car was observed to have sustained damage on its right body panels (circled) were amongst the body parts that were damaged as a result of the accident.

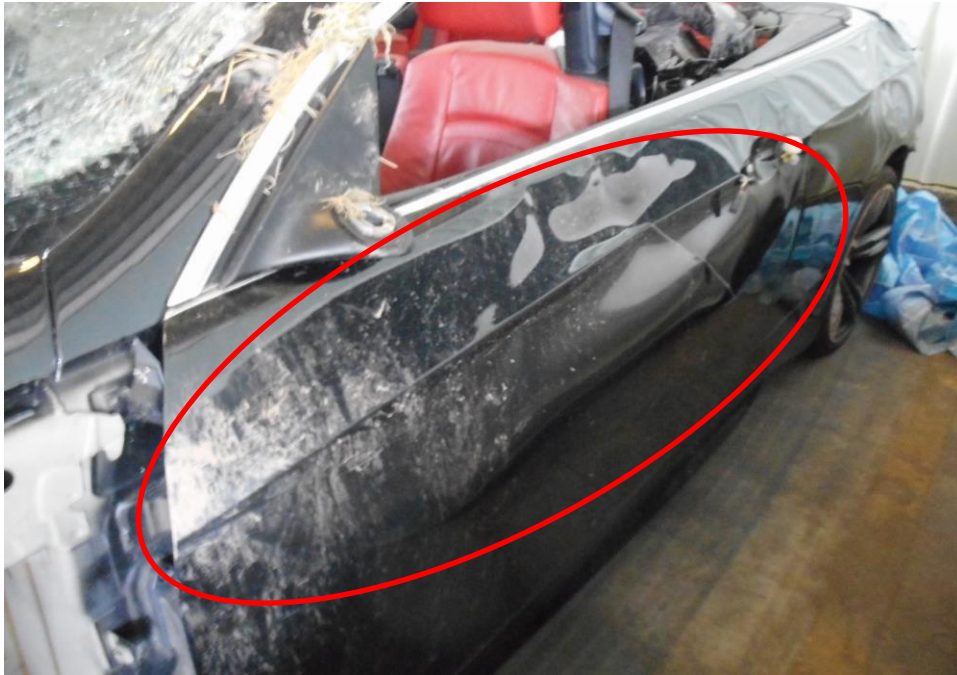
Photo 8 shows the general view of the Motor Car's left body at the time of my inspection. The Motor Car was observed to have sustained damage on its right body panels were amongst the body parts that were damaged as a result of the accident.

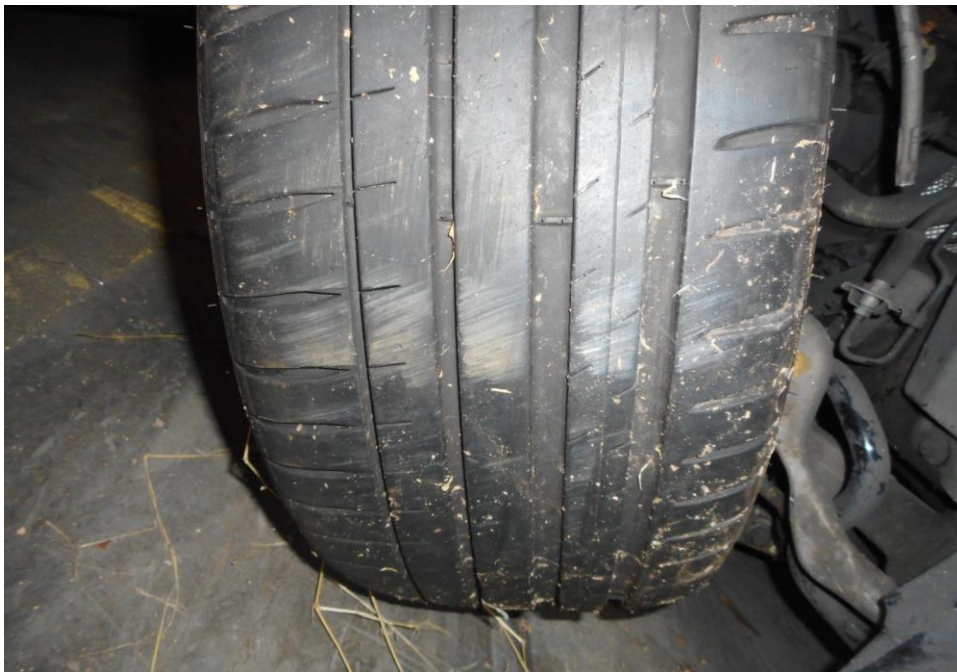
Photo 9 shows the condition of the front right tyre of the Motor Car, which was observed to be in serviceable condition with remaining tread depth of approximately 5.5mm. The tyre was sufficiently inflated for vehicular operation with no tear, cut or burst mark(s) on the outer and the inner sidewalls as well as across the tread. The 4 tyres of the Motor Car were wrapped around standard steel wheel rims without any damage.

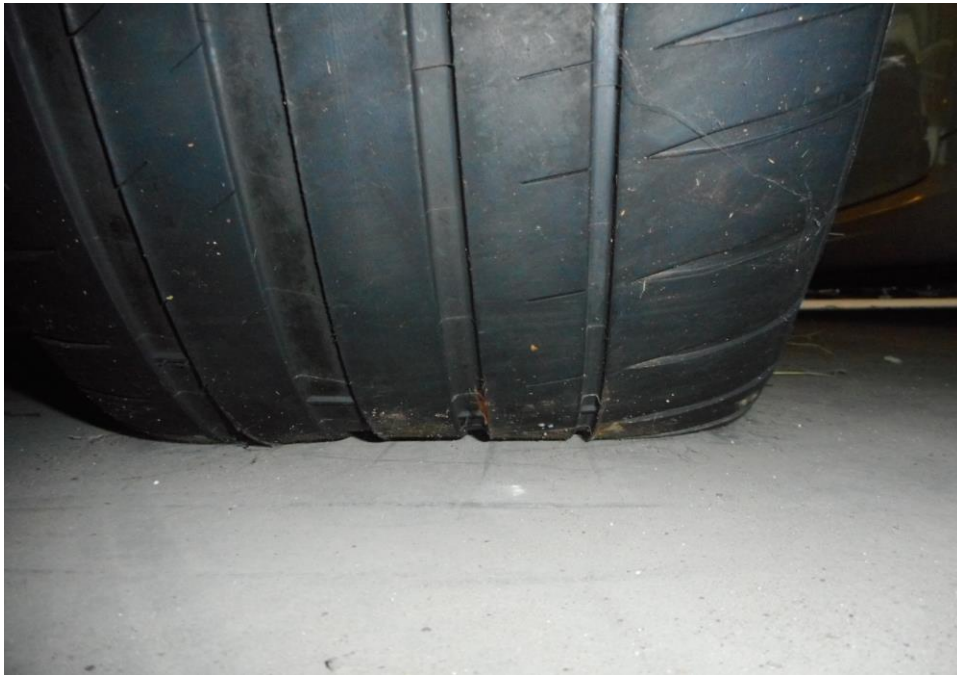
Photo 10 shows the condition of the rear right tyre of the Motor Car, which was observed to be in serviceable condition with remaining tread depth of approximately 3.4mm. The tyre was also observed to be sufficiently inflated for vehicular operation with no tear, cut or burst mark(s).

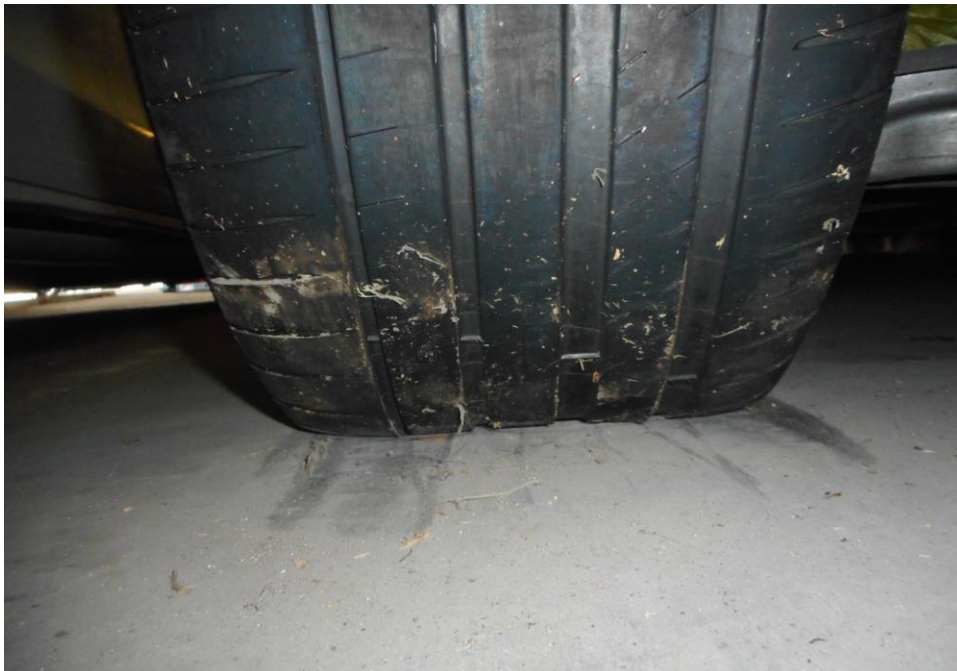
Photo 11 shows the condition of the rear left tyre of the Motor Car, which was observed to be in serviceable condition with remaining tread depth of approximately 3mm. The tyre, which was wrapped around steel wheel rim, was also observed to be sufficiently inflated for vehicular operation. The 4 tyres of the Motor Car were wrapped around standard steel wheel rims.

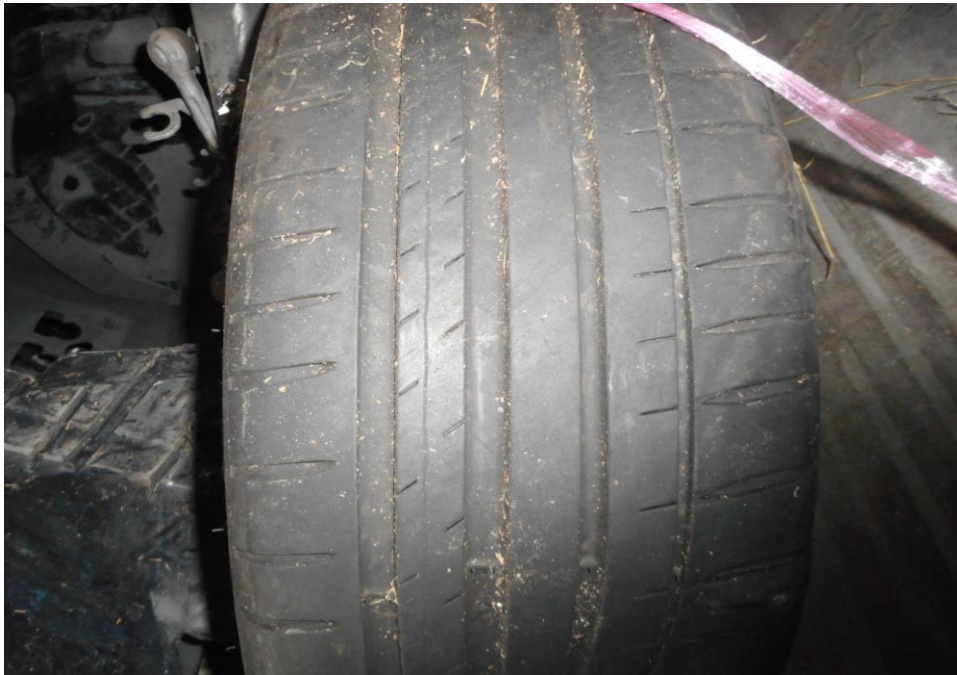
Photo 12 shows the condition of the front left tyre of the Motor Car, which was observed to be in serviceable condition with remaining tread depth of approximately 5.3mm. The tyre, which was wrapped around steel wheel rim, was also observed to be sufficiently inflated for vehicular operation. The 4 tyres of the Motor Car were wrapped around standard steel wheel rims.

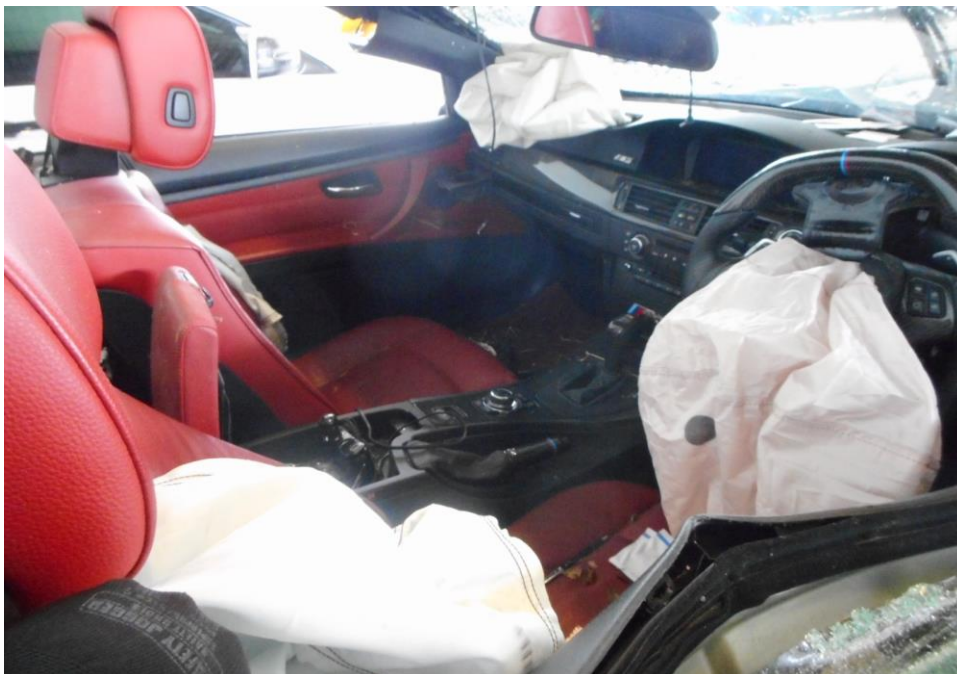
Photo 13 shows the deployment of the Supplemental Restraint System (SRS) airbag in the Motor Car as a result of the accident.

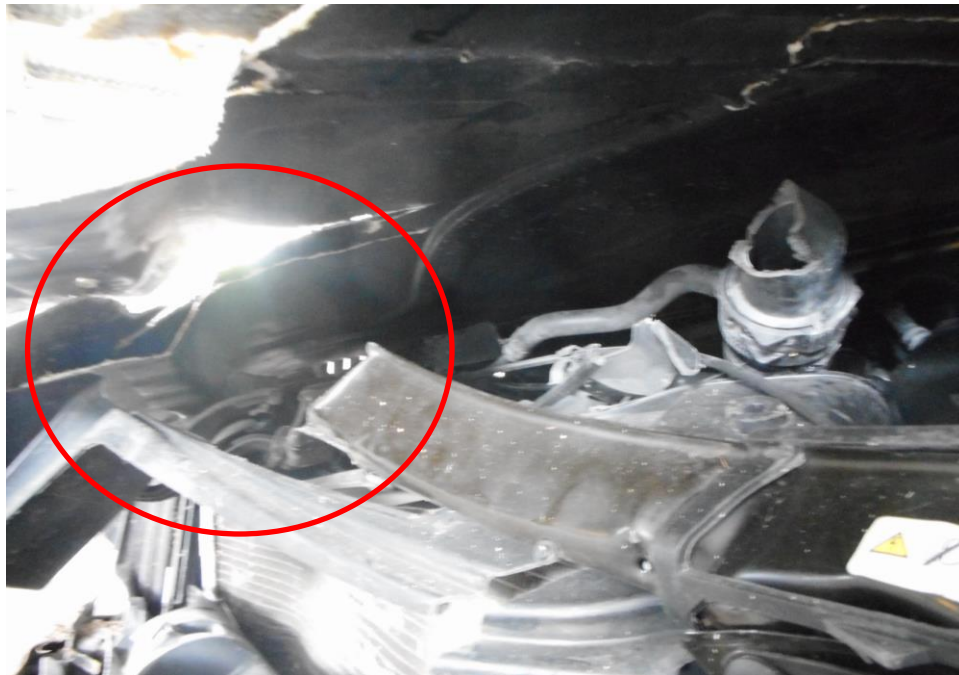
8. We were unable to raise the front bonnet of the Motor car to conduct the examination of the Motor Car's engine compartment because the damage caused by the accident had resulted in the damages to the lock mechanism of the bonnet and the structure of the engine compartment. (unable to open)
See photo 14 below

Photo 14 shows a close up view of the damaged front bonnet lock mechanism and the structure of the engine compartment of the Motor Car at the time of my inspection resulting it unable to open a result of the accident. (circled) (Unable to open)

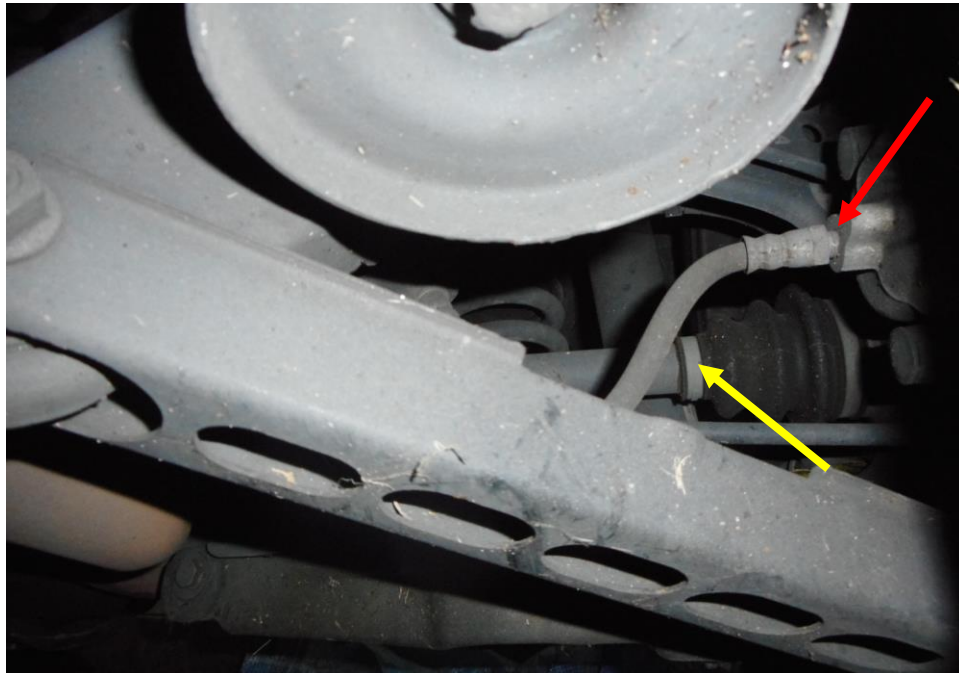
Photo 15 shows the brake hose/pipe (red arrow) and drive shaft (yellow arrow) at the rear right wheel of the Motor Car. No leakage of brake fluid was observed. Visual examination of the various components revealed to be intact and without visible damage.

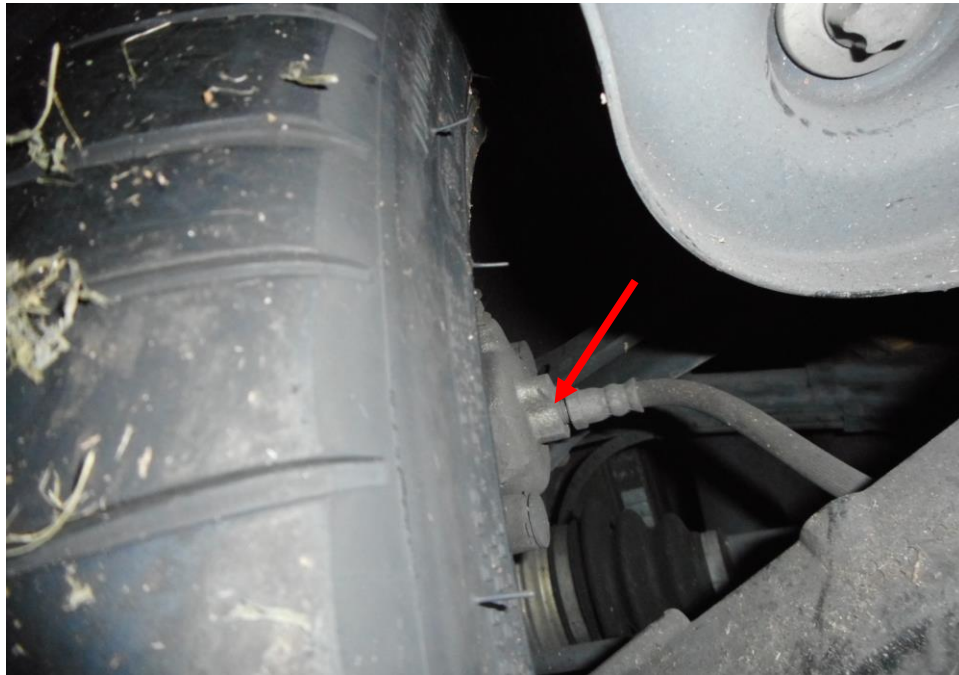
Photo 16 shows the brake hose/pipe (arrowed) at the rear left wheel of the Motor Car. I did not observe any leakage of brake fluid at the time of my inspection of the Motor Car and found to be intact and without any visible damage.

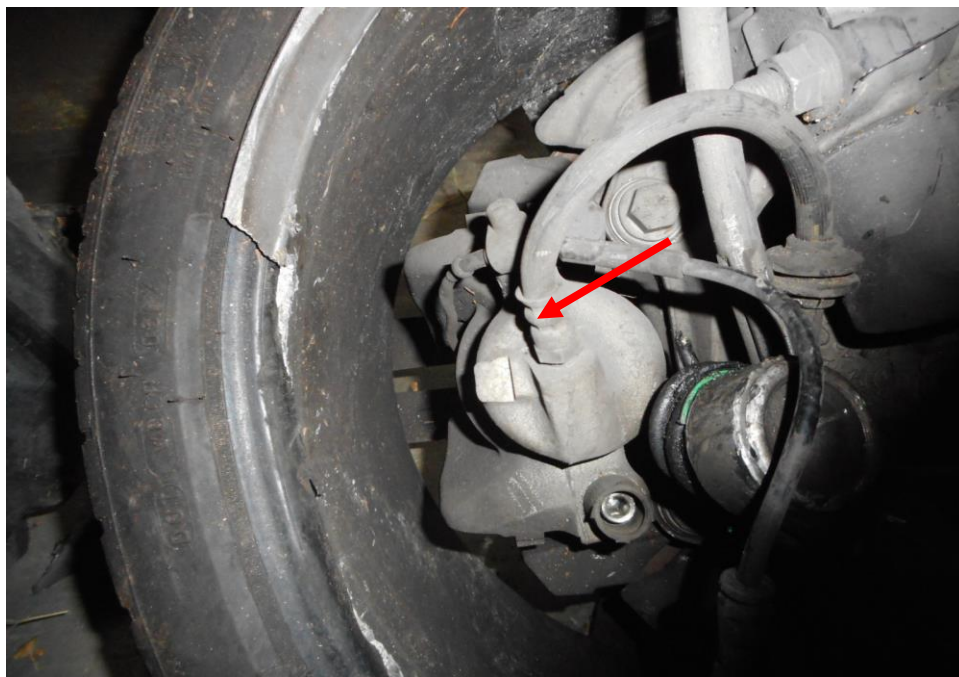
Photo 17 shows the brake hose/pipe (arrowed) at the front right wheel of the Motor Car. I did not observe any leakage of brake fluid at the time of my inspection of the Motor Car and found to be intact and without any visible damage.

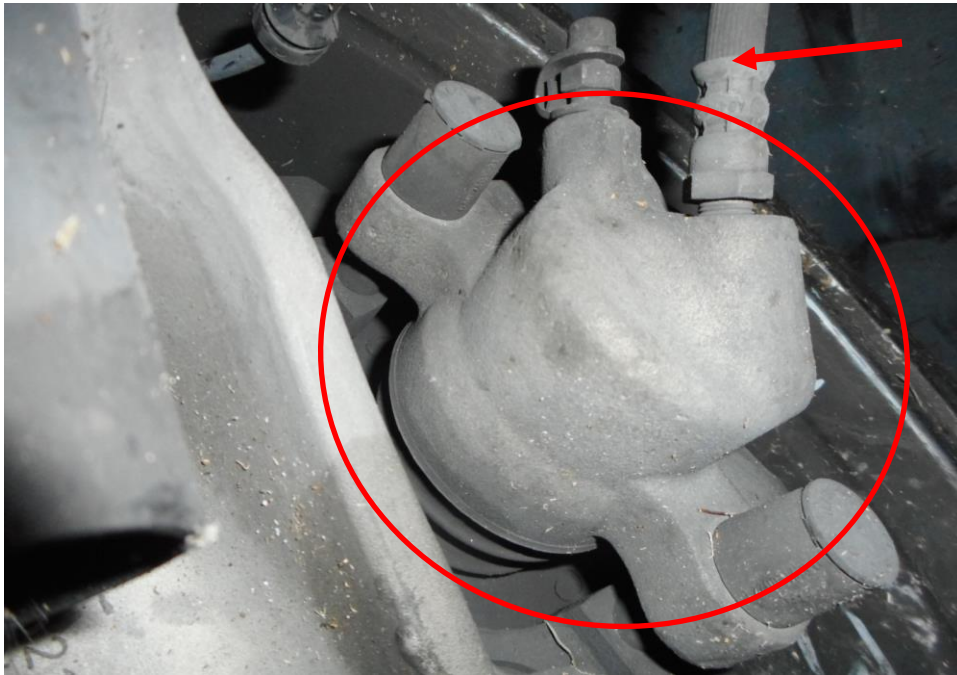
Photo 18 shows the brake hose/pipe (arrowed) at the front left wheel of the Motor Car. No leakage of brake fluid was observed. Visual examination of the various components of the braking system like the brake caliper (circled), had revealed to be intact and without visible damage.

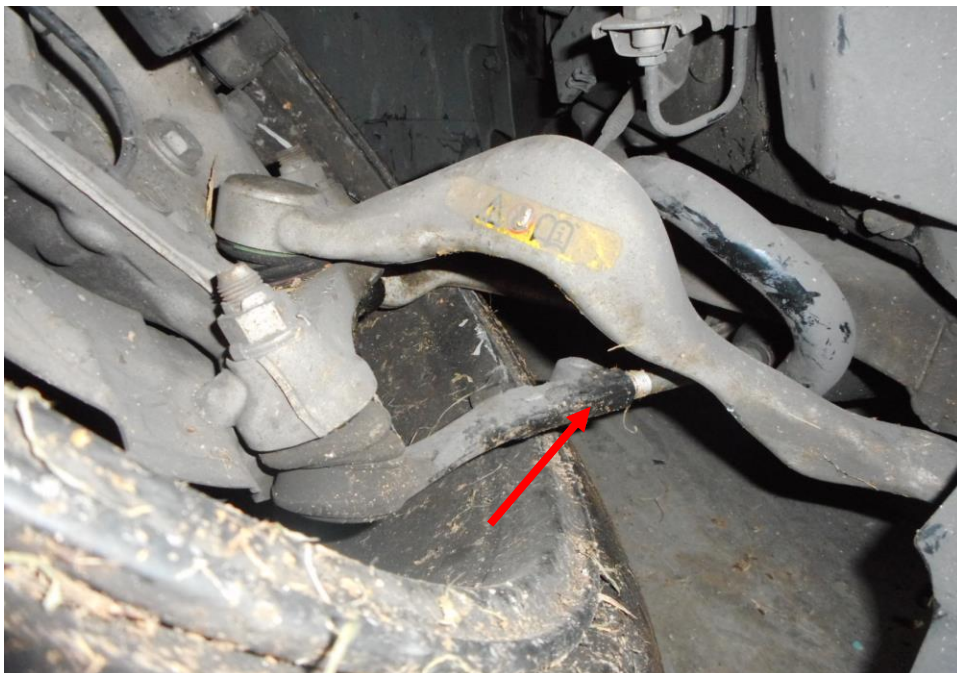
10. My visual examination of the various steering and braking components which had included the rack and pinion, tie rods, tie rod ends and ball joints, brake hoses and brake pipes had revealed that these components were all generally intact. However, the front right tie rod was observed to be damaged as a result of the accident. See photo 15 - 20 below.

Photo 19 shows the various undercarriage components at the front right wheel of the Motor Car, in particular the steering tie rod (red arrow) and various steering components were all found to be damaged as a result of the accident.

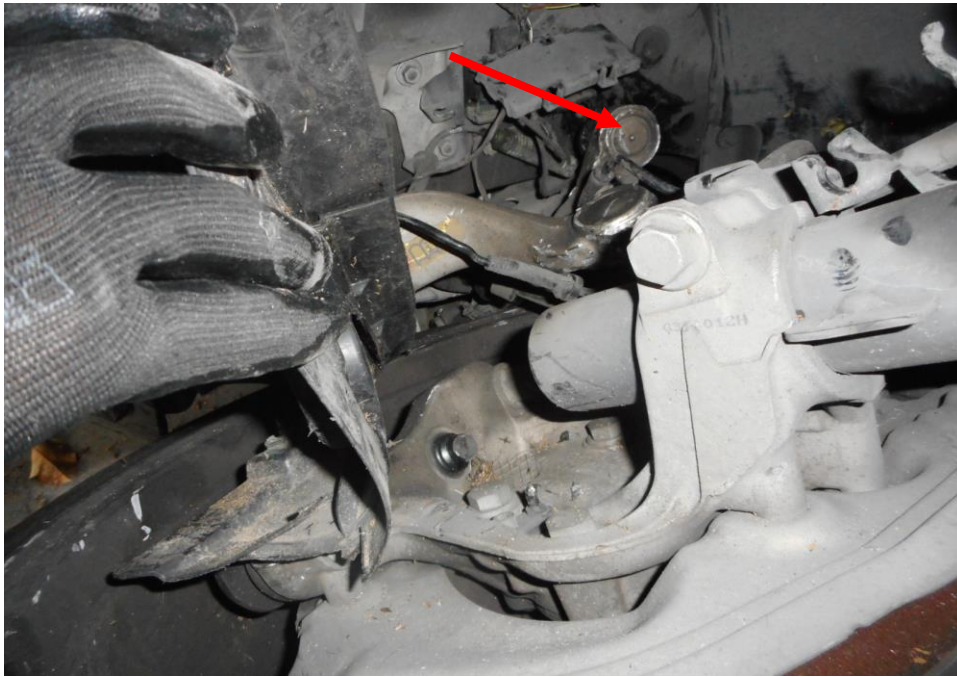
Photo 20 shows the various undercarriage components at the front left wheel of the Motor Car, in particular the steering tie rod (red arrow) and various steering components were all found to be damaged as a result of the accident.

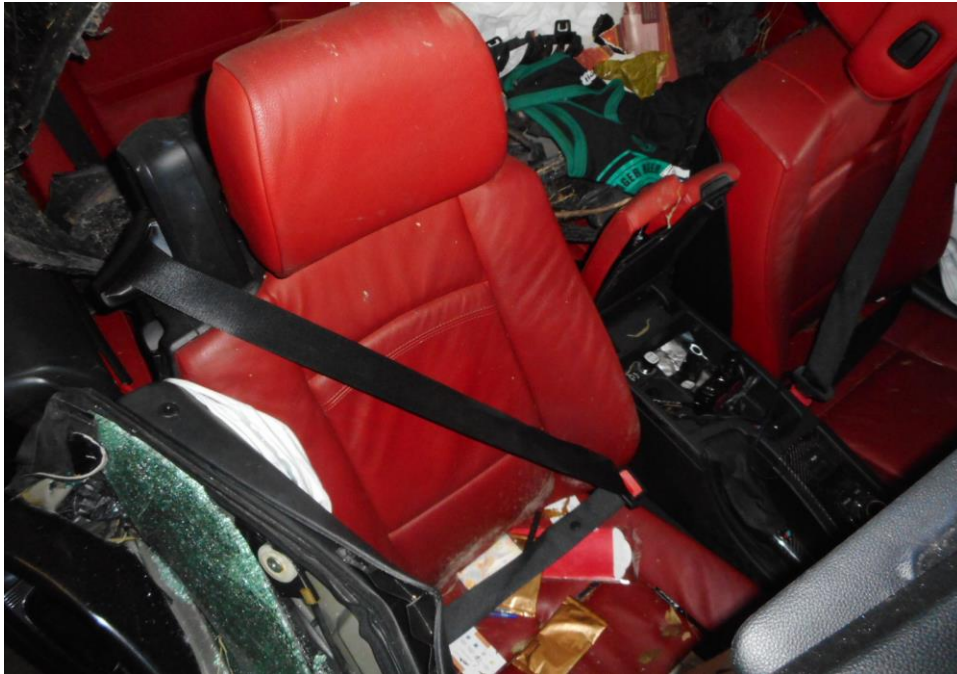
12. For this particular case, we understand that the driver was thrown out of the vehicle in the accident. In our understanding, the likely reasons for the driver to be thrown out is due to a faulty seat belt or the seat belt was not worn at the material time. During our inspection, checks were conducted to the front right and left seat belts of the "Motor Car" were tested and were able to be fastened securely into the respective pre-tensioners that were fitted at the sides of each seat without any issue. So the likely caused to the driver thrown out of the vehicle was likely due to the unworn seat belt by the driver at the material time. See photo 21 & 22 below.

Photo 21 shows that the seat belt on the right seat were able to be fastened securely into the respective pre-tensioners that were fitted at the sides of each seat.

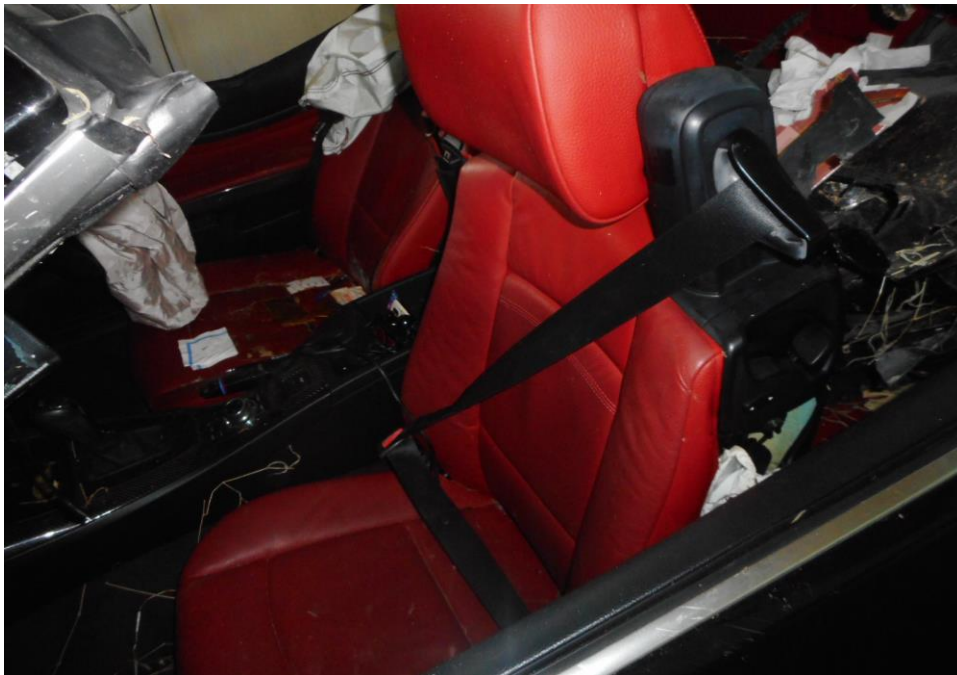
Photo 22 shows that the seat belt on the left seat were able to be fastened securely into the respective pre-tensioners that were fitted at the sides of each seat.
